**The Road Inventory
of
Andrew Johnson National Historic Site
ANJO - 5450**

Road Inventory Program

Prepared By:
Federal Highway Administration
Eastern Federal Lands Highway Division
Cycle 3

Andrew Johnson National Historic Site in Tennessee

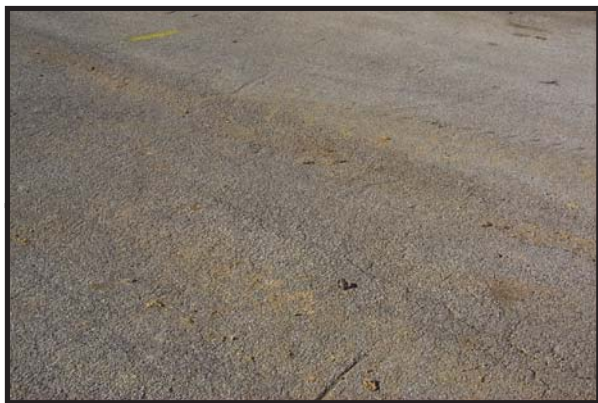
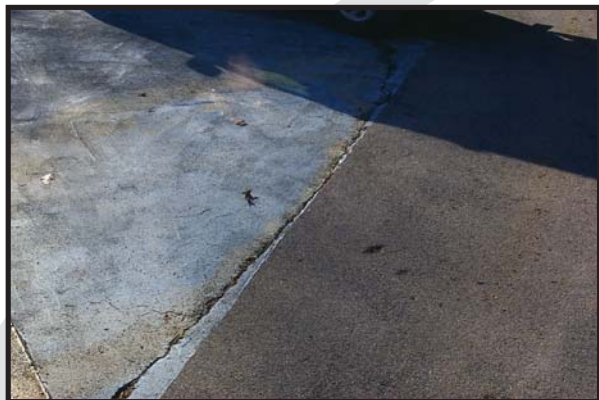
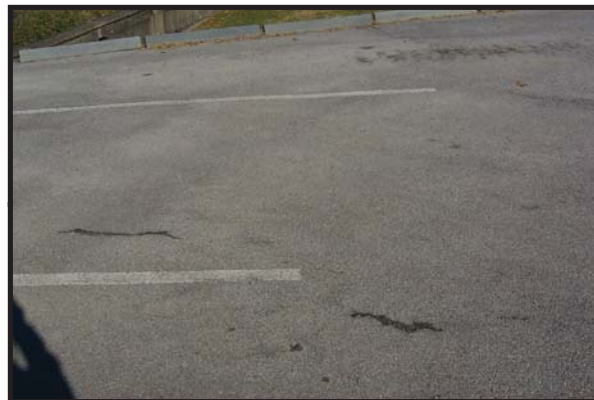
Route 0900

Route	Public / NonPublic	Date Visited	Area (sq ft)	Lane Miles *	Surface Type	Condition / PCR
0900	NonPublic	12/7/2002	4560	0.08	AS	FAIR / 73

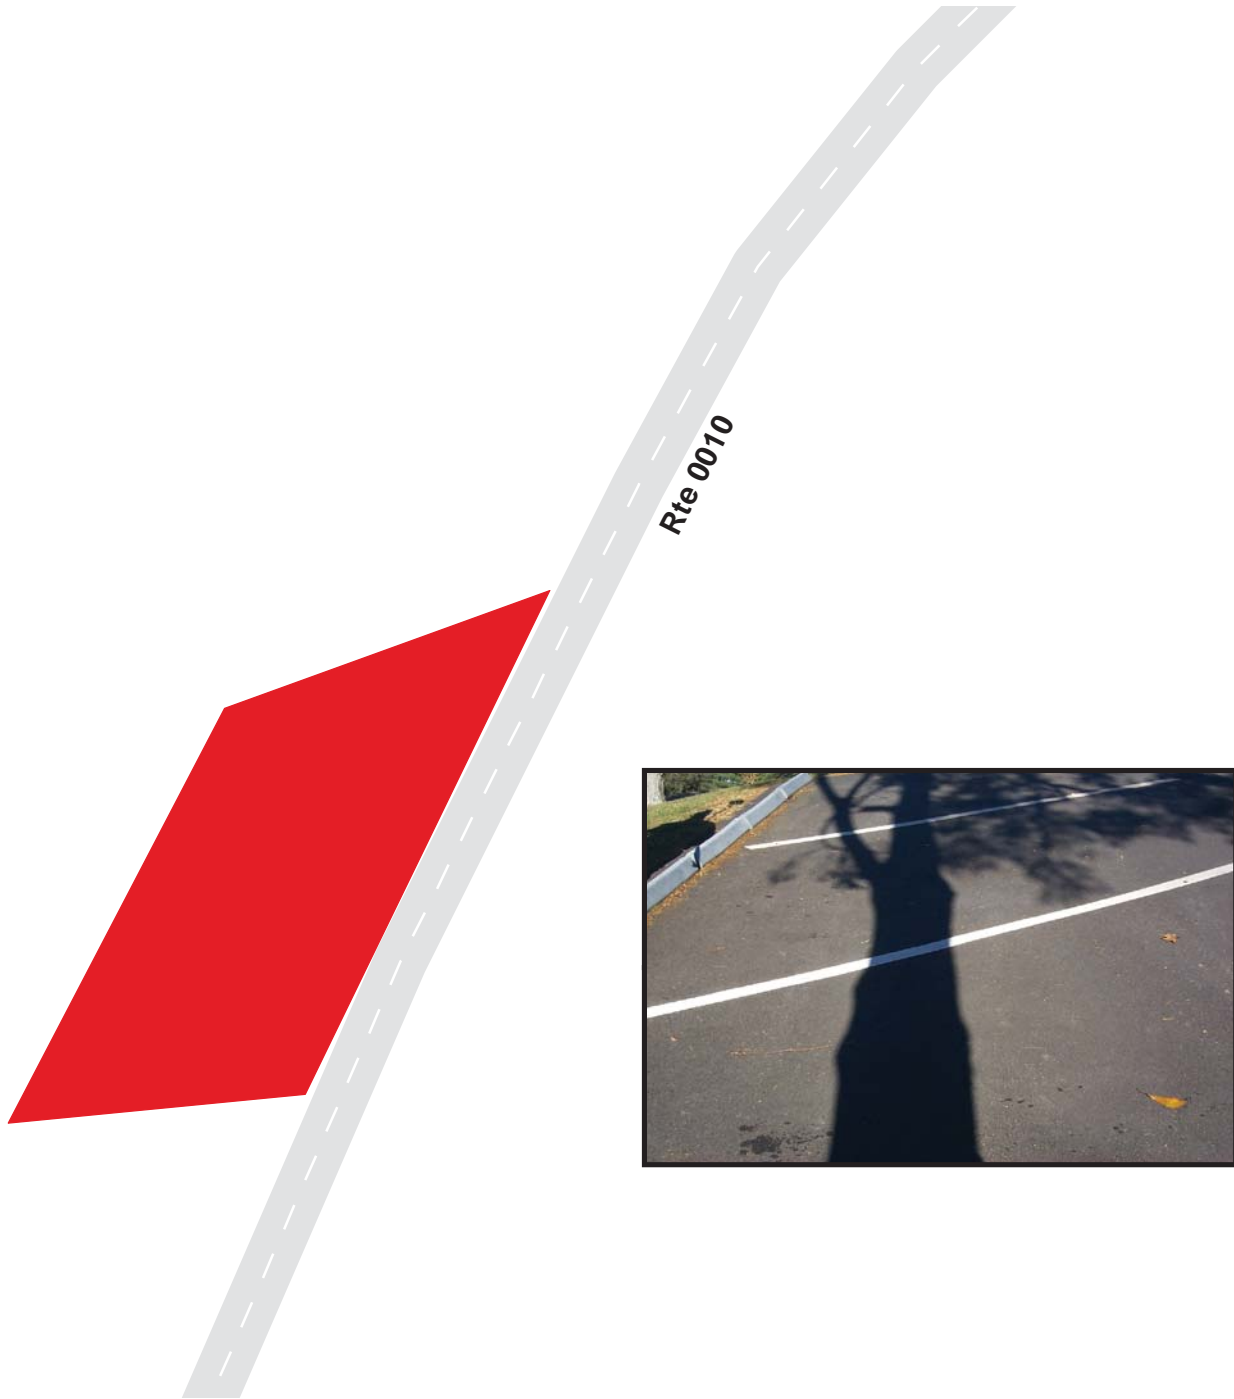
Route 0901

Route	Public / NonPublic	Date Visited	Area (sq ft)	Lane Miles *	Surface Type	Condition / PCR
0901	Public	12/7/2002	501	0.01	AS	GOOD / 90

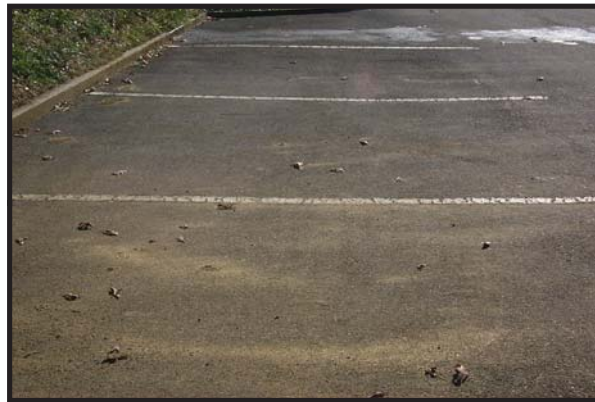
Route 0902

Route	Public / NonPublic	Date Visited	Area (sq ft)	Lane Miles *	Surface Type	Condition / PCR
0902	Public	12/7/2002	2807	0.05	AS	GOOD / 90

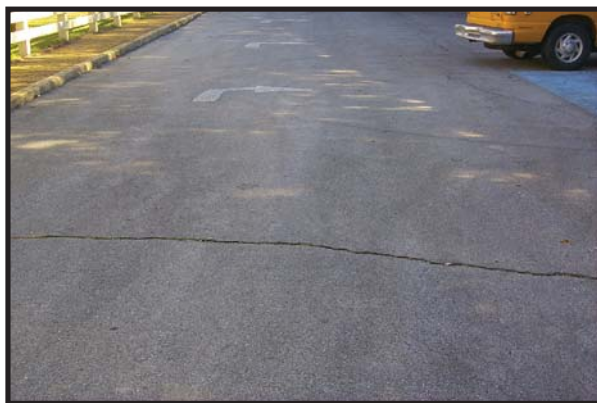
Route 0903

Route	Public / NonPublic	Date Visited	Area (sq ft)	Lane Miles *	Surface Type	Condition / PCR
0903	Public	12/7/2002	3958	0.07	AS	FAIR / 73

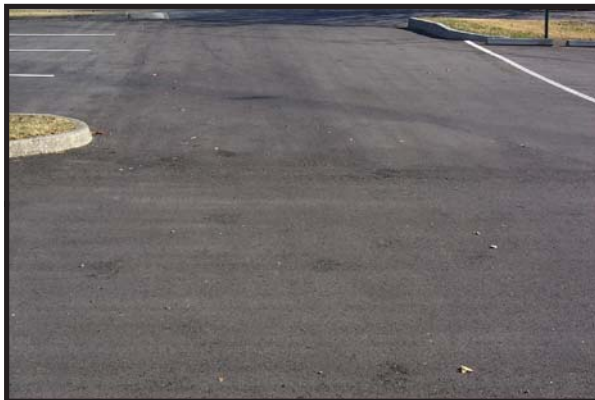
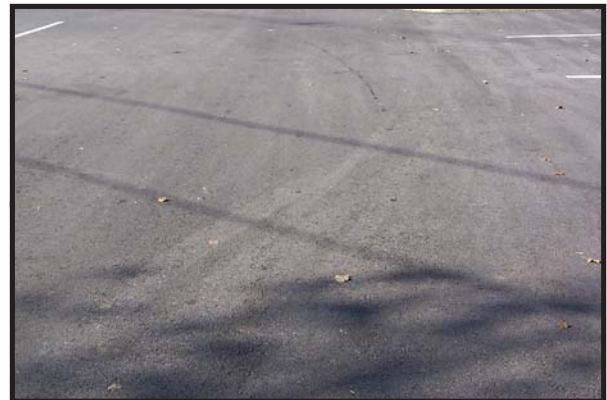
Route 0904

Route	Public / NonPublic	Date Visited	Area (sq ft)	Lane Miles *	Surface Type	Condition / PCR
0904	Public	12/7/2002	5752	0.10	AS	GOOD / 90
