The Road Inventory of Antietam National Battlefield ANTI - 3120

Road Inventory Program

Prepared By:
Federal Highway Administration
Eastern Federal Lands Highway Division
Cycle 3

Antietam National Battlefield in Maryland

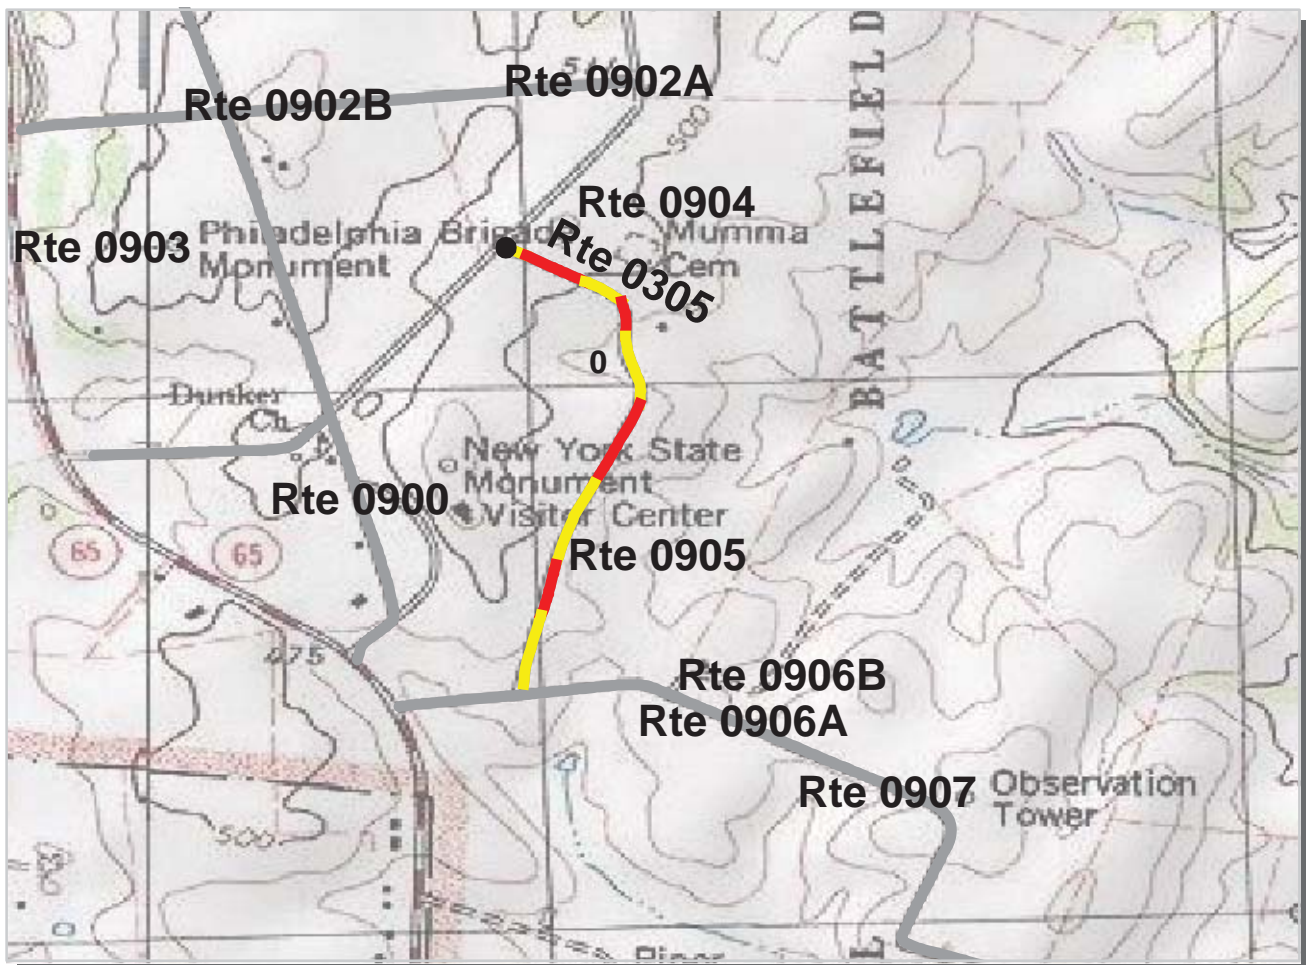
ROUTE: 0305 Mumma Lane **TOTAL LENGTH: 0.60 Miles**

Section Number	0				
Section Length (mi)	0.60				
AADT	**				
SADT	**				
ADT Date	**				
Cross Section Information					
Number of Lanes	1				
Paved Width (ft)	14				
Lane Width (ft)	14				
Shoulder Width (ft)	0				
Roadway Condition Information					
PCR (Pavement Condition Rating)	62				
RCI (Roughness Condition Index)	70				
SCR (Surface Condition Rating)	59				
Alligator Cracking Index	99				
Rutting Index	64				
Patching Index	99				
Transverse Cracking Index	96				
Longitudinal Cracking Index	98				
Shoulder Condition Rating	N/A				
Drainage Condition Rating	GOOD

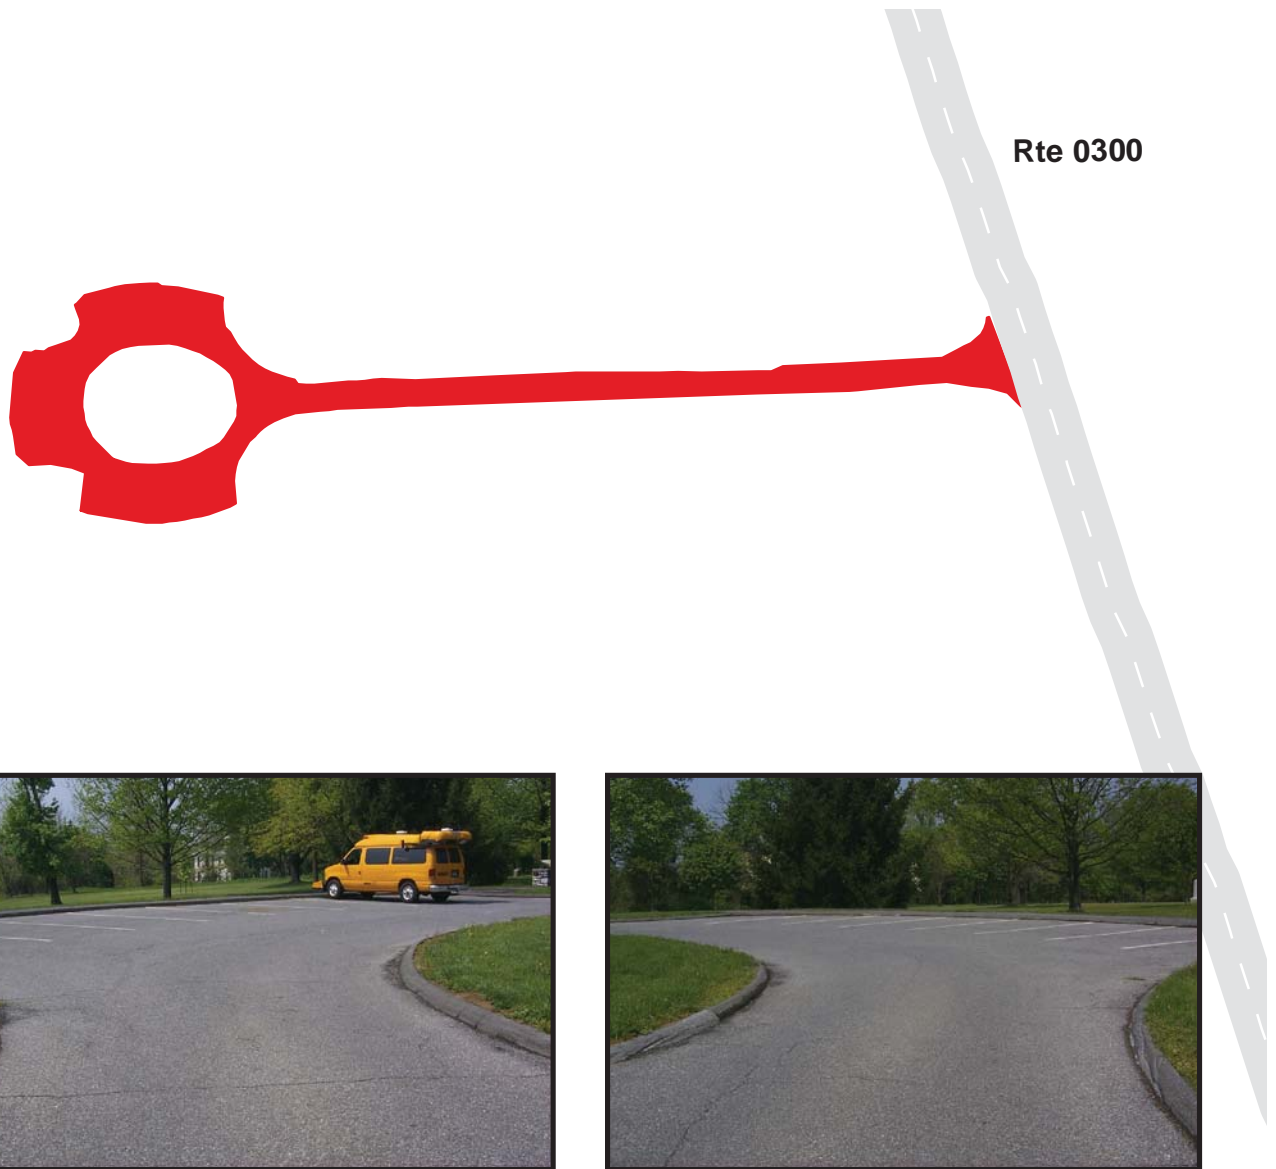
Route 0903

Route	Public / NonPublic	Date Visited	Area (sq ft)	Lane Miles *	Surface Type	Condition / PCR
0903	Public	5/2/2002	19149	0.33	AS	FAIR / 73

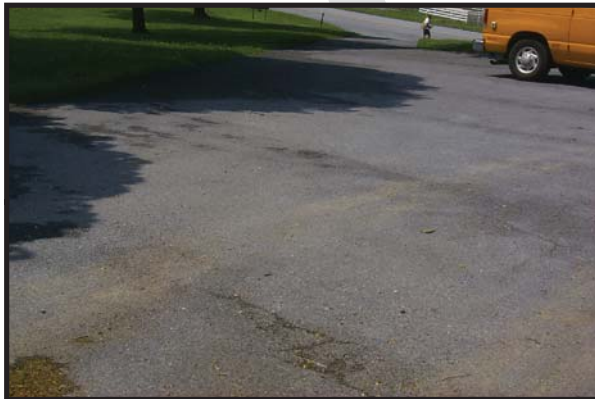
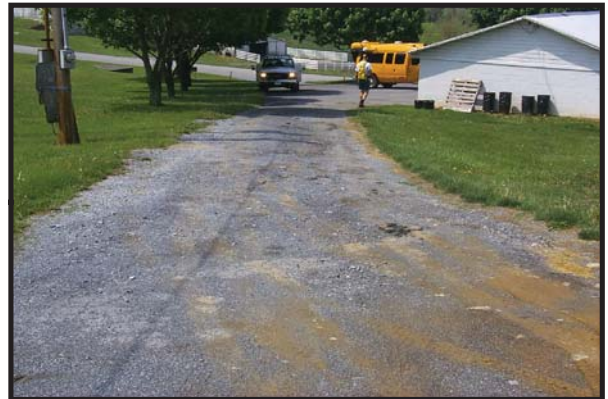
Route 0916

Route	Public / NonPublic	Date Visited	Area (sq ft)	Lane Miles *	Surface Type	Condition / PCR
0916	NonPublic	5/2/2002	8002	0.14	AS	POOR / 45
