The Road Inventory of Appomattox Court House National Historical Park APCO – 4180

Road Inventory Program

Prepared By:
Federal Highway Administration
Eastern Federal Lands Highway Division
Cycle 3

Appomattox Court House National Historical Park in Virginia

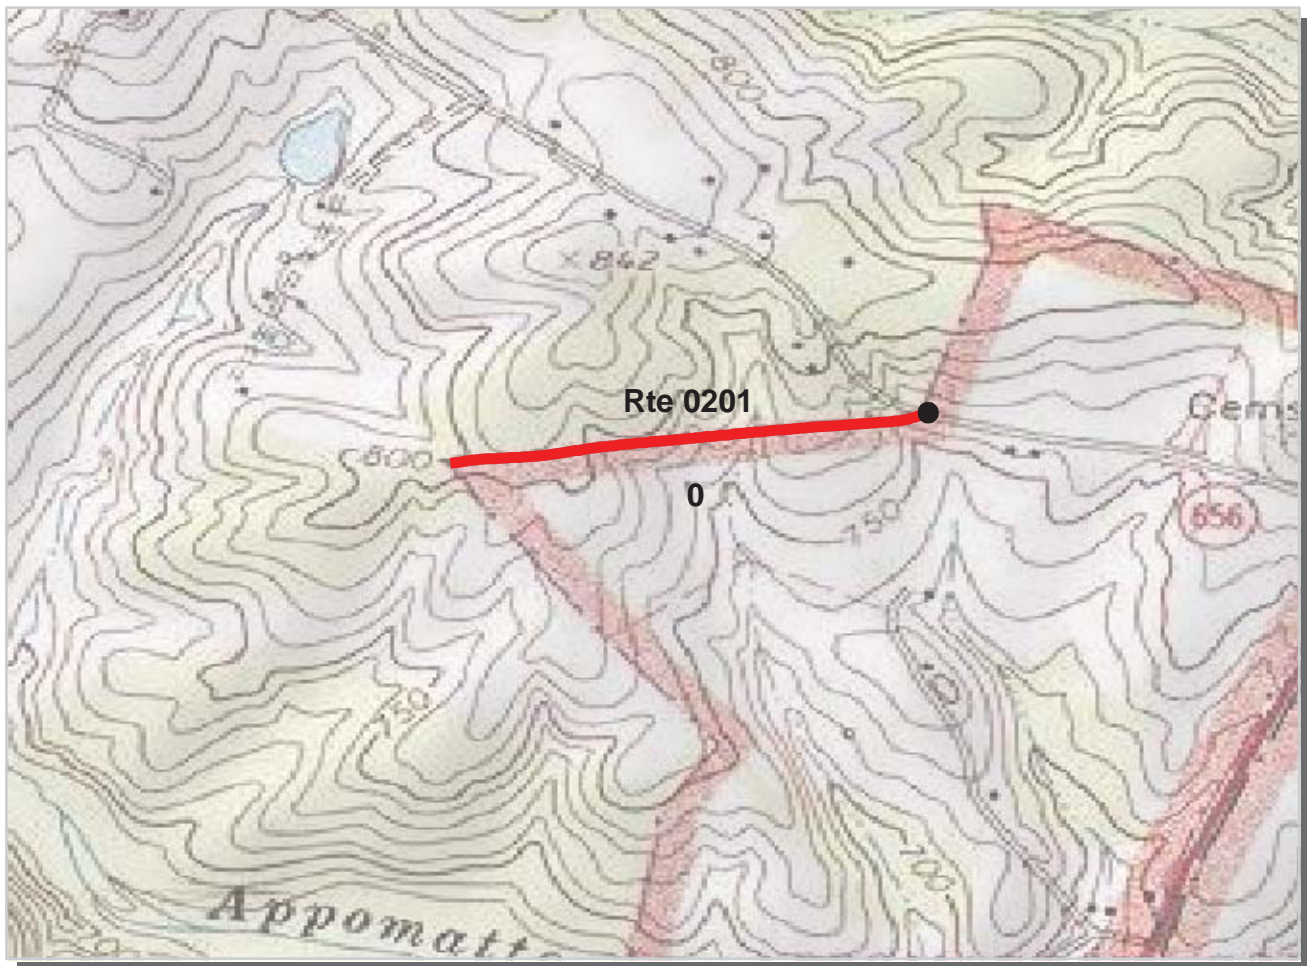
ROUTE: 0201 O'Brien Road

Section Number	0				
Section Length (mi)	0.39				
AADT	**				
SADT	**				
ADT Date	**				
Cross Section Information					
Number of Lanes	1				
Paved Width (ft)	11				
Lane Width (ft)	11				
Shoulder Width (ft)	6				
Roadway Condition Information					
PCR (Pavement Condition Rating)	14				
RCI (Roughness Condition Index)	41				
SCR (Surface Condition Rating)	7				
Alligator Cracking Index	56				
Rutting Index	28				
Patching Index	96				
Transverse Cracking Index	99				
Longitudinal Cracking Index	98				
Shoulder Condition Rating	POOR				
Drainage Condition Rating	GOOD

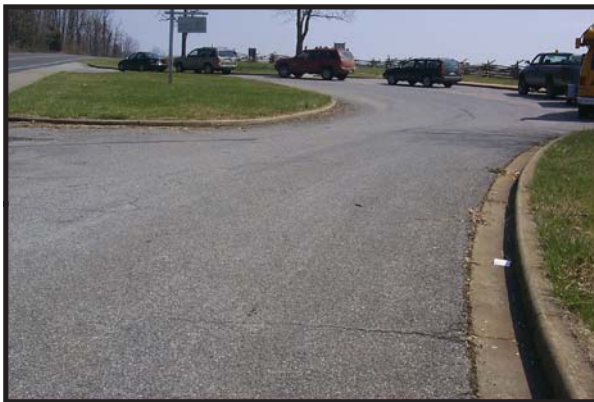
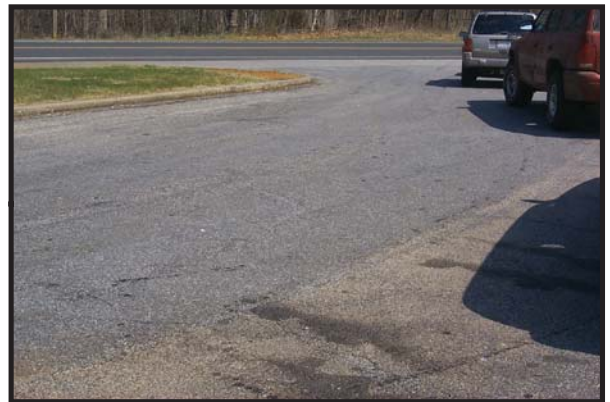
Route	Public / NonPublic	Date Visited	Area (sq ft)	Lane Miles *	Surface Type	Condition / PCR
0900	Public	3/29/2002	9153	0.16	AS	FAIR / 73

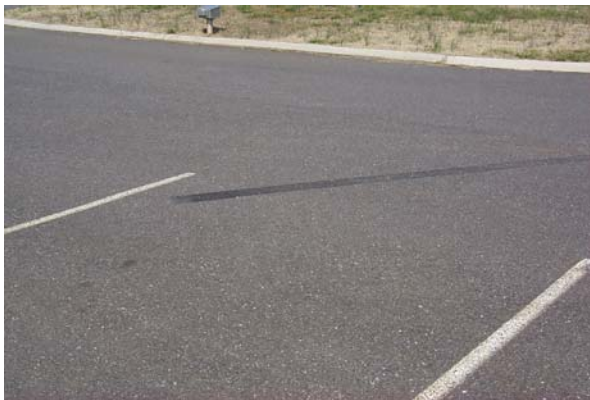
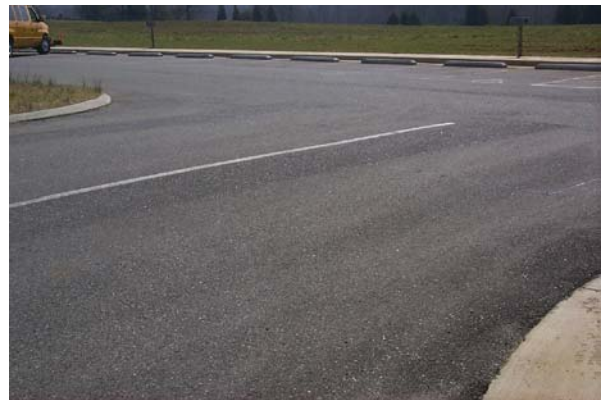
Route 0901

Route	Public / NonPublic	Date Visited	Area (sq ft)	Lane Miles *	Surface Type	Condition / PCR
0901	Public	3/29/2002	8008	0.14	AS	GOOD / 90

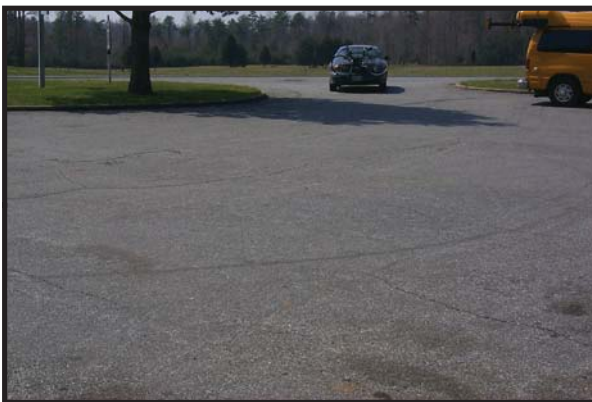
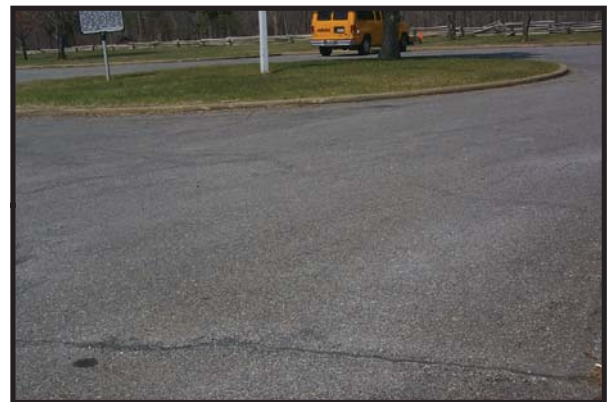
Route 0902

Route	Public / NonPublic	Date Visited	Area (sq ft)	Lane Miles *	Surface Type	Condition / PCR
0902	Public	3/29/2002	7635	0.13	AS	FAIR / 73

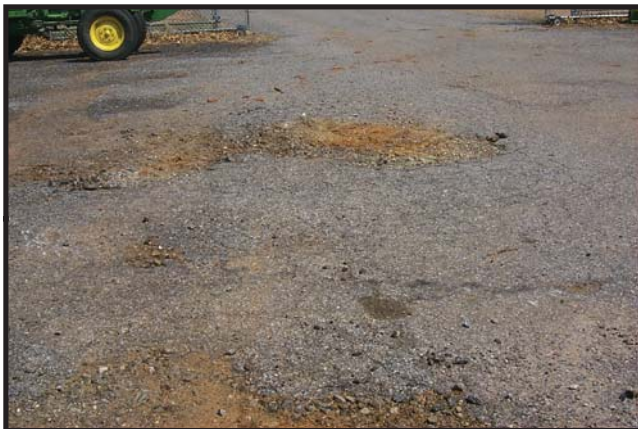
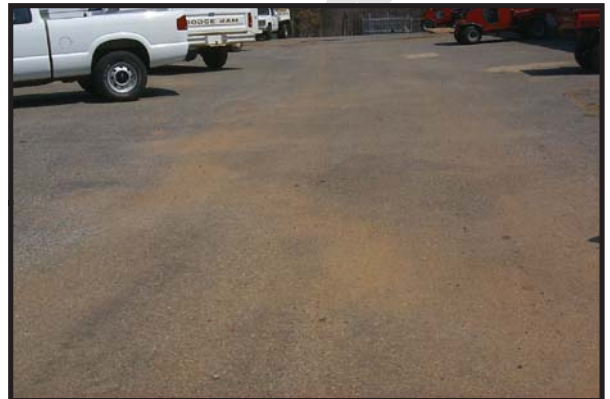
Route 0903

Route	Public / NonPublic	Date Visited	Area (sq ft)	Lane Miles *	Surface Type	Condition / PCR
0903	NonPublic	3/29/2002	14013	0.24	AS	POOR / 45

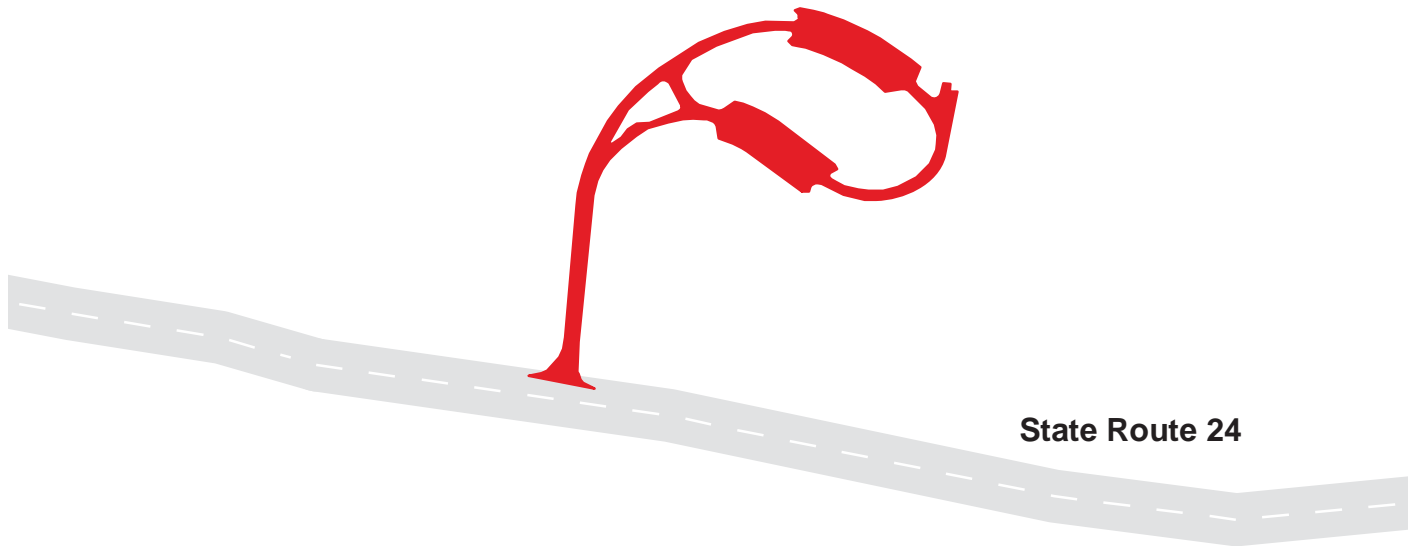
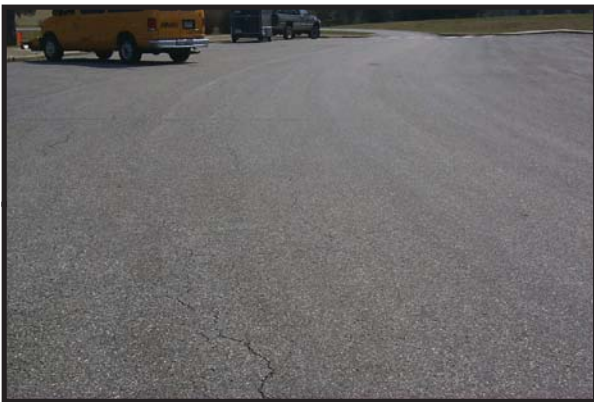
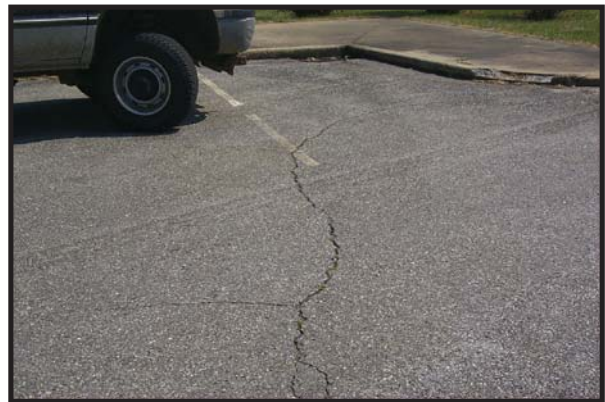
Route 0904

Route	Public / NonPublic	Date Visited	Area (sq ft)	Lane Miles *	Surface Type	Condition / PCR
0904	Public	3/29/2002	50103	0.86	OC	FAIR / 73

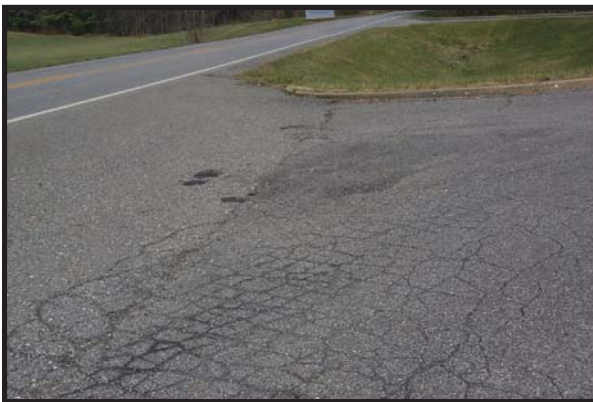
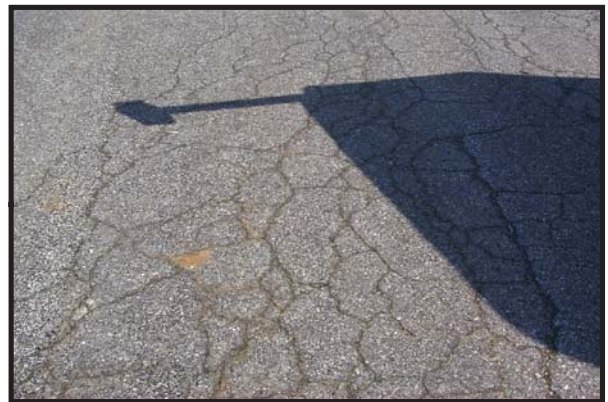
Route	Public / NonPublic	Date Visited	Area (sq ft)	Lane Miles *	Surface Type	Condition / PCR
0905	Public	3/29/2002	9812	0.17	OC	POOR / 45
