**The Road Inventory
of
Apostle Islands National Lakeshore
APIS - 6140**

Road Inventory Program

Prepared By:
Federal Highway Administration
Eastern Federal Lands Highway Division
Cycle 3

Apostle Islands National Lakeshore in Wisconsin

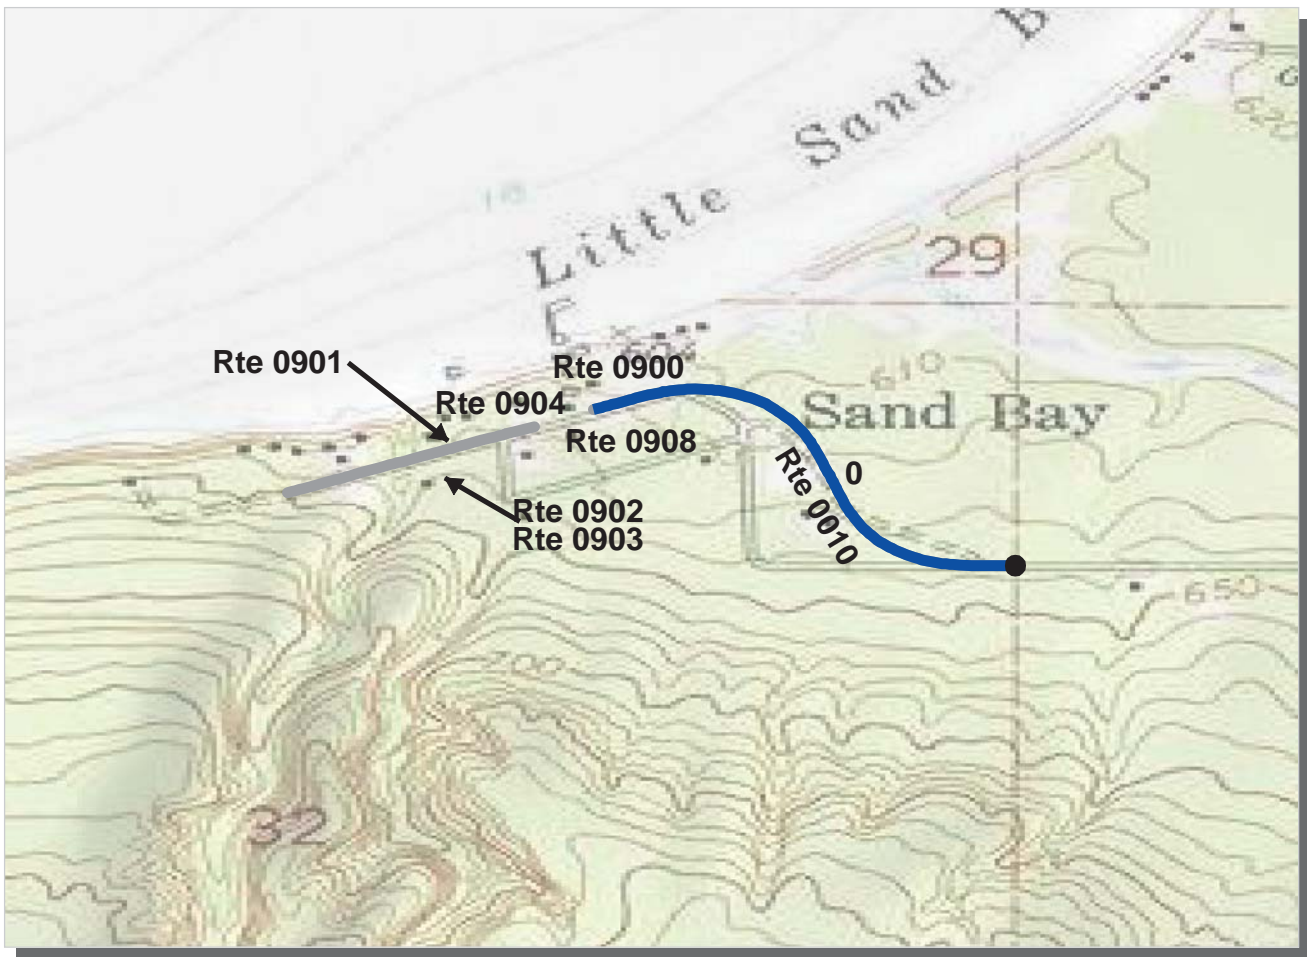
ROUTE: 0010 Little Sand Bay Road

Section Number	0				
Section Length (mi)	0.40				
AADT	**				
SADT	**				
ADT Date	**				
Cross Section Information					
Number of Lanes	2				
Paved Width (ft)	23				
Lane Width (ft)	12				
Shoulder Width (ft)	4				
Roadway Condition Information					
PCR (Pavement Condition Rating)	99				
RCI (Roughness Condition Index)	98				
SCR (Surface Condition Rating)	100				
Alligator Cracking Index	100				
Rutting Index	100				
Patching Index	100				
Transverse Cracking Index	100				
Longitudinal Cracking Index	100				
Shoulder Condition Rating	GOOD				
Drainage Condition Rating	GOOD

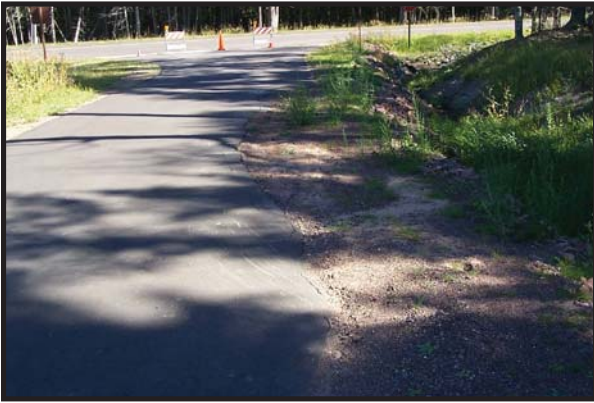
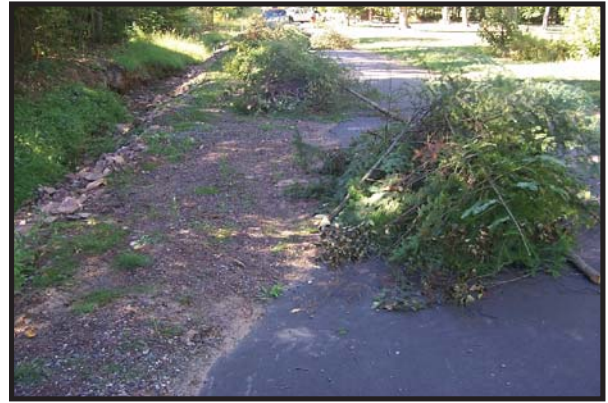
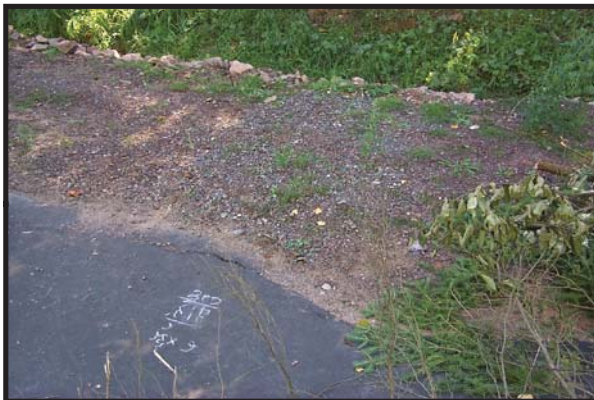
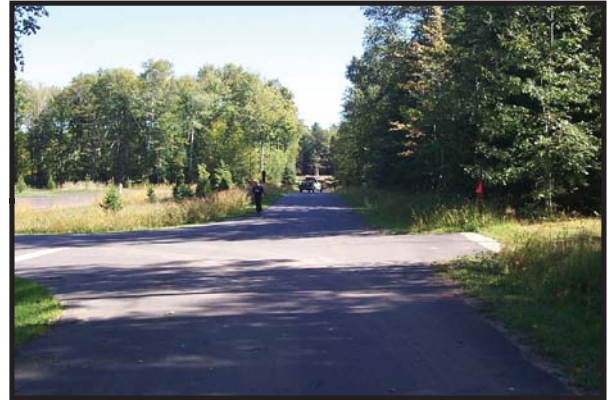
Route 0200

Route	Length (mi)	Width (ft)	Area (sq ft)	Lane Miles *	Condition / PCR	Surface Type
0200	0.22	15.00	0	0.00	GOOD / 90	AS

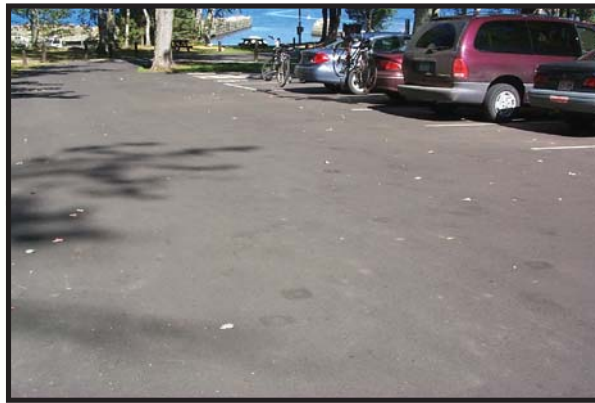
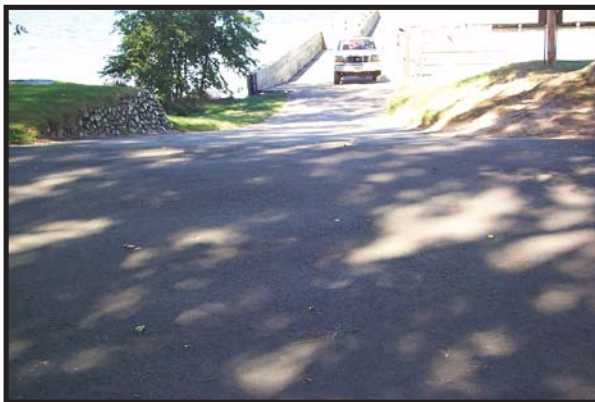
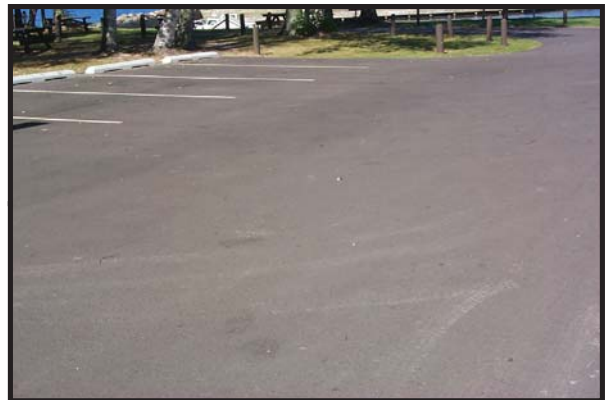
Route 0900

Route	Public / NonPublic	Date Visited	Area (sq ft)	Lane Miles *	Surface Type	Condition / PCR
0900	Public	9/25/2001	17784	0.31	AS	EXCELLENT / 97

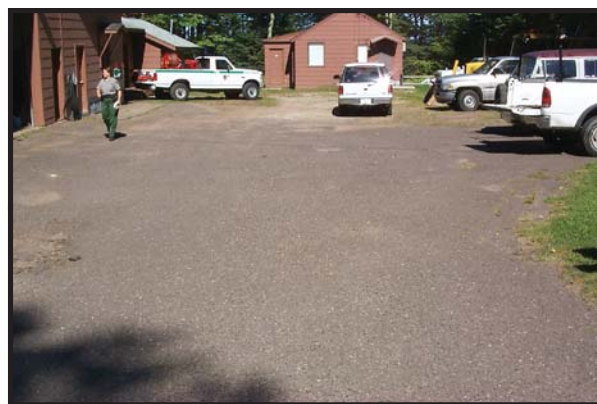
Apostle Islands National Lakeshore
Route 0901
MAINTENANCE SHOP/FIRE CACHE PARKING
From Route 0400

Route	Public / NonPublic	Date Visited	Area (sq ft)	Lane Miles *	Surface Type	Condition / PCR
0901	NonPublic	9/25/2001	3597	0.06	AS	POOR / 45

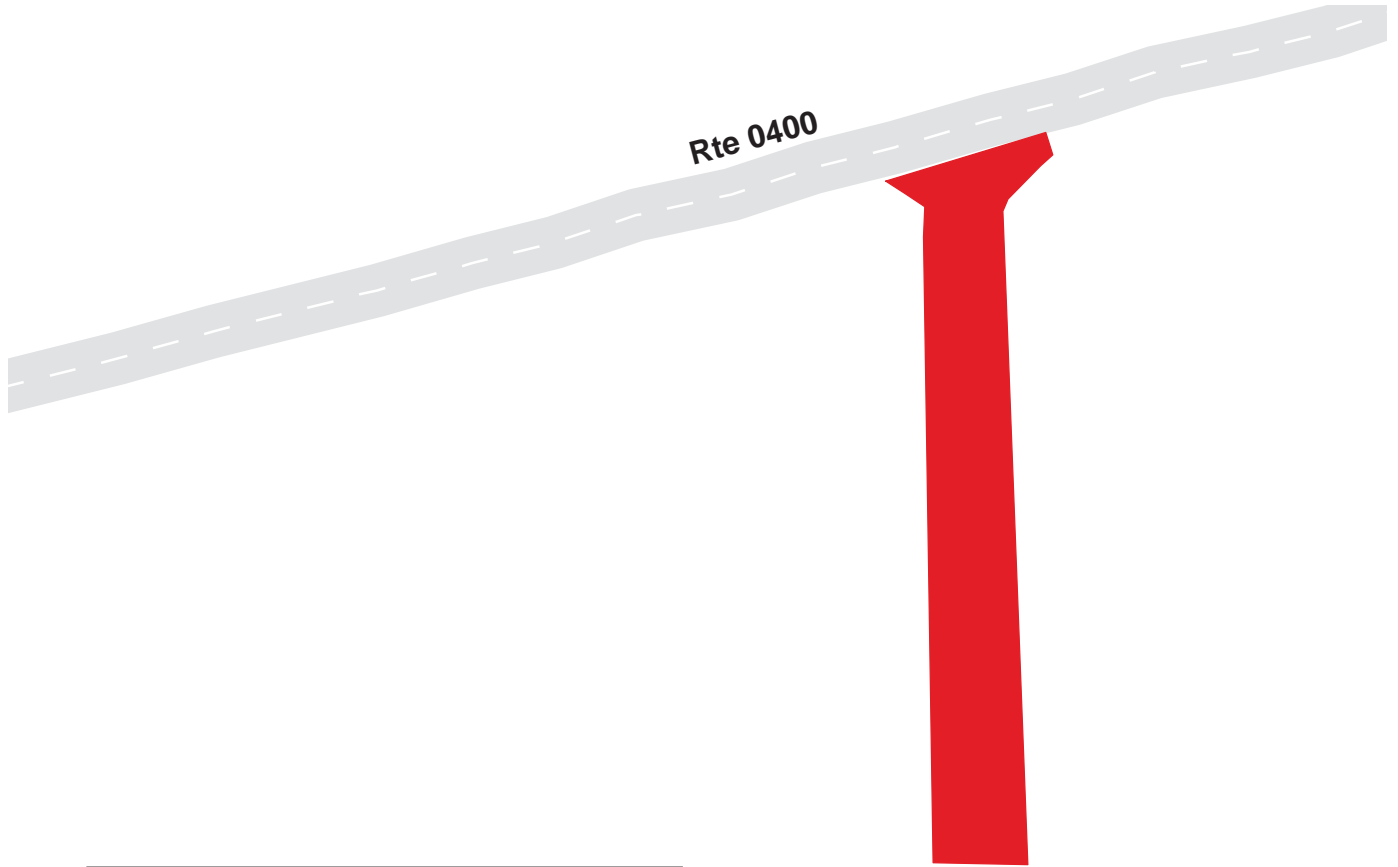
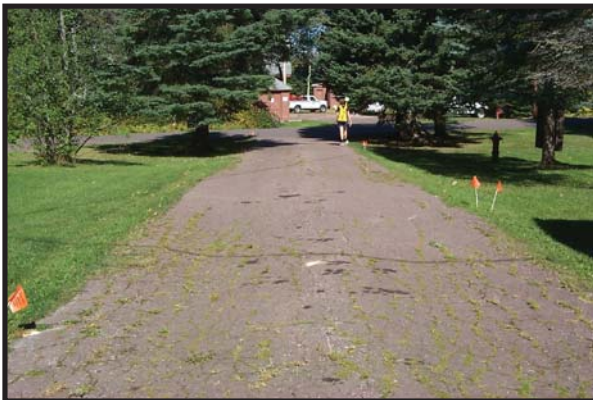
Route 0902

Route	Public / NonPublic	Date Visited	Area (sq ft)	Lane Miles *	Surface Type	Condition / PCR
0902	NonPublic	9/25/2001	1821	0.03	AS	POOR / 45

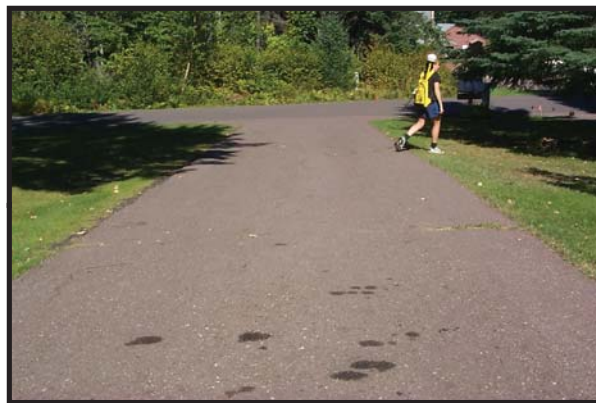
Route 0903

Route	Public / NonPublic	Date Visited	Area (sq ft)	Lane Miles *	Surface Type	Condition / PCR
0903	NonPublic	9/25/2001	1116	0.02	AS	FAIR / 73

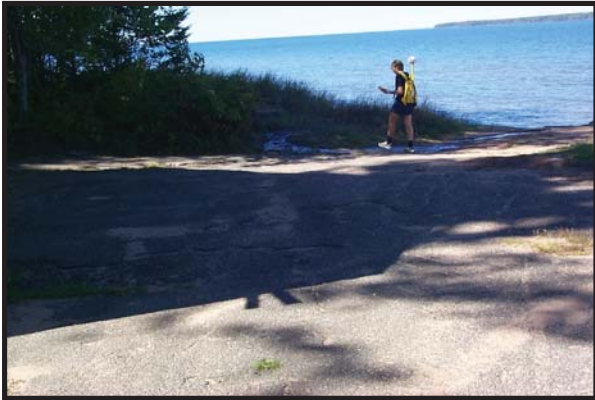
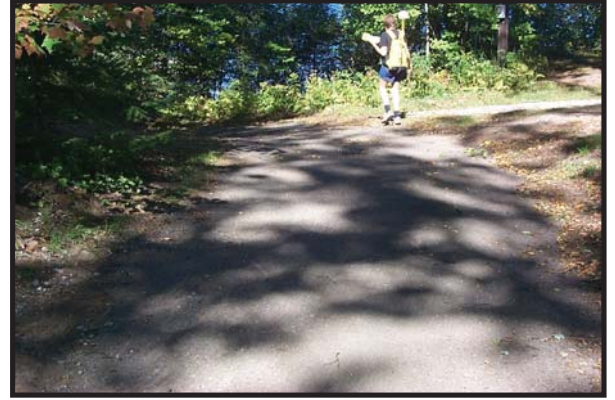
Apostle Islands National Lakeshore
Route 0904
 HOKENSON HISTORIC FISHERY PARKING
 From Route 0402

Route	Public / NonPublic	Date Visited	Area (sq ft)	Lane Miles *	Surface Type	Condition / PCR
0904	NonPublic	9/25/2001	2060	0.04	AS	POOR / 45

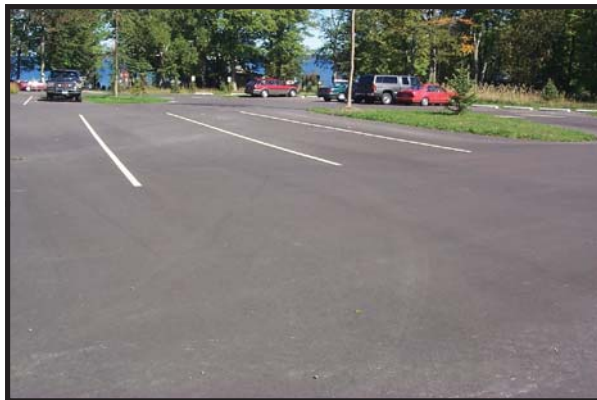
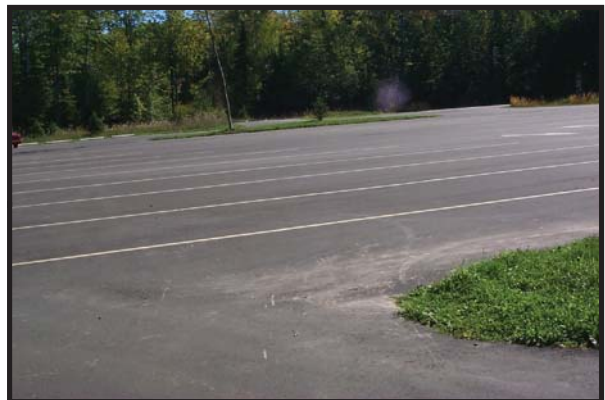
Route 0908

Route	Public / NonPublic	Date Visited	Area (sq ft)	Lane Miles *	Surface Type	Condition / PCR
0908	Public	9/25/2001	73630	1.27	AS	EXCELLENT / 97
