The Road Inventory of Arches National Park ARCH - 1348

Road Inventory Program

Prepared By:
Federal Highway Administration
Eastern Federal Lands Highway Division
Cycle 3

Arches National Park in Utah

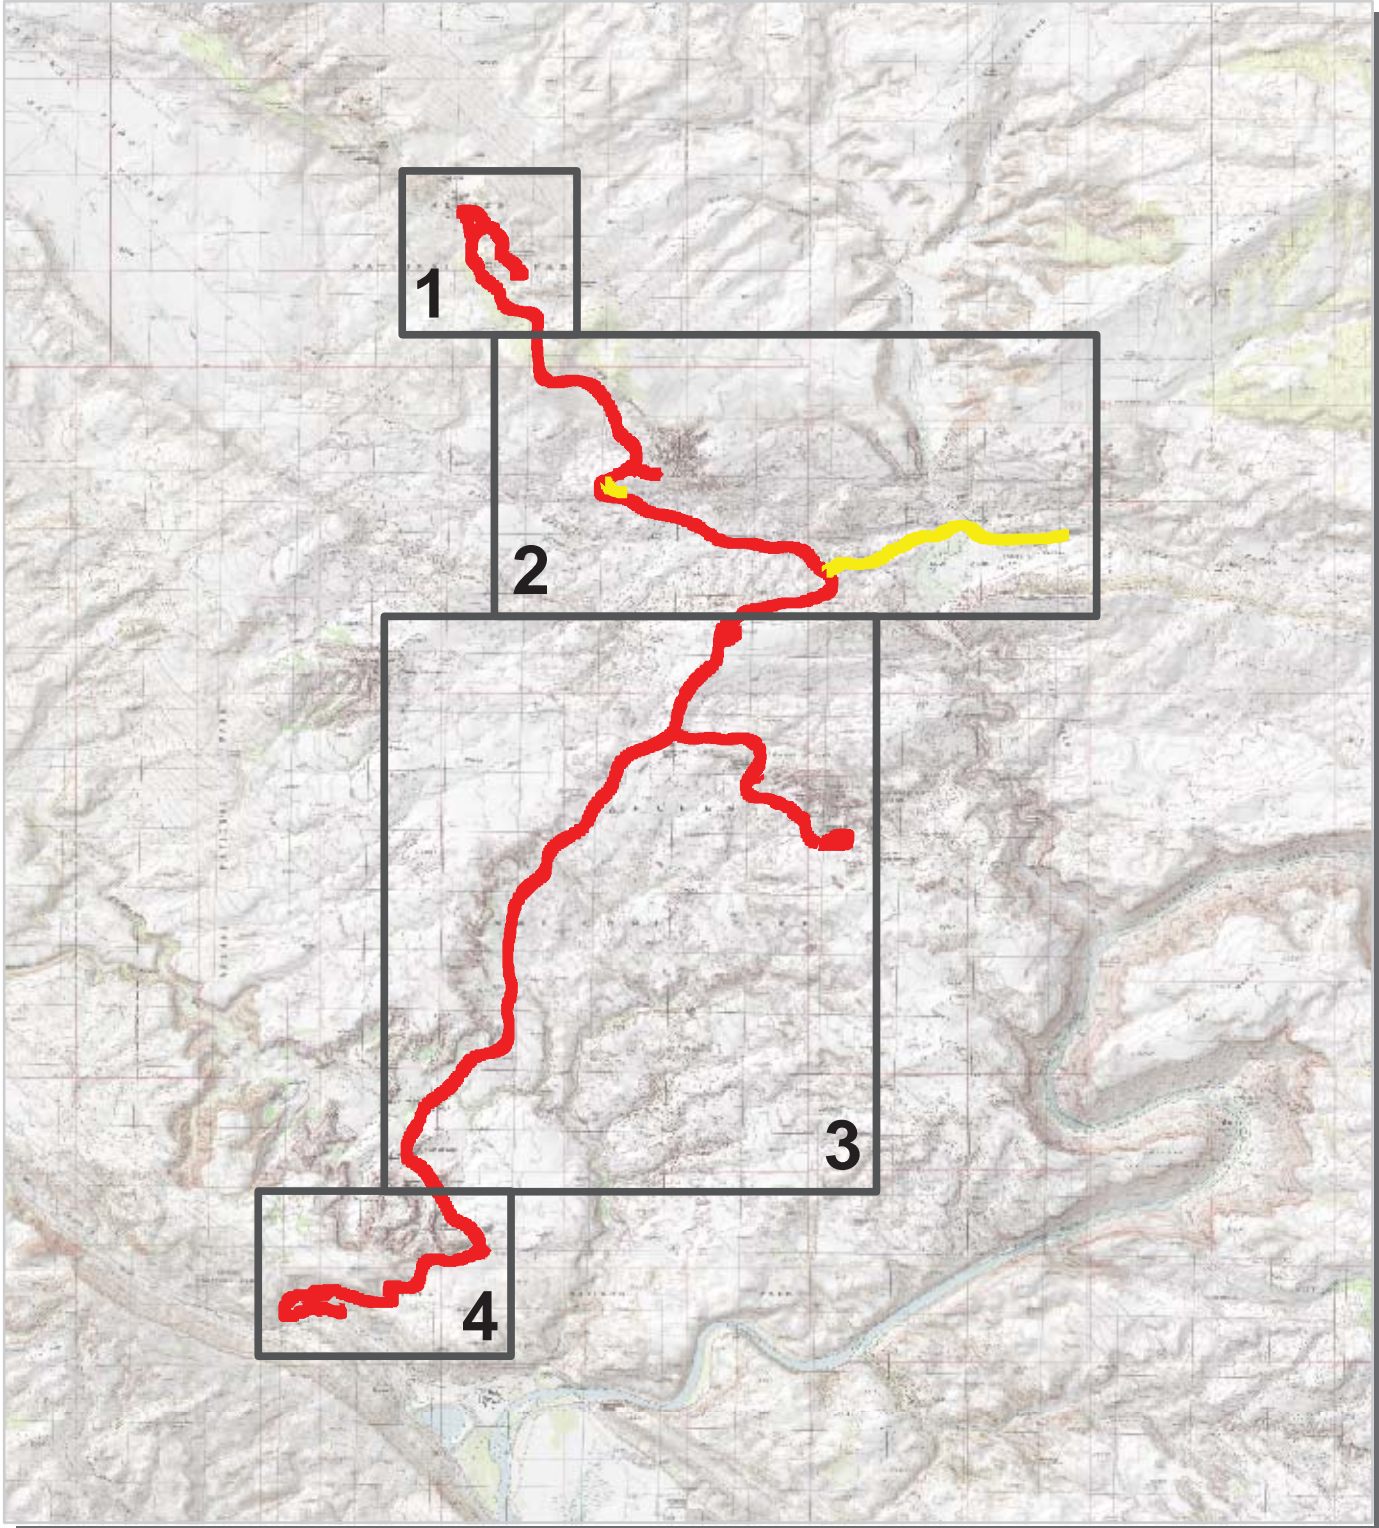
Arches National Park Route Condition Key Map PCR - Mile by Mile

PCR	Poor	(<=60)	Fair	(61 - 84)	Good	(85 - 94)	Excellent	(95 - 100)
-----	------	--------	------	-----------	------	-----------	-----------	------------

* If the PCR rating is not available for a section, the SCR rating will be displayed. See appendix for definitions and formulas.

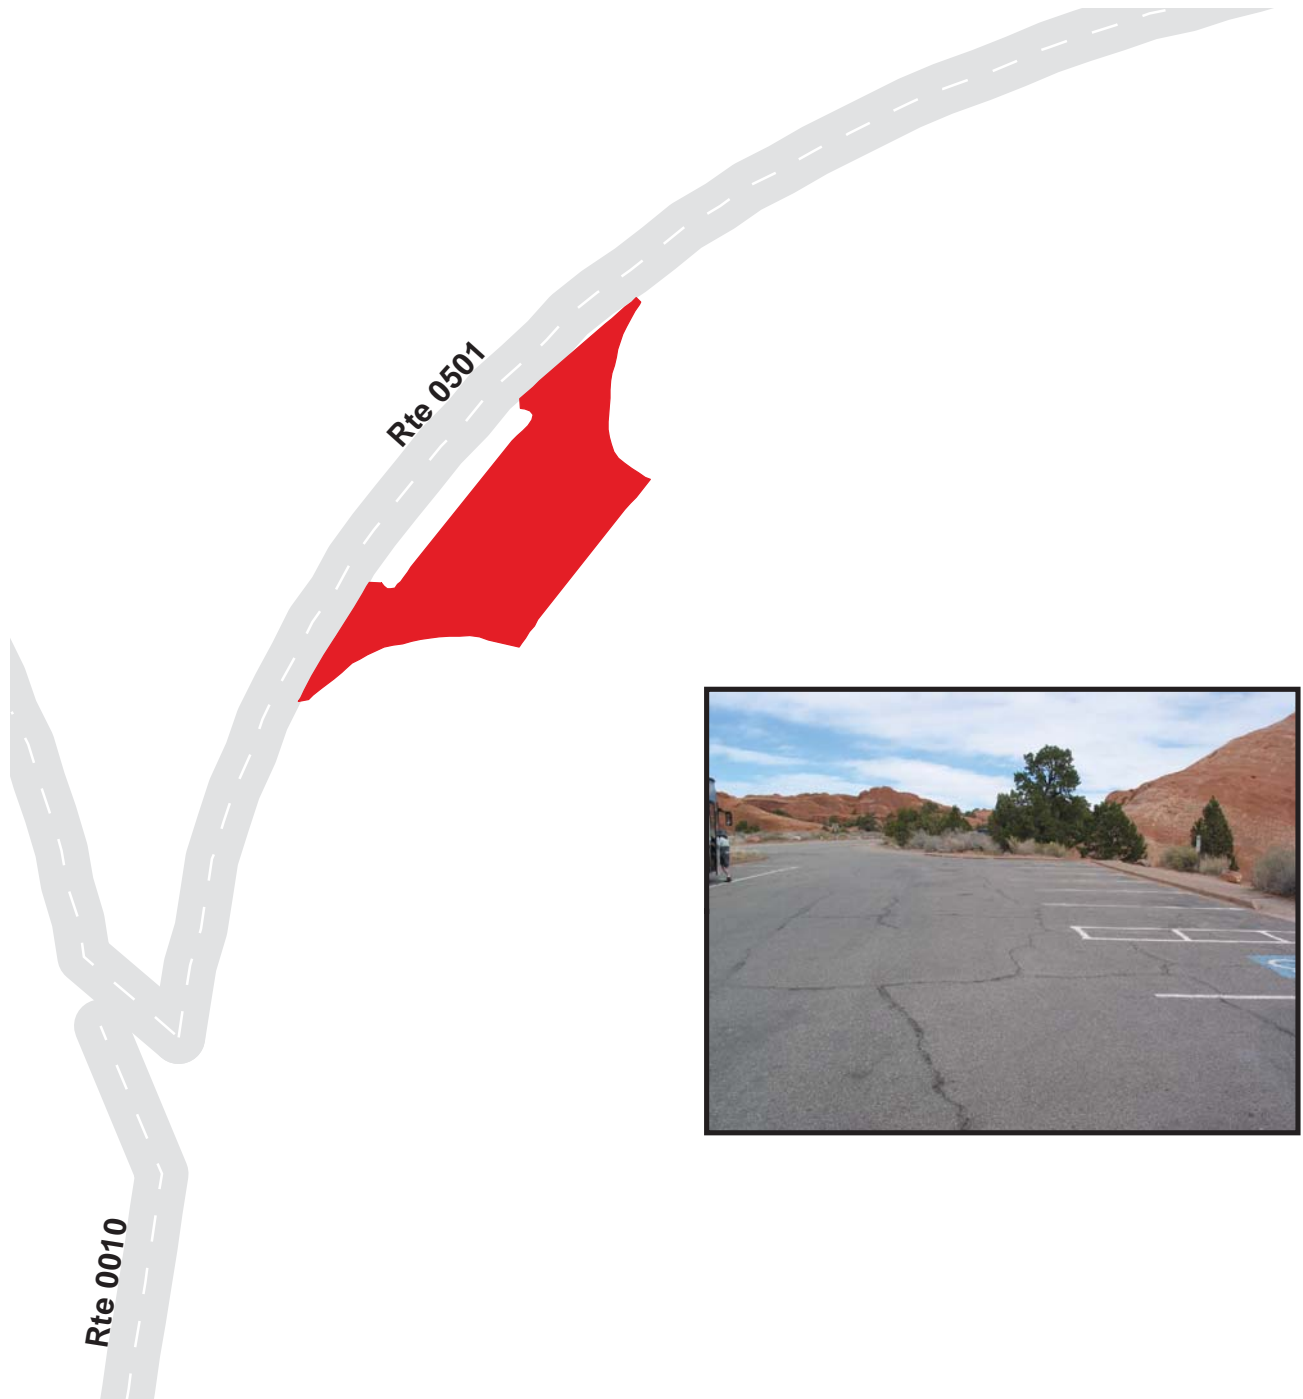
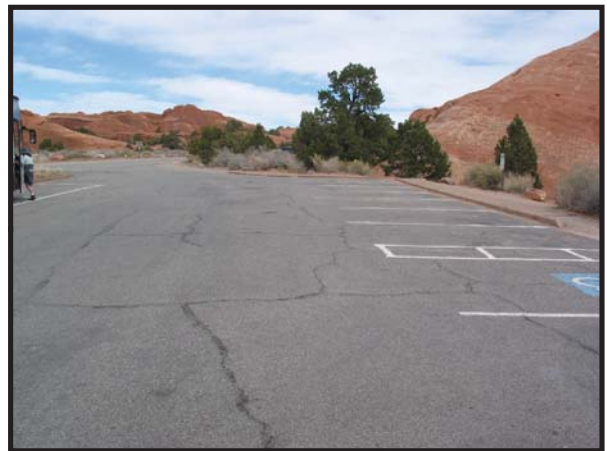
Route	Public / NonPublic	Date Visited	Area (sq ft)	Lane Miles *	Surface Type	Condition / PCR
0900A	Public	4/1/2003	8370	0.14	AS	FAIR / 73

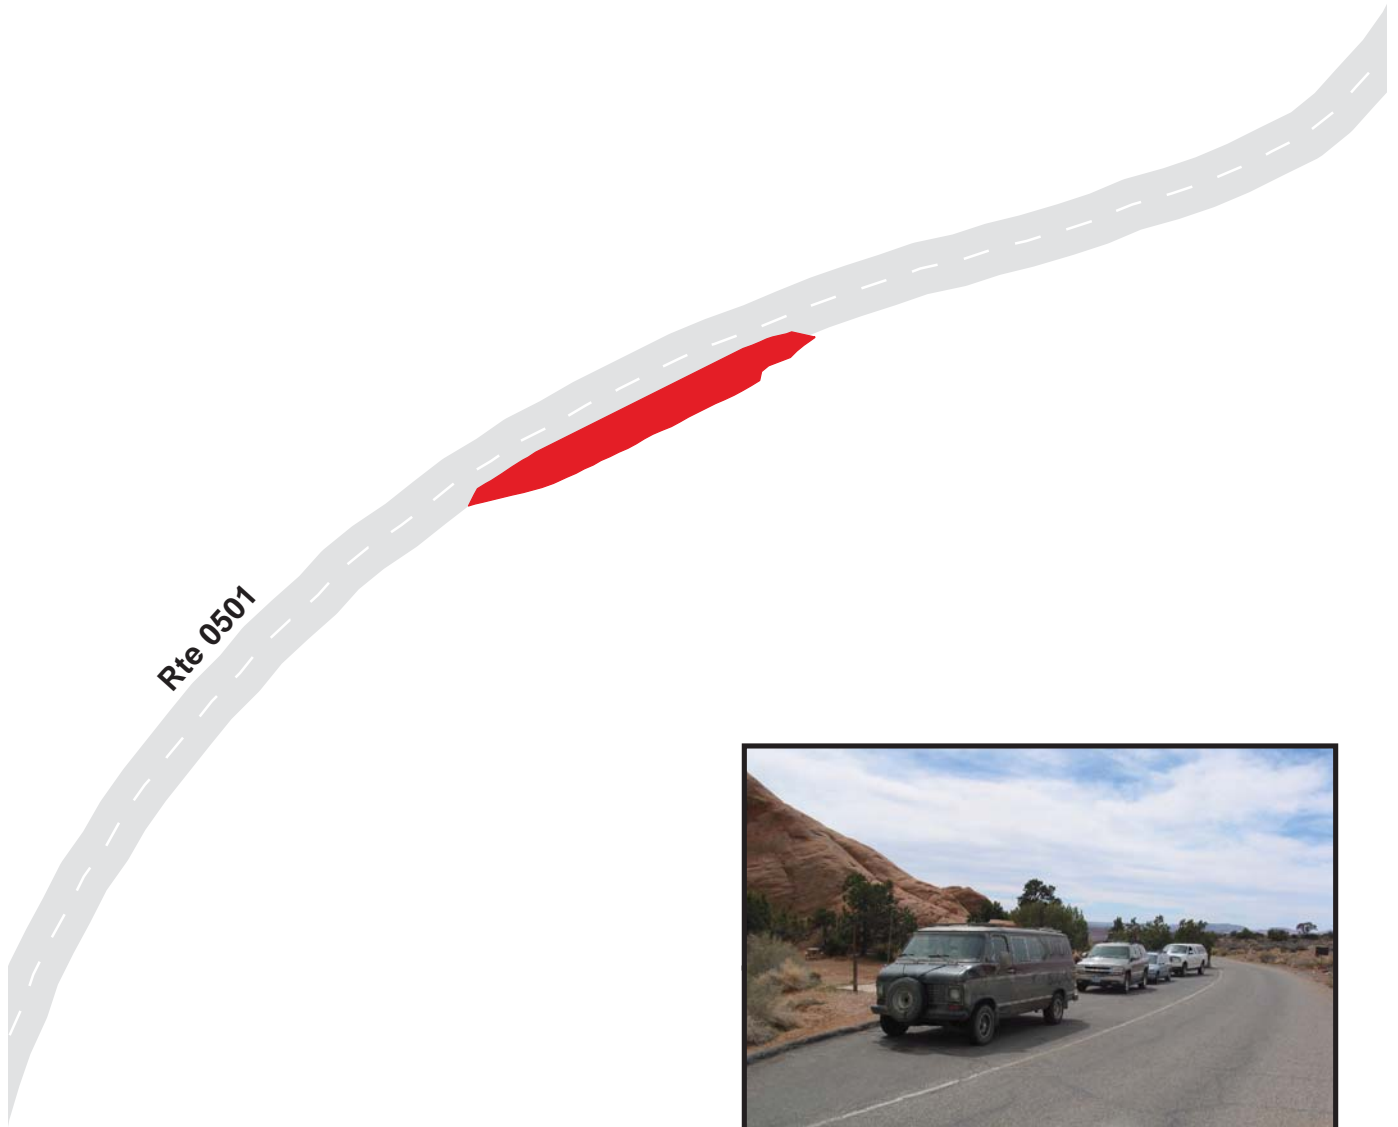
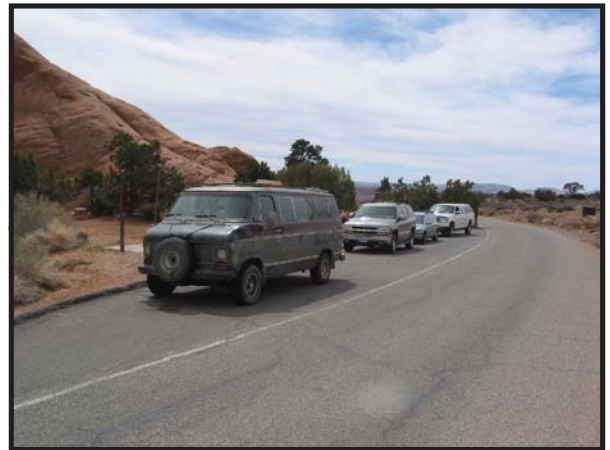
Route 0900B

Route	Public / NonPublic	Date Visited	Area (sq ft)	Lane Miles *	Surface Type	Condition / PCR
0900B	Public	4/1/2003	2319	0.04	AS	FAIR / 73

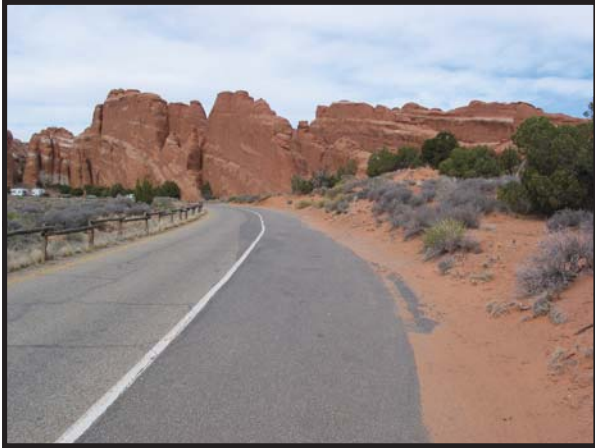
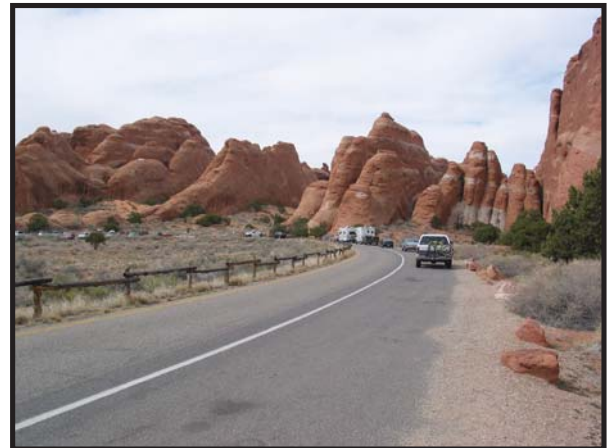
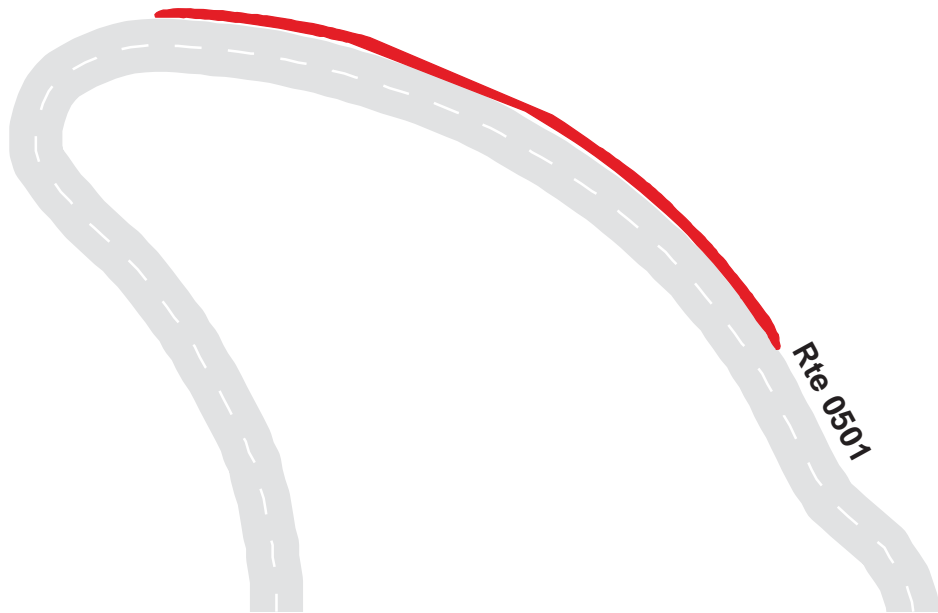
Arches National Park
Route 0901A
 DEVILS GARDEN PARKING A
 Adjacent to Route 0501 at MP 0.34 on Right

Route	Public / NonPublic	Date Visited	Area (sq ft)	Lane Miles *	Surface Type	Condition / PCR
0901A	Public	4/1/2003	13346	0.23	OC	GOOD / 90

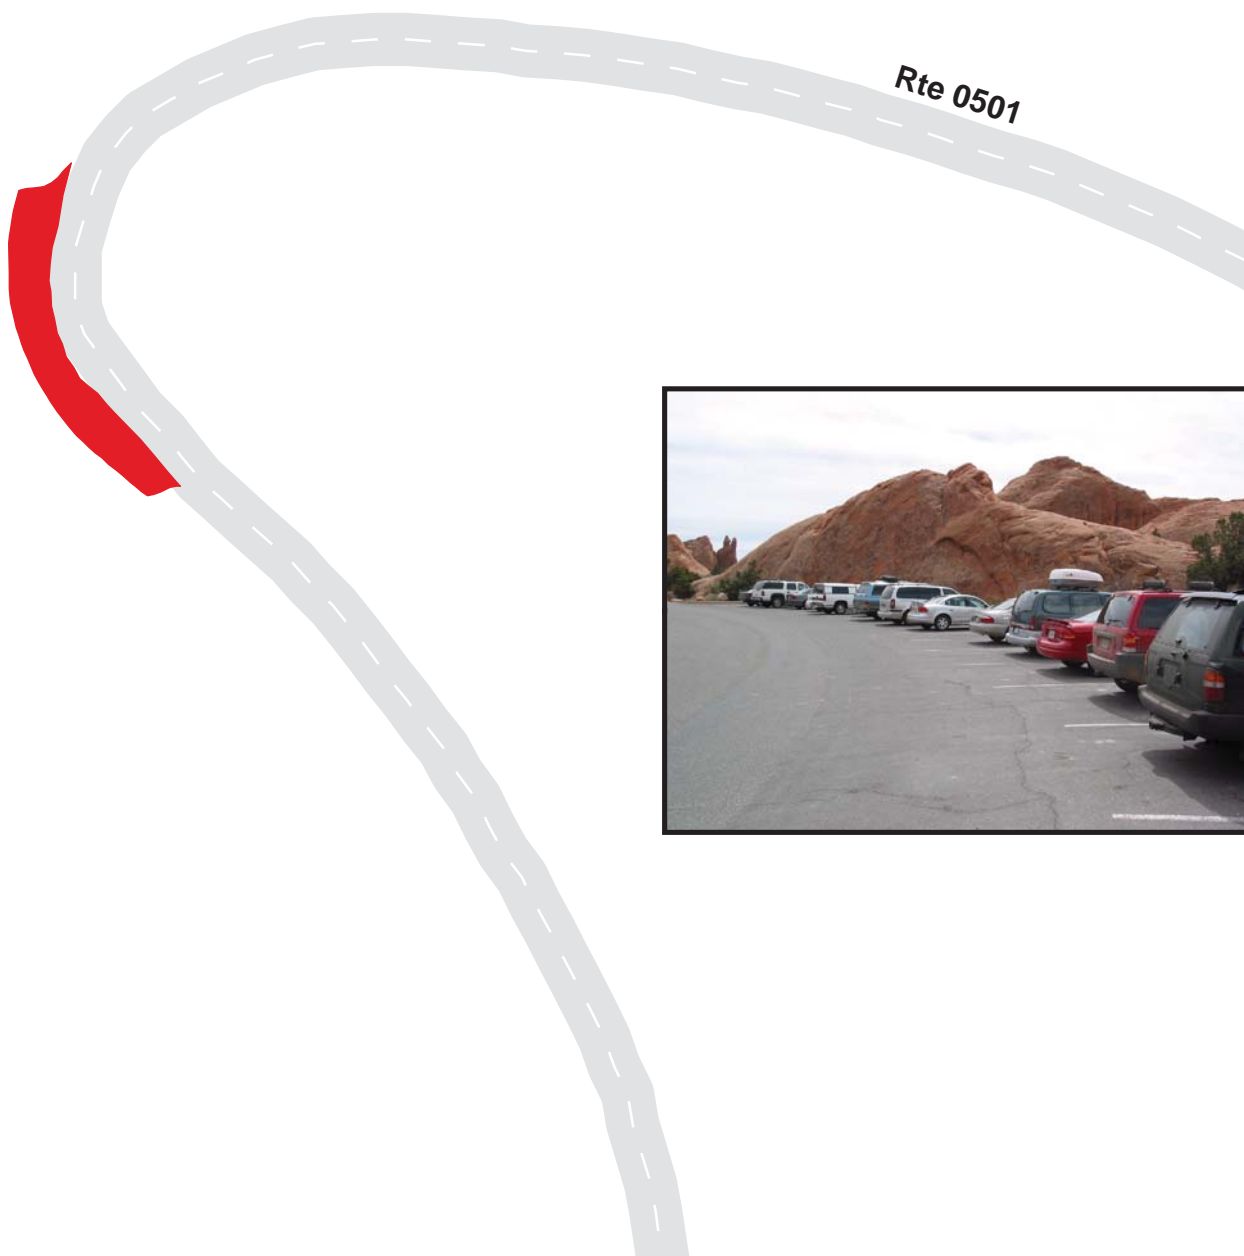
Route 0901B

Route	Public / NonPublic	Date Visited	Area (sq ft)	Lane Miles *	Surface Type	Condition / PCR
0901B	Public	4/1/2003	4081	0.07	OC	FAIR / 73

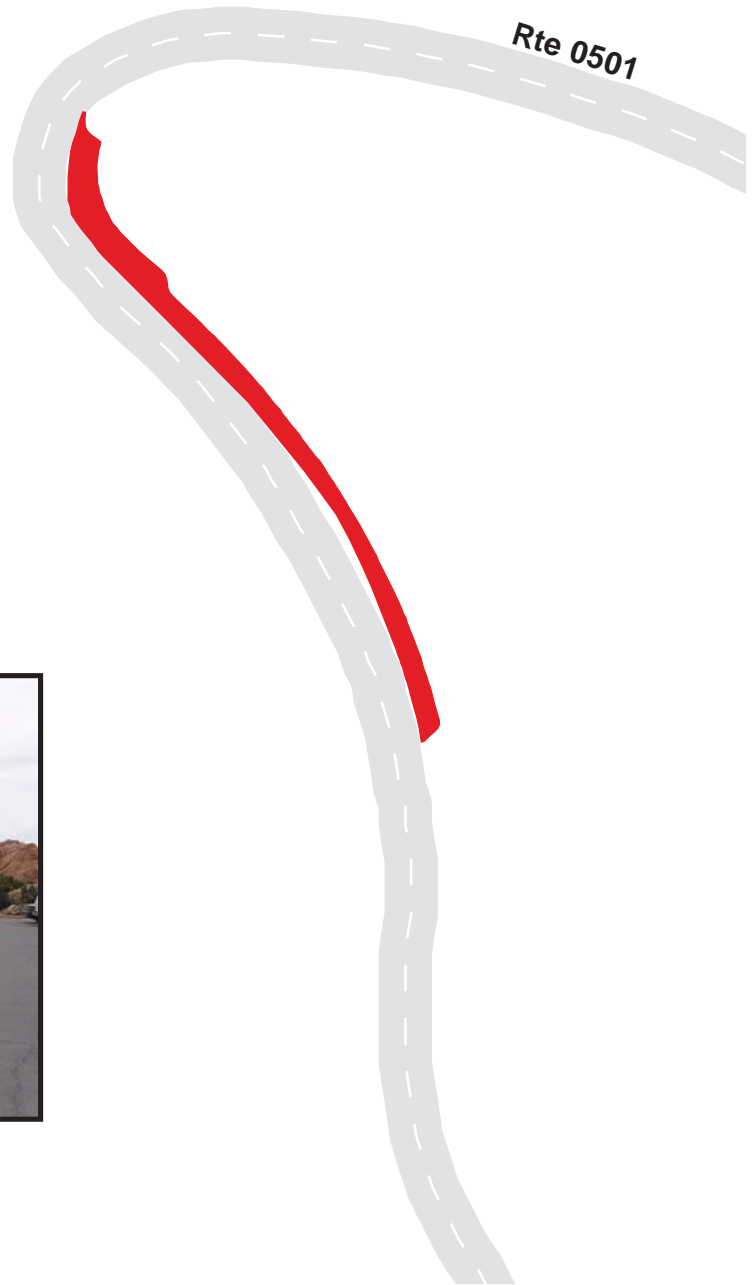
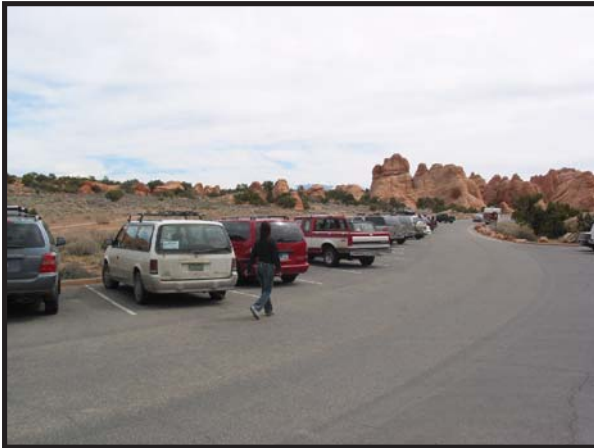
Route 0901C

Route	Public / NonPublic	Date Visited	Area (sq ft)	Lane Miles *	Surface Type	Condition / PCR
0901C	Public	4/1/2003	12030	0.21	OC	GOOD / 90

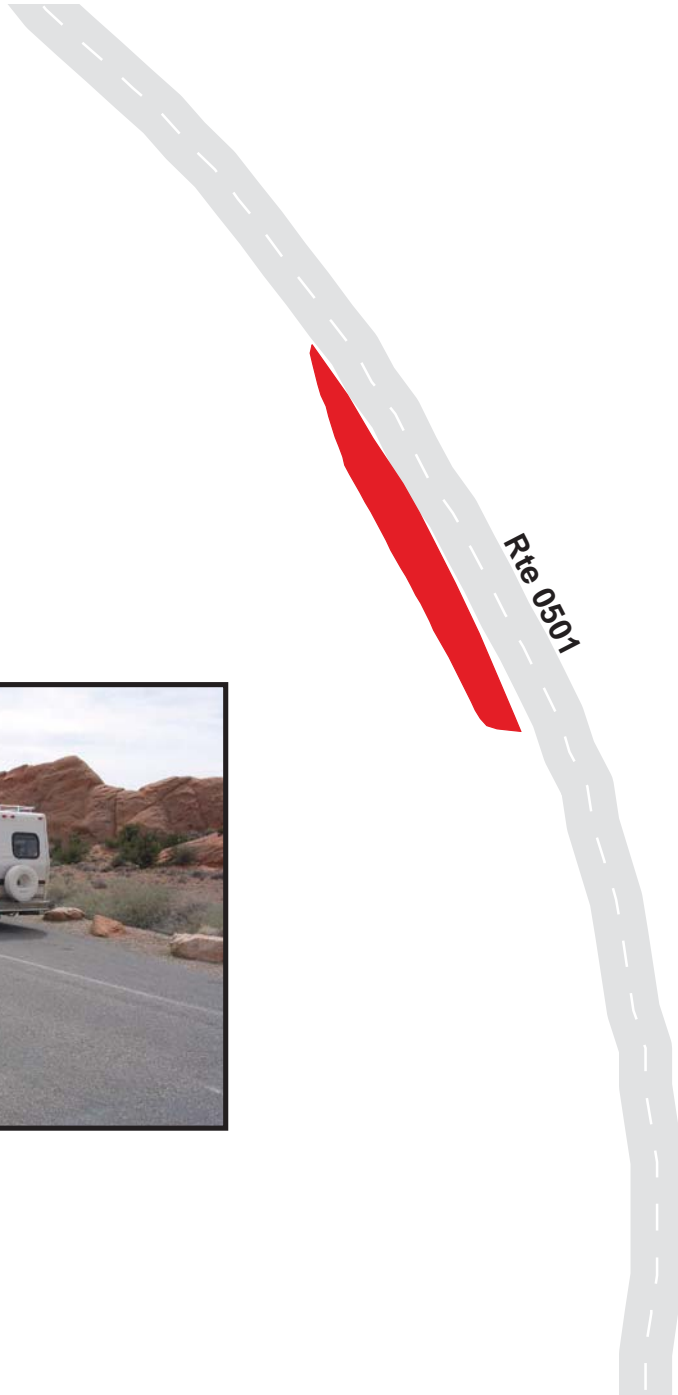
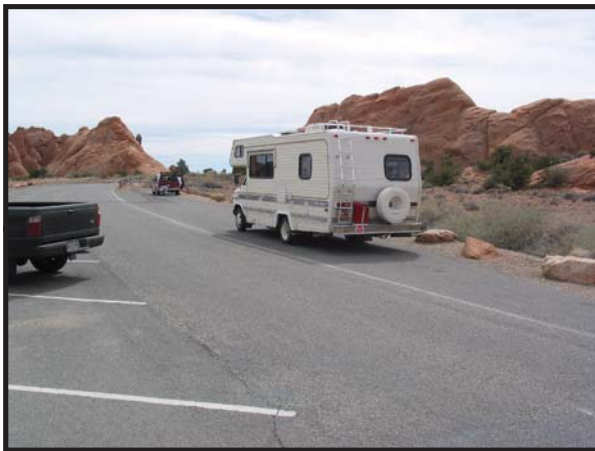
Route 0901D

Route	Public / NonPublic	Date Visited	Area (sq ft)	Lane Miles *	Surface Type	Condition / PCR
0901D	Public	4/1/2003	2625	0.05	OC	GOOD / 90

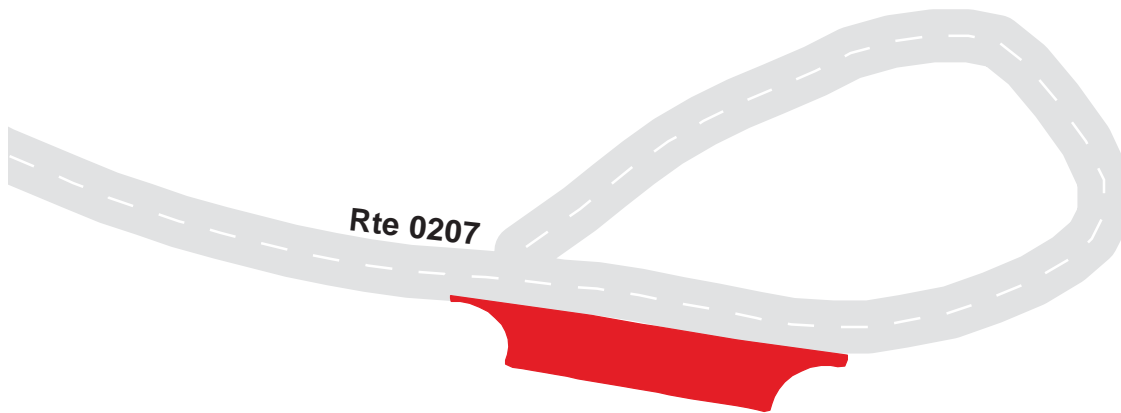
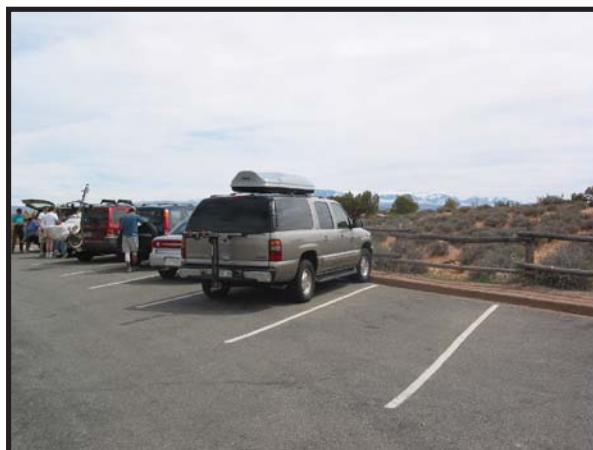
Route 0902A

Route	Public / NonPublic	Date Visited	Area (sq ft)	Lane Miles *	Surface Type	Condition / PCR
0902A	Public	4/1/2003	3417	0.06	AS	GOOD / 90

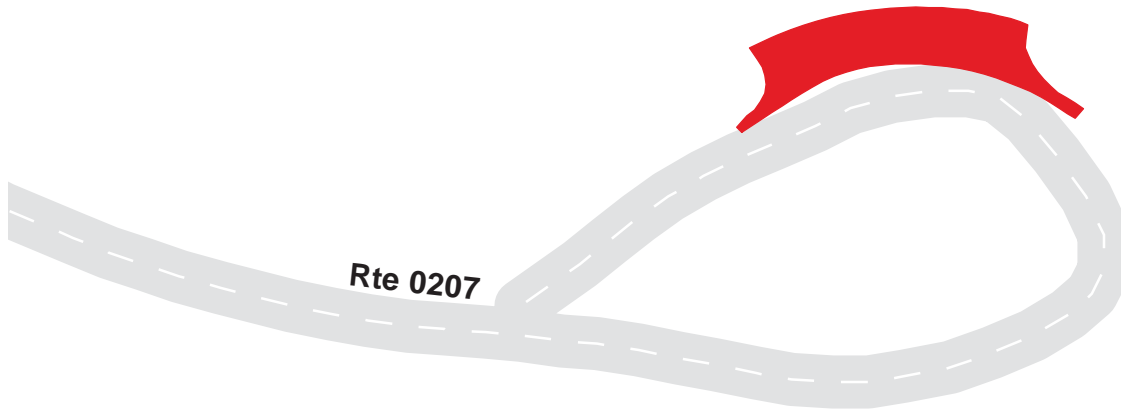
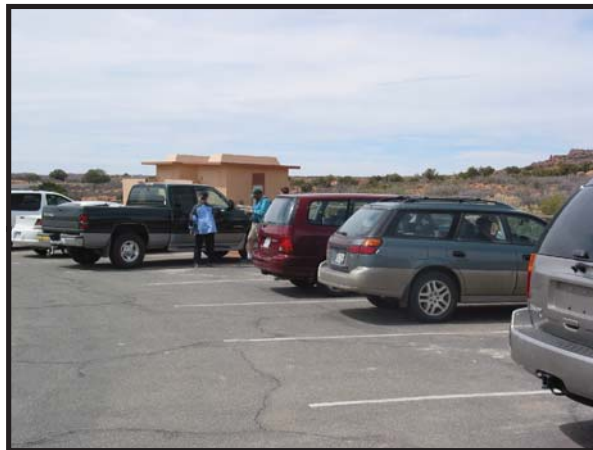
Route 0902B

Route	Public / NonPublic	Date Visited	Area (sq ft)	Lane Miles *	Surface Type	Condition / PCR
0902B	Public	4/1/2003	3089	0.05	AS	FAIR / 73

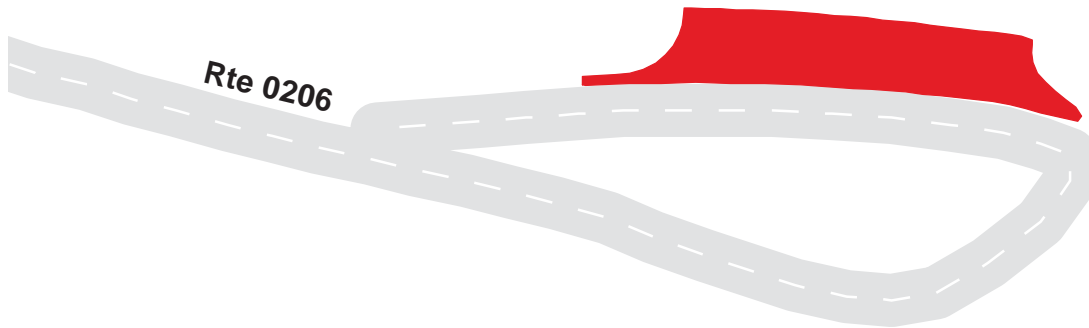
Route 0903

Route	Public / NonPublic	Date Visited	Area (sq ft)	Lane Miles *	Surface Type	Condition / PCR
0903	Public	4/1/2003	3042	0.05	OC	FAIR / 73

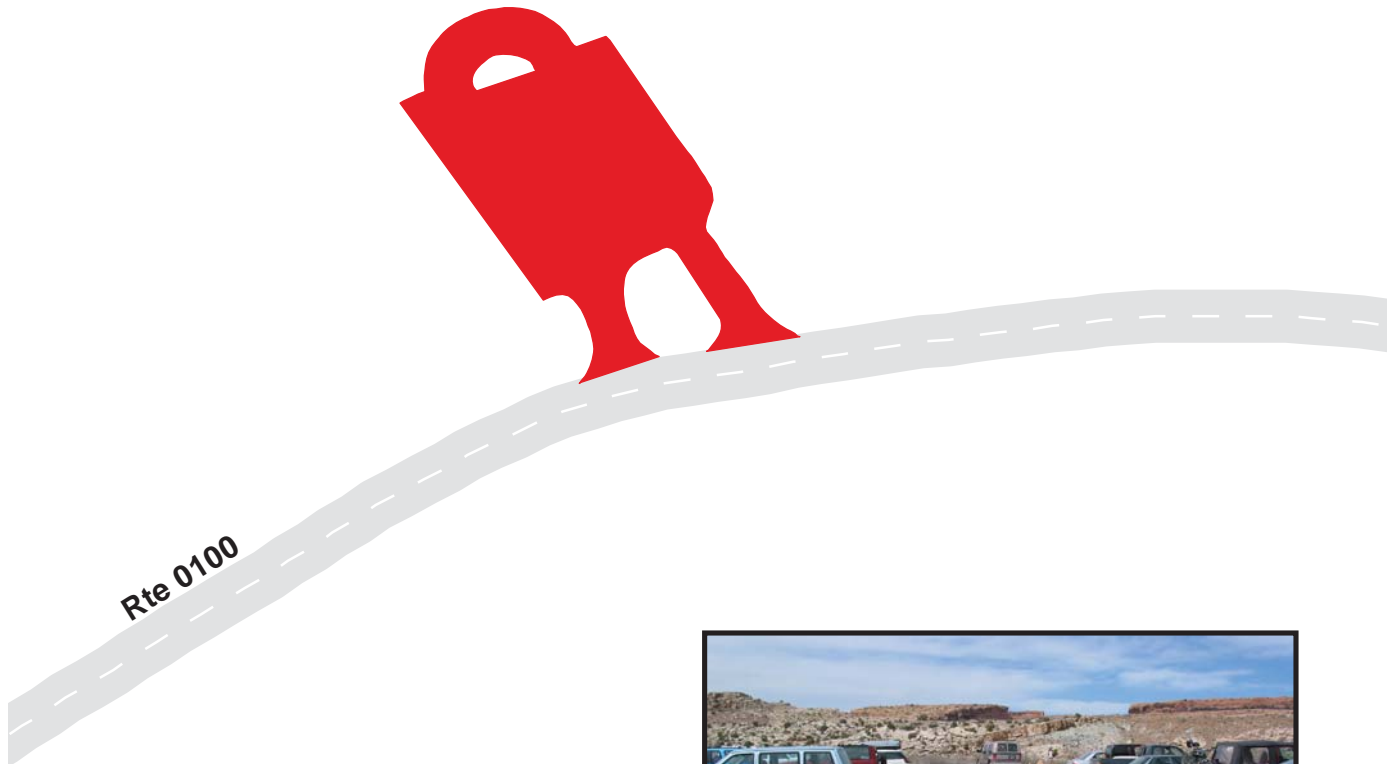
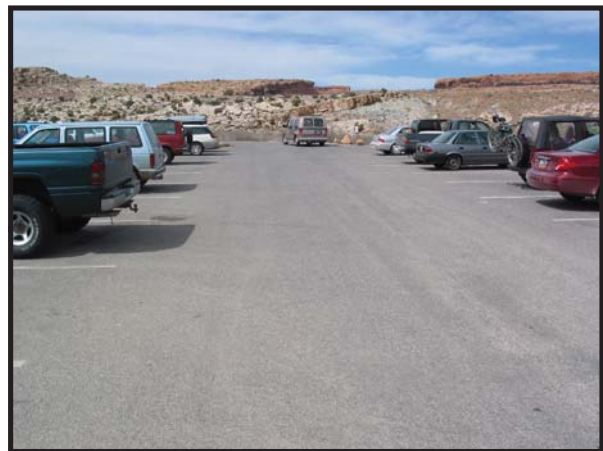
Route 0904A

Route	Public / NonPublic	Date Visited	Area (sq ft)	Lane Miles *	Surface Type	Condition / PCR
0904A	Public	4/1/2003	24347	0.42	AS	GOOD / 90

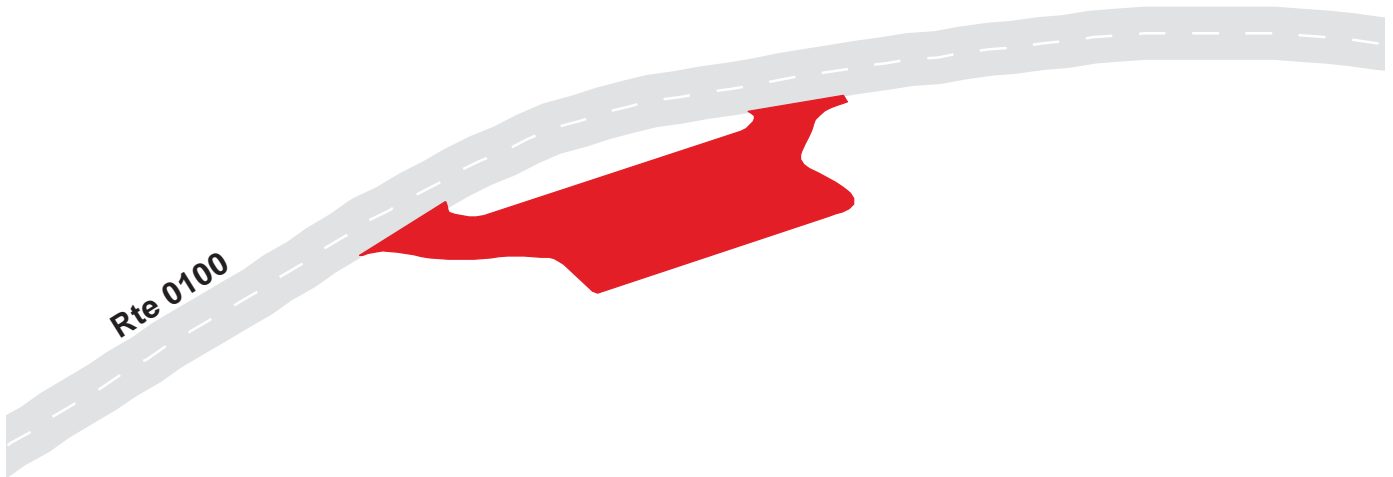
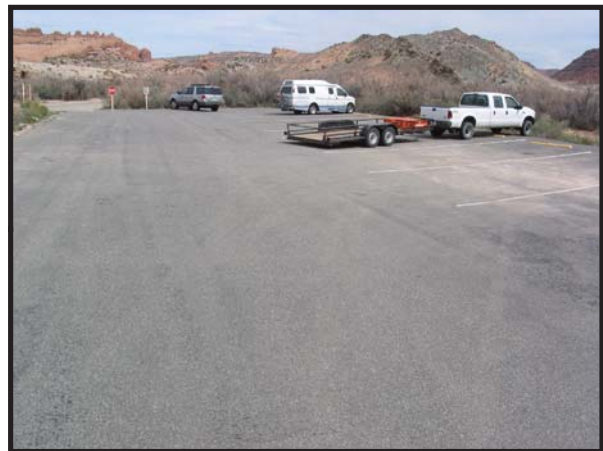
Arches National Park
Route 0904B
WOLFE RANCH PARKING SOUTH
Adjacent to Route 0100 on Right

Route	Public / NonPublic	Date Visited	Area (sq ft)	Lane Miles *	Surface Type	Condition / PCR
0904B	Public	4/1/2003	14636	0.25	AS	GOOD / 90

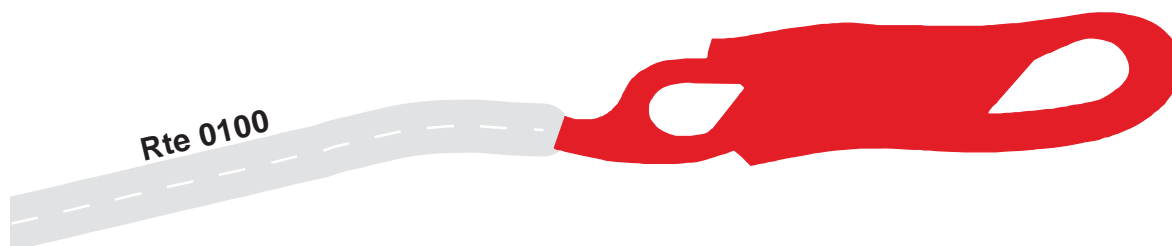
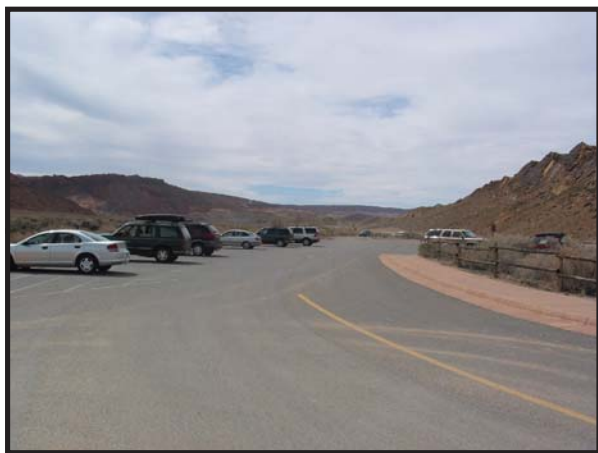
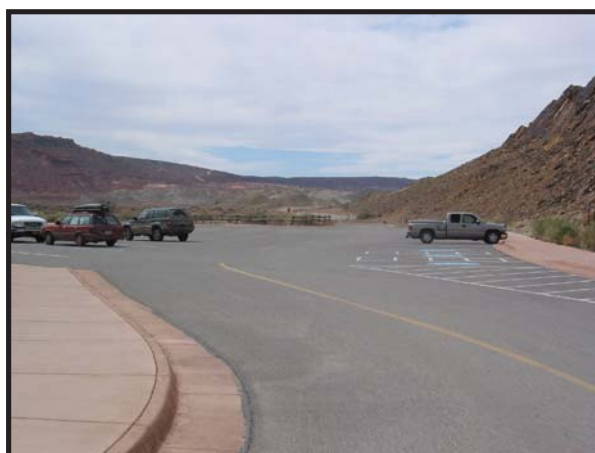
Route 0905

Route	Public / NonPublic	Date Visited	Area (sq ft)	Lane Miles *	Surface Type	Condition / PCR
0905	Public	4/1/2003	56779	0.98	OC	GOOD / 90

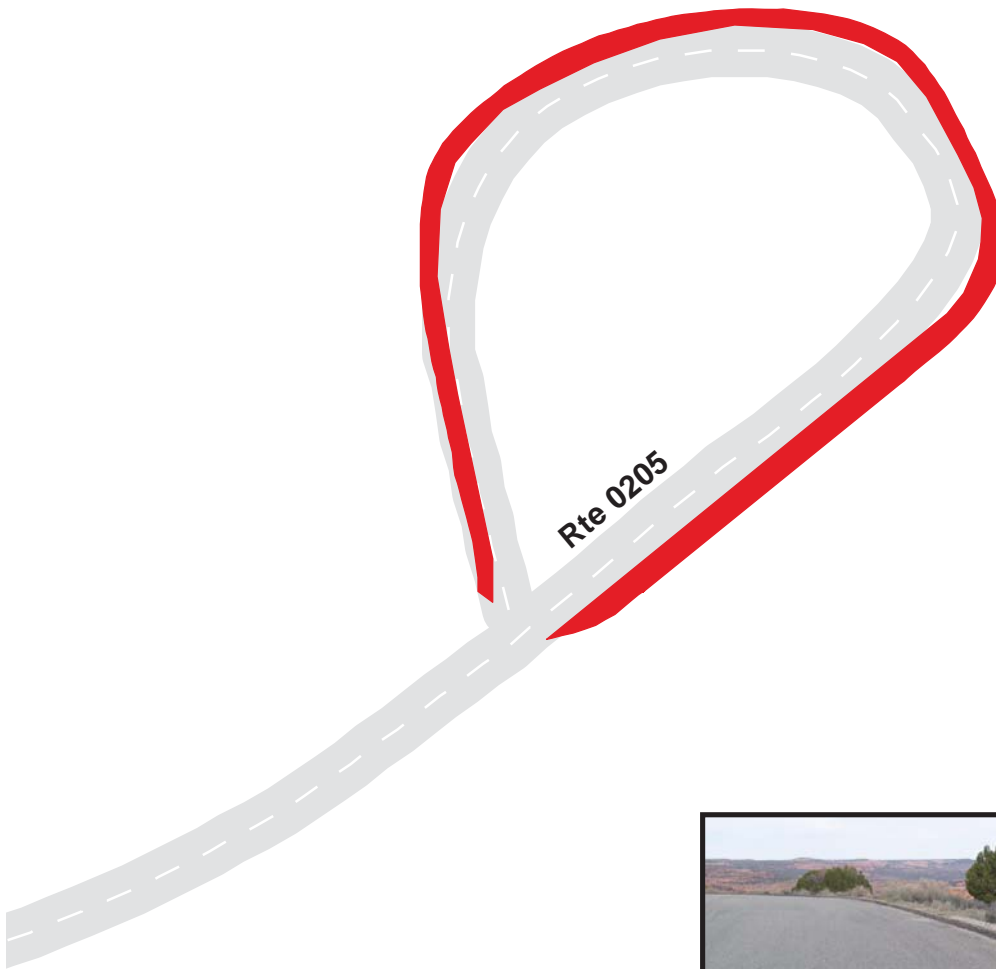
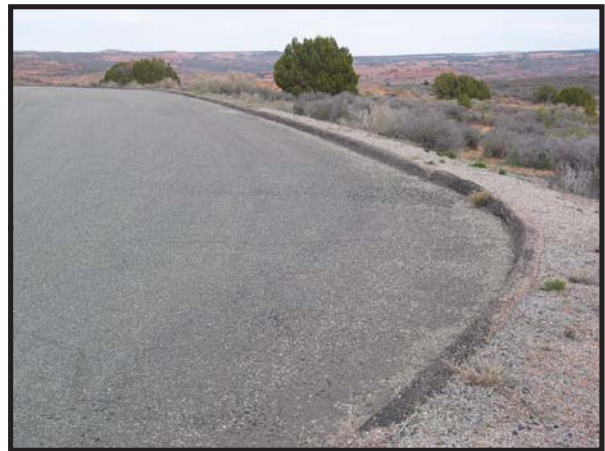
Route 0906

Route	Public / NonPublic	Date Visited	Area (sq ft)	Lane Miles *	Surface Type	Condition / PCR
0906	Public	4/1/2003	11908	0.21	AS	FAIR / 73

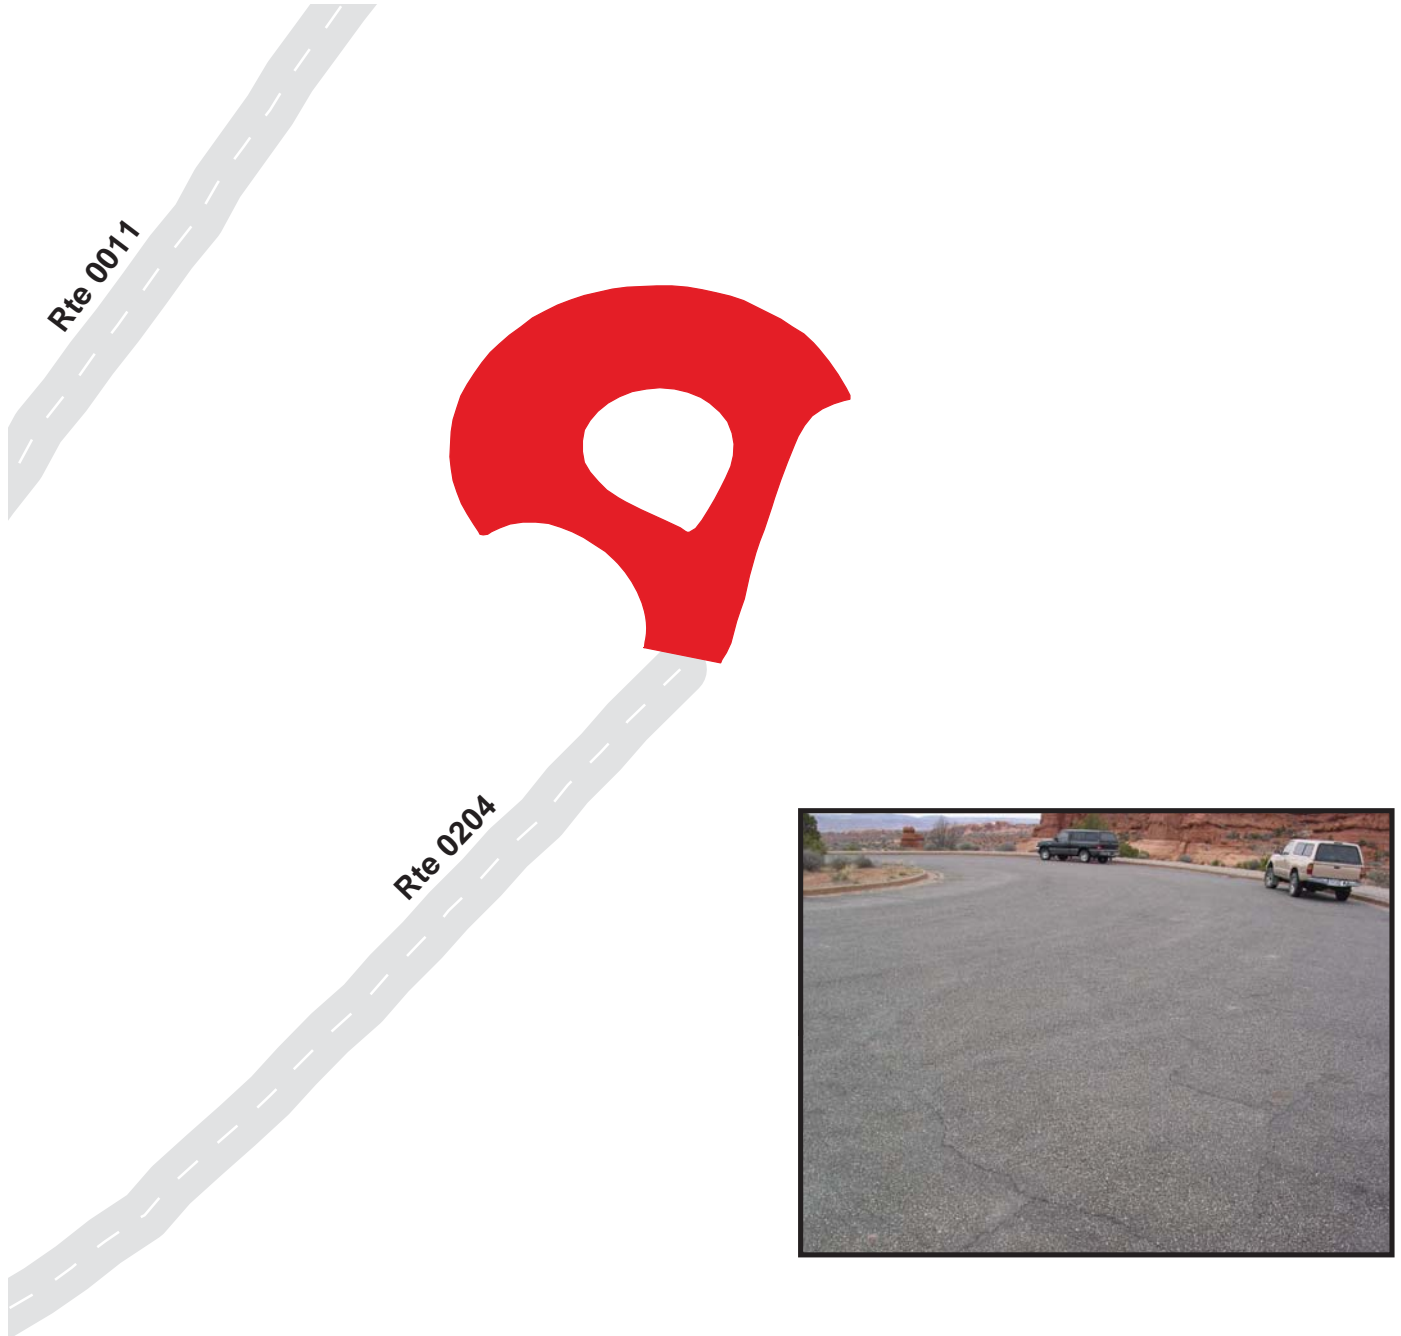
Arches National Park
Route 0907
 GARDEN OF EDEN PARKING
 At End of Route 0204

Route	Public / NonPublic	Date Visited	Area (sq ft)	Lane Miles *	Surface Type	Condition / PCR
0907	Public	4/1/2003	10340	0.18	OC	FAIR / 73

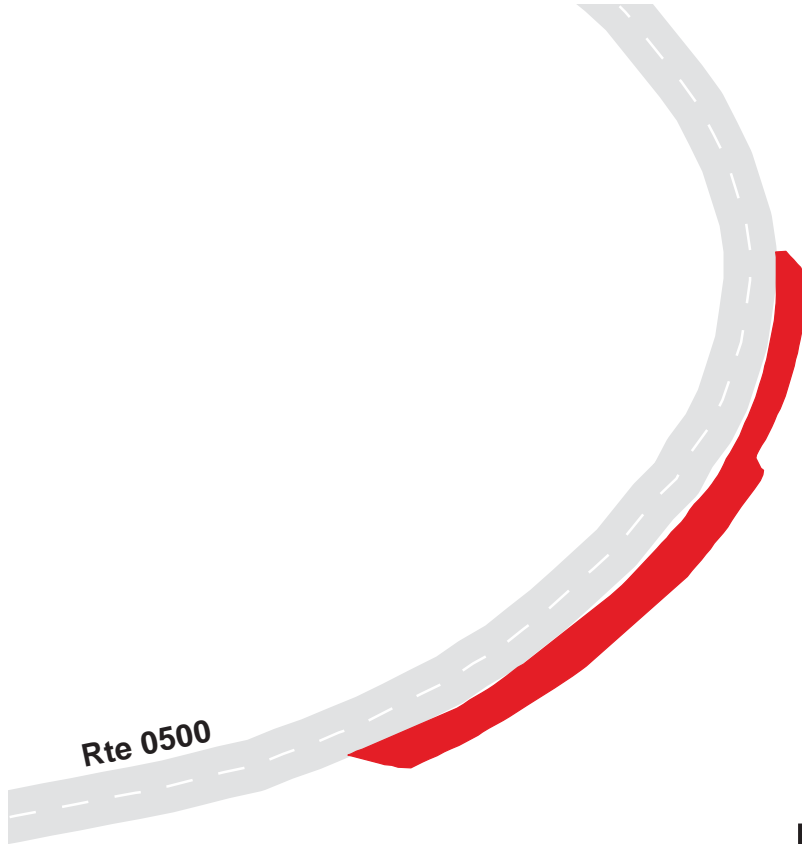
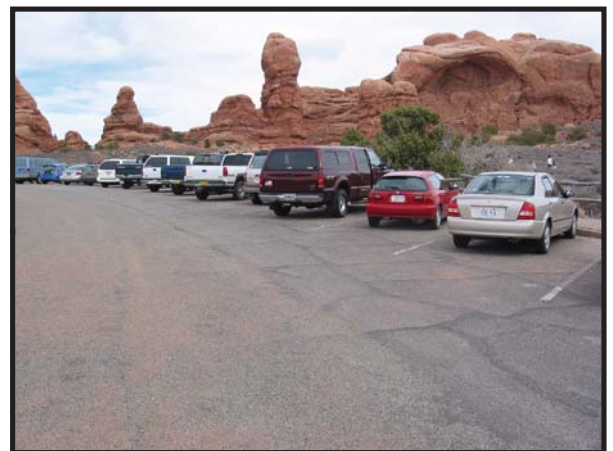
Route 0908A

Route	Public / NonPublic	Date Visited	Area (sq ft)	Lane Miles *	Surface Type	Condition / PCR
0908A	Public	4/1/2003	6777	0.12	OC	FAIR / 73

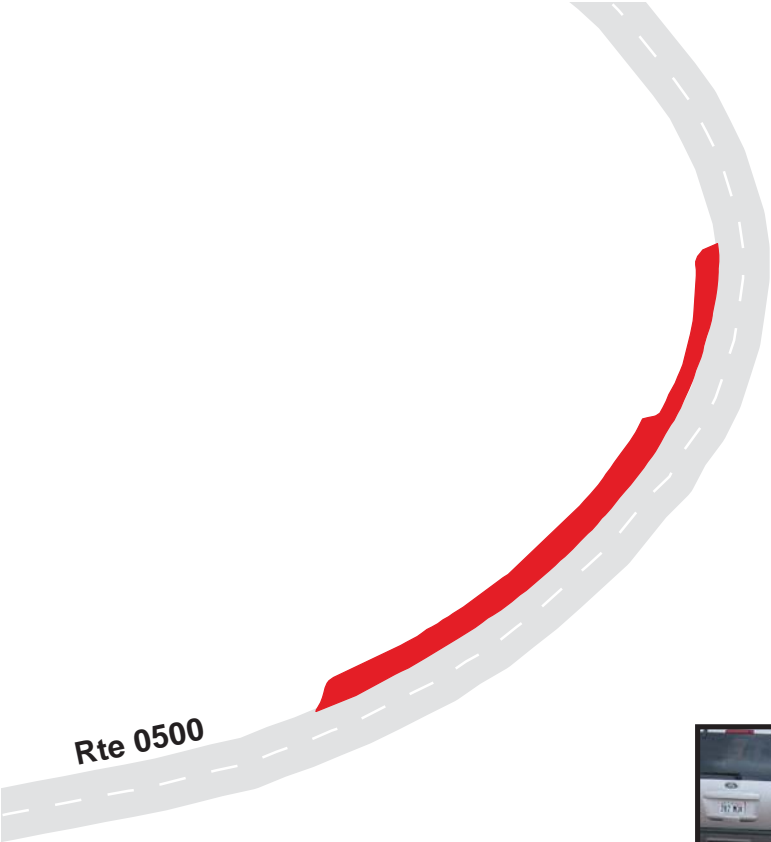
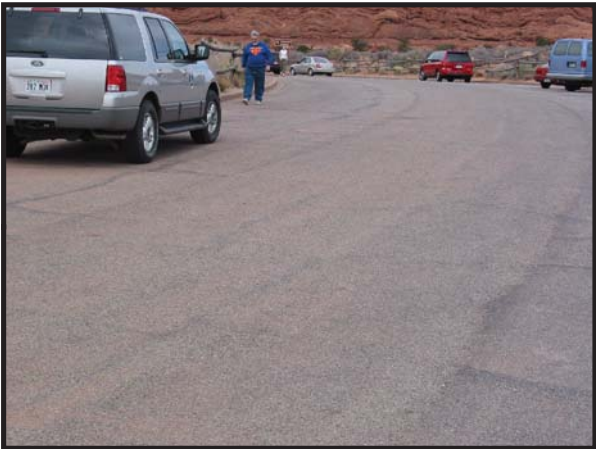
Route 0908B

Route	Public / NonPublic	Date Visited	Area (sq ft)	Lane Miles *	Surface Type	Condition / PCR
0908B	Public	4/1/2003	4006	0.07	OC	FAIR / 73

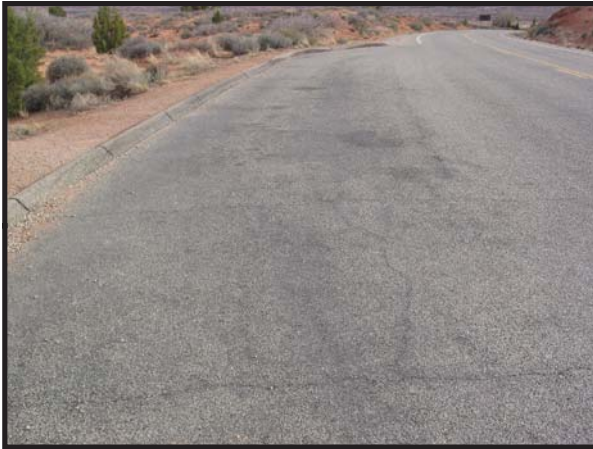
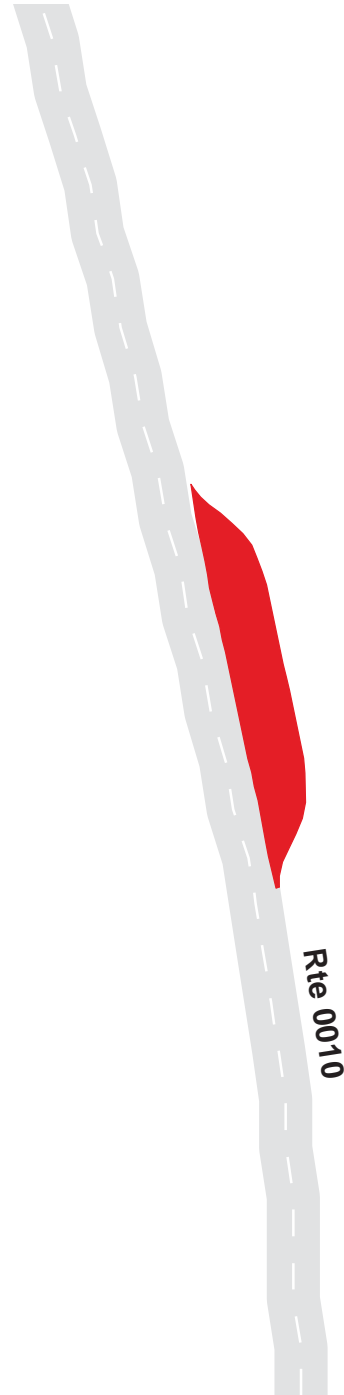
Arches National Park
Route 0909
 PETRIFIED DUNES PARKING
 Adjacent to Route 0010 at MP 6.2

Route	Public / NonPublic	Date Visited	Area (sq ft)	Lane Miles *	Surface Type	Condition / PCR
0909	Public	4/1/2003	1895	0.03	AS	FAIR / 73
