The Road Inventory of Arches National Park ARCH - 1348

Road Inventory Program

Prepared By:
Federal Highway Administration
Eastern Federal Lands Highway Division
Cycle 3

Arches National Park in Utah

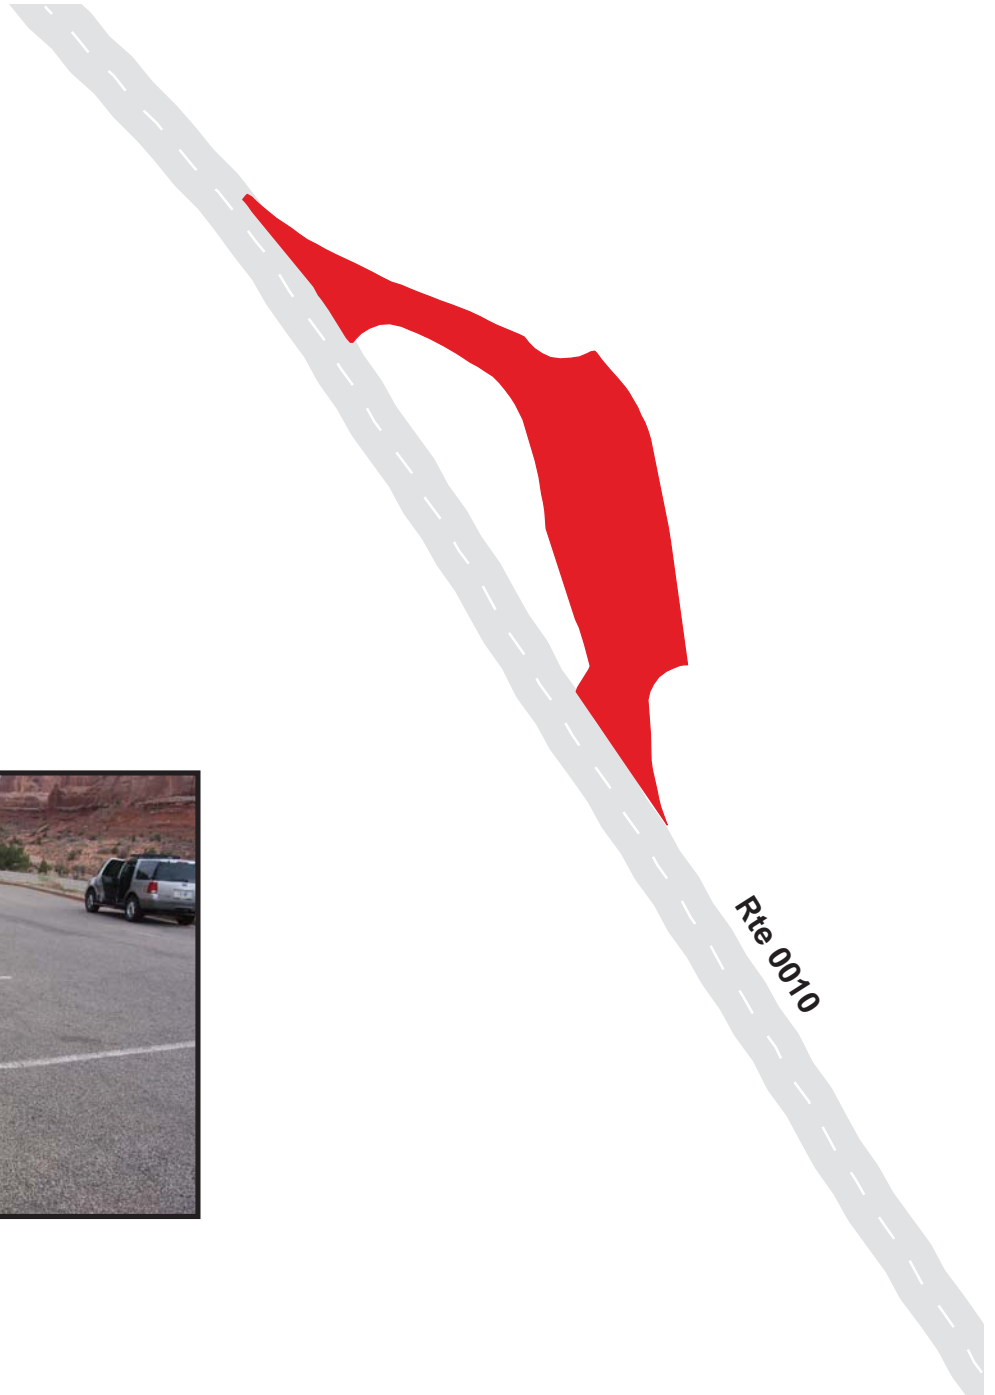
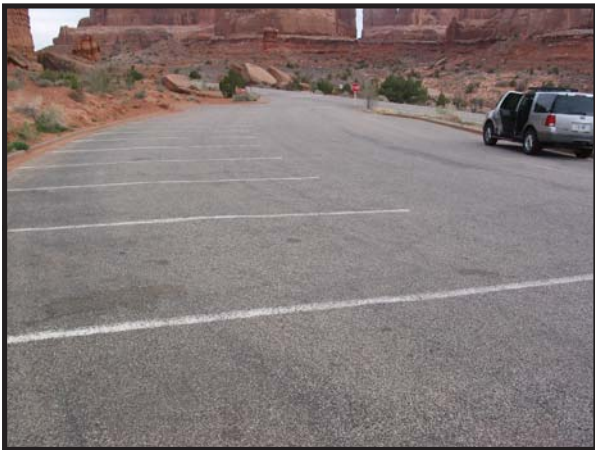
Arches National Park
Route 0910
 COURTHOUSE TOWERS PARKING
 Adjacent to Route 0010 at MP 3.8

Route	Public / NonPublic	Date Visited	Area (sq ft)	Lane Miles *	Surface Type	Condition / PCR
0910	Public	4/1/2003	14585	0.25	OC	GOOD / 90

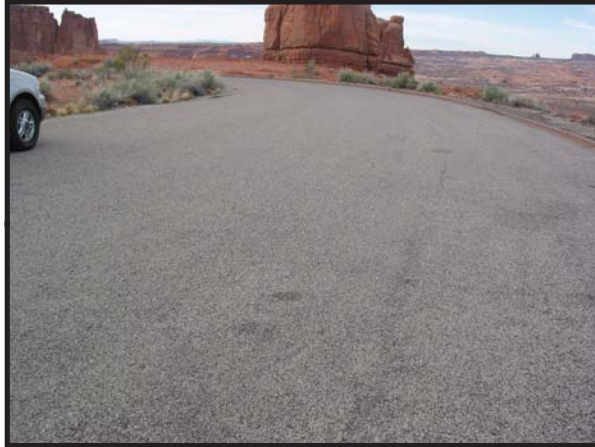
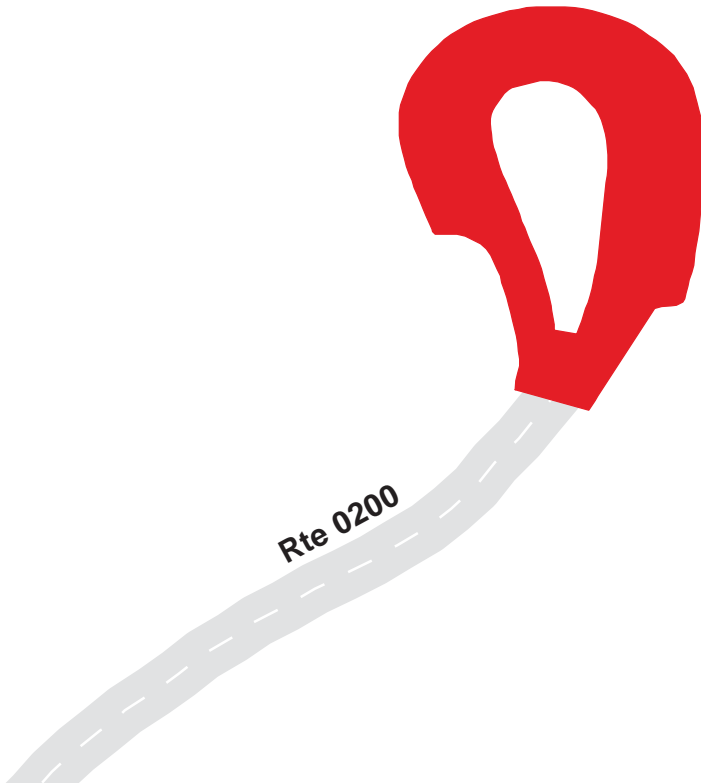
Route 0911

Route	Public / NonPublic	Date Visited	Area (sq ft)	Lane Miles *	Surface Type	Condition / PCR
0911	Public	4/1/2003	16570	0.29	OC	GOOD / 90

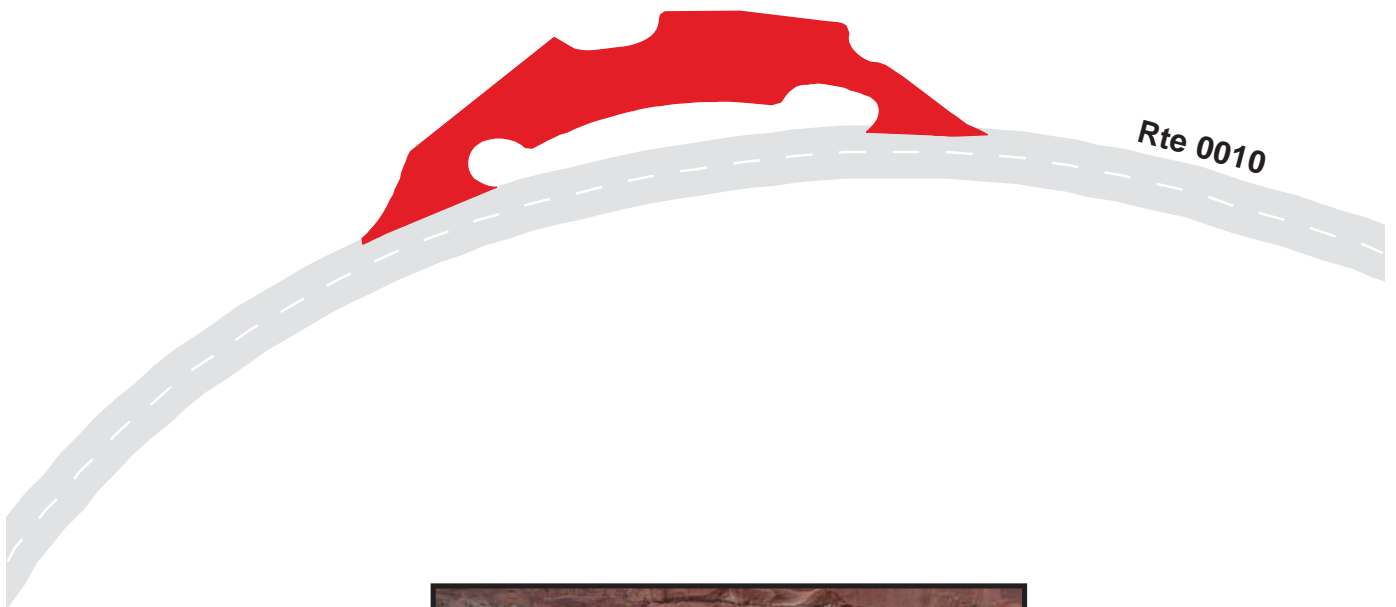
Arches National Park
Route 0912
PARK AVENUE PARKING
Adjacent to Route 0010 at MP 2.5

Route	Public / NonPublic	Date Visited	Area (sq ft)	Lane Miles *	Surface Type	Condition / PCR
0912	Public	4/1/2003	16977	0.29	OC	GOOD / 90

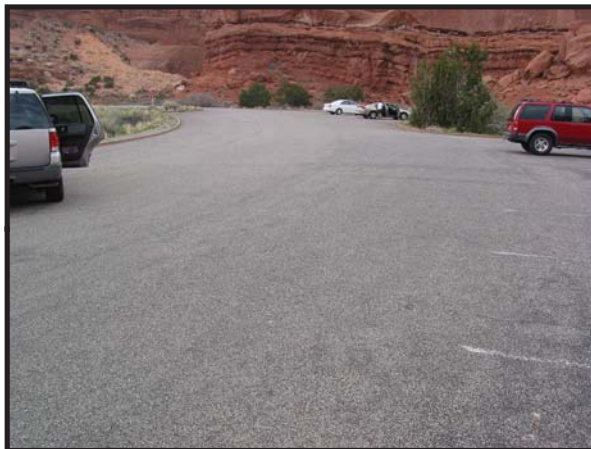
Arches National Park
Route 0913
 VISITOR CENTER PARKING
 Adjacent to Route 0010 at MP 0.3

Route	Public / NonPublic	Date Visited	Area (sq ft)	Lane Miles *	Surface Type	Condition / PCR
0913	Public	4/1/2003	34025	0.59	AS	GOOD / 90

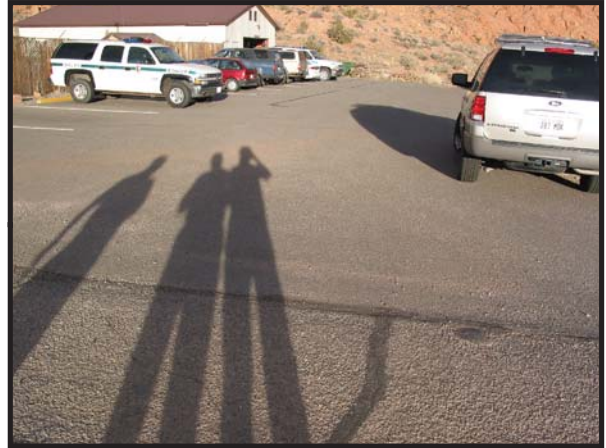
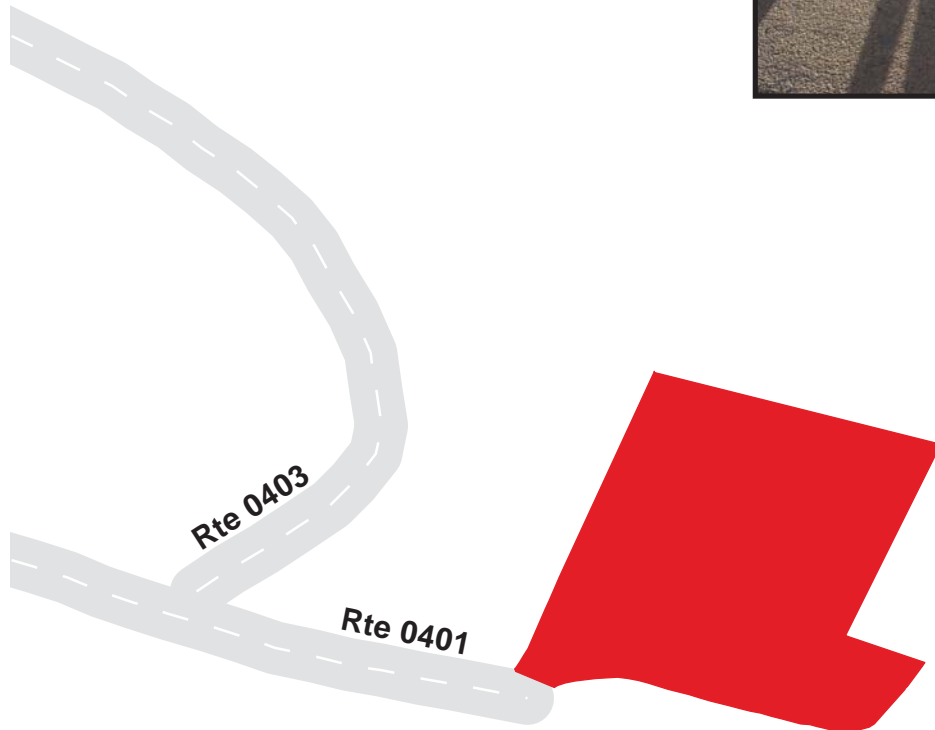
Route 0914

Route	Public / NonPublic	Date Visited	Area (sq ft)	Lane Miles *	Surface Type	Condition / PCR
0914	Public	4/1/2003	18585	0.32	AS	GOOD / 90

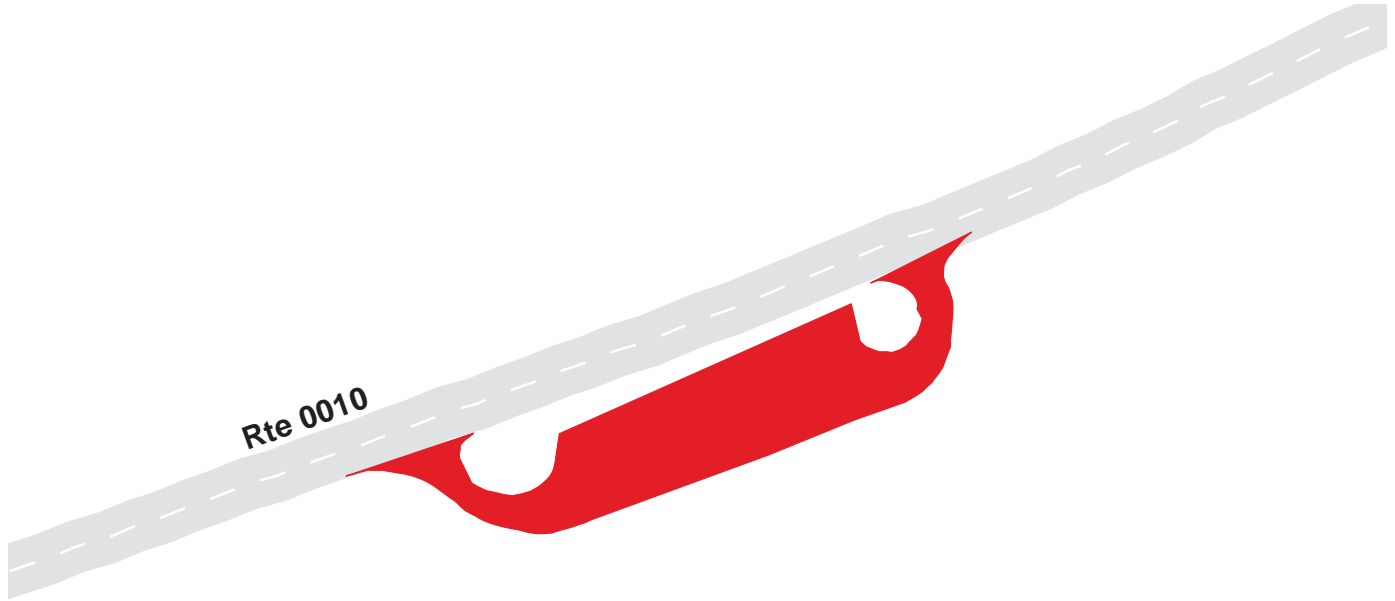
Arches National Park
Route 0915
 BALANCED ROCK PARKING
 Adjacent to Route 0010 at MP 9.1

Route	Public / NonPublic	Date Visited	Area (sq ft)	Lane Miles *	Surface Type	Condition / PCR
0915	Public	4/1/2003	13407	0.23	AS	GOOD / 90

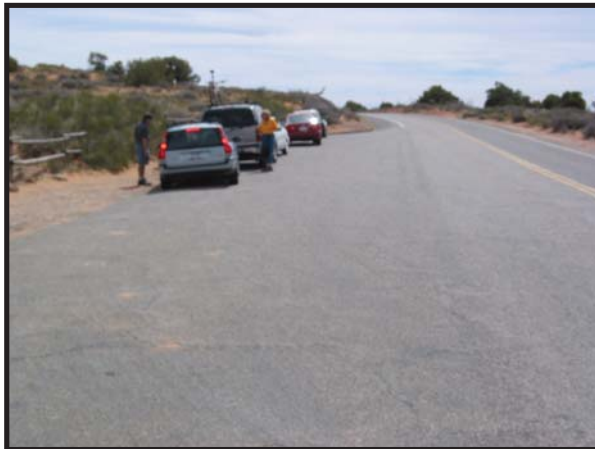
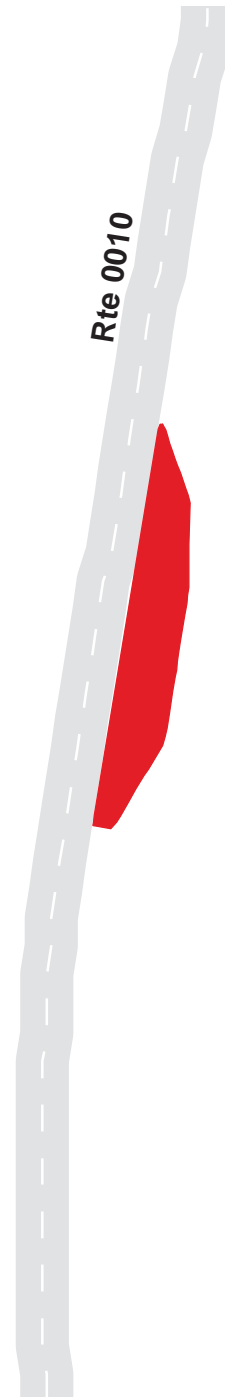
Route 0916

Route	Public / NonPublic	Date Visited	Area (sq ft)	Lane Miles *	Surface Type	Condition / PCR
0916	Public	4/1/2003	5897	0.10	OC	GOOD / 90

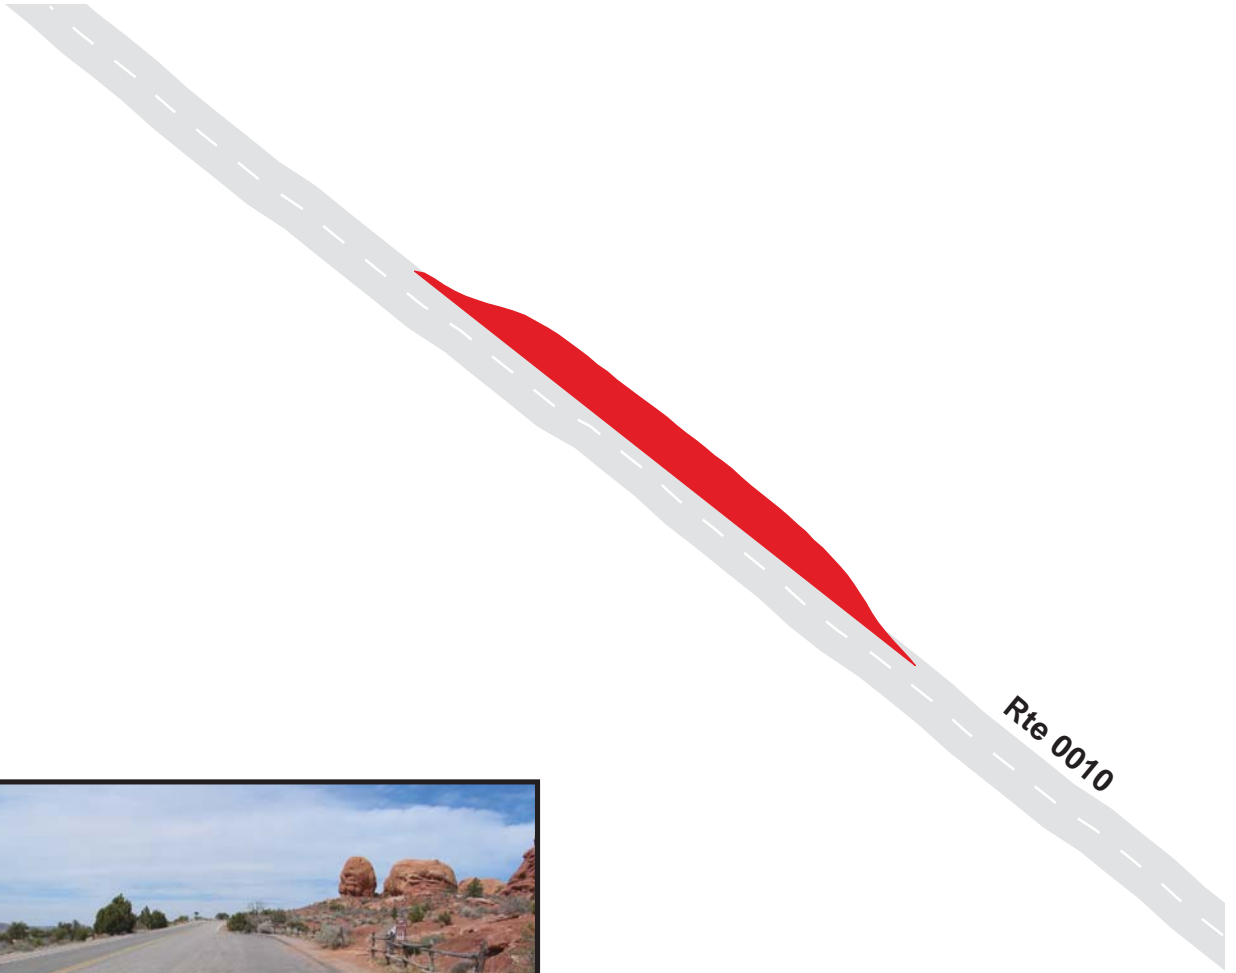
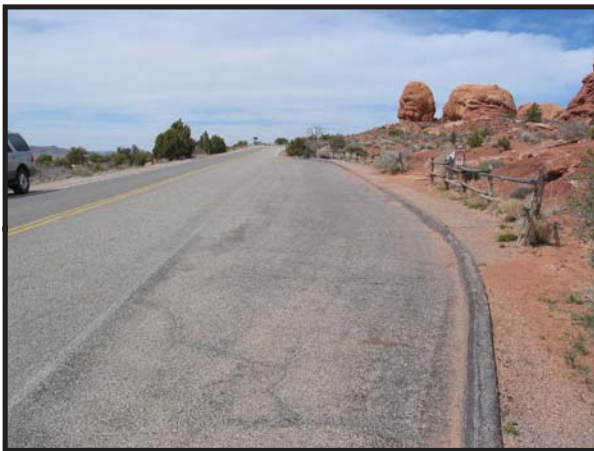
Route 0917

Route	Public / NonPublic	Date Visited	Area (sq ft)	Lane Miles *	Surface Type	Condition / PCR
0917	Public	4/1/2003	3042	0.05	OC	GOOD / 90

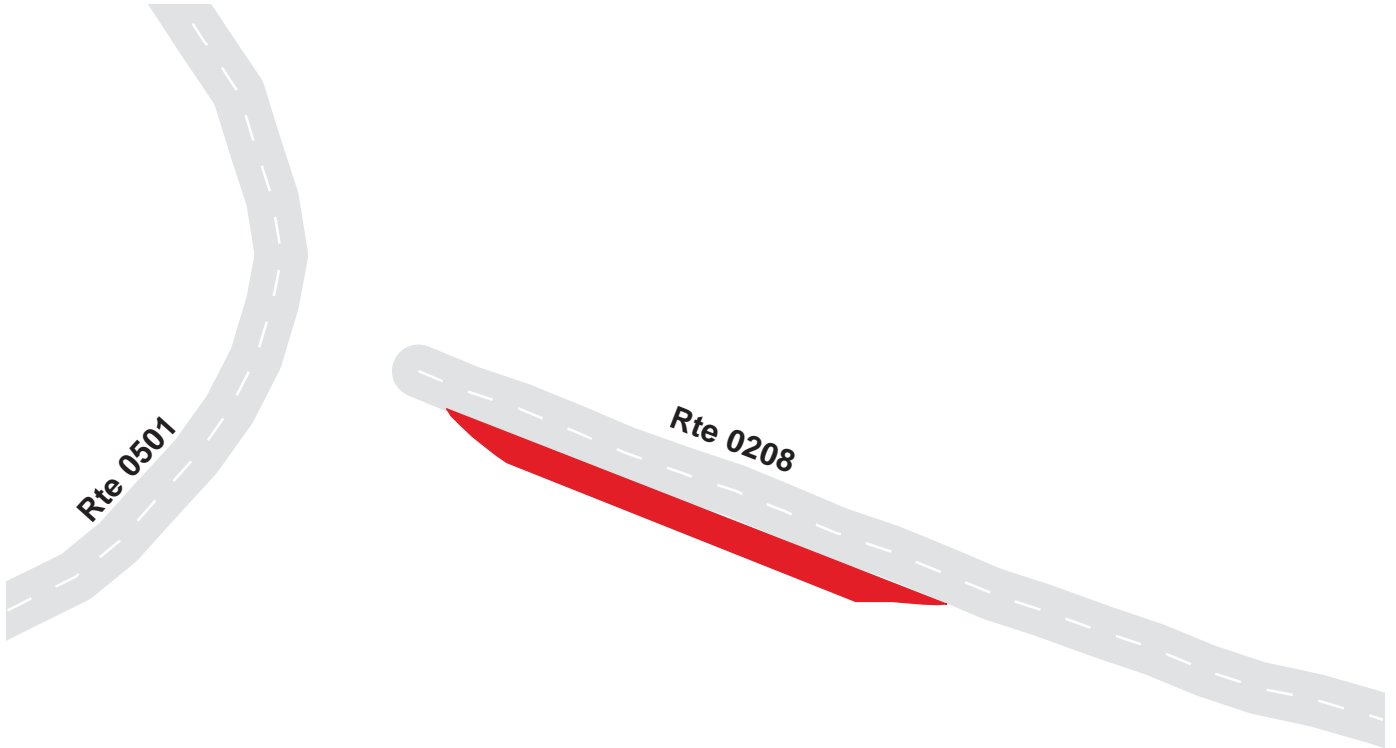
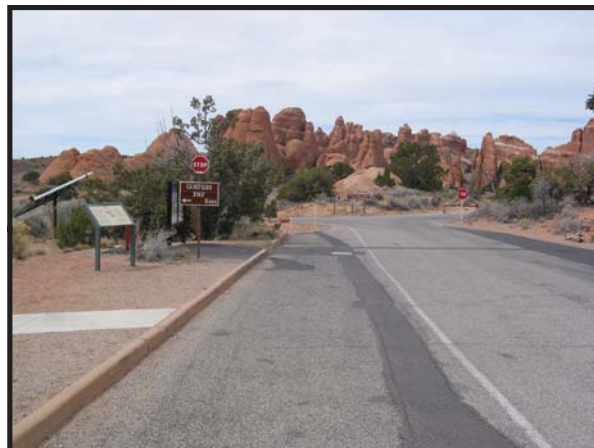
Route 0918

Route	Public / NonPublic	Date Visited	Area (sq ft)	Lane Miles *	Surface Type	Condition / PCR
0918	Public	4/1/2003	1123	0.02	AS	FAIR / 73

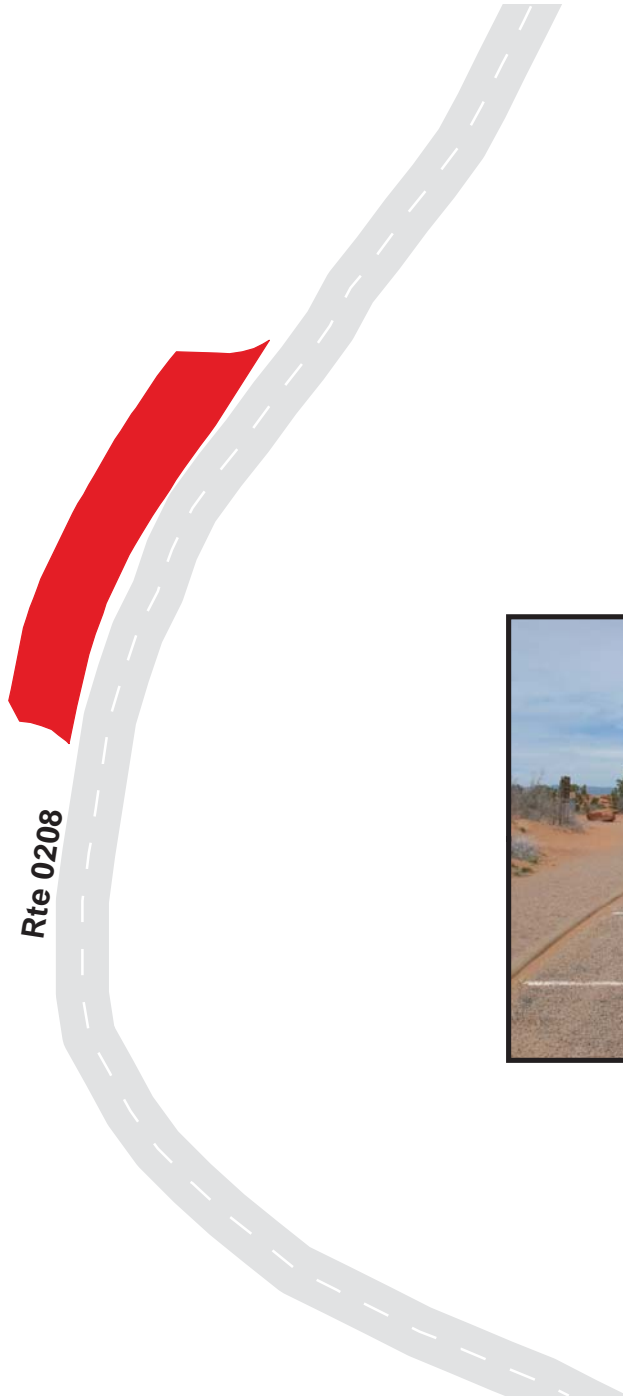
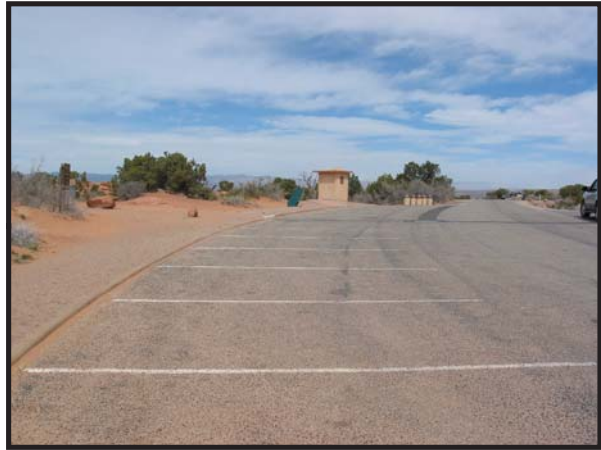
Route 0919

Route	Public / NonPublic	Date Visited	Area (sq ft)	Lane Miles *	Surface Type	Condition / PCR
0919	Public	4/1/2003	3779	0.07	AS	FAIR / 73

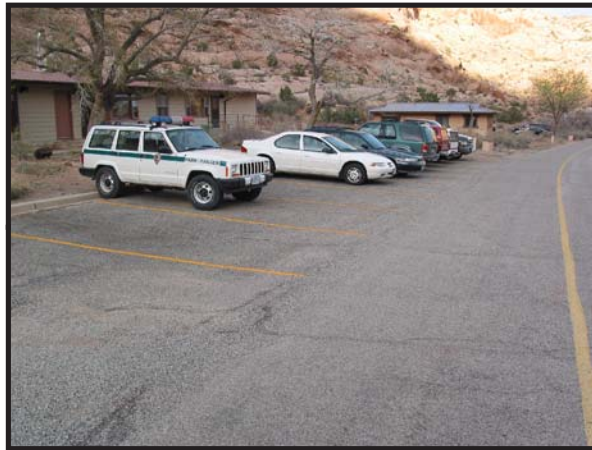
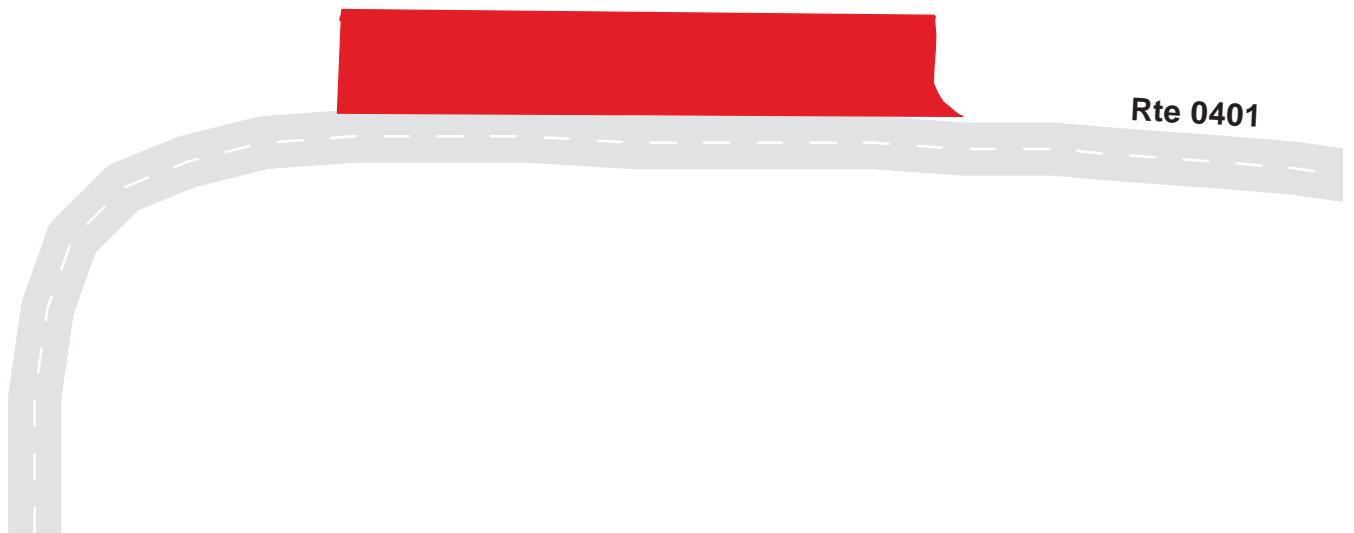
Route 0920

Route	Public / NonPublic	Date Visited	Area (sq ft)	Lane Miles *	Surface Type	Condition / PCR
0920	NonPublic	4/1/2003	2295	0.04	OC	GOOD / 90

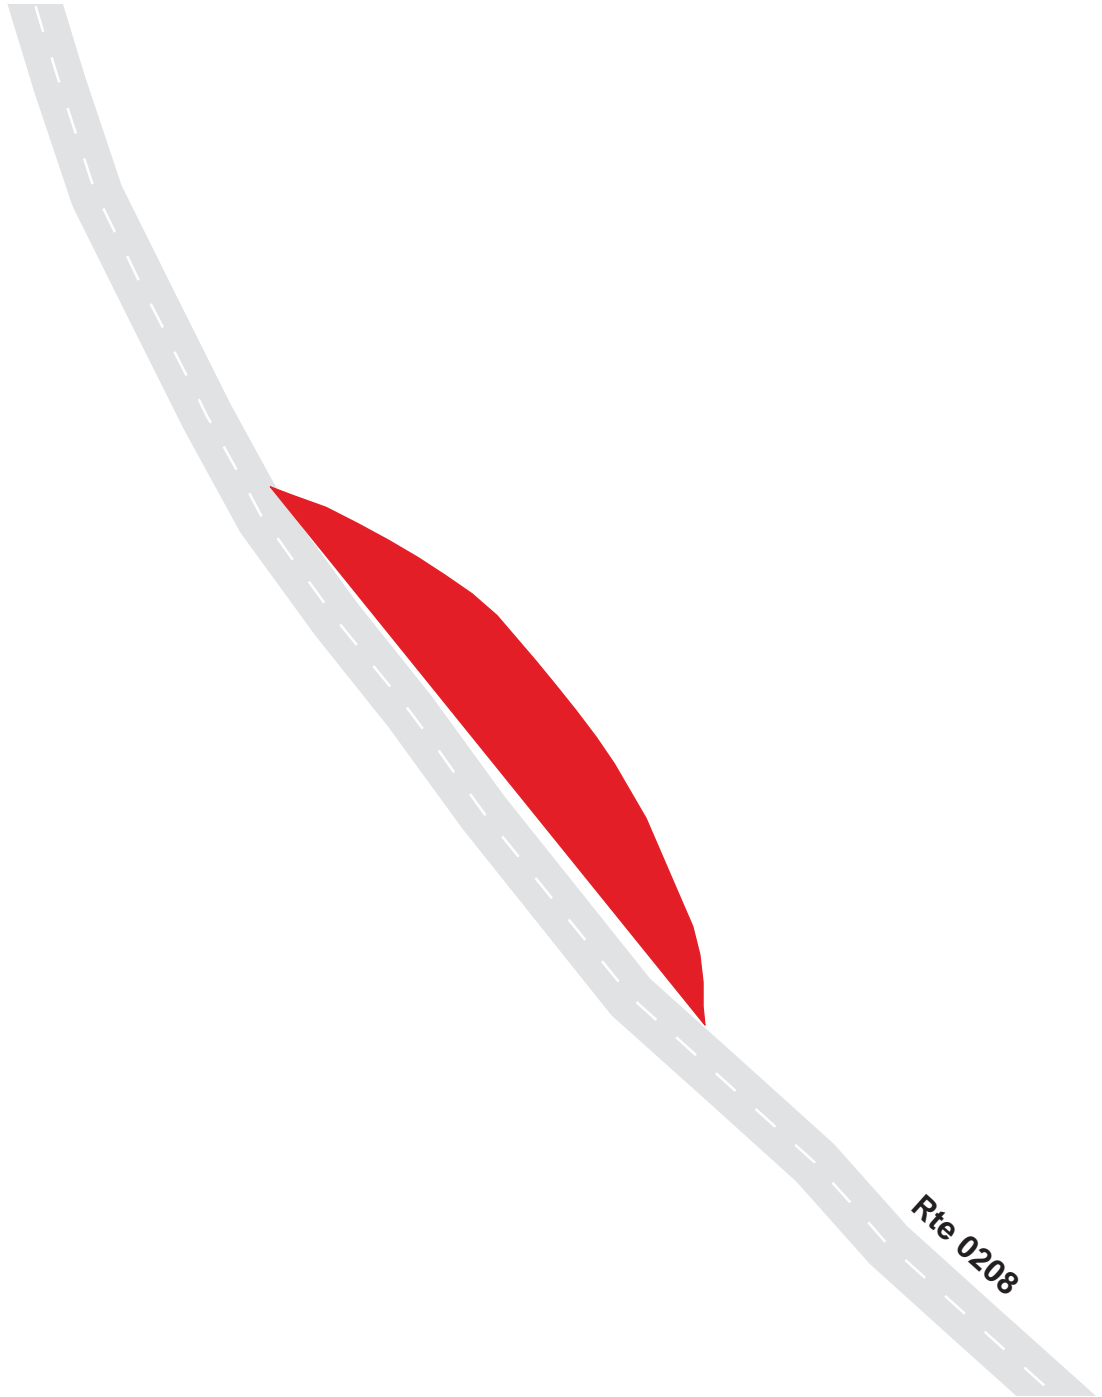
Arches National Park
Route 0921
 CAMPGROUND RESTROOM PARKING
 Adjacent to Route 0208

Route	Public / NonPublic	Date Visited	Area (sq ft)	Lane Miles *	Surface Type	Condition / PCR
0921	Public	4/1/2003	849	0.01	AS	FAIR / 73

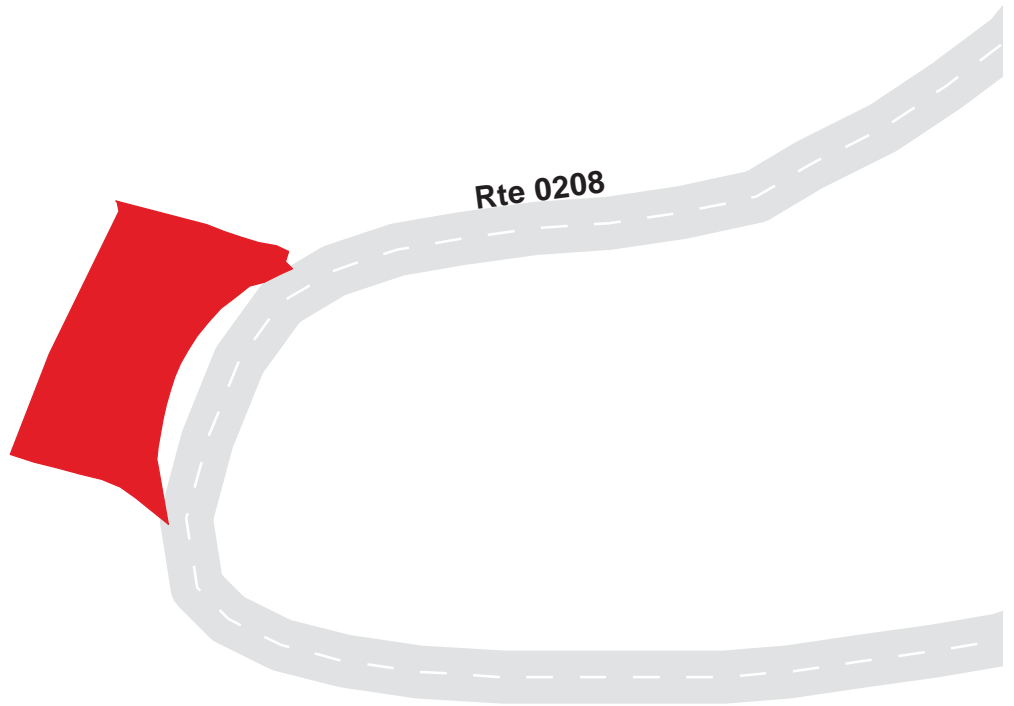
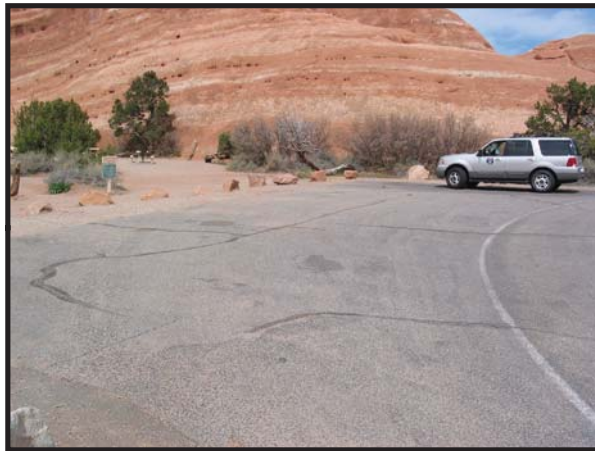
Arches National Park
Route 0922
 JUNIPER GROUP CAMPGROUND PARKING
 Adjacent to Route 0208

Route	Public / NonPublic	Date Visited	Area (sq ft)	Lane Miles *	Surface Type	Condition / PCR
0922	Public	4/1/2003	2115	0.04	OC	FAIR / 73

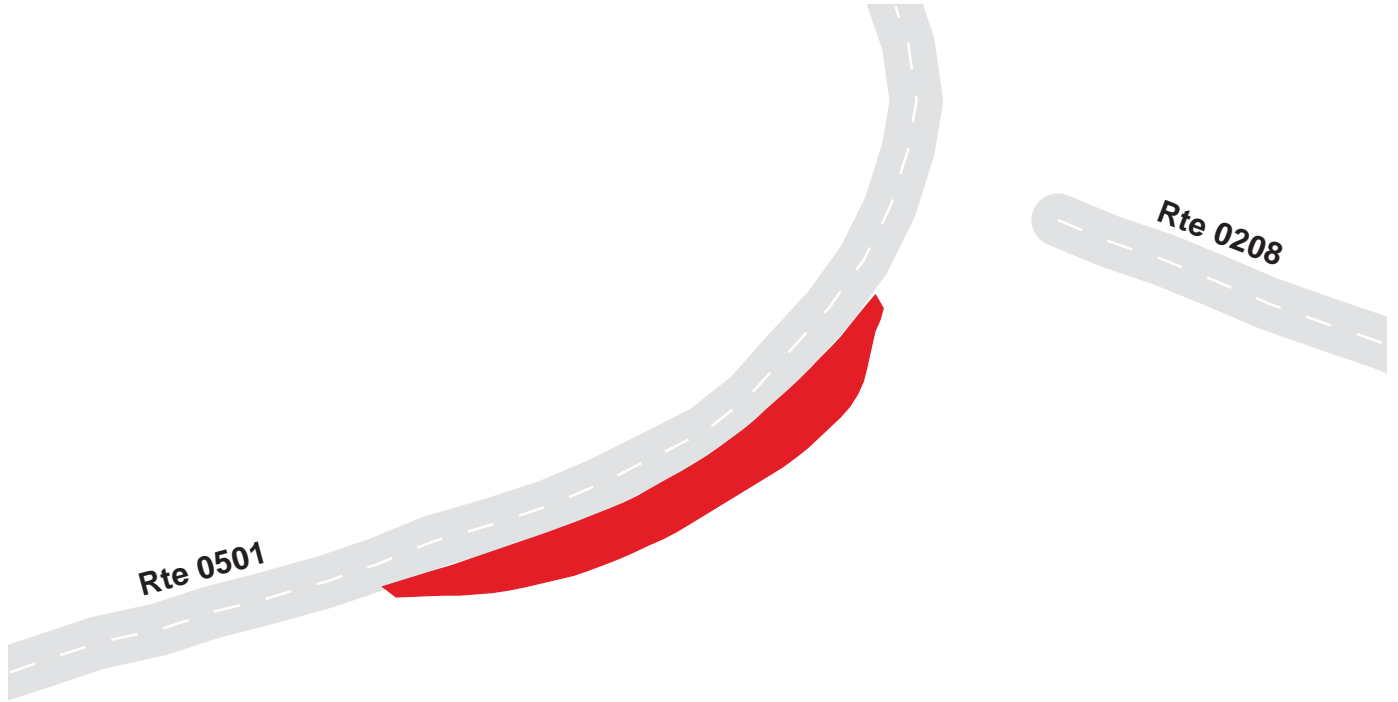
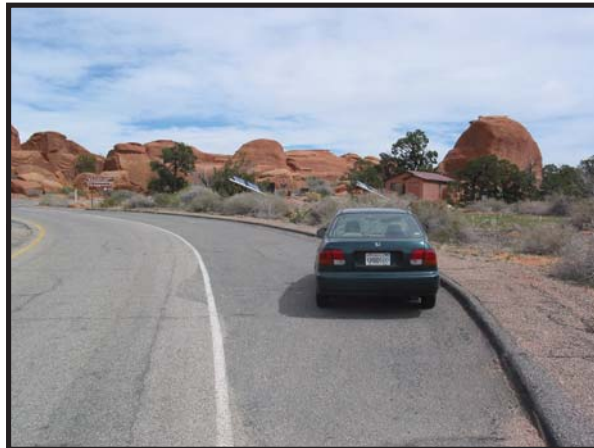
Arches National Park
Route 0923
 CAMPGROUND PARKING
 Adjacent to Route 0501

Route	Public / NonPublic	Date Visited	Area (sq ft)	Lane Miles *	Surface Type	Condition / PCR
0923	Public	4/1/2003	1991	0.03	AS	FAIR / 73

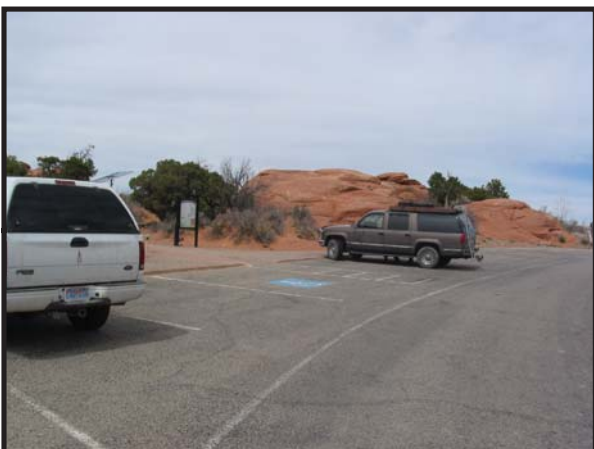
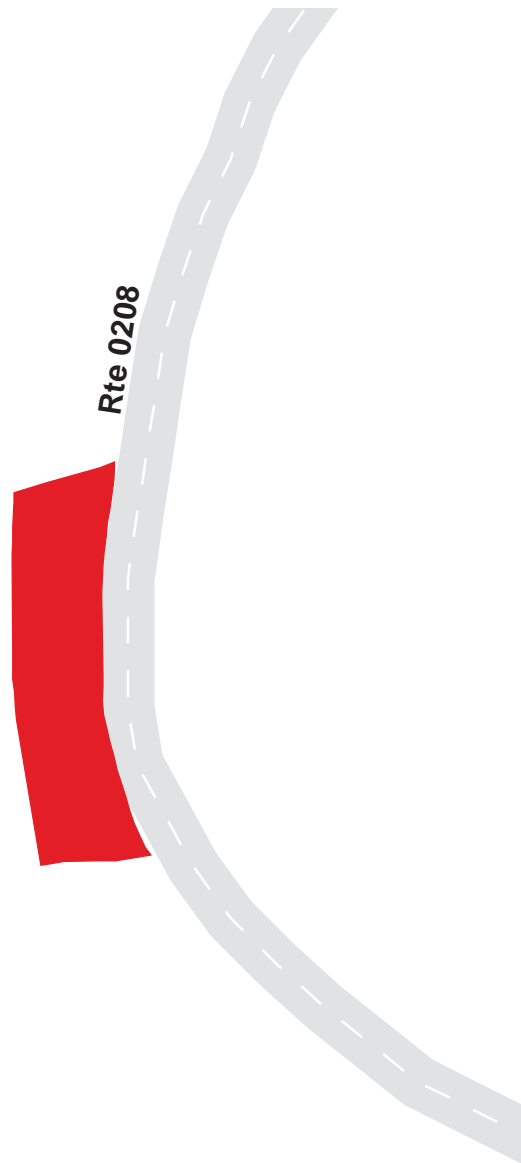
Route 0924

Route	Public / NonPublic	Date Visited	Area (sq ft)	Lane Miles *	Surface Type	Condition / PCR
0924	Public	4/1/2003	2460	0.04	AS	FAIR / 73

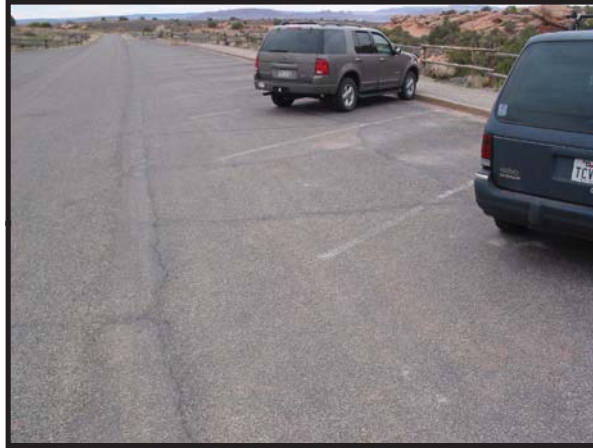
Arches National Park
Route 0925B
 DOUBLE ARCH PARKING B
 Adjacent to Route 0500

Route	Public / NonPublic	Date Visited	Area (sq ft)	Lane Miles *	Surface Type	Condition / PCR
0925B	Public	4/1/2003	4735	0.08	OC	FAIR / 73

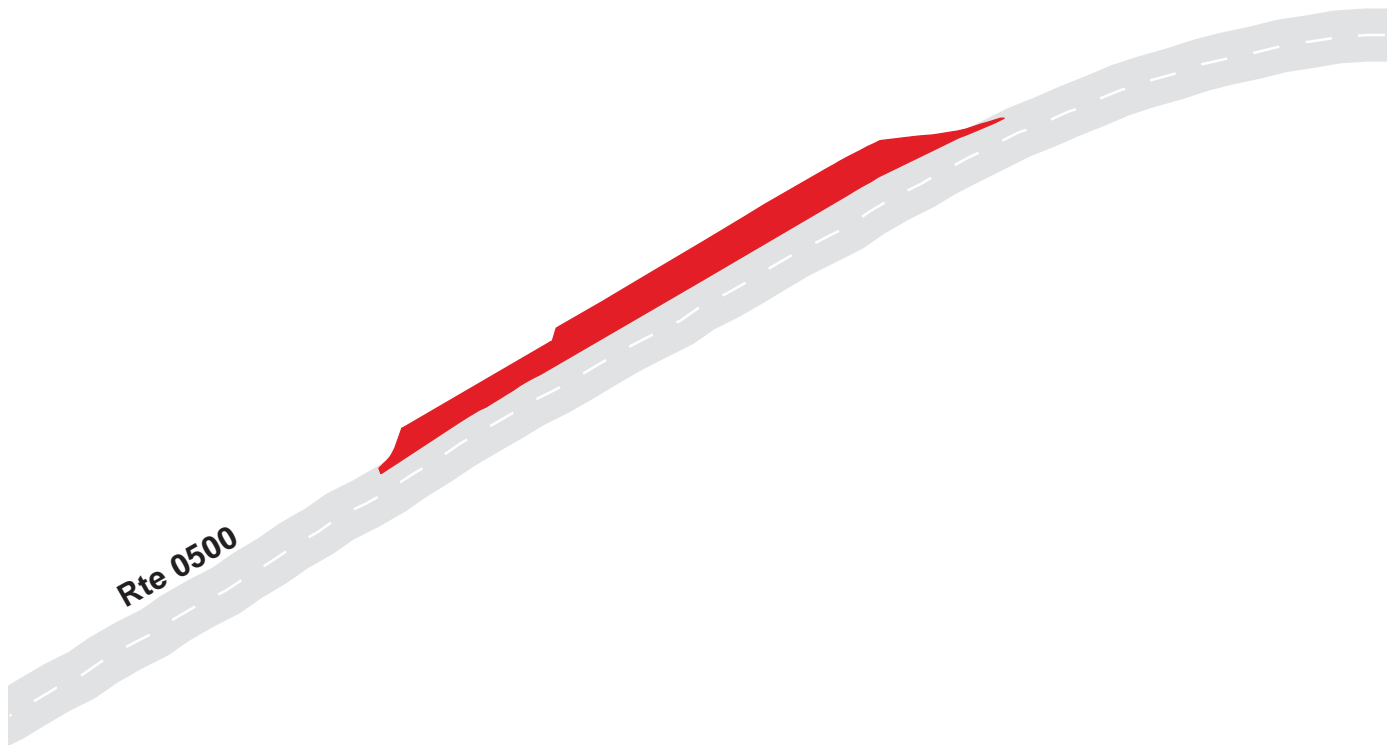
Arches National Park
Route 0925A
 DOUBLE ARCH PARKING A
 Adjacent to Route 0500

Route	Public / NonPublic	Date Visited	Area (sq ft)	Lane Miles *	Surface Type	Condition / PCR
0925A	Public	4/1/2003	6309	0.11	OC	FAIR / 73

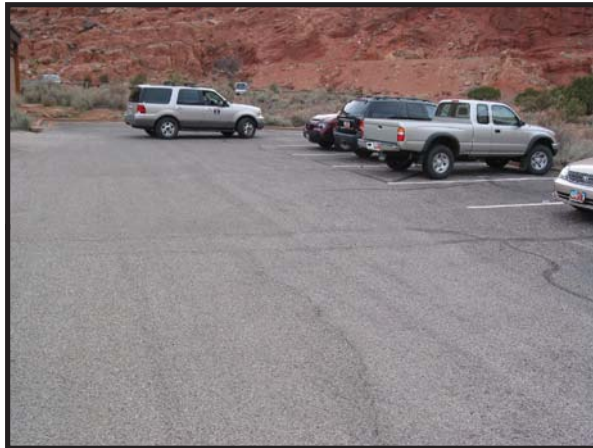
Arches National Park
Route 0927
 ADMINISTRATIVE PARKING
 Adjacent to Route 0404

Route	Public / NonPublic	Date Visited	Area (sq ft)	Lane Miles *	Surface Type	Condition / PCR
0927	NonPublic	4/1/2003	1354	0.02	AS	GOOD / 90
