# The Road Inventory of Arkansas Post National Memorial ARPO - 7110

## Road Inventory Program

Prepared By:  
Federal Highway Administration  
Eastern Federal Lands Highway Division  
Cycle 3

# Arkansas Post National Memorial in Arkansas

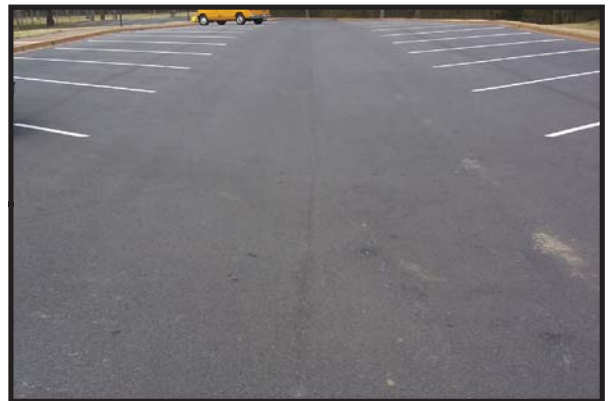
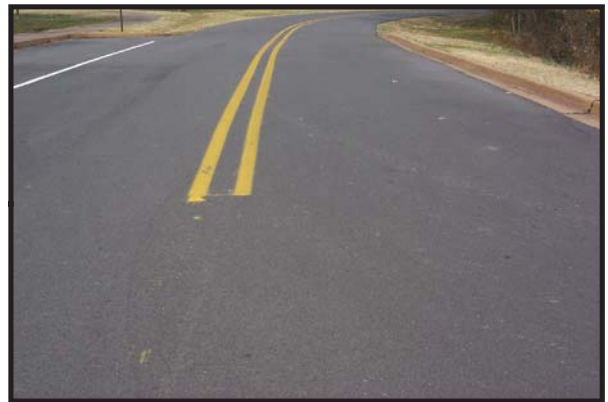
## Route 0900

Route	Public / NonPublic	Date Visited	Area (sq ft)	Lane Miles *	Surface Type	Condition / PCR
0900	Public	3/8/2002	35055	0.60	AS	GOOD / 90

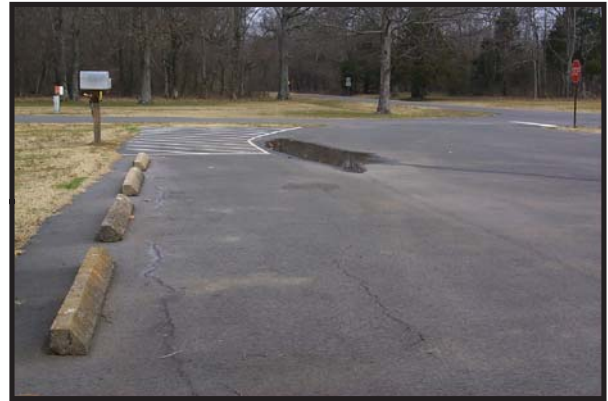
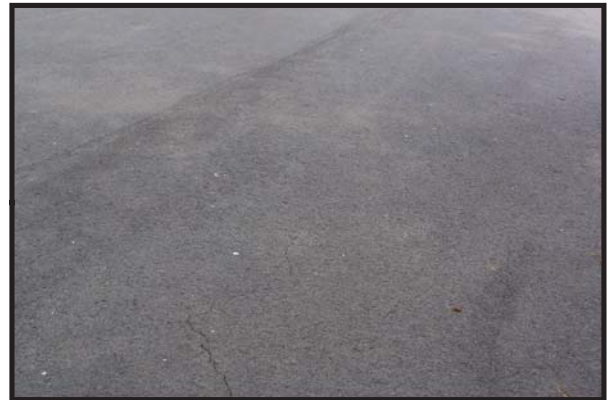
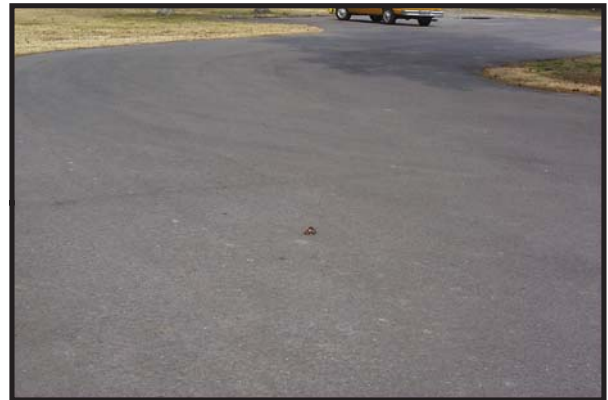
## Route 0901

Route	Public / NonPublic	Date Visited	Area (sq ft)	Lane Miles *	Surface Type	Condition / PCR
0901	NonPublic	3/8/2002	8641	0.15	AS	FAIR / 73

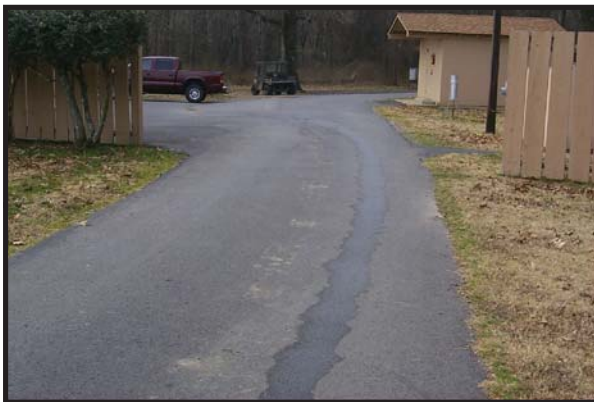
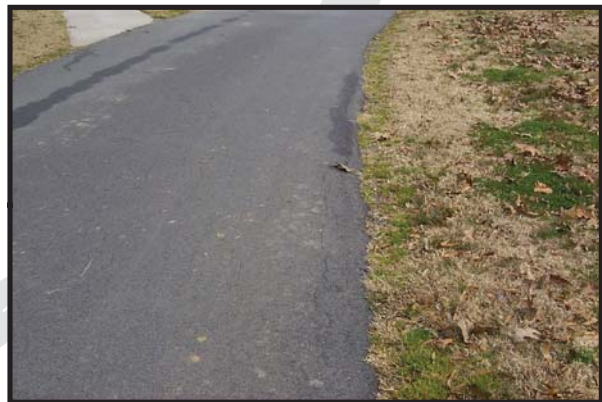
## Route 0902

Route	Public / NonPublic	Date Visited	Area (sq ft)	Lane Miles *	Surface Type	Condition / PCR
0902	NonPublic	3/8/2002	8304	0.14	AS	FAIR / 73

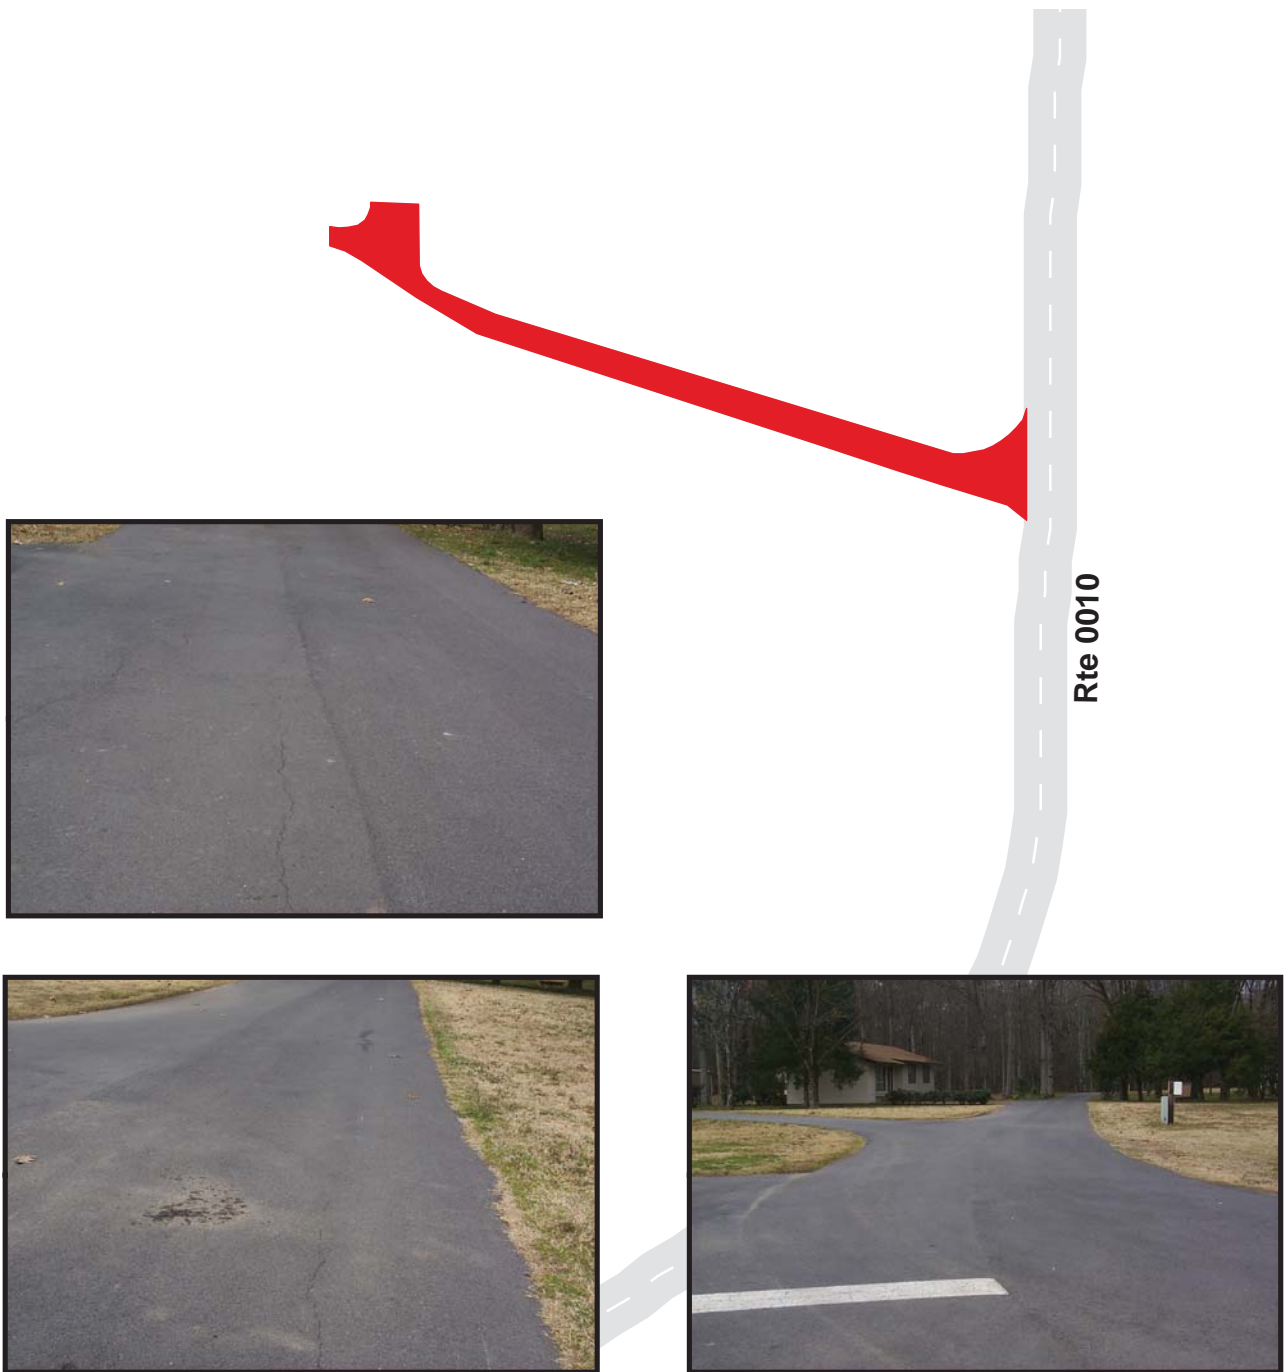
## Route 0903

Route	Public / NonPublic	Date Visited	Area (sq ft)	Lane Miles *	Surface Type	Condition / PCR
0903	NonPublic	3/8/2002	6961	0.12	AS	GOOD / 90

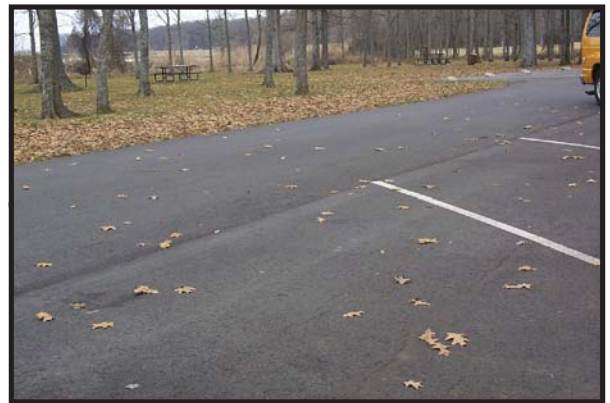
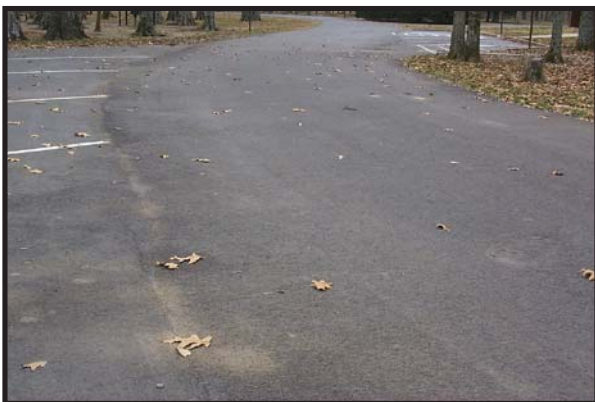
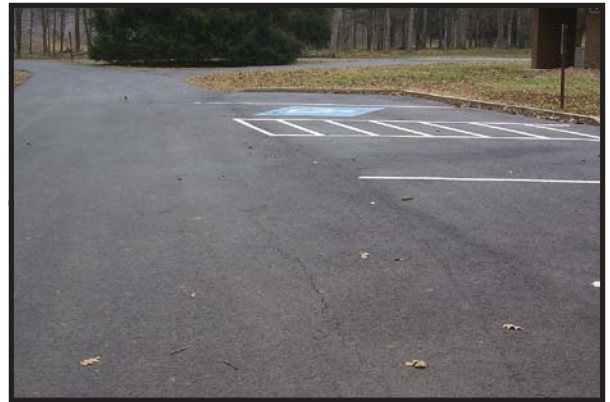
## Route 0904

Route	Public / NonPublic	Date Visited	Area (sq ft)	Lane Miles *	Surface Type	Condition / PCR
0904	Public	3/8/2002	22733	0.39	AS	GOOD / 90

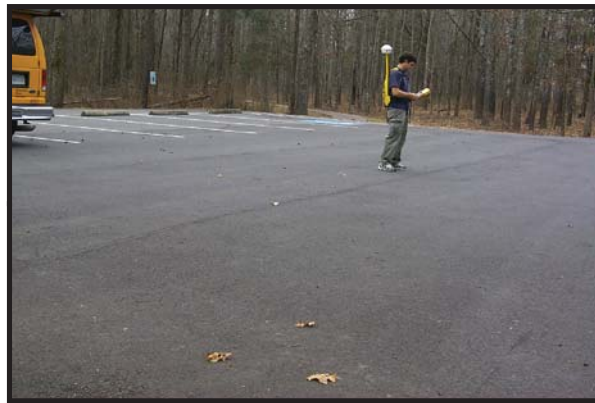
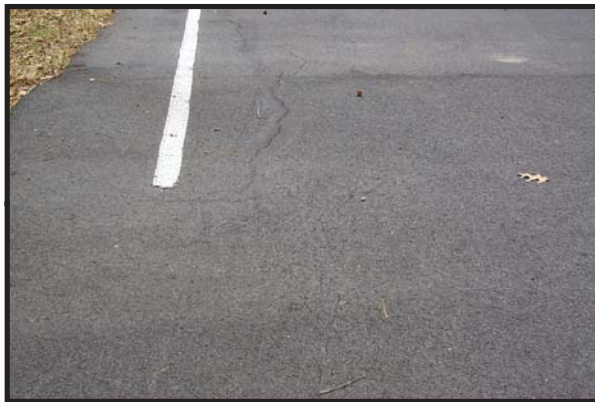
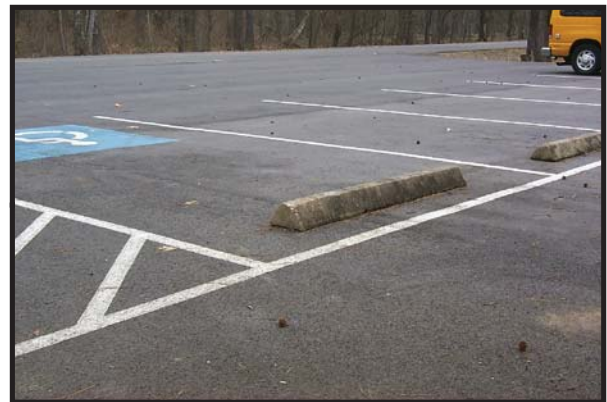
## Route 0905

Route	Public / NonPublic	Date Visited	Area (sq ft)	Lane Miles *	Surface Type	Condition / PCR
0905	Public	3/8/2002	5144	0.09	AS	GOOD / 90

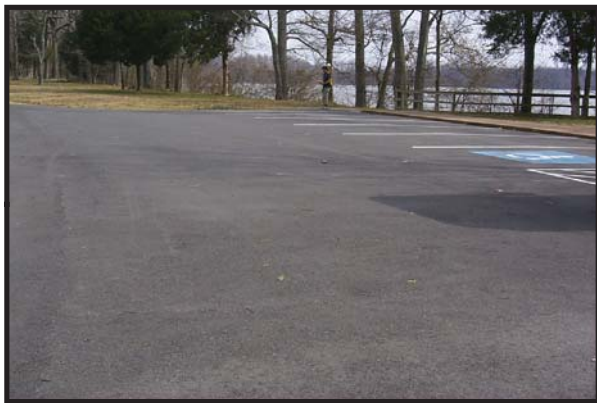
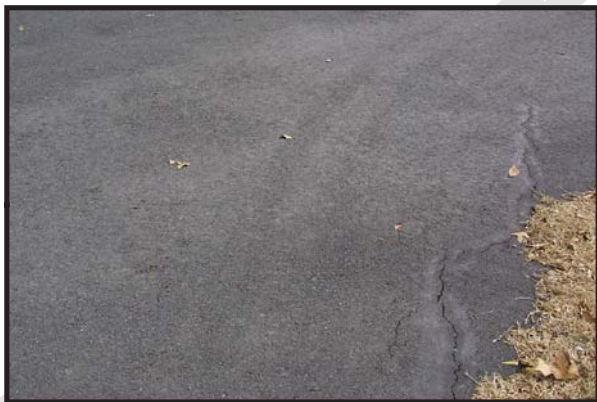
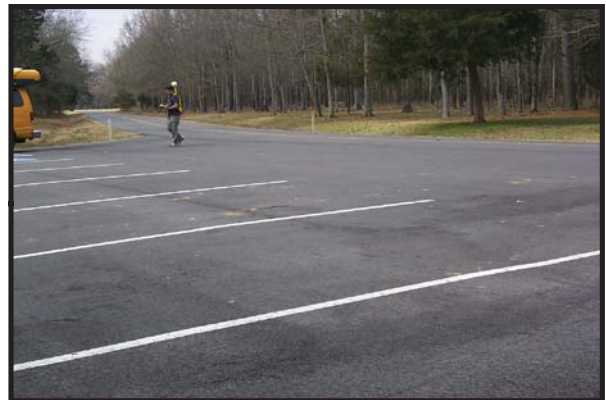
## Route 0906

Route	Public / NonPublic	Date Visited	Area (sq ft)	Lane Miles *	Surface Type	Condition / PCR
0906	Public	3/8/2002	3775	0.06	AS	GOOD / 90
