The Road Inventory of Assateague Island National Lakeshore ASIS - 4190

Road Inventory Program

Prepared By:
Federal Highway Administration
Eastern Federal Lands Highway Division
Cycle 3

Assateague Island National Seashore in Maryland

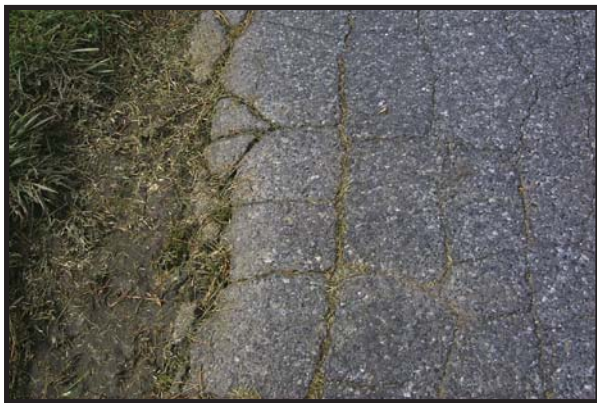
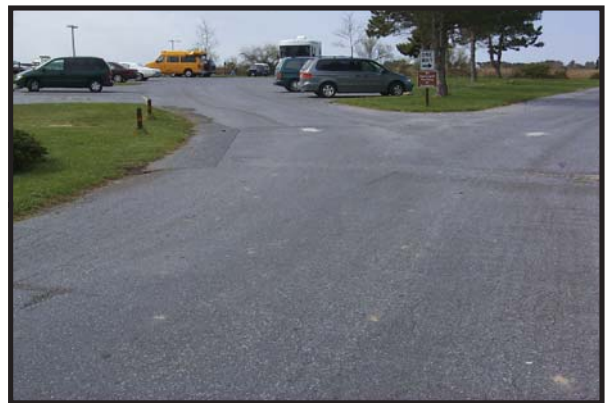
Route	Public / NonPublic	Date Visited	Area (sq ft)	Lane Miles *	Surface Type	Condition / PCR
0900	PUBLIC	4/5/2002	22303	0.38	AS	FAIR / 73

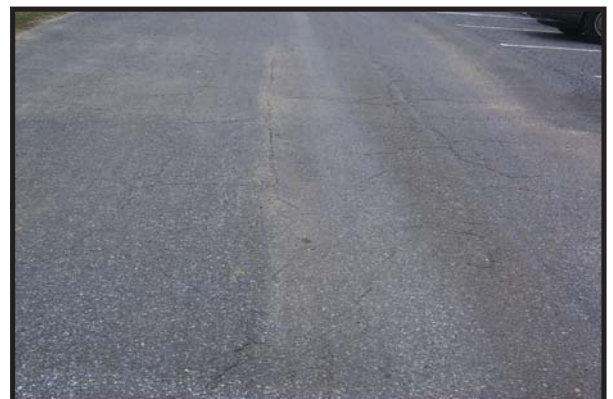
Route 0902

Route	Public / NonPublic	Date Visited	Area (sq ft)	Lane Miles *	Surface Type	Condition / PCR
0902	NONPUBLIC	4/5/2002	38438	0.66	AS	POOR / 45

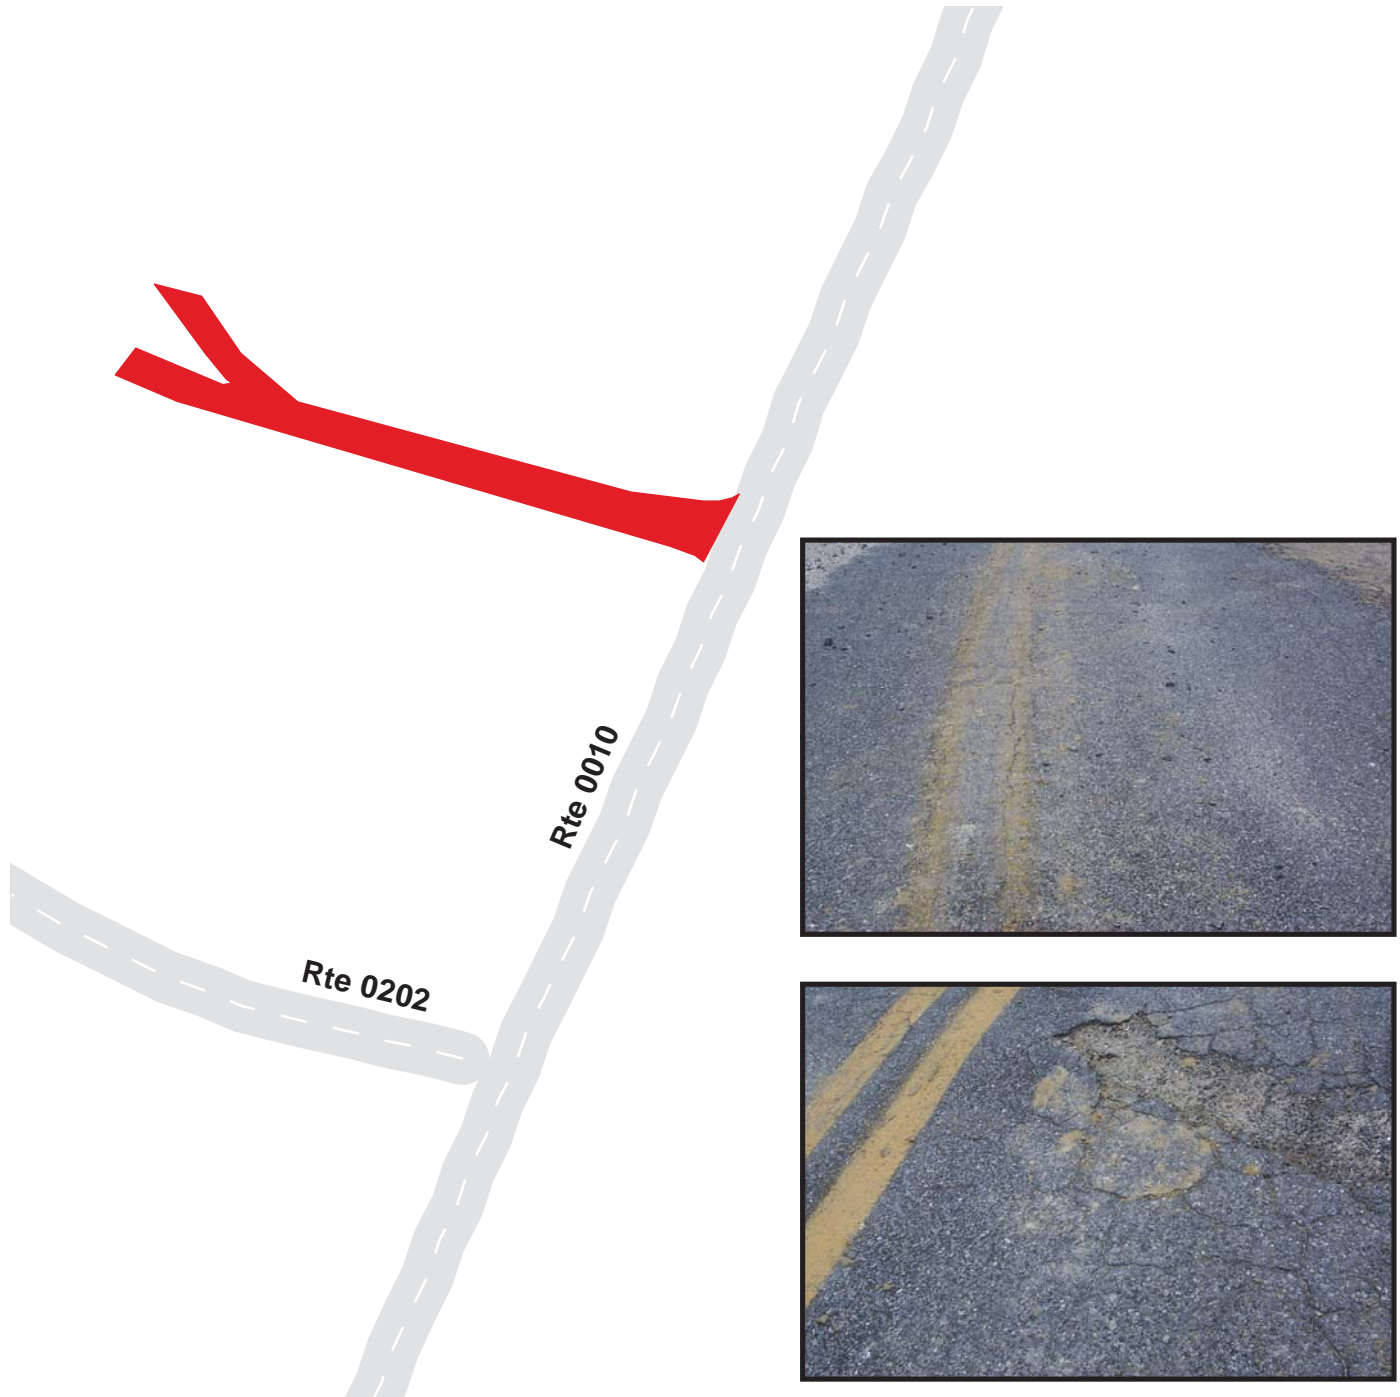
Route 0913

Route	Public / NonPublic	Date Visited	Area (sq ft)	Lane Miles *	Surface Type	Condition / PCR
0913	NONPUBLIC	4/5/2002	4935	0.08	AS	POOR / 45
