# The Road Inventory of Aztec Ruins National Monument AZRU - 7380

## Road Inventory Program

Prepared By:  
Federal Highway Administration  
Eastern Federal Lands Highway Division  
Cycle 3

# Aztec Ruins National Monument in New Mexico

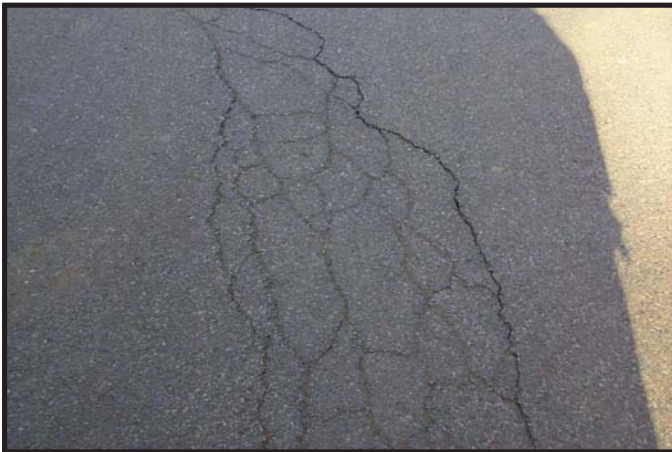
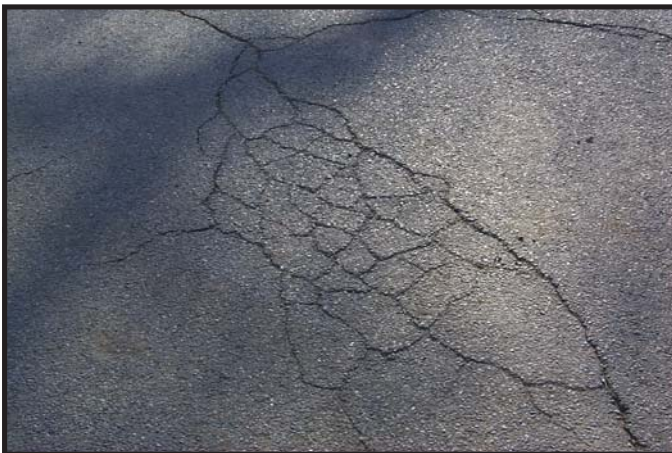
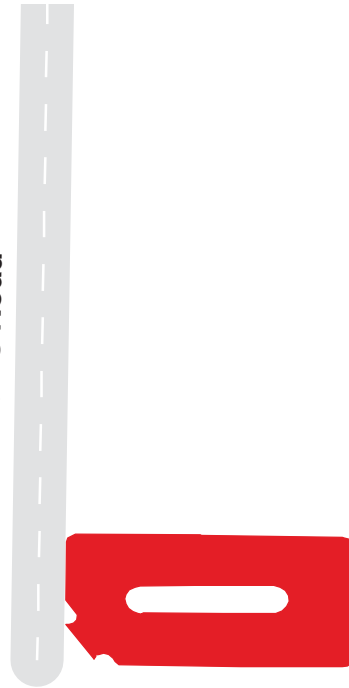
## Route 0900

### VISITOR CENTER PARKING

Route	Public / NonPublic	Date Visited	Area (sq ft)	Lane Miles *	Surface Type	Condition / PCR
0900	Public	4/4/2003	15109	0.26	AS	POOR / 45

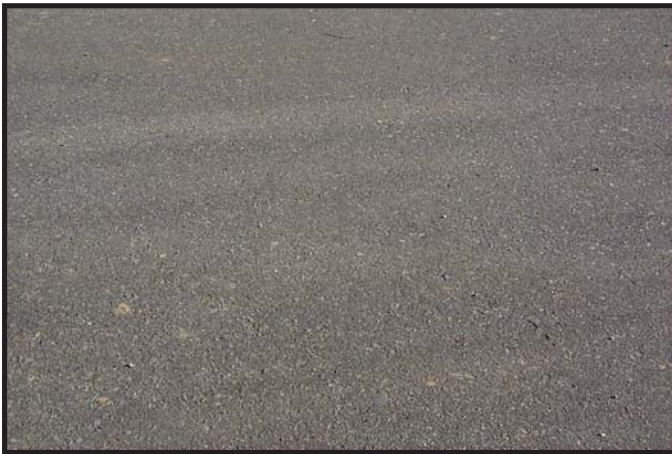
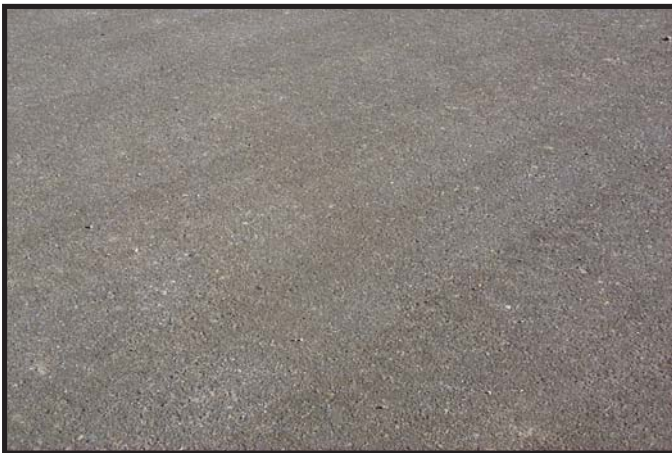
## Route 0901

RV PARKING

Route	Public / NonPublic	Date Visited	Area (sq ft)	Lane Miles *	Surface Type	Condition / PCR
0901	Public	4/4/2003	21721	0.37	AS	FAIR / 73

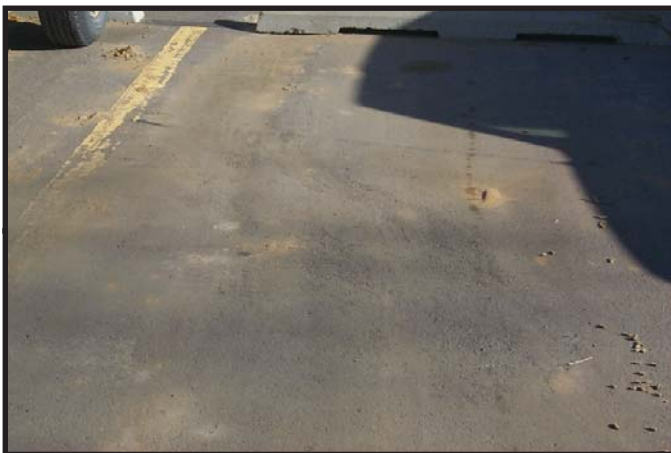
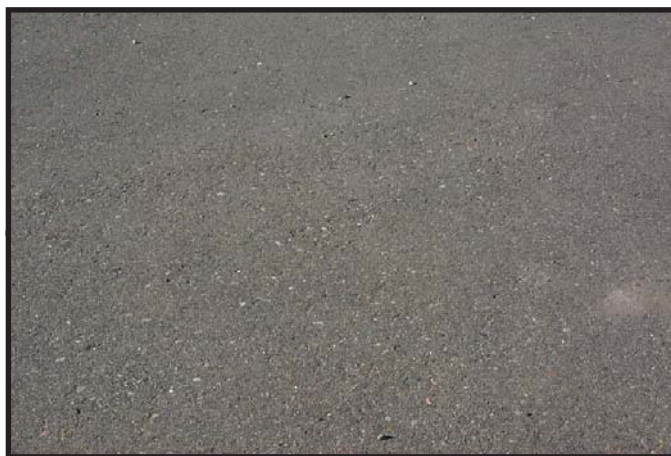
## Route 0902

### ADMINISTRATIVE PARKING

Route	Public / NonPublic	Date Visited	Area (sq ft)	Lane Miles *	Surface Type	Condition / PCR
0902	NonPublic	4/4/2003	9759	0.17	AS	FAIR / 73

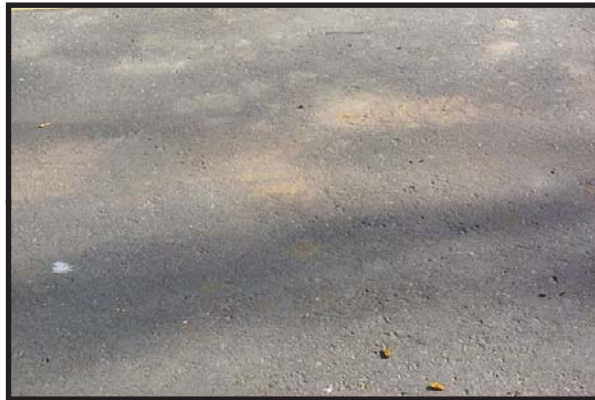
## Route 0903

### OVERFLOW PARKING

Route	Public / NonPublic	Date Visited	Area (sq ft)	Lane Miles *	Surface Type	Condition / PCR
0903	Public	4/4/2003	1225	0.02	AS	GOOD / 90

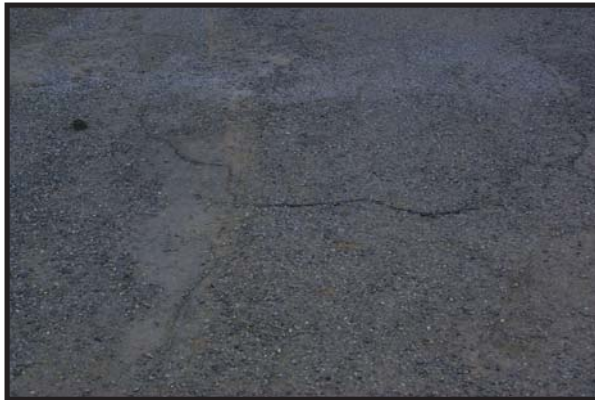
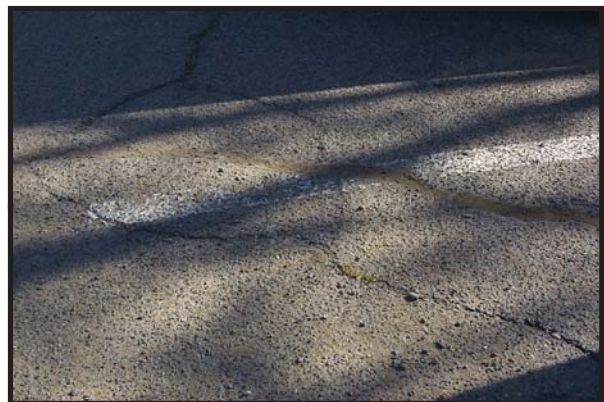
## Route 0904

MAINTENANCE PARKING

Route	Public / NonPublic	Date Visited	Area (sq ft)	Lane Miles *	Surface Type	Condition / PCR
0904	NonPublic	4/4/2003	7211	0.12	OC	POOR / 45
