The Road Inventory of Badlands National Park BADL - 1300

Road Inventory Program

Prepared By:
Federal Highway Administration
Eastern Federal Lands Highway Division
Cycle 3

Badlands National Park in South Dakota

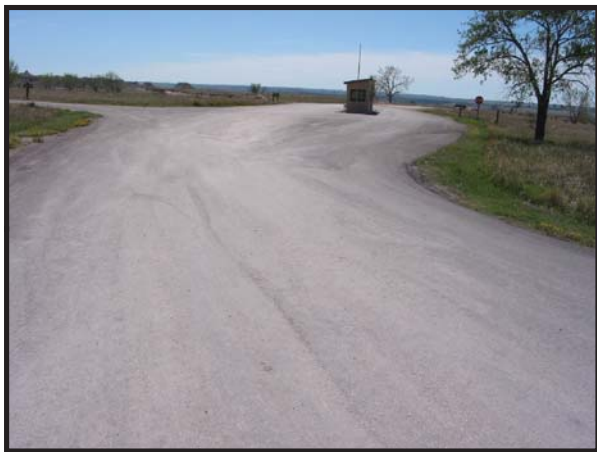
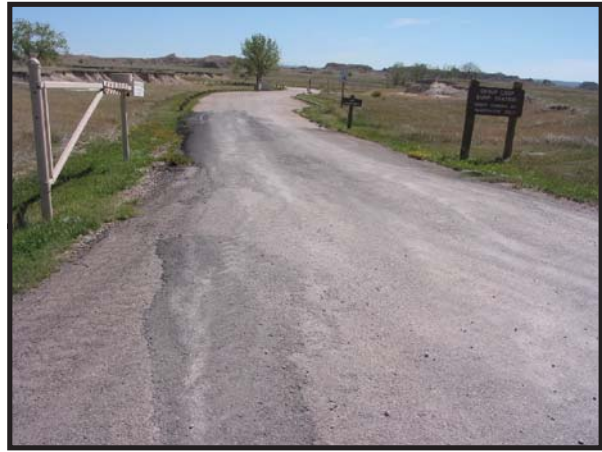
Route	Length (mi)	Width (ft)	Area (sq ft)	Lane Miles *	Condition / PCR	Surface Type
0203	0.29	0.00	34000	0.59	FAIR / 73	AS

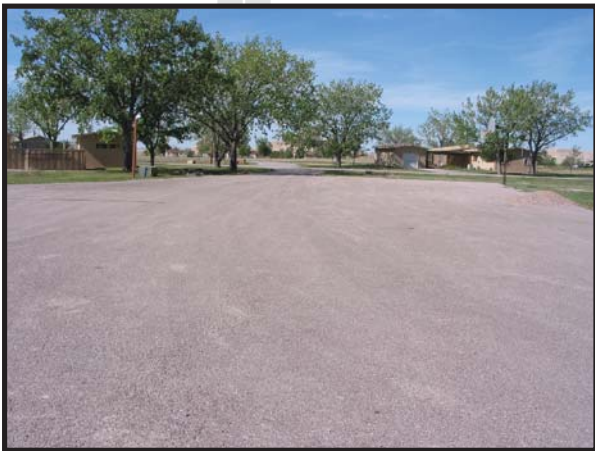
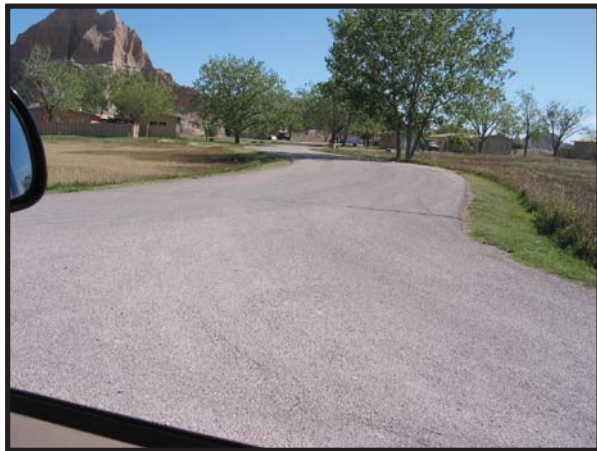
Badlands National Park
Route 0401
 Residence Area Road & Parking
 From Route 0400 at MP 0.2 on Left

Route	Length (mi)	Width (ft)	Area (sq ft)	Lane Miles *	Condition / PCR	Surface Type
0401	0.28	0.00	31795	0.55	GOOD / 90	AS

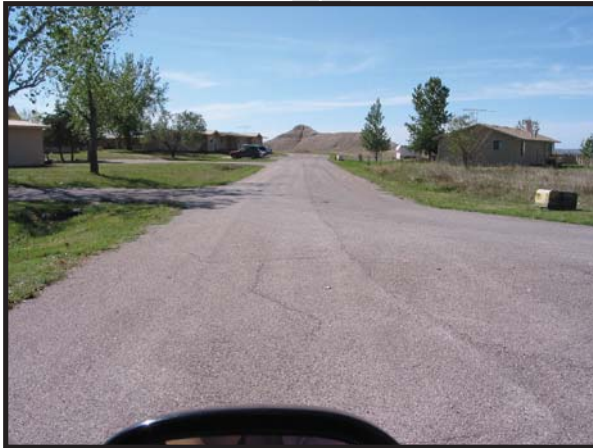
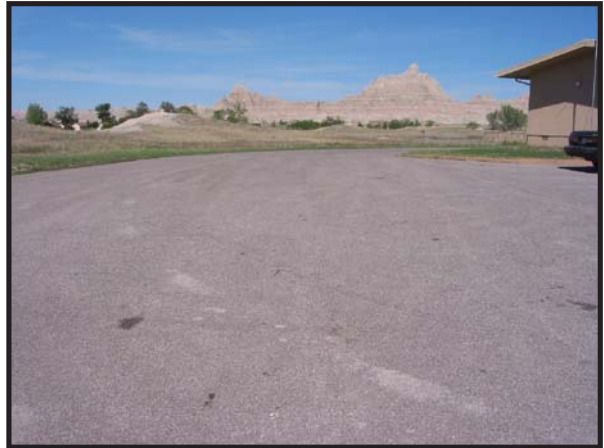
Badlands National Park
Route 0402
 Residence Area Spur & Parking
 From Route 0401

Route	Length (mi)	Width (ft)	Area (sq ft)	Lane Miles *	Condition / PCR	Surface Type
0402	0.34	0.00	17052	0.29	GOOD / 90	AS

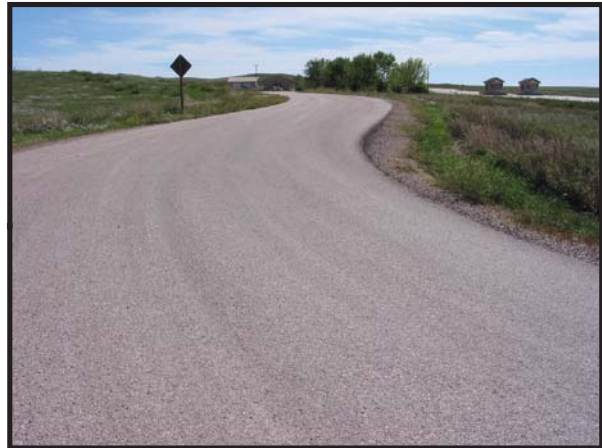
Route 0900

Route	Public / NonPublic	Date Visited	Area (sq ft)	Lane Miles *	Surface Type	Condition / PCR
0900	Public	9/17/2002	9984	0.17	NC	EXCELLENT / 97

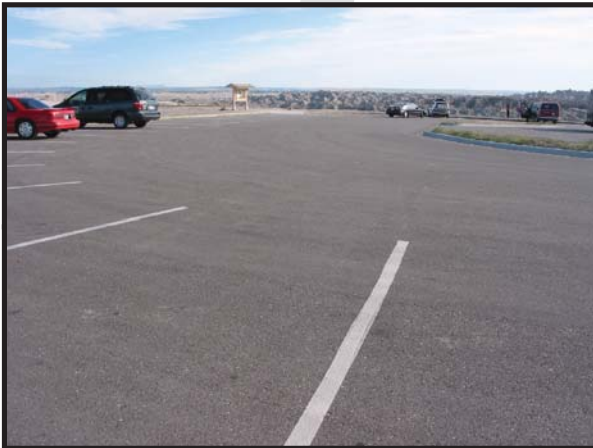
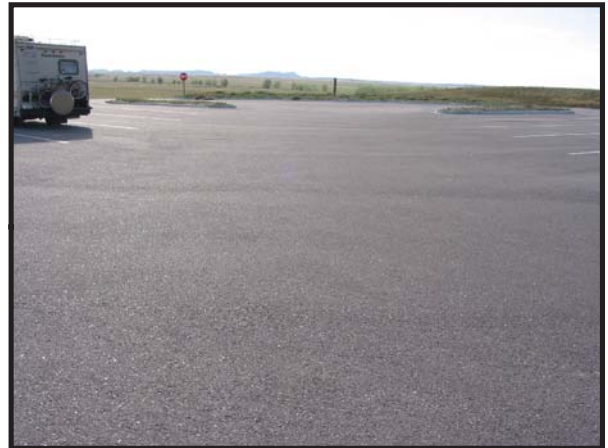
Route 0902

Route	Public / NonPublic	Date Visited	Area (sq ft)	Lane Miles *	Surface Type	Condition / PCR
0902	Public	7/15/1998	121939	2.10	AS	GOOD / 90

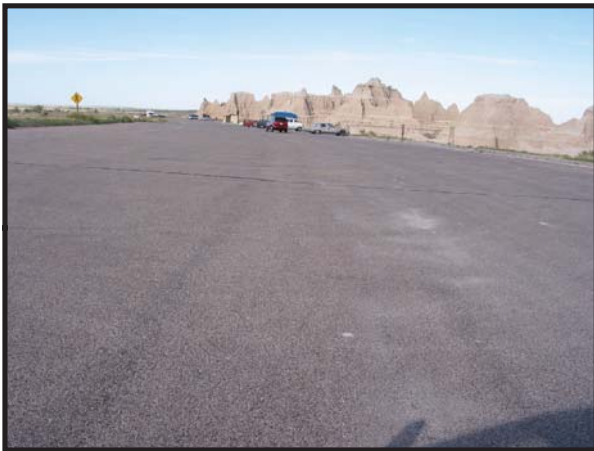
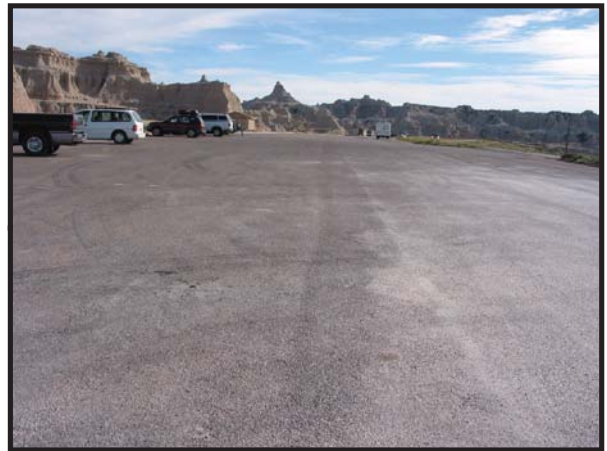
Route 0903

Route	Public / NonPublic	Date Visited	Area (sq ft)	Lane Miles *	Surface Type	Condition / PCR
0903	Public	7/15/1998	21046	0.36	AS	GOOD / 90

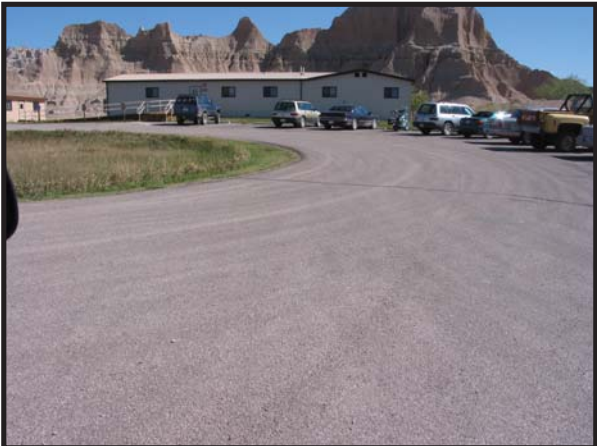
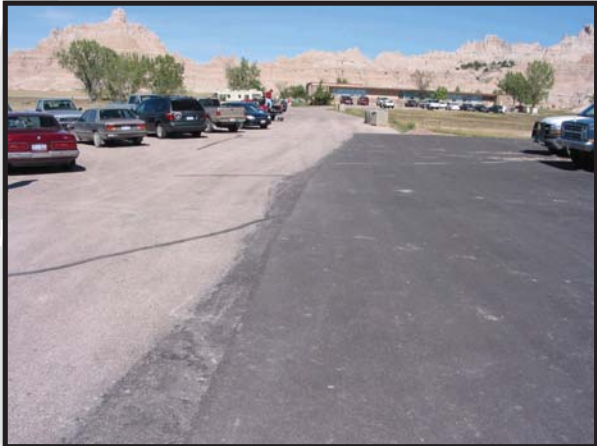
Route 0906

Route	Public / NonPublic	Date Visited	Area (sq ft)	Lane Miles *	Surface Type	Condition / PCR
0906	NonPublic	7/15/1998	32508	0.56	AS	GOOD / 90

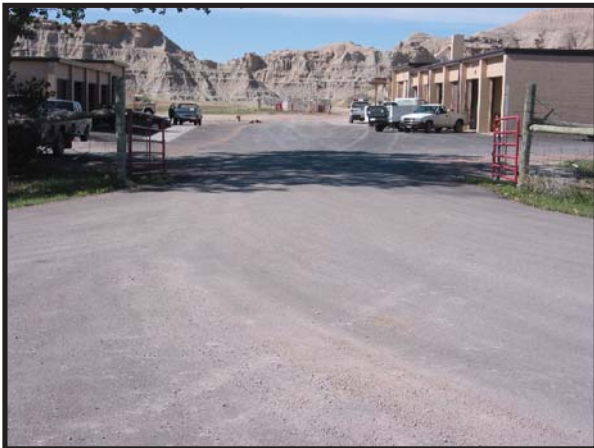
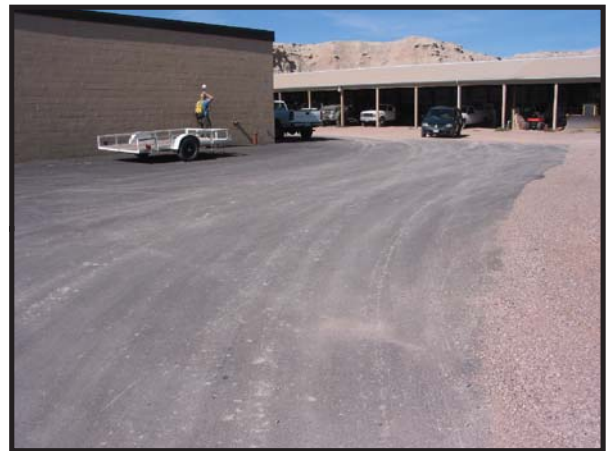
Route 0908

Route	Public / NonPublic	Date Visited	Area (sq ft)	Lane Miles *	Surface Type	Condition / PCR
0908	Public	7/15/1998	57852	1.00	AS	GOOD / 90

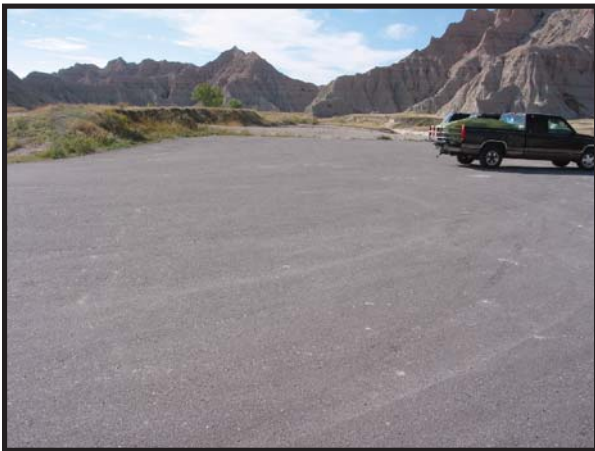
Route 0912

Route	Public / NonPublic	Date Visited	Area (sq ft)	Lane Miles *	Surface Type	Condition / PCR
0912	Public	9/17/2002	58774	1.01	AS	EXCELLENT / 97

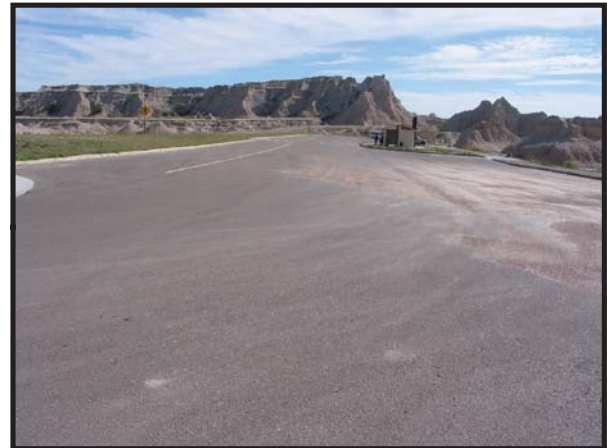
Route 0913

Route	Public / NonPublic	Date Visited	Area (sq ft)	Lane Miles *	Surface Type	Condition / PCR
0913	Public	7/15/1998	25882	0.45	AS	EXCELLENT / 97

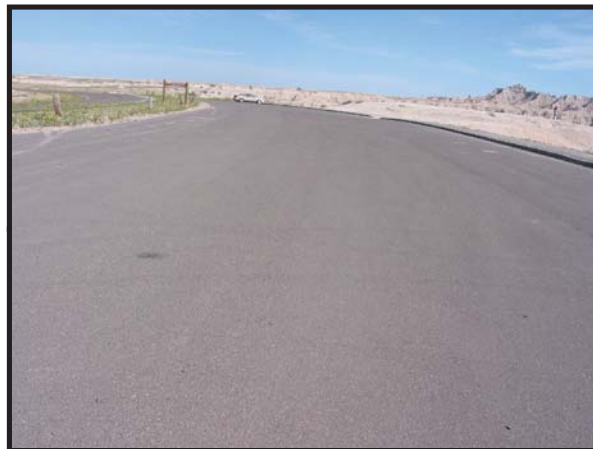
Route 0914

Route	Public / NonPublic	Date Visited	Area (sq ft)	Lane Miles *	Surface Type	Condition / PCR
0914	Public	9/17/2002	33096	0.57	AS	EXCELLENT / 97

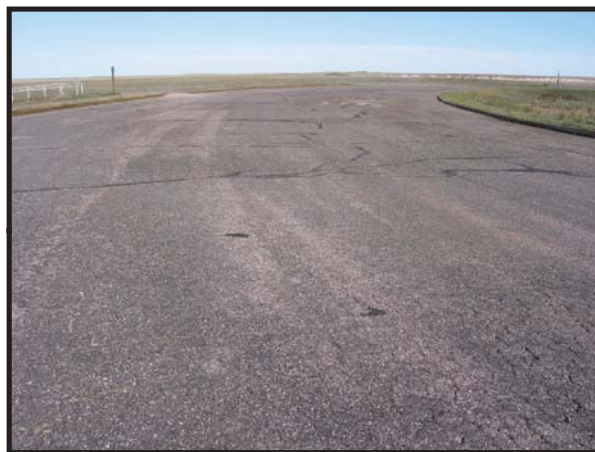
Route 0917

Burns Basin Overlook Parking
Adjacent to Route 0010 at MP 18.3 on Left

Route	Public / NonPublic	Date Visited	Area (sq ft)	Lane Miles *	Surface Type	Condition / PCR
0917	Public	7/15/1998	25557	0.44	AS	FAIR / 73

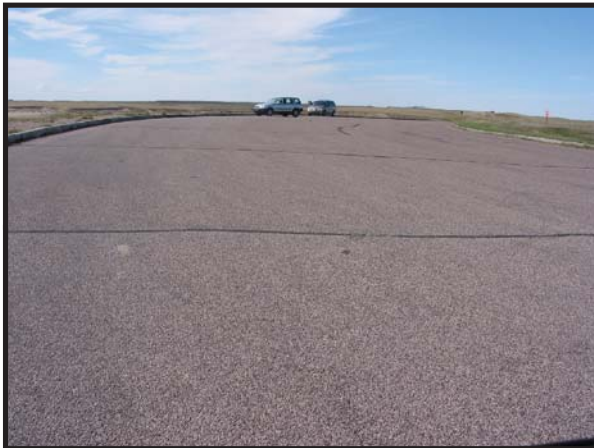
Route 0918

Route	Public / NonPublic	Date Visited	Area (sq ft)	Lane Miles *	Surface Type	Condition / PCR
0918	Public	7/15/1998	20307	0.35	AS	FAIR / 73

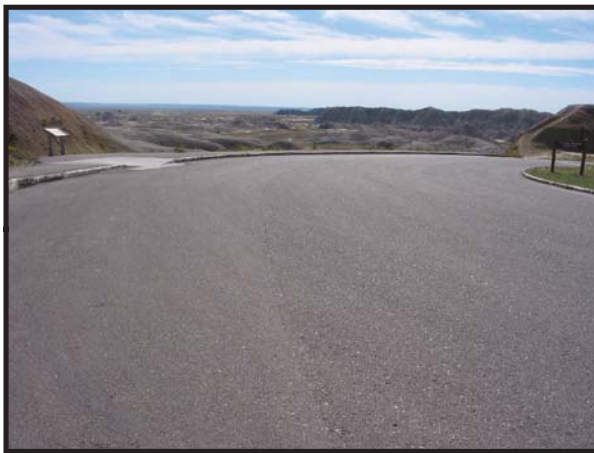
Route 0921

Route	Public / NonPublic	Date Visited	Area (sq ft)	Lane Miles *	Surface Type	Condition / PCR
0921	Public	7/15/1998	8852	0.15	AS	EXCELLENT / 97

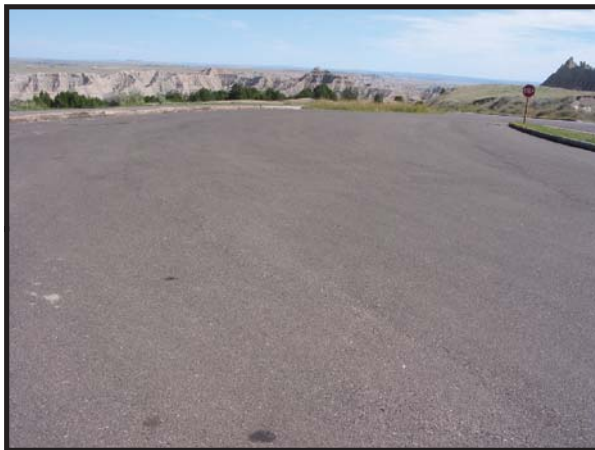
Route 0922

Route	Public / NonPublic	Date Visited	Area (sq ft)	Lane Miles *	Surface Type	Condition / PCR
0922	Public	9/17/2002	33428	0.58	AS	FAIR / 73
