The Road Inventory of **Baltimore-Washington Parkway** **BAWA - 3230**

Road Inventory Program

Prepared By:
Federal Highway Administration
Eastern Federal Lands Highway Division
Cycle 3

Baltimore-Washington Parkway in Washington DC

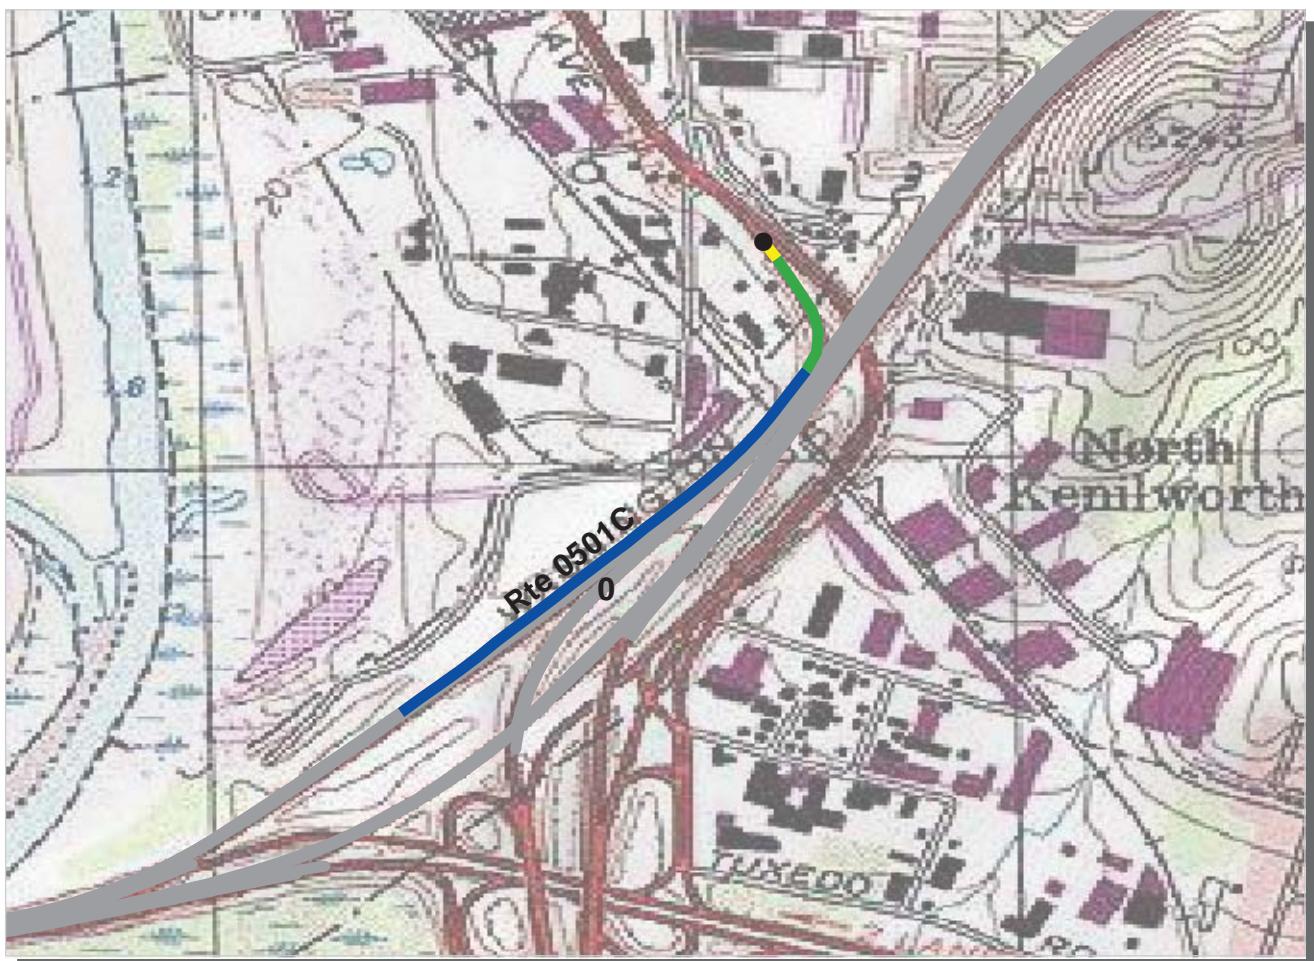
ROUTE: 0501BB Kenilworth Avenue Interchange Ramp B Lane 2

Section Number	0				
Section Length (mi)	0.38				
AADT	**				
SADT	**				
ADT Date	**				
Cross Section Information					
Number of Lanes	3				
Paved Width (ft)	34				
Lane Width (ft)	11				
Shoulder Width (ft)	0				
Roadway Condition Information					
PCR (Pavement Condition Rating)	99				
RCI (Roughness Condition Index)	99				
SCR (Surface Condition Rating)	98				
Alligator Cracking Index	100				
Rutting Index	99				
Patching Index	100				
Transverse Cracking Index	99				
Longitudinal Cracking Index	100				
Shoulder Condition Rating	N/A				
Drainage Condition Rating	GOOD
