The Road Inventory of Bent's Old Fort National Historic Site BEOL - 1310

Road Inventory Program

Prepared By:
Federal Highway Administration
Eastern Federal Lands Highway Division
Cycle 3

Bent's Old Fort National Historic Site in Colorado

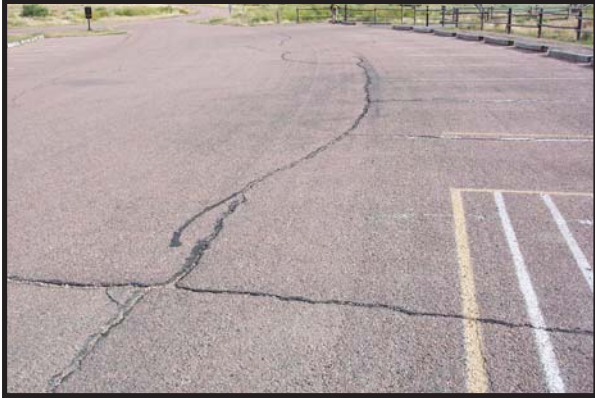
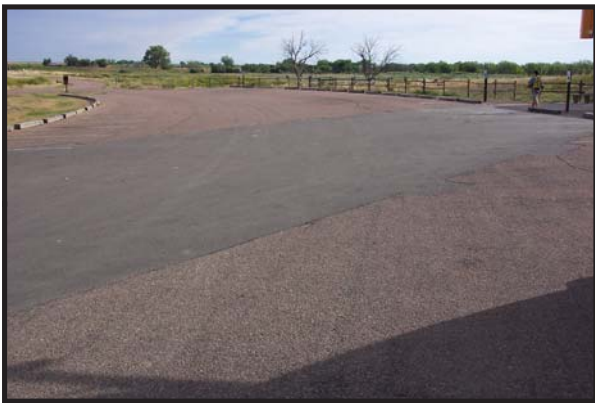
Route 0900

Route	Public / NonPublic	Date Visited	Area (sq ft)	Lane Miles *	Surface Type	Condition / PCR
0900	Public	9/17/2003	32345	0.56	AS	POOR / 45
