# The Road Inventory of Big Bend National Park BIBE - 7130

## Road Inventory Program

Prepared By:  
Federal Highway Administration  
Eastern Federal Lands Highway Division  
Cycle 3

# Big Bend National Park in Texas

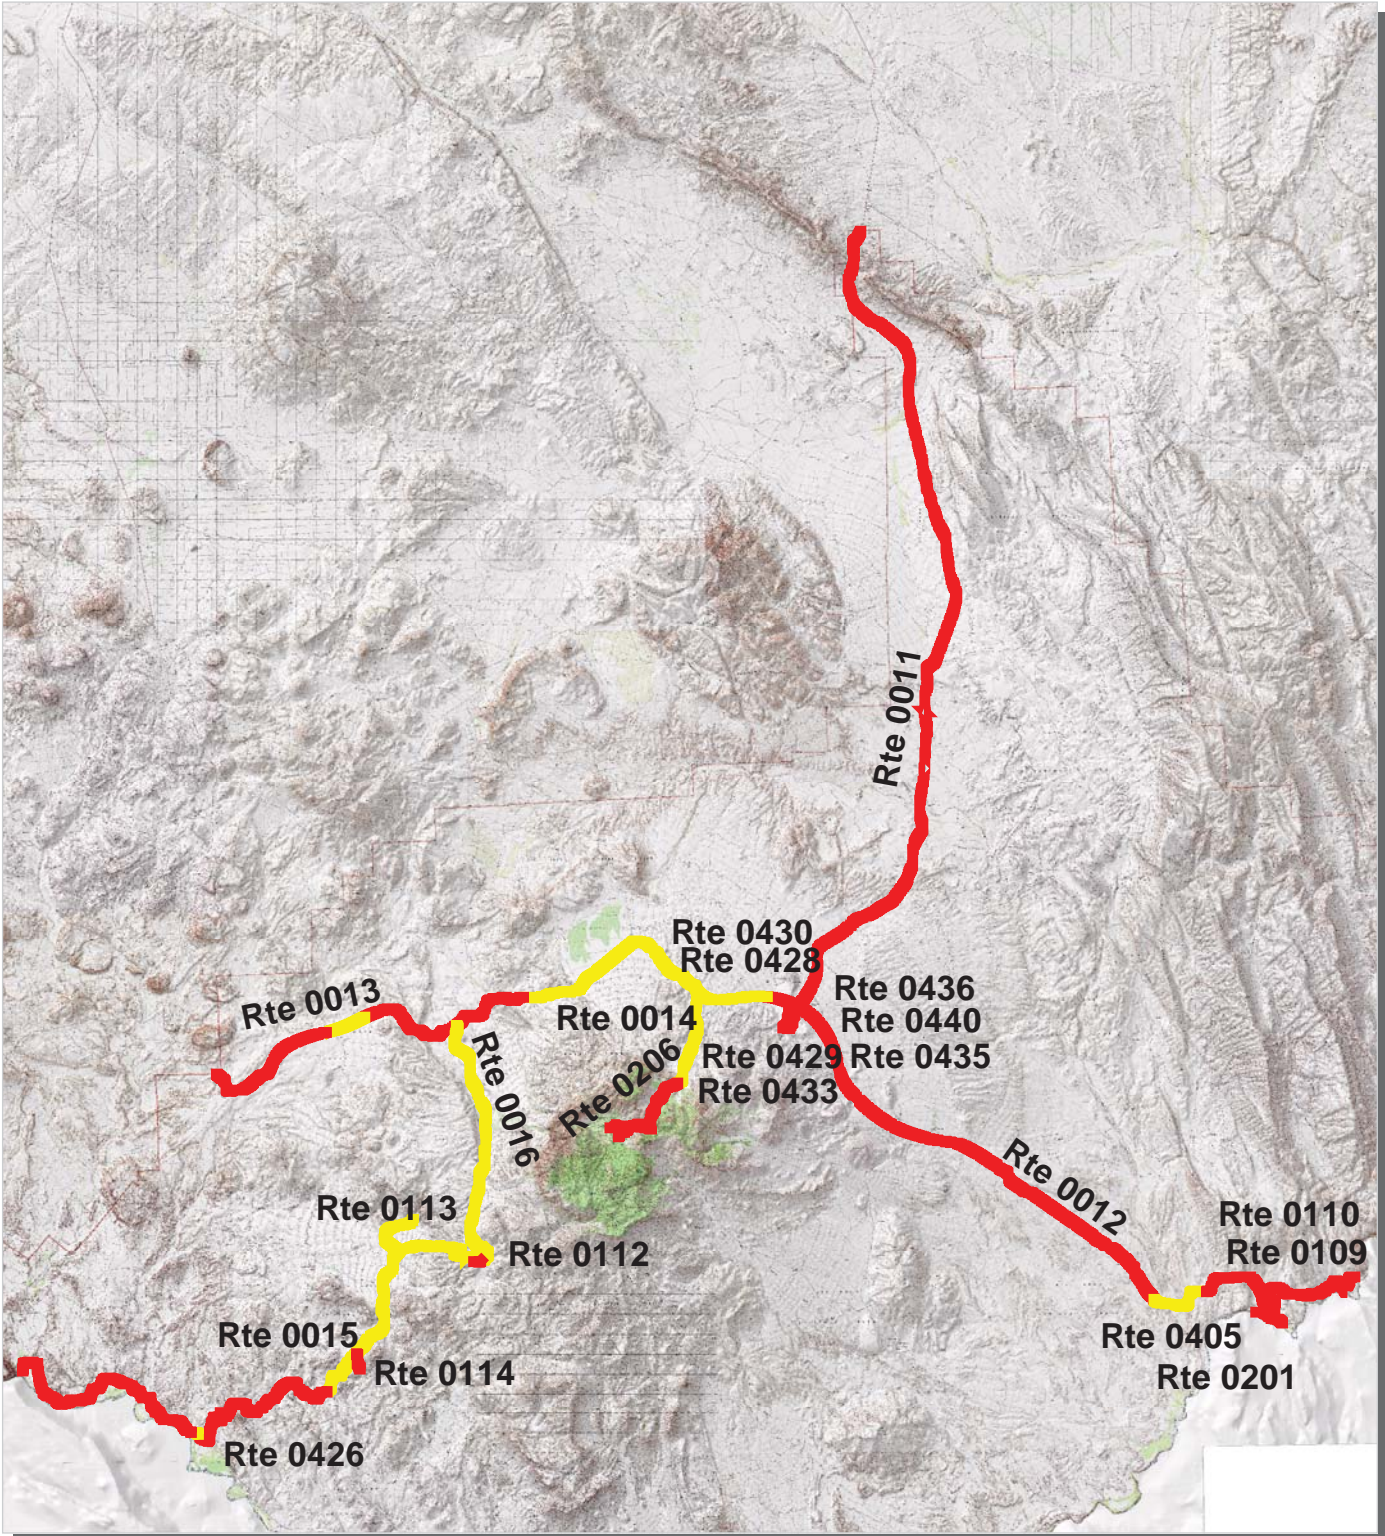
# Big Bend National Park Route Condition Key Map PCR - Mile by Mile

PCR	Poor	<span style="display: inline-block; width: 20px; height: 10px; background-color: red; border: 1px solid black;"></span>	Fair	<span style="display: inline-block; width: 20px; height: 10px; background-color: yellow; border: 1px solid black;"></span>	Good	<span style="display: inline-block; width: 20px; height: 10px; background-color: green; border: 1px solid black;"></span>	Excellent	<span style="display: inline-block; width: 20px; height: 10px; background-color: blue; border: 1px solid black;"></span>
	(<=60)		(61 - 84)		(85 - 94)		(95 - 100)

\* If the PCR rating is not available for a section, the SCR rating will be displayed. See appendix for definitions and formulas.

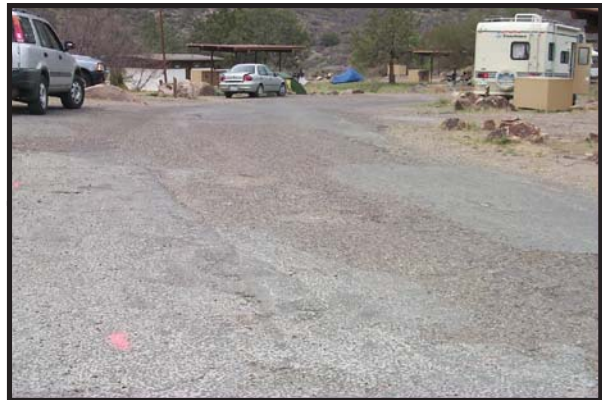
## Route 0233

Route	Length (mi)	Width (ft)	Area (sq ft)	Lane Miles *	Condition / PCR	Surface Type
0233	1.81	0.00	104072	1.79	POOR / 45	AS

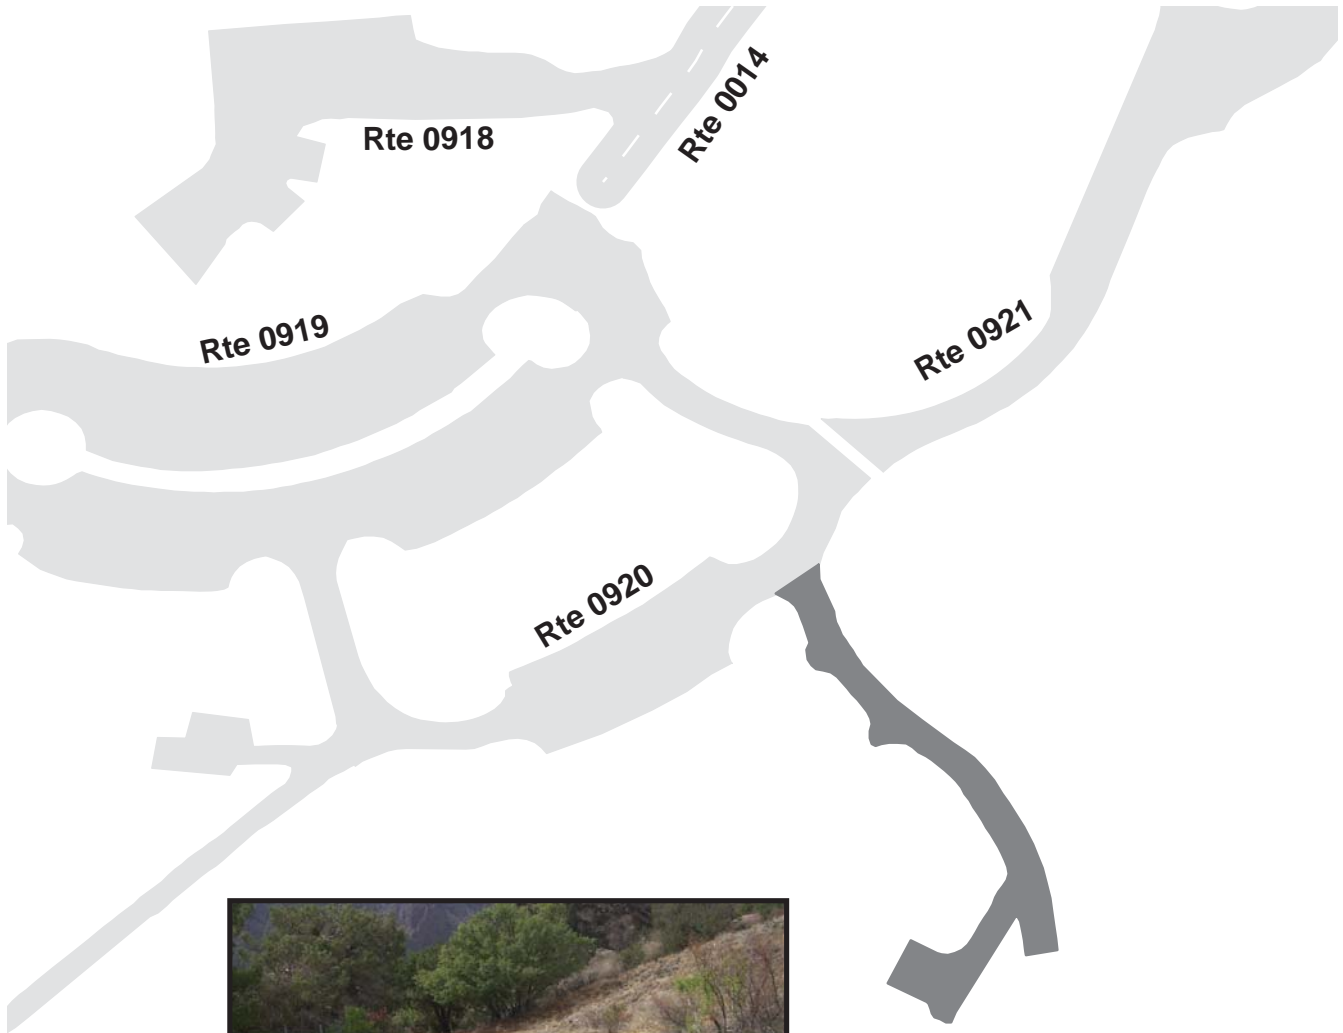
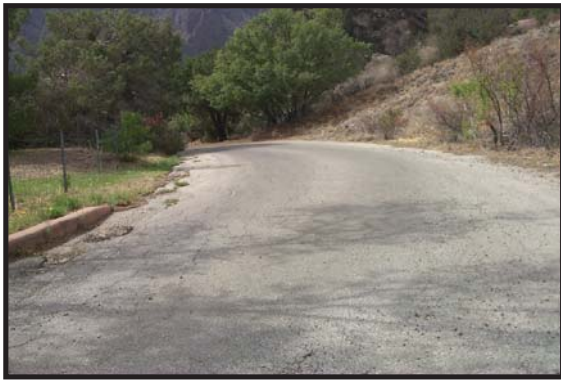
**Big Bend National Park**  
**Route 0418**  
 Basin Residence Road Behind Motel  
 From Route 0920

Route	Length (mi)	Width (ft)	Area (sq ft)	Lane Miles *	Condition / PCR	Surface Type
0418	0.13	0.00	7373	0.13	FAIR / 73	AS

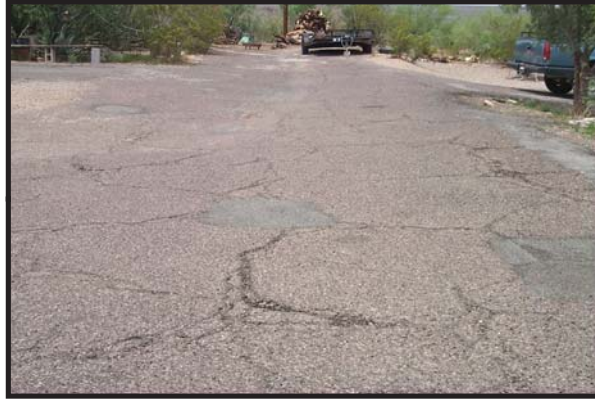
## Route 0431

Route	Length (mi)	Width (ft)	Area (sq ft)	Lane Miles *	Condition / PCR	Surface Type
0431	0.03	0.00	2925	0.05	POOR / 45	OC

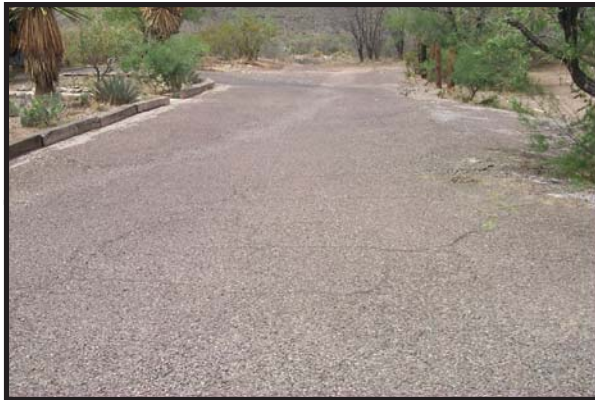
**Big Bend National Park**  
**Route 0432**  
Chuparosa  
From Route 0429 (Bobcat Loop) at MP 0.25

Route	Length (mi)	Width (ft)	Area (sq ft)	Lane Miles *	Condition / PCR	Surface Type
0432	0.02	0.00	2328	0.04	POOR / 45	OC

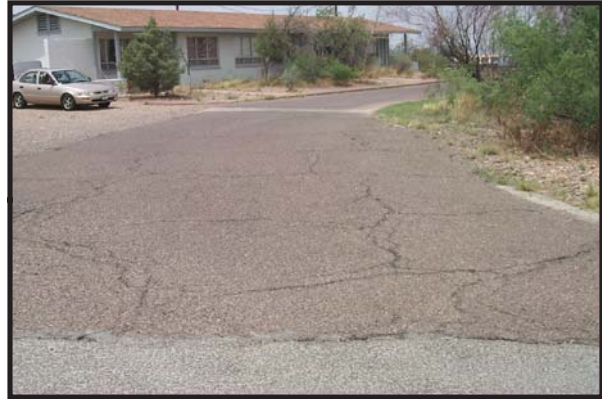
**Big Bend National Park**  
**Route 0437**  
Chino Court  
From Route 0436 (Nolina Drive) at MP 0.06

Route	Length (mi)	Width (ft)	Area (sq ft)	Lane Miles *	Condition / PCR	Surface Type
0437	0.08	0.00	9353	0.16	POOR / 45	AS

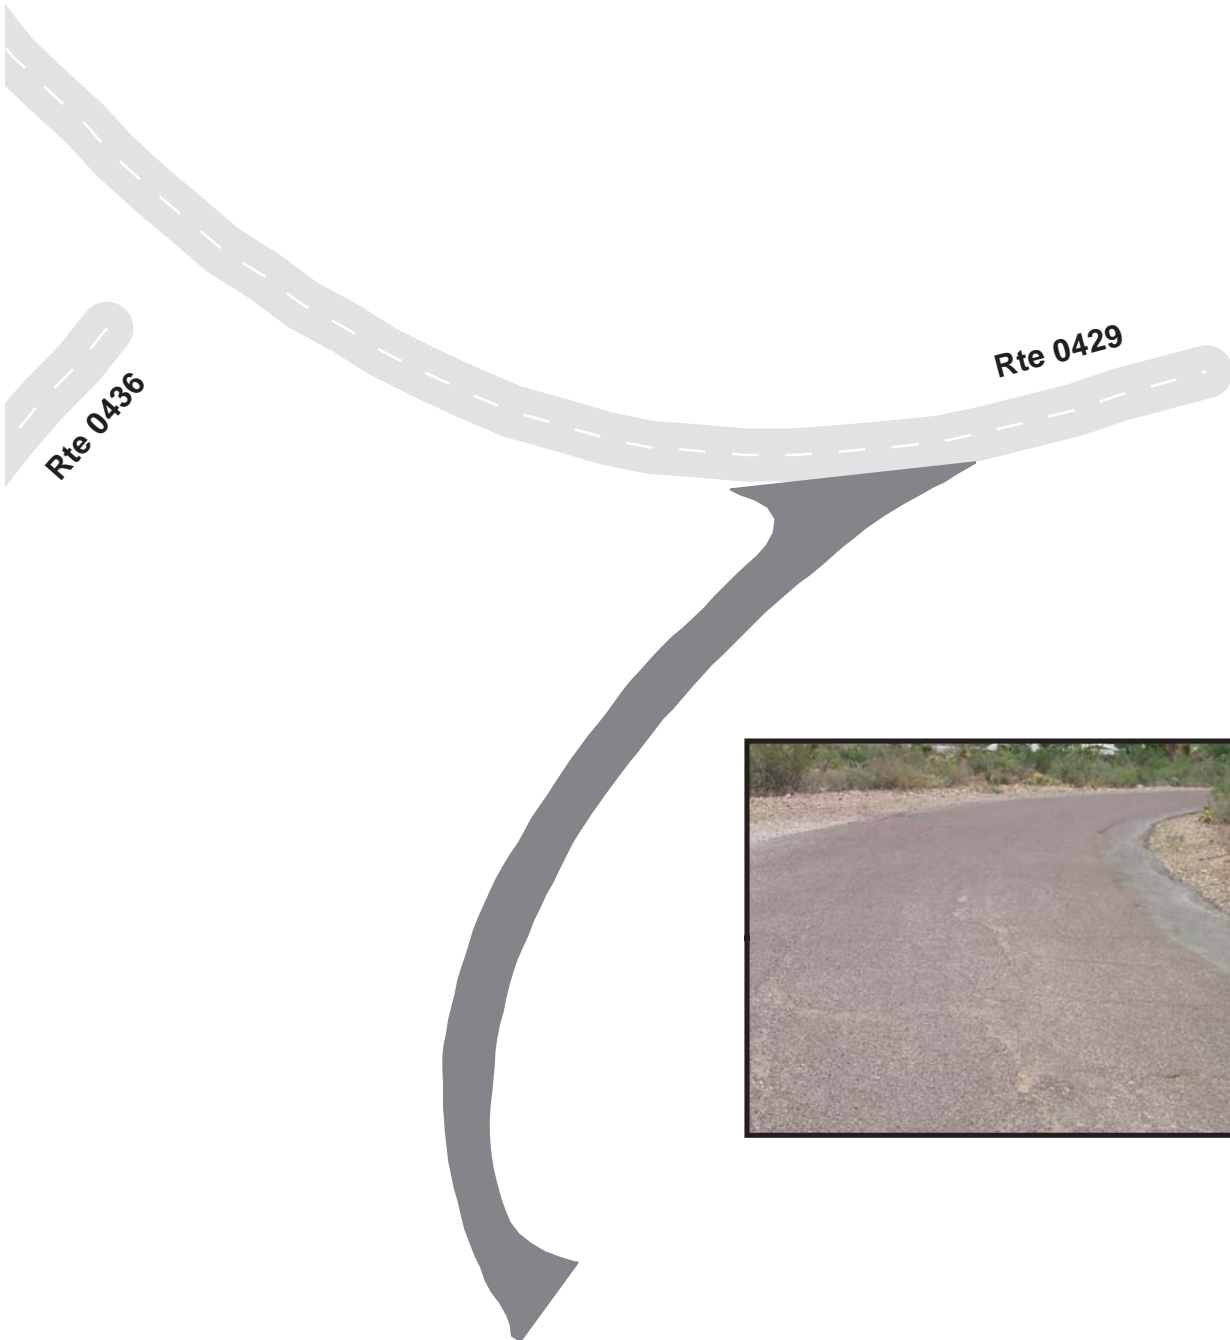
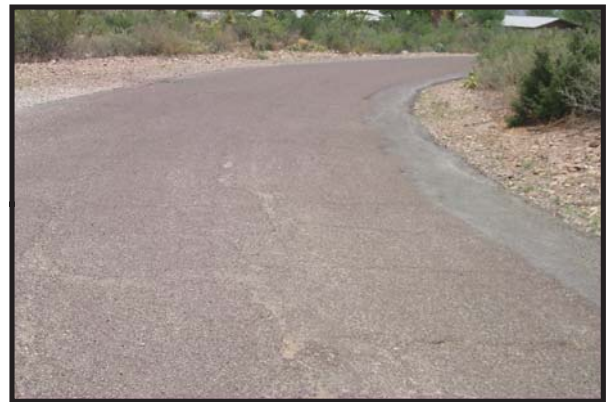
**Big Bend National Park**  
**Route 0443**  
 Escuela Vista  
 From Route 0429 (Bobcat Loop) at MP 0.40

Route	Length (mi)	Width (ft)	Area (sq ft)	Lane Miles *	Condition / PCR	Surface Type
0443	0.00	0.00	6793	0.12	POOR / 45	AS

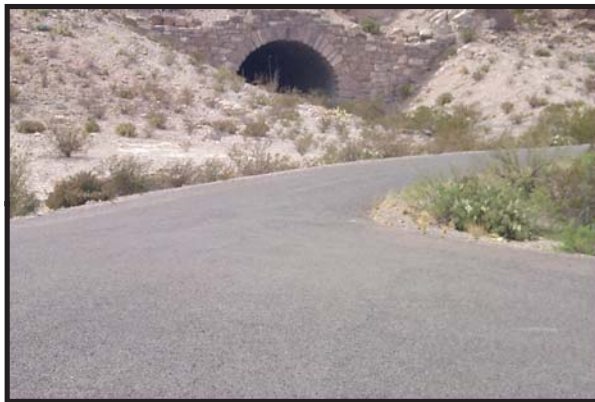
Route	Public / NonPublic	Date Visited	Area (sq ft)	Lane Miles *	Surface Type	Condition / PCR
0902	Public	4/24/2002	14932	0.26	AS	GOOD / 90

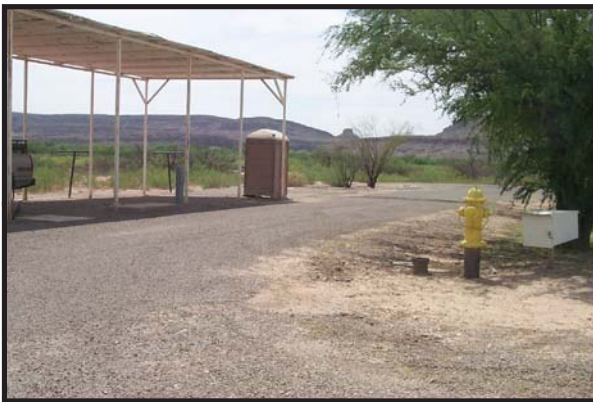
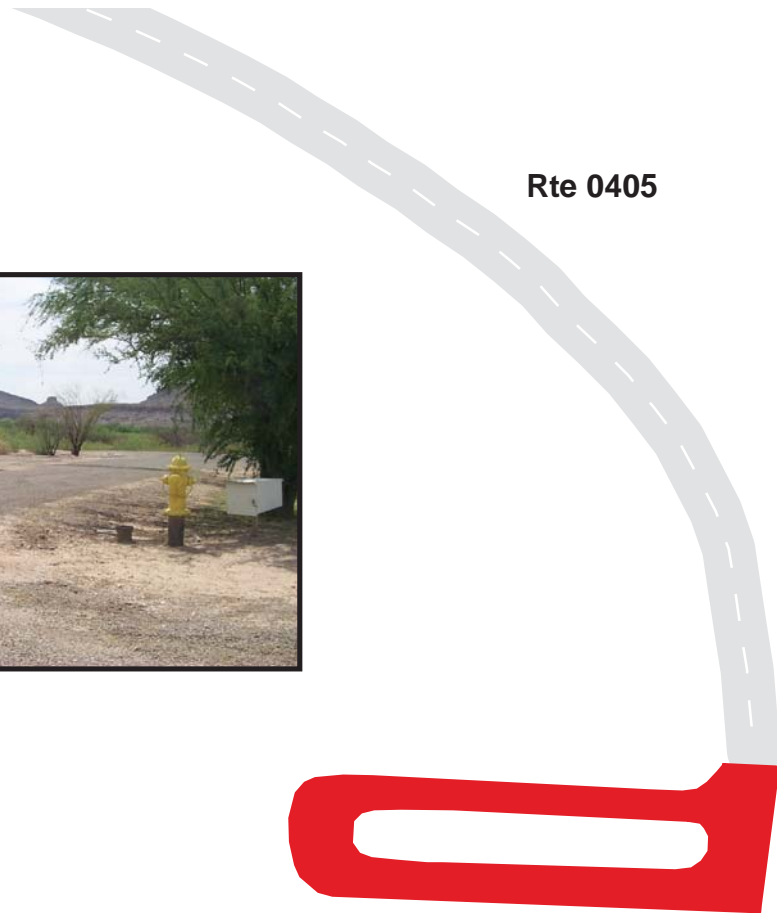
## Route 0904

Route	Public / NonPublic	Date Visited	Area (sq ft)	Lane Miles *	Surface Type	Condition / PCR
0904	NonPublic	4/24/2002	6847	0.12	OC	FAIR / 73

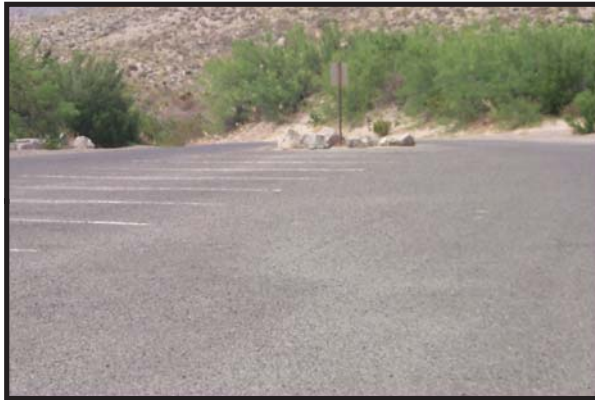
## Route 0905

Route	Public / NonPublic	Date Visited	Area (sq ft)	Lane Miles *	Surface Type	Condition / PCR
0905	Public	4/24/2002	15016	0.26	OC	FAIR / 73

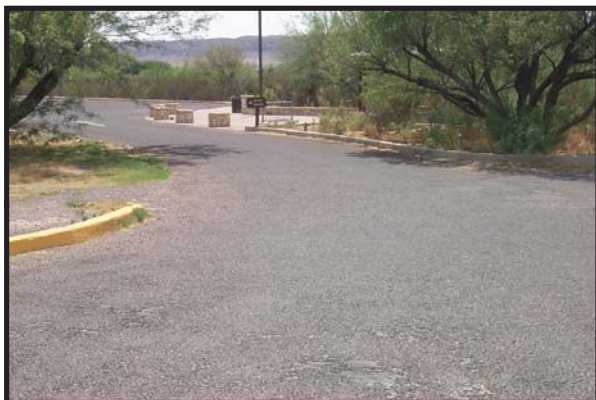
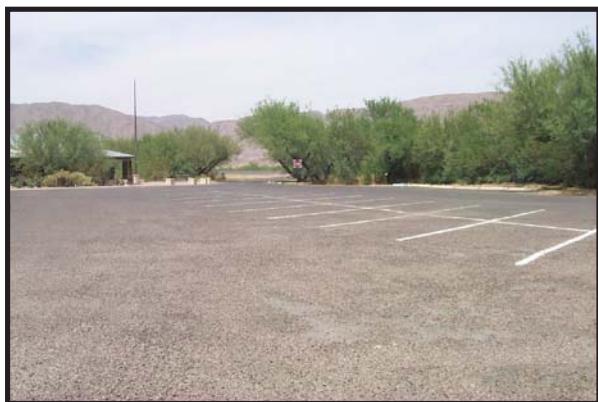
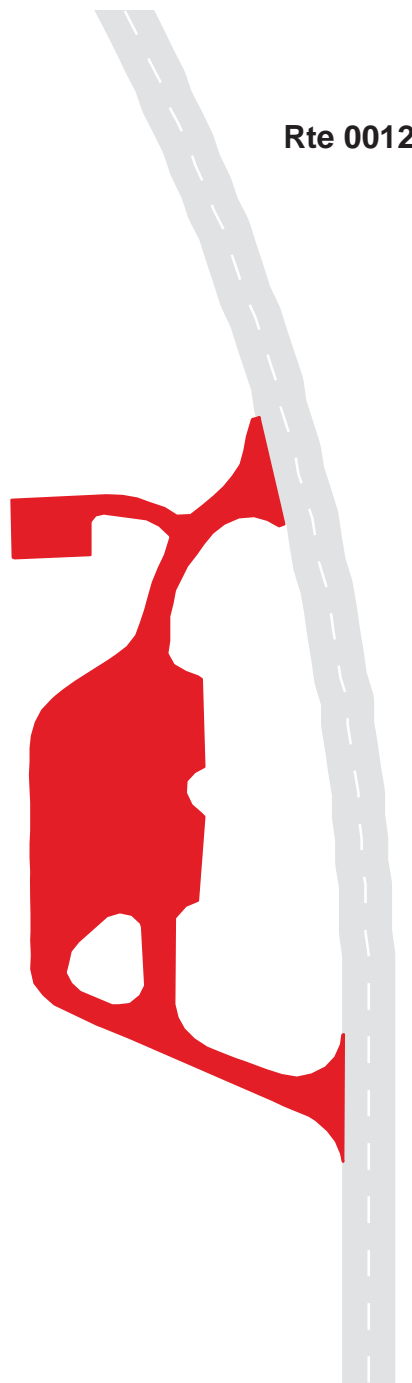
## Route 0906

Route	Public / NonPublic	Date Visited	Area (sq ft)	Lane Miles *	Surface Type	Condition / PCR
0906	Public	4/24/2002	38574	0.66	OC	FAIR / 73

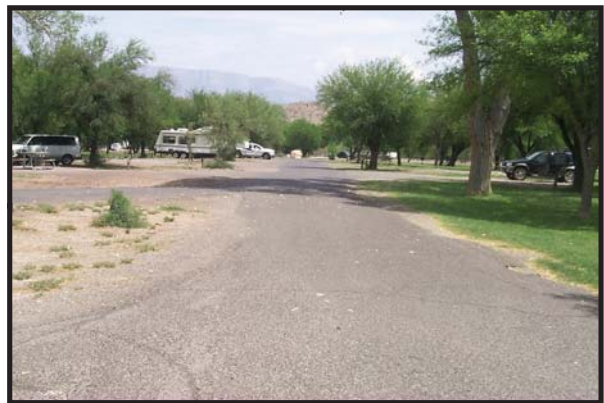
## Route 0907

Route	Public / NonPublic	Date Visited	Area (sq ft)	Lane Miles *	Surface Type	Condition / PCR
0907	Public	4/24/2002	5999	0.10	AS	POOR / 45

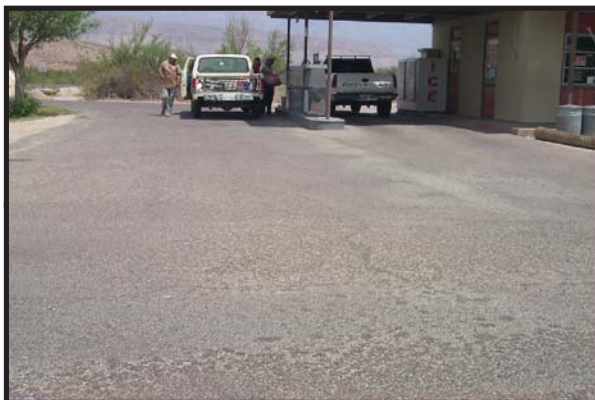
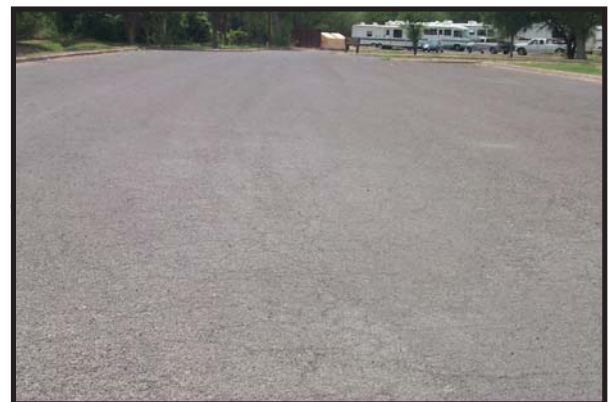
Route	Public / NonPublic	Date Visited	Area (sq ft)	Lane Miles *	Surface Type	Condition / PCR
0909	Public	4/24/2002	44086	0.76	AS	FAIR / 73

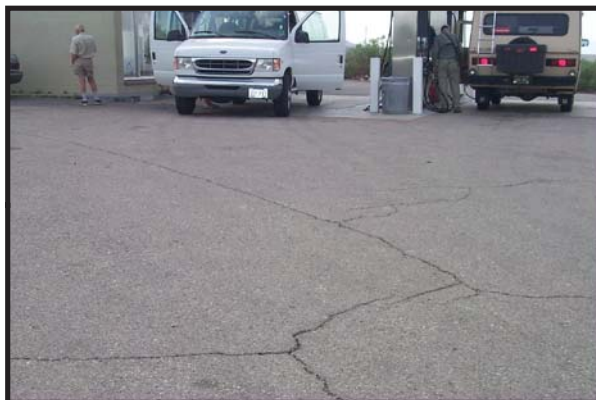
Route	Public / NonPublic	Date Visited	Area (sq ft)	Lane Miles *	Surface Type	Condition / PCR
0912	Public	4/24/2002	9066	0.16	AS	FAIR / 73
