The Road Inventory of Bighorn Canyon National Recreation Area BICA - 1320

Road Inventory Program

Prepared By:
Federal Highway Administration
Eastern Federal Lands Highway Division
Cycle 3

Bighorn Canyon National Recreation Area in Montana

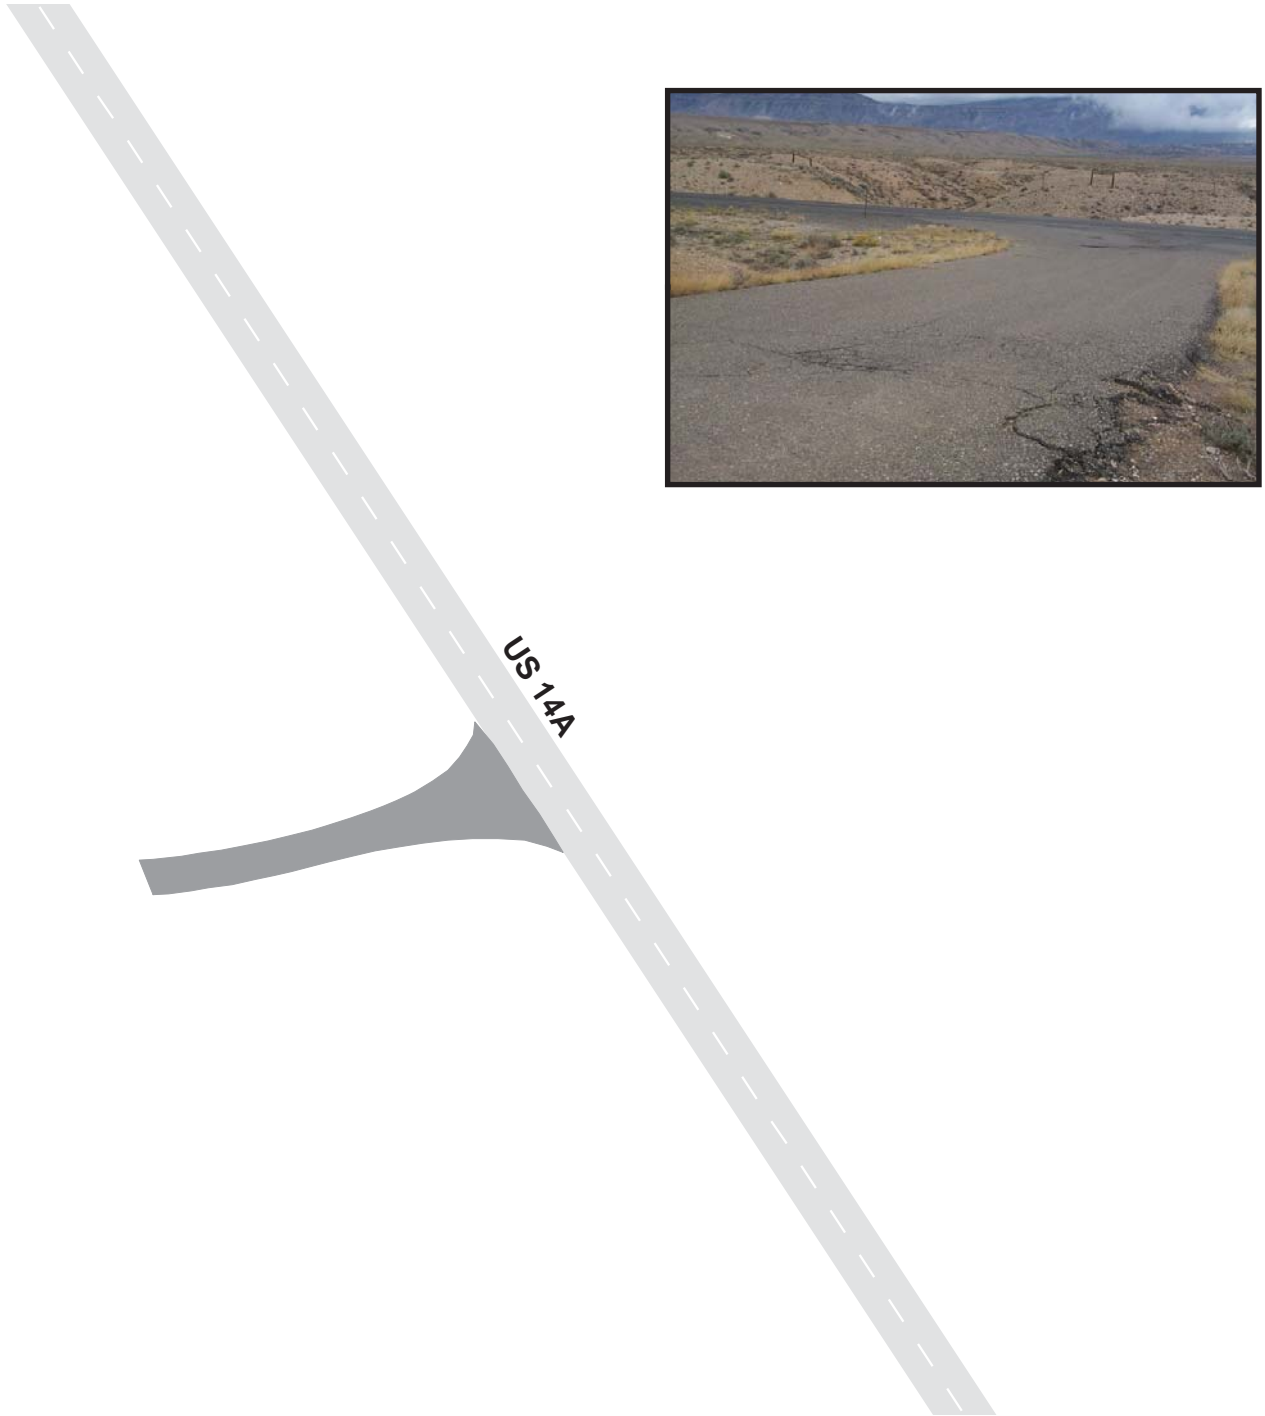
Route 0209

Route	Length (mi)	Width (ft)	Area (sq ft)	Lane Miles *	Condition / PCR	Surface Type
0209	0.03	0.00	3469	0.06	POOR / 45	AS
