# The Road Inventory of Big Cypress National Preserve BICY - 5120

Prepared By:  
Federal Highway Administration  
Eastern Federal Lands Highway Division  
Cycle 3

# Big Cypress National Preserve in Florida

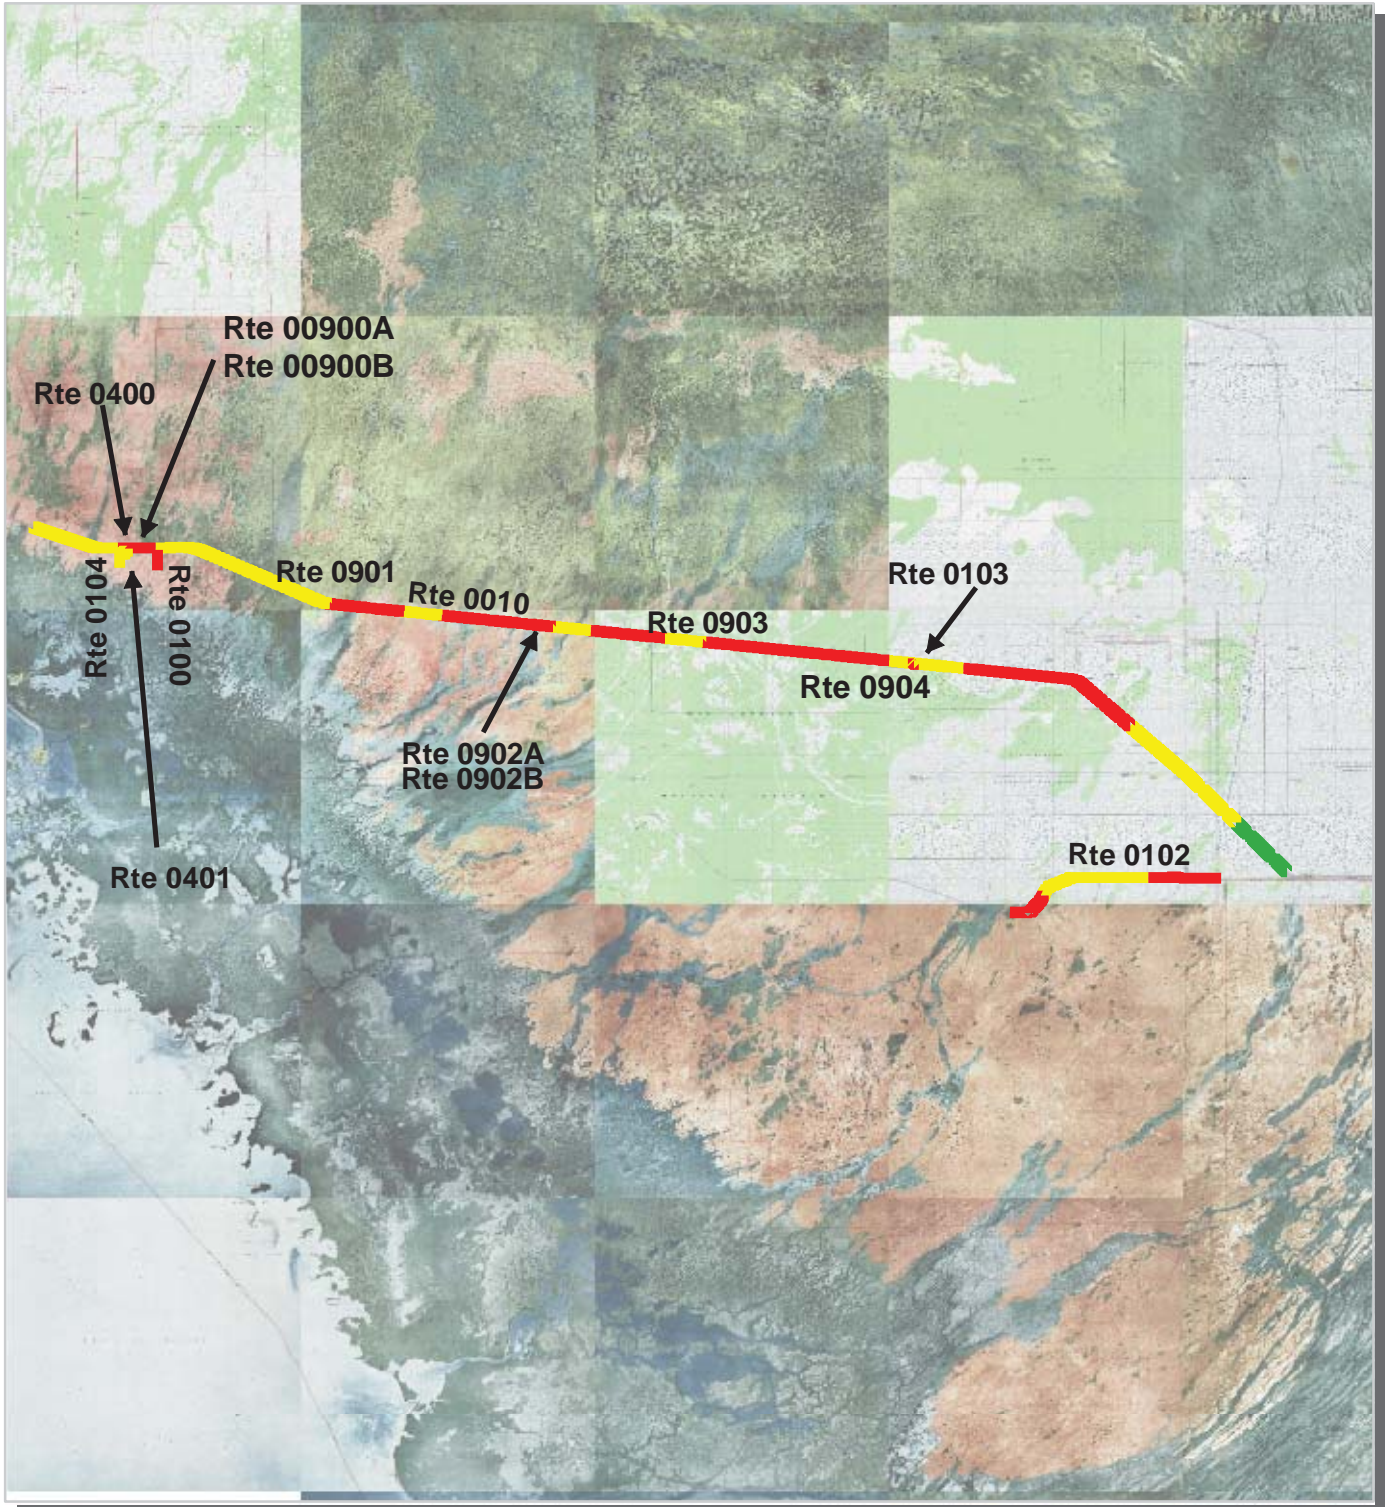
# Big Cypress National Preserve Route Condition Key Map PCR - Mile by Mile

PCR	Poor

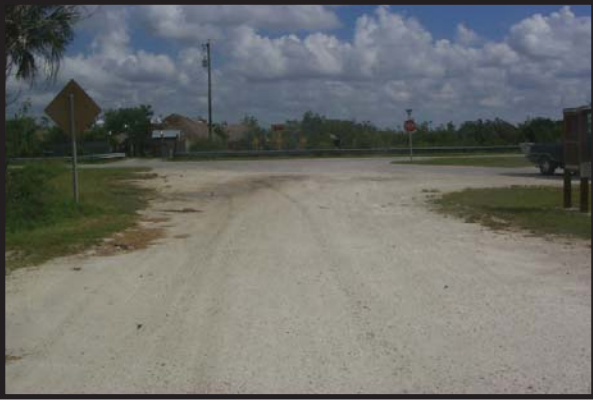
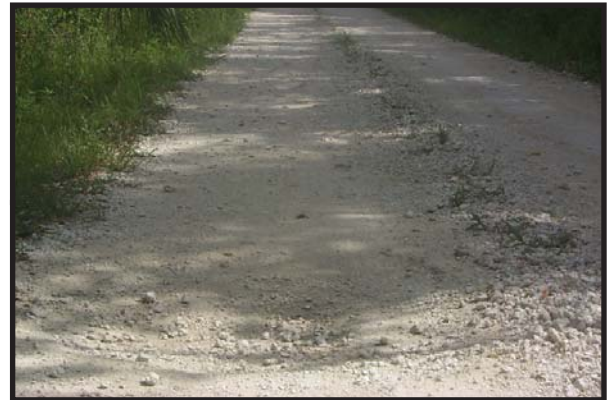
## Route 0900A

Route	Public / NonPublic	Date Visited	Area (sq ft)	Lane Miles *	Surface Type	Condition / PCR
0900A	NonPublic	6/30/2001	38818	0.67	AS	POOR / 45

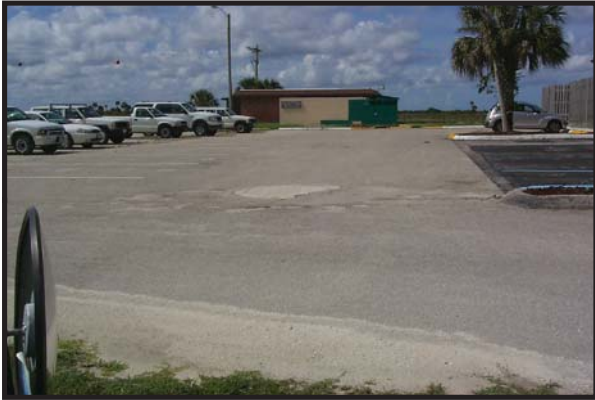
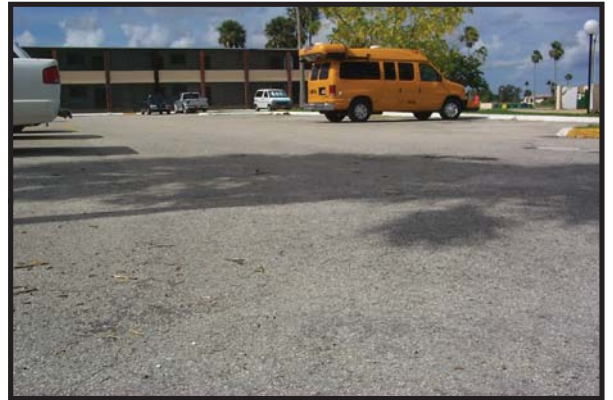
**Big Cypress National Preserve**  
**Route 0900B**  
 HEADQUARTERS PARKING (UNPAVED)  
 From Route 0900A

Route	Public / NonPublic	Date Visited	Area (sq ft)	Lane Miles *	Surface Type	Condition / PCR
0900B	NonPublic	6/30/2001	18056	0.31	GR	N/A

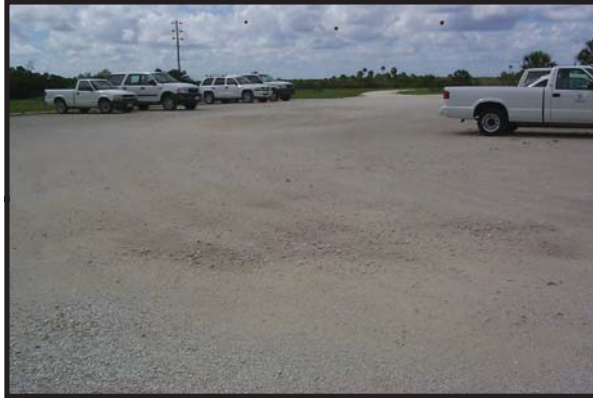
## Route 0901

Route	Public / NonPublic	Date Visited	Area (sq ft)	Lane Miles *	Surface Type	Condition / PCR
0901	Public	6/30/2001	15006	0.26	AS	FAIR / 73

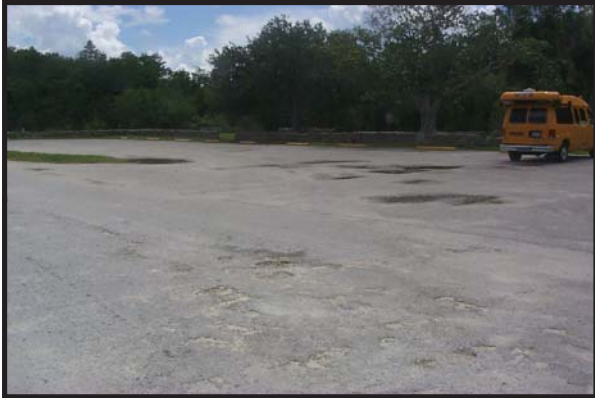
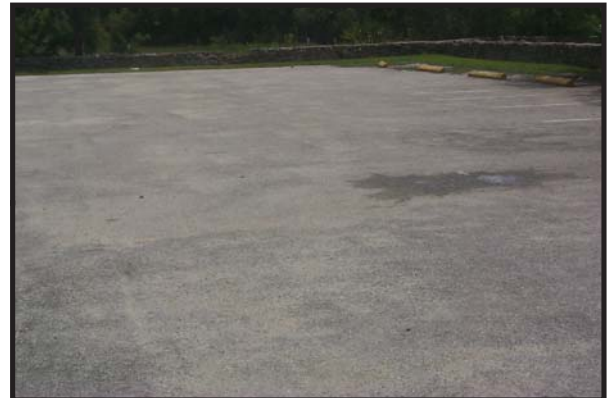
## Route 0902A

Route	Public / NonPublic	Date Visited	Area (sq ft)	Lane Miles *	Surface Type	Condition / PCR
0902A	Public	6/30/2001	13506	0.23	AS	FAIR / 73

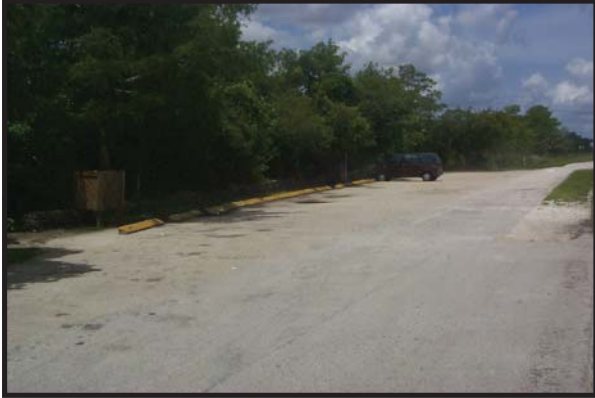
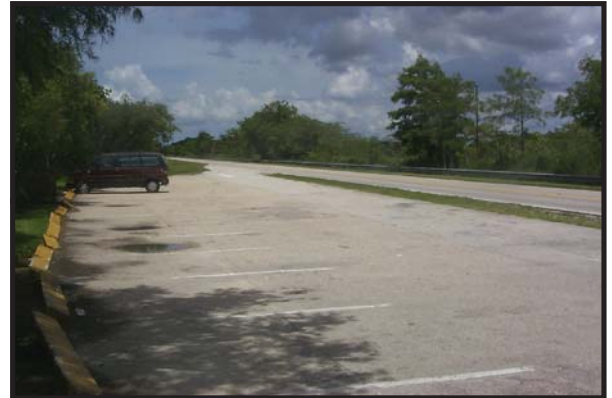
## Route 0902B

Route	Public / NonPublic	Date Visited	Area (sq ft)	Lane Miles *	Surface Type	Condition / PCR
0902B	Public	6/30/2001	7538	0.13	AS	GOOD / 90

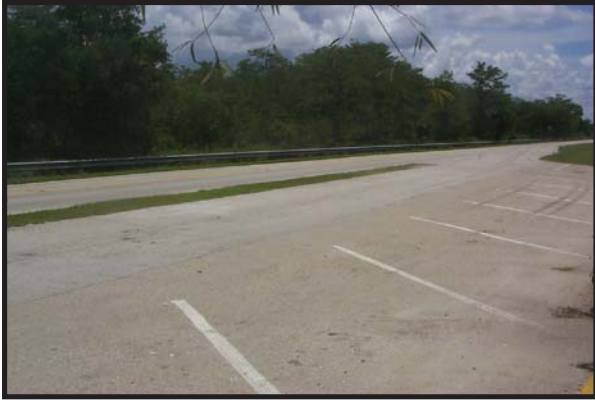
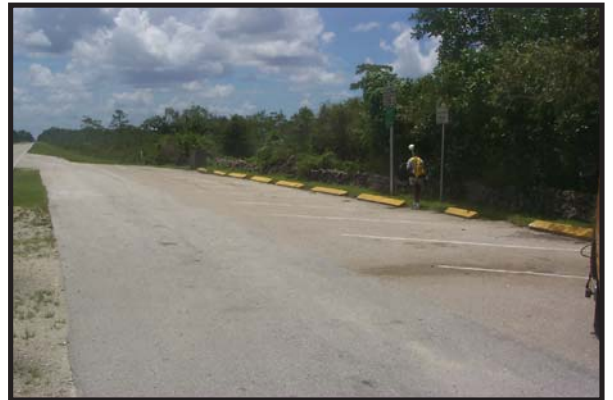
## Route 0903

Route	Public / NonPublic	Date Visited	Area (sq ft)	Lane Miles *	Surface Type	Condition / PCR
0903	Public	6/30/2001	32511	0.56	AS	POOR / 45

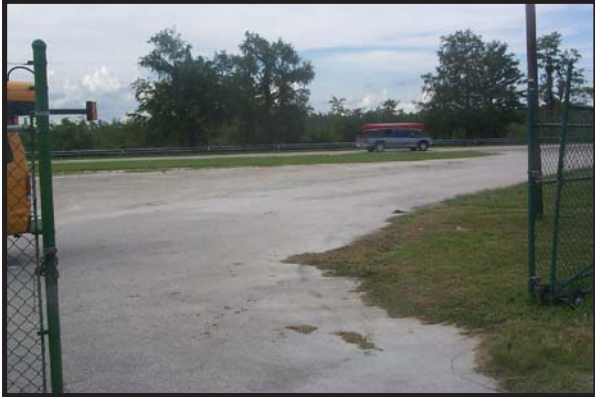
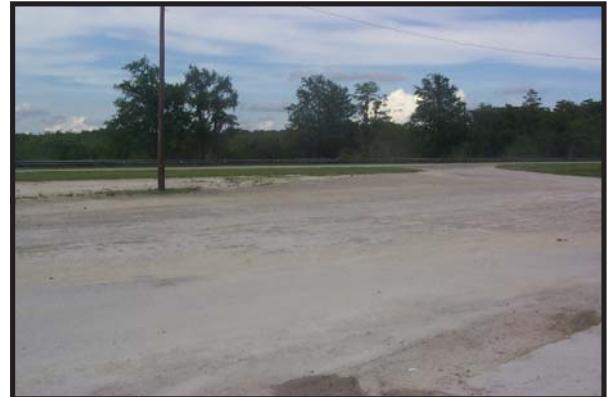
## Route 0904

Route	Public / NonPublic	Date Visited	Area (sq ft)	Lane Miles *	Surface Type	Condition / PCR
0904	Public	6/30/2001	40124	0.69	AS	GOOD / 90
