# The Road Inventory of Big Hole National Battlefield BIHO - 9374

## Road Inventory Program

Prepared By:  
Federal Highway Administration  
Eastern Federal Lands Highway Division  
Cycle 3

# Big Hole National Battlefield in Montana

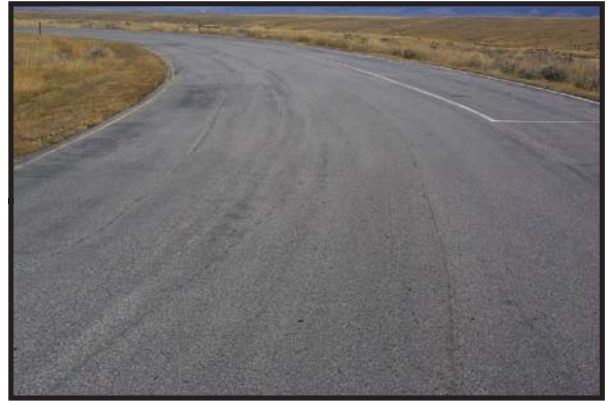
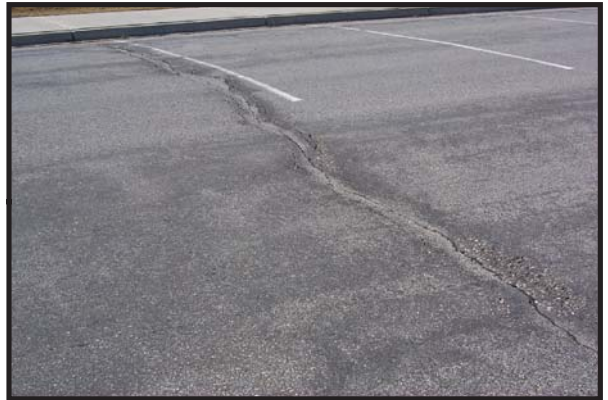
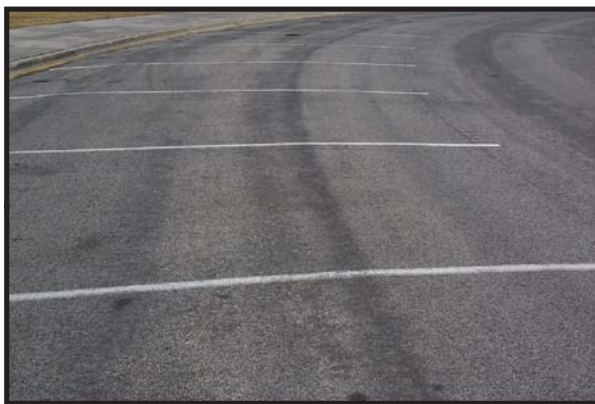
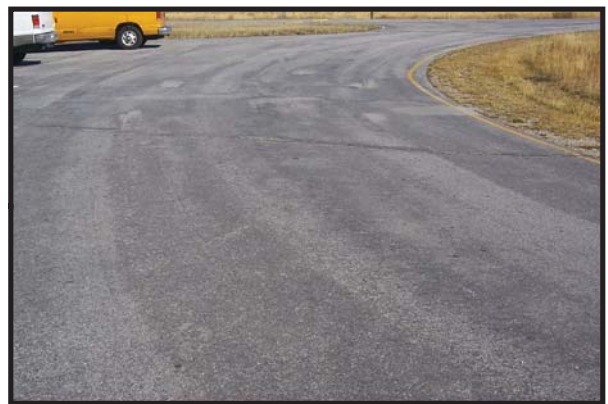
## Route 0900

Route	Public / NonPublic	Date Visited	Area (sq ft)	Lane Miles *	Surface Type	Condition / PCR
0900	Public	10/8/2002	30547	0.53	AS	FAIR / 73

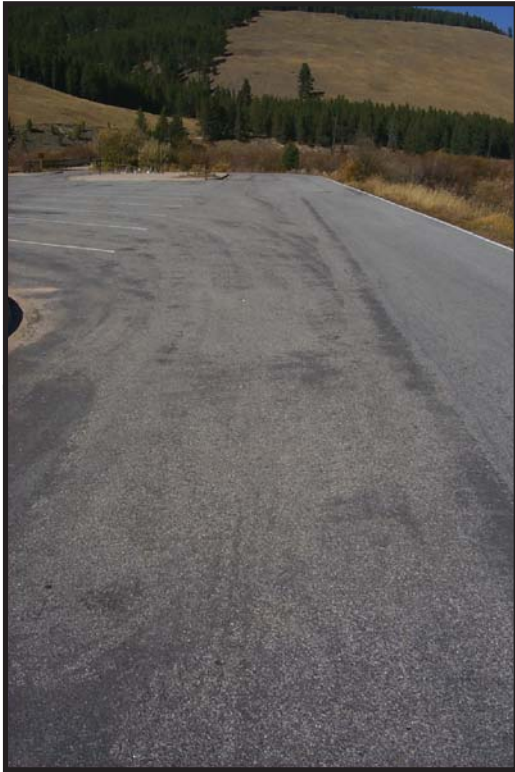
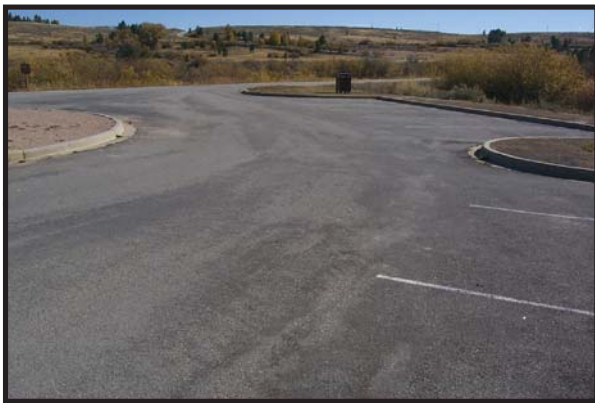
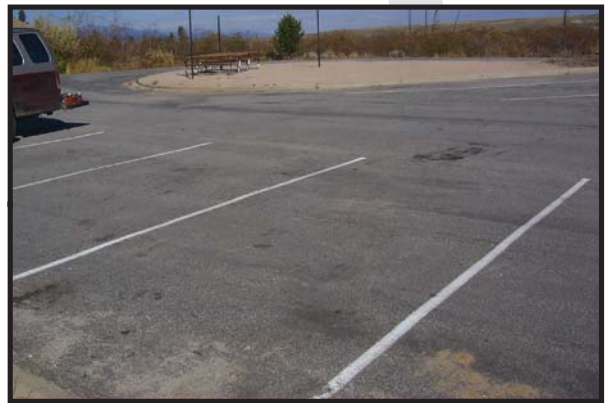
## Route 0901

Route	Public / NonPublic	Date Visited	Area (sq ft)	Lane Miles *	Surface Type	Condition / PCR
0901	Public	10/8/2002	27770	0.48	AS	FAIR / 73

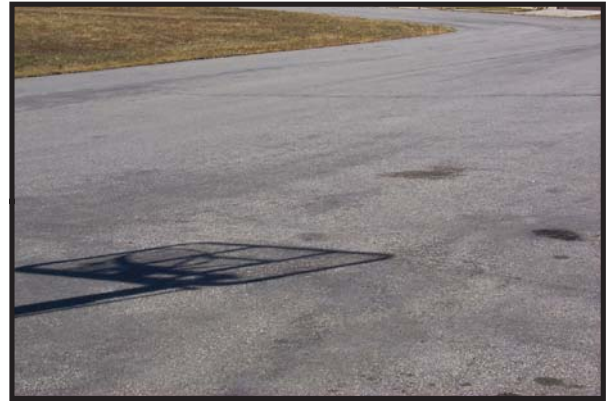
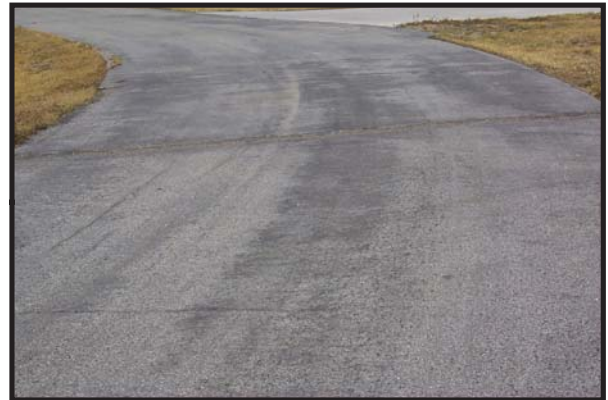
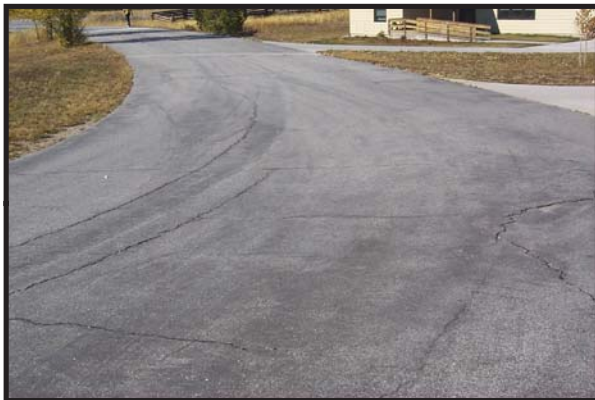
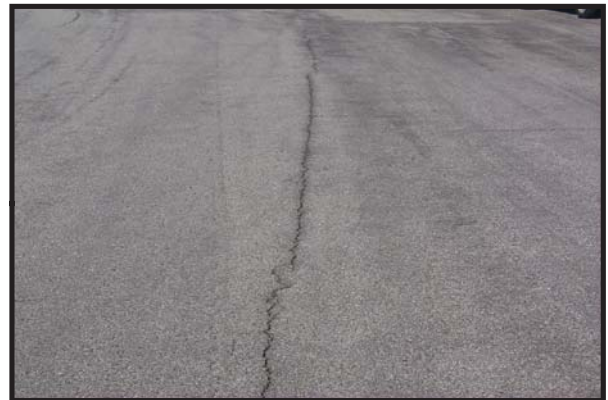
## Route 0902

Route	Public / NonPublic	Date Visited	Area (sq ft)	Lane Miles *	Surface Type	Condition / PCR
0902	NonPublic	10/8/2002	20164	0.35	AS	GOOD / 90

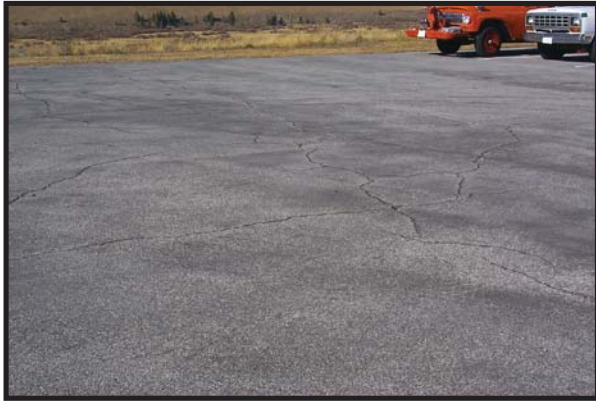
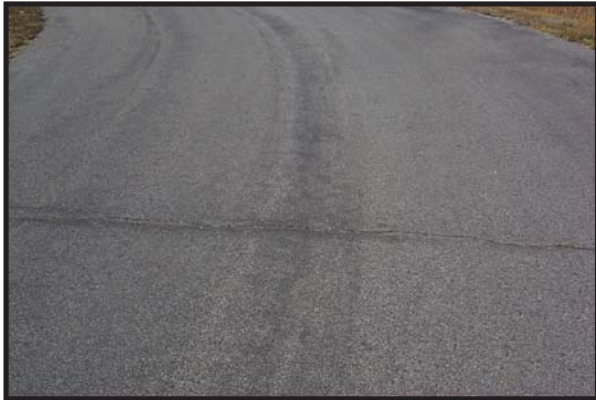
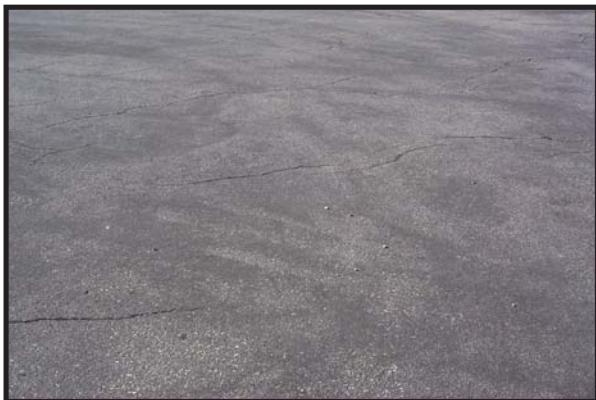
## Route 0903

Route	Public / NonPublic	Date Visited	Area (sq ft)	Lane Miles *	Surface Type	Condition / PCR
0903	NonPublic	10/8/2002	17977	0.31	AS	FAIR / 73
