The Road Inventory of Biscayne National Park BISC - 5250

Road Inventory Program

Prepared By:
Federal Highway Administration
Eastern Federal Lands Highway Division
Cycle 3

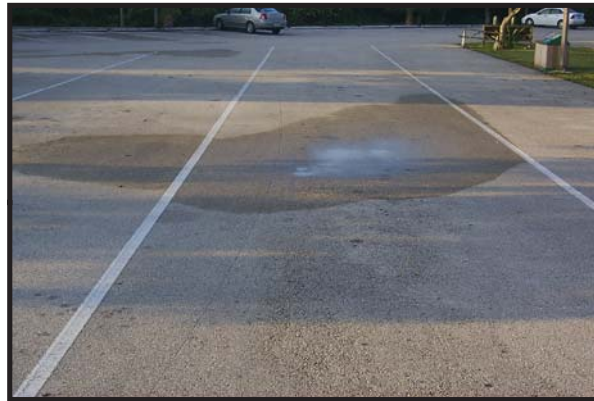
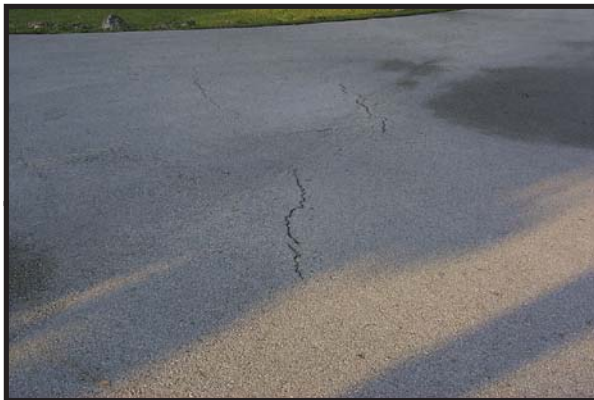
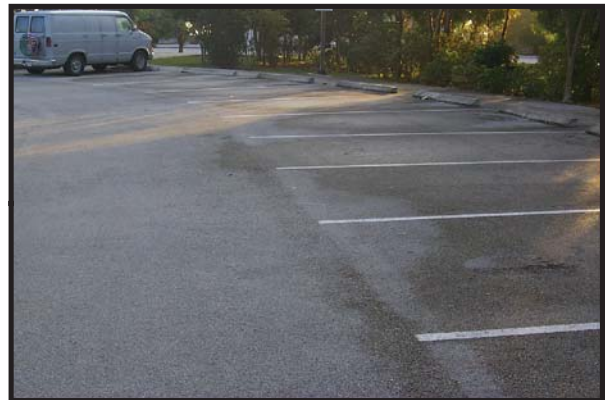
Route	Public / NonPublic	Date Visited	Area (sq ft)	Lane Miles *	Surface Type	Condition / PCR
0900	Public	2/26/2003	43762	0.75	AS	GOOD / 90

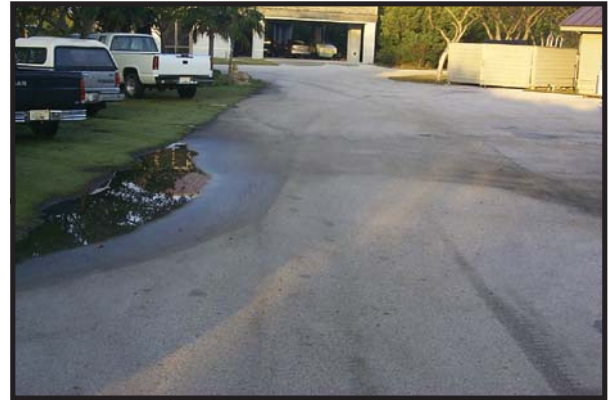
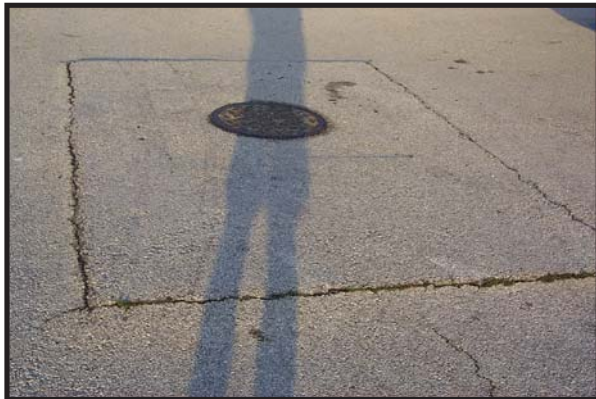
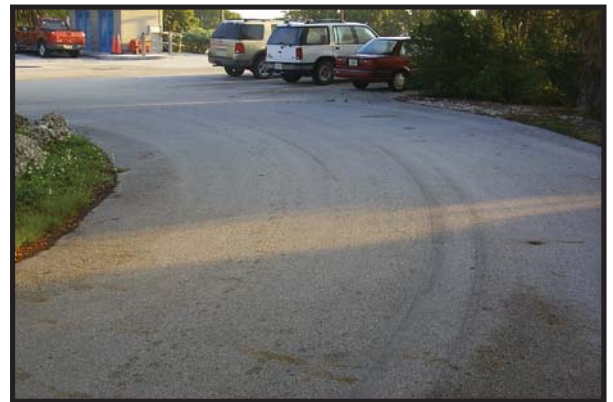
Route 0901A

Route	Public / NonPublic	Date Visited	Area (sq ft)	Lane Miles *	Surface Type	Condition / PCR
0901A	NonPublic	2/26/2003	27969	0.48	AS	FAIR / 73

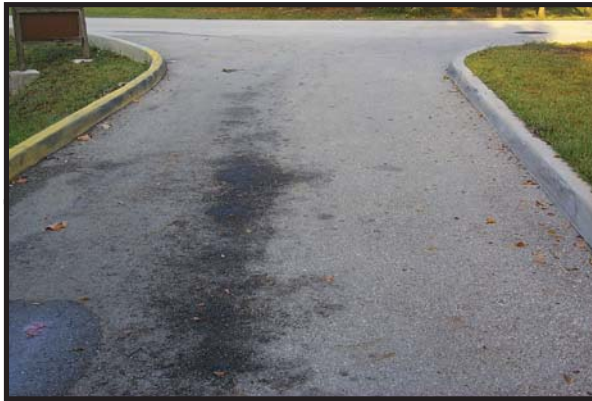
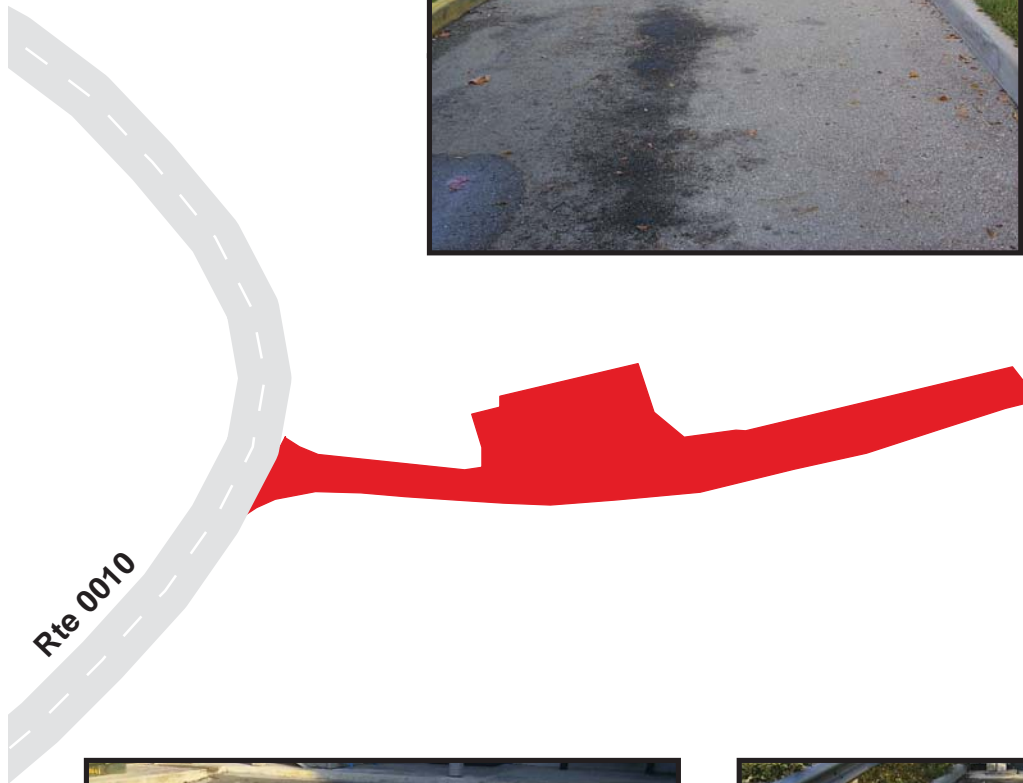
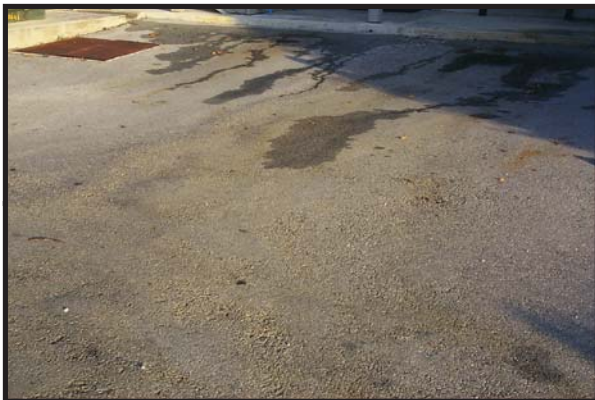
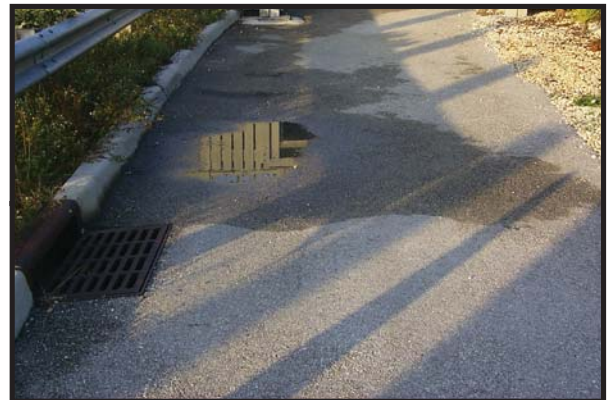
Route 0902

Route	Public / NonPublic	Date Visited	Area (sq ft)	Lane Miles *	Surface Type	Condition / PCR
0902	Public	2/26/2003	2109	0.04	AS	FAIR / 73

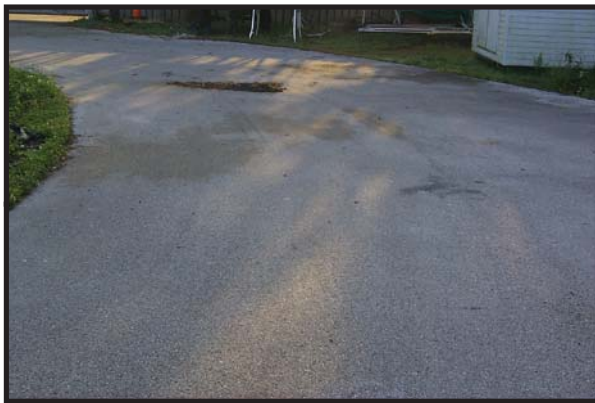
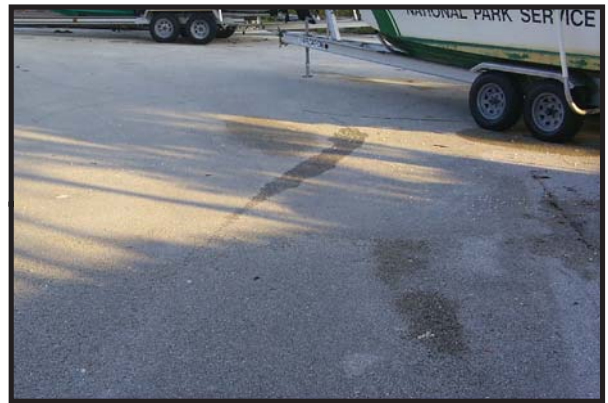
Route 0903

Route	Public / NonPublic	Date Visited	Area (sq ft)	Lane Miles *	Surface Type	Condition / PCR
0903	NonPublic	2/26/2003	11855	0.20	AS	GOOD / 90
