# The Road Inventory of Big South Fork National River and Recreation Area BISO - 5130

## Road Inventory Program

Prepared By:  
Federal Highway Administration  
Eastern Federal Lands Highway Division  
Cycle 3

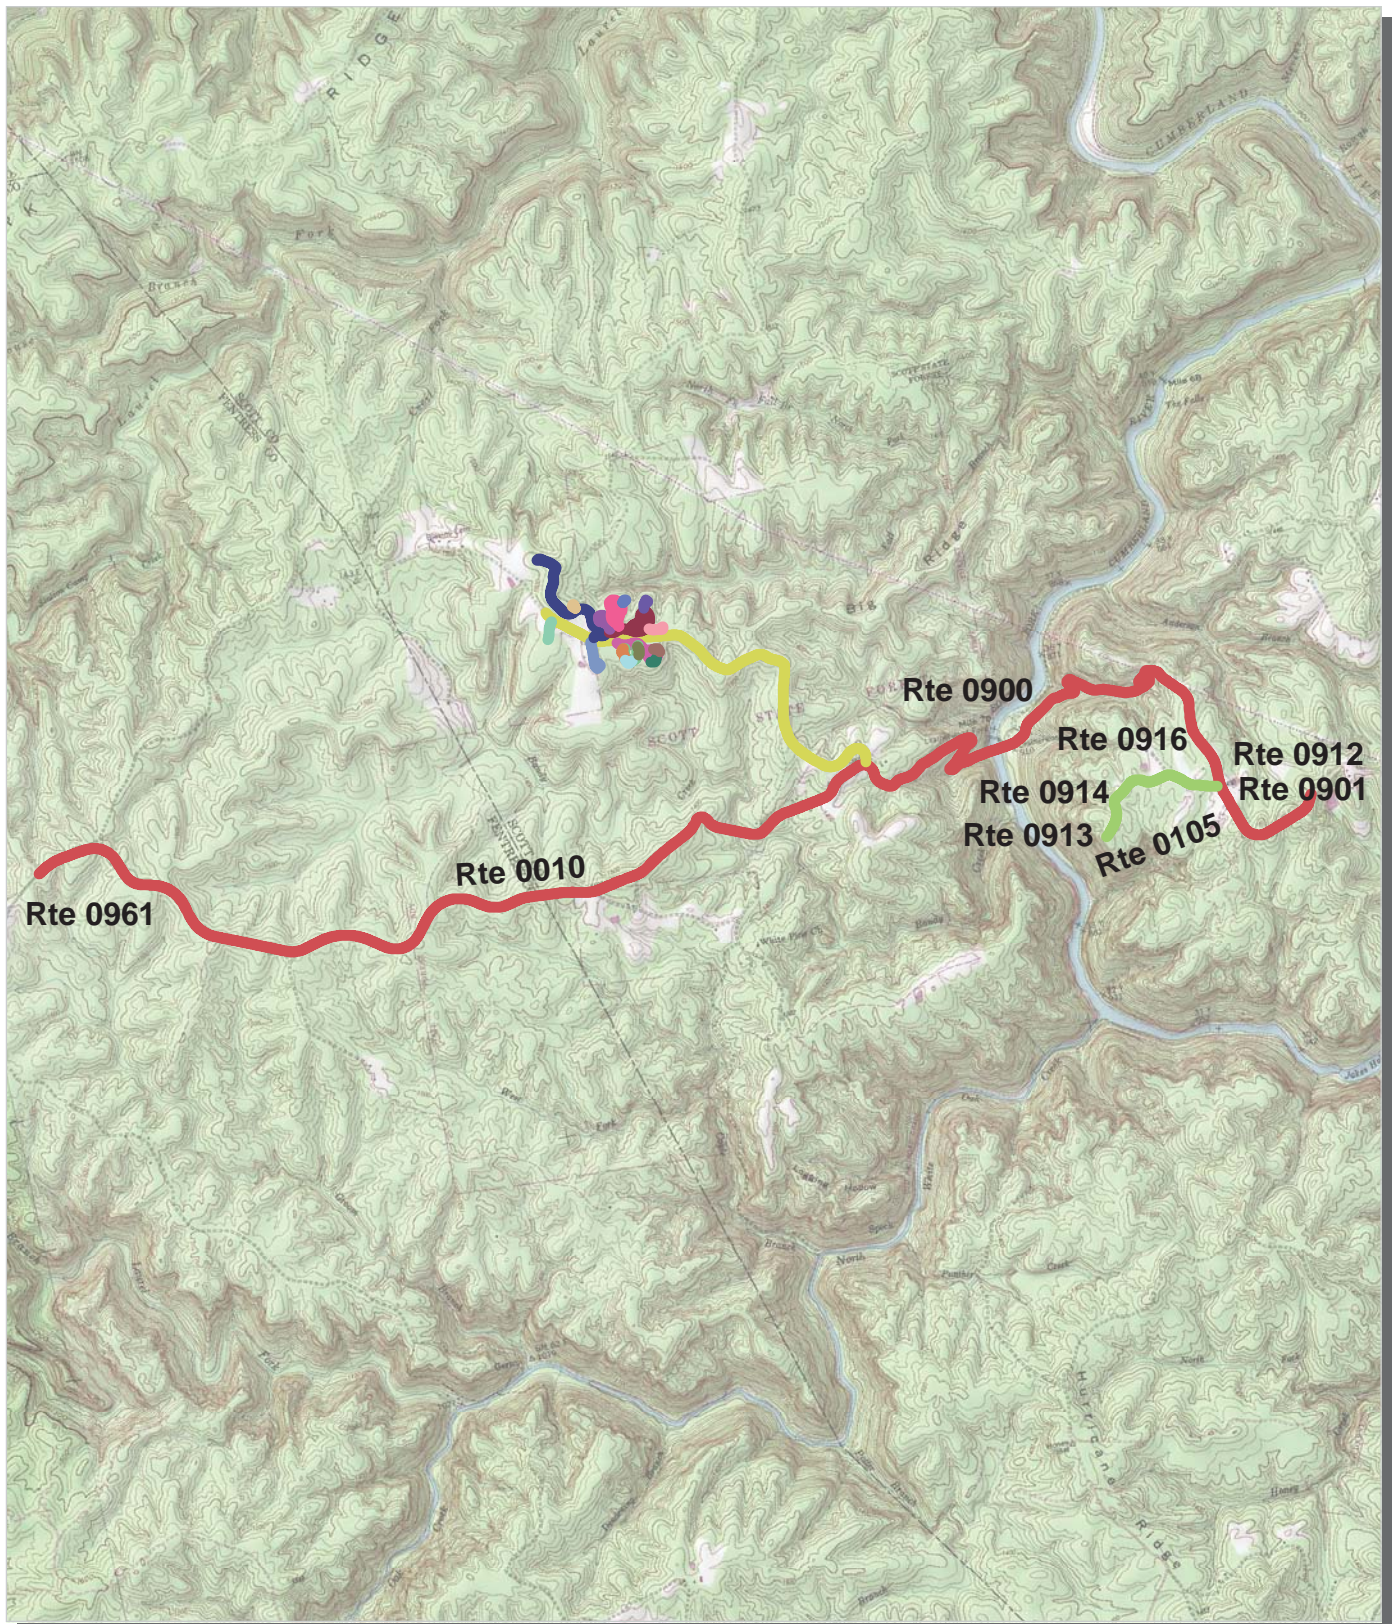
# Big South Fork National River and Recreation Area Route Location Map Area Map 3

Unique colors used to differentiate routes

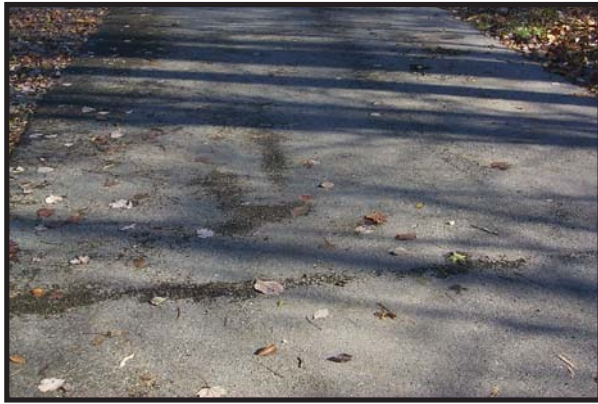
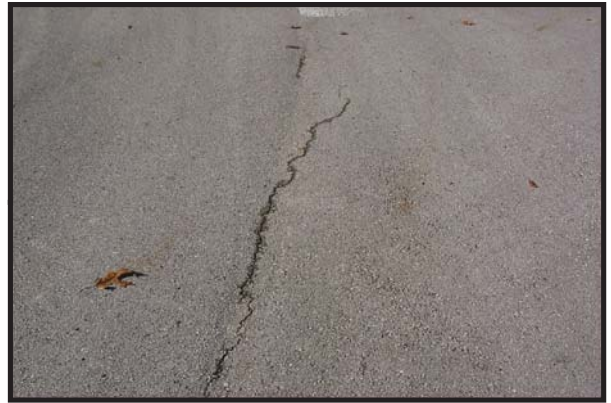
Route	Public / NonPublic	Date Visited	Area (sq ft)	Lane Miles *	Surface Type	Condition / PCR
0900	Public	11/18/2002	37313	0.64	AS	FAIR / 73

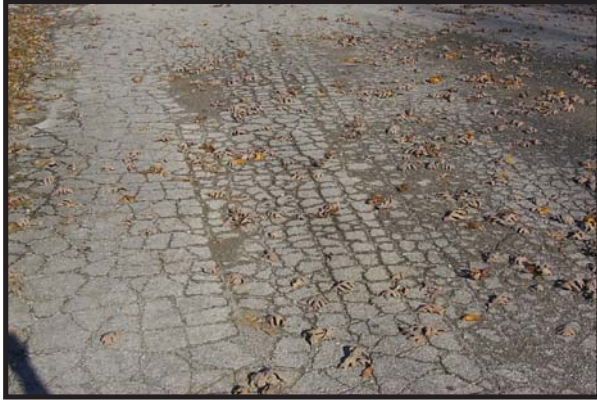
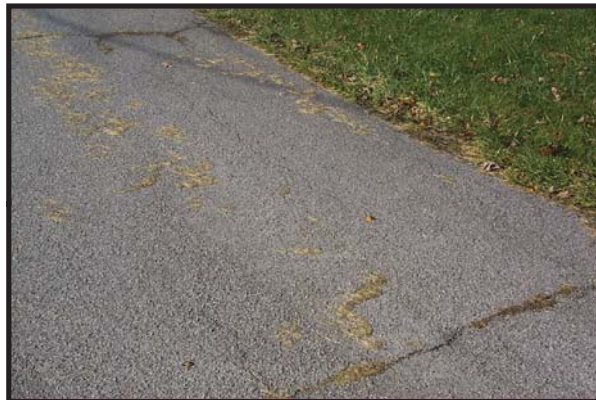
Route	Public / NonPublic	Date Visited	Area (sq ft)	Lane Miles *	Surface Type	Condition / PCR
0901	NonPublic	11/18/2002	11883	0.20	AS	POOR / 45

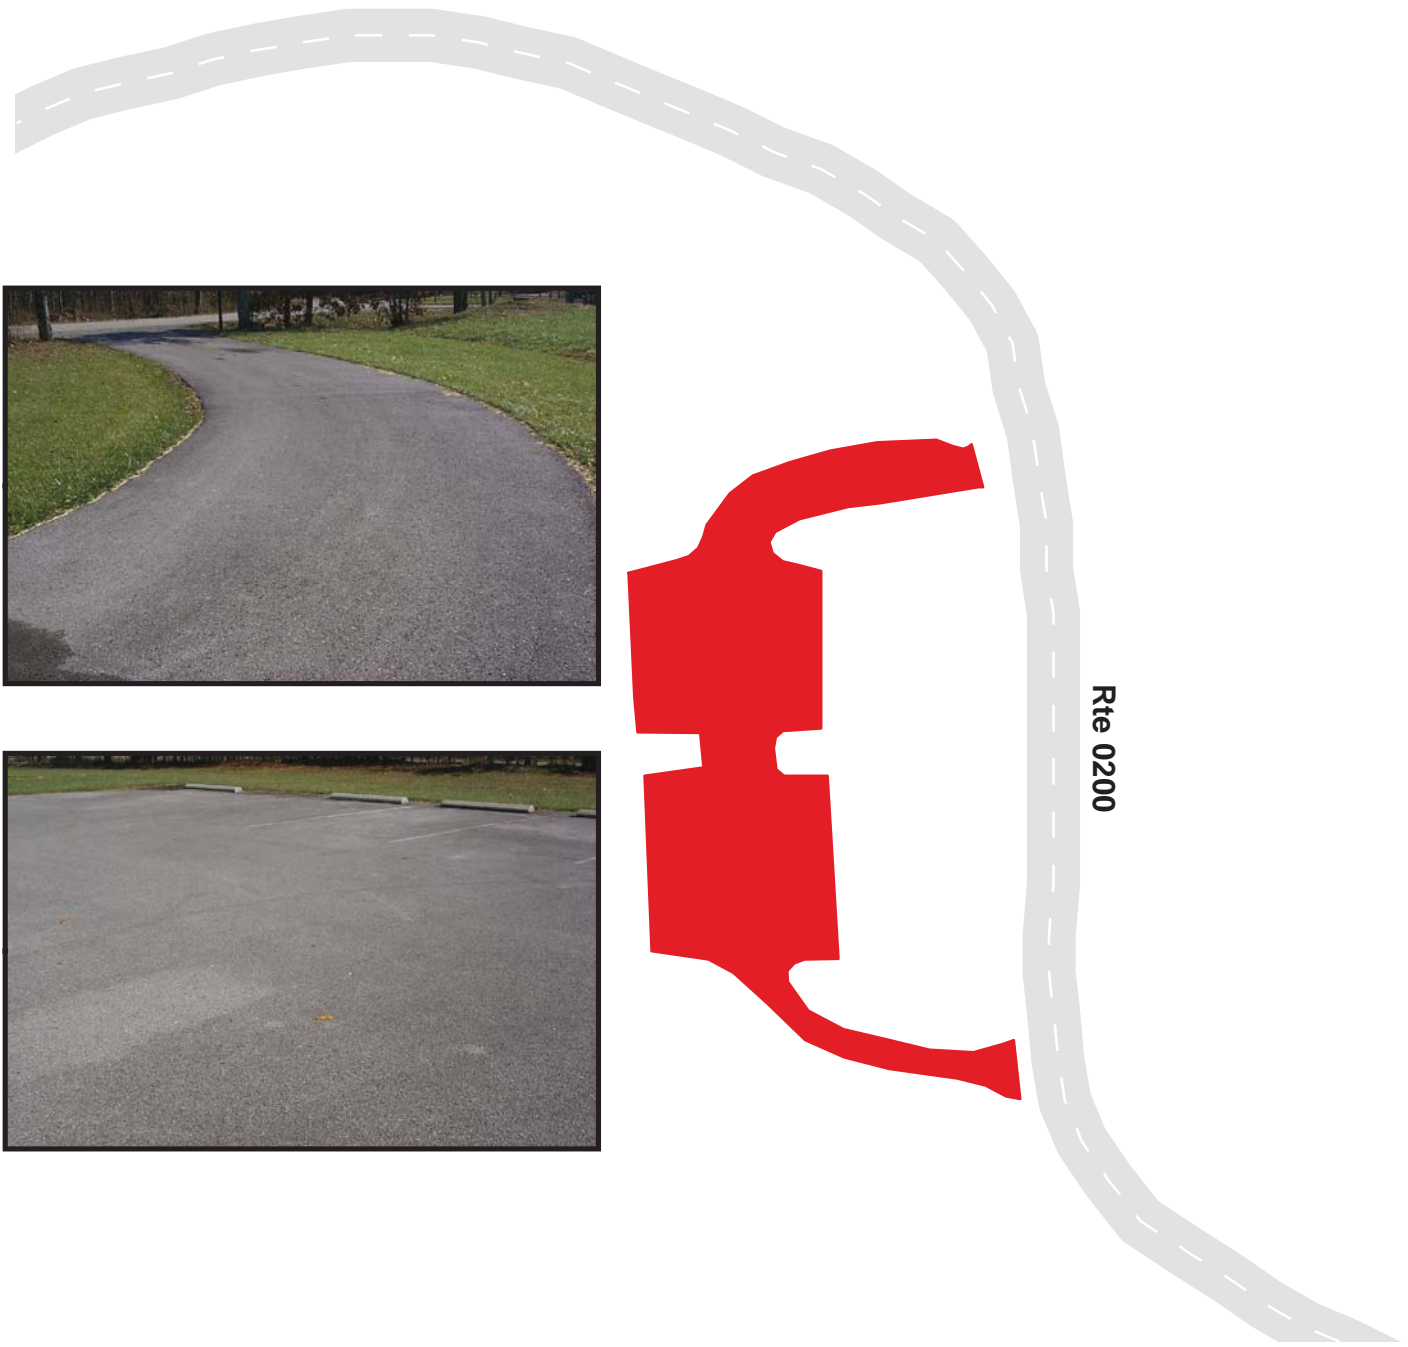
## Route 0903

Route	Public / NonPublic	Date Visited	Area (sq ft)	Lane Miles *	Surface Type	Condition / PCR
0903	Public	11/18/2002	12706	0.22	AS	GOOD / 90

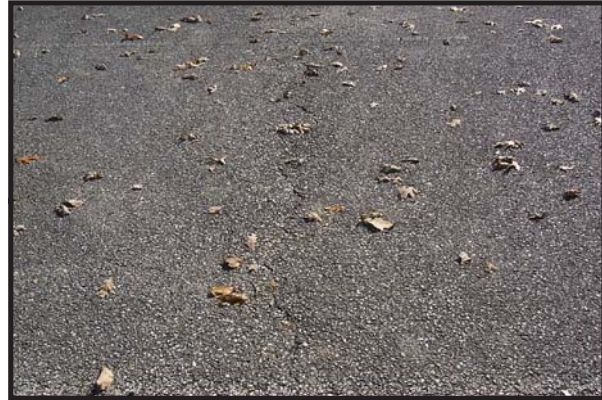
Route	Public / NonPublic	Date Visited	Area (sq ft)	Lane Miles *	Surface Type	Condition / PCR
0904	Public	11/18/2002	1437	0.02	AS	FAIR / 73

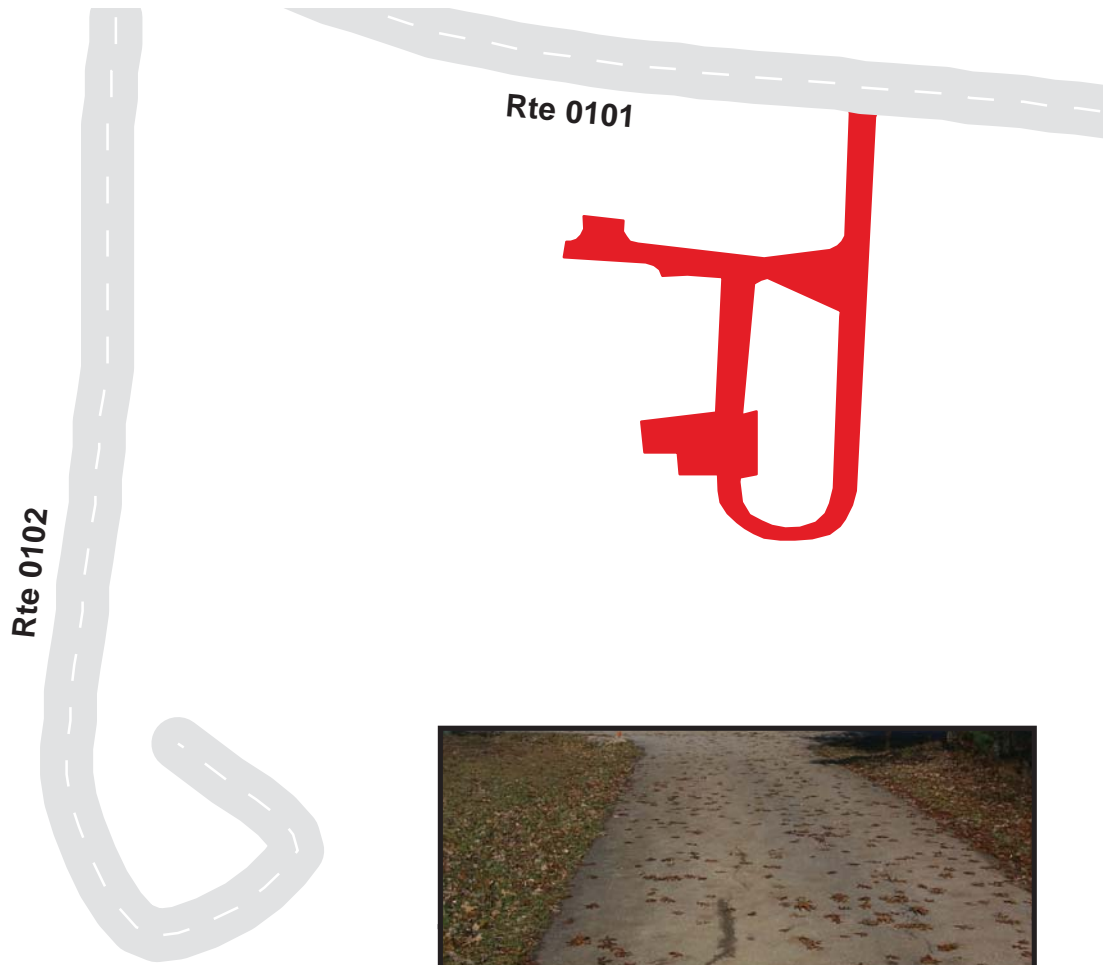
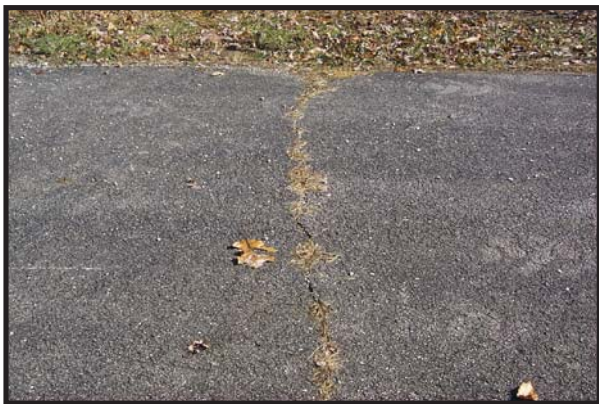
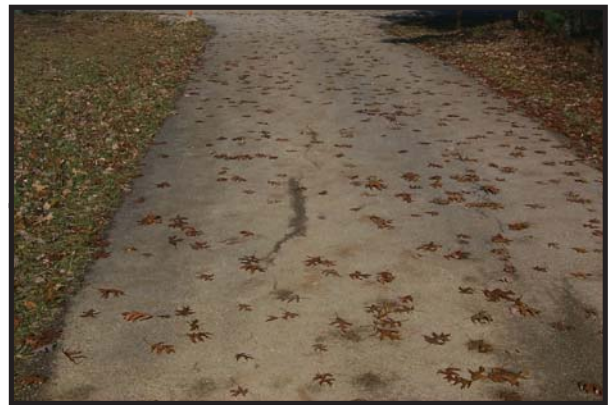
Route	Public / NonPublic	Date Visited	Area (sq ft)	Lane Miles *	Surface Type	Condition / PCR
0905	NonPublic	11/18/2002	11029	0.19	AS	FAIR / 73

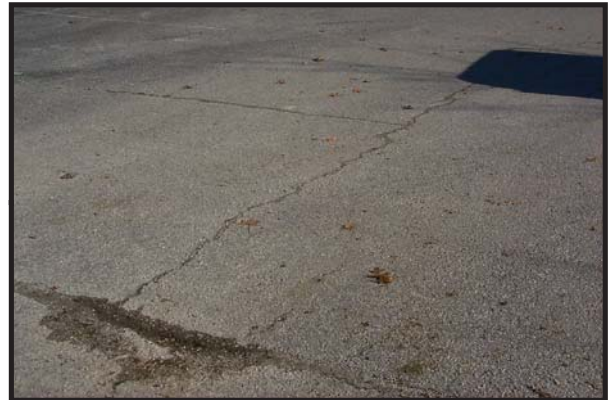
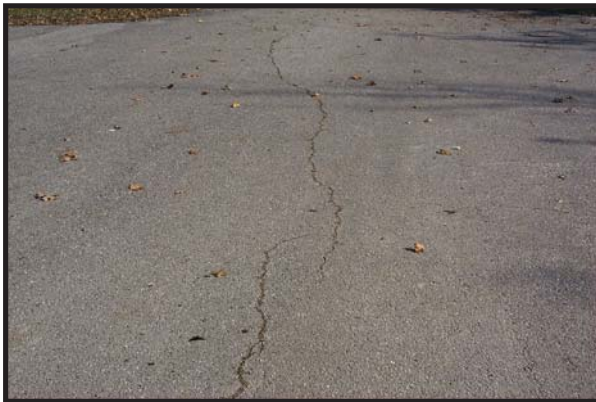
Route	Public / NonPublic	Date Visited	Area (sq ft)	Lane Miles *	Surface Type	Condition / PCR
0906	Public	11/18/2002	14365	0.25	AS	FAIR / 73

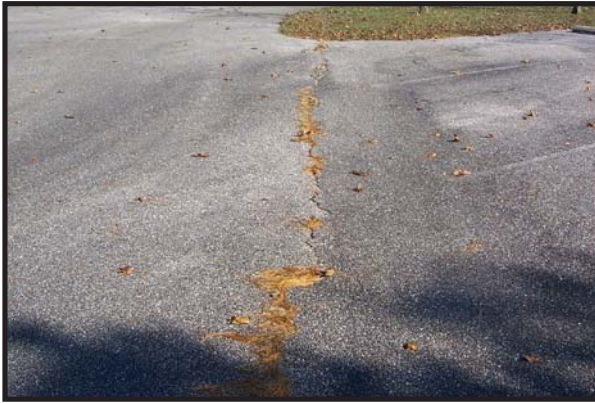
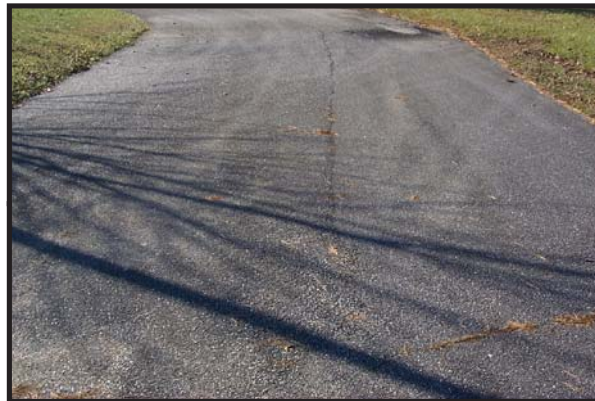
Route	Public / NonPublic	Date Visited	Area (sq ft)	Lane Miles *	Surface Type	Condition / PCR
0907A	Public	11/18/2002	27306	0.47	AS	FAIR / 73

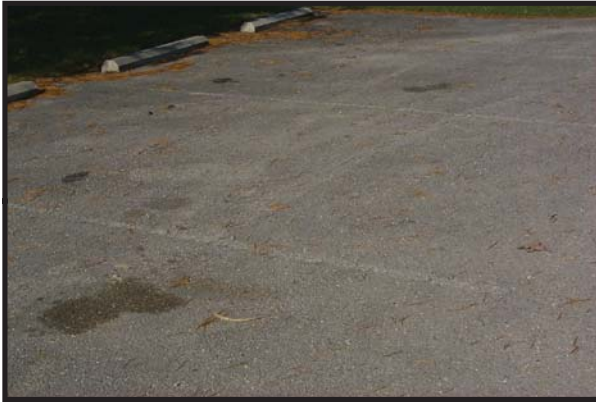
Route	Public / NonPublic	Date Visited	Area (sq ft)	Lane Miles *	Surface Type	Condition / PCR
0907B	Public	11/18/2002	1064	0.02	AS	GOOD / 90

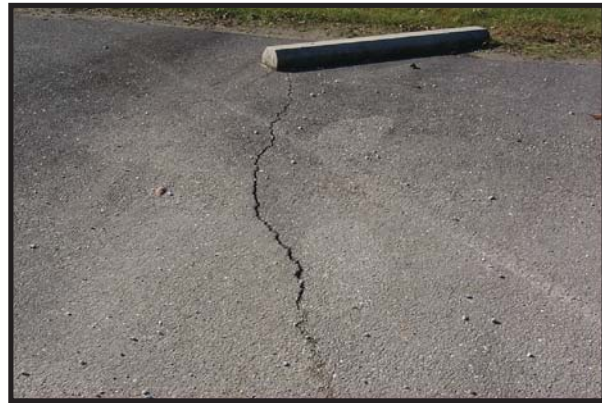
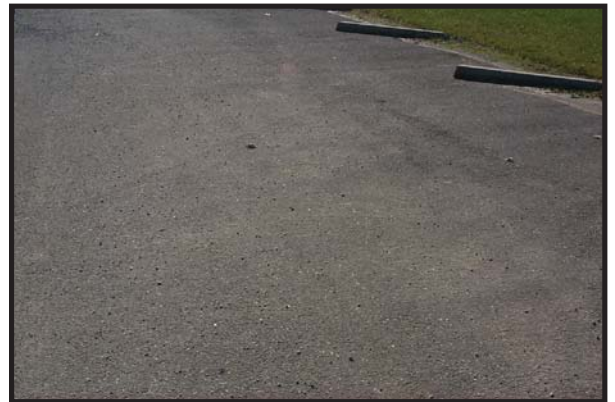
Route	Public / NonPublic	Date Visited	Area (sq ft)	Lane Miles *	Surface Type	Condition / PCR
0907C	Public	11/18/2002	1851	0.03	AS	GOOD / 90

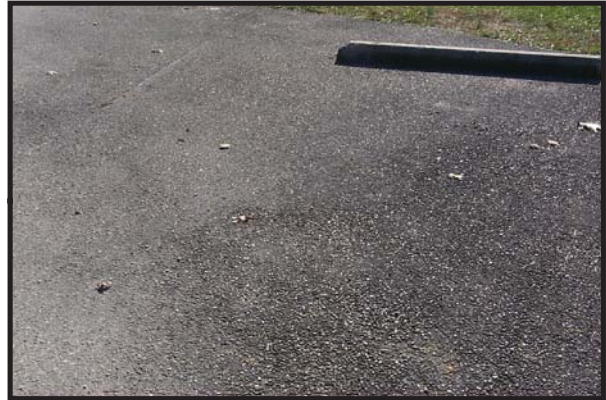
Route	Public / NonPublic	Date Visited	Area (sq ft)	Lane Miles *	Surface Type	Condition / PCR
0907D	Public	11/18/2002	396	0.01	AS	GOOD / 90

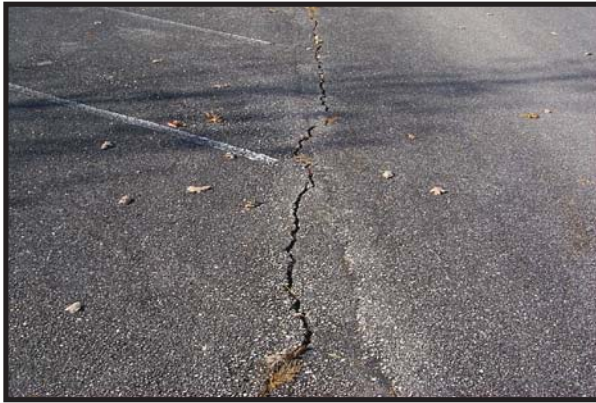
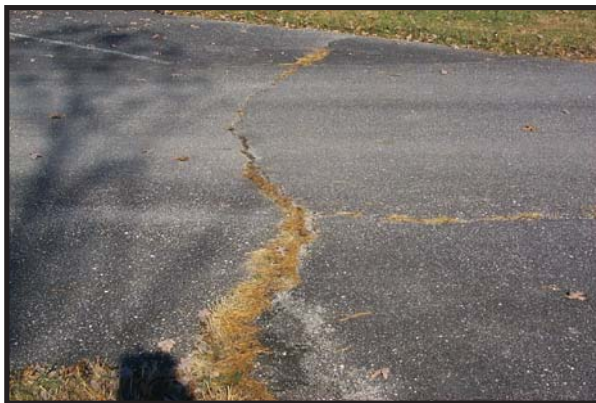
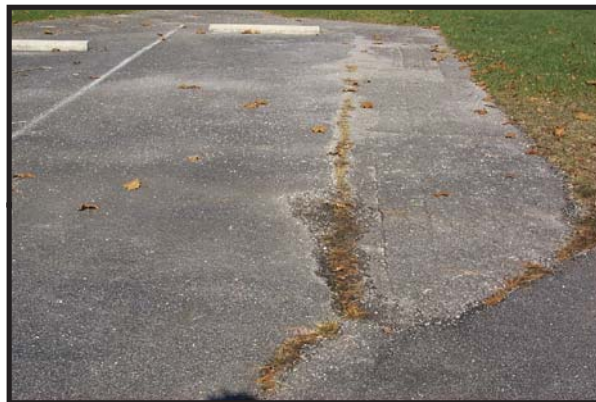
Route	Public / NonPublic	Date Visited	Area (sq ft)	Lane Miles *	Surface Type	Condition / PCR
0908	Public	11/18/2002	23664	0.41	AS	GOOD / 90

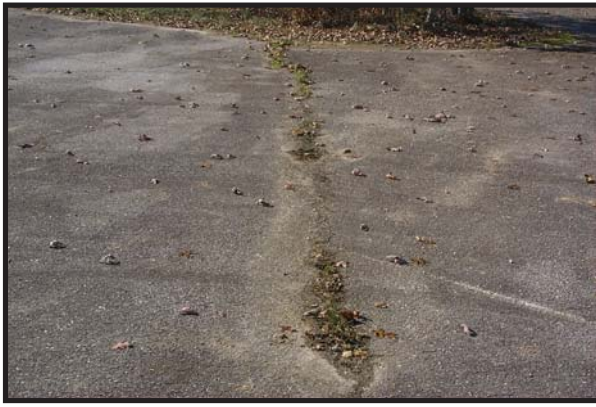
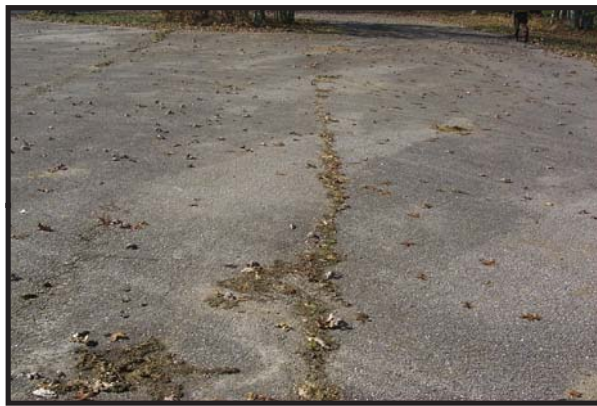
Route	Public / NonPublic	Date Visited	Area (sq ft)	Lane Miles *	Surface Type	Condition / PCR
0909	Public	11/18/2002	19152	0.33	AS	FAIR / 73

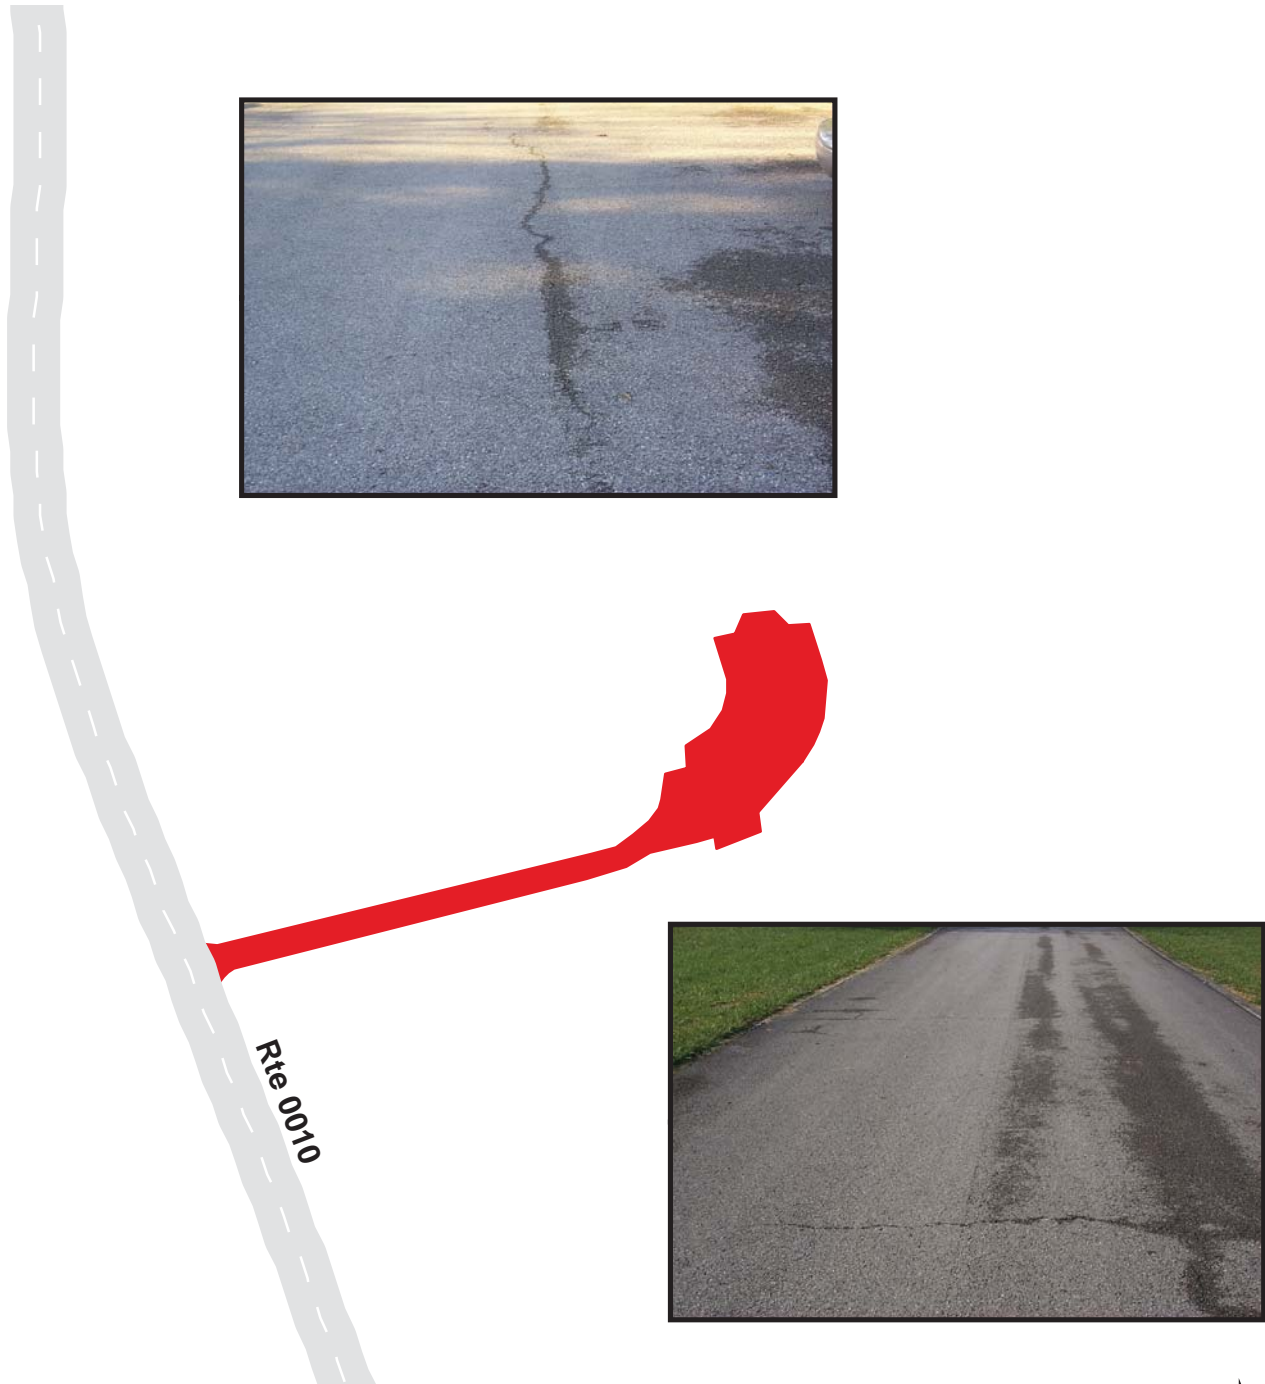
Route	Public / NonPublic	Date Visited	Area (sq ft)	Lane Miles *	Surface Type	Condition / PCR
0912	Public	11/18/2002	19761	0.34	AS	FAIR / 73

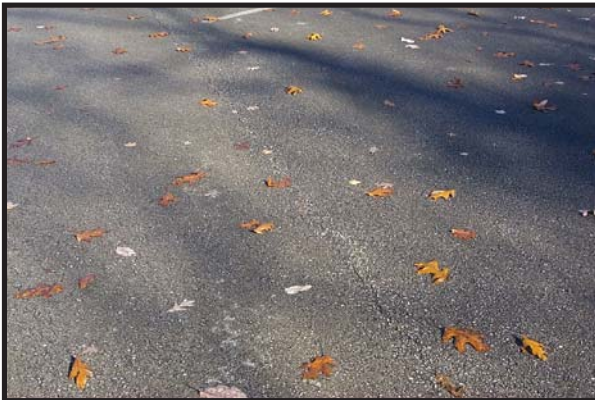
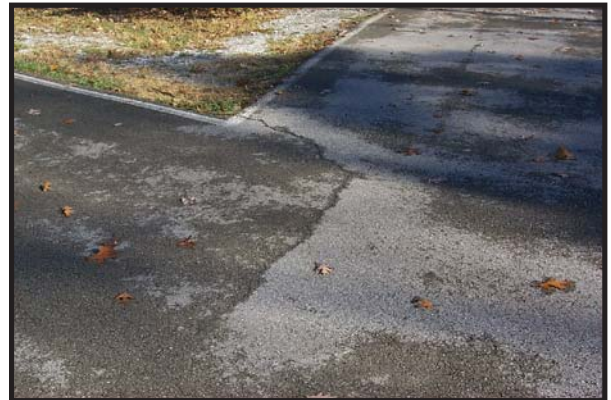
Route	Public / NonPublic	Date Visited	Area (sq ft)	Lane Miles *	Surface Type	Condition / PCR
0913	Public	11/18/2002	14584	0.25	AS	GOOD / 90

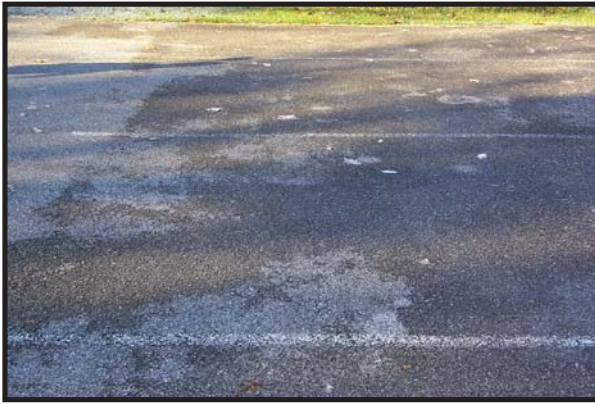
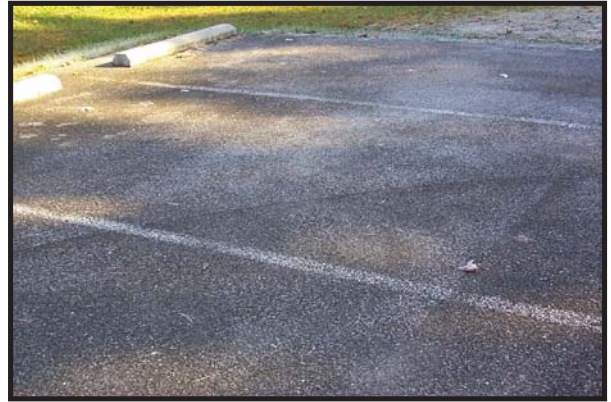
Route	Public / NonPublic	Date Visited	Area (sq ft)	Lane Miles *	Surface Type	Condition / PCR
0914	Public	11/18/2002	2231	0.04	AS	GOOD / 90

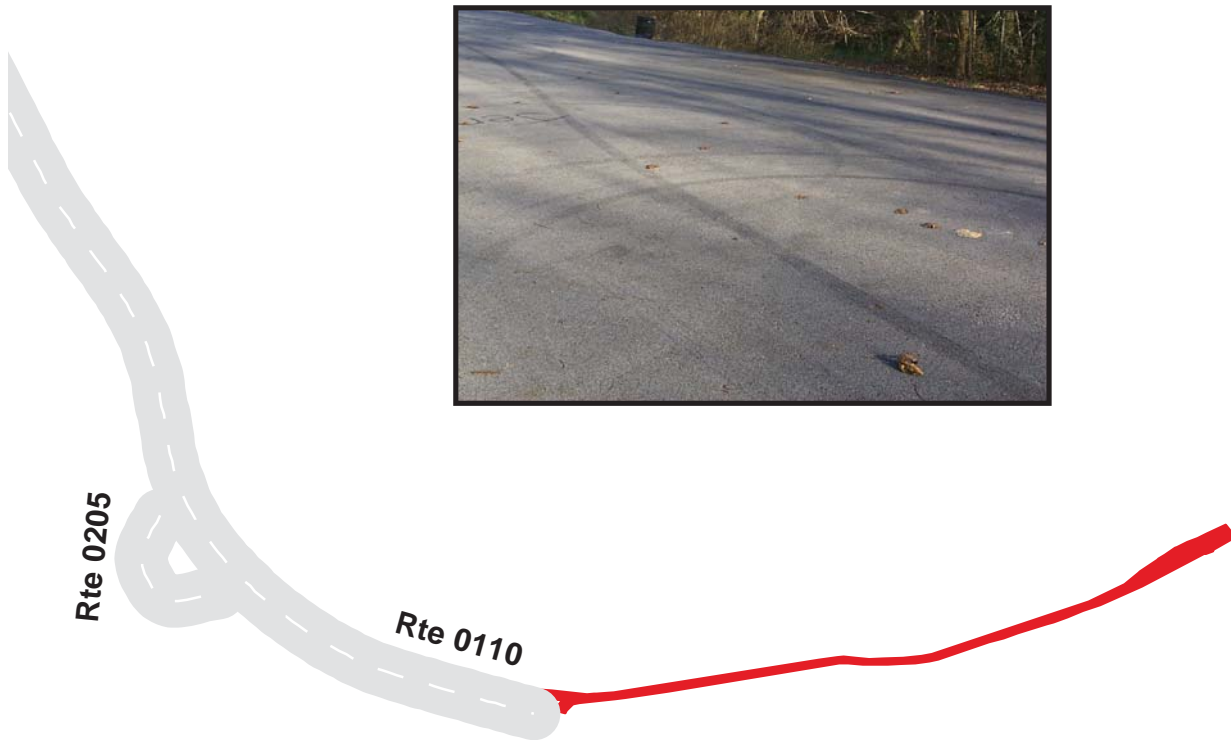
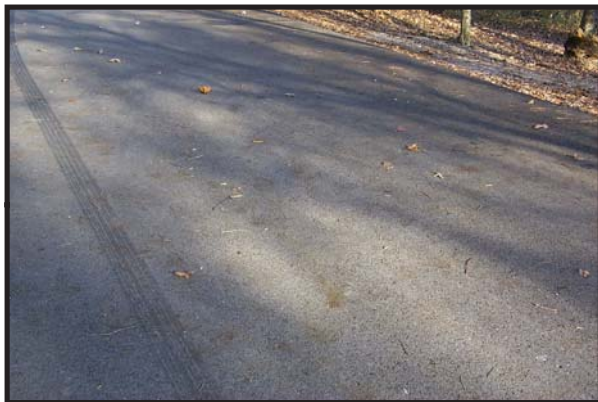
## Route 0925

Route	Public / NonPublic	Date Visited	Area (sq ft)	Lane Miles *	Surface Type	Condition / PCR
0925	Public	11/18/2002	29110	0.50	AS	GOOD / 90

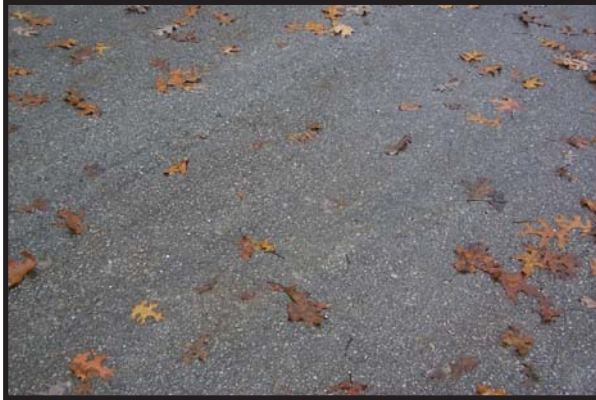
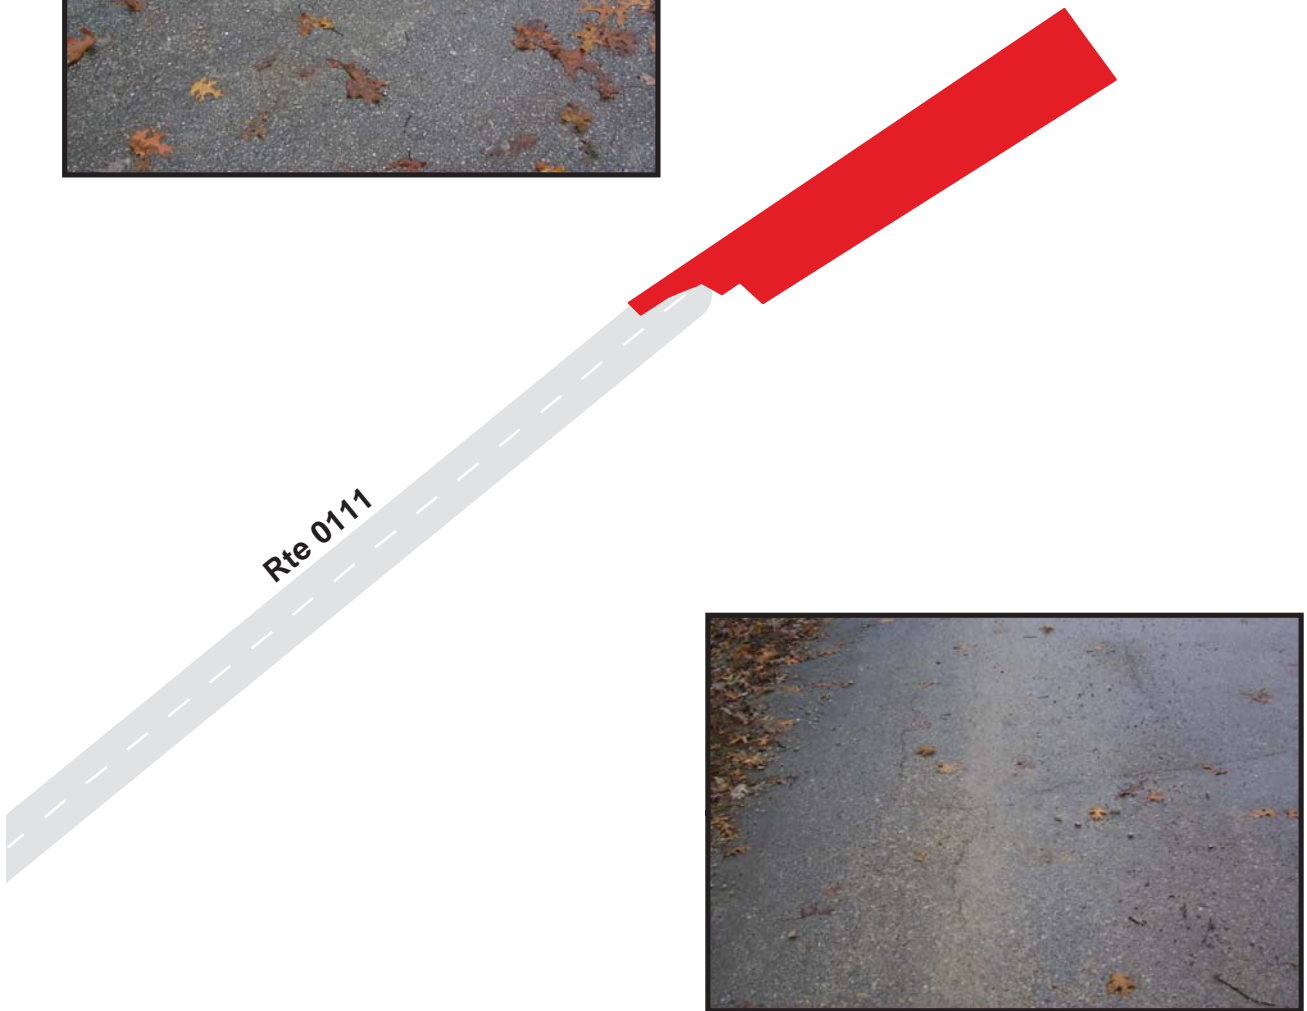
## Route 0926

Route	Public / NonPublic	Date Visited	Area (sq ft)	Lane Miles *	Surface Type	Condition / PCR
0926	Public	11/19/2002	7879	0.14	AS	GOOD / 90

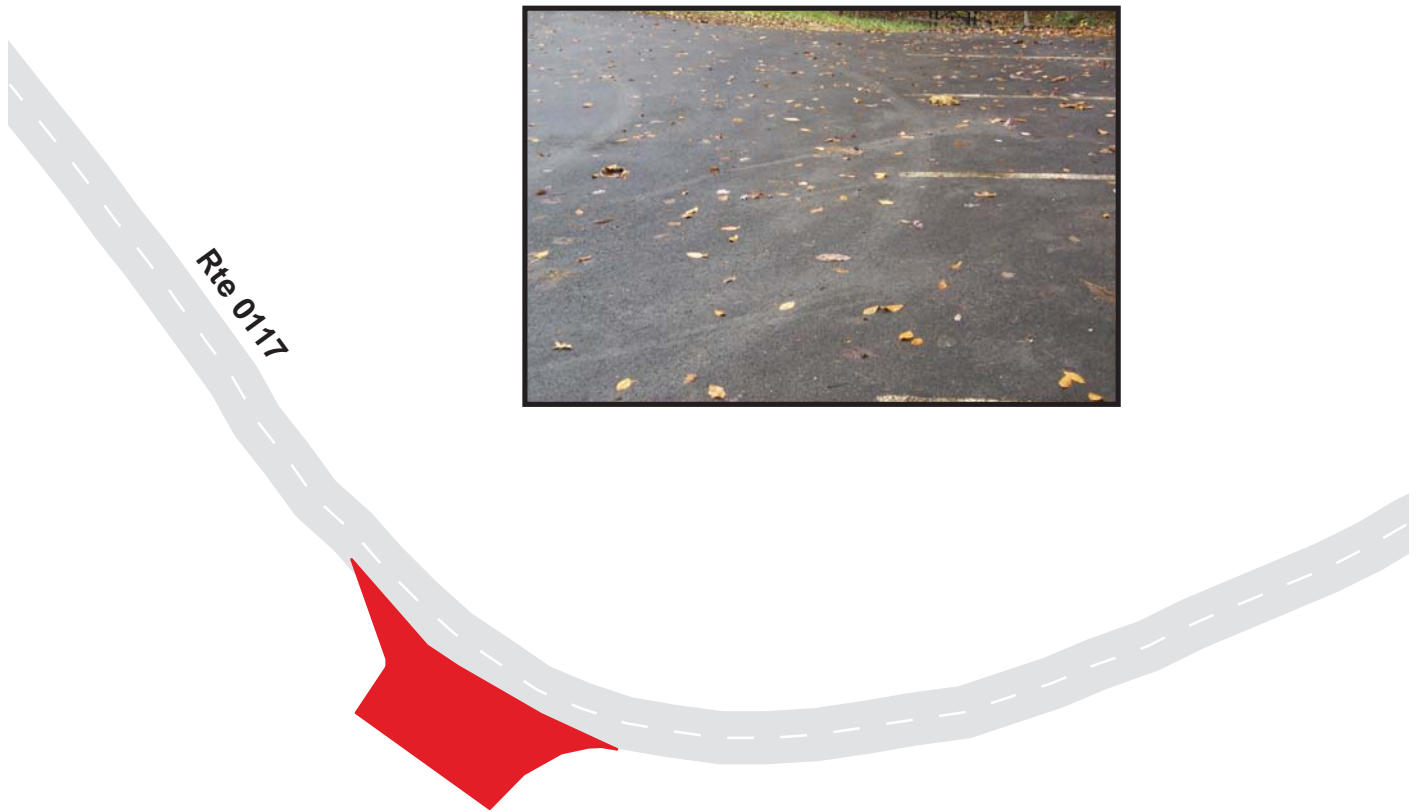
## Route 0934

Route	Public / NonPublic	Date Visited	Area (sq ft)	Lane Miles *	Surface Type	Condition / PCR
0934	Public	11/17/2002	2346	0.04	AS	GOOD / 90

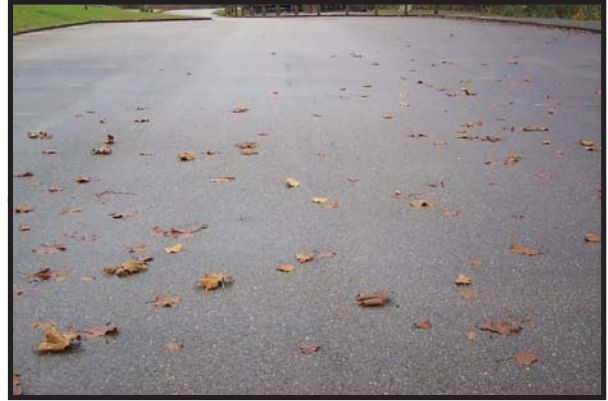
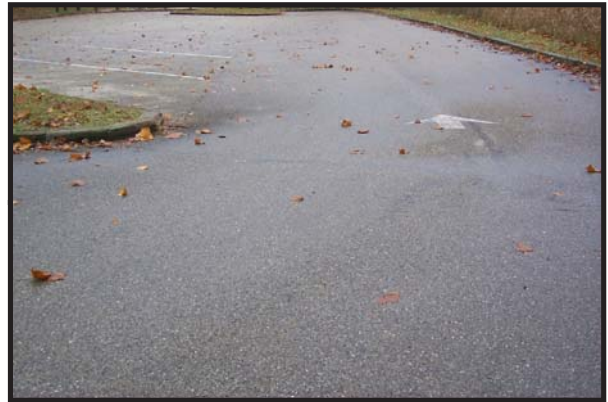
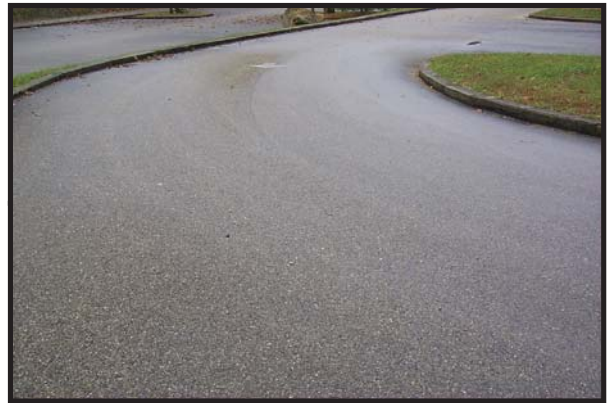
## Route 0935

Route	Public / NonPublic	Date Visited	Area (sq ft)	Lane Miles *	Surface Type	Condition / PCR
0935	Public	11/17/2002	70126	1.21	AS	GOOD / 90

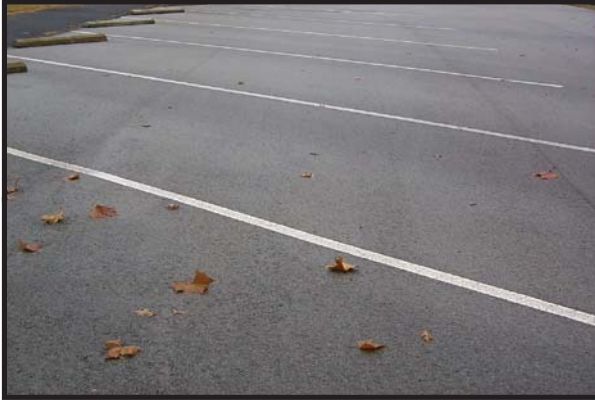
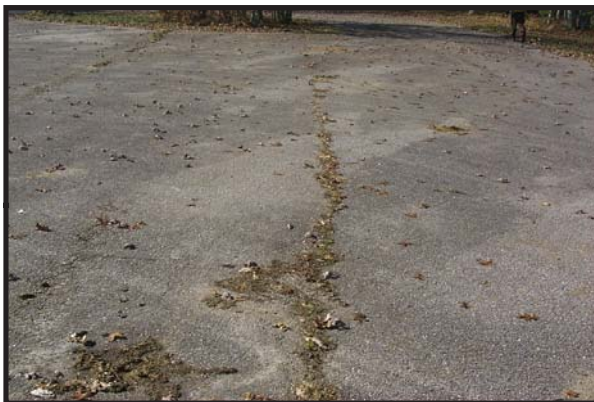
## Route 0936

Route	Public / NonPublic	Date Visited	Area (sq ft)	Lane Miles *	Surface Type	Condition / PCR
0936	Public	11/17/2002	37187	0.64	AS	GOOD / 90

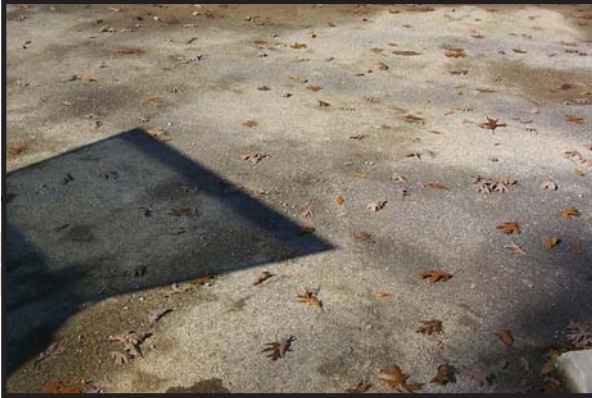
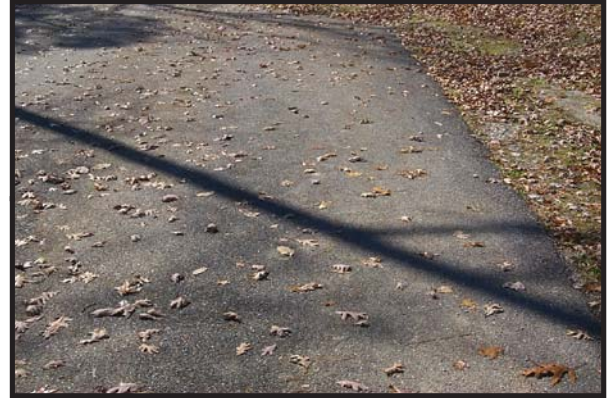
## Route 0940

Route	Public / NonPublic	Date Visited	Area (sq ft)	Lane Miles *	Surface Type	Condition / PCR
0940	Public	11/18/2002	2045	0.04	AS	GOOD / 90

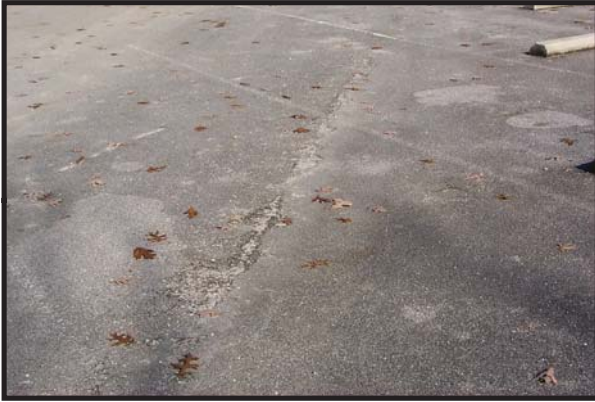
## Route 0941

Route	Public / NonPublic	Date Visited	Area (sq ft)	Lane Miles *	Surface Type	Condition / PCR
0941	Public	11/18/2002	1504	0.03	AS	GOOD / 90

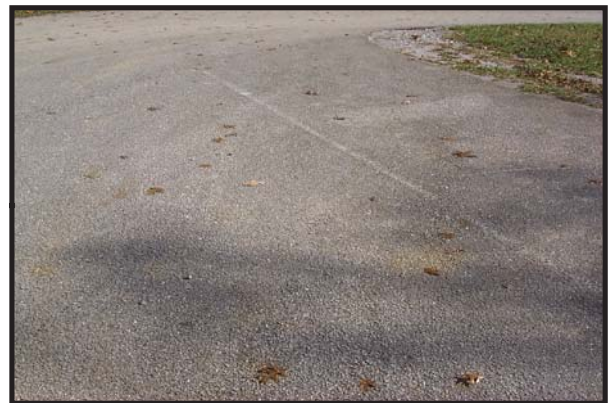
## Route 0942A

Route	Public / NonPublic	Date Visited	Area (sq ft)	Lane Miles *	Surface Type	Condition / PCR
0942A	Public	11/18/2002	692	0.01	AS	GOOD / 90

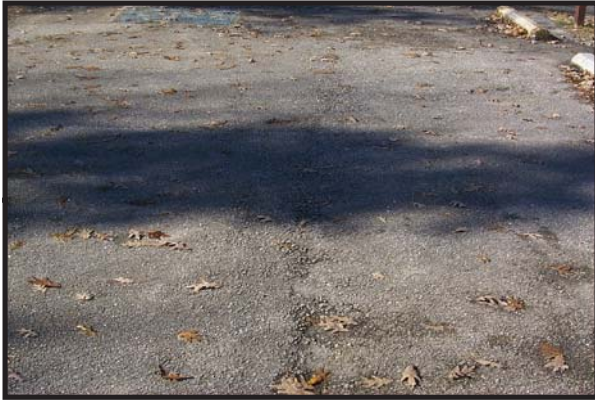
Route	Public / NonPublic	Date Visited	Area (sq ft)	Lane Miles *	Surface Type	Condition / PCR
0943	Public	11/18/2002	1316	0.02	AS	GOOD / 90

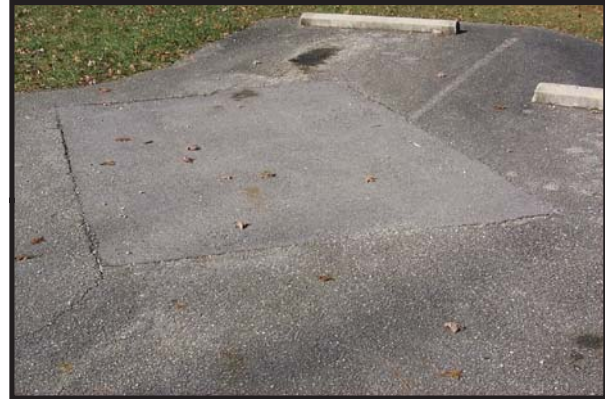
## Route 0944

Route	Public / NonPublic	Date Visited	Area (sq ft)	Lane Miles *	Surface Type	Condition / PCR
0944	Public	11/18/2002	1122	0.02	AS	FAIR / 73

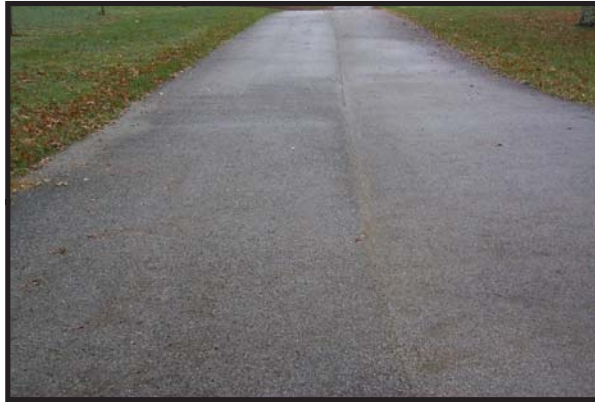
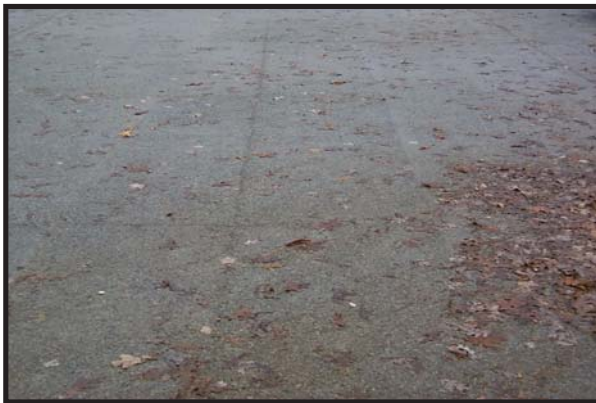
## Route 0946

Route	Public / NonPublic	Date Visited	Area (sq ft)	Lane Miles *	Surface Type	Condition / PCR
0946	Public	11/17/2002	31690	0.55	AS	FAIR / 73

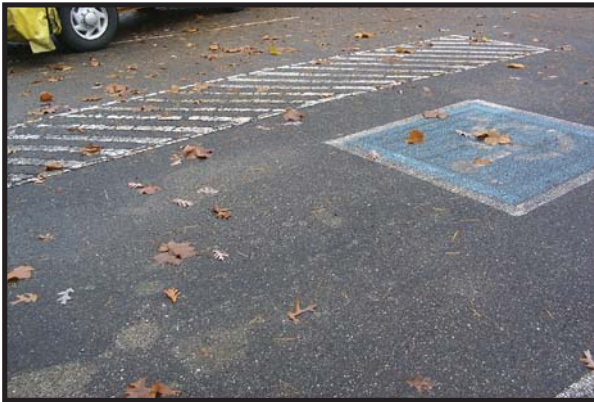
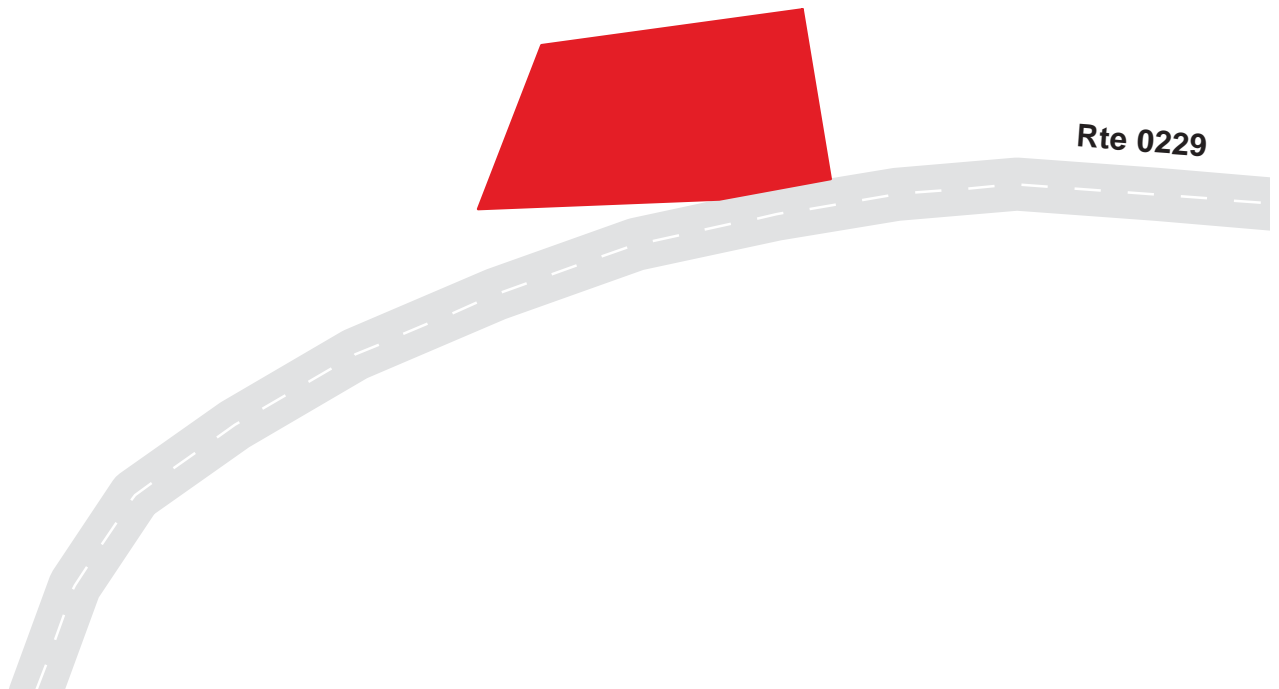
## Route 0948

Route	Public / NonPublic	Date Visited	Area (sq ft)	Lane Miles *	Surface Type	Condition / PCR
0948	Public	11/17/2002	813	0.01	AS	GOOD / 90

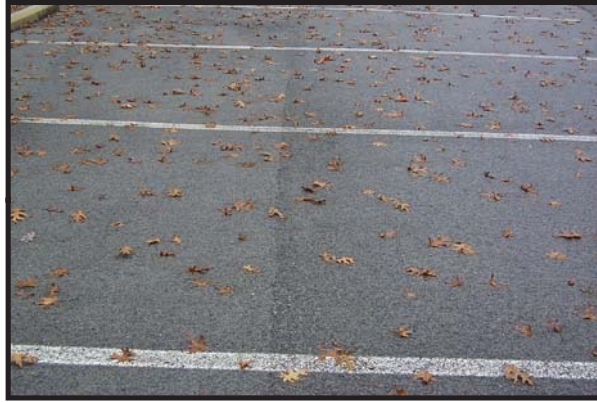
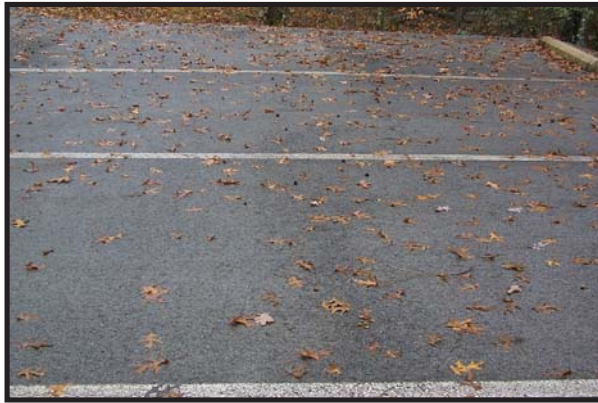
## Route 0949

Route	Public / NonPublic	Date Visited	Area (sq ft)	Lane Miles *	Surface Type	Condition / PCR
0949	Public	11/17/2002	2119	0.04	AS	GOOD / 90

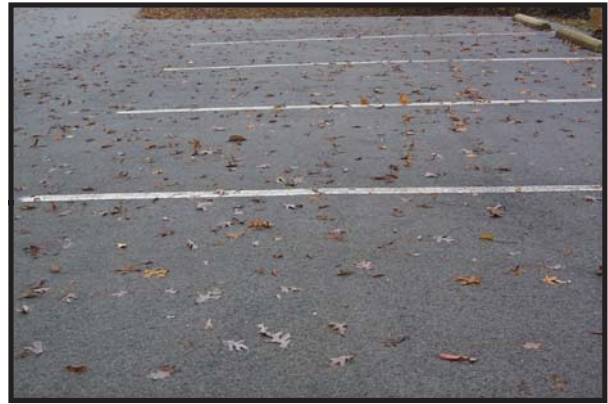
## Route 0950

Route	Public / NonPublic	Date Visited	Area (sq ft)	Lane Miles *	Surface Type	Condition / PCR
0950	Public	11/17/2002	1899	0.03	AS	GOOD / 90

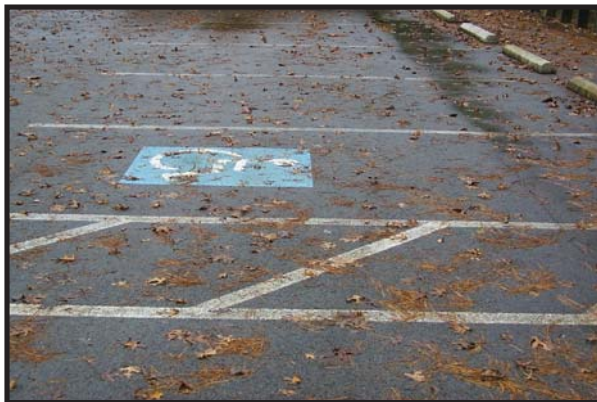
## Route 0951

Route	Public / NonPublic	Date Visited	Area (sq ft)	Lane Miles *	Surface Type	Condition / PCR
0951	Public	11/17/2002	4186	0.07	AS	GOOD / 90
