# The Road Inventory of Big South Fork National River and Recreation Area BISO - 5130

## Road Inventory Program

Prepared By:  
Federal Highway Administration  
Eastern Federal Lands Highway Division  
Cycle 3

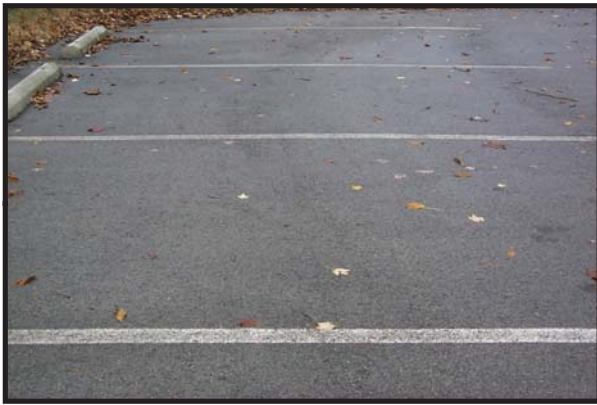
## Route 0952B

Route	Public / NonPublic	Date Visited	Area (sq ft)	Lane Miles *	Surface Type	Condition / PCR
0952B	Public	11/17/2002	1234	0.02	AS	GOOD / 90

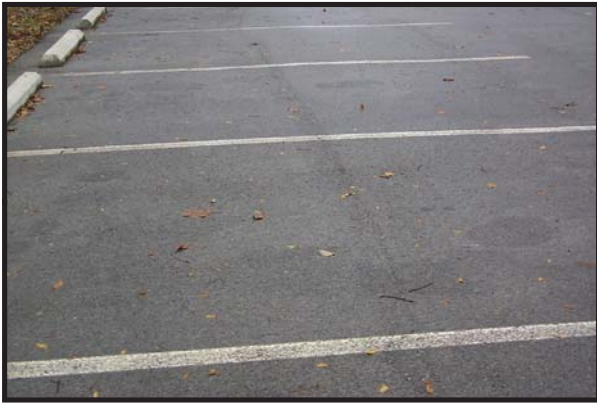
## Route 0952C

Route	Public / NonPublic	Date Visited	Area (sq ft)	Lane Miles *	Surface Type	Condition / PCR
0952C	Public	11/17/2002	1623	0.03	AS	GOOD / 90

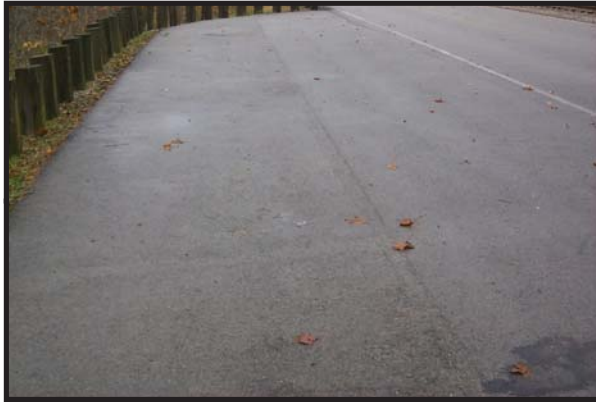
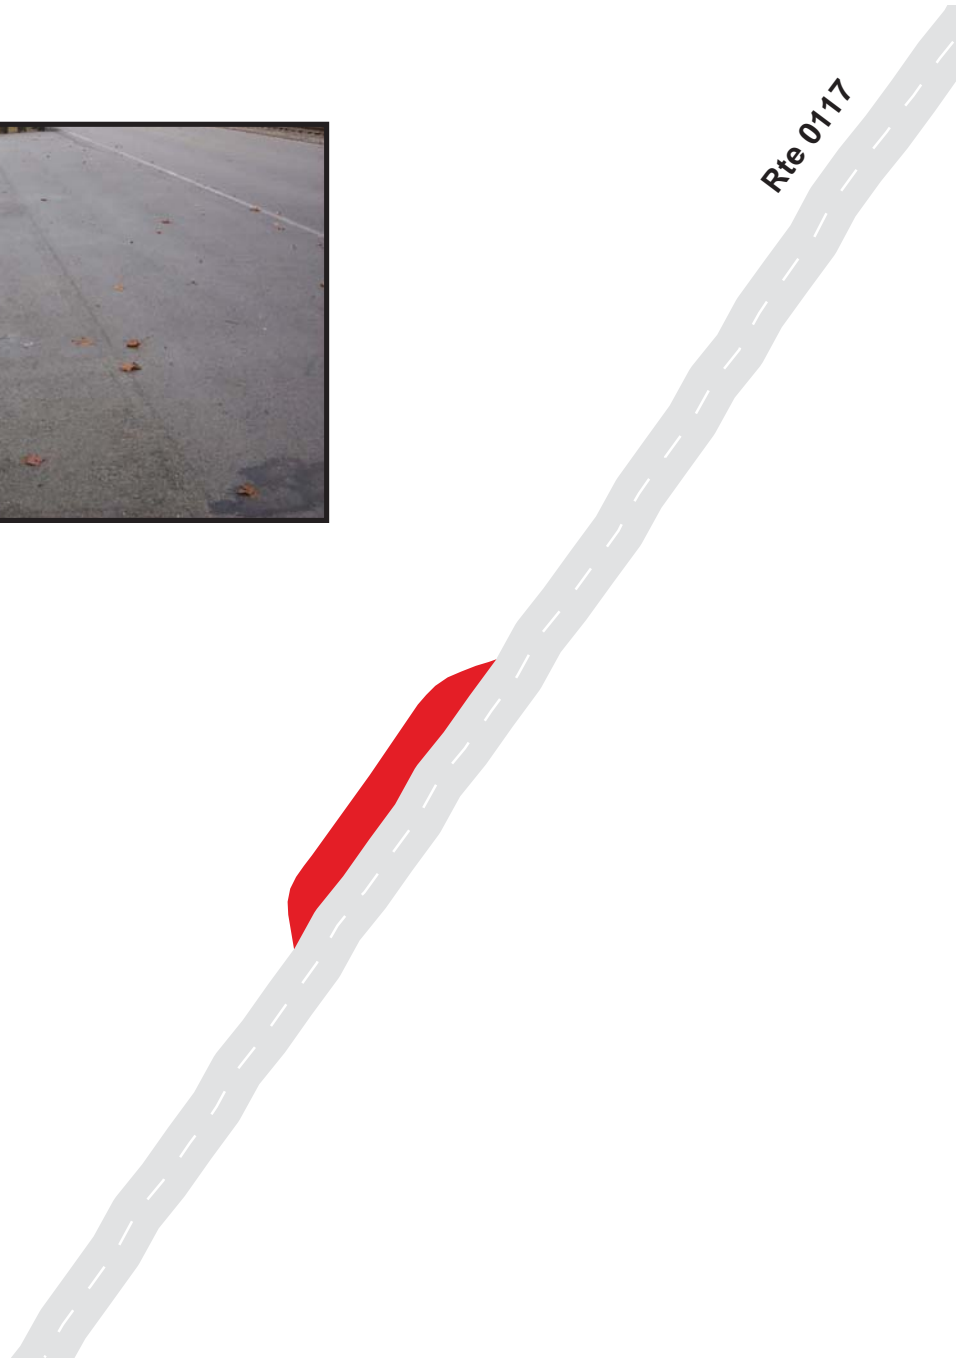
## Route 0952D

Route	Public / NonPublic	Date Visited	Area (sq ft)	Lane Miles *	Surface Type	Condition / PCR
0952D	Public	11/17/2002	1922	0.03	AS	GOOD / 90

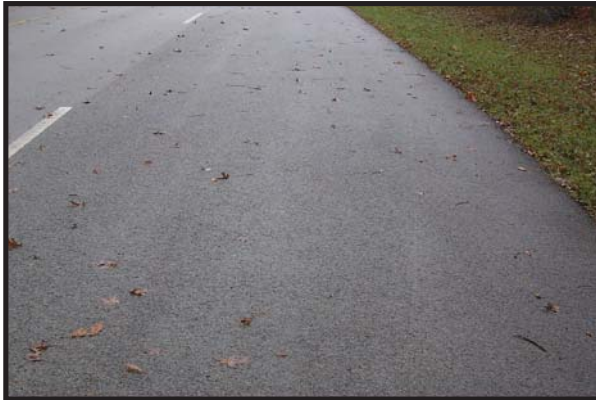
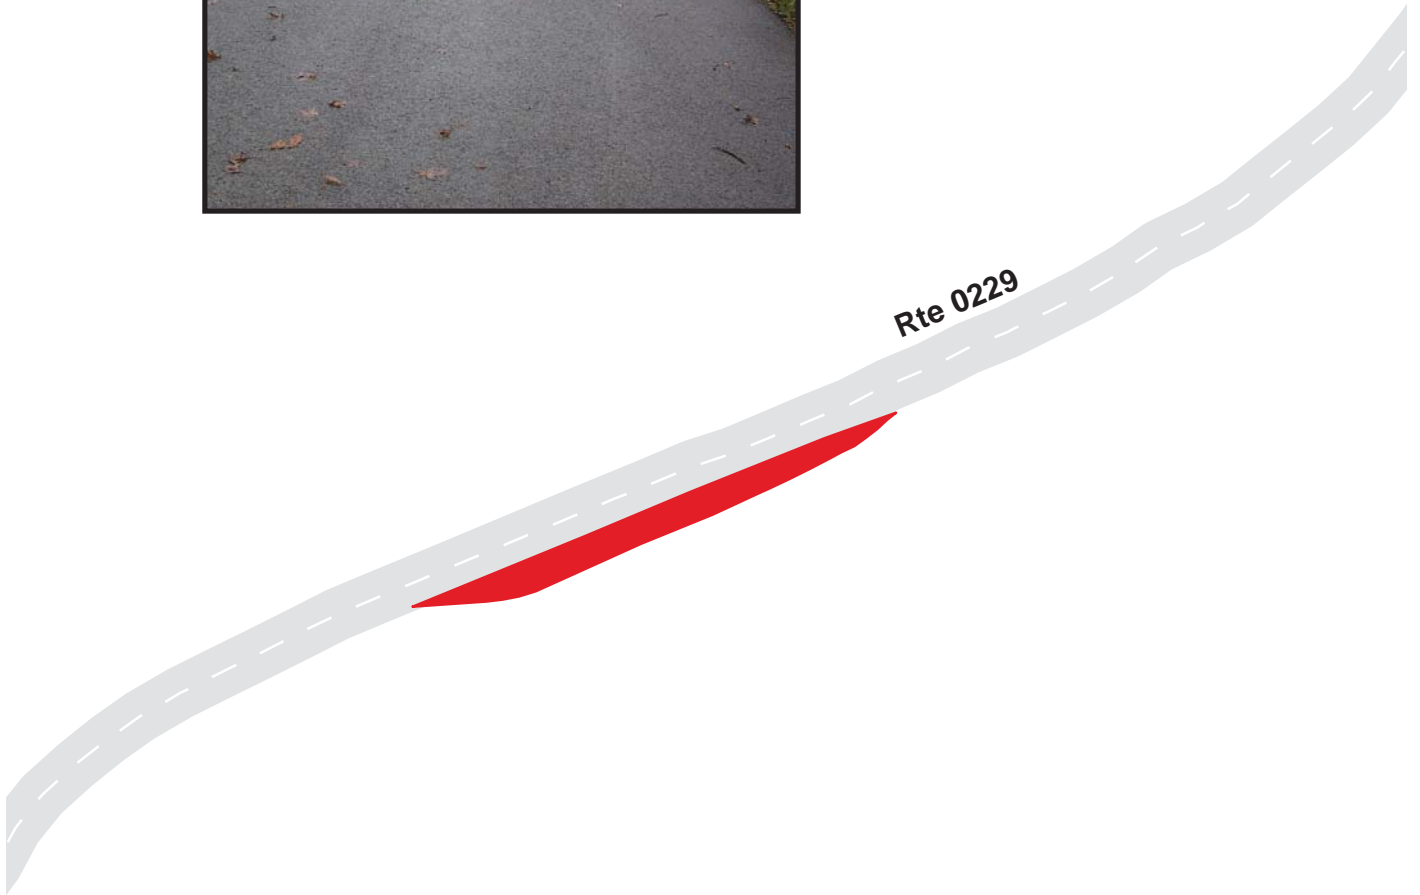
## Route 0953

Route	Public / NonPublic	Date Visited	Area (sq ft)	Lane Miles *	Surface Type	Condition / PCR
0953	Public	11/17/2002	1771	0.03	AS	GOOD / 90

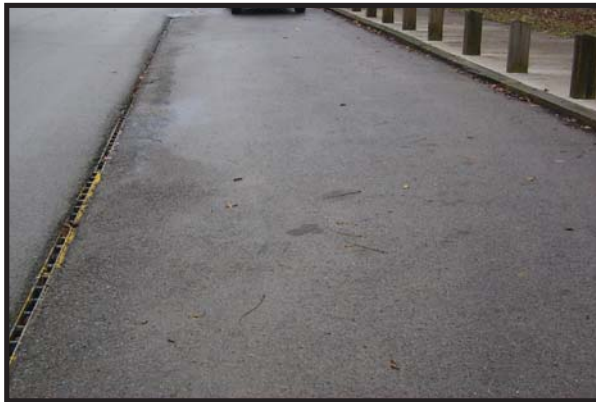
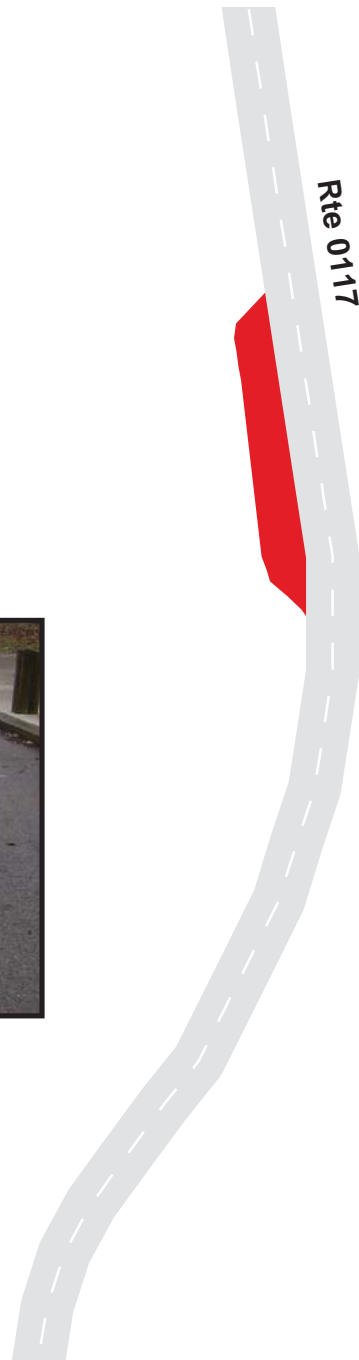
## Route 0954

Route	Public / NonPublic	Date Visited	Area (sq ft)	Lane Miles *	Surface Type	Condition / PCR
0954	Public	11/17/2002	1067	0.02	AS	GOOD / 90
