# The Road Inventory of Big Thicket National Preserve BITH – 7140

Prepared By:  
Federal Highway Administration  
Eastern Federal Lands Highway Division  
Cycle 3

# Big Thicket National Preserve in Texas

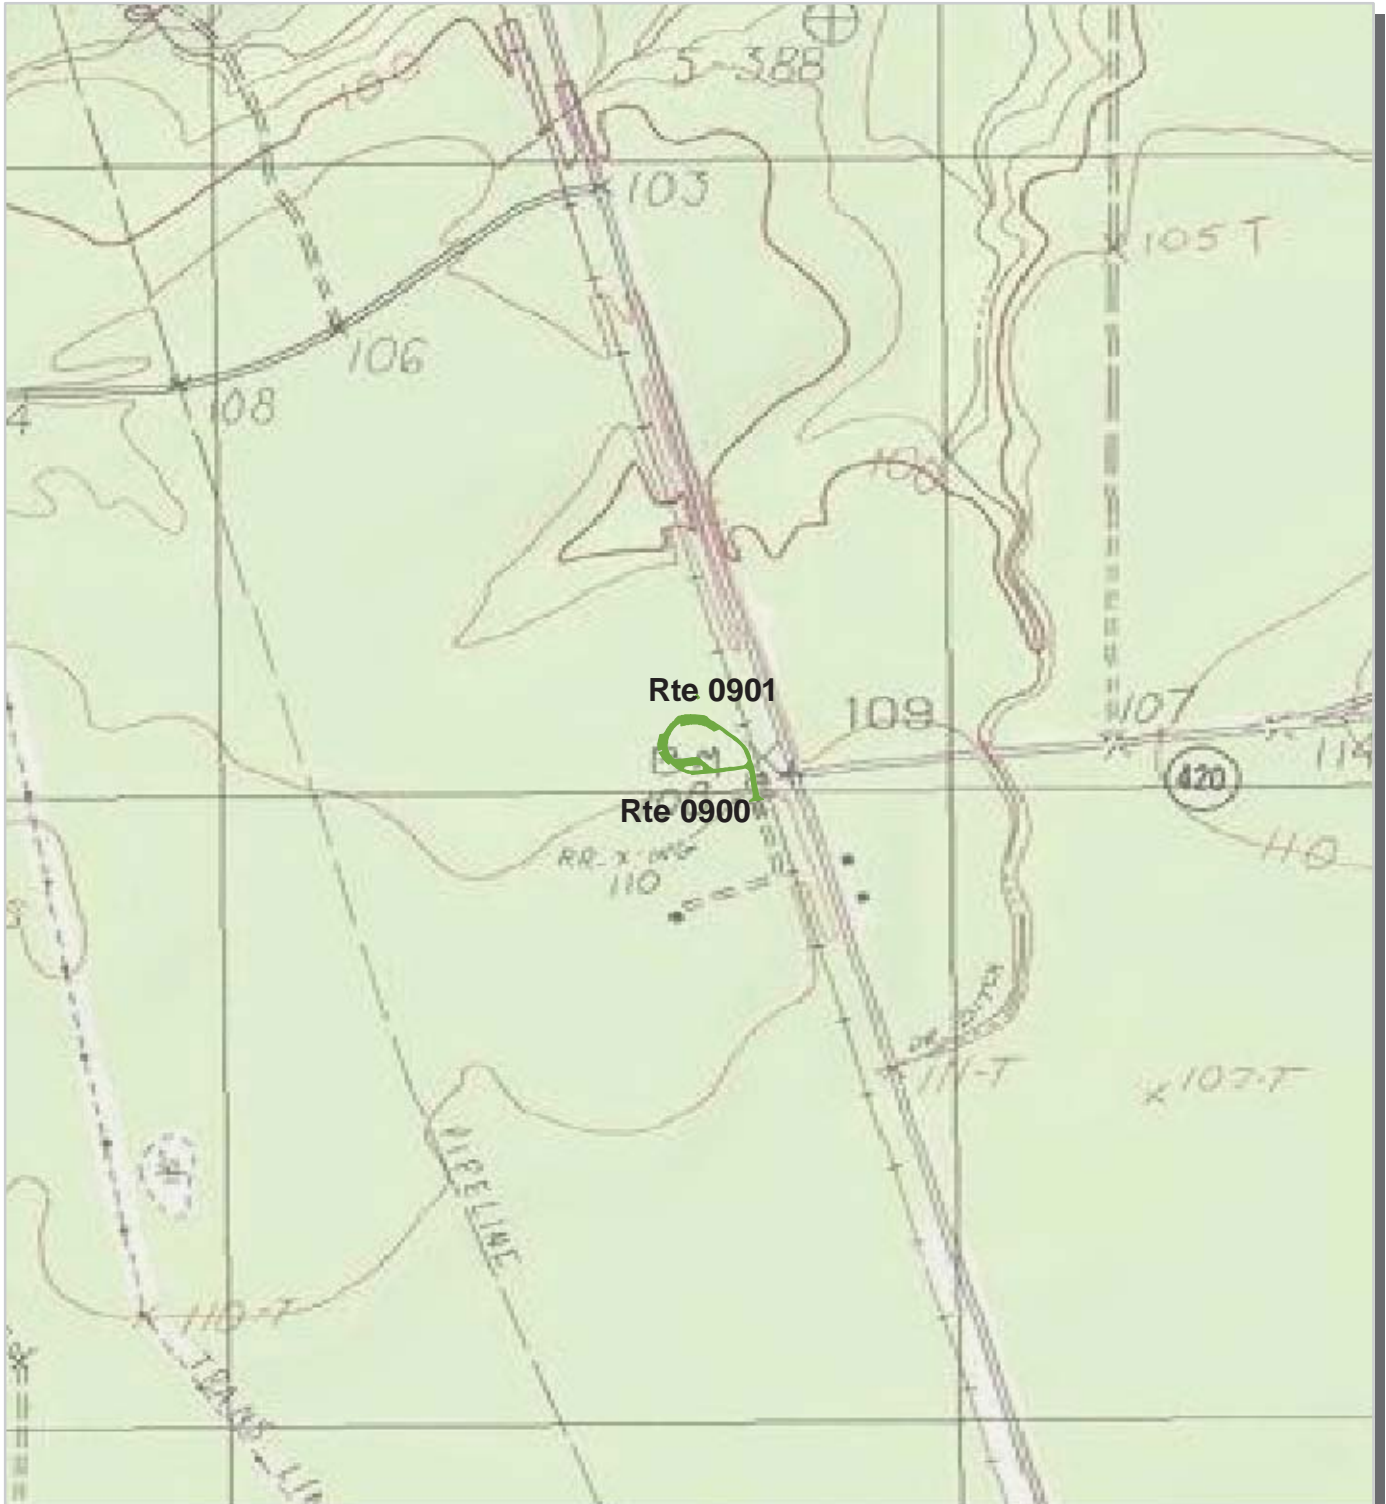
## Route Condition Area Map 1

PCR	Poor	<span style="display: inline-block; width: 20px; height: 10px; background-color: red; border: 1px solid black;"></span>	Fair	<span style="display: inline-block; width: 20px; height: 10px; background-color: yellow; border: 1px solid black;"></span>	Good	<span style="display: inline-block; width: 20px; height: 10px; background-color: green; border: 1px solid black;"></span>	Excellent	<span style="display: inline-block; width: 20px; height: 10px; background-color: blue; border: 1px solid black;"></span>
	( $\leq 60$ )		(61 - 84)		(85 - 94)		(95 - 100)

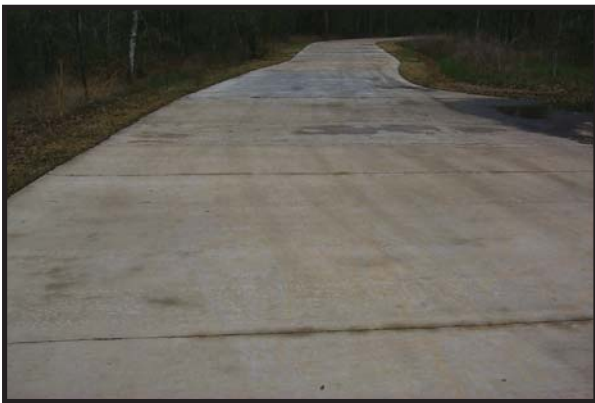
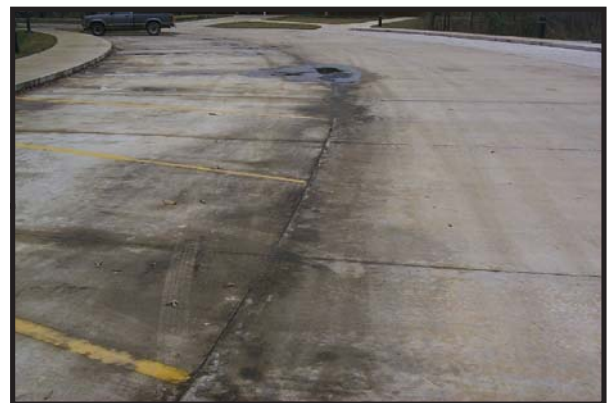
## Route 0900

VISITOR CENTER  
FROM STATE HIGHWAY 420

Route	Public / NonPublic	Date Visited	Area (sq ft)	Lane Miles *	Surface Type	Condition / PCR
0900	Public	2/28/2003	34502	0.59	CO	GOOD / 90

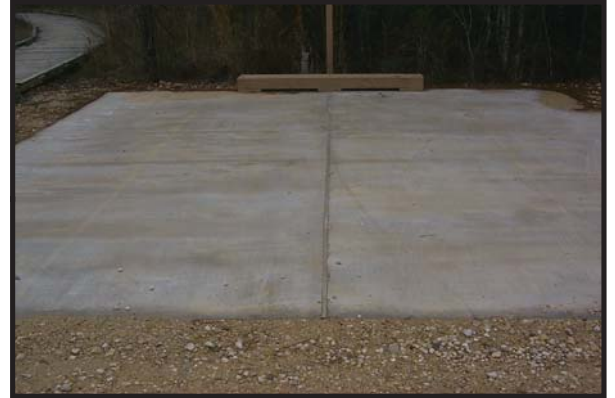
**Big Thicket National Preserve**  
**Route 0901**  
MAINTENANCE HANDICAP PARKING  
FROM ROUTE 0902

Route	Public / NonPublic	Date Visited	Area (sq ft)	Lane Miles *	Surface Type	Condition / PCR
0901	NonPublic	2/28/2003	204	0.00	CO	GOOD / 90

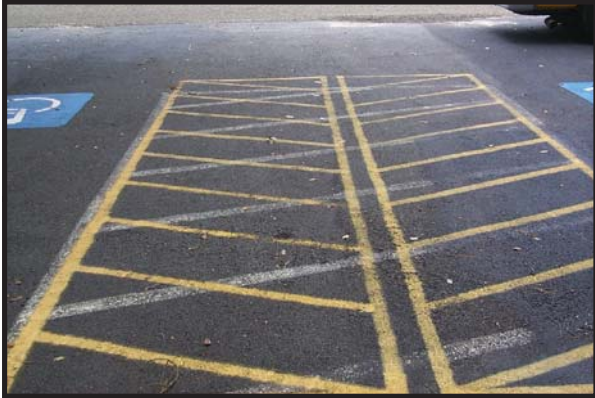
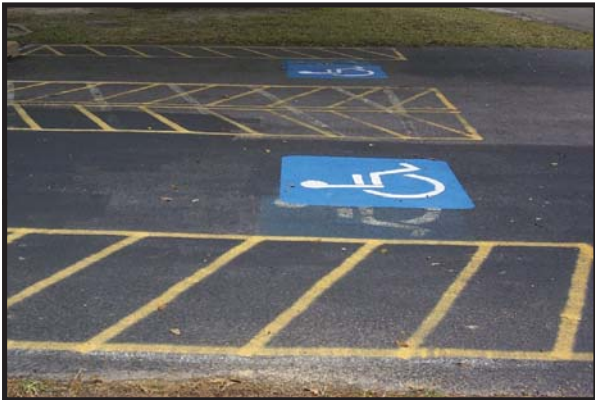
## Route 0903

STALEY CABIN PARKING  
FROM STATE HIGHWAY 420

Route	Public / NonPublic	Date Visited	Area (sq ft)	Lane Miles *	Surface Type	Condition / PCR
0903	Public	2/28/2003	486	0.01	AS	GOOD / 90

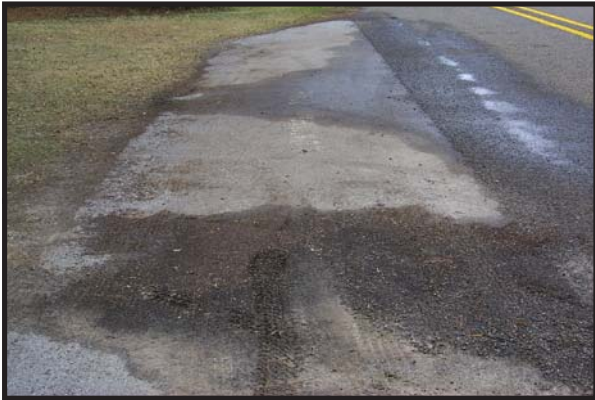
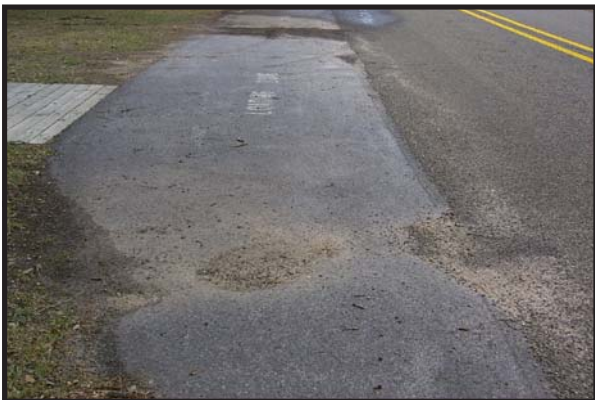
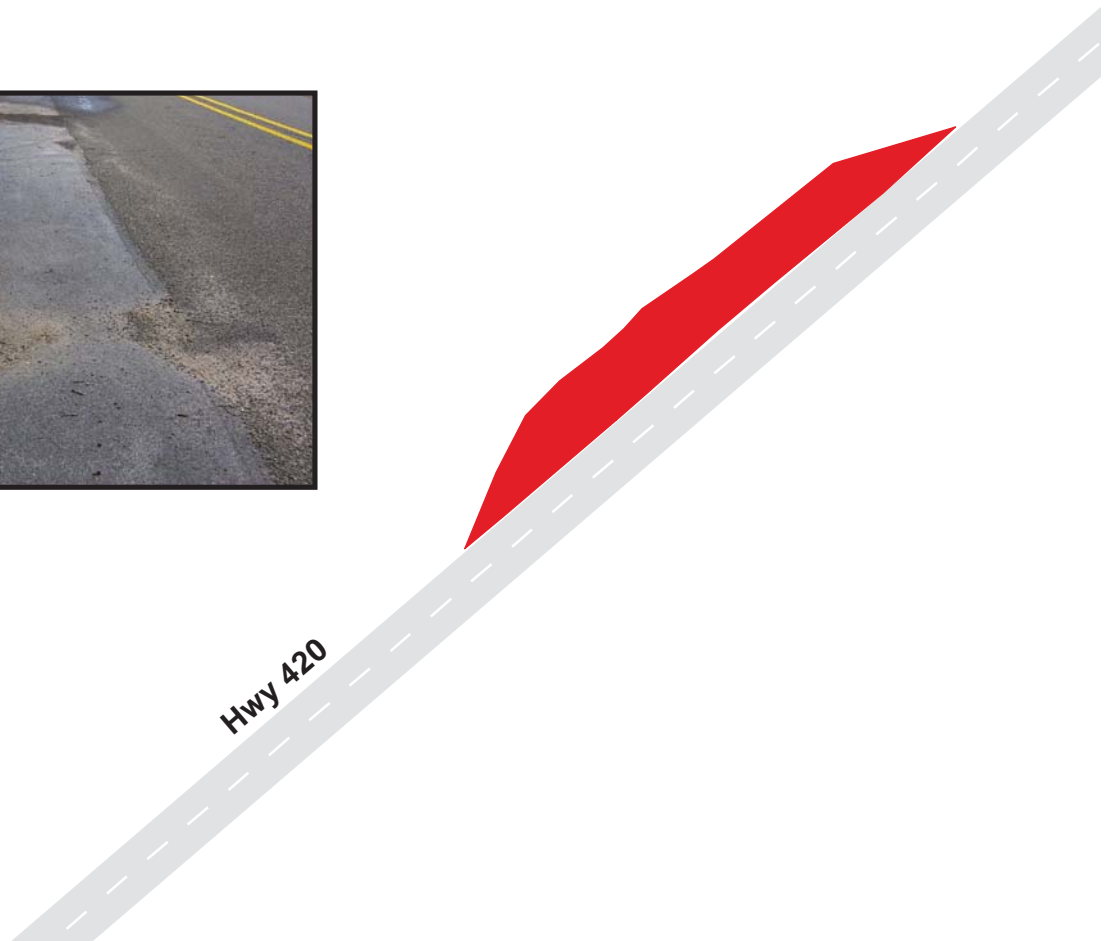
## Route 0904

KIRBY NATURE TRAIL PARKING  
FROM STATE HIGHWAY 420

Route	Public / NonPublic	Date Visited	Area (sq ft)	Lane Miles *	Surface Type	Condition / PCR
0904	Public	2/28/2003	940	0.02	AS	GOOD / 90
