The Road Inventory of Black Canyon of the Gunnison National Park BLCA – 1377

Road Inventory Program

Prepared By:
Federal Highway Administration
Eastern Federal Lands Highway Division
Cycle 3

Black Canyon of the Gunnison National Park in Colorado

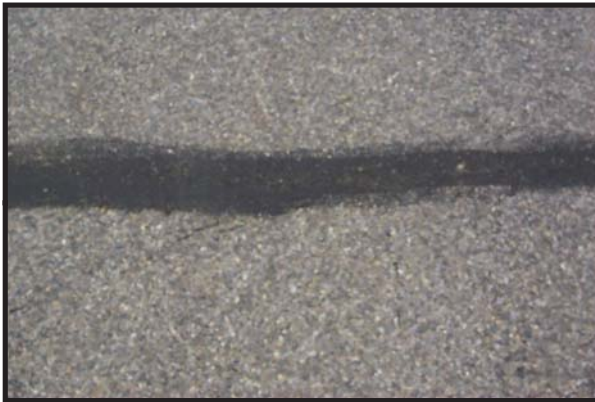
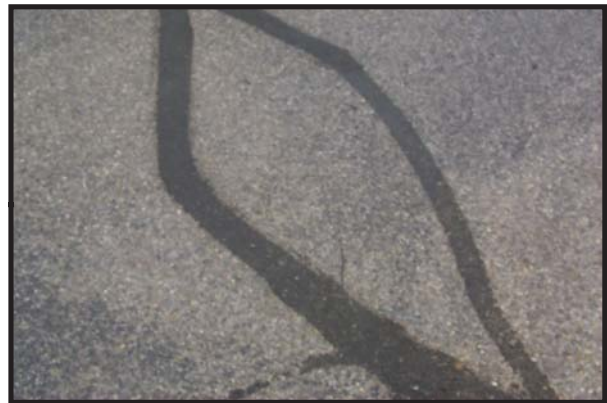
Route 0901

Route	Public / NonPublic	Date Visited	Area (sq ft)	Lane Miles *	Surface Type	Condition / PCR
0901	Public	6/15/2003	16364	0.28	AS	FAIR / 73

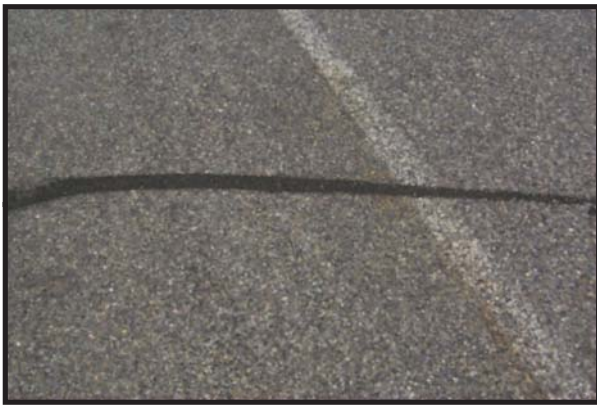
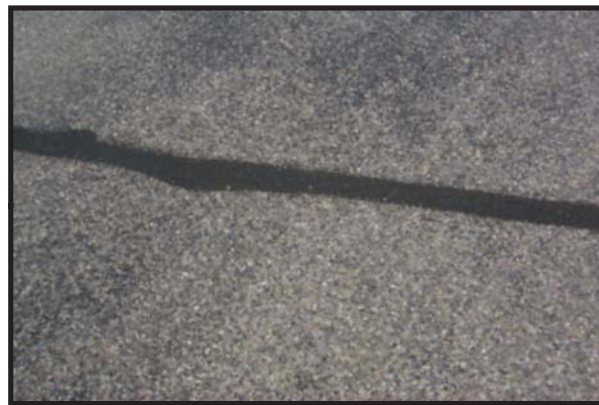
Route 0902

Route	Public / NonPublic	Date Visited	Area (sq ft)	Lane Miles *	Surface Type	Condition / PCR
0902	Public	6/15/2003	7696	0.13	AS	FAIR / 73

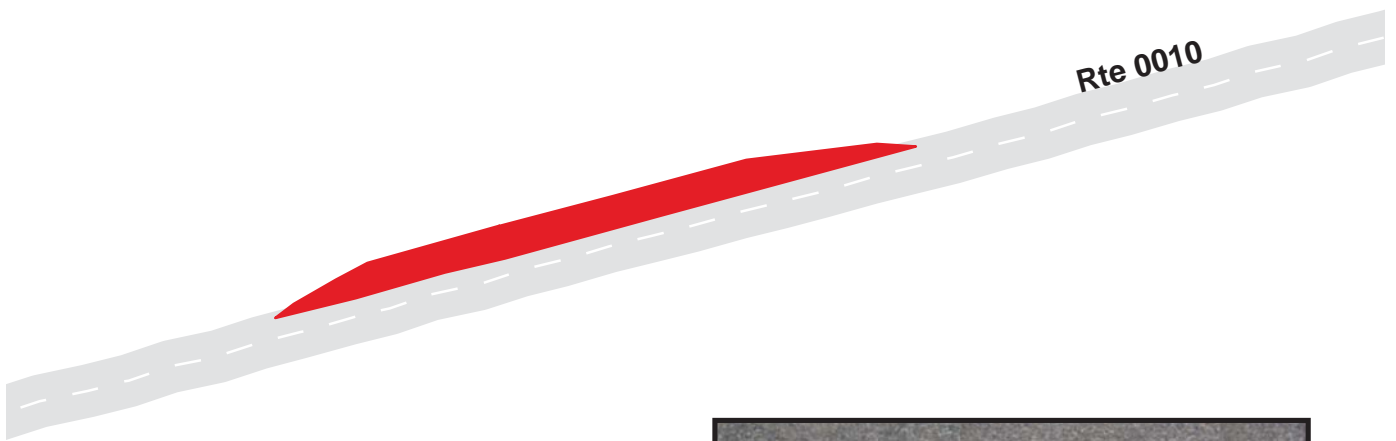
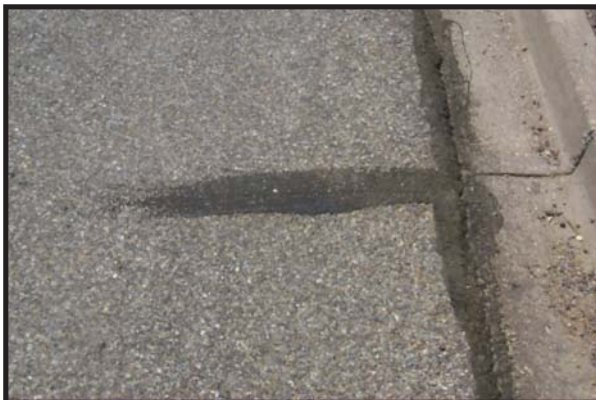
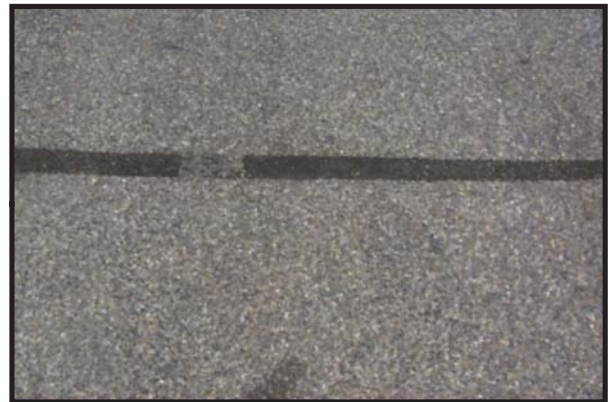
Route 0903

Route	Public / NonPublic	Date Visited	Area (sq ft)	Lane Miles *	Surface Type	Condition / PCR
0903	Public	6/15/2003	2222	0.04	AS	GOOD / 90

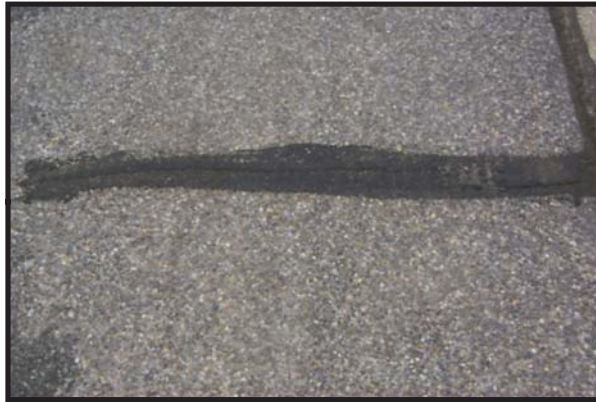
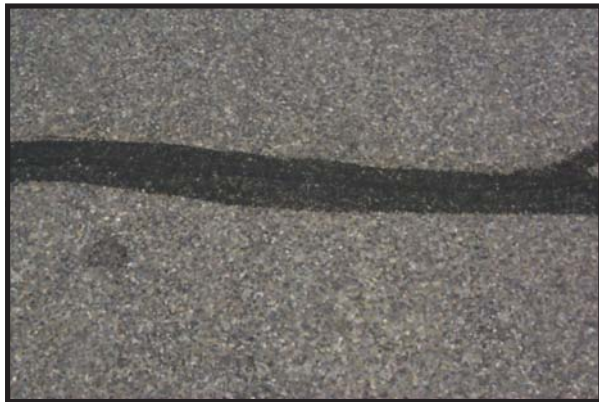
Route 0904

Route	Public / NonPublic	Date Visited	Area (sq ft)	Lane Miles *	Surface Type	Condition / PCR
0904	Public	6/15/2003	2985	0.05	AS	GOOD / 90

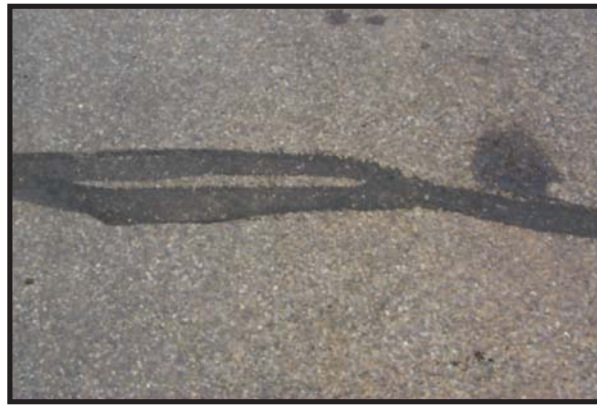
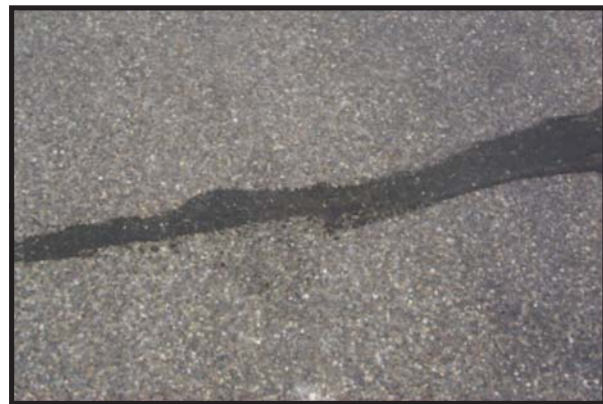
Route 0905

Route	Public / NonPublic	Date Visited	Area (sq ft)	Lane Miles *	Surface Type	Condition / PCR
0905	Public	6/15/2003	2345	0.04	AS	GOOD / 90

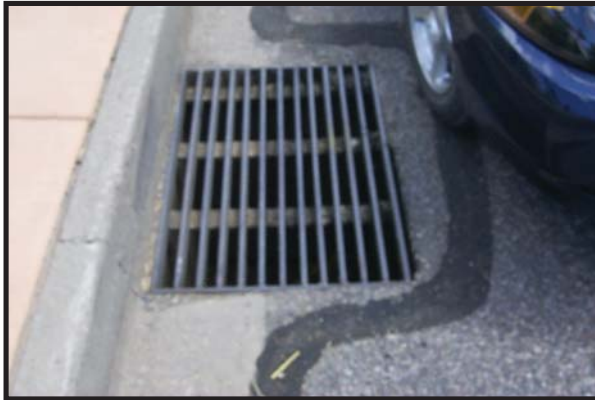
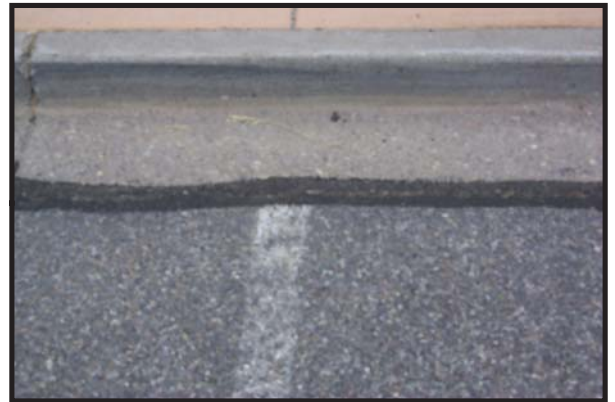
Route 0906

Route	Public / NonPublic	Date Visited	Area (sq ft)	Lane Miles *	Surface Type	Condition / PCR
0906	Public	6/15/2003	5997	0.10	AS	GOOD / 90

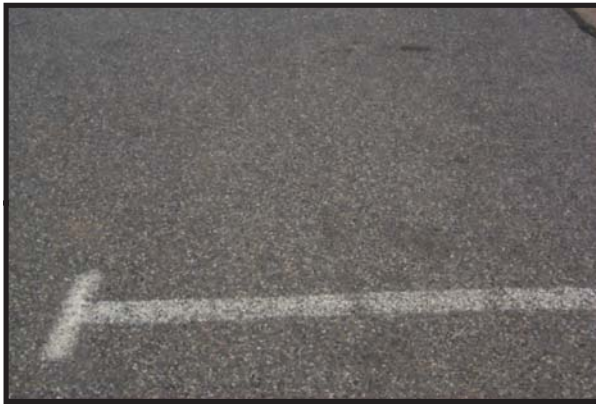
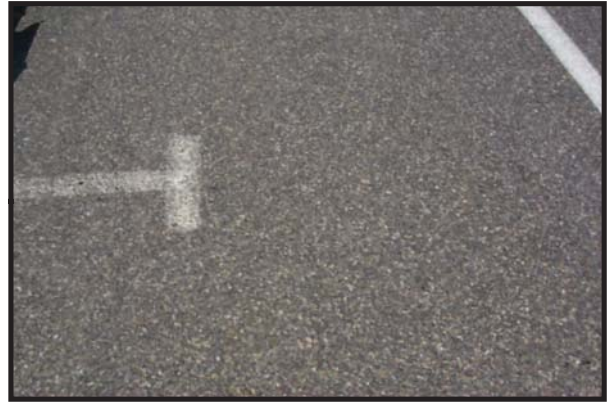
Route 0907

Route	Public / NonPublic	Date Visited	Area (sq ft)	Lane Miles *	Surface Type	Condition / PCR
0907	Public	6/15/2003	2803	0.05	AS	GOOD / 90

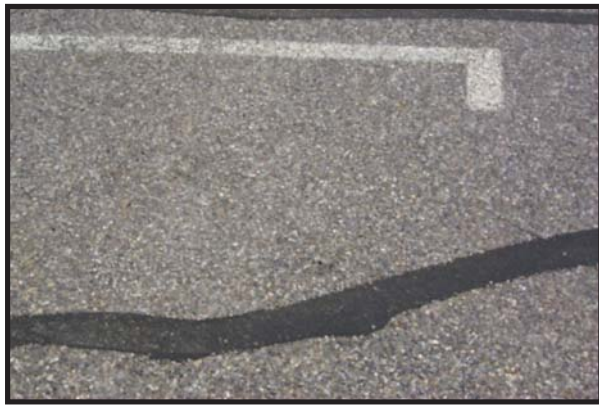
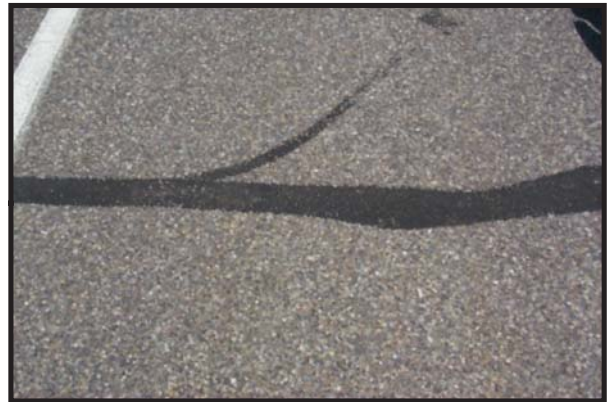
Route 0908

Route	Public / NonPublic	Date Visited	Area (sq ft)	Lane Miles *	Surface Type	Condition / PCR
0908	Public	6/15/2003	3088	0.05	AS	FAIR / 73

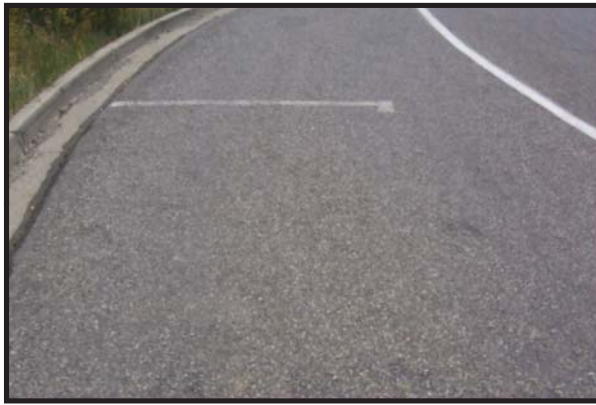
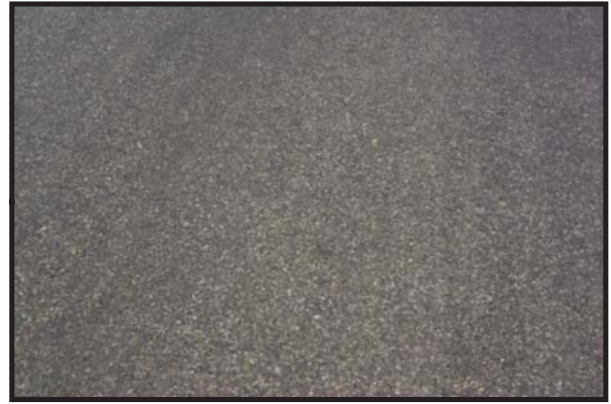
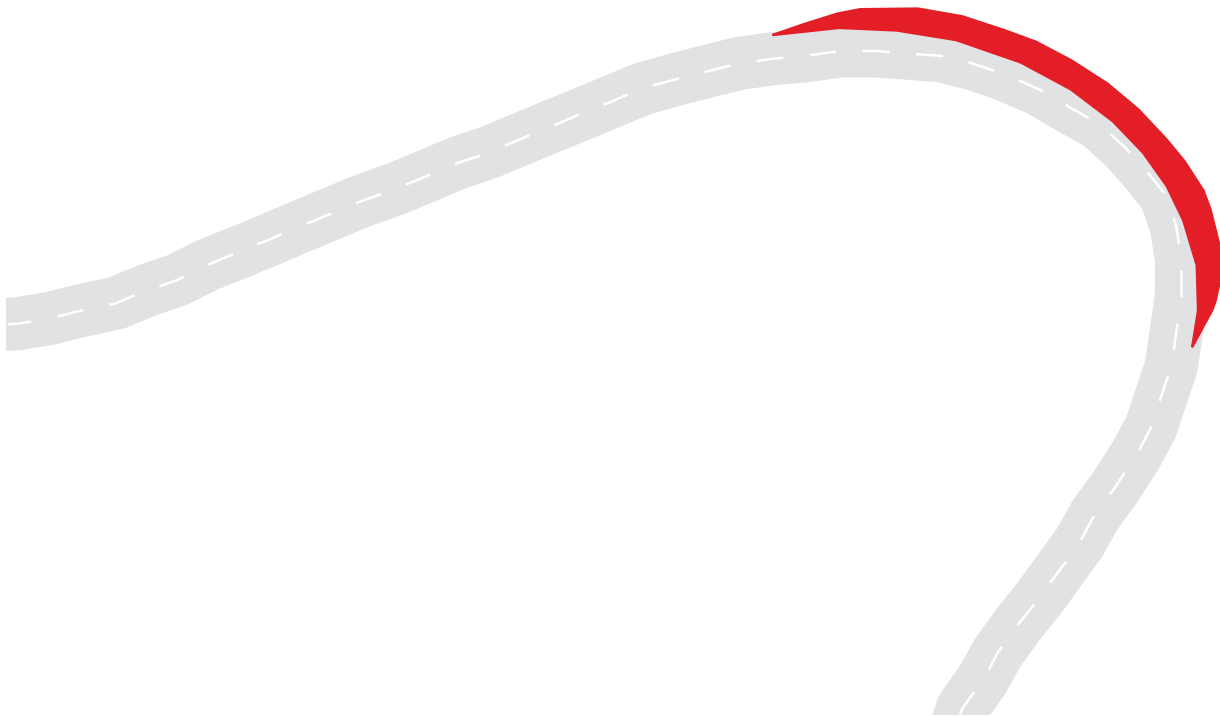
Route 0909

Cross Fissures Overlook
FROM ROUTE 0010

Route	Public / NonPublic	Date Visited	Area (sq ft)	Lane Miles *	Surface Type	Condition / PCR
0909	Public	6/15/2003	3266	0.06	AS	GOOD / 90

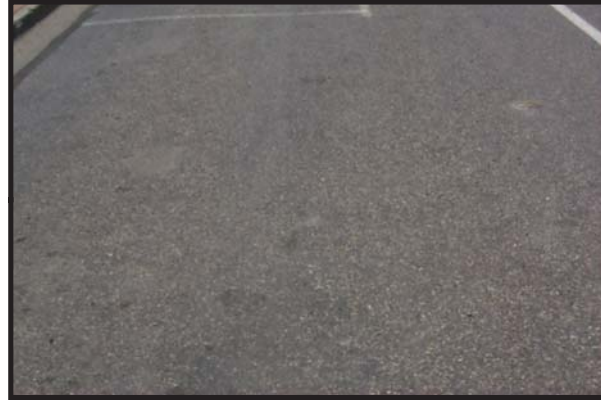
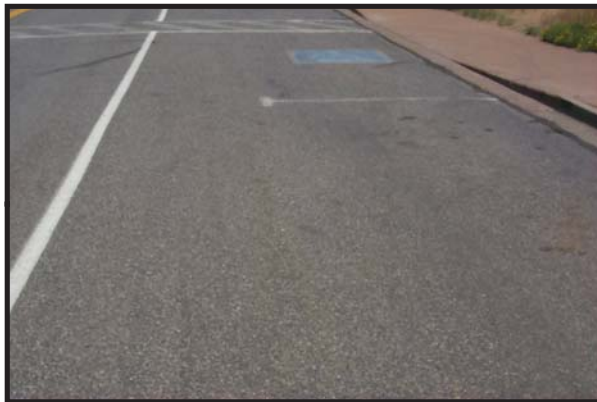
Route 0910

Route	Public / NonPublic	Date Visited	Area (sq ft)	Lane Miles *	Surface Type	Condition / PCR
0910	Public	6/15/2003	3688	0.06	AS	FAIR / 73

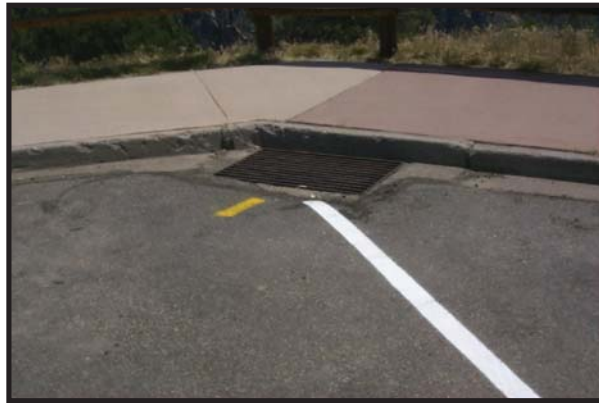
Route 0911

Route	Public / NonPublic	Date Visited	Area (sq ft)	Lane Miles *	Surface Type	Condition / PCR
0911	Public	6/15/2003	10473	0.18	AS	FAIR / 73

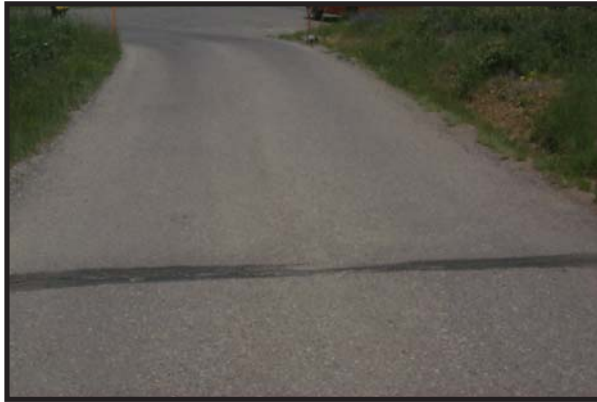
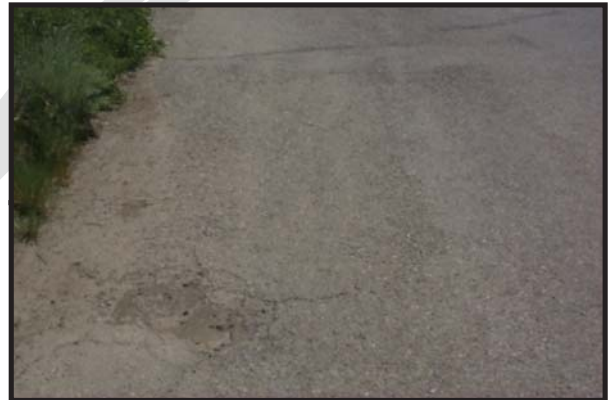
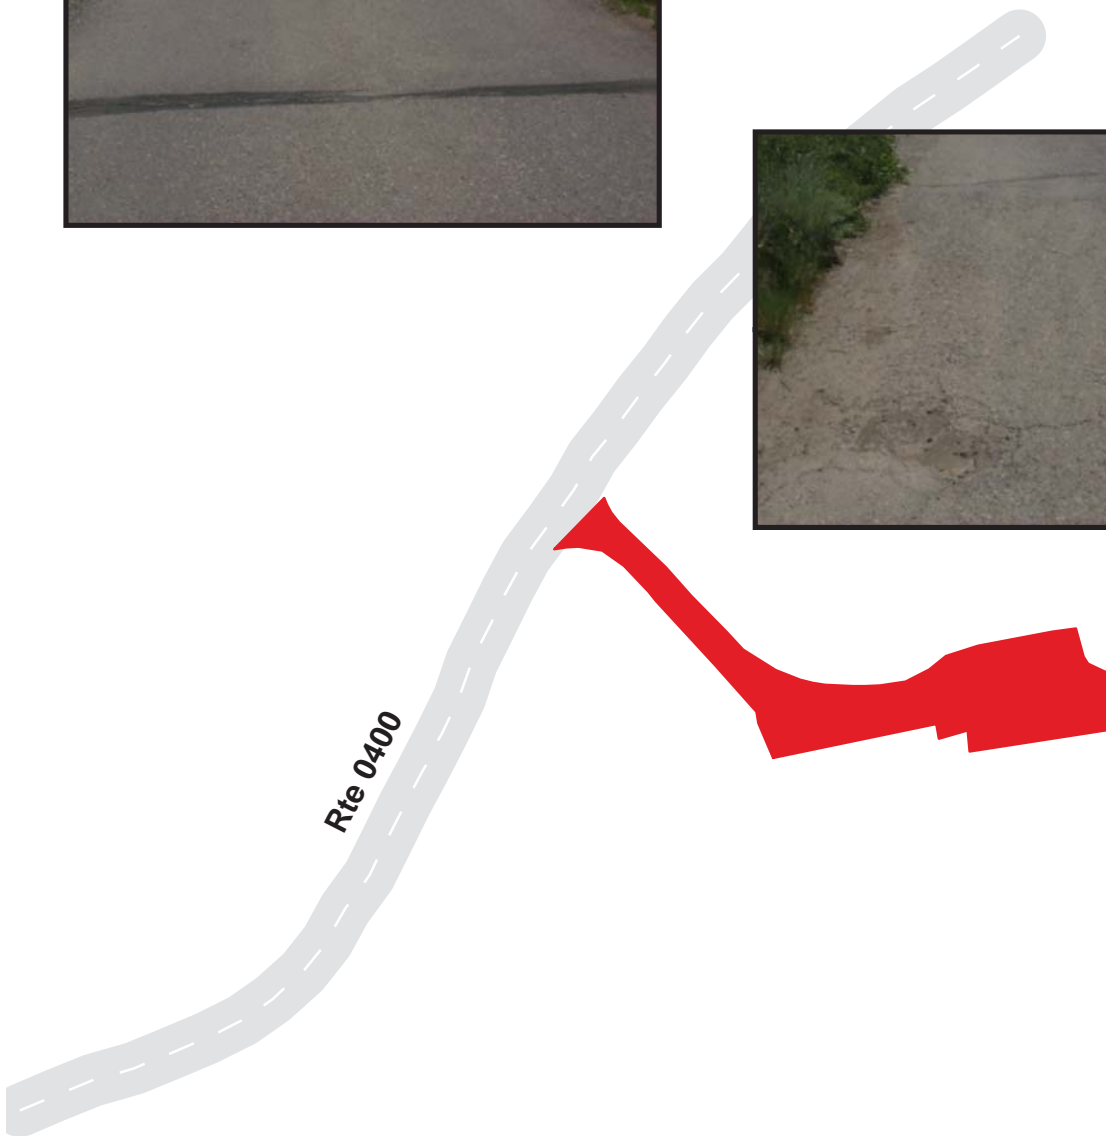
Route 0912

Route	Public / NonPublic	Date Visited	Area (sq ft)	Lane Miles *	Surface Type	Condition / PCR
0912	NonPublic	6/15/2003	5908	0.10	AS	FAIR / 73

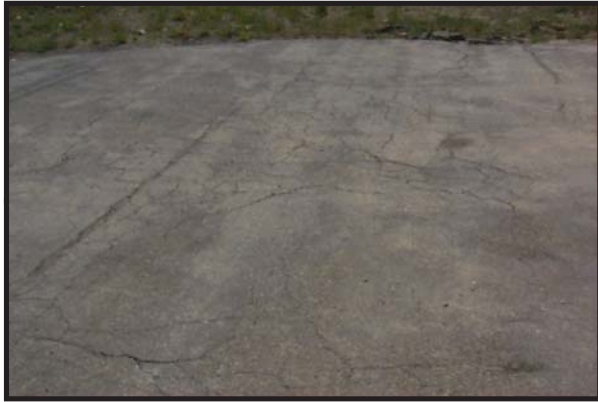
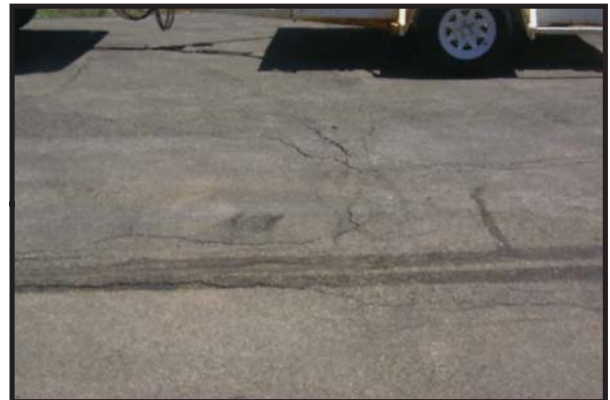
Route 0913

Route	Public / NonPublic	Date Visited	Area (sq ft)	Lane Miles *	Surface Type	Condition / PCR
0913	NonPublic	6/15/2003	5776	0.10	AS	POOR / 45
