# The Road Inventory of Booker T. Washington National Monument BOWA- 4210

## Road Inventory Program

Prepared By:  
Federal Highway Administration  
Eastern Federal Lands Highway Division  
Cycle 3

# Booker T. Washington National Monument in Virginia

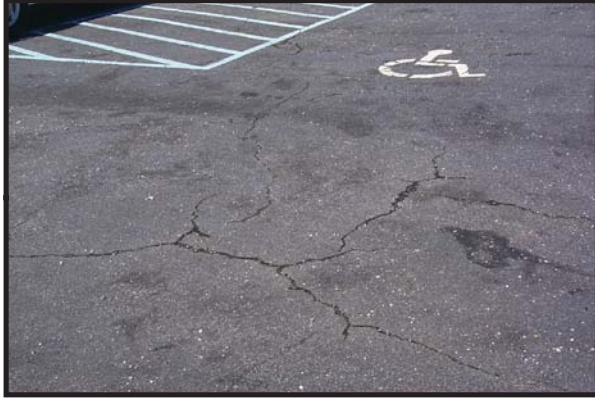
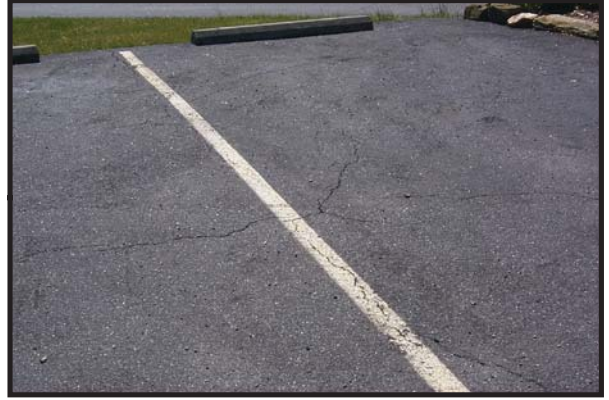
Route	Public / NonPublic	Date Visited	Area (sq ft)	Lane Miles *	Surface Type	Condition / PCR
0900	Public	3/27/2002	25716	0.44	AS	FAIR / 73

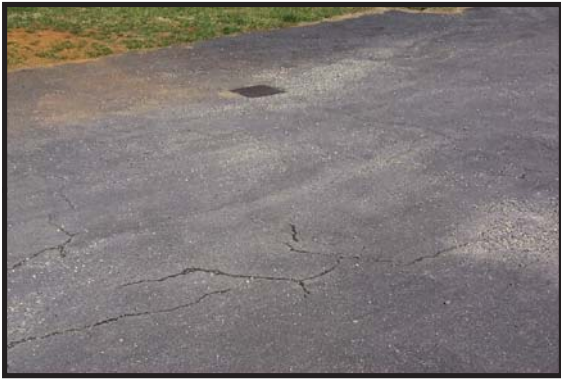
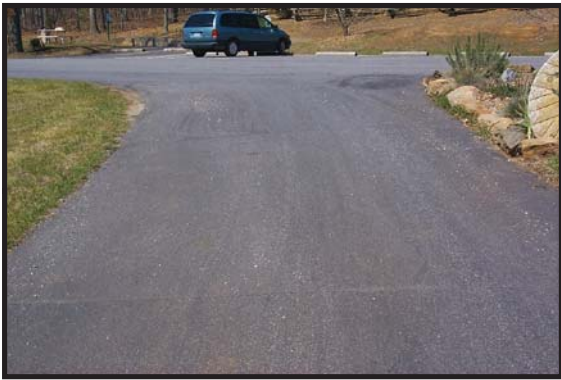
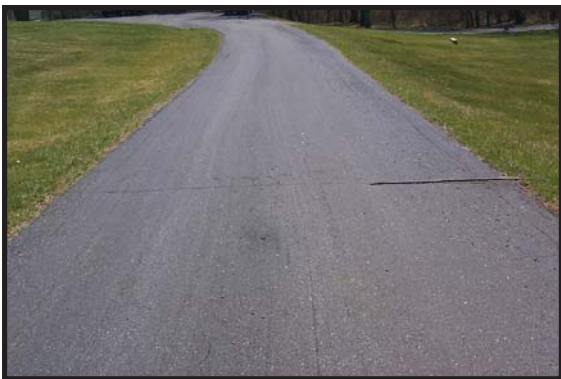
## Route 0901

Route	Public / NonPublic	Date Visited	Area (sq ft)	Lane Miles *	Surface Type	Condition / PCR
0901	NonPublic	3/27/2002	6558	0.11	AS	GOOD / 90

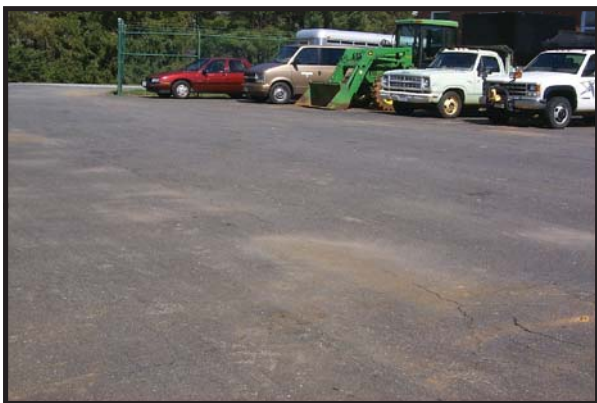
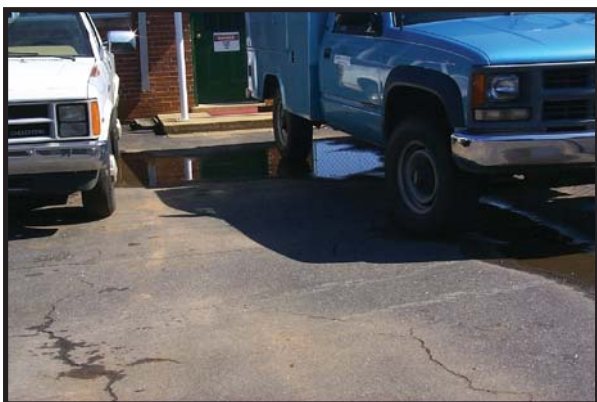
## Route 0903

Route	Public / NonPublic	Date Visited	Area (sq ft)	Lane Miles *	Surface Type	Condition / PCR
0903	NonPublic	3/27/2002	8054	0.14	AS	FAIR / 73
