The Road Inventory of Bryce Canyon National Park BRCA - 1330

Road Inventory Program

Prepared By:
Federal Highway Administration
Eastern Federal Lands Highway Division
Cycle 3

Bryce Canyon National Park in Utah

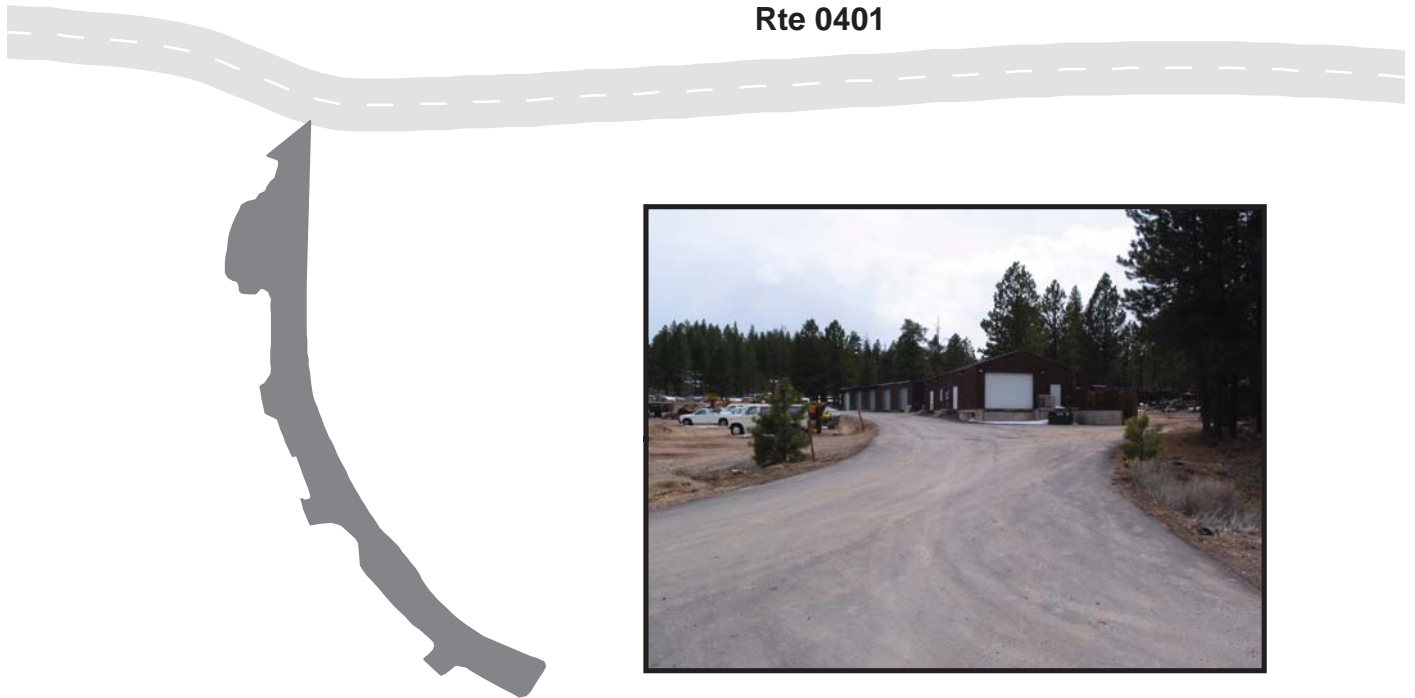
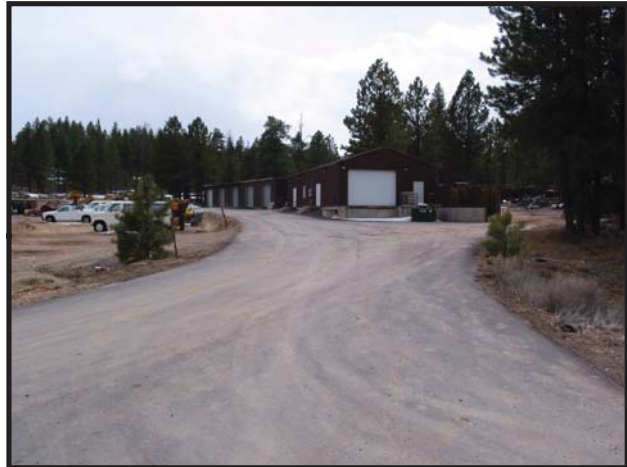
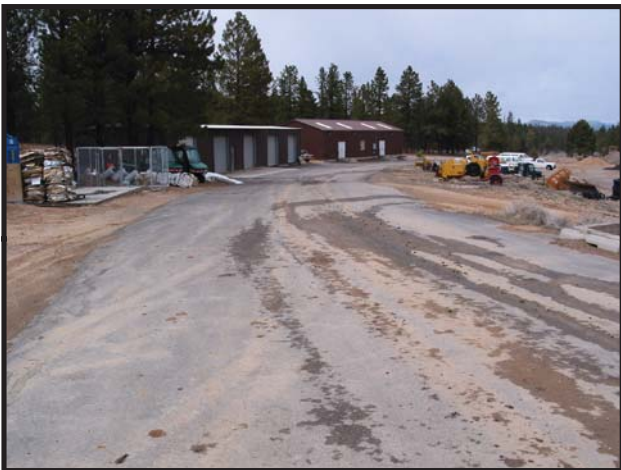
Route 0412

Route	Length (mi)	Width (ft)	Area (sq ft)	Lane Miles *	Condition / PCR	Surface Type
0412	0.27	0.00	16002	0.28	GOOD / 90	AS

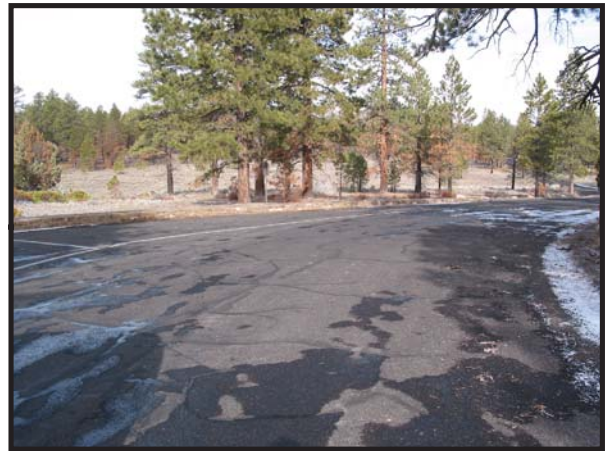
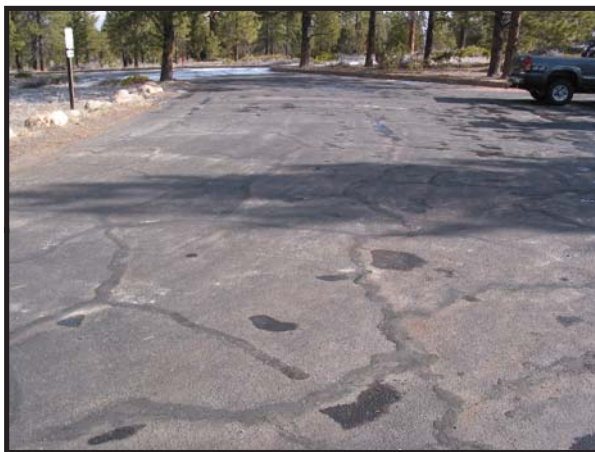
Route 0900

Route	Public / NonPublic	Date Visited	Area (sq ft)	Lane Miles *	Surface Type	Condition / PCR
0900	Public	4/3/2003	19303	0.33	AS	FAIR / 73

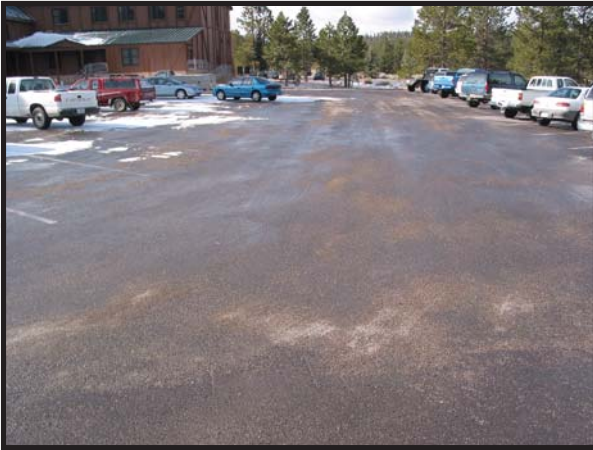
Bryce Canyon National Park
Route 0902
 Visitor Center Parking
 Adjacent To Route 0010 at Fee Station

Route	Public / NonPublic	Date Visited	Area (sq ft)	Lane Miles *	Surface Type	Condition / PCR
0902	Public	4/3/2003	43020	0.74	AS	GOOD / 90

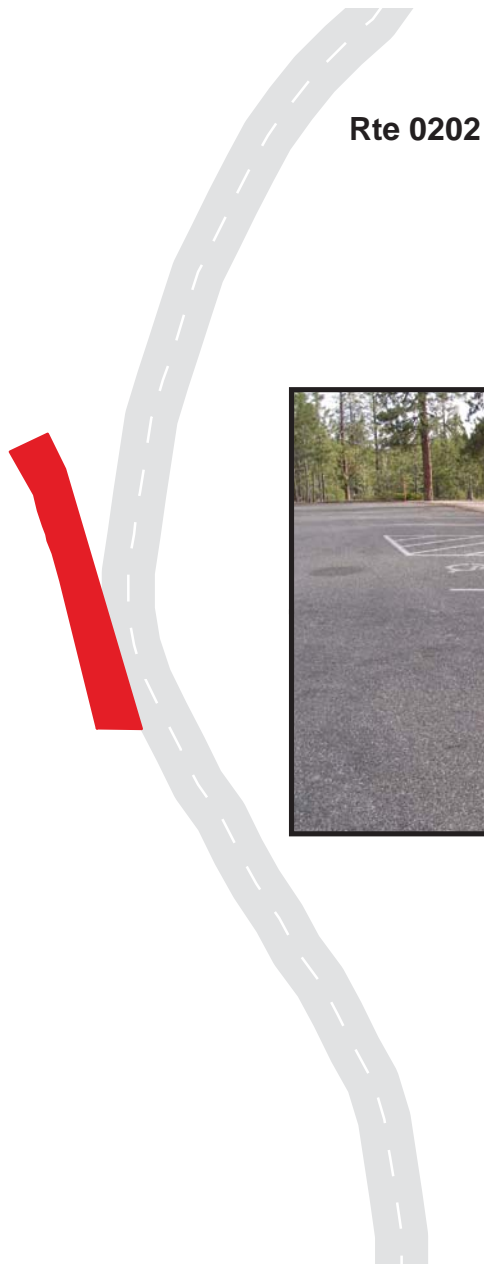
Route	Public / NonPublic	Date Visited	Area (sq ft)	Lane Miles *	Surface Type	Condition / PCR
0904	Public	4/3/2003	2111	0.04	OC	GOOD / 90

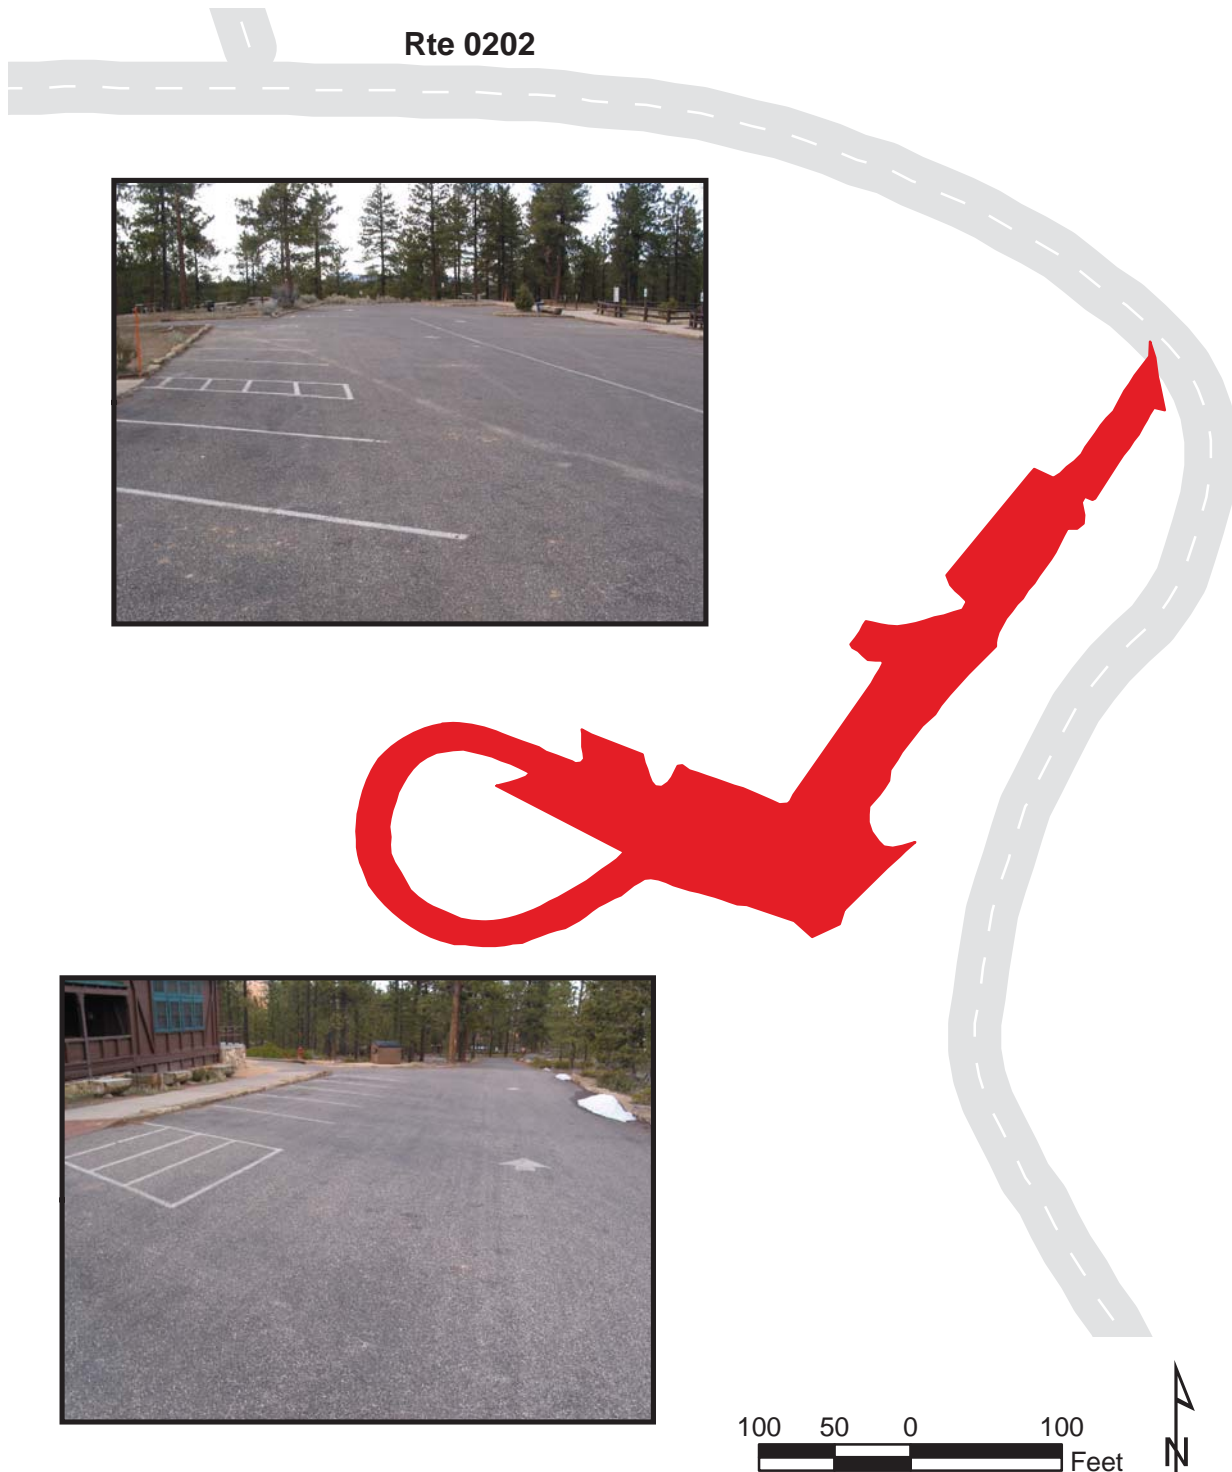
Route 0906

Route	Public / NonPublic	Date Visited	Area (sq ft)	Lane Miles *	Surface Type	Condition / PCR
0906	Public	4/3/2003	2381	0.04	NC	GOOD / 90

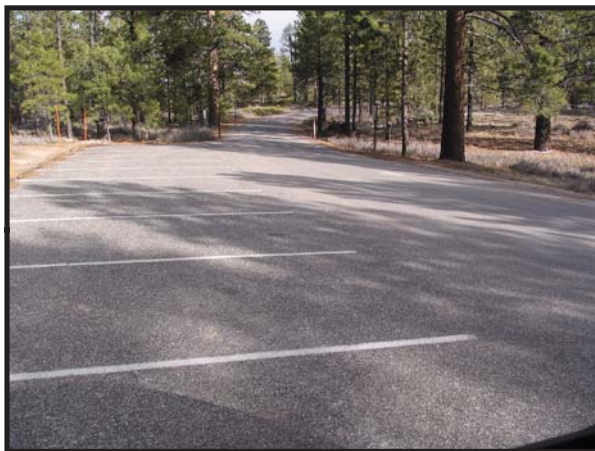
Route 0907

Route	Public / NonPublic	Date Visited	Area (sq ft)	Lane Miles *	Surface Type	Condition / PCR
0907	Public	4/3/2003	6608	0.11	NC	GOOD / 90

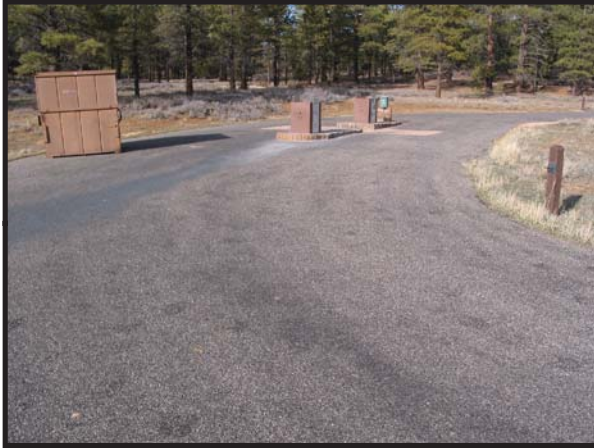
Route 0908

Route	Public / NonPublic	Date Visited	Area (sq ft)	Lane Miles *	Surface Type	Condition / PCR
0908	Public	4/3/2003	3739	0.06	NC	GOOD / 90

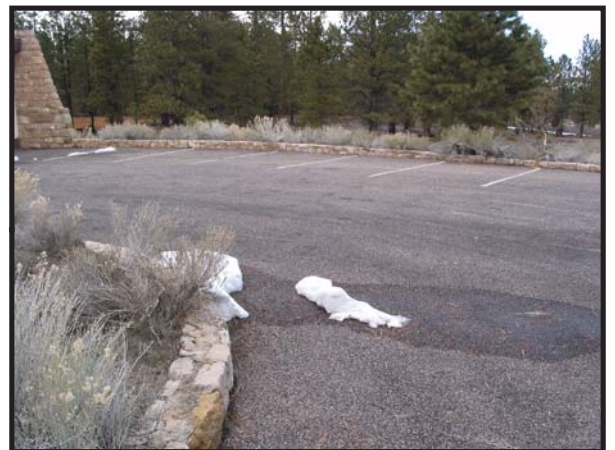
Route 0909

Route	Public / NonPublic	Date Visited	Area (sq ft)	Lane Miles *	Surface Type	Condition / PCR
0909	Public	4/3/2003	16249	0.28	NC	GOOD / 90

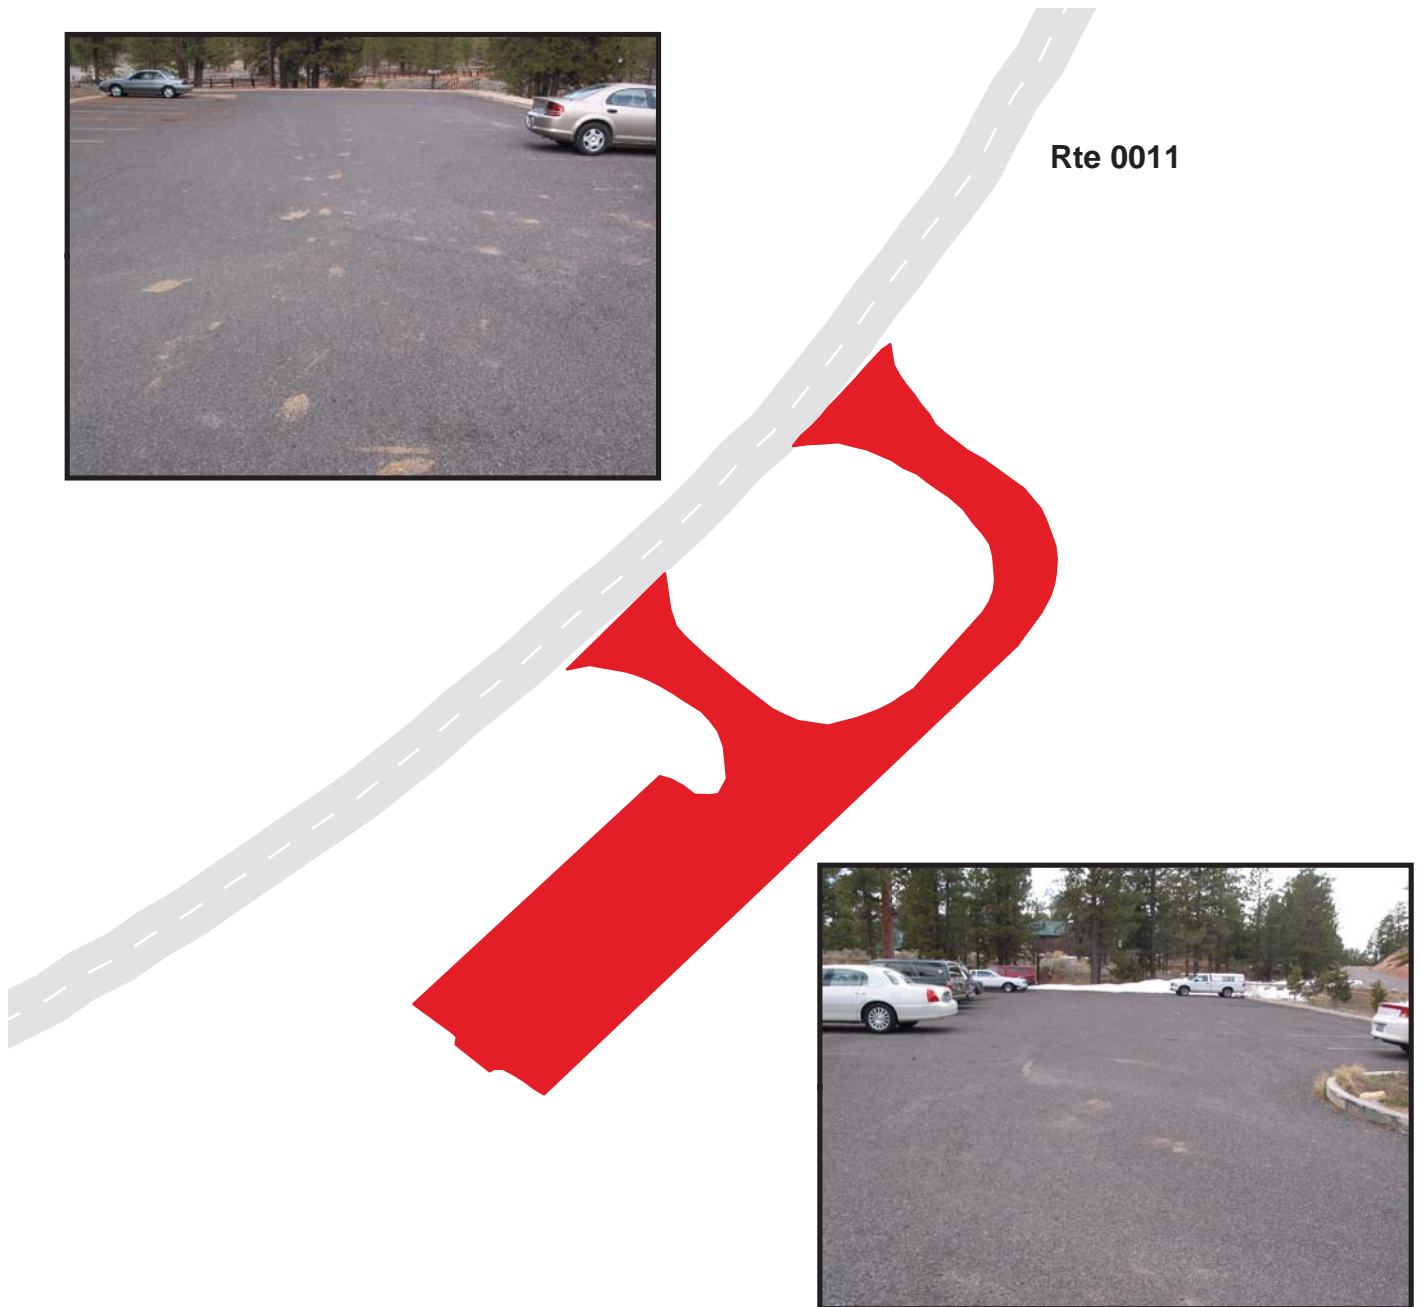
Route	Public / NonPublic	Date Visited	Area (sq ft)	Lane Miles *	Surface Type	Condition / PCR
0910	Public	4/3/2003	43804	0.75	NC	GOOD / 90

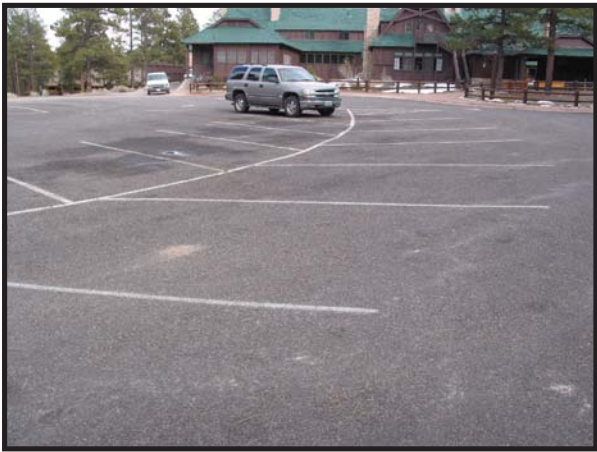
Route 0911

Route	Public / NonPublic	Date Visited	Area (sq ft)	Lane Miles *	Surface Type	Condition / PCR
0911	Public	4/3/2003	19053	0.33	NC	GOOD / 90

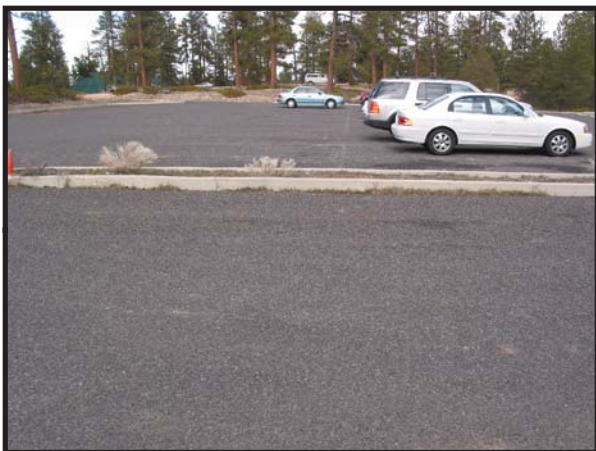
Route 0912

Route	Public / NonPublic	Date Visited	Area (sq ft)	Lane Miles *	Surface Type	Condition / PCR
0912	Public	4/3/2003	4780	0.08	NC	GOOD / 90

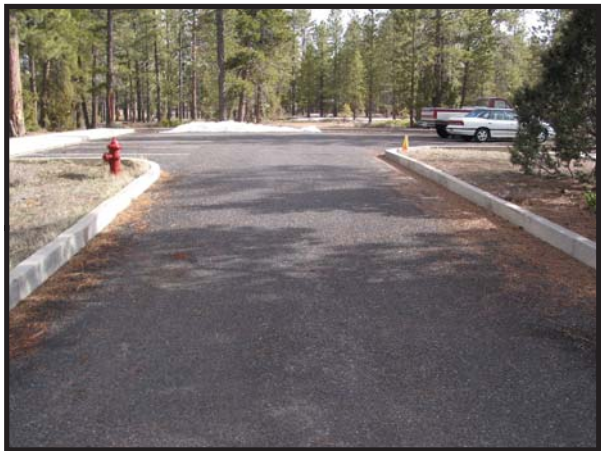
Route 0913

Route	Public / NonPublic	Date Visited	Area (sq ft)	Lane Miles *	Surface Type	Condition / PCR
0913	Public	4/3/2003	3043	0.05	NC	GOOD / 90

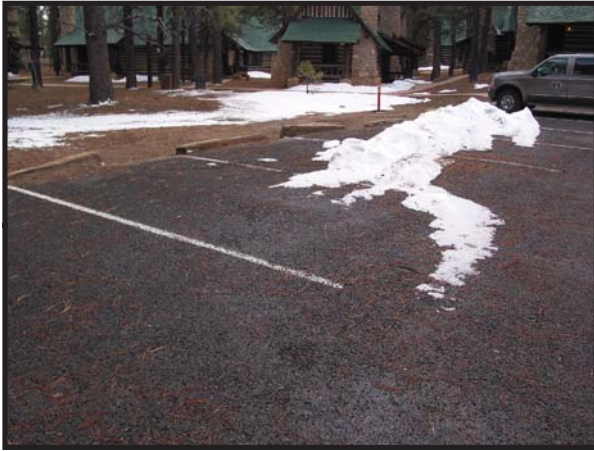
Route 0914

Route	Public / NonPublic	Date Visited	Area (sq ft)	Lane Miles *	Surface Type	Condition / PCR
0914	Public	4/3/2003	8079	0.14	AS	POOR / 45

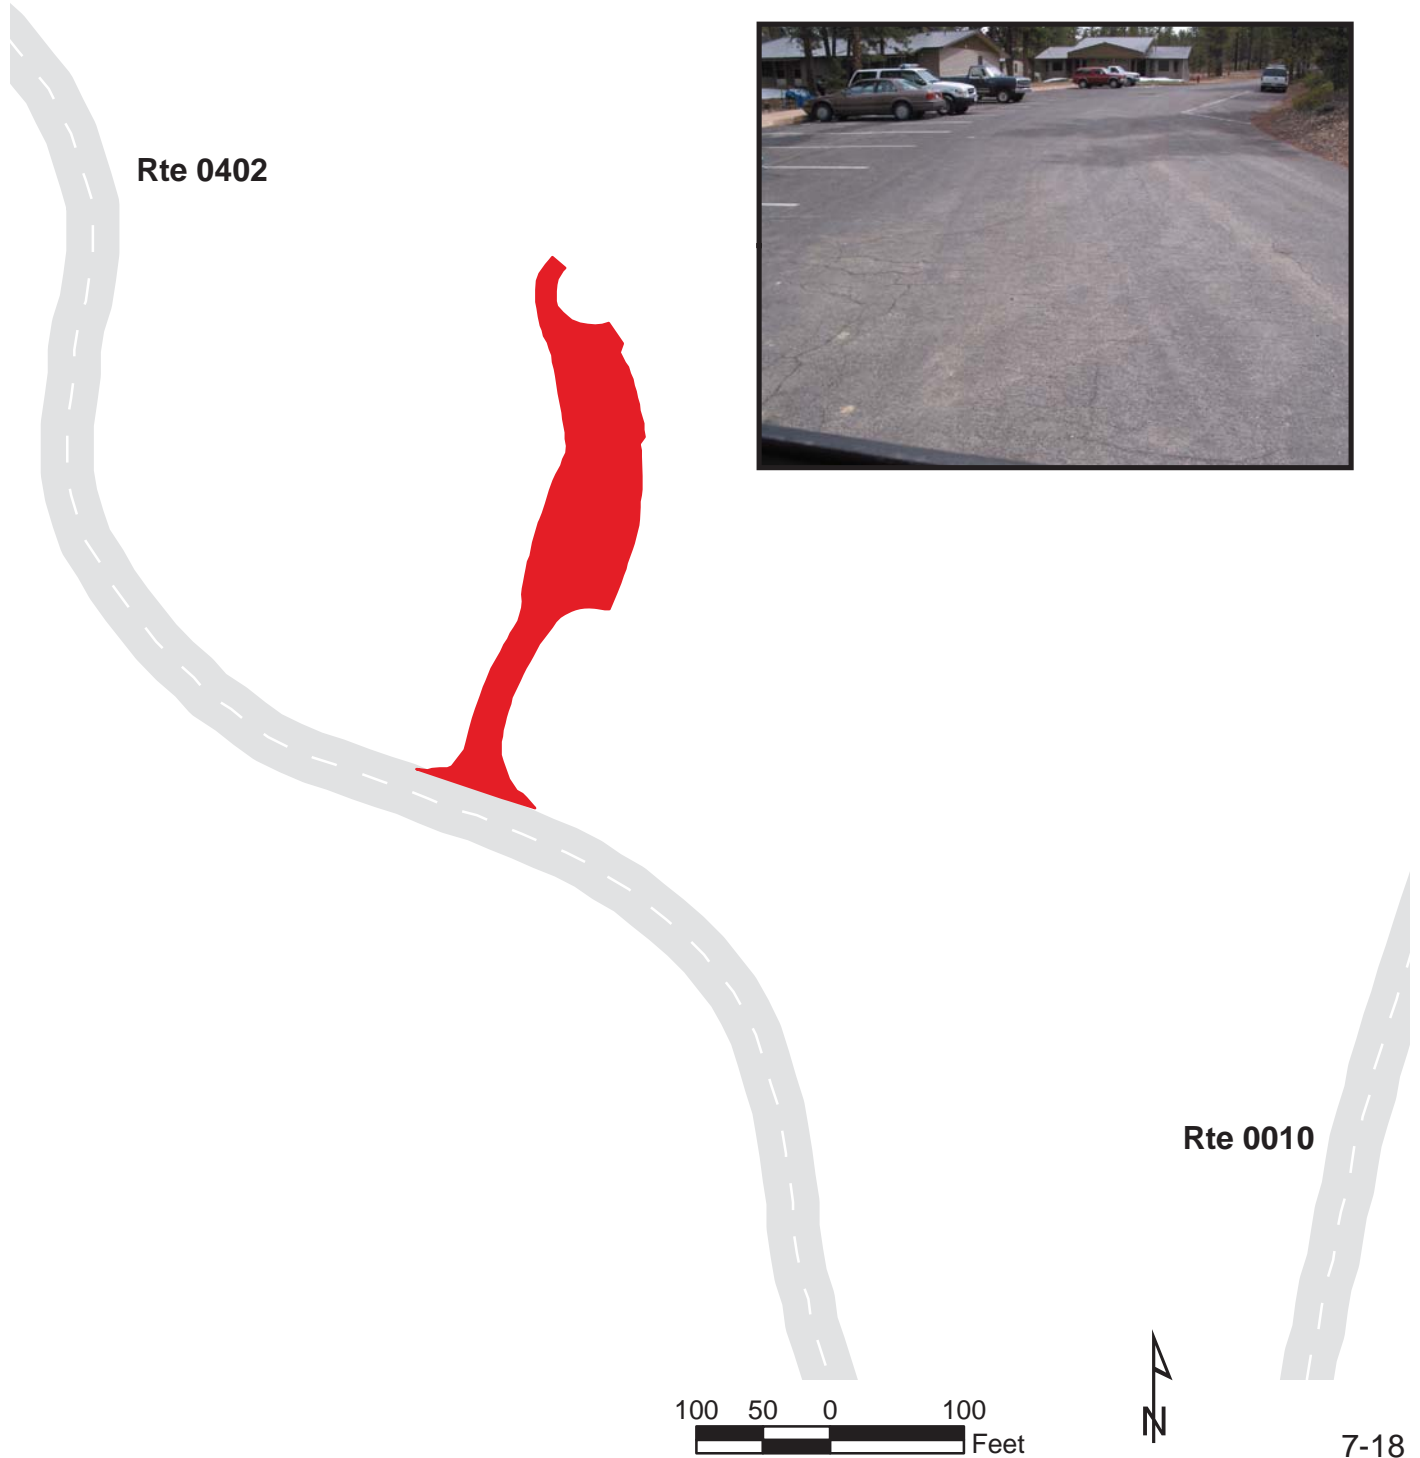
Route 0917

Route	Public / NonPublic	Date Visited	Area (sq ft)	Lane Miles *	Surface Type	Condition / PCR
0917	NonPublic	4/3/2003	14528	0.25	OC	POOR / 45

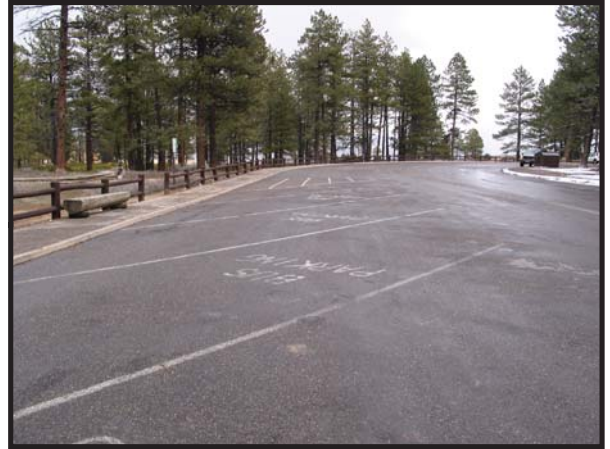
Route 0918B

Route	Public / NonPublic	Date Visited	Area (sq ft)	Lane Miles *	Surface Type	Condition / PCR
0918B	Public	4/3/2003	11465	0.20	AS	GOOD / 90

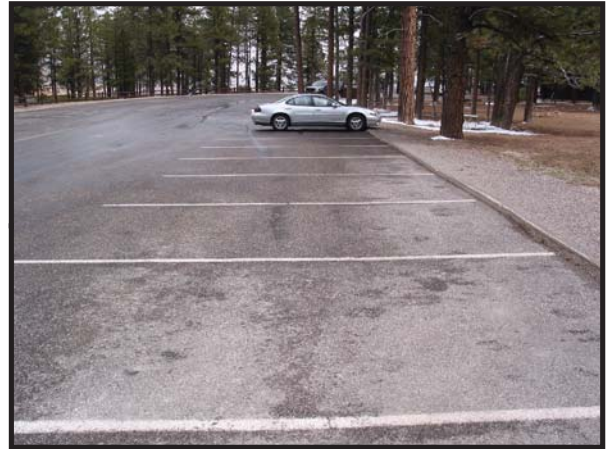
Route 0919

Route	Public / NonPublic	Date Visited	Area (sq ft)	Lane Miles *	Surface Type	Condition / PCR
0919	Public	4/3/2003	26599	0.46	AS	GOOD / 90

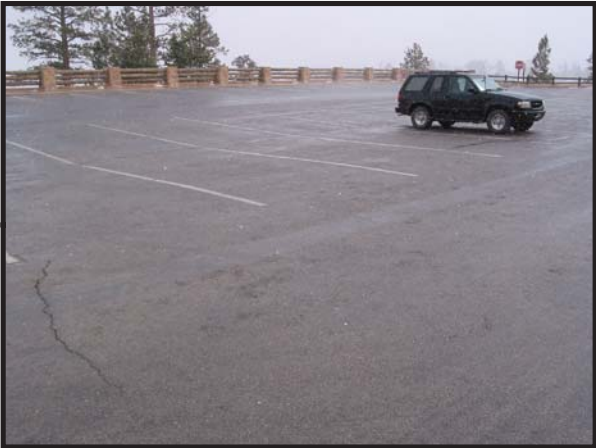
Route 0920

Route	Public / NonPublic	Date Visited	Area (sq ft)	Lane Miles *	Surface Type	Condition / PCR
0920	Public	4/3/2003	11845	0.20	AS	GOOD / 90

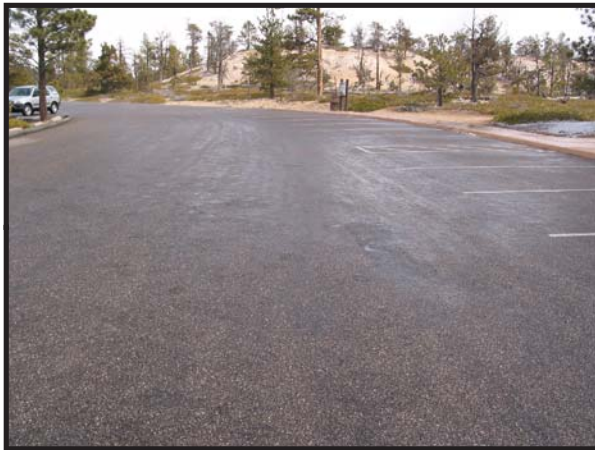
Route 0921

Route	Public / NonPublic	Date Visited	Area (sq ft)	Lane Miles *	Surface Type	Condition / PCR
0921	Public	4/3/2003	33318	0.57	AS	GOOD / 90

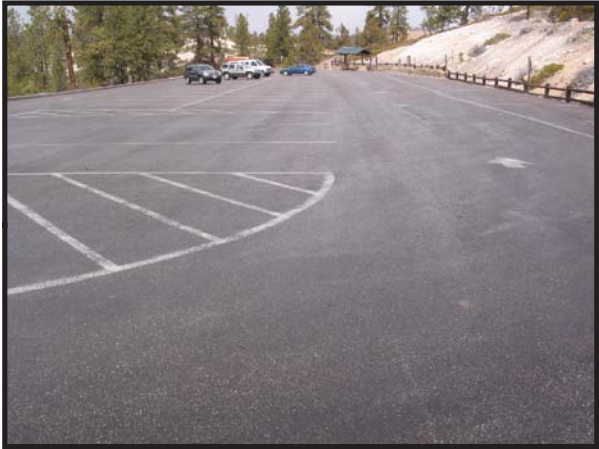
Route 0922

Route	Public / NonPublic	Date Visited	Area (sq ft)	Lane Miles *	Surface Type	Condition / PCR
0922	Public	4/3/2003	45894	0.79	AS	GOOD / 90

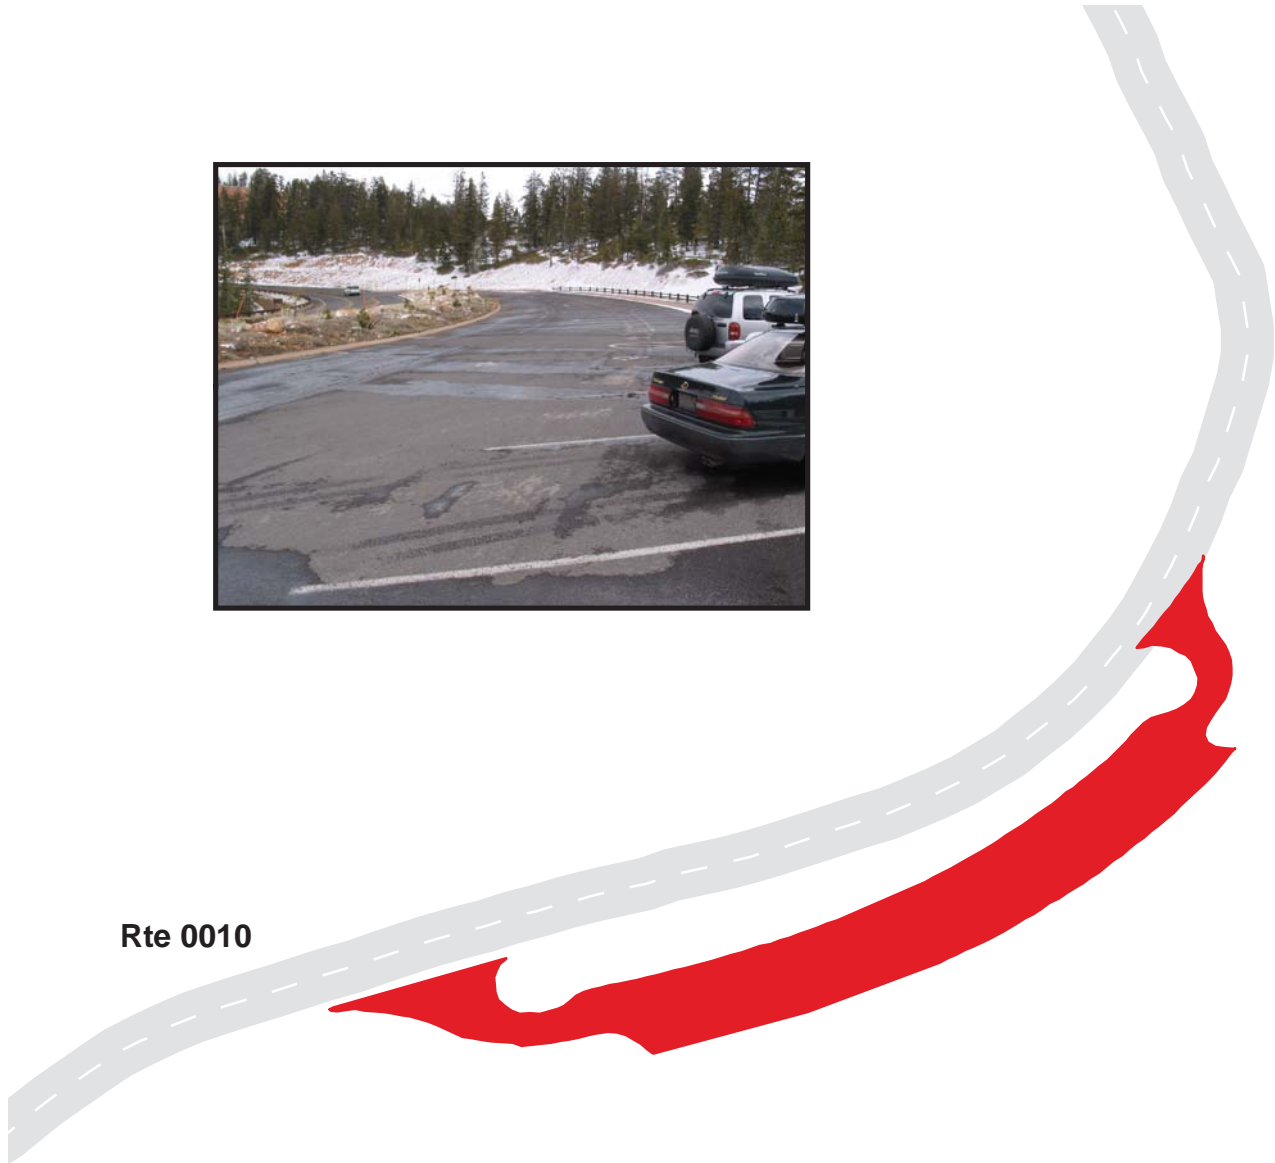
Route 0924

Route	Public / NonPublic	Date Visited	Area (sq ft)	Lane Miles *	Surface Type	Condition / PCR
0924	Public	4/3/2003	10348	0.18	AS	GOOD / 90

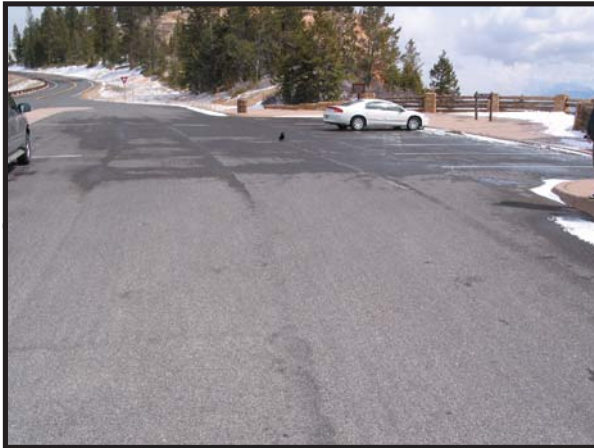
Route 0925

Route	Public / NonPublic	Date Visited	Area (sq ft)	Lane Miles *	Surface Type	Condition / PCR
0925	Public	4/3/2003	12417	0.21	AS	GOOD / 90

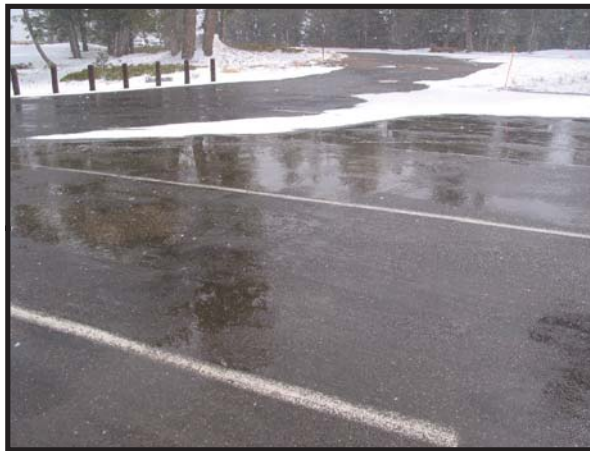
Route 0927

Route	Public / NonPublic	Date Visited	Area (sq ft)	Lane Miles *	Surface Type	Condition / PCR
0927	Public	4/3/2003	15902	0.27	AS	EXCELLENT / 97

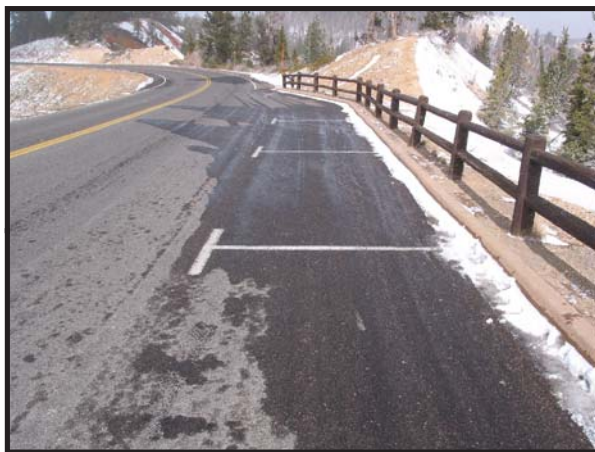
Route 0929

Route	Public / NonPublic	Date Visited	Area (sq ft)	Lane Miles *	Surface Type	Condition / PCR
0929	Public	4/3/2003	2017	0.03	AS	GOOD / 90

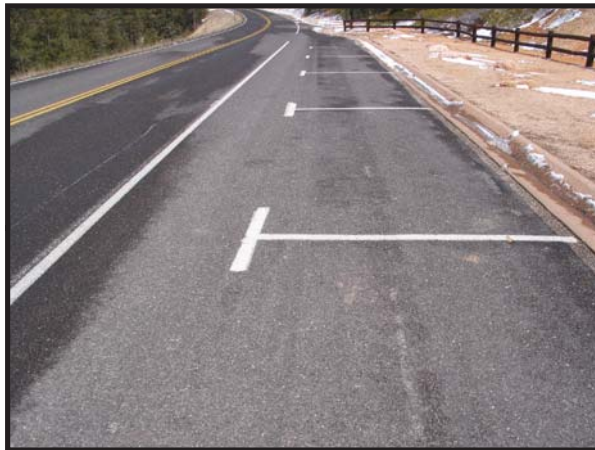
Route 0932

Route	Public / NonPublic	Date Visited	Area (sq ft)	Lane Miles *	Surface Type	Condition / PCR
0932	Public	4/3/2003	3825	0.07	AS	POOR / 45

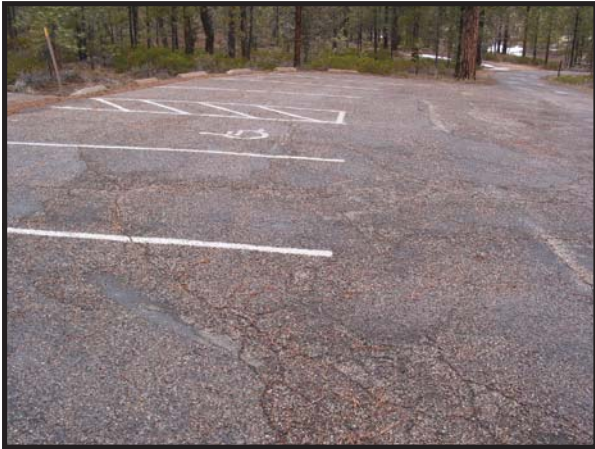
Route 0933

Route	Public / NonPublic	Date Visited	Area (sq ft)	Lane Miles *	Surface Type	Condition / PCR
0933	Public	4/3/2003	5311	0.09	AS	POOR / 45

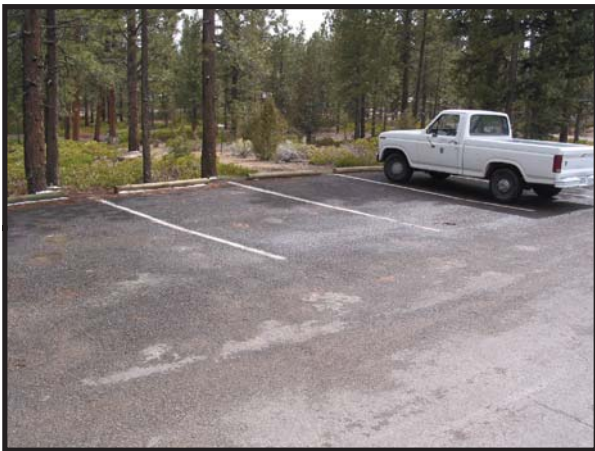
Route 0934C

Route	Public / NonPublic	Date Visited	Area (sq ft)	Lane Miles *	Surface Type	Condition / PCR
0934C	NonPublic	4/3/2003	1106	0.02	OC	GOOD / 90

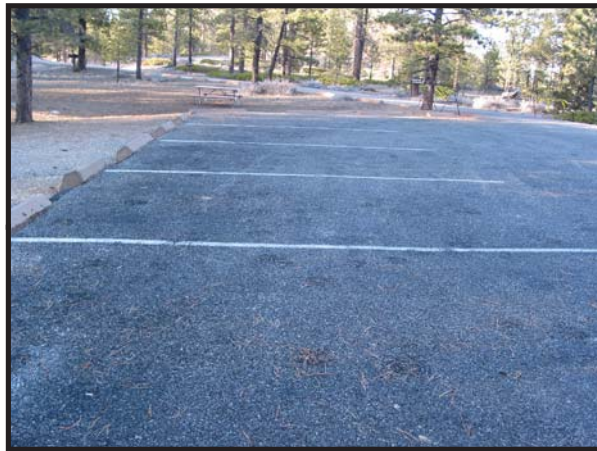
Route 0935B

Route	Public / NonPublic	Date Visited	Area (sq ft)	Lane Miles *	Surface Type	Condition / PCR
0935B	Public	4/3/2003	2015	0.03	NC	GOOD / 90

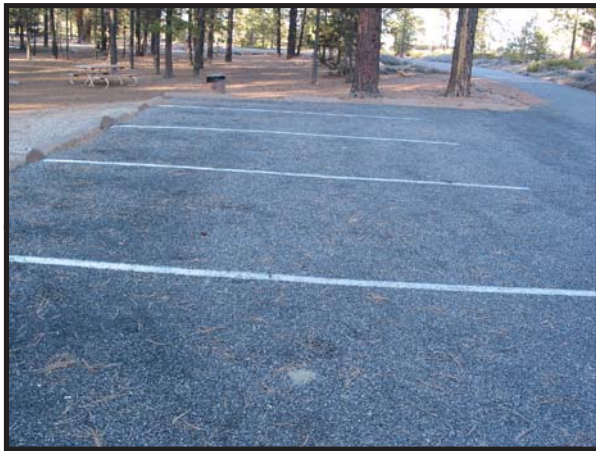
Route 0936

Route	Public / NonPublic	Date Visited	Area (sq ft)	Lane Miles *	Surface Type	Condition / PCR
0936	Public	4/3/2003	3112	0.05	NC	GOOD / 90
