**The Road Inventory  
of  
Brown v. Board of Education National  
Historic Site  
BRVB – 6145**

**Road Inventory Program**

Prepared By:  
Federal Highway Administration  
Eastern Federal Lands Highway Division  
Cycle 3

# Brown v. Board of Education National Historic Site in Kansas

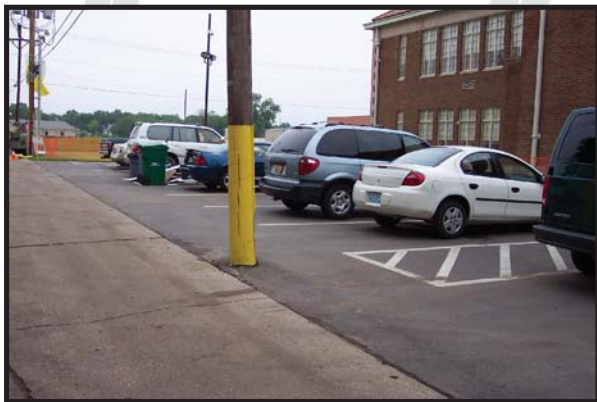
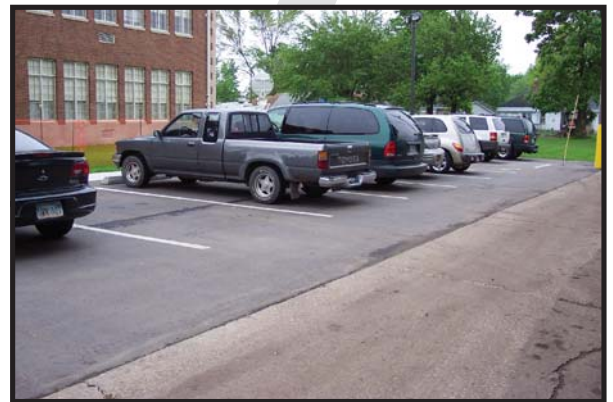
## Route 0900

### EMPLOYEE PARKING

From Alley between S.E. Monroe Street and S.E. Quincy Street

Route	Public / NonPublic	Date Visited	Area (sq ft)	Lane Miles *	Surface Type	Condition / PCR
0900	NonPublic	5/13/2004	4821	0.08	AS	GOOD / 90
