The Road Inventory of Cabrillo National Monument CABR – 8110

Road Inventory Program

Prepared By:
Federal Highway Administration
Eastern Federal Lands Highway Division
Cycle 3

Cabrillo National Monument in California

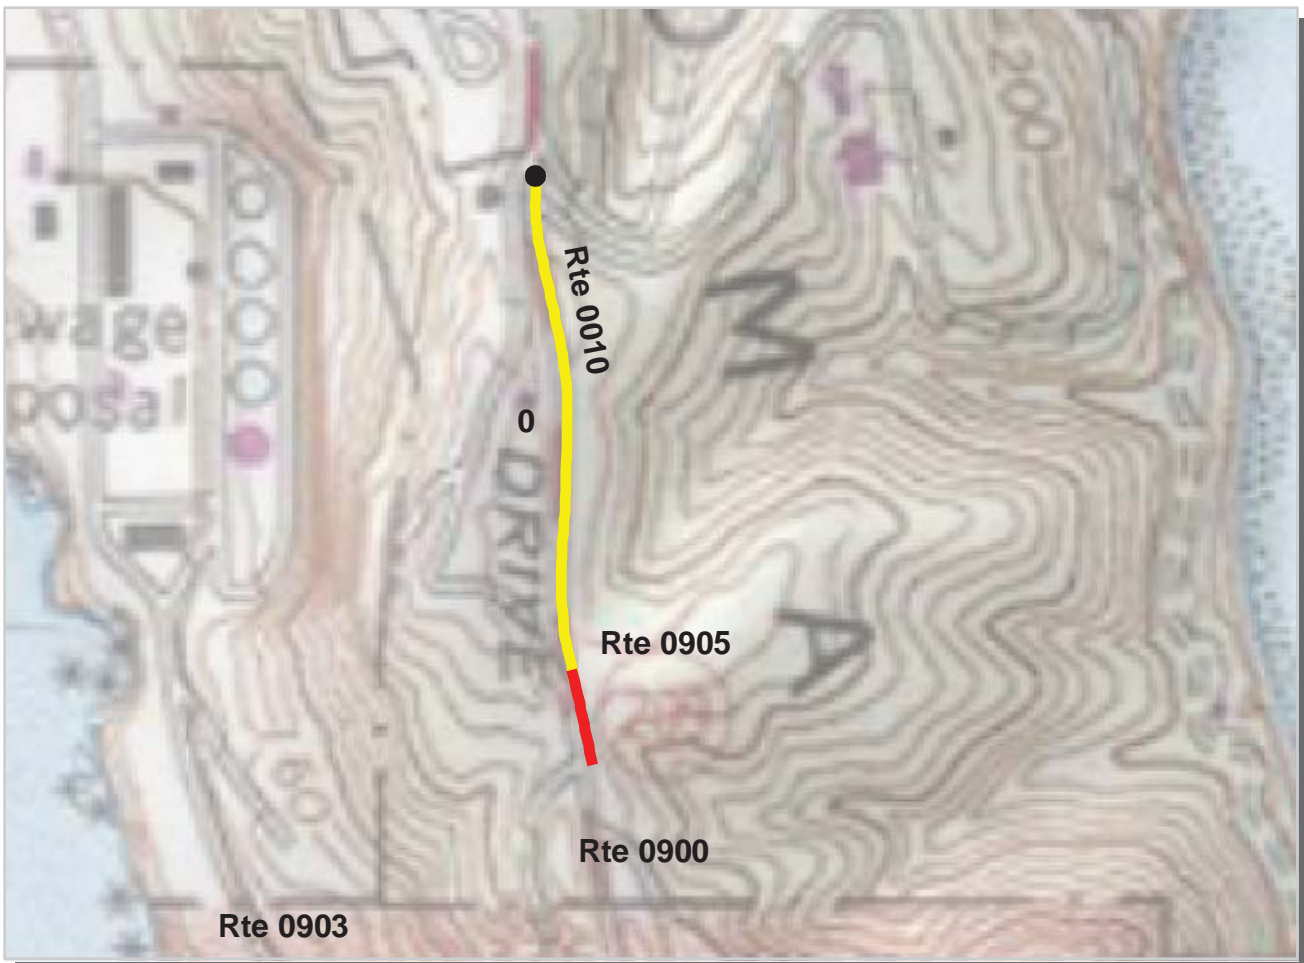
ROUTE: 0010 Cabrillo Memorial Drive

Section Number	0				
Section Length (mi)	0.30				
AADT	**				
SADT	**				
ADT Date	**				
Cross Section Information					
Number of Lanes	2				
Paved Width (ft)	22				
Lane Width (ft)	11				
Shoulder Width (ft)	5				
Roadway Condition Information					
PCR (Pavement Condition Rating)	66				
RCI (Roughness Condition Index)	85				
SCR (Surface Condition Rating)	53				
Alligator Cracking Index	100				
Rutting Index	54				
Patching Index	99				
Transverse Cracking Index	99				
Longitudinal Cracking Index	99				
Shoulder Condition Rating	N/C				
Drainage Condition Rating	N/A

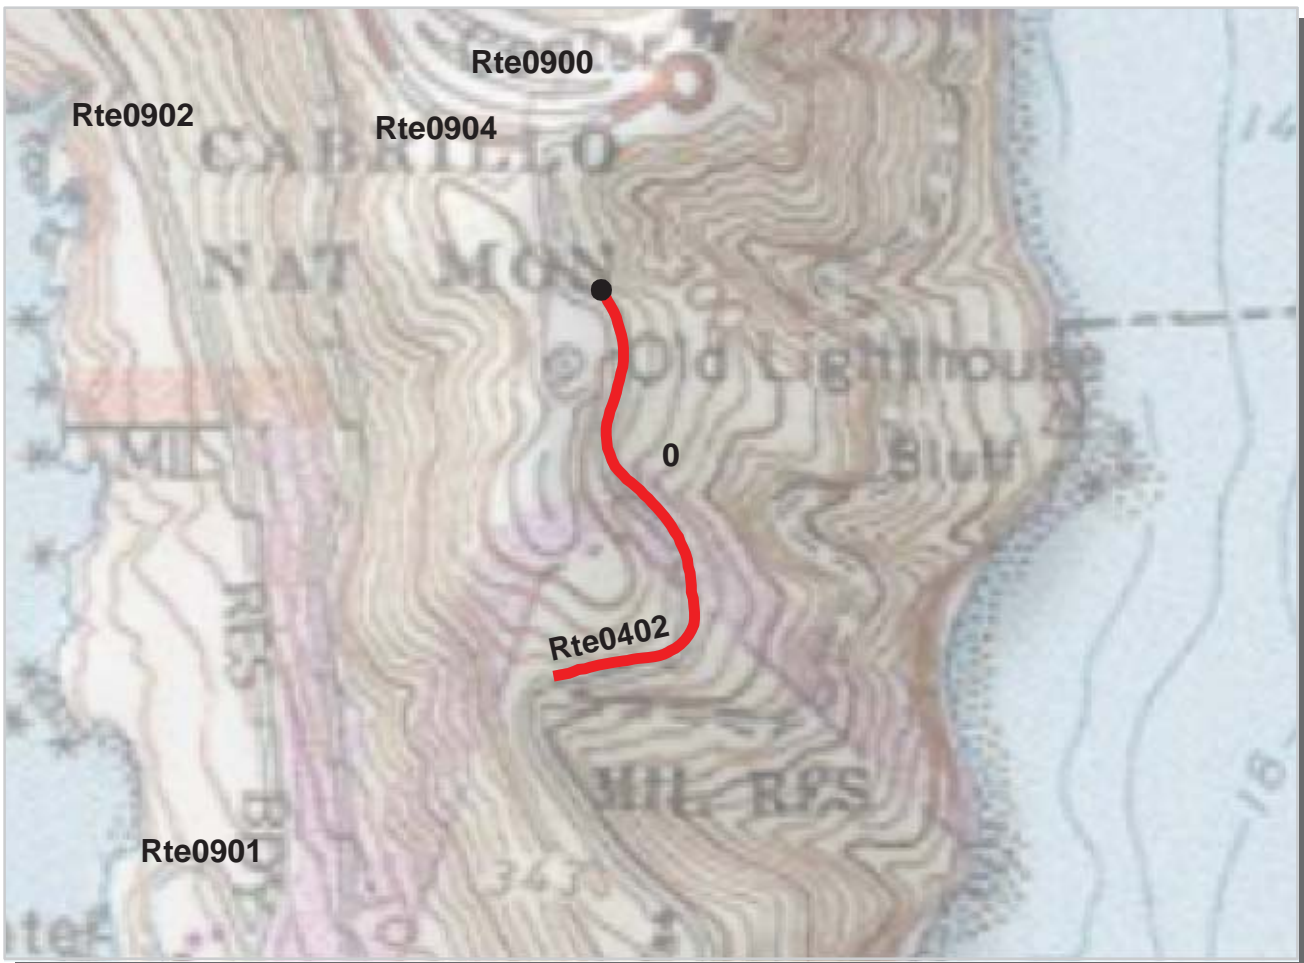
ROUTE: 0402 Battery Humphreys Road **TOTAL LENGTH: 0.30 Miles**

Section Number	0				
Section Length (mi)	0.30				
AADT	**				
SADT	**				
ADT Date	**				
Cross Section Information					
Number of Lanes	1				
Paved Width (ft)	13				
Lane Width (ft)	13				
Shoulder Width (ft)	0				
Roadway Condition Information					
PCR (Pavement Condition Rating)	19				
RCI (Roughness Condition Index)	45				
SCR (Surface Condition Rating)	7				
Alligator Cracking Index	97				
Rutting Index	17				
Patching Index	89				
Transverse Cracking Index	98				
Longitudinal Cracking Index	96				
Shoulder Condition Rating	N/A				
Drainage Condition Rating	N/A

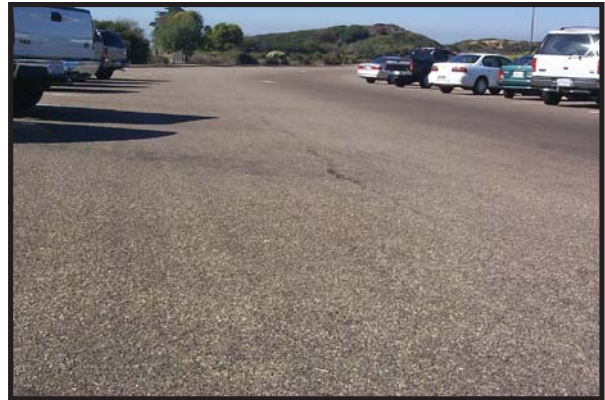
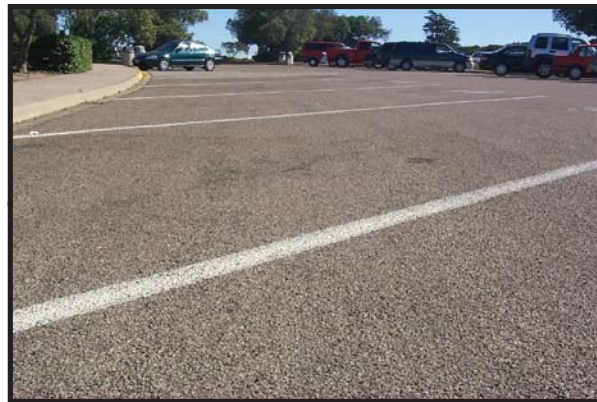
Route 0900

Route	Public / NonPublic	Date Visited	Area (sq ft)	Lane Miles *	Surface Type	Condition / PCR
0900	Public	11/15/2001	210046	3.62	NC	GOOD / 90

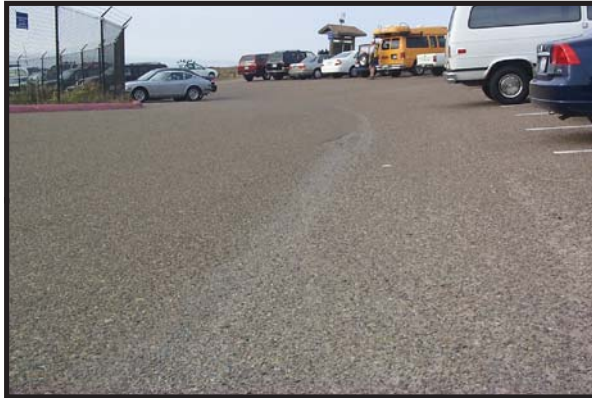
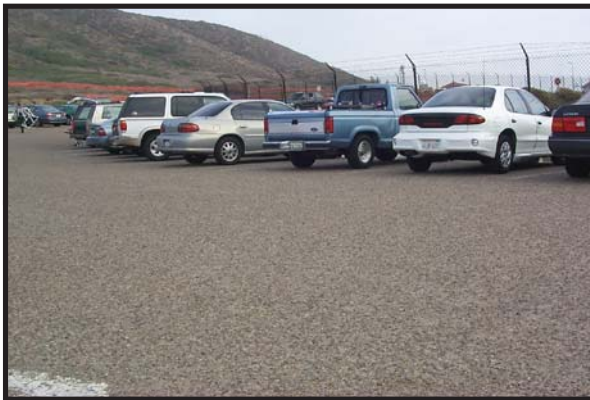
Route 0901

Route	Public / NonPublic	Date Visited	Area (sq ft)	Lane Miles *	Surface Type	Condition / PCR
0901	Public	11/15/2001	22150	0.38	NC	FAIR / 73

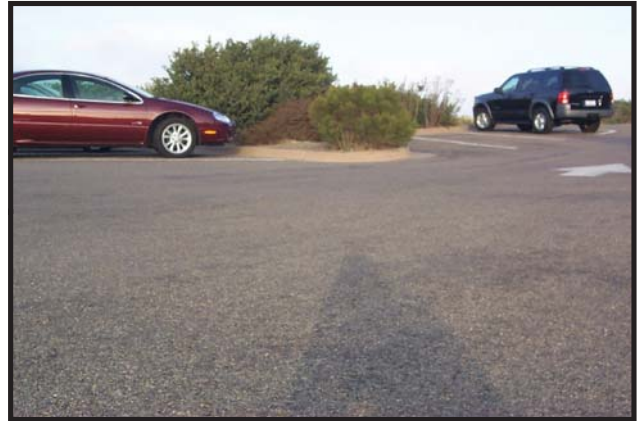
Route 0904

Route	Public / NonPublic	Date Visited	Area (sq ft)	Lane Miles *	Surface Type	Condition / PCR
0904	Public	11/15/2001	8477	0.15	NC	GOOD / 90

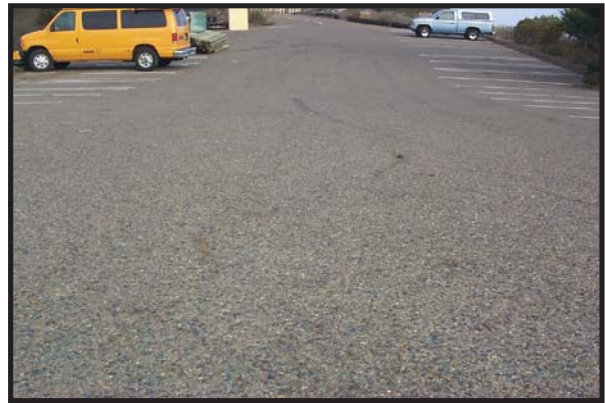
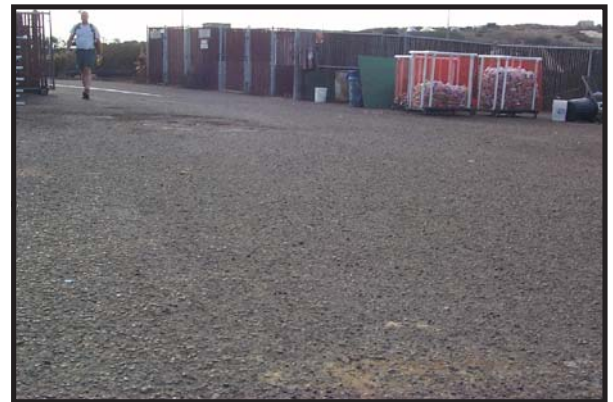
Route 0905

Route	Public / NonPublic	Date Visited	Area (sq ft)	Lane Miles *	Surface Type	Condition / PCR
0905	NonPublic	11/15/2001	23478	0.40	NC	FAIR / 73
