# The Road Inventory of Canyon de Chelly National Monument CACH - 7390

## Road Inventory Program

Prepared By:  
Federal Highway Administration  
Eastern Federal Lands Highway Division  
Cycle 3

# Canyon de Chelly National Monument in Arizona

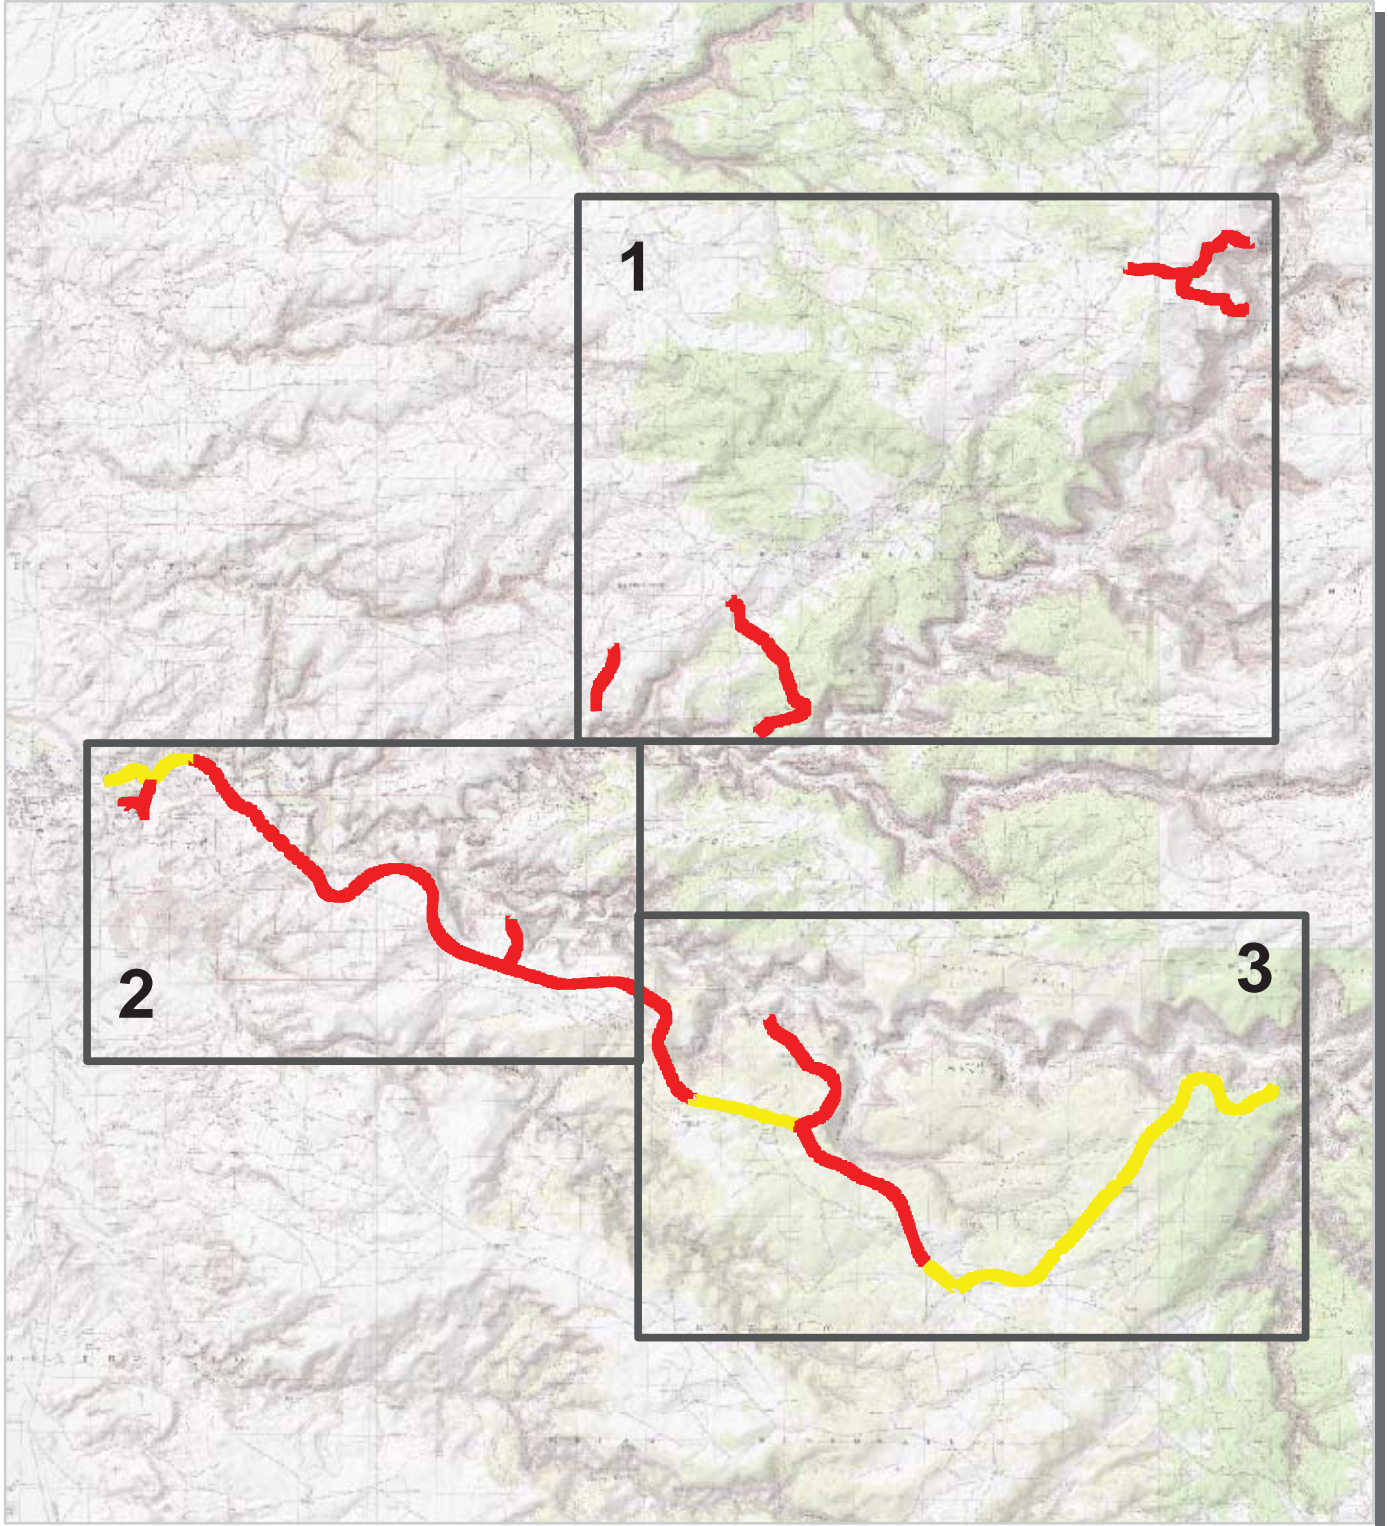
## Route Condition Key Map

### PCR - Mile by Mile

PCR	Poor	<span style="display: inline-block; width: 20px; height: 10px; background-color: red; border: 1px solid black;"></span>	Fair	<span style="display: inline-block; width: 20px; height: 10px; background-color: yellow; border: 1px solid black;"></span>	Good	<span style="display: inline-block; width: 20px; height: 10px; background-color: green; border: 1px solid black;"></span>	Excellent	<span style="display: inline-block; width: 20px; height: 10px; background-color: blue; border: 1px solid black;"></span>
		(<=60)		(61 - 84)		(85 - 94)		(95 - 100)

\* If the PCR rating is not available for a section, the SCR rating will be displayed. See appendix for definitions and formulas.

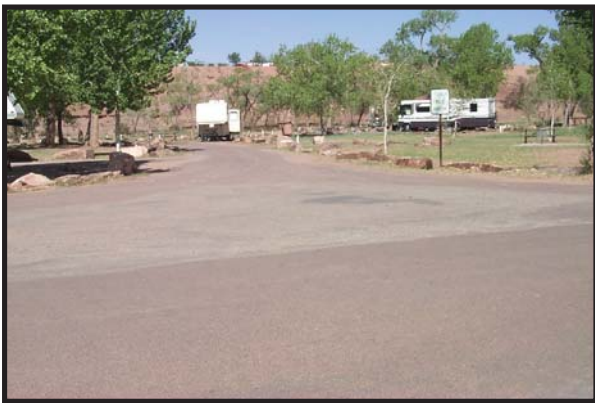
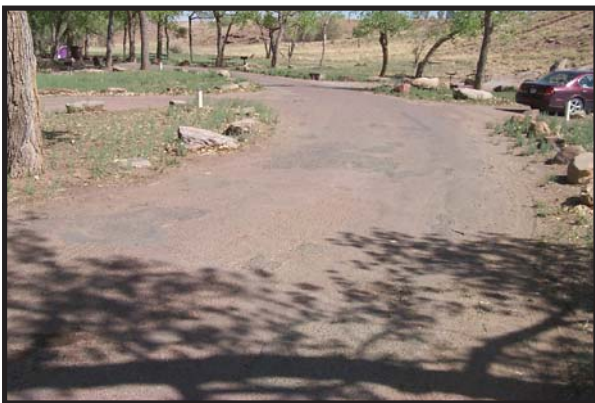
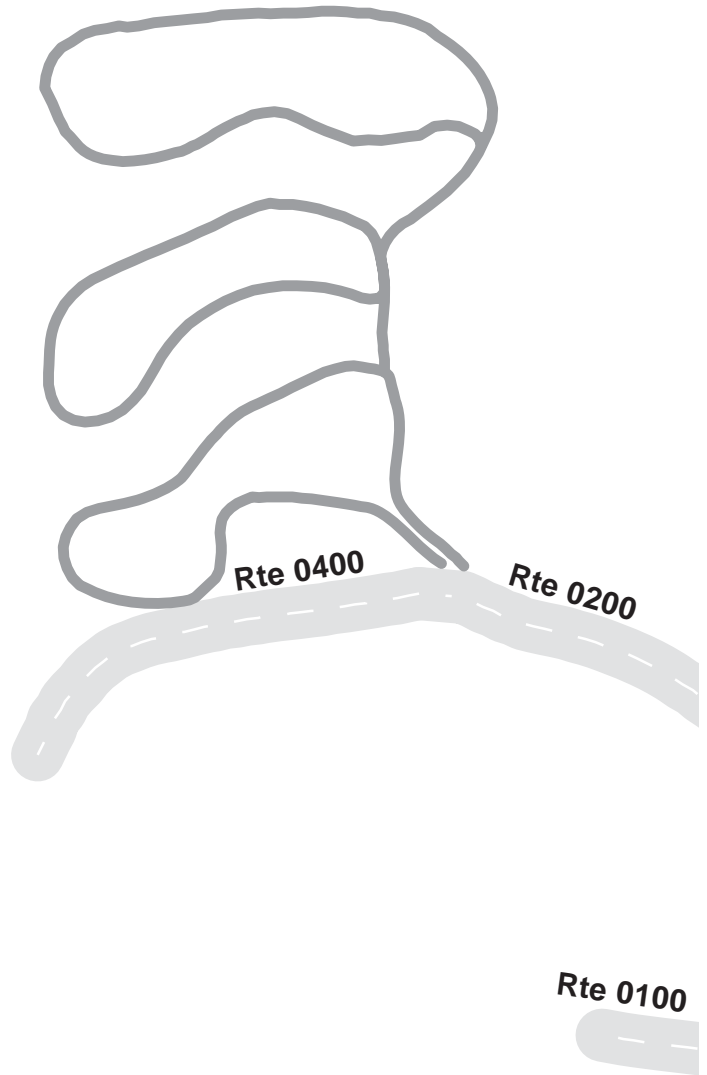
Route	Length (mi)	Width (ft)	Area (sq ft)	Lane Miles *	Condition / PCR	Surface Type
0201	0.94	15.00	74606	1.28	FAIR / 73	AS

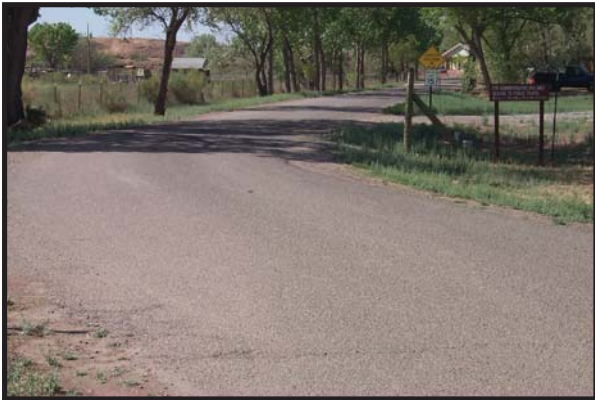
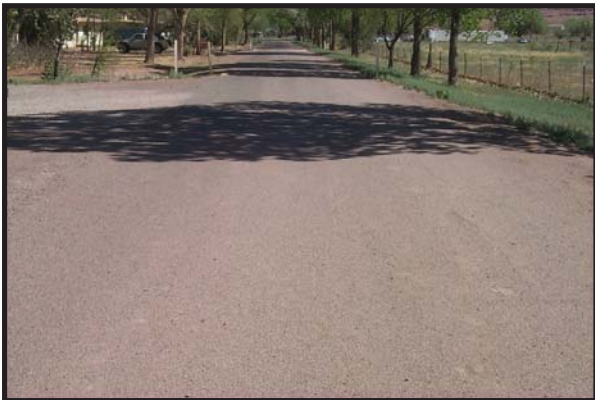
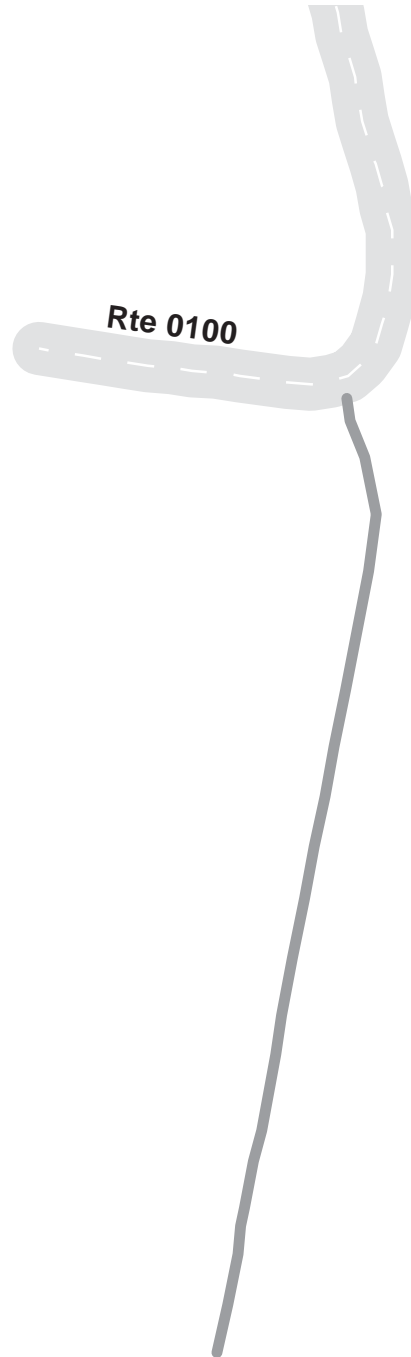
## Route 0401

Route	Length (mi)	Width (ft)	Area (sq ft)	Lane Miles *	Condition / PCR	Surface Type
0401	0.15	17.00	13464	0.23	FAIR / 73	AS

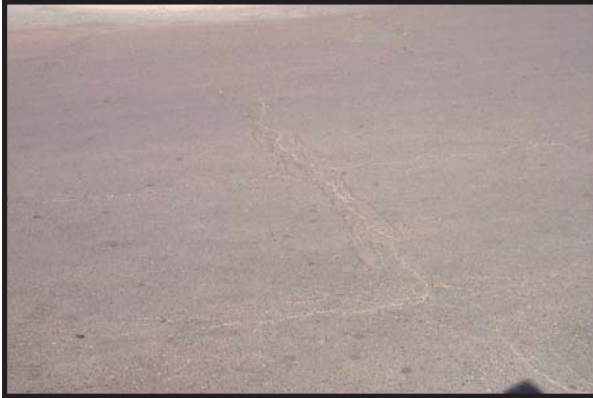
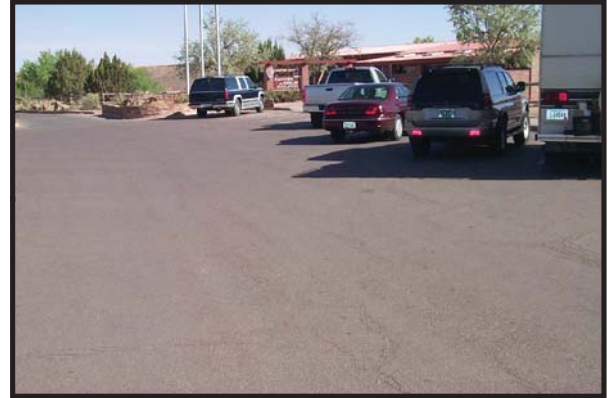
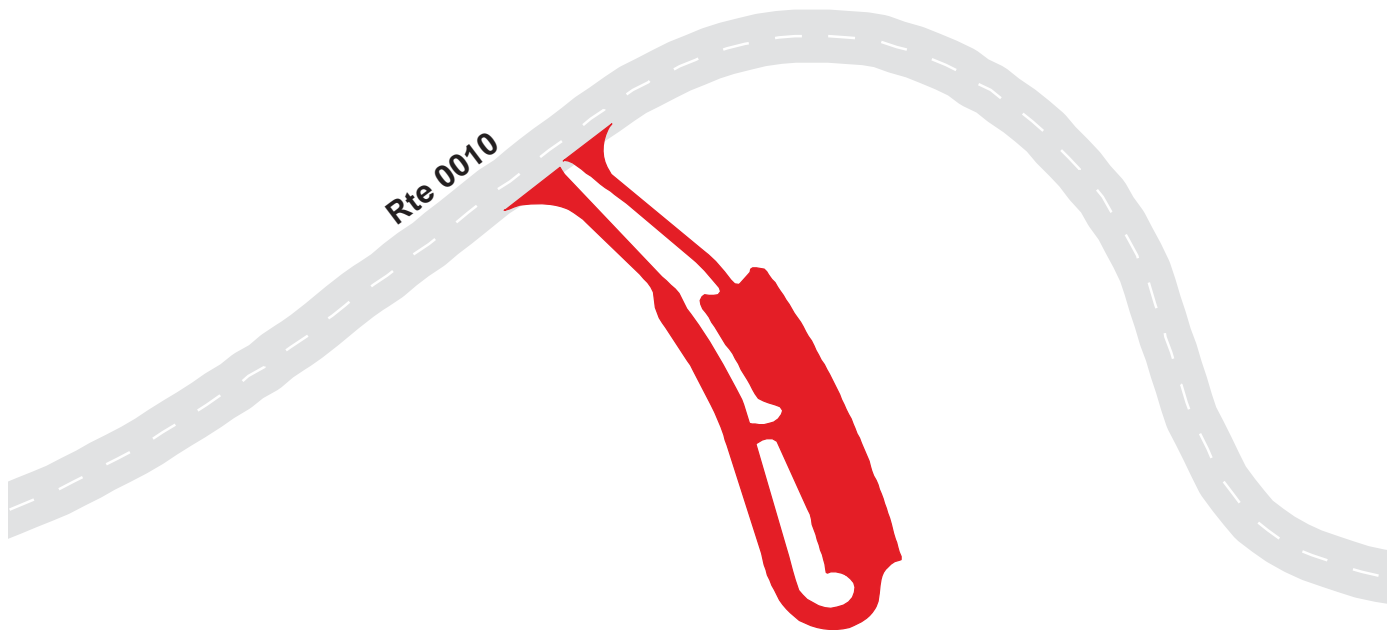
## Route 0900

Route	Public / NonPublic	Date Visited	Area (sq ft)	Lane Miles *	Surface Type	Condition / PCR
0900	Public	5/7/2002	38798	0.67	AS	FAIR / 73

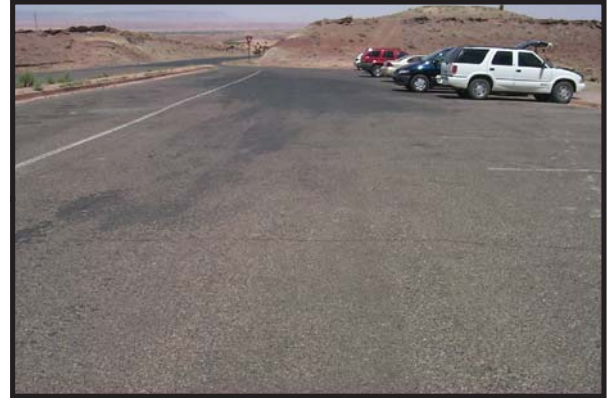
Route	Public / NonPublic	Date Visited	Area (sq ft)	Lane Miles *	Surface Type	Condition / PCR
0901	Public	5/7/2002	9942	0.17	AS	FAIR / 73

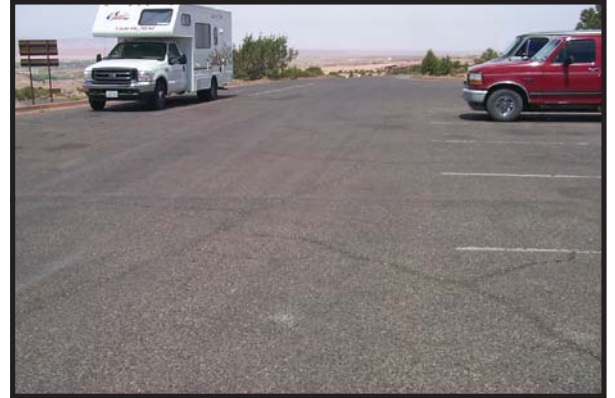
## Route 0902

Route	Public / NonPublic	Date Visited	Area (sq ft)	Lane Miles *	Surface Type	Condition / PCR
0902	Public	5/7/2002	13368	0.23	AS	FAIR / 73

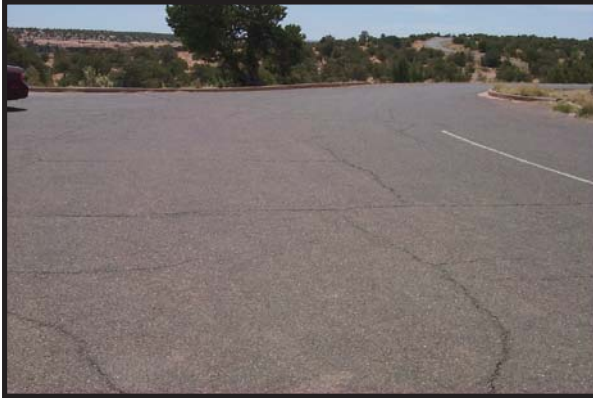
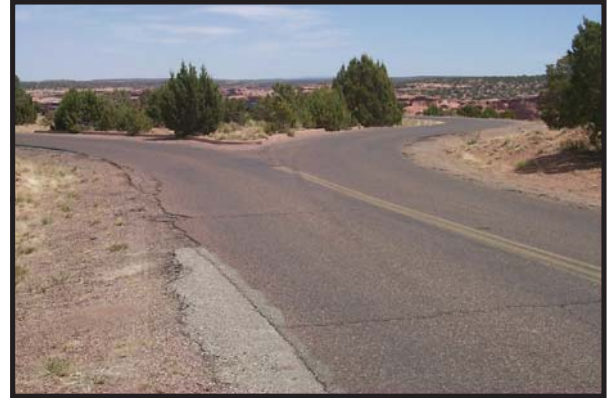
Route	Public / NonPublic	Date Visited	Area (sq ft)	Lane Miles *	Surface Type	Condition / PCR
0903	Public	5/7/2002	24003	0.41	OC	FAIR / 73

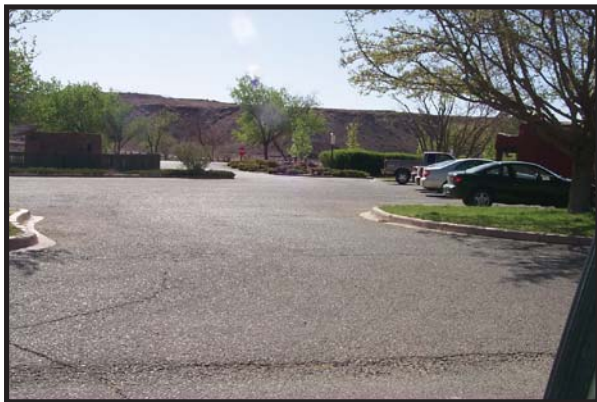
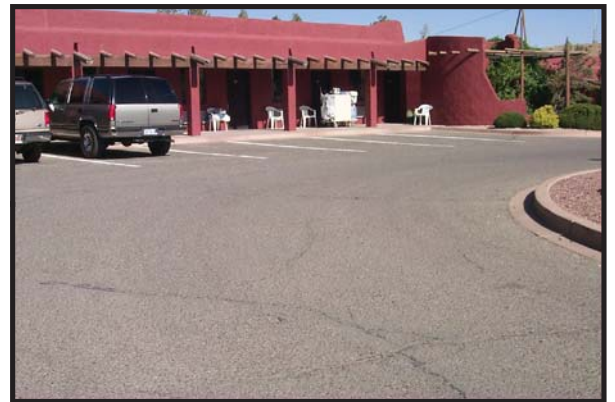
## Route 0906

Route	Public / NonPublic	Date Visited	Area (sq ft)	Lane Miles *	Surface Type	Condition / PCR
0906	Public	5/7/2002	107374	1.85	AS	FAIR / 73

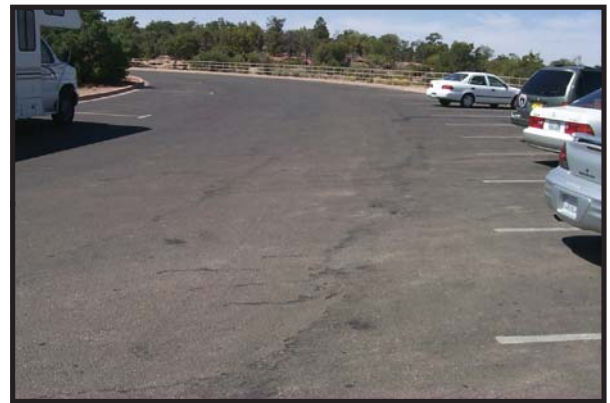
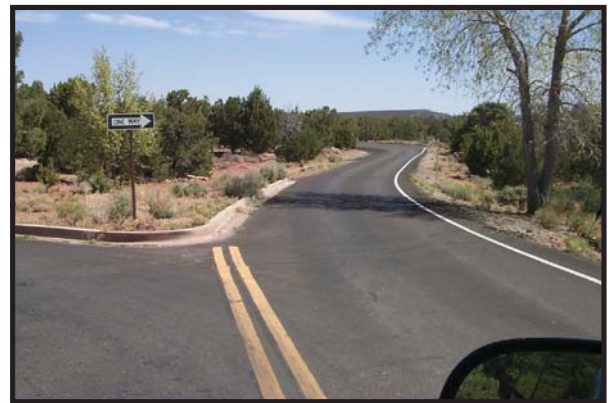
## Route 0907

Route	Public / NonPublic	Date Visited	Area (sq ft)	Lane Miles *	Surface Type	Condition / PCR
0907	Public	5/7/2002	23967	0.41	AS	GOOD / 90

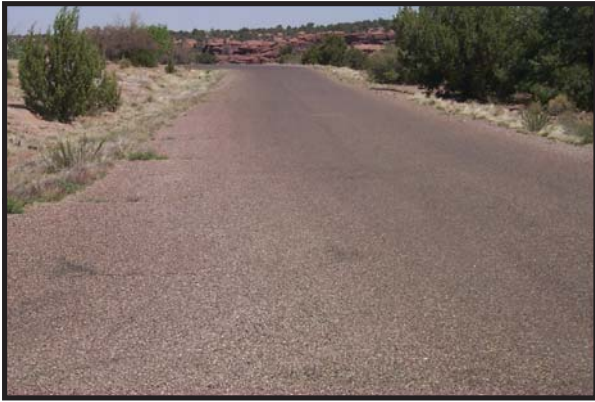
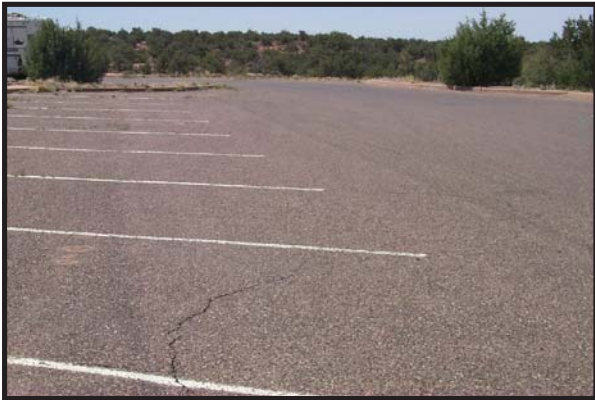
## Route 0908

Route	Public / NonPublic	Date Visited	Area (sq ft)	Lane Miles *	Surface Type	Condition / PCR
0908	Public	5/7/2002	24549	0.42	AS	FAIR / 73

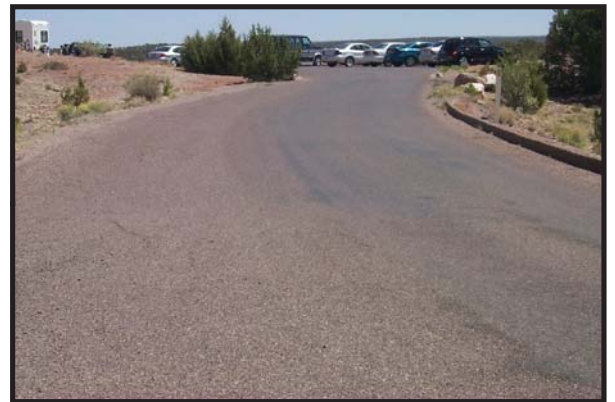
## Route 0909

Route	Public / NonPublic	Date Visited	Area (sq ft)	Lane Miles *	Surface Type	Condition / PCR
0909	Public	5/7/2002	26283	0.45	AS	GOOD / 90

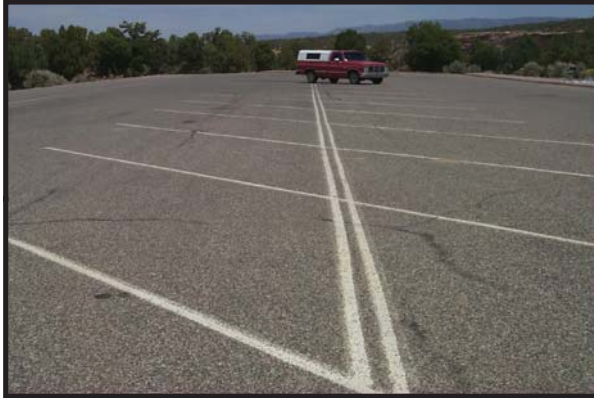
## Route 0910

Route	Public / NonPublic	Date Visited	Area (sq ft)	Lane Miles *	Surface Type	Condition / PCR
0910	Public	5/7/2002	23560	0.41	OC	FAIR / 73

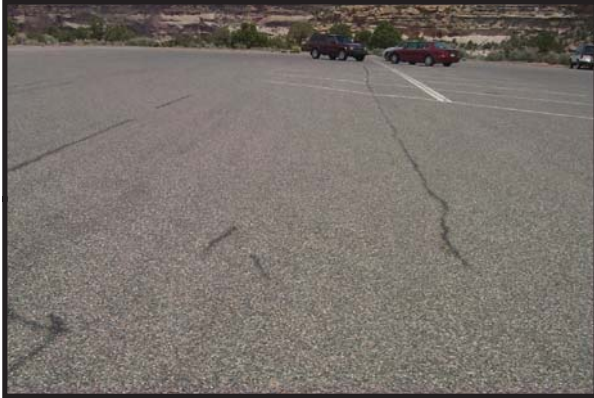
## Route 0911

Route	Public / NonPublic	Date Visited	Area (sq ft)	Lane Miles *	Surface Type	Condition / PCR
0911	Public	5/7/2002	31366	0.54	AS	FAIR / 73

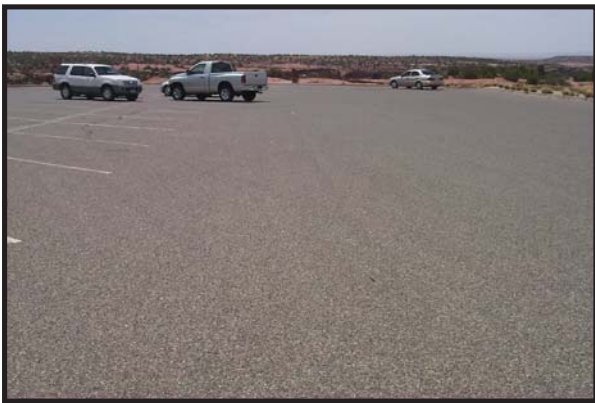
## Route 0912

Route	Public / NonPublic	Date Visited	Area (sq ft)	Lane Miles *	Surface Type	Condition / PCR
0912	Public	5/7/2002	29811	0.51	AS	GOOD / 90

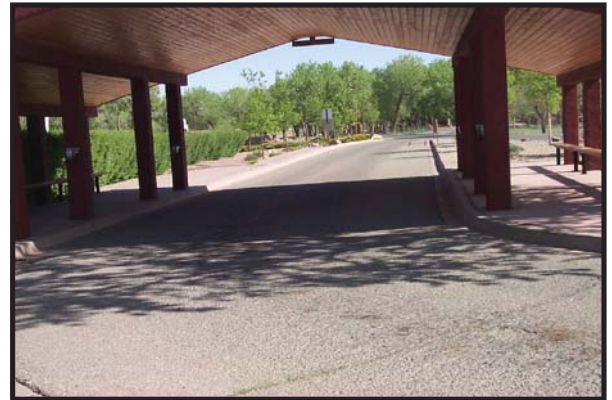
## Route 0914

Route	Public / NonPublic	Date Visited	Area (sq ft)	Lane Miles *	Surface Type	Condition / PCR
0914	NonPublic	5/7/2002	4890	0.08	AS	GOOD / 90

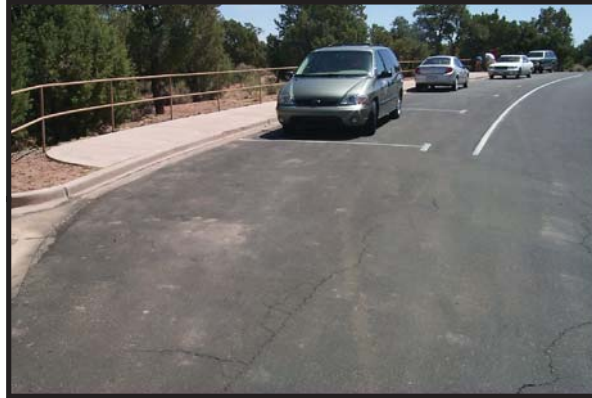
## Route 0915

Route	Public / NonPublic	Date Visited	Area (sq ft)	Lane Miles *	Surface Type	Condition / PCR
0915	Public	5/7/2002	2623	0.05	AS	GOOD / 90

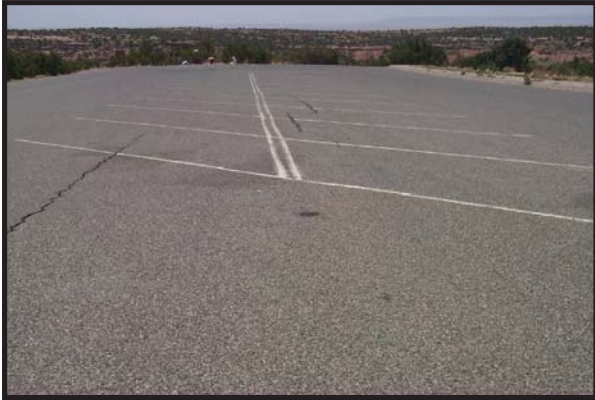
## Route 0916

Route	Public / NonPublic	Date Visited	Area (sq ft)	Lane Miles *	Surface Type	Condition / PCR
0916	Public	5/7/2002	32777	0.56	AS	FAIR / 73

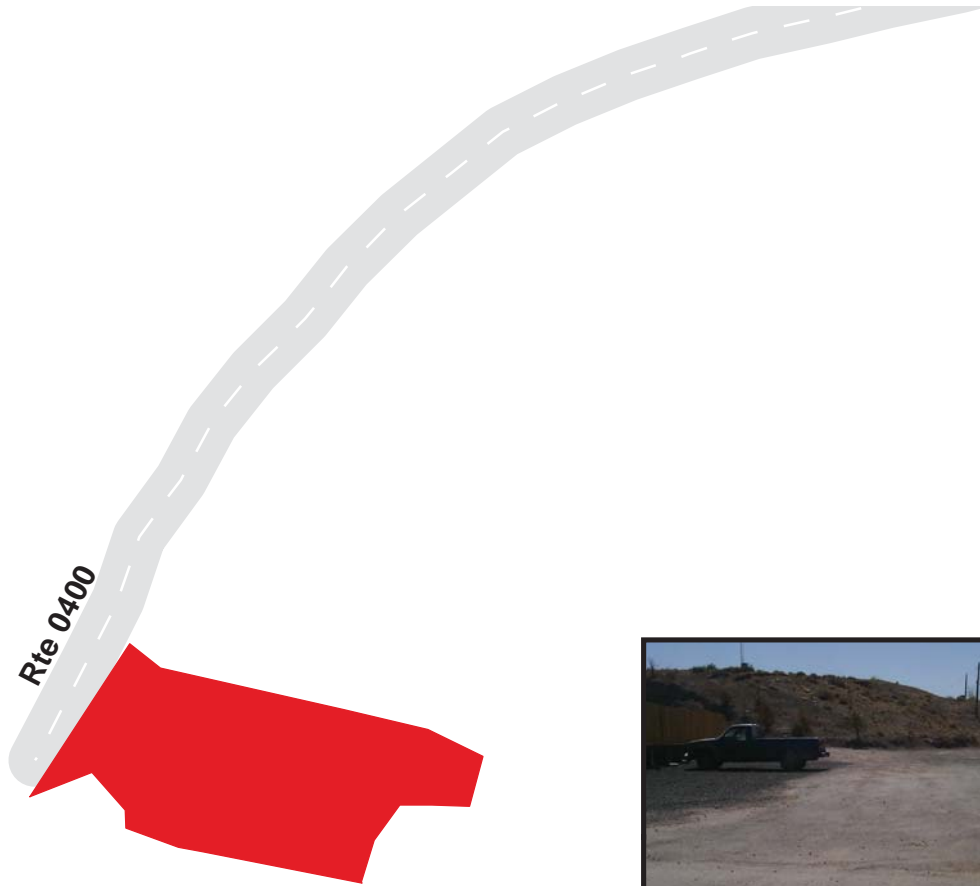
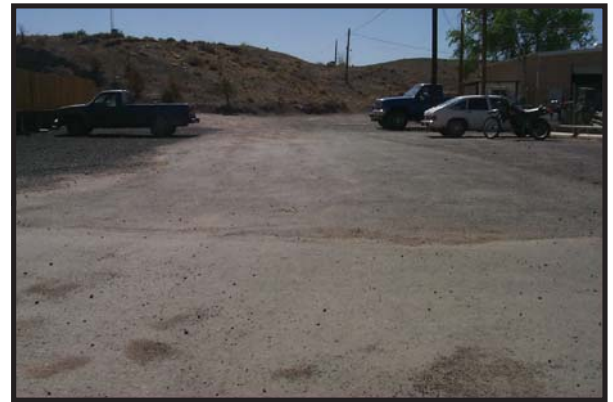
## Route 0917

Route	Public / NonPublic	Date Visited	Area (sq ft)	Lane Miles *	Surface Type	Condition / PCR
0917	NonPublic	5/7/2002	3288	0.06	AS	POOR / 45
