# The Road Inventory of Casa Grande Ruins National Monument CAGR – 8610

## Road Inventory Program

Prepared By:  
Federal Highway Administration  
Eastern Federal Lands Highway Division  
Cycle 3

# Casa Grande Ruins Monument in Arizona

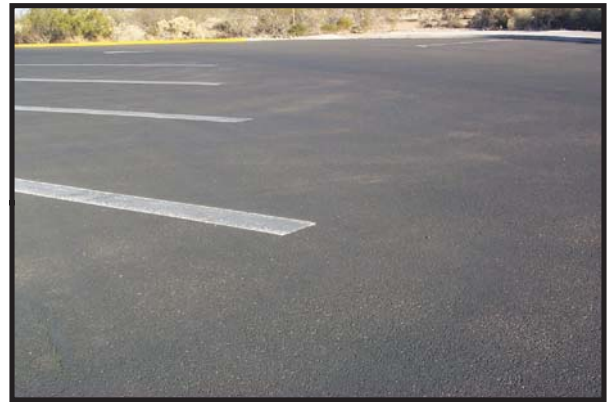
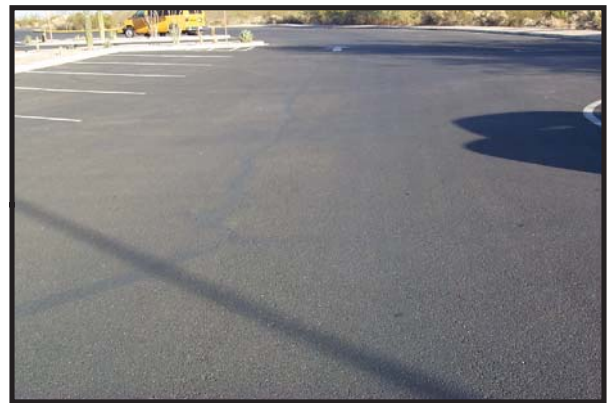
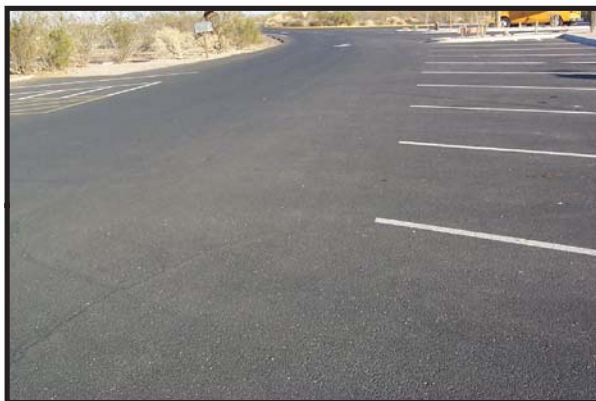
## Route 0900

Route	Public / NonPublic	Date Visited	Area (sq ft)	Lane Miles *	Surface Type	Condition / PCR
0900	Public	4/7/2003	47749	0.82	AS	GOOD / 90

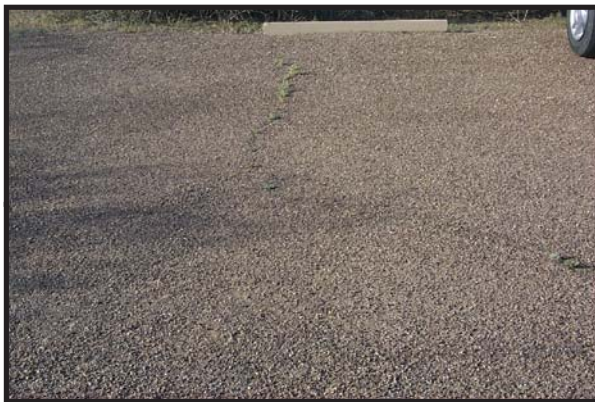
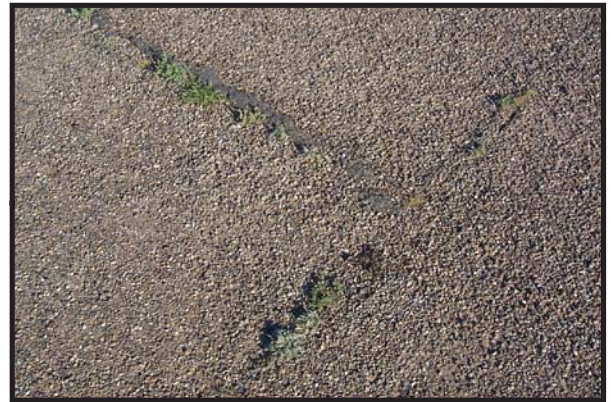
## Route 0903

Route	Public / NonPublic	Date Visited	Area (sq ft)	Lane Miles *	Surface Type	Condition / PCR
0903	NonPublic	4/7/2003	5094	0.09	OC	FAIR / 73
