**The Road Inventory  
of  
Cape Hatteras National Seashore  
CAHA – 5190**

**Road Inventory Program**

Prepared By:  
Federal Highway Administration  
Eastern Federal Lands Highway Division  
Cycle 3

# Cape Hatteras National Seashore in North Carolina

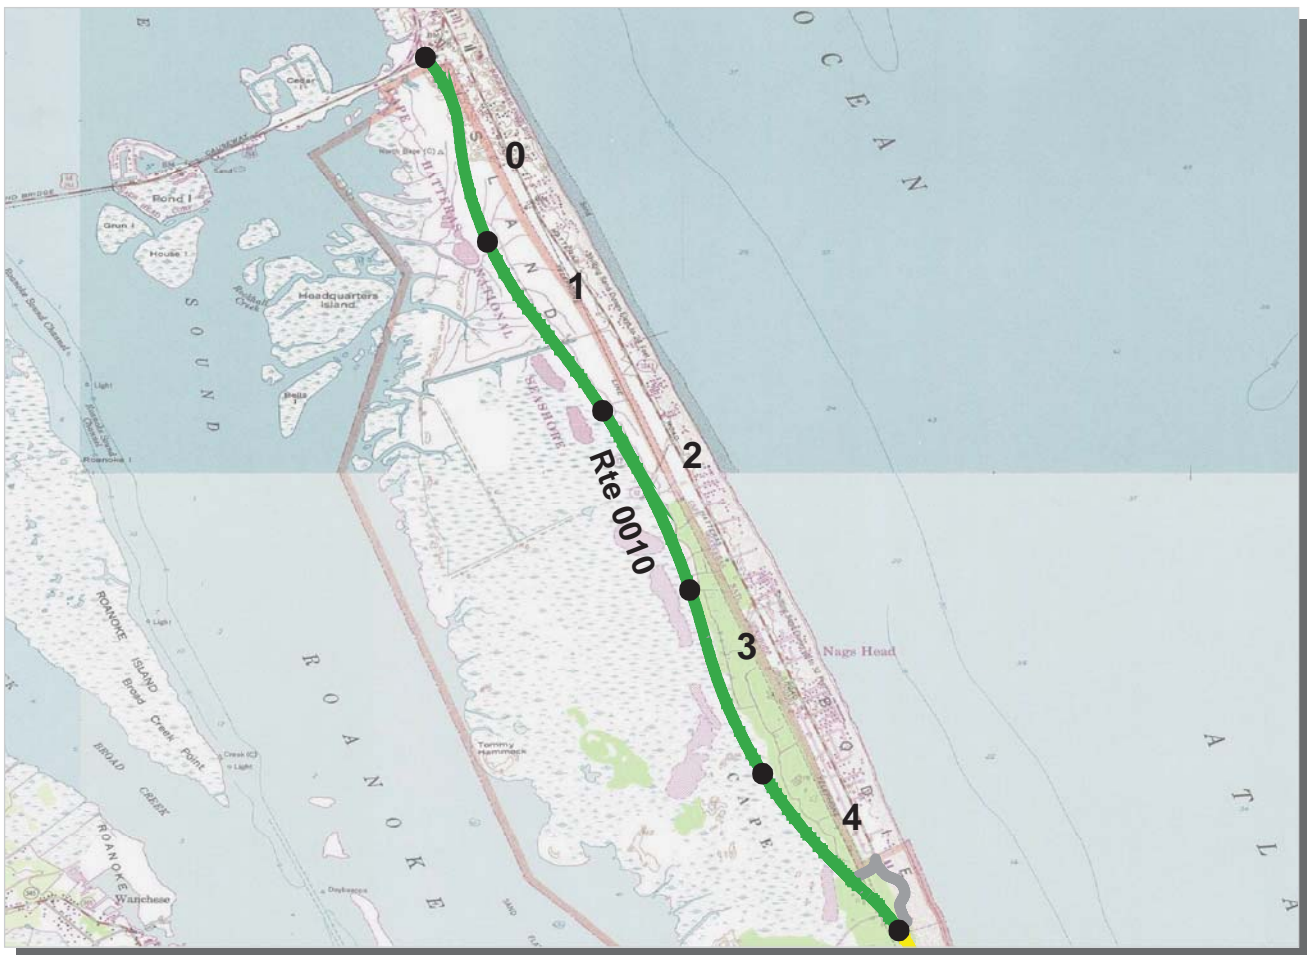
ROUTE: 0010 Bodie Island Entrance Road

Section Number	0	1	2	3	4
Section Length (mi)	1.00	1.00	1.00	1.00	1.00
AADT	**				
SADT	**				
ADT Date	**				
<b>Cross Section Information</b>					
Number of Lanes	2	2	2	2	2
Paved Width (ft)	24	21	21	22	21
Lane Width (ft)	12	11	11	11	11
Shoulder Width (ft)	11	2	2	2	2
<b>Roadway Condition Information</b>					
PCR (Pavement Condition Rating)	93	87	91	90	87
RCI (Roughness Condition Index)	98	94	94	97	96
SCR (Surface Condition Rating)	90	83	88	86	82
Alligator Cracking Index	100	100	100	100	100
Rutting Index	91	84	88	86	83
Patching Index	99	98	100	99	99
Transverse Cracking Index	99	99	99	99	99
Longitudinal Cracking Index	99	99	100	99	99
Shoulder Condition Rating	GOOD	GOOD	GOOD	GOOD	GOOD
Drainage Condition Rating	GOOD	GOOD	GOOD	GOOD	GOOD

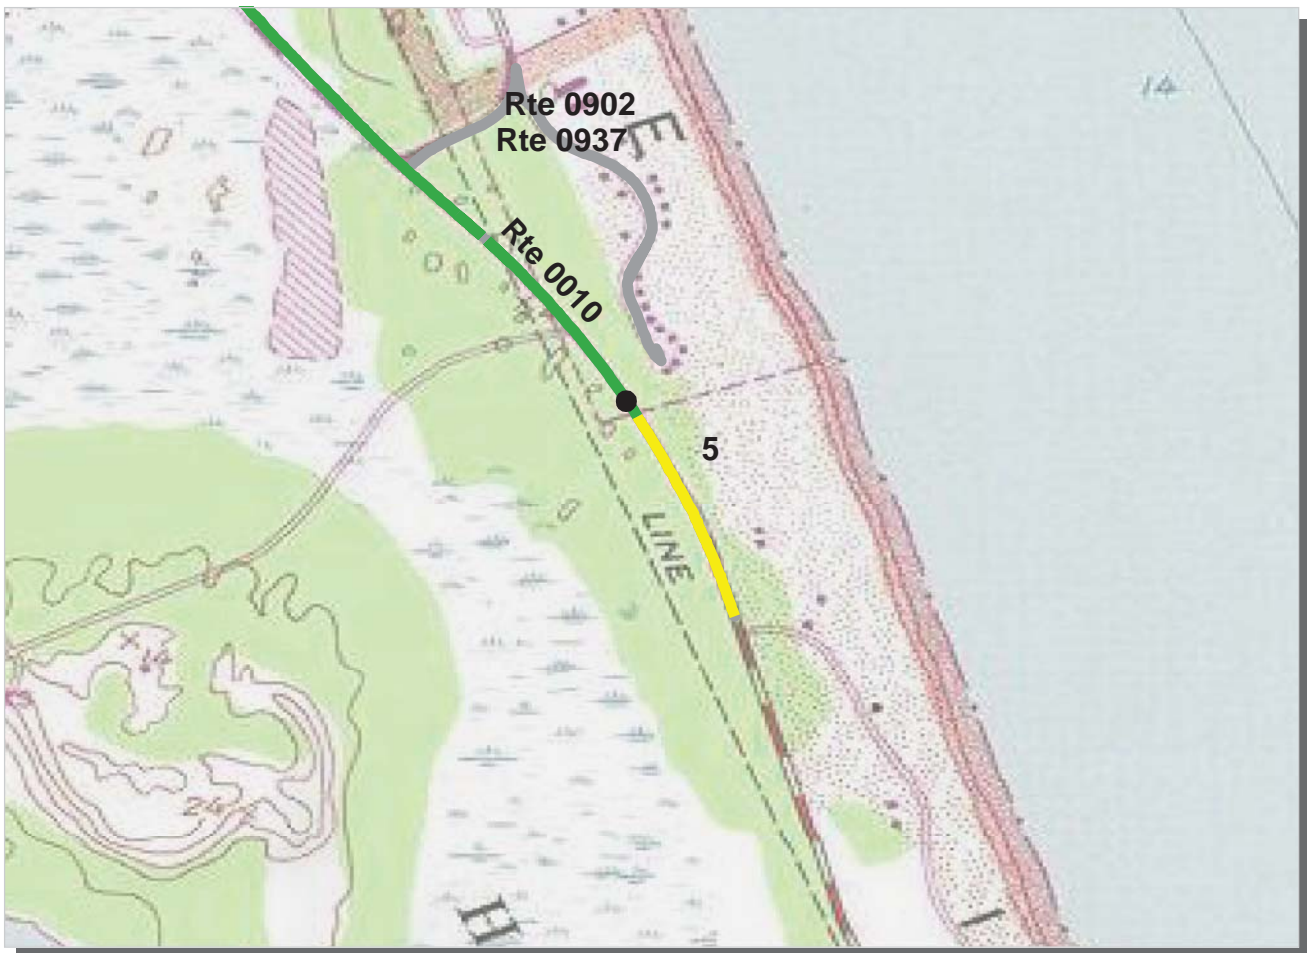
**ROUTE: 0010 Bodie Island Entrance Road** **TOTAL LENGTH: 5.28 Miles**

Section Number	5				
Section Length (mi)	0.28				
ADT	**				
SADT	**				
ADT Date	**				
<b>Cross Section Information</b>					
Number of Lanes	2				
Paved Width (ft)	22				
Lane Width (ft)	11				
Shoulder Width (ft)	2				
<b>Roadway Condition Information</b>					
PCR (Pavement Condition Rating)	82				
RCI (Roughness Condition Index)	98				
SCR (Surface Condition Rating)	72				
Alligator Cracking Index	100				
Rutting Index	74				
Patching Index	100				
Transverse Cracking Index	99				
Longitudinal Cracking Index	98				
Shoulder Condition Rating	GOOD				
Drainage Condition Rating	GOOD

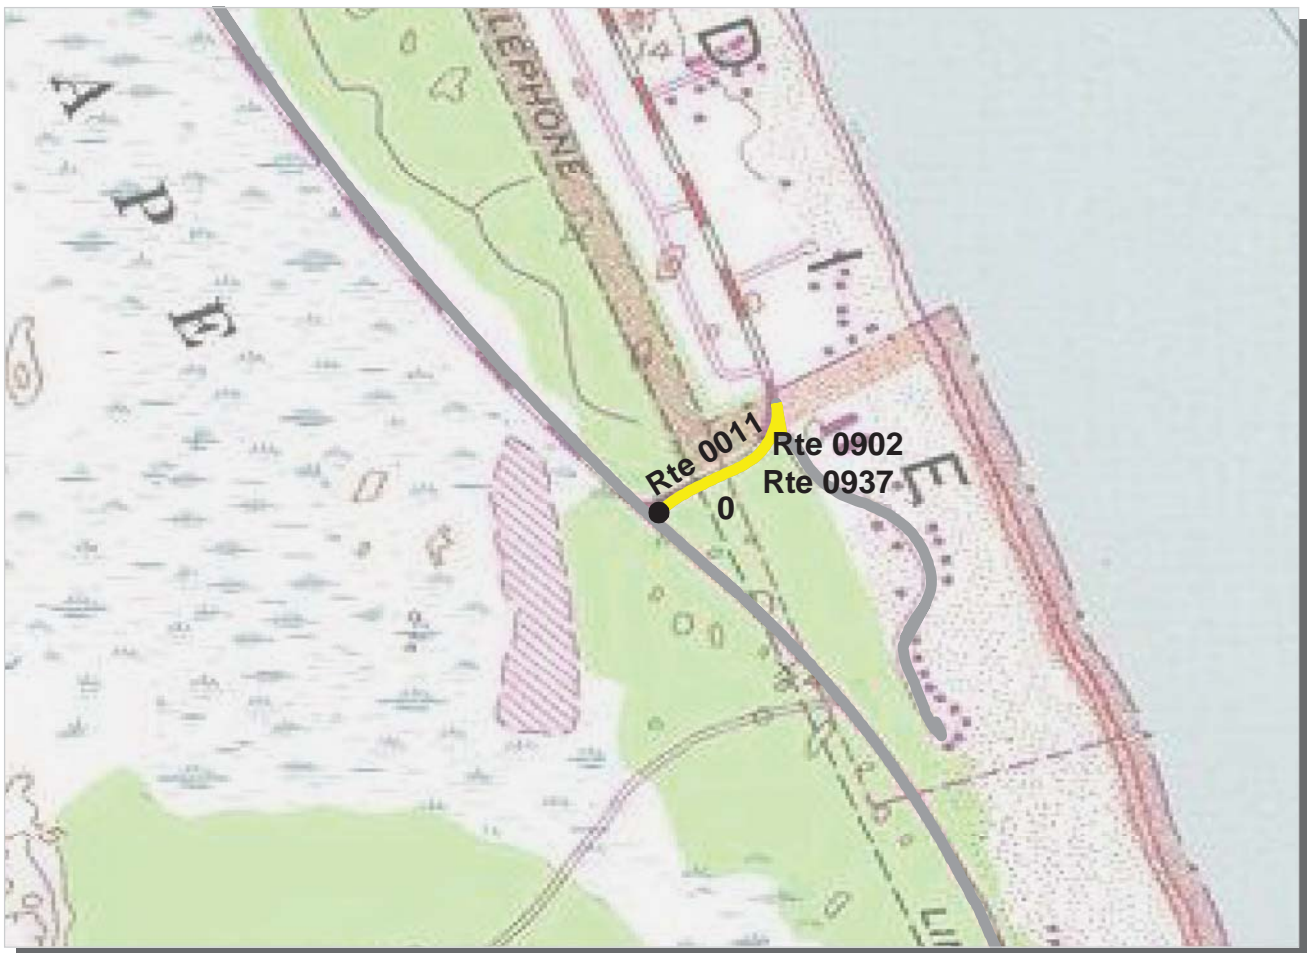
ROUTE: 0011 S. Old Oregon Inlet Road

Section Number	0				
Section Length (mi)	0.17				
AADT	**				
SADT	**				
ADT Date	**				
<b>Cross Section Information</b>					
Number of Lanes	2				
Paved Width (ft)	19				
Lane Width (ft)	10				
Shoulder Width (ft)	0				
<b>Roadway Condition Information</b>					
PCR (Pavement Condition Rating)	75				
RCI (Roughness Condition Index)	92				
SCR (Surface Condition Rating)	68				
Alligator Cracking Index	100				
Rutting Index	68				
Patching Index	100				
Transverse Cracking Index	100				
Longitudinal Cracking Index	100				
Shoulder Condition Rating	N/A				
Drainage Condition Rating	N/C

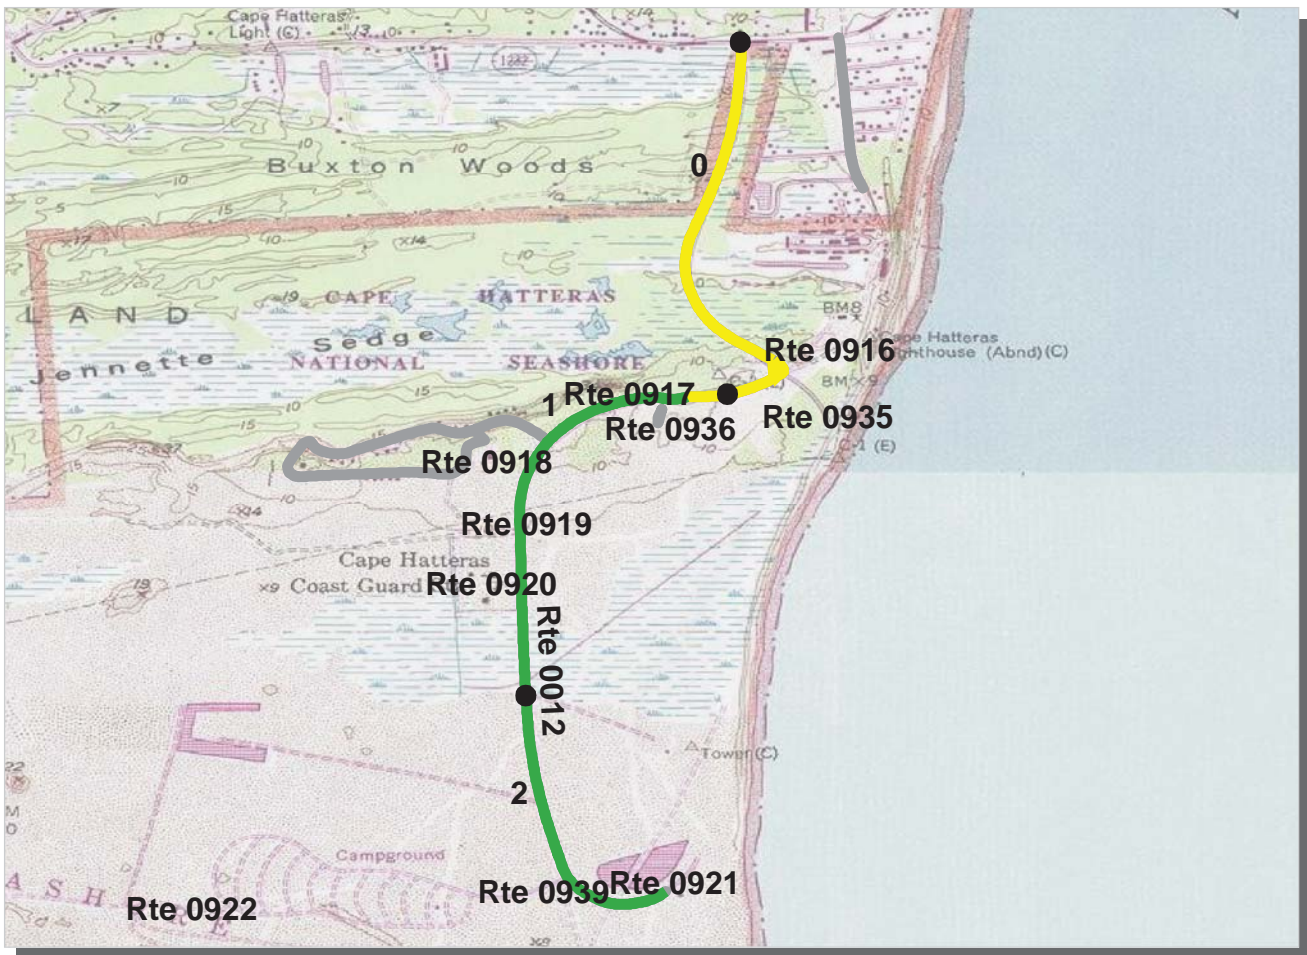
**ROUTE: 0012 Lighthouse Road** **TOTAL LENGTH: 2.67 Miles**

Section Number	0	1	2		
Section Length (mi)	1.00	1.00	0.67		
AADT	**				
SADT	**				
ADT Date	**				
<b>Cross Section Information</b>					
Number of Lanes	2	2	2		
Paved Width (ft)	21	20	20		
Lane Width (ft)	11	10	10		
Shoulder Width (ft)	2	2	2		
<b>Roadway Condition Information</b>					
PCR (Pavement Condition Rating)	79	92	85		
RCI (Roughness Condition Index)	94	99	91		
SCR (Surface Condition Rating)	71	90	83		
Alligator Cracking Index	100	100	100		
Rutting Index	82	90	83		
Patching Index	100	100	100		
Transverse Cracking Index	92	99	99		
Longitudinal Cracking Index	96	99	99		
Shoulder Condition Rating	GOOD	GOOD	GOOD		
Drainage Condition Rating	GOOD	GOOD	GOOD

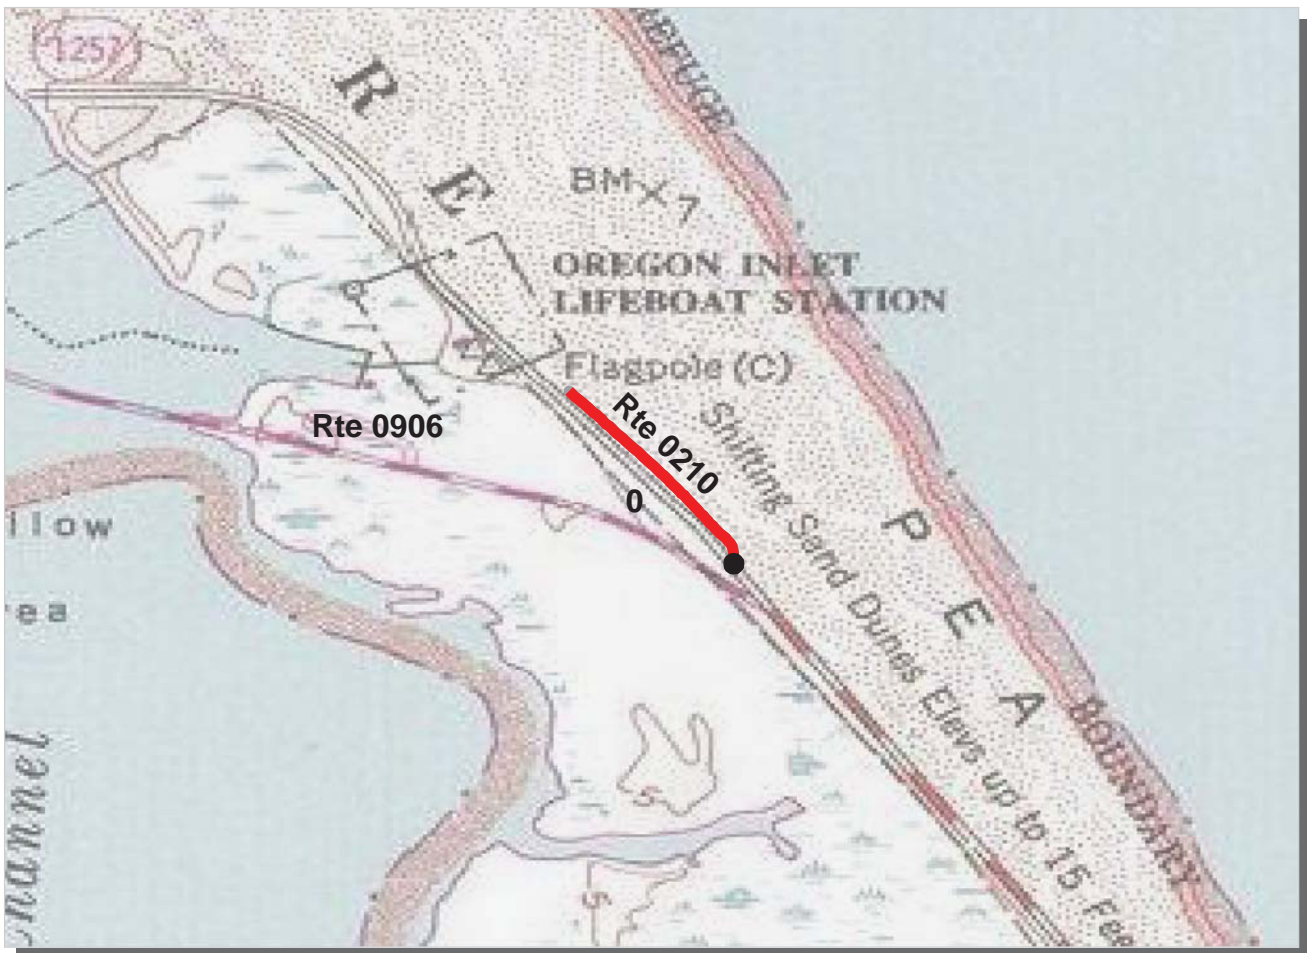
Section Number	0				
Section Length (mi)	0.23				
AADT	**				
SADT	**				
ADT Date	**				
<b>Cross Section Information</b>					
Number of Lanes	2				
Paved Width (ft)	22				
Lane Width (ft)	12				
Shoulder Width (ft)	14				
<b>Roadway Condition Information</b>					
PCR (Pavement Condition Rating)	14				
RCI (Roughness Condition Index)	53				
SCR (Surface Condition Rating)	5				
Alligator Cracking Index	93				
Rutting Index	31				
Patching Index	74				
Transverse Cracking Index	83				
Longitudinal Cracking Index	93				
Shoulder Condition Rating	POOR				
Drainage Condition Rating	POOR

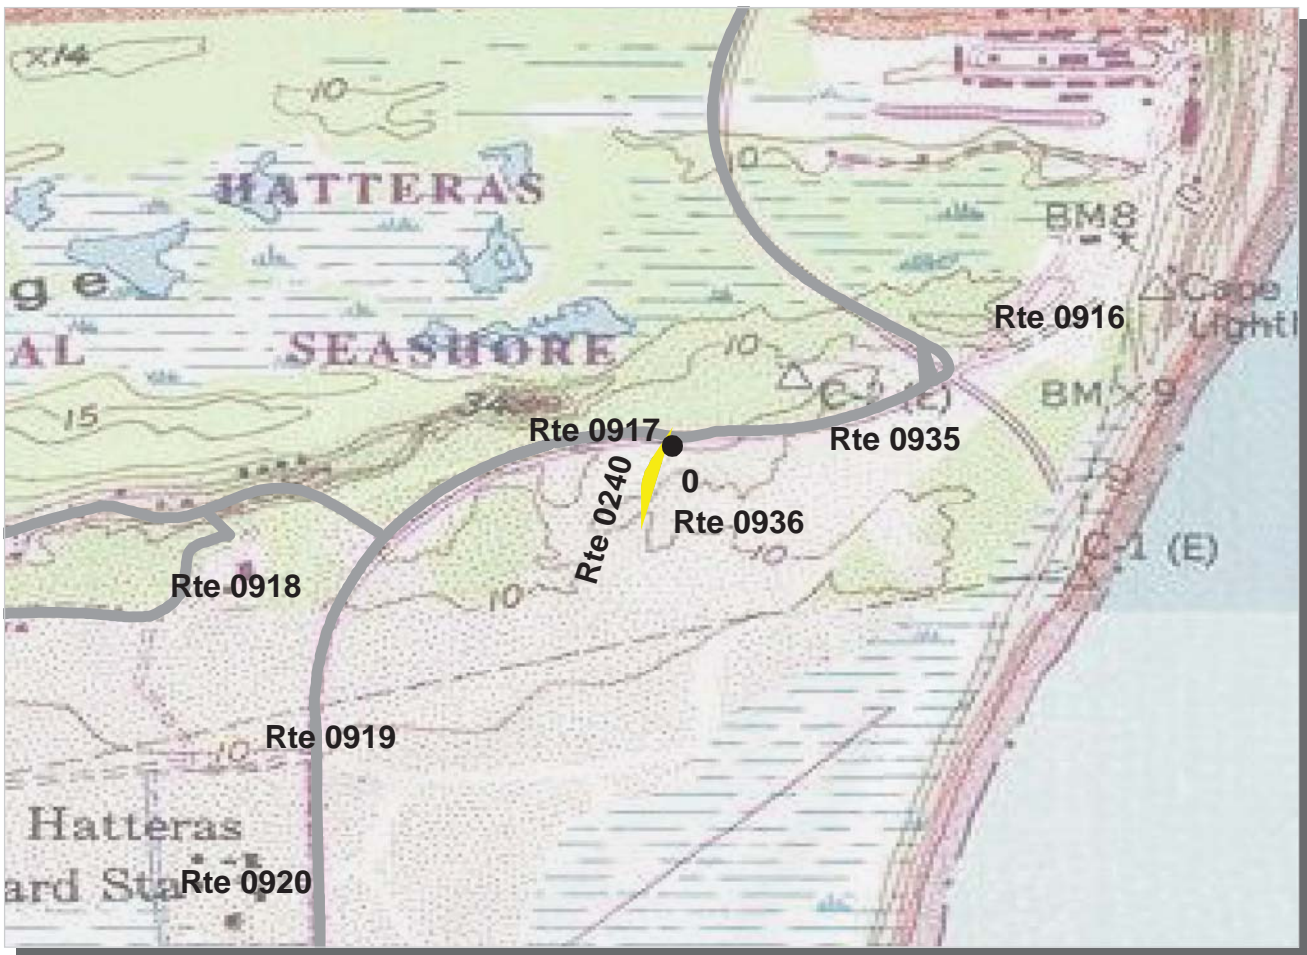
ROUTE: 0240 Lighthouse Access Road

Section Number	0				
Section Length (mi)	0.07				
AADT	**				
SADT	**				
ADT Date	**				
<b>Cross Section Information</b>					
Number of Lanes	2				
Paved Width (ft)	23				
Lane Width (ft)	11				
Shoulder Width (ft)	4				
<b>Roadway Condition Information</b>					
PCR (Pavement Condition Rating)	65				
RCI (Roughness Condition Index)	78				
SCR (Surface Condition Rating)	62				
Alligator Cracking Index	100				
Rutting Index	62				
Patching Index	100				
Transverse Cracking Index	100				
Longitudinal Cracking Index	100				
Shoulder Condition Rating	N/C				
Drainage Condition Rating	N/C

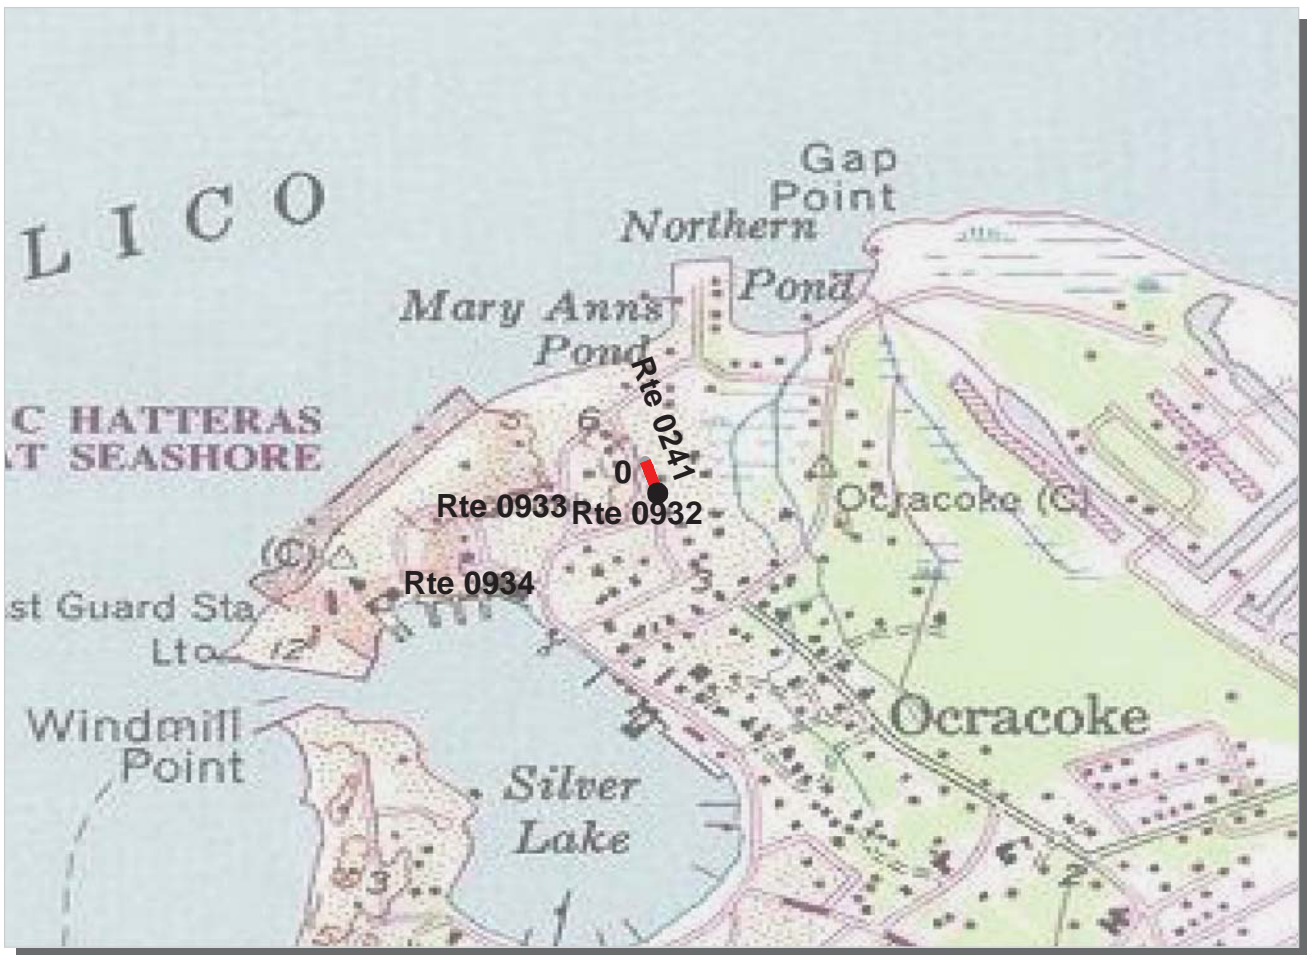
**ROUTE: 0241 Ocracoke Residence Road**

Section Number	0				
Section Length (mi)	0.08				
AADT	**				
SADT	**				
ADT Date	**				
<b>Cross Section Information</b>					
Number of Lanes	2				
Paved Width (ft)	18				
Lane Width (ft)	8				
Shoulder Width (ft)	0				
<b>Roadway Condition Information</b>					
PCR (Pavement Condition Rating)	42				
RCI (Roughness Condition Index)	NC				
SCR (Surface Condition Rating)	42				
Alligator Cracking Index	98				
Rutting Index	50				
Patching Index	99				
Transverse Cracking Index	98				
Longitudinal Cracking Index	96				
Shoulder Condition Rating	N/A				
Drainage Condition Rating	N/C

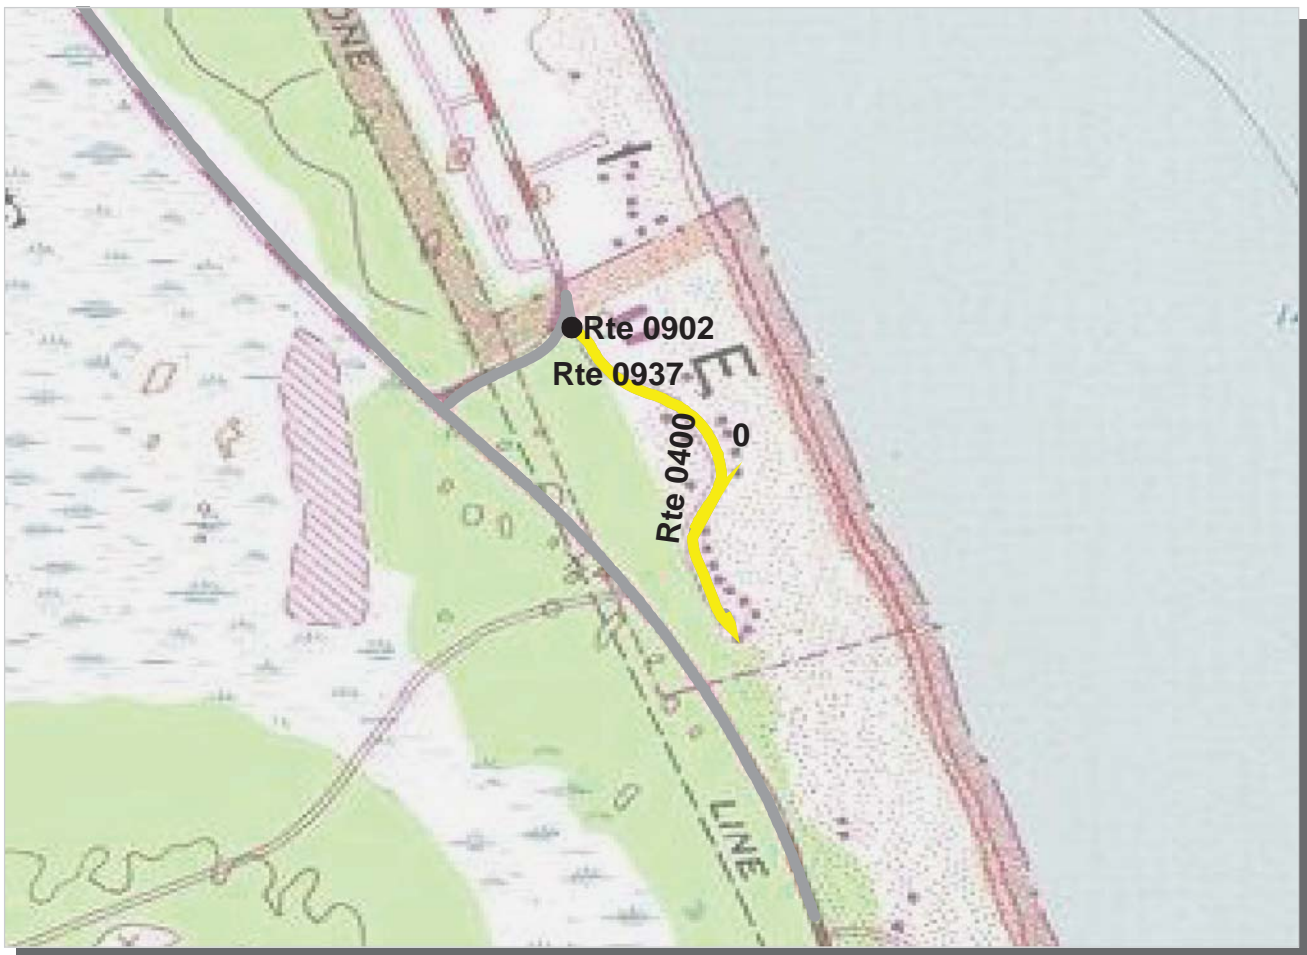
**ROUTE: 0400 Park Service Road** **TOTAL LENGTH: 0.39 Miles**

Section Number	0				
Section Length (mi)	0.39				
AADT	**				
SADT	**				
ADT Date	**				
<b>Cross Section Information</b>					
Number of Lanes	2				
Paved Width (ft)	17				
Lane Width (ft)	9				
Shoulder Width (ft)	2				
<b>Roadway Condition Information</b>					
PCR (Pavement Condition Rating)	65				
RCI (Roughness Condition Index)	68				
SCR (Surface Condition Rating)	63				
Alligator Cracking Index	100				
Rutting Index	68				
Patching Index	99				
Transverse Cracking Index	98				
Longitudinal Cracking Index	97				
Shoulder Condition Rating	GOOD				
Drainage Condition Rating	GOOD

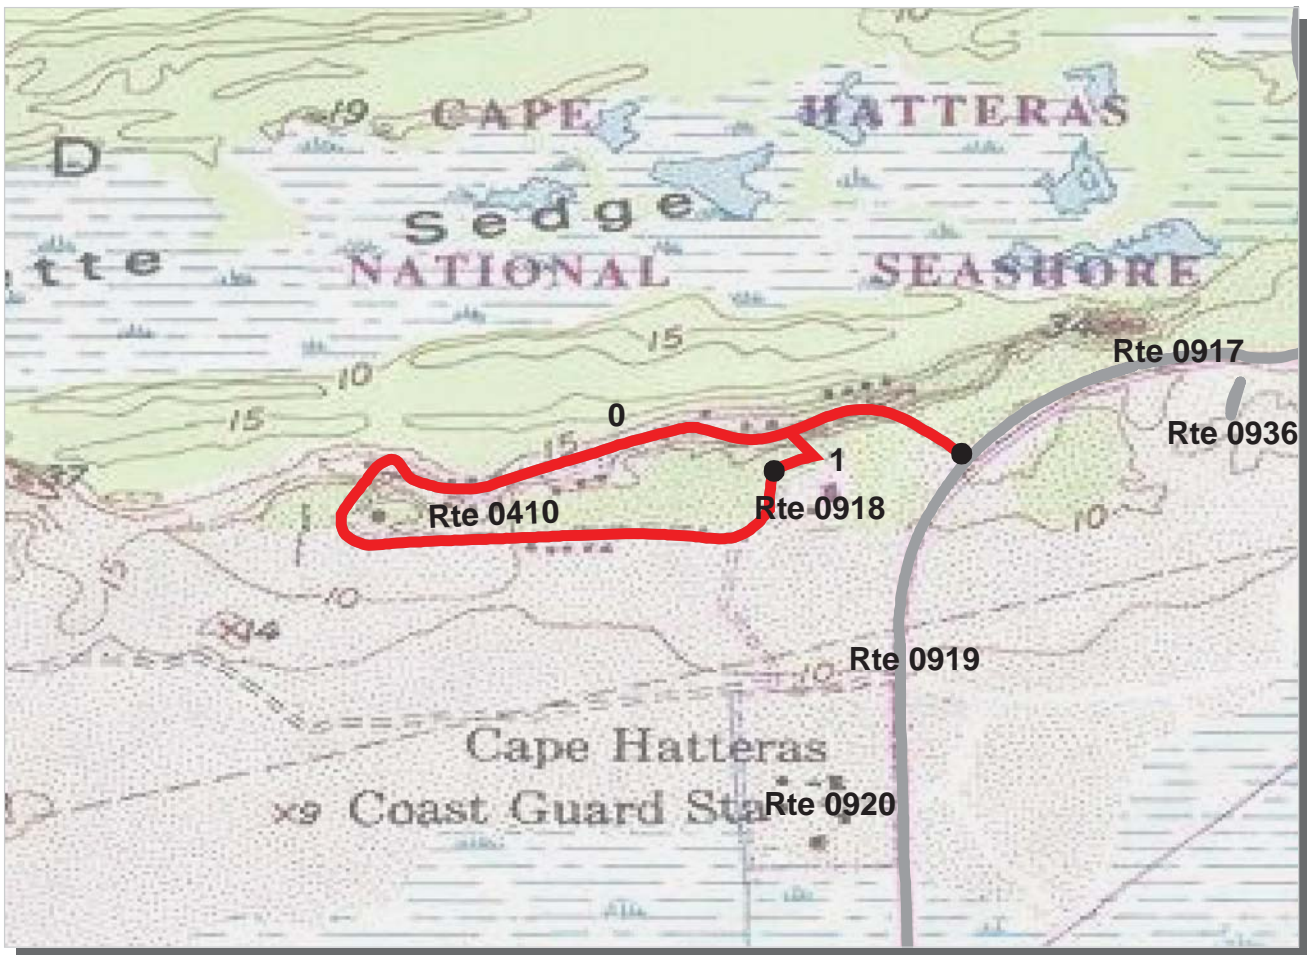
**ROUTE: 0410 Loggerhead Lane** **TOTAL LENGTH: 1.06 Miles**

Section Number	0	1			
Section Length (mi)	1.00	0.06			
AADT	**				
SADT	**				
ADT Date	**				
<b>Cross Section Information</b>					
Number of Lanes	2	1			
Paved Width (ft)	17	9			
Lane Width (ft)	8	9			
Shoulder Width (ft)	0	0			
<b>Roadway Condition Information</b>					
PCR (Pavement Condition Rating)	55	41			
RCI (Roughness Condition Index)	78	-1			
SCR (Surface Condition Rating)	48	41			
Alligator Cracking Index	99	100			
Rutting Index	50	42			
Patching Index	99	100			
Transverse Cracking Index	99	100			
Longitudinal Cracking Index	99	99			
Shoulder Condition Rating	N/A	N/A			
Drainage Condition Rating	POOR	POOR

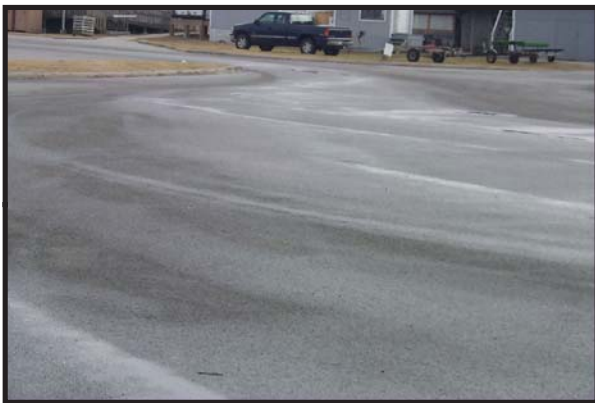
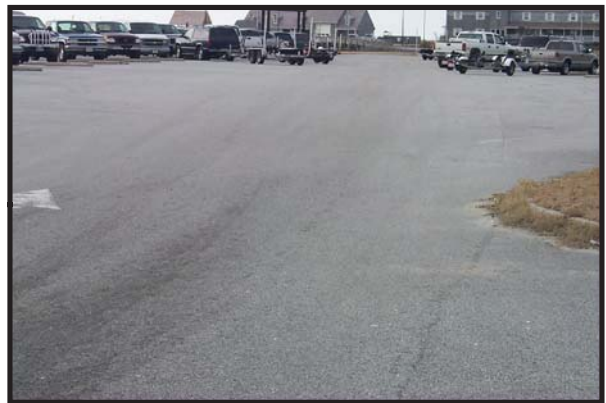
Route	Length (mi)	Width (ft)	Area (sq ft)	Lane Miles *	Condition / PCR	Surface Type
0209	1.11	0.00	129411	2.23	GOOD / 90	AS

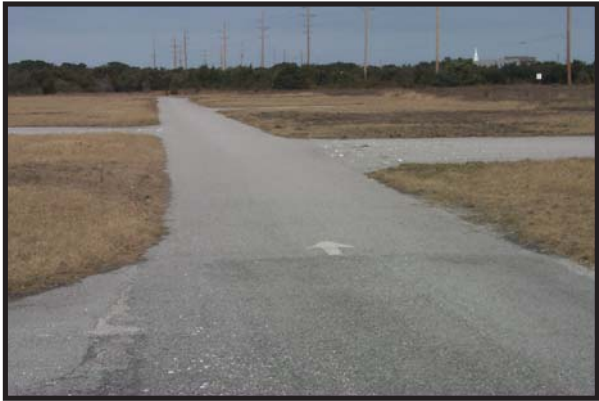
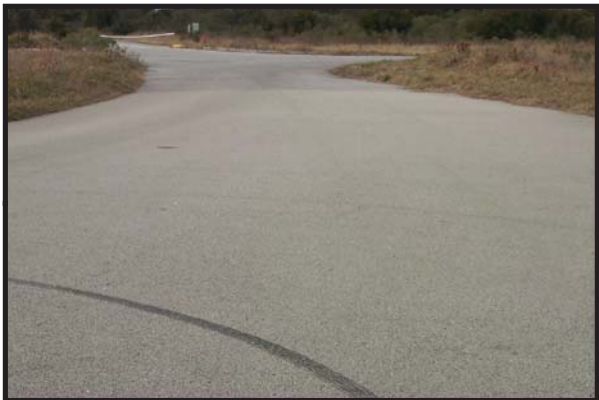
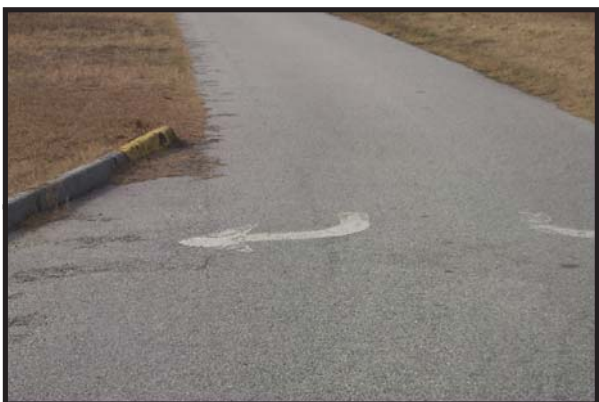
## Route 0215

Route	Length (mi)	Width (ft)	Area (sq ft)	Lane Miles *	Condition / PCR	Surface Type
0215	1.59	0.00	92575	1.59	GOOD / 90	AS

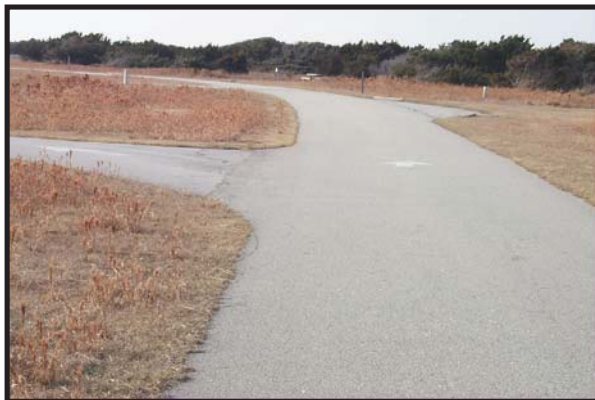
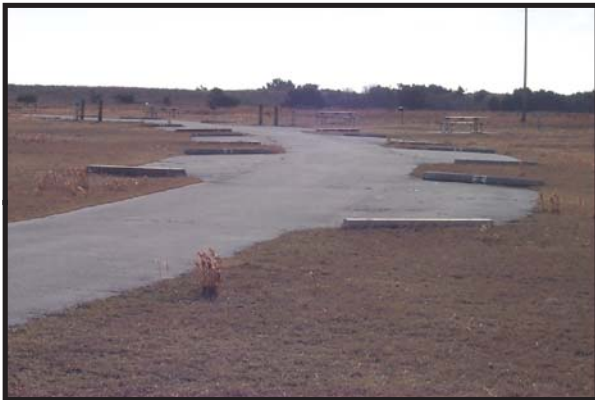
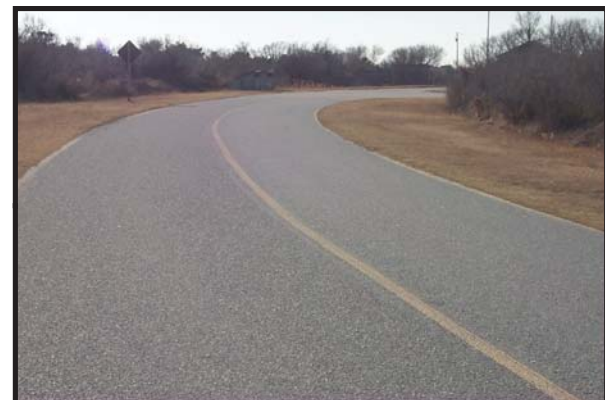
Route	Length (mi)	Width (ft)	Area (sq ft)	Lane Miles *	Condition / PCR	Surface Type
0225	5.11	0.00	297326	5.12	GOOD / 90	AS

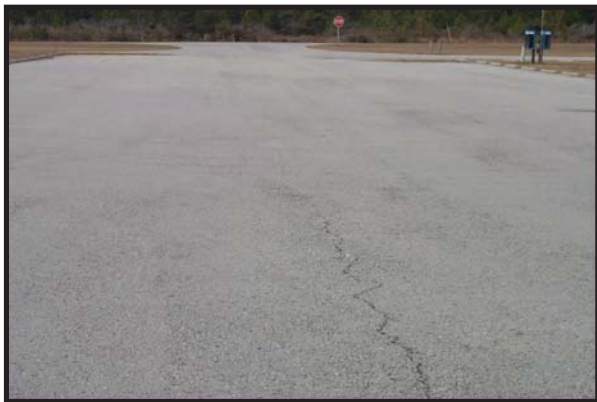
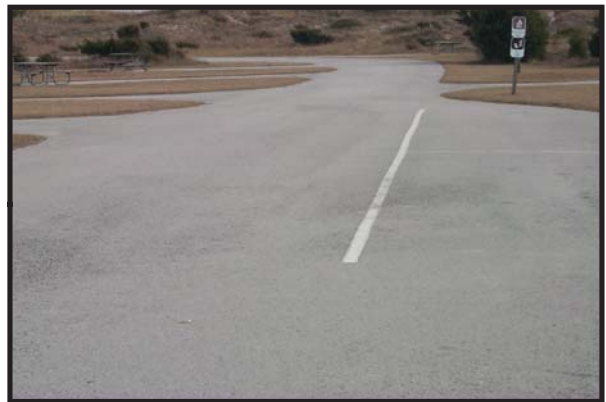
## Route 0234

Route	Length (mi)	Width (ft)	Area (sq ft)	Lane Miles *	Condition / PCR	Surface Type
0234	1.47	0.00	170406	2.93	GOOD / 90	AS

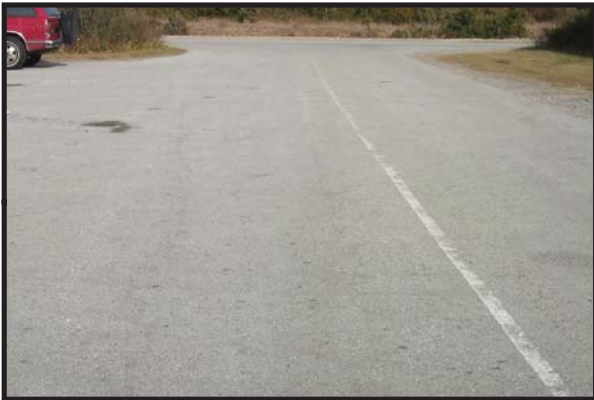
## Route 0237

Route	Length (mi)	Width (ft)	Area (sq ft)	Lane Miles *	Condition / PCR	Surface Type
0237	1.11	0.00	12400	0.21	GOOD / 90	AS

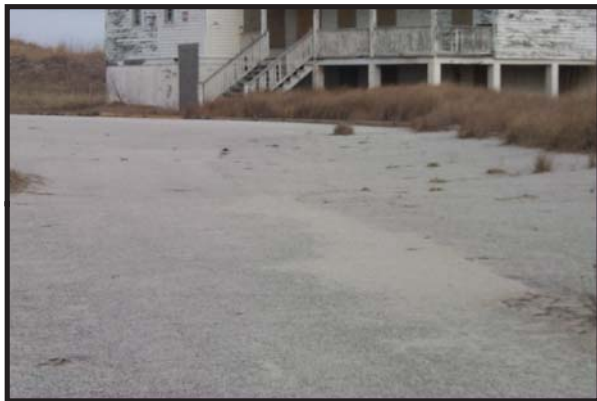
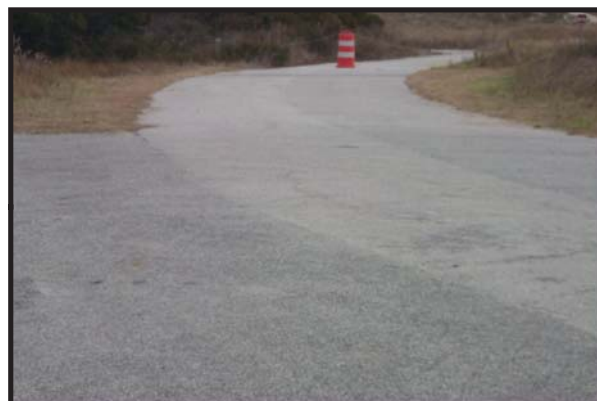
## Route 0404

Route	Length (mi)	Width (ft)	Area (sq ft)	Lane Miles *	Condition / PCR	Surface Type
0404	0.14	0.00	16807	0.29	POOR / 45	AS

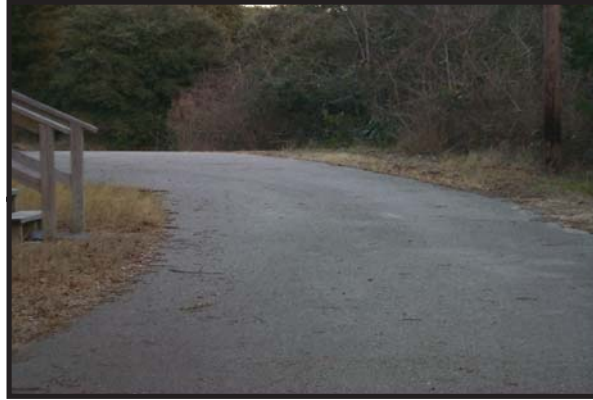
## Route 0411

Route	Length (mi)	Width (ft)	Area (sq ft)	Lane Miles *	Condition / PCR	Surface Type
0411	0.07	0.00	8173	0.14	GOOD / 90	AS

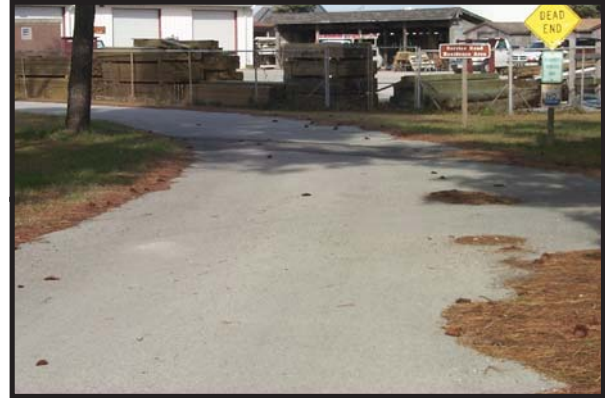
## Route 0417

Route	Length (mi)	Width (ft)	Area (sq ft)	Lane Miles *	Condition / PCR	Surface Type
0417	0.26	0.00	15334	0.26	GOOD / 90	AS

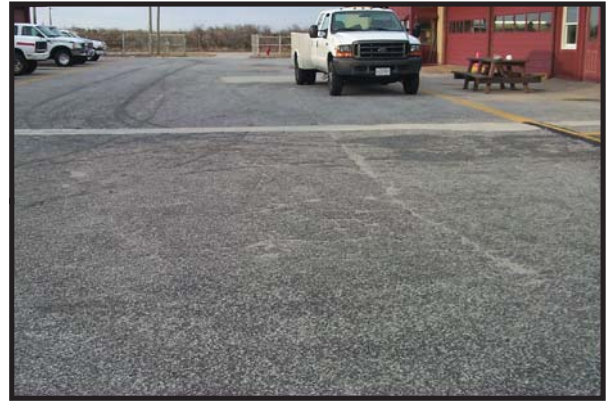
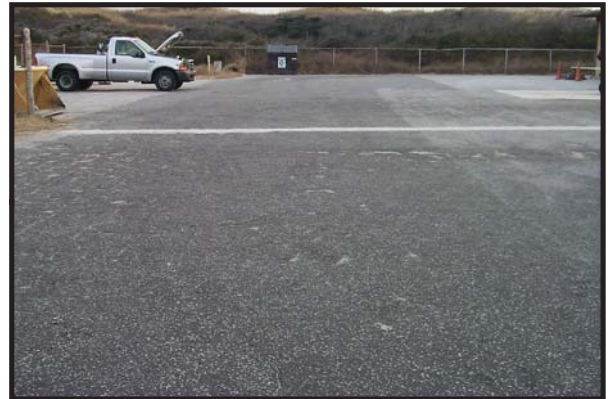
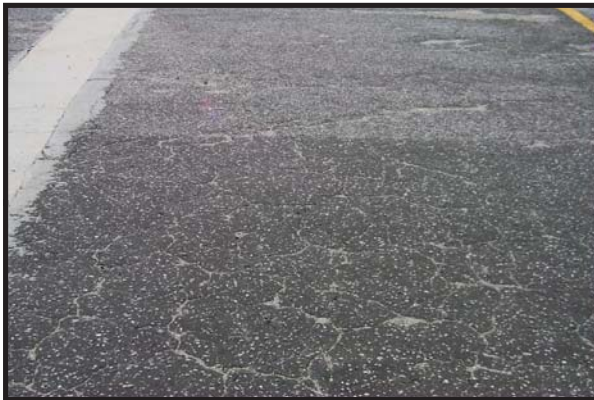
Route	Public / NonPublic	Date Visited	Area (sq ft)	Lane Miles *	Surface Type	Condition / PCR
0902	NonPublic	5/21/1999	45140	0.78	AS	FAIR / 73

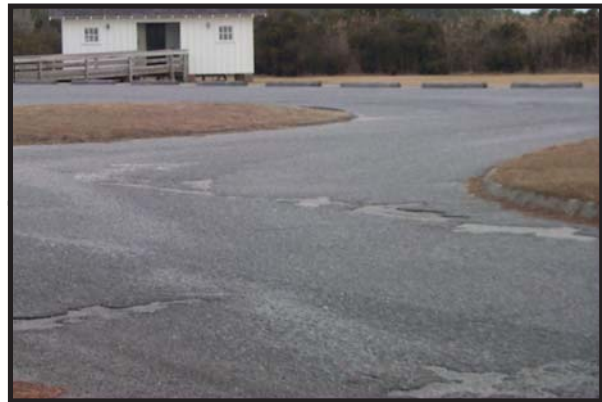
Route	Public / NonPublic	Date Visited	Area (sq ft)	Lane Miles *	Surface Type	Condition / PCR
0903B	Public	5/21/1999	11016	0.19	AS	POOR / 45

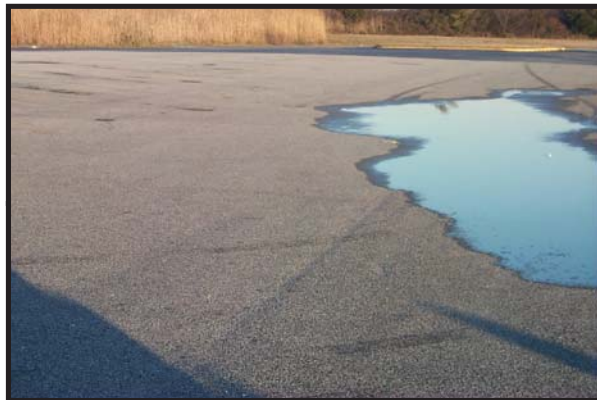
## Route 0906

Route	Public / NonPublic	Date Visited	Area (sq ft)	Lane Miles *	Surface Type	Condition / PCR
0906	Public	5/21/1999	48562	0.84	AS	FAIR / 73

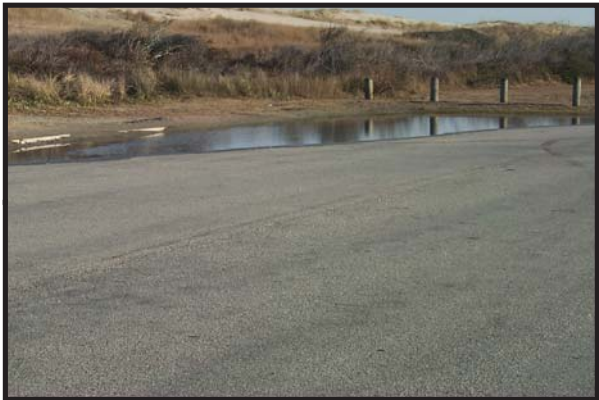
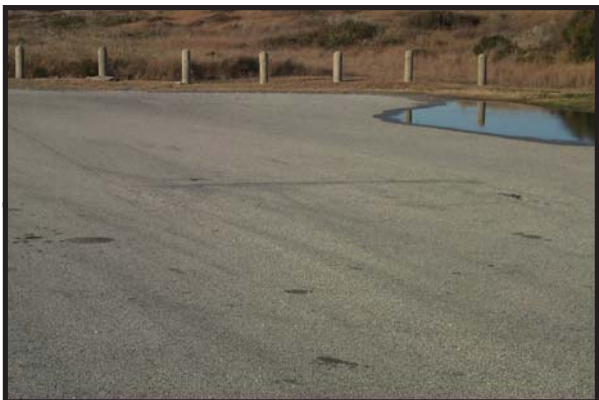
Route	Public / NonPublic	Date Visited	Area (sq ft)	Lane Miles *	Surface Type	Condition / PCR
0908	Public	5/20/1999	13066	0.22	OC	FAIR / 73

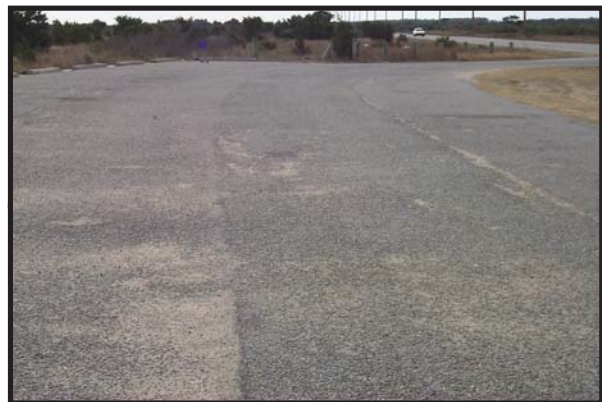
## Route 0909

Route	Public / NonPublic	Date Visited	Area (sq ft)	Lane Miles *	Surface Type	Condition / PCR
0909	Public	5/20/1999	10012	0.17	AS	FAIR / 73

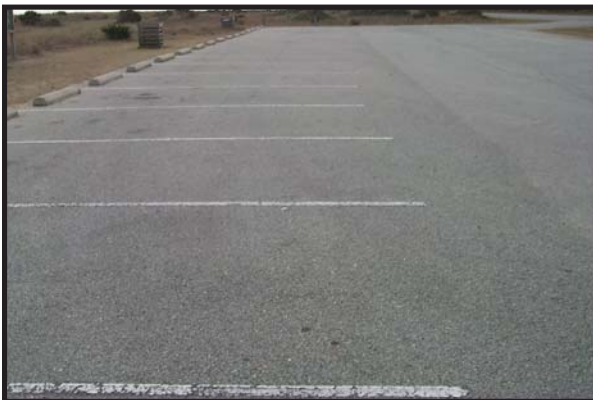
## Route 0910

Route	Public / NonPublic	Date Visited	Area (sq ft)	Lane Miles *	Surface Type	Condition / PCR
0910	Public	5/20/1999	14964	0.26	AS	GOOD / 90

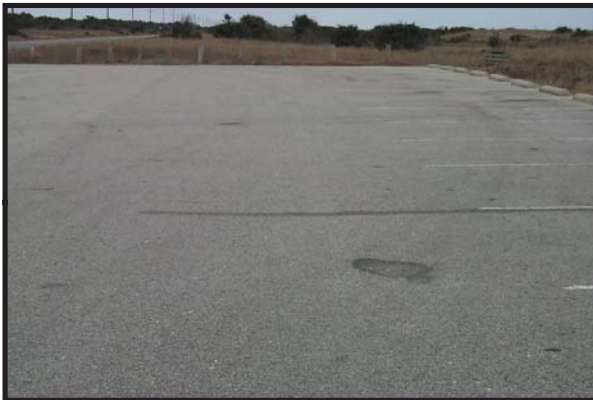
## Route 0911

Route	Public / NonPublic	Date Visited	Area (sq ft)	Lane Miles *	Surface Type	Condition / PCR
0911	Public	5/20/1999	13936	0.24	AS	GOOD / 90

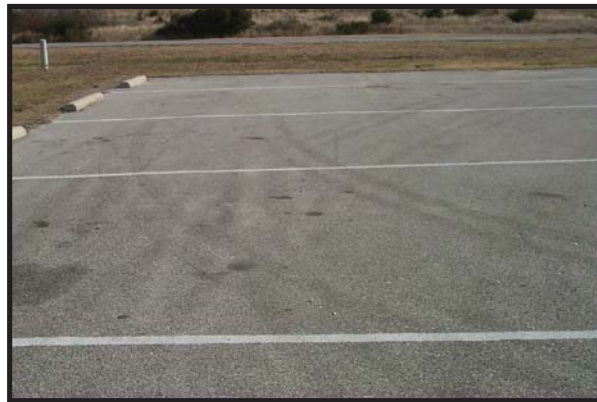
## Route 0939

Route	Public / NonPublic	Date Visited	Area (sq ft)	Lane Miles *	Surface Type	Condition / PCR
0939	Public	1/17/2002	5772	0.10	AS	GOOD / 90

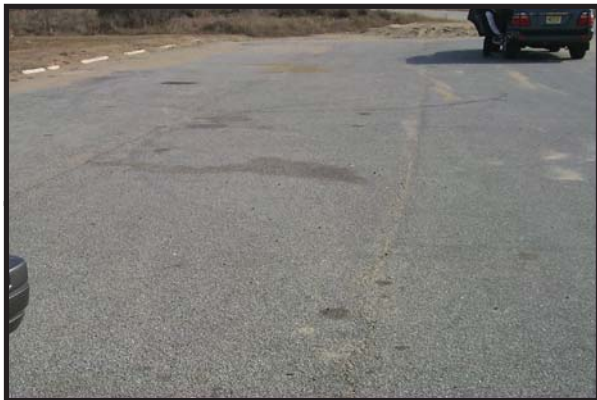
## Route 0940

Route	Public / NonPublic	Date Visited	Area (sq ft)	Lane Miles *	Surface Type	Condition / PCR
0940	Public	1/17/2002	8723	0.15	AS	FAIR / 73

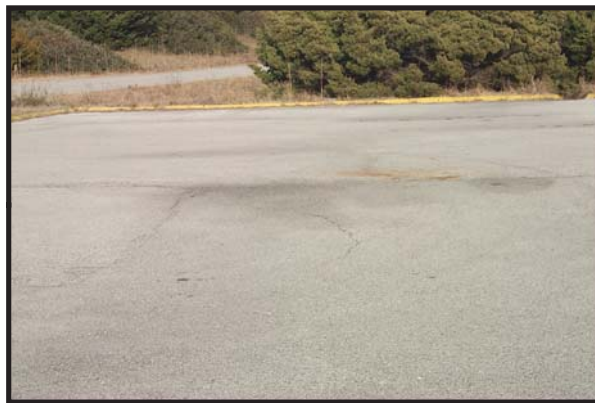
## Route 0941

Route	Public / NonPublic	Date Visited	Area (sq ft)	Lane Miles *	Surface Type	Condition / PCR
0941	Public	1/17/2002	1808	0.03	AS	GOOD / 90

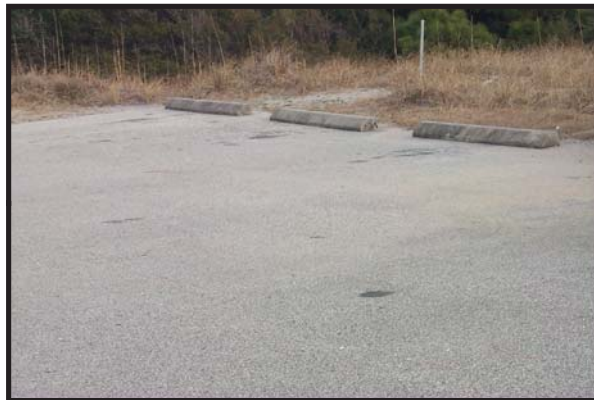
## Route 0942

Route	Public / NonPublic	Date Visited	Area (sq ft)	Lane Miles *	Surface Type	Condition / PCR
0942	Public	1/17/2002	1349	0.02	AS	GOOD / 90
