The Road Inventory of Cape Lookout National Seashore CALO – 5210

Road Inventory Program

Prepared By:
Federal Highway Administration
Eastern Federal Lands Highway Division
Cycle 3

Cape Lookout National Seashore in North Carolina

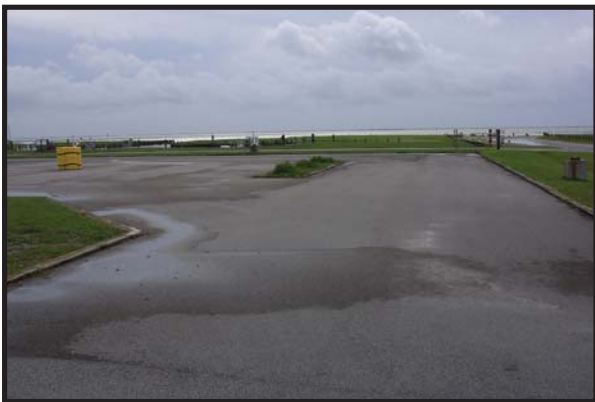
Route	Public / NonPublic	Date Visited	Area (sq ft)	Lane Miles *	Surface Type	Condition / PCR
0900	Public	8/13/2004	40629	0.70	AS	GOOD / 90

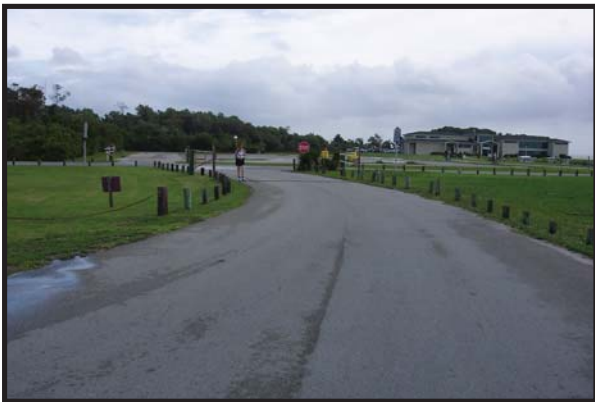
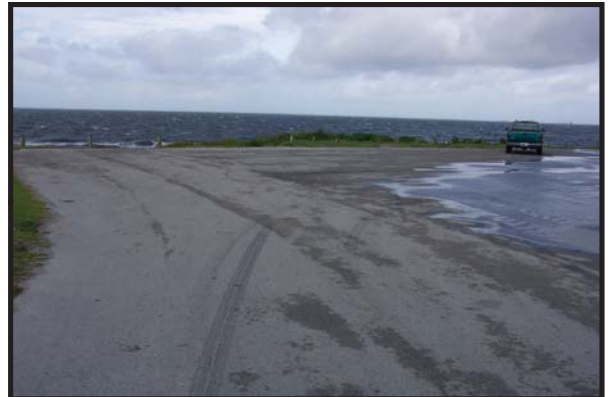
Route 0901

Route	Public / NonPublic	Date Visited	Area (sq ft)	Lane Miles *	Surface Type	Condition / PCR
0901	Public	8/13/2004	21042	0.36	AS	FAIR / 73

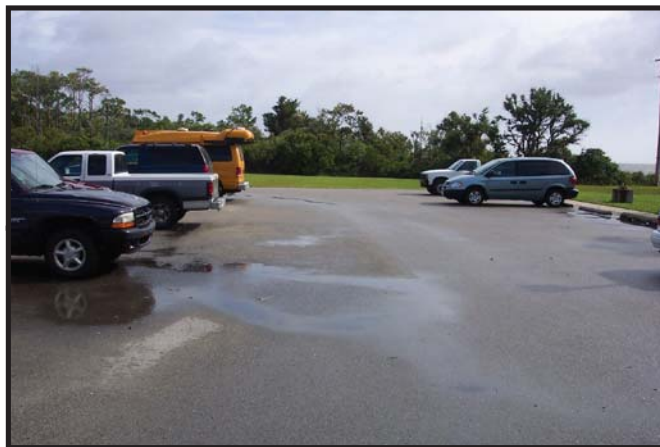
Route 0902

Route	Public / NonPublic	Date Visited	Area (sq ft)	Lane Miles *	Surface Type	Condition / PCR
0902	NonPublic	8/13/2004	7629	0.13	AS	GOOD / 90

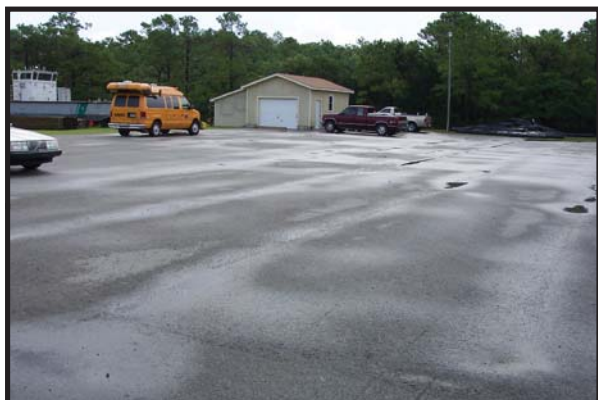
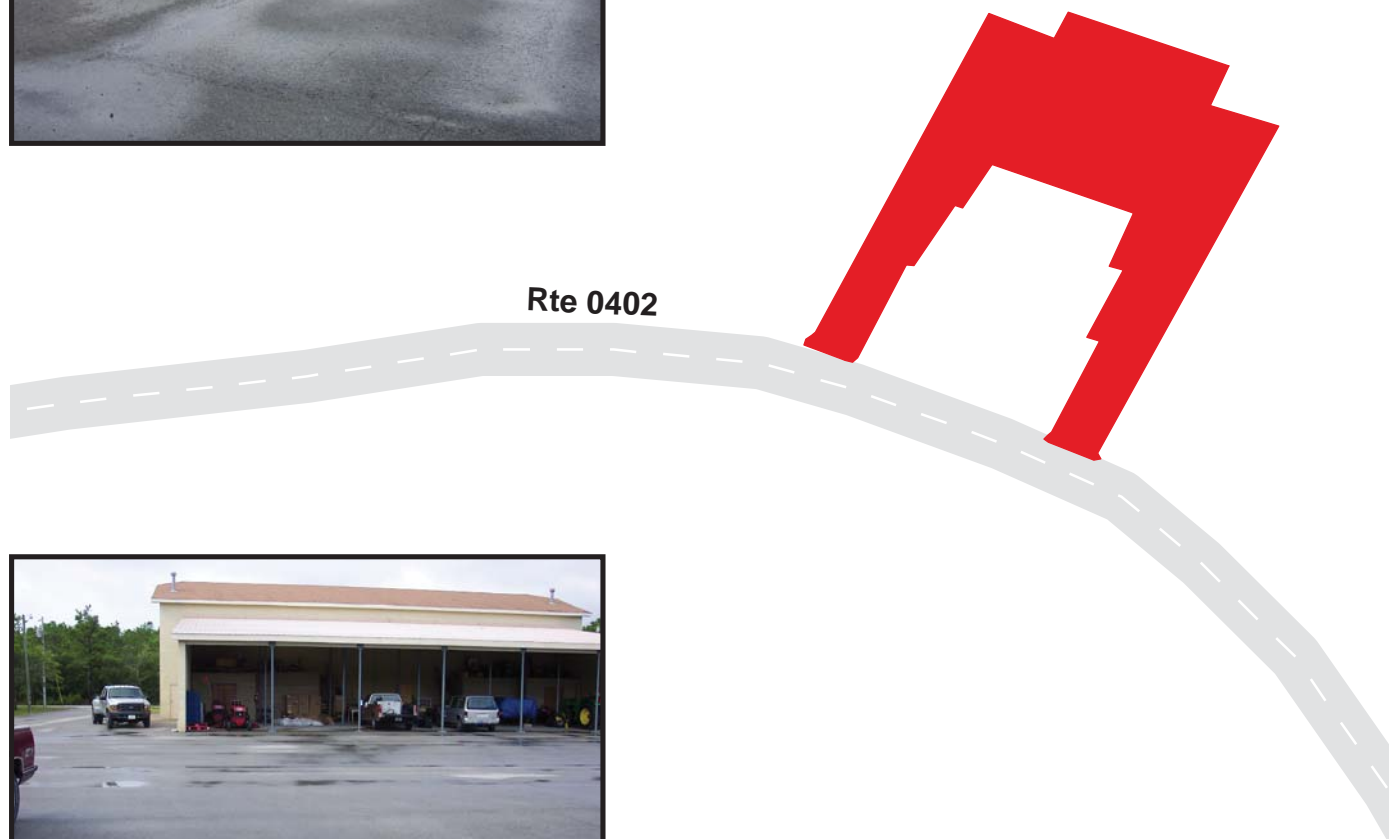
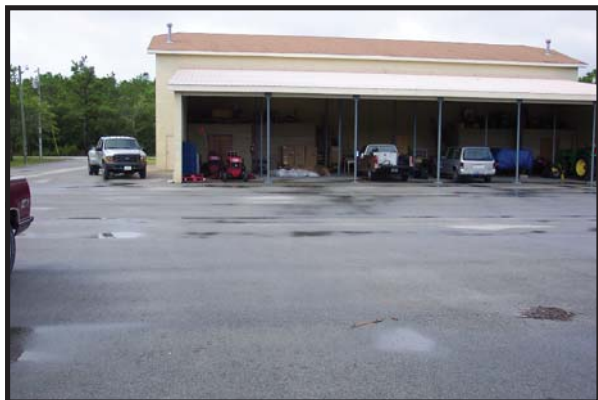
Route 0903

Route	Public / NonPublic	Date Visited	Area (sq ft)	Lane Miles *	Surface Type	Condition / PCR
0903	NonPublic	8/13/2004	25196	0.43	AS	GOOD / 90
