# The Road Inventory of Canaveral National Seashore CANA - 5180

## Road Inventory Program

Prepared By:  
Federal Highway Administration  
Eastern Federal Lands Highway Division  
Cycle 3

# Canaveral National Seashore in Florida

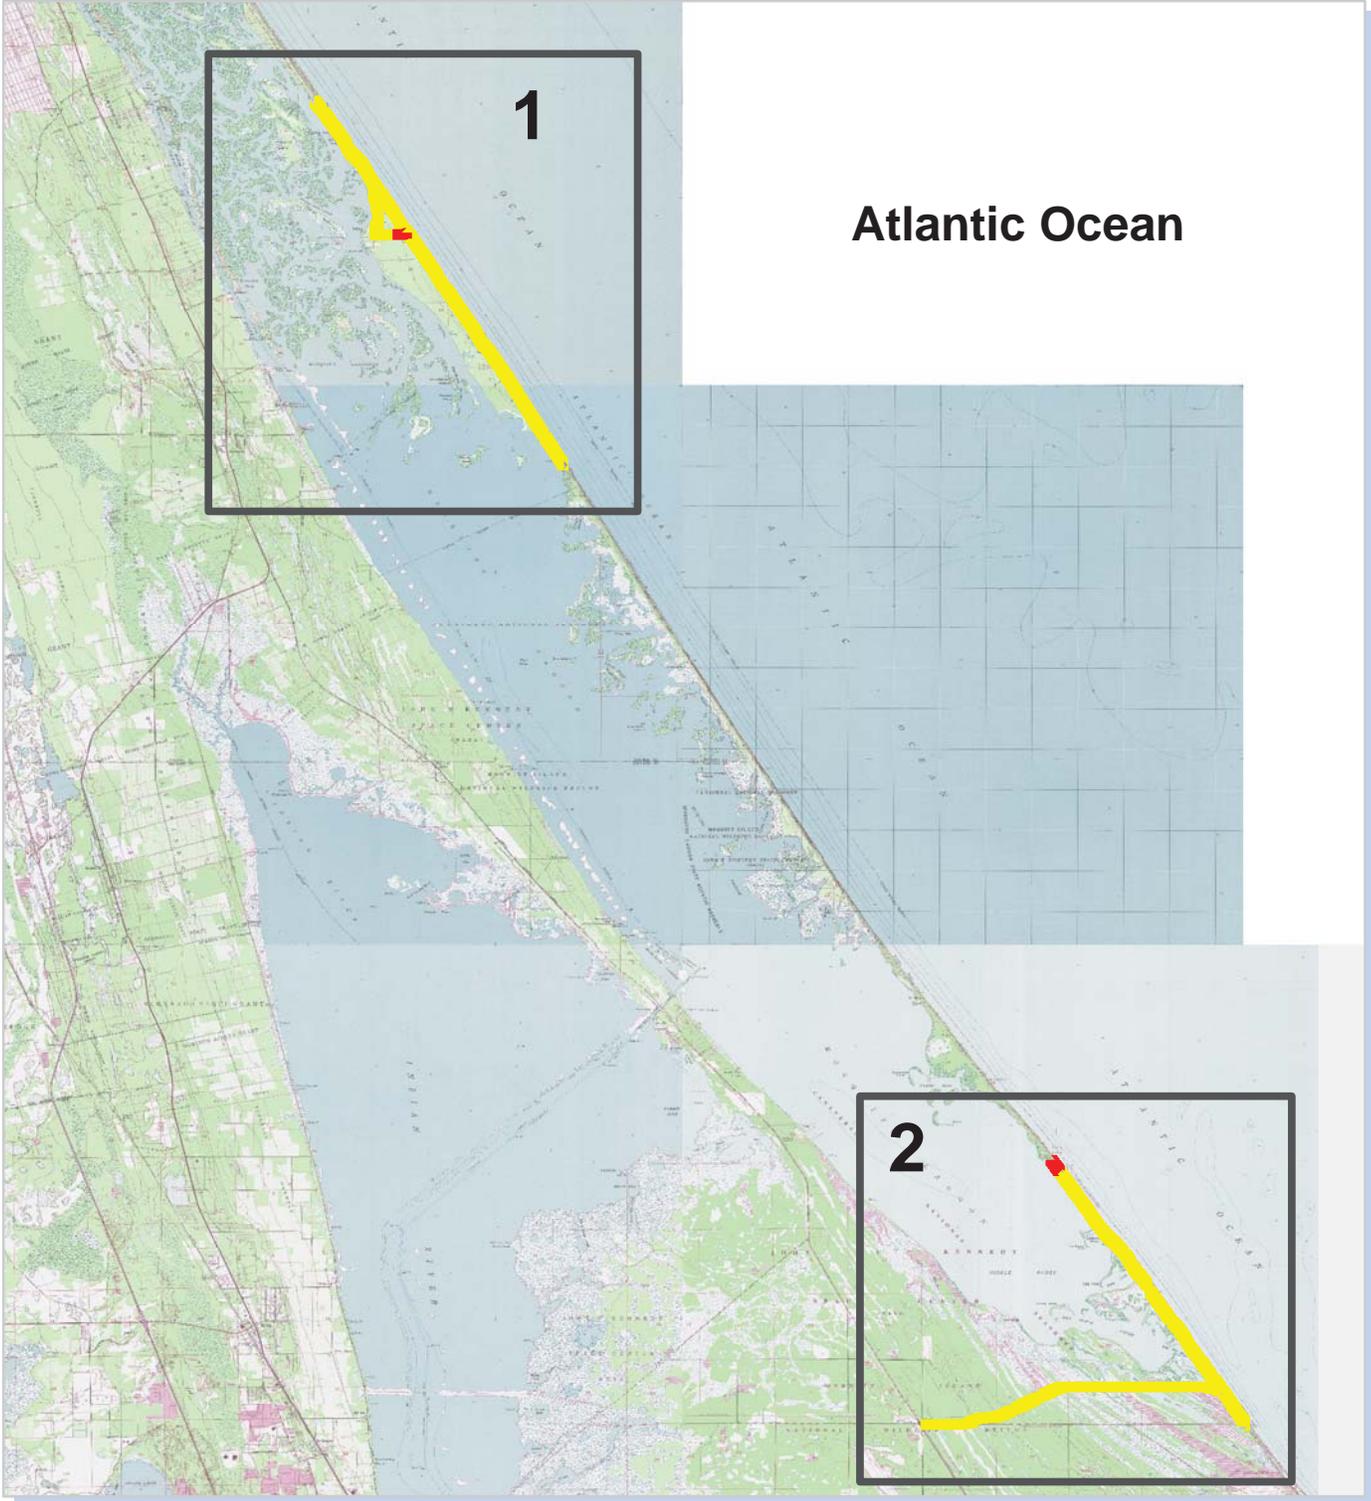
# Canaveral National Seashore Route Condition Key Map PCR - Mile by Mile

PCR	Poor	<span style="display: inline-block; width: 20px; height: 10px; background-color: red; border: 1px solid black;"></span>	Fair	<span style="display: inline-block; width: 20px; height: 10px; background-color: yellow; border: 1px solid black;"></span>	Good	<span style="display: inline-block; width: 20px; height: 10px; background-color: green; border: 1px solid black;"></span>	Excellent	<span style="display: inline-block; width: 20px; height: 10px; background-color: blue; border: 1px solid black;"></span>
	(<=60)		(61 - 84)		(85 - 94)		(95 - 100)

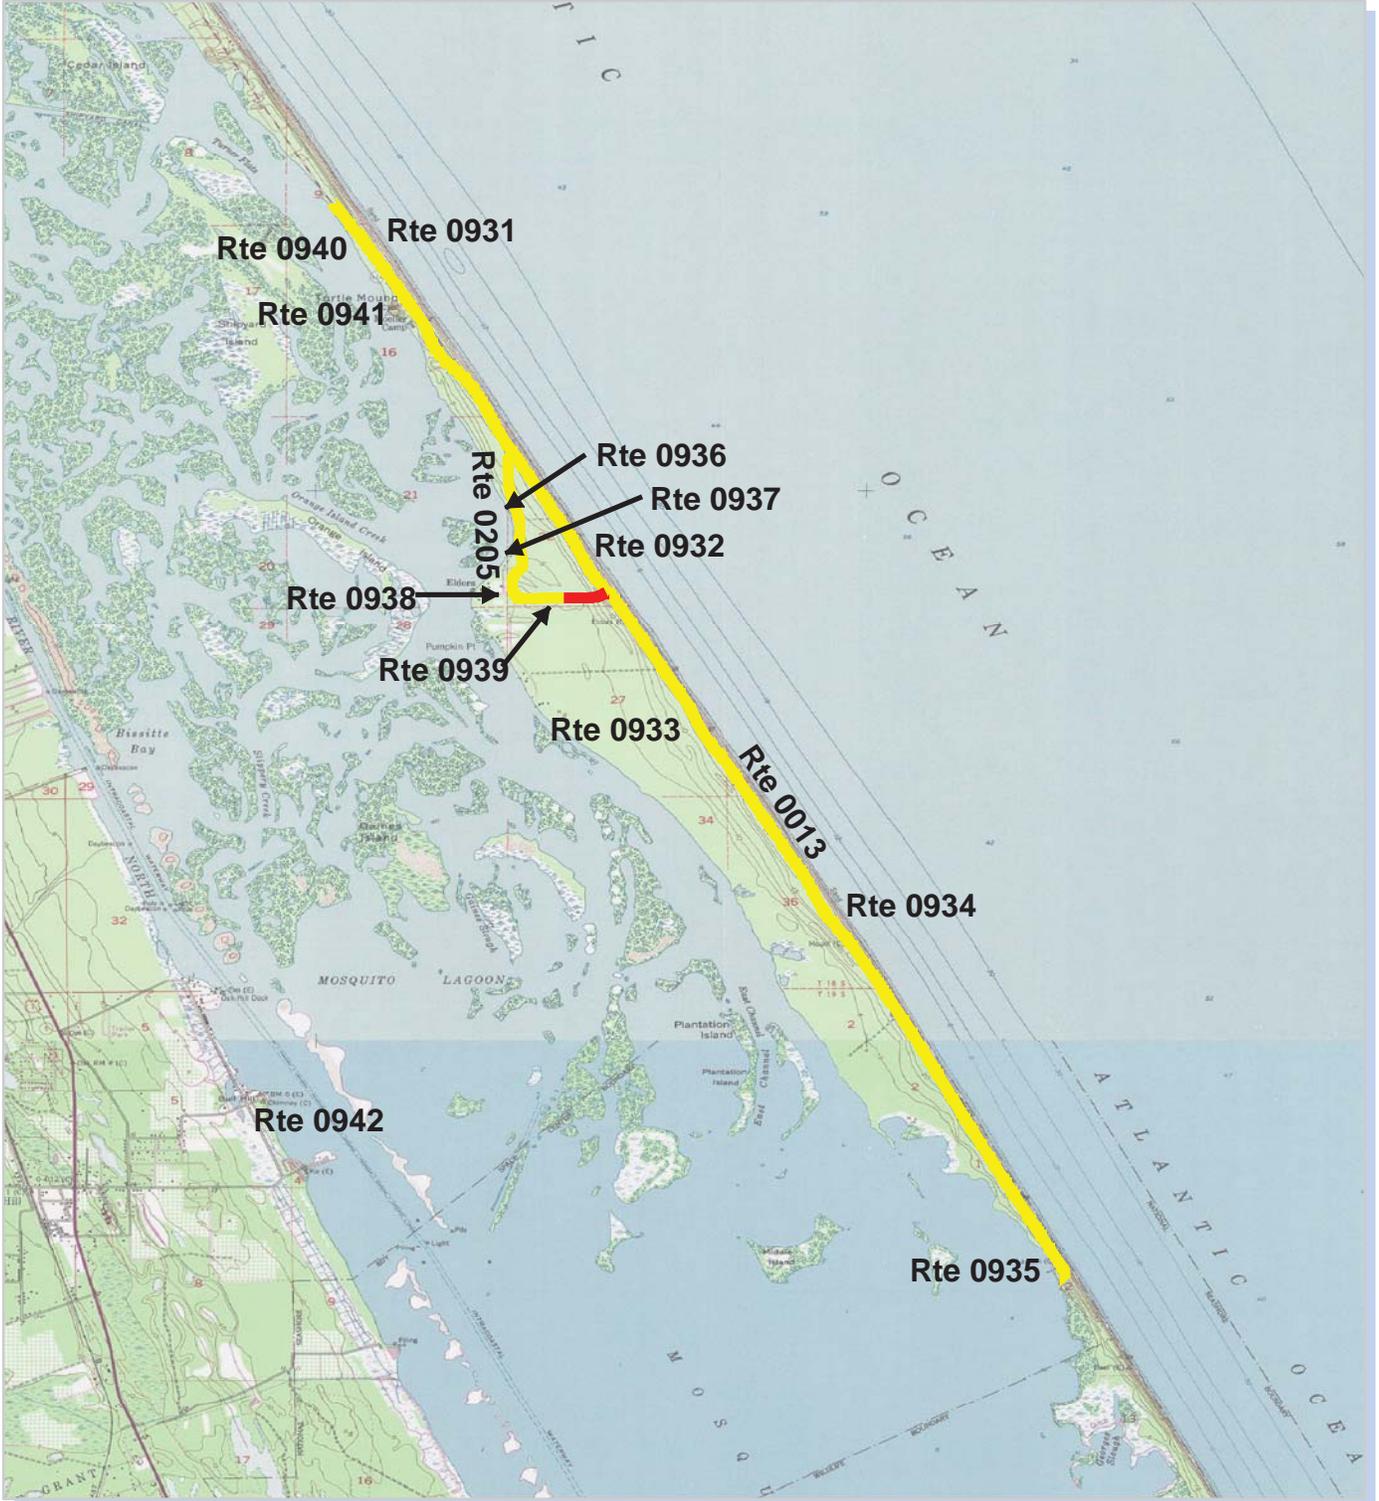
# Canaveral National Seashore Route Condition Area Map 1 PCR - Mile by Mile

PCR	Poor	Fair	Good	Excellent
	(≤60)	(61 - 84)	(85 - 94)	(95 - 100)

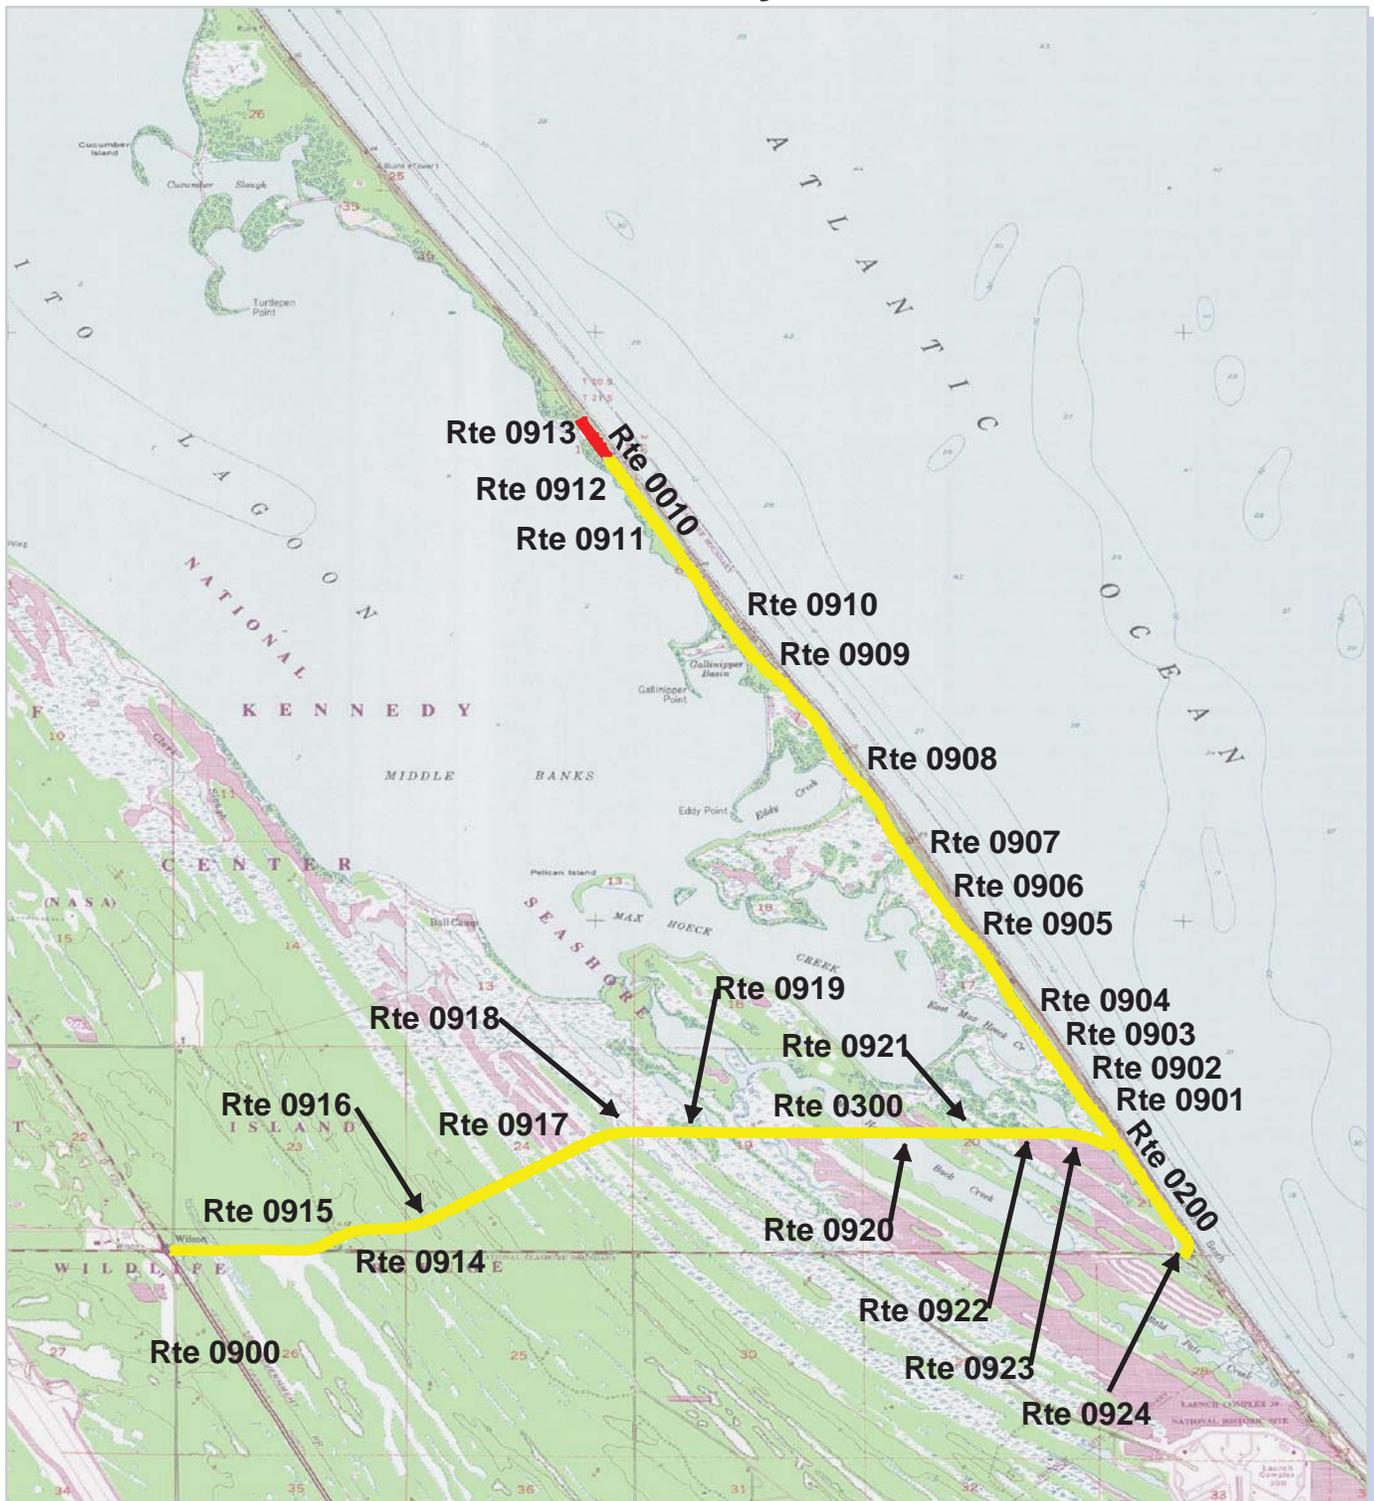
# Canaveral National Seashore Route Condition Area Map 2 PCR - Mile by Mile

PCR	Poor	Fair	Good	Excellent
	( $\leq 60$ )	(61 - 84)	(85 - 94)	(95 - 100)

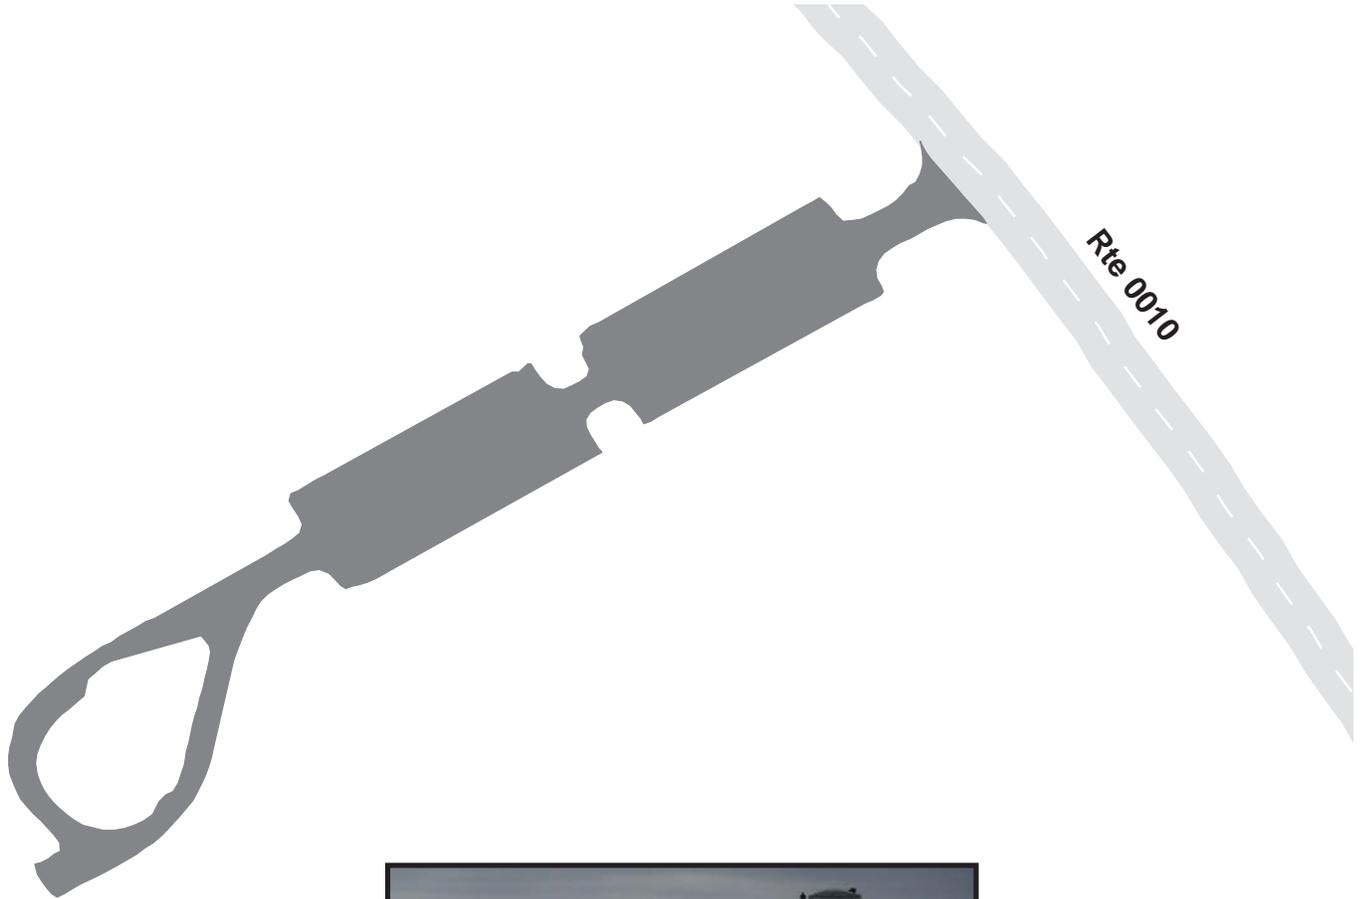
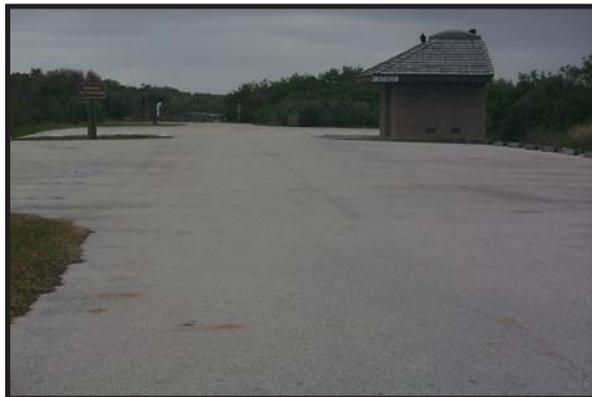
**Canaveral National Seashore**  
**Route 0900**

Route	Public / NonPublic	Date Visited	Area (sq ft)	Lane Miles *	Surface Type	Condition / PCR
0900	Public	2/7/2002	3810	0.07	AS	GOOD / 90

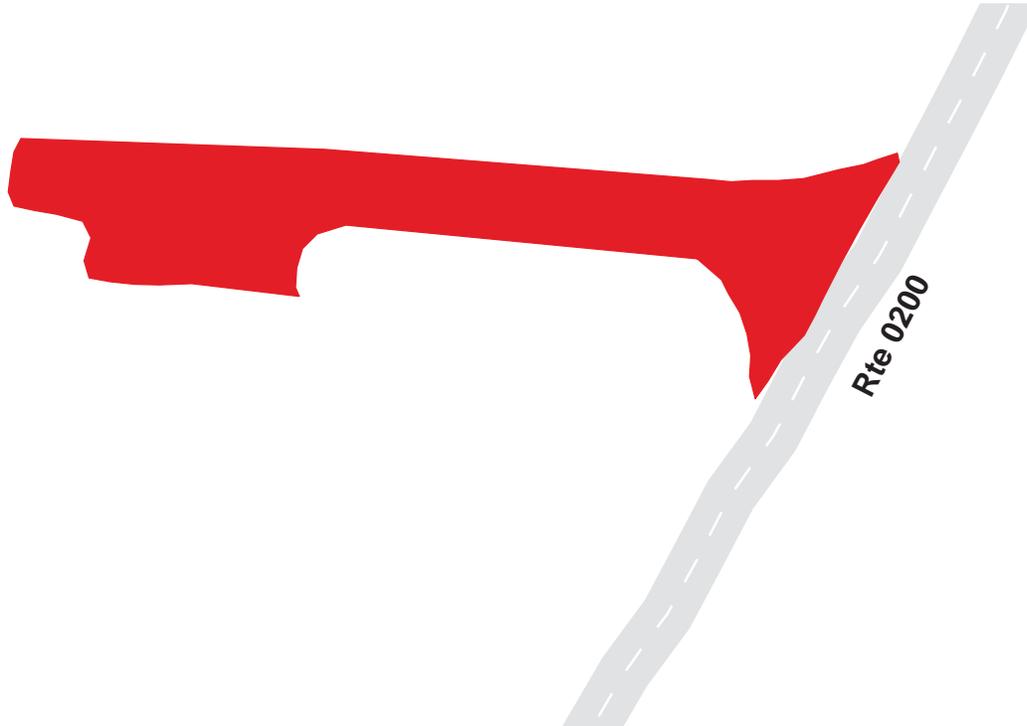
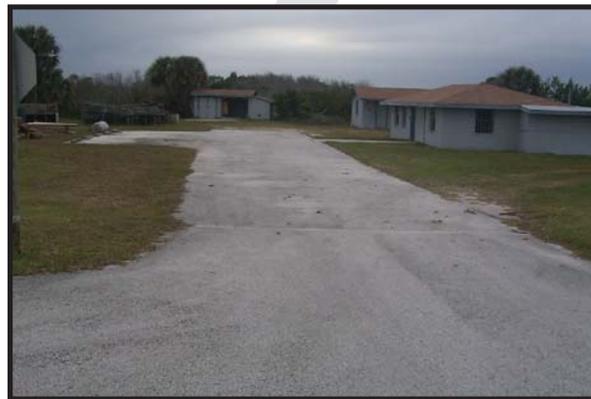
**Canaveral National Seashore**  
**Route 0931**  
 Parking #1  
 Adjacent to Route 0013 at MP 0.1 on Left

Route	Public / NonPublic	Date Visited	Area (sq ft)	Lane Miles *	Surface Type	Condition / PCR
0931	Public	2/7/2002	49533	0.85	AS	FAIR / 73
