# The Road Inventory of Canyonlands National Park CANY - 1340

Prepared By:  
Federal Highway Administration  
Eastern Federal Lands Highway Division  
Cycle 3

# Canyonlands National Park in Utah

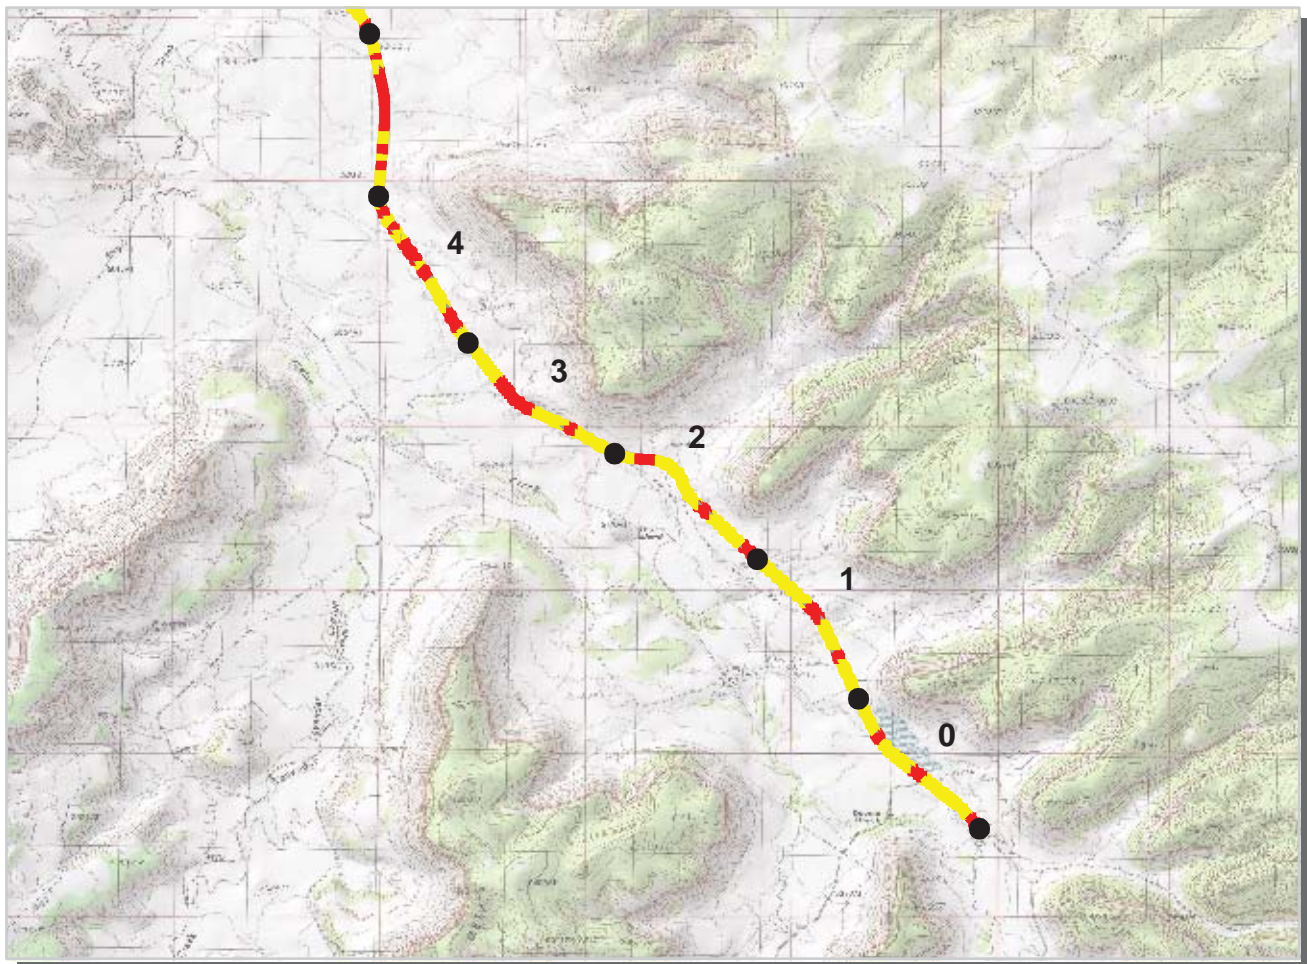
**ROUTE: 0010 Needles Access Road** **TOTAL LENGTH: 21.76 Miles**

Section Number	0	1	2	3	4
Section Length (mi)	1.00	1.00	1.00	1.00	1.00
AADT	**				
SADT	**				
ADT Date	**				
<b>Cross Section Information</b>					
Number of Lanes	2	2	2	2	2
Paved Width (ft)	21	21	22	21	21
Lane Width (ft)	10	10	11	10	11
Shoulder Width (ft)	0	2	3	4	4
<b>Roadway Condition Information</b>					
PCR (Pavement Condition Rating)	63	65	60	66	61
RCI (Roughness Condition Index)	93	86	80	88	86
SCR (Surface Condition Rating)	44	51	46	51	45
Alligator Cracking Index	100	99	100	100	100
Rutting Index	54	55	49	53	47
Patching Index	100	100	100	100	100
Transverse Cracking Index	92	97	97	98	97
Longitudinal Cracking Index	97	99	99	99	99
Shoulder Condition Rating	N/A	GOOD	GOOD	GOOD	GOOD
Drainage Condition Rating	GOOD	GOOD	GOOD	GOOD	GOOD

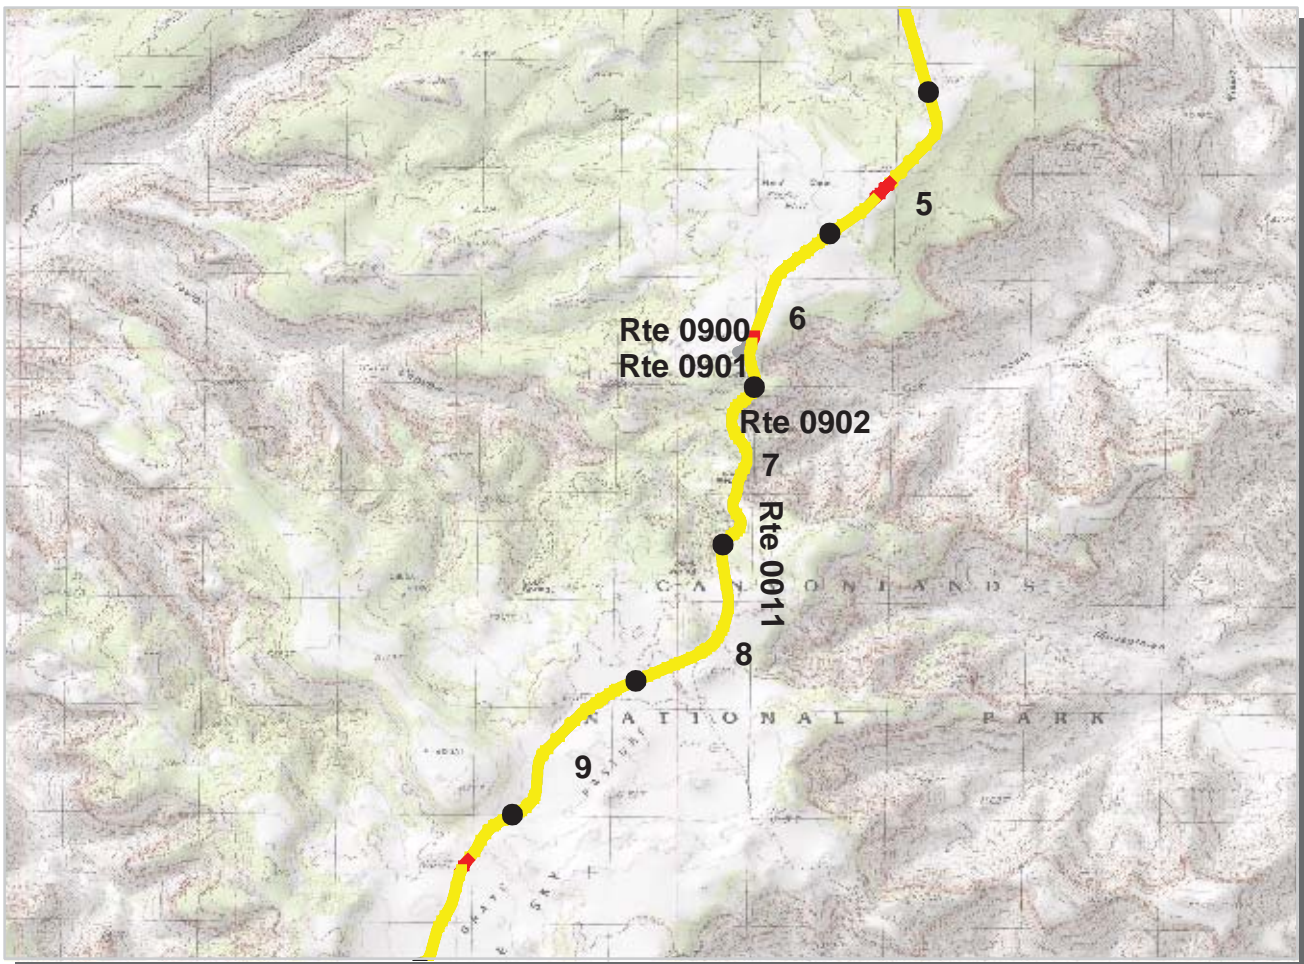
**ROUTE: 0011 Island In The Sky Road** **TOTAL LENGTH: 18.82 Miles**

Section Number	5	6	7	8	9
Section Length (mi)	1.00	1.00	1.00	1.00	1.00
AADT	**				
SADT	**				
ADT Date	**				
<b>Cross Section Information</b>					
Number of Lanes	2	2	2	2	2
Paved Width (ft)	22	22	23	22	22
Lane Width (ft)	12	12	13	11	10
Shoulder Width (ft)	0	5	5	6	6
<b>Roadway Condition Information</b>					
PCR (Pavement Condition Rating)	66	69	70	70	68
RCI (Roughness Condition Index)	99	99	99	99	100
SCR (Surface Condition Rating)	49	49	50	50	47
Alligator Cracking Index	99	100	100	100	100
Rutting Index	52	53	55	50	48
Patching Index	99	100	100	100	100
Transverse Cracking Index	98	98	98	99	99
Longitudinal Cracking Index	98	97	97	99	99
Shoulder Condition Rating	N/A	GOOD	GOOD	GOOD	GOOD
Drainage Condition Rating	GOOD	GOOD	GOOD	GOOD	GOOD

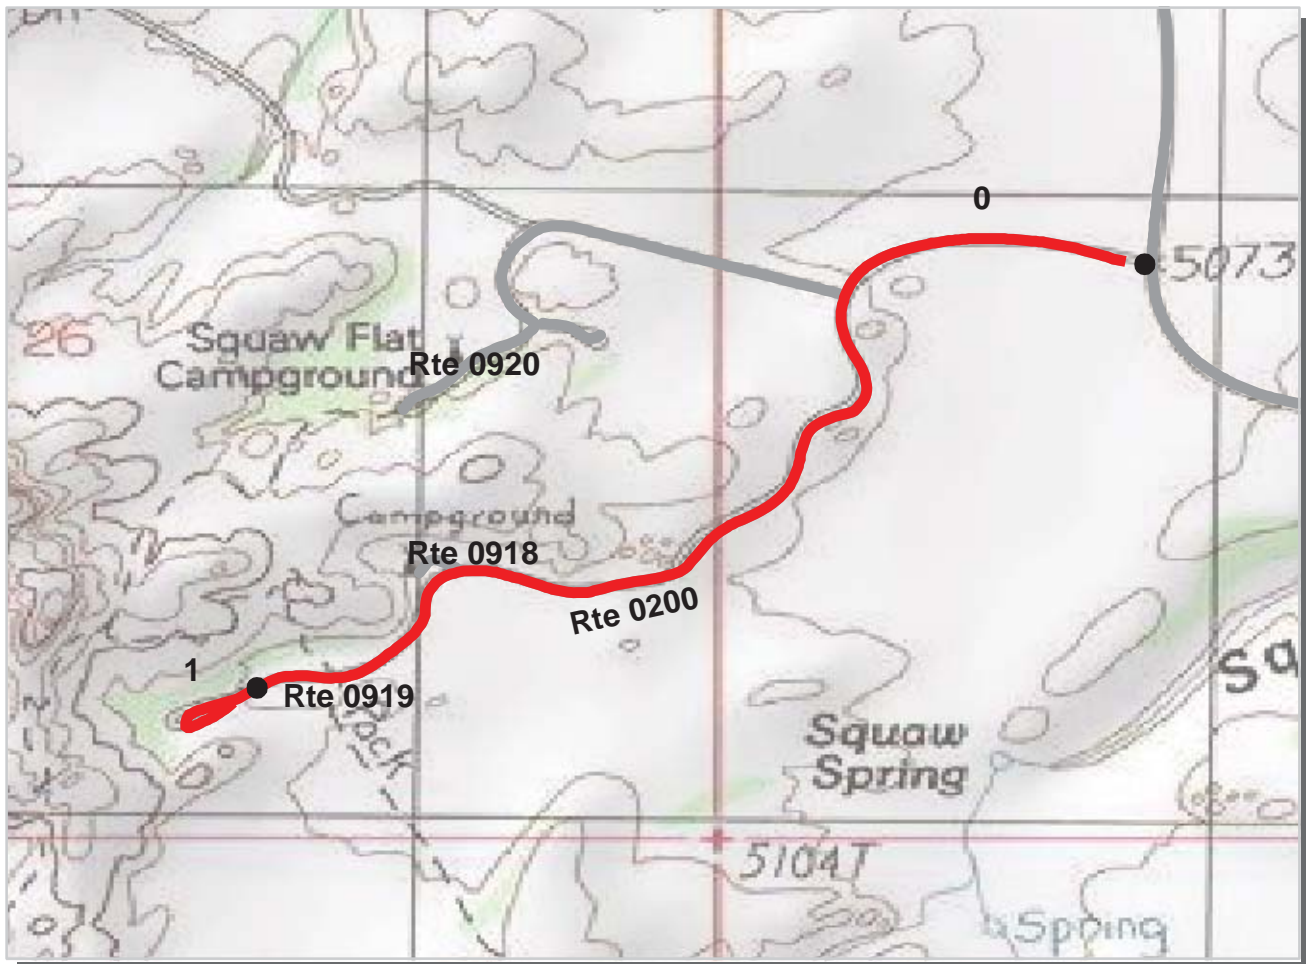
**ROUTE: 0200 Squaw Flat Campground Road (Loop A) TOTAL LENGTH: 1.13 Miles**

Section Number	0	1			
Section Length (mi)	1.00	0.13			
AADT	**				
SADT	**				
ADT Date	**				
<b>Cross Section Information</b>					
Number of Lanes	2	2			
Paved Width (ft)	21	22			
Lane Width (ft)	11	12			
Shoulder Width (ft)	4	0			
<b>Roadway Condition Information</b>					
PCR (Pavement Condition Rating)	42	33			
RCI (Roughness Condition Index)	65	77			
SCR (Surface Condition Rating)	27	26			
Alligator Cracking Index	100	100			
Rutting Index	48	52			
Patching Index	100	100			
Transverse Cracking Index	87	84			
Longitudinal Cracking Index	91	89			
Shoulder Condition Rating	GOOD	N/A			
Drainage Condition Rating	GOOD	GOOD

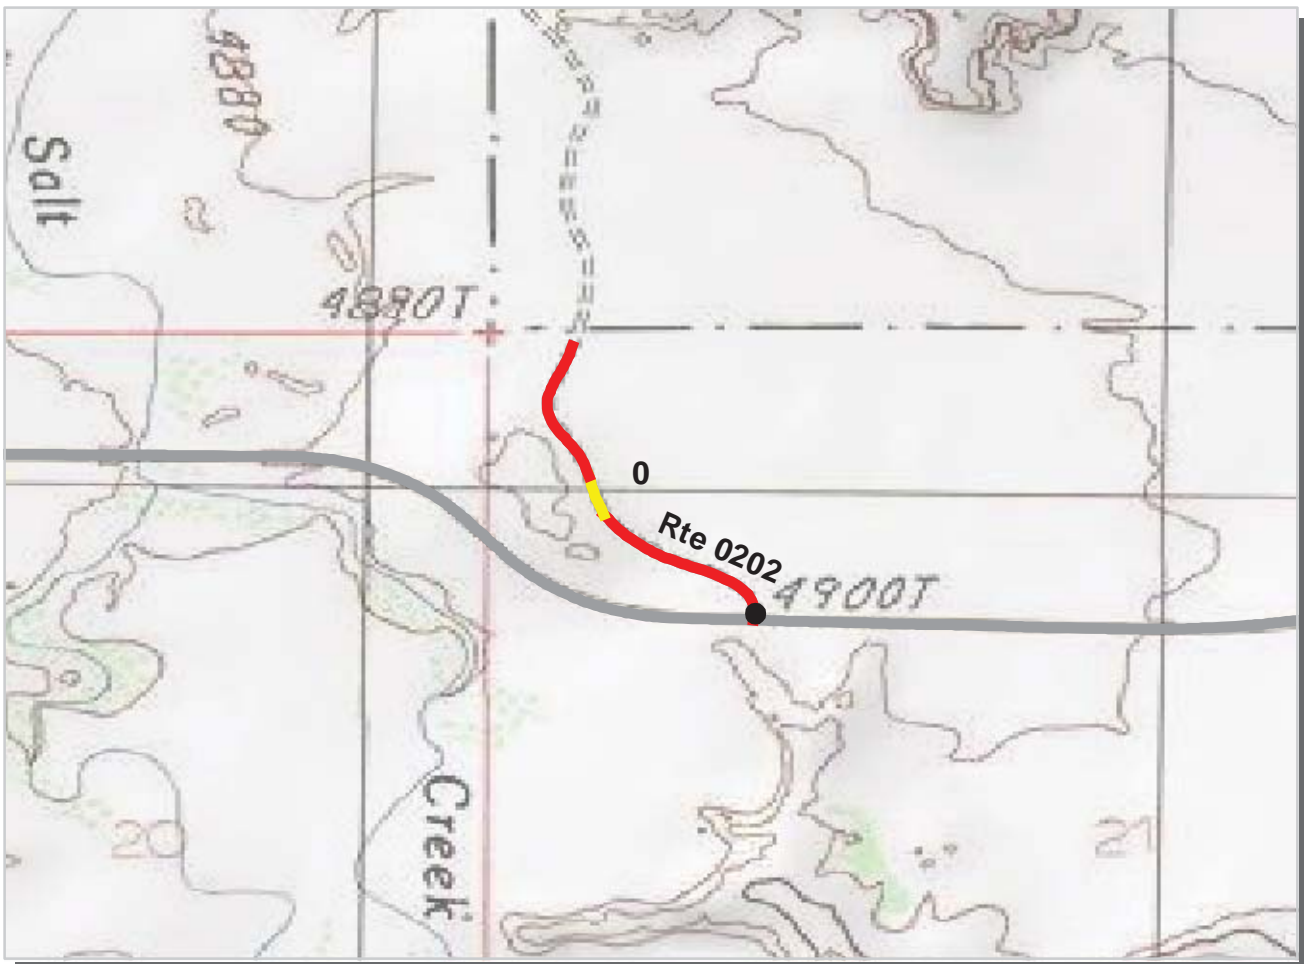
**ROUTE: 0202 Needles Outpost Road** **TOTAL LENGTH: 0.36 Miles**

Section Number	0				
Section Length (mi)	0.36				
AADT	**				
SADT	**				
ADT Date	**				
<b>Cross Section Information</b>					
Number of Lanes	2				
Paved Width (ft)	20				
Lane Width (ft)	11				
Shoulder Width (ft)	0				
<b>Roadway Condition Information</b>					
PCR (Pavement Condition Rating)	51				
RCI (Roughness Condition Index)	89				
SCR (Surface Condition Rating)	37				
Alligator Cracking Index	100				
Rutting Index	43				
Patching Index	100				
Transverse Cracking Index	94				
Longitudinal Cracking Index	99				
Shoulder Condition Rating	N/A				
Drainage Condition Rating	GOOD

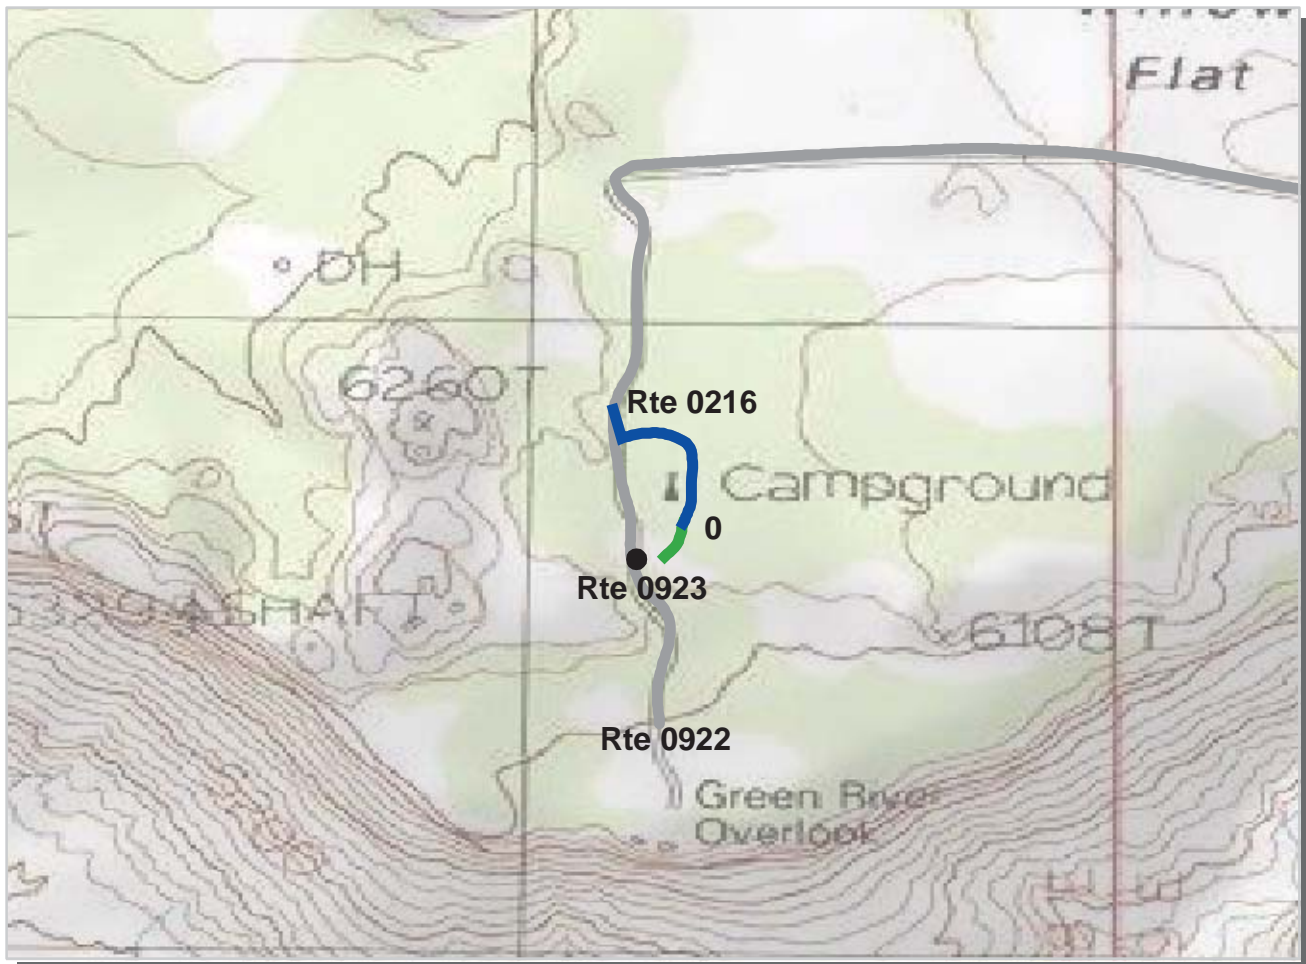
**ROUTE: 0216 Willow Flats Campground** **TOTAL LENGTH: 0.21 Miles**

Section Number	0				
Section Length (mi)	0.21				
AADT	**				
SADT	**				
ADT Date	**				
<b>Cross Section Information</b>					
Number of Lanes	1				
Paved Width (ft)	11				
Lane Width (ft)	11				
Shoulder Width (ft)	0				
<b>Roadway Condition Information</b>					
PCR (Pavement Condition Rating)	90				
RCI (Roughness Condition Index)	NC				
SCR (Surface Condition Rating)	90				
Alligator Cracking Index	100				
Rutting Index	90				
Patching Index	100				
Transverse Cracking Index	99				
Longitudinal Cracking Index	100				
Shoulder Condition Rating	N/A				
Drainage Condition Rating	GOOD

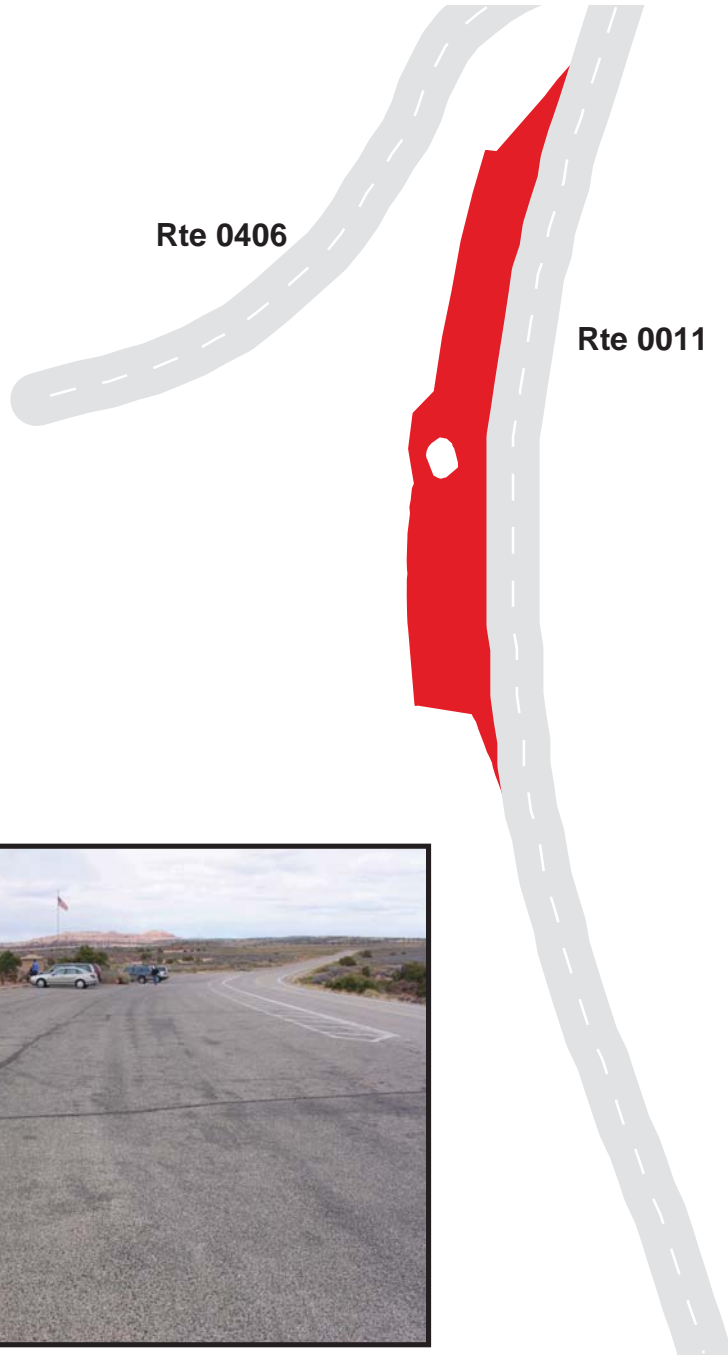
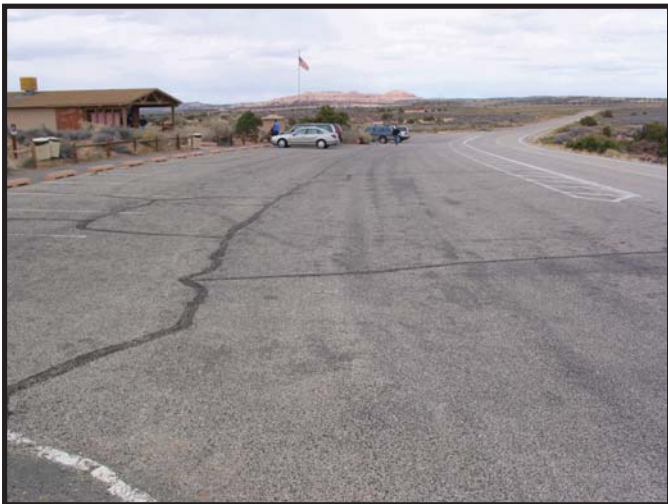
Route	Public / NonPublic	Date Visited	Area (sq ft)	Lane Miles *	Surface Type	Condition / PCR
0900	Public	4/3/2003	22997	0.40	OC	FAIR / 73

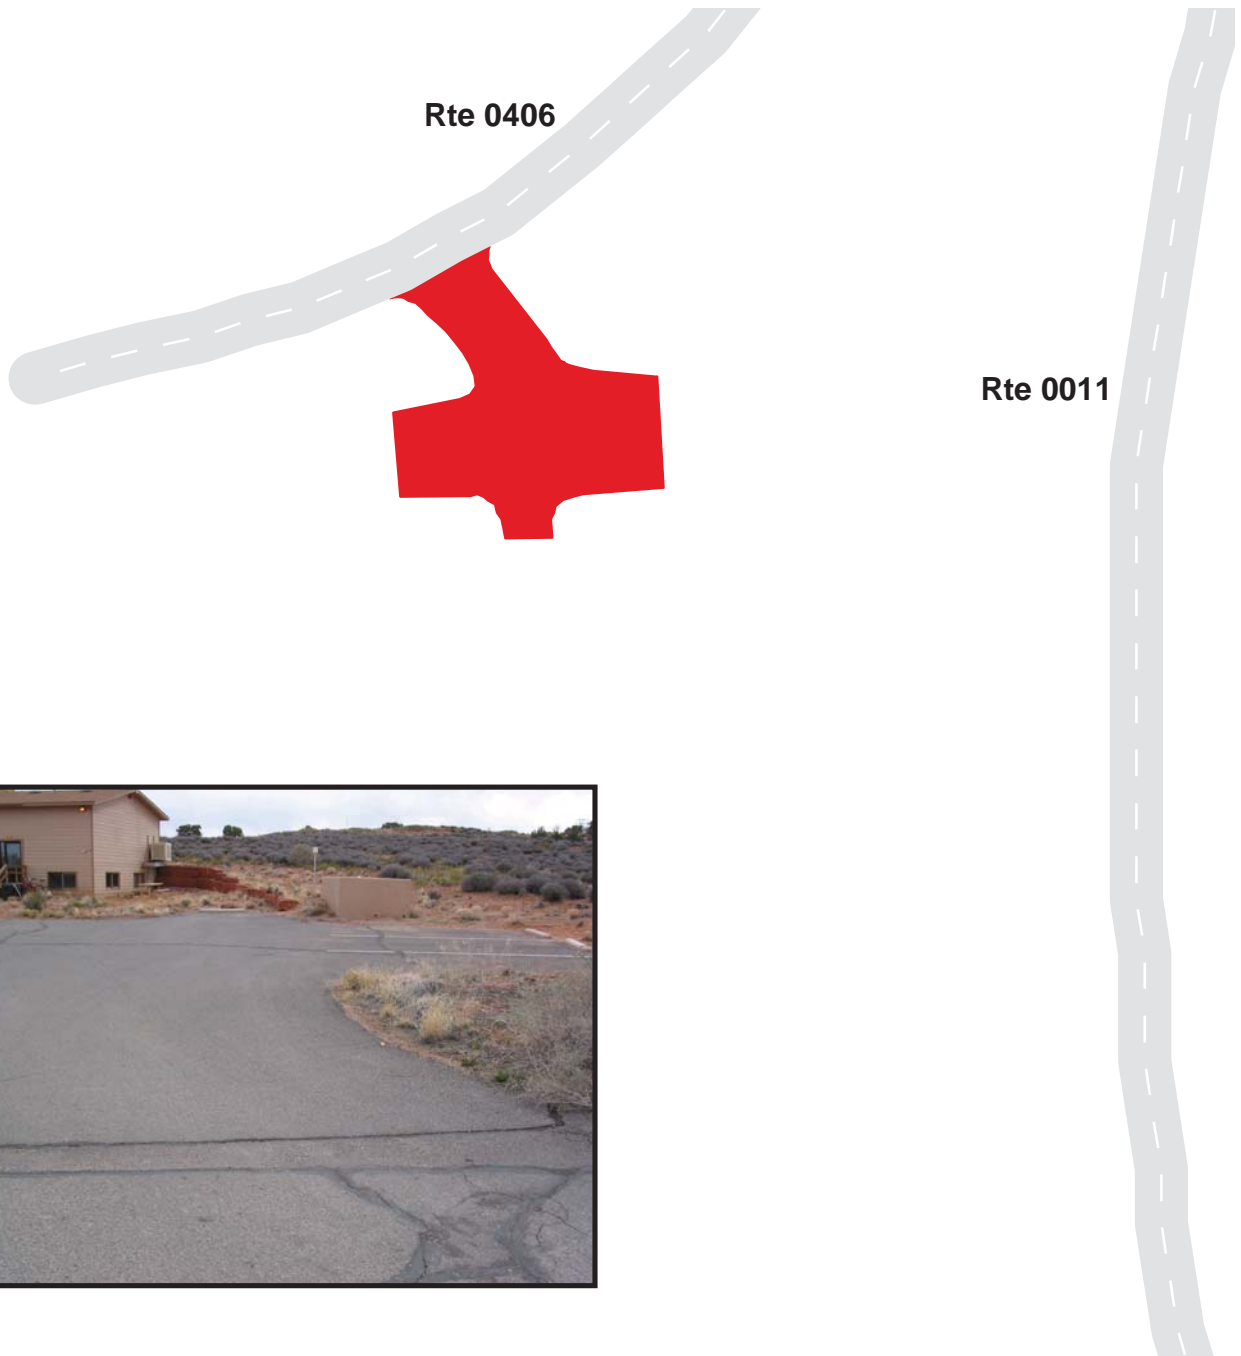
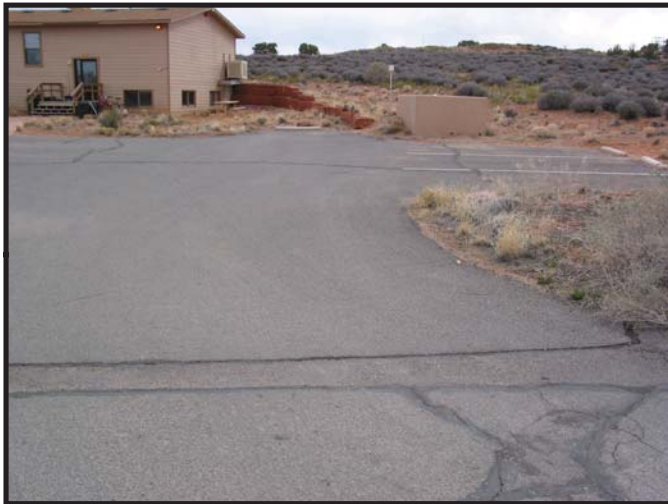
**Canyonlands National Park**  
**Route 0901**  
 Sky Visitor Center Employee Parking  
 Adjacent to Route 0406

Route	Public / NonPublic	Date Visited	Area (sq ft)	Lane Miles *	Surface Type	Condition / PCR
0901	NonPublic	4/3/2003	3720	0.06	AS	FAIR / 73

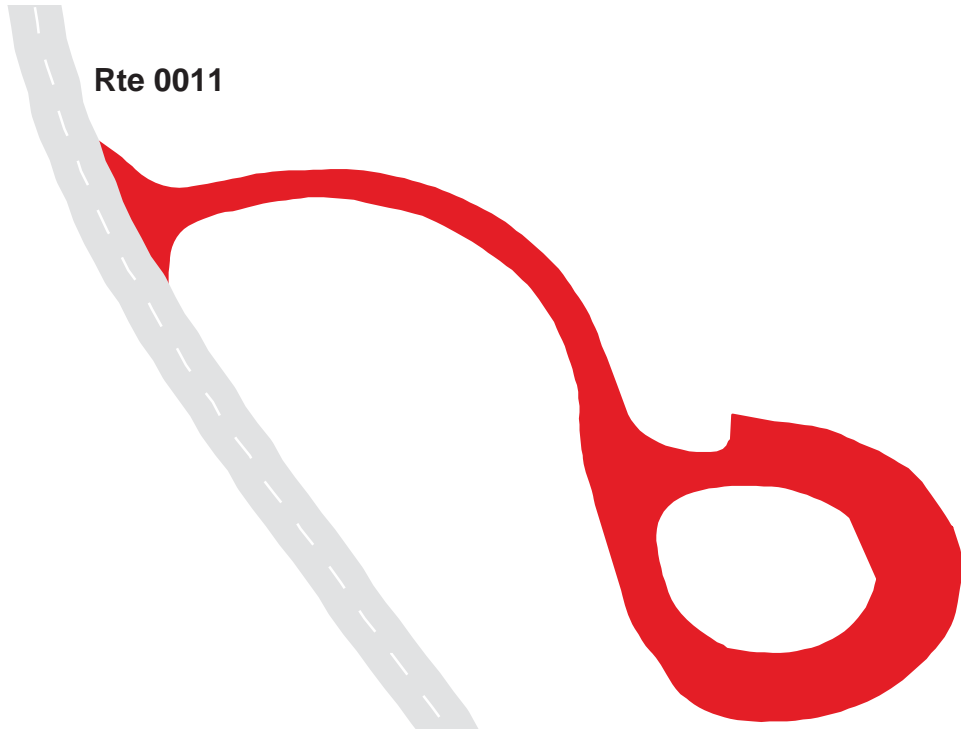
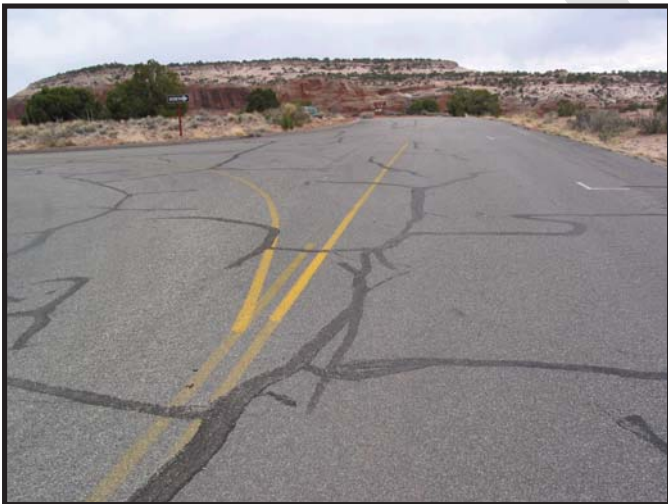
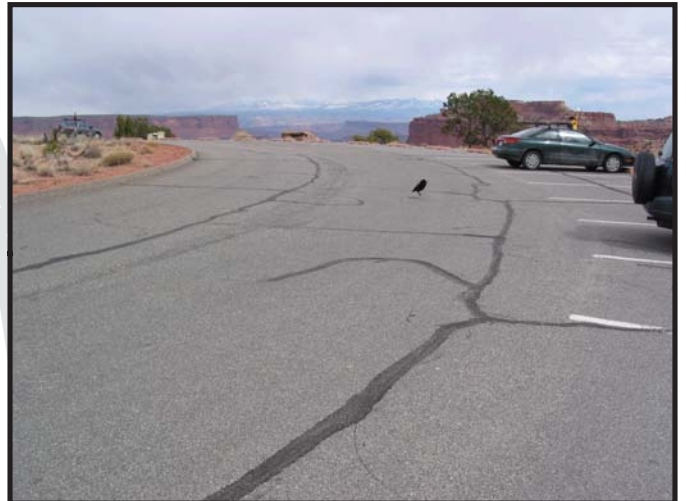
## Route 0902

Route	Public / NonPublic	Date Visited	Area (sq ft)	Lane Miles *	Surface Type	Condition / PCR
0902	Public	4/3/2003	41017	0.71	AS	FAIR / 73

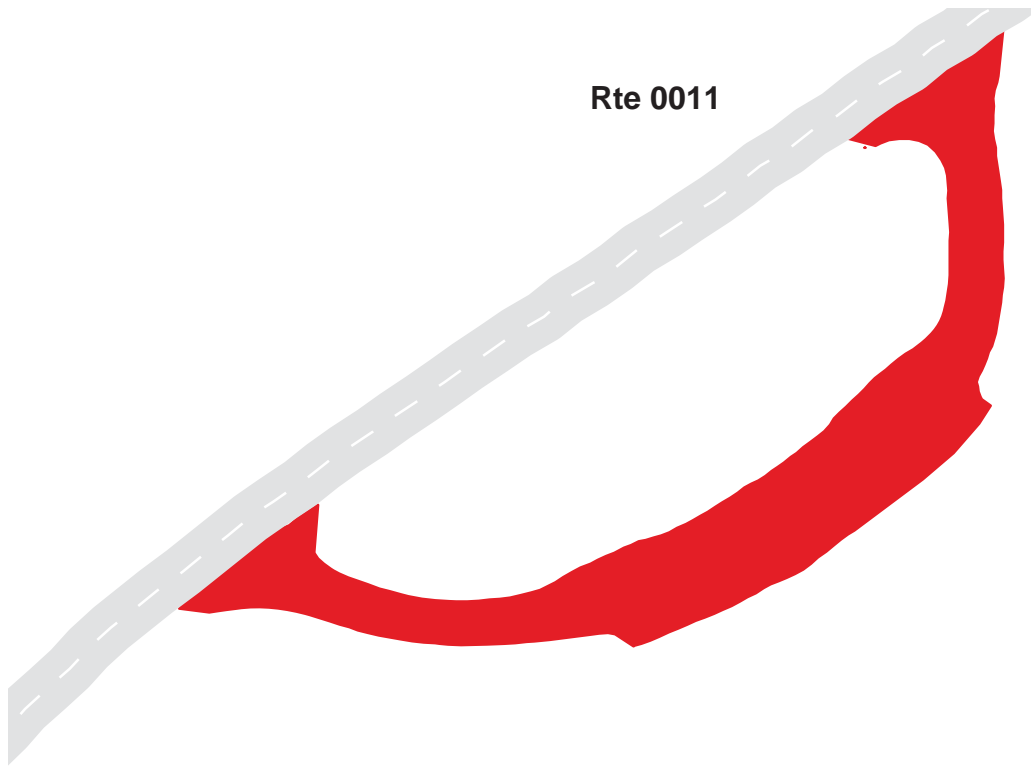
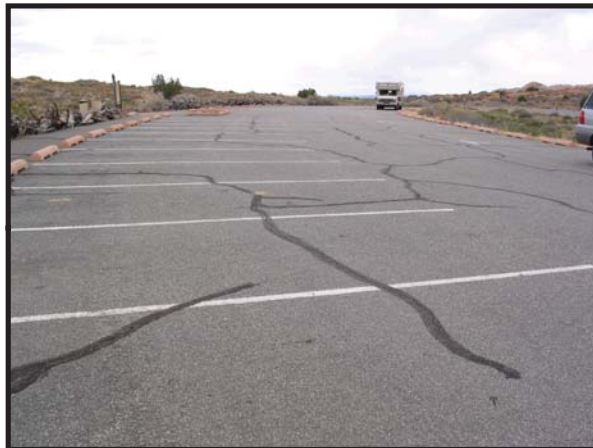
## Route 0903

Route	Public / NonPublic	Date Visited	Area (sq ft)	Lane Miles *	Surface Type	Condition / PCR
0903	Public	4/3/2003	23532	0.41	AS	GOOD / 90

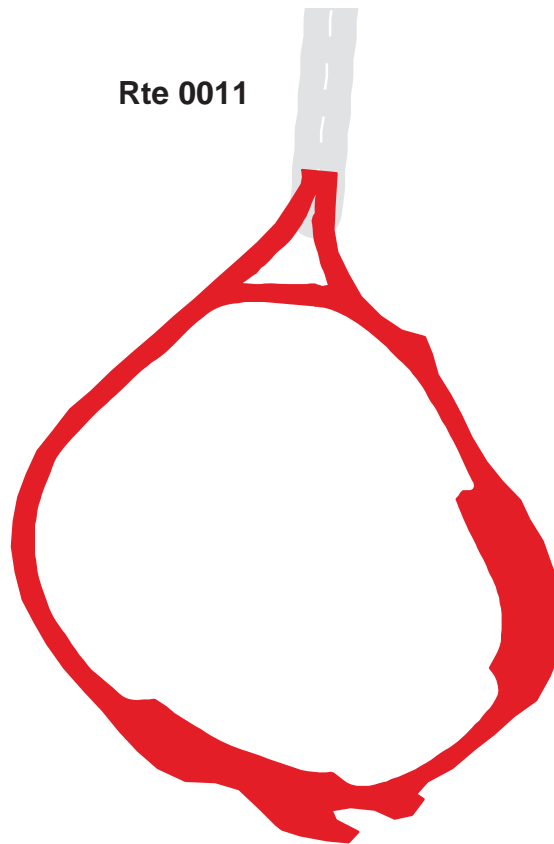
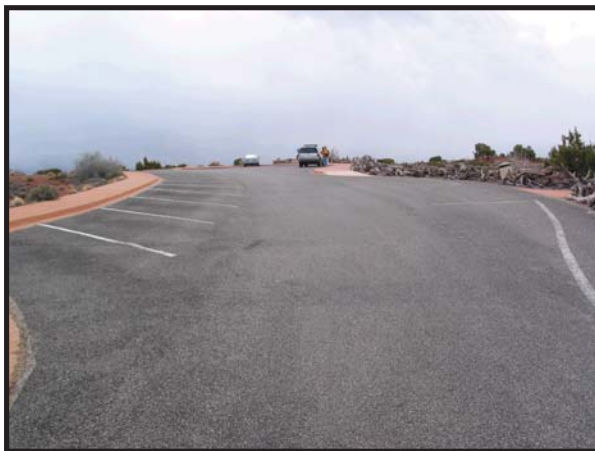
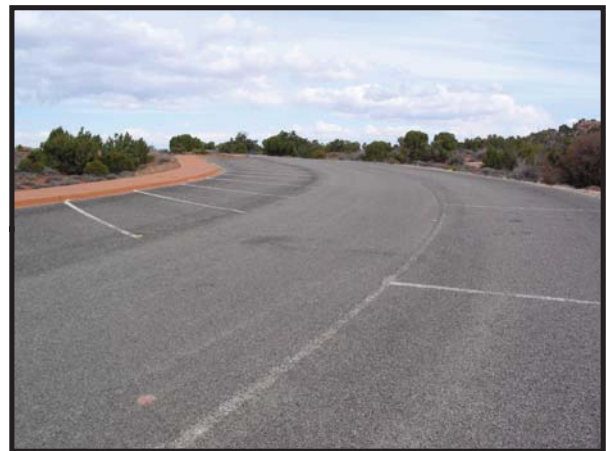
## Route 0906

Route	Public / NonPublic	Date Visited	Area (sq ft)	Lane Miles *	Surface Type	Condition / PCR
0906	Public	4/3/2003	38550	0.66	OC	GOOD / 90

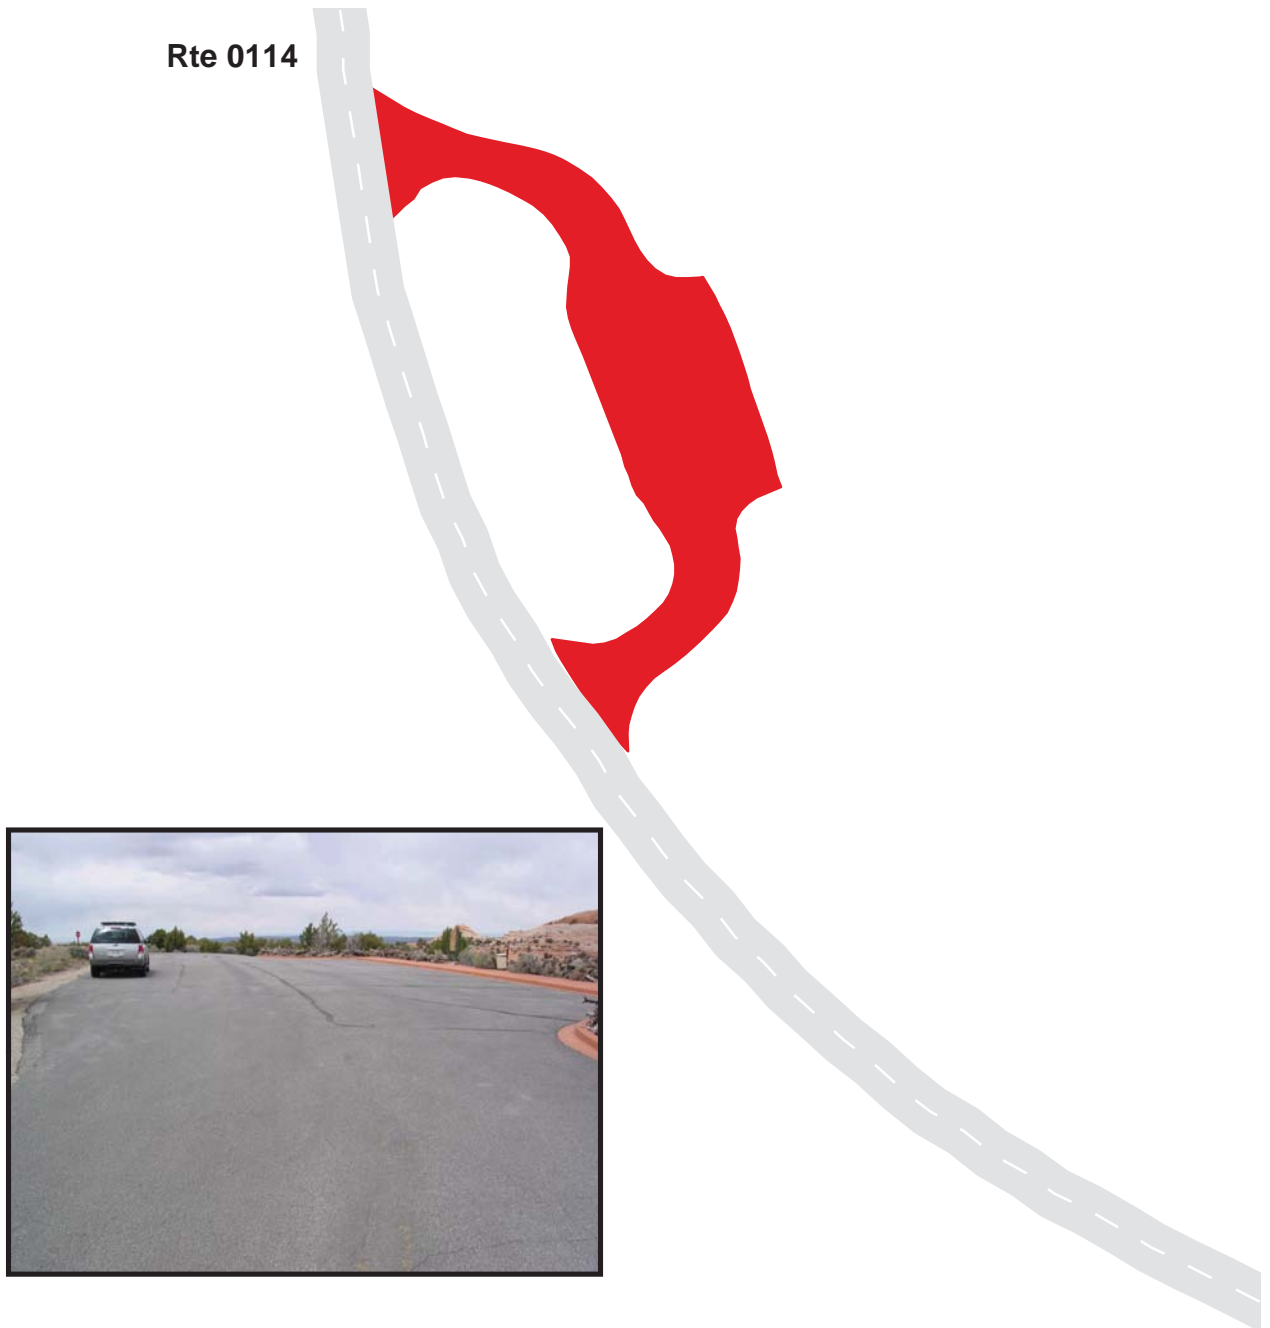
## Route 0907

Route	Public / NonPublic	Date Visited	Area (sq ft)	Lane Miles *	Surface Type	Condition / PCR
0907	Public	4/3/2003	12892	0.22	AS	GOOD / 90

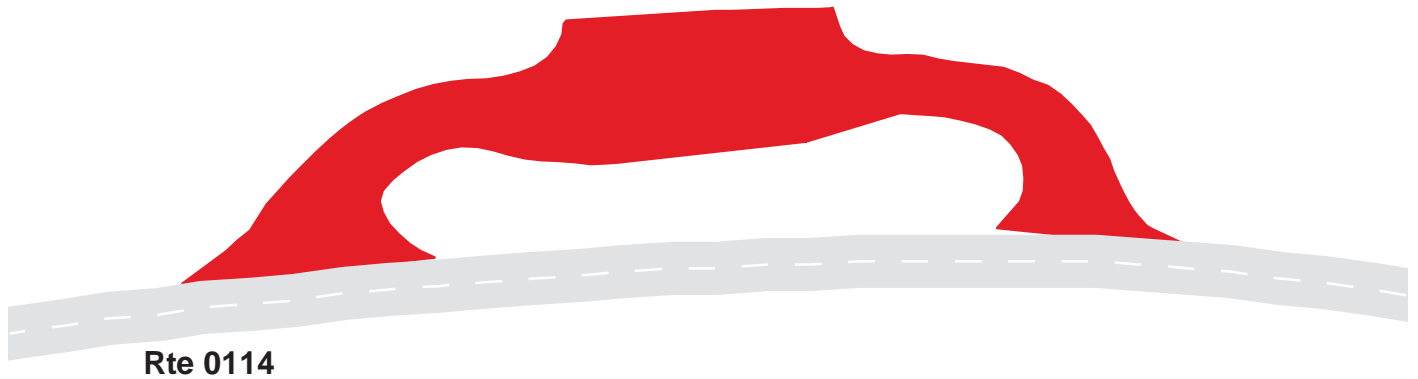
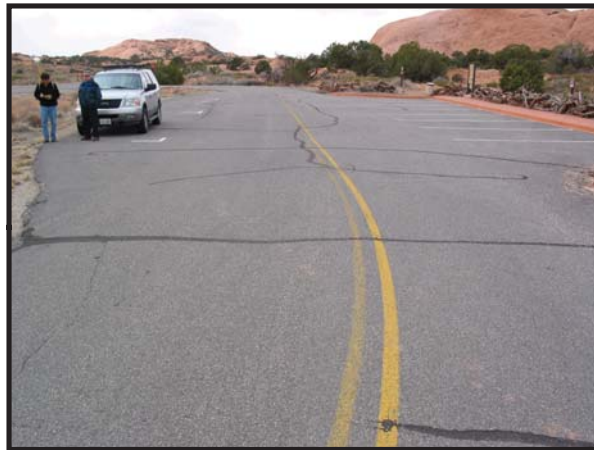
## Route 0908

Route	Public / NonPublic	Date Visited	Area (sq ft)	Lane Miles *	Surface Type	Condition / PCR
0908	Public	4/3/2003	11364	0.20	AS	GOOD / 90

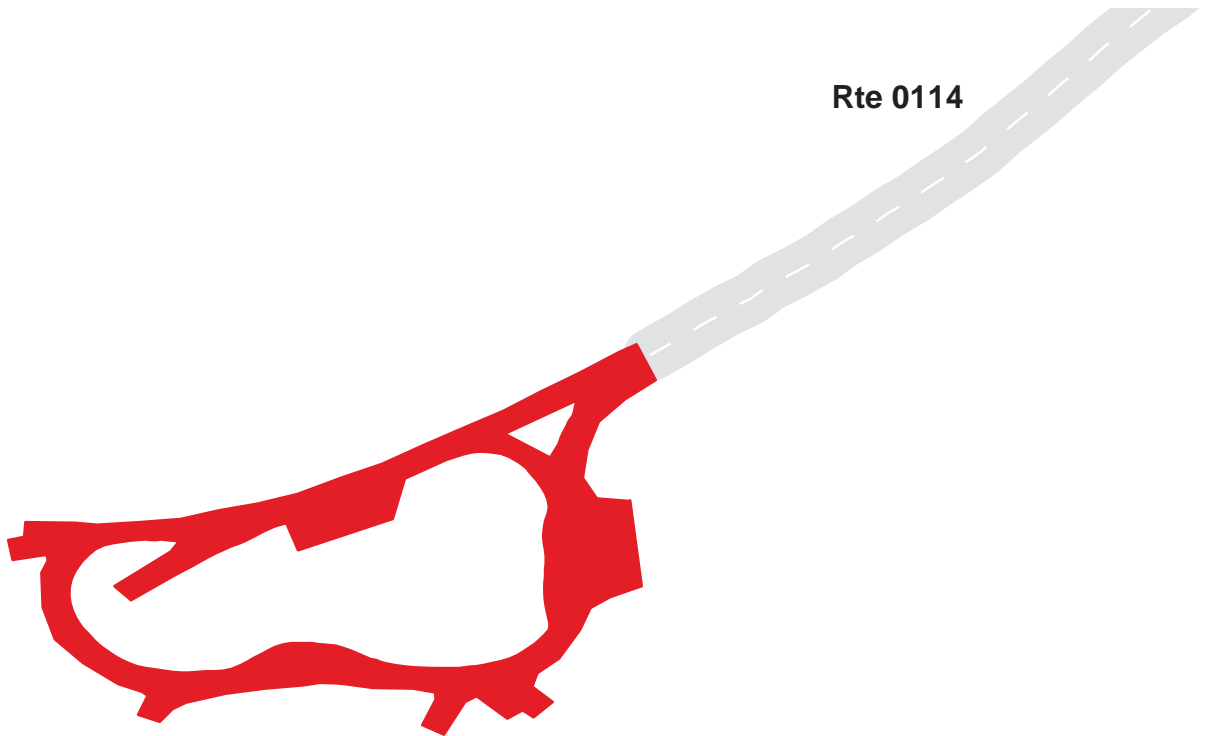
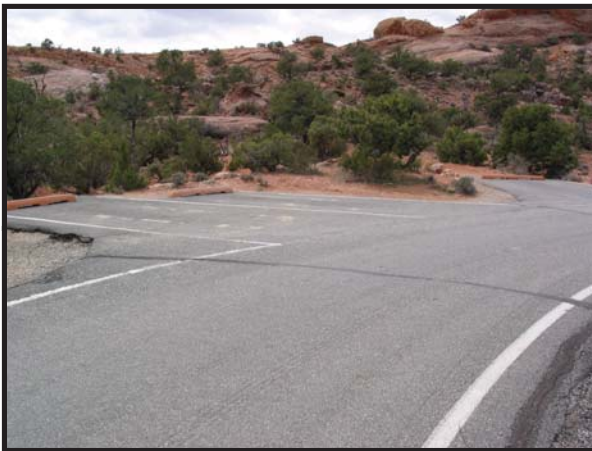
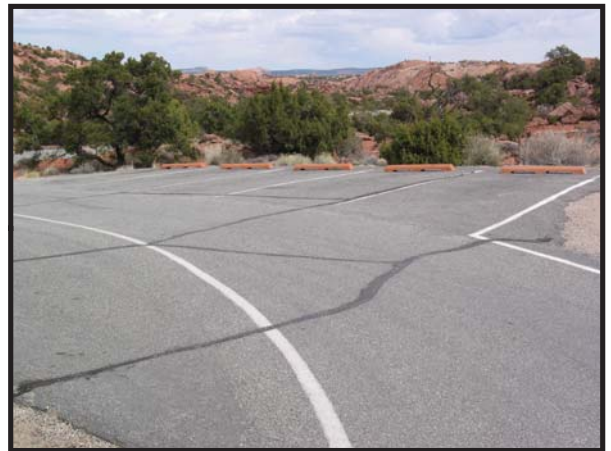
## Route 0909

Route	Public / NonPublic	Date Visited	Area (sq ft)	Lane Miles *	Surface Type	Condition / PCR
0909	Public	4/3/2003	20726	0.36	AS	GOOD / 90

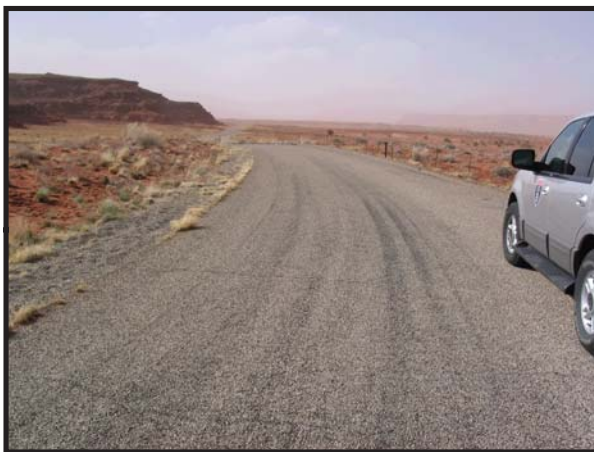
Route	Public / NonPublic	Date Visited	Area (sq ft)	Lane Miles *	Surface Type	Condition / PCR
0910	Public	4/2/2003	9309	0.16	OC	GOOD / 90

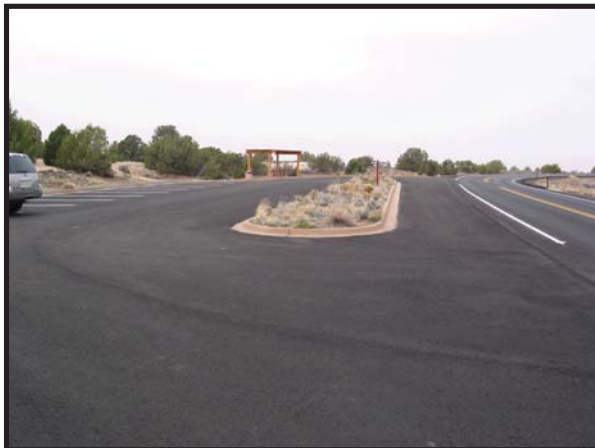
## Route 0914

Route	Public / NonPublic	Date Visited	Area (sq ft)	Lane Miles *	Surface Type	Condition / PCR
0914	Public	4/2/2003	8276	0.14	AS	EXCELLENT / 97

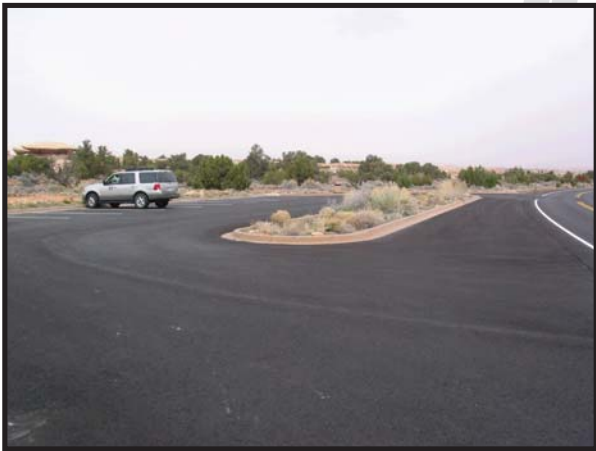
## Route 0915

Route	Public / NonPublic	Date Visited	Area (sq ft)	Lane Miles *	Surface Type	Condition / PCR
0915	Public	4/2/2003	17796	0.31	AS	EXCELLENT / 97

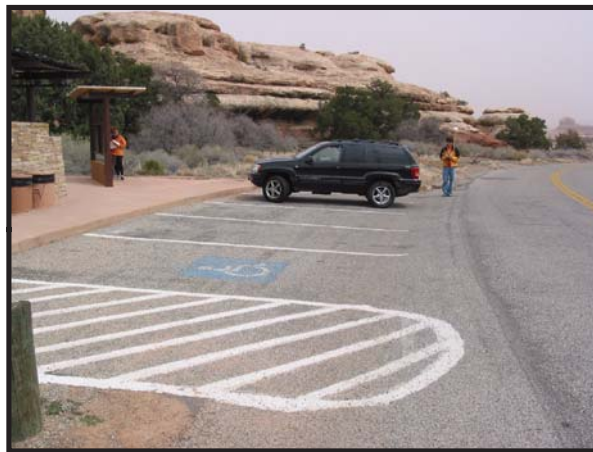
## Route 0919

Route	Public / NonPublic	Date Visited	Area (sq ft)	Lane Miles *	Surface Type	Condition / PCR
0919	Public	4/2/2003	10721	0.18	OC	GOOD / 90

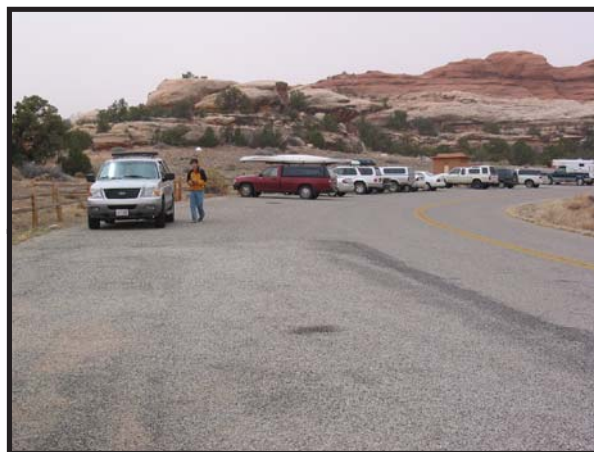
## Route 0920

Route	Public / NonPublic	Date Visited	Area (sq ft)	Lane Miles *	Surface Type	Condition / PCR
0920	Public	4/2/2003	561	0.01	OC	GOOD / 90

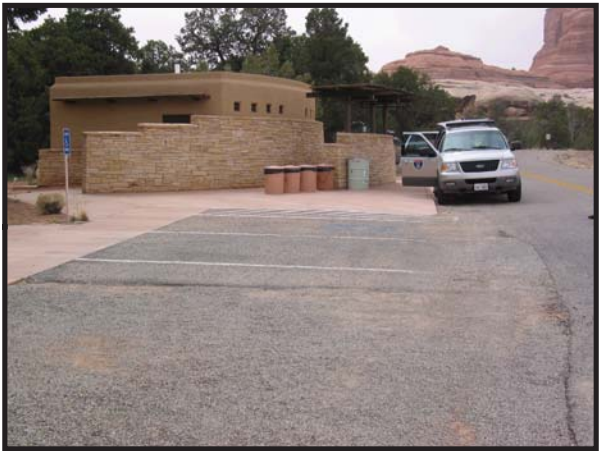
## Route 0921

Route	Public / NonPublic	Date Visited	Area (sq ft)	Lane Miles *	Surface Type	Condition / PCR
0921	Public	4/3/2003	1058	0.02	AS	GOOD / 90

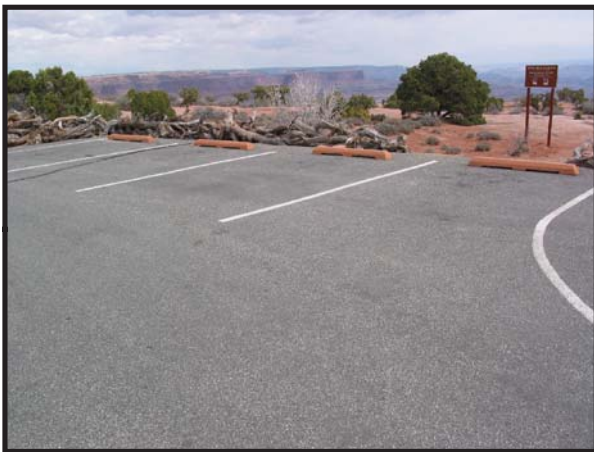
## Route 0922

Route	Public / NonPublic	Date Visited	Area (sq ft)	Lane Miles *	Surface Type	Condition / PCR
0922	Public	4/3/2003	19076	0.33	AS	EXCELLENT / 97
