The Road Inventory of Capitol Reef National Park CARE - 1350

Road Inventory Program

Prepared By:
Federal Highway Administration
Eastern Federal Lands Highway Division
Cycle 3

Capitol Reef National Park in Utah

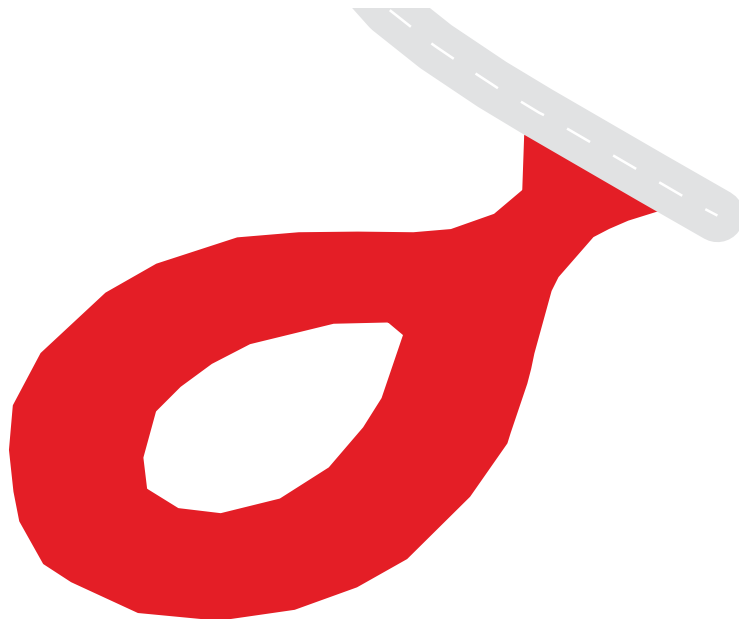
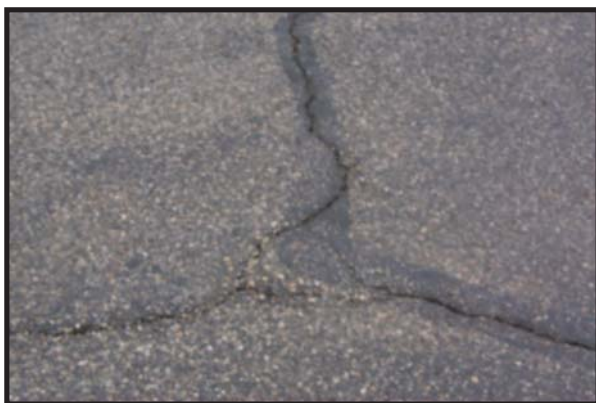
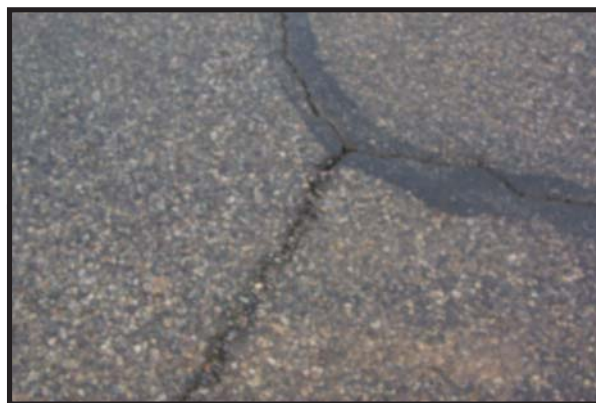
Route 0902

Route	Public / NonPublic	Date Visited	Area (sq ft)	Lane Miles *	Surface Type	Condition / PCR
0901	Public	4/24/2003	9522	0.16	OC	FAIR / 73

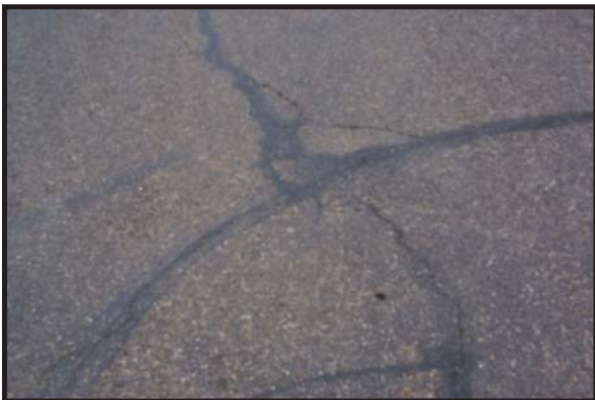
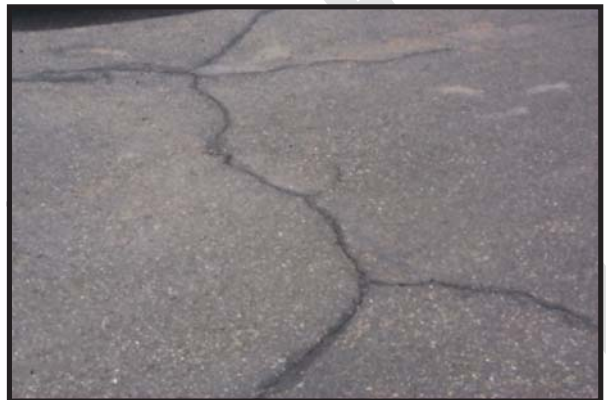
Route 0903

Route	Public / NonPublic	Date Visited	Area (sq ft)	Lane Miles *	Surface Type	Condition / PCR
0902	Public	4/24/2003	14676	0.25	AS	POOR / 45

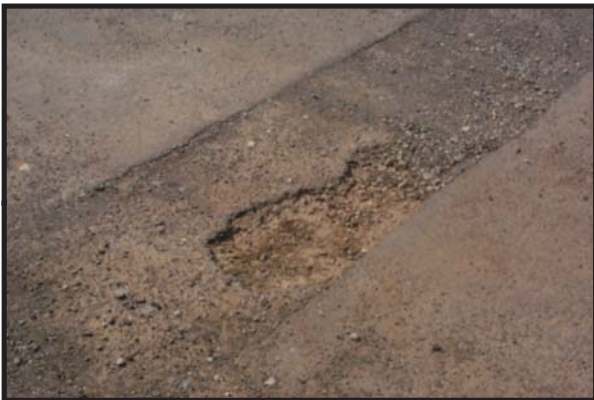
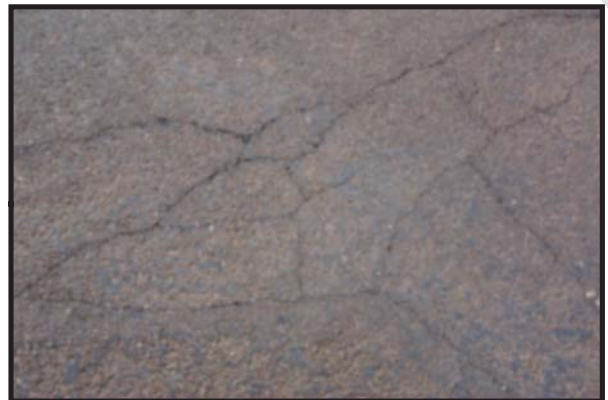
Route 0904

Route	Public / NonPublic	Date Visited	Area (sq ft)	Lane Miles *	Surface Type	Condition / PCR
0903	NonPublic	4/24/2003	40660	0.70	OC	POOR / 45

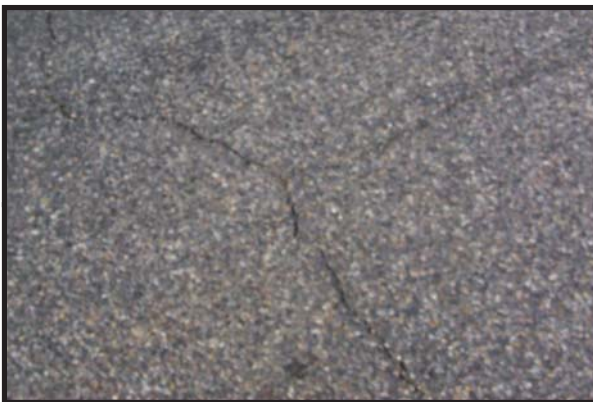
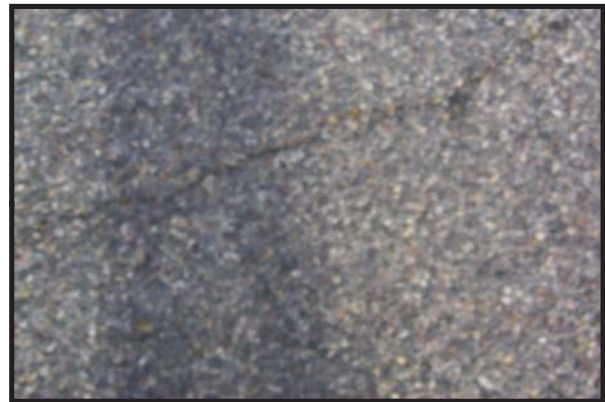
Route 0914

Route	Public / NonPublic	Date Visited	Area (sq ft)	Lane Miles *	Surface Type	Condition / PCR
0904	Public	4/24/2003	11373	0.20	OC	FAIR / 73

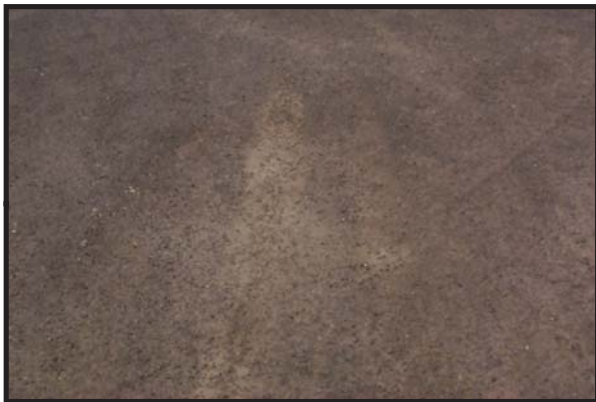
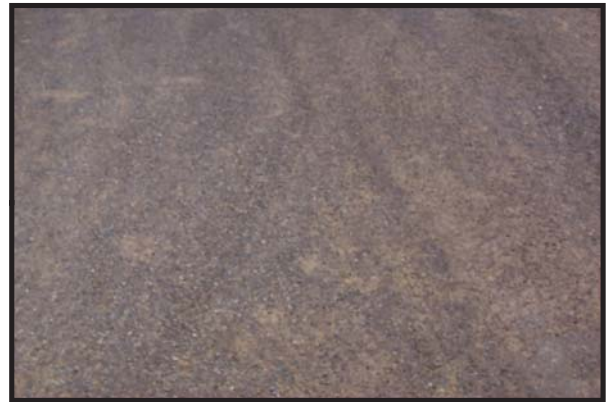
Route 0915

Route	Public / NonPublic	Date Visited	Area (sq ft)	Lane Miles *	Surface Type	Condition / PCR
0914	Public	4/24/2003	13254	0.23	OC	POOR / 45

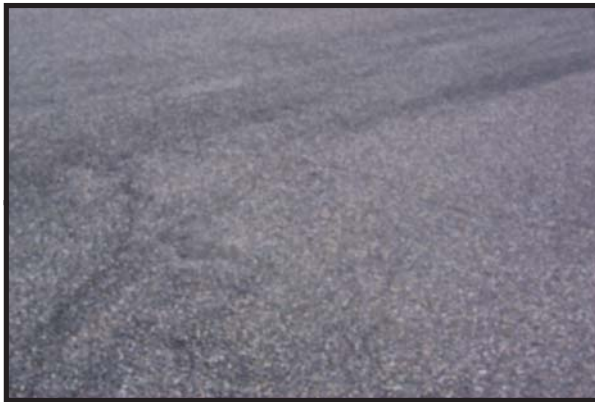
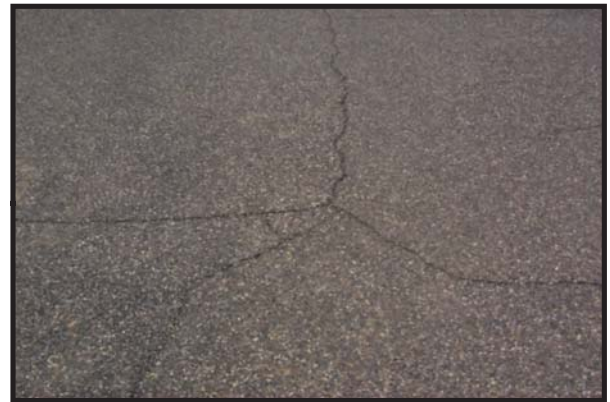
Route 0916

Route	Public / NonPublic	Date Visited	Area (sq ft)	Lane Miles *	Surface Type	Condition / PCR
0915	Public	4/24/2003	18798	0.32	OC	FAIR / 73

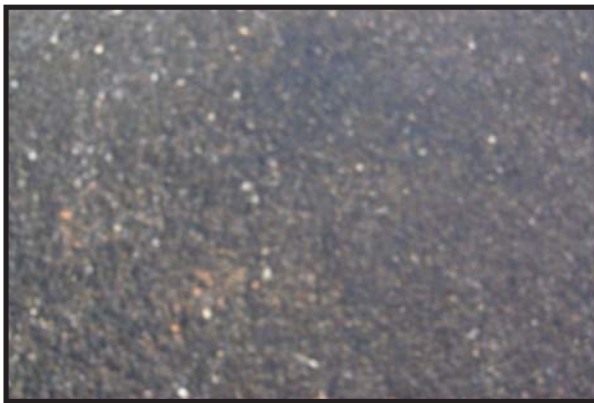
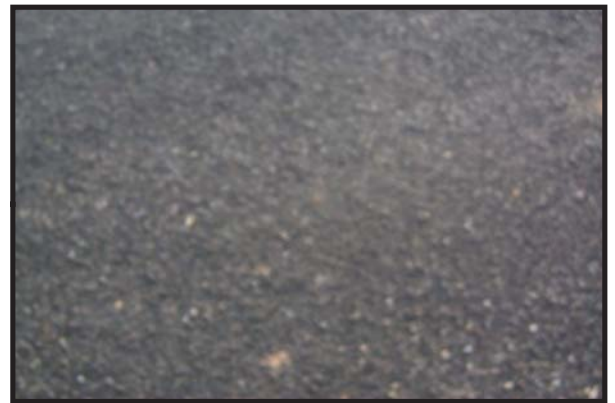
Route 0917

Route	Public / NonPublic	Date Visited	Area (sq ft)	Lane Miles *	Surface Type	Condition / PCR
0916	Public	4/24/2003	5342	0.09	NC	GOOD / 90
