**The Road Inventory
of
Carl Sandburg Home National Historic Site
CARL - 5160**

Road Inventory Program

Prepared By:
Federal Highway Administration
Eastern Federal Lands Highway Division
Cycle 3

Carl Sandburg Home National Historic Site in North Carolina

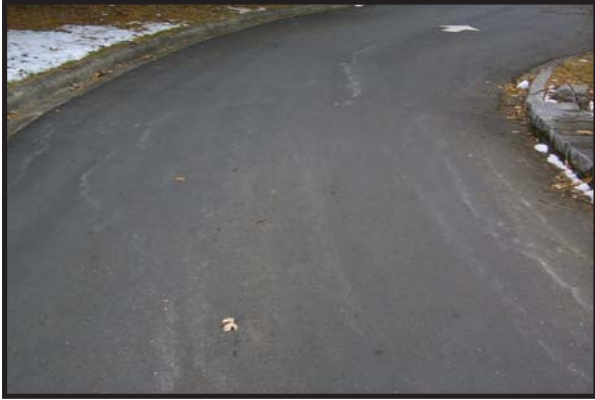
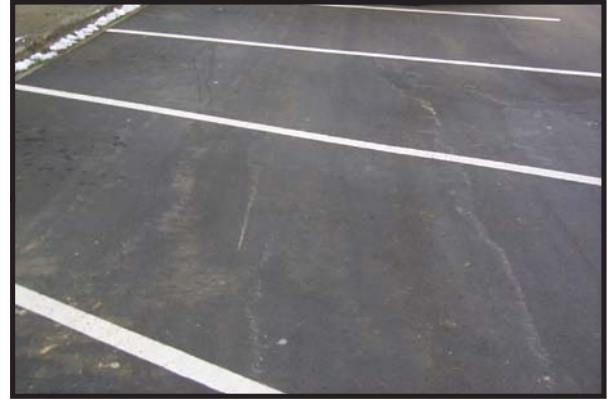
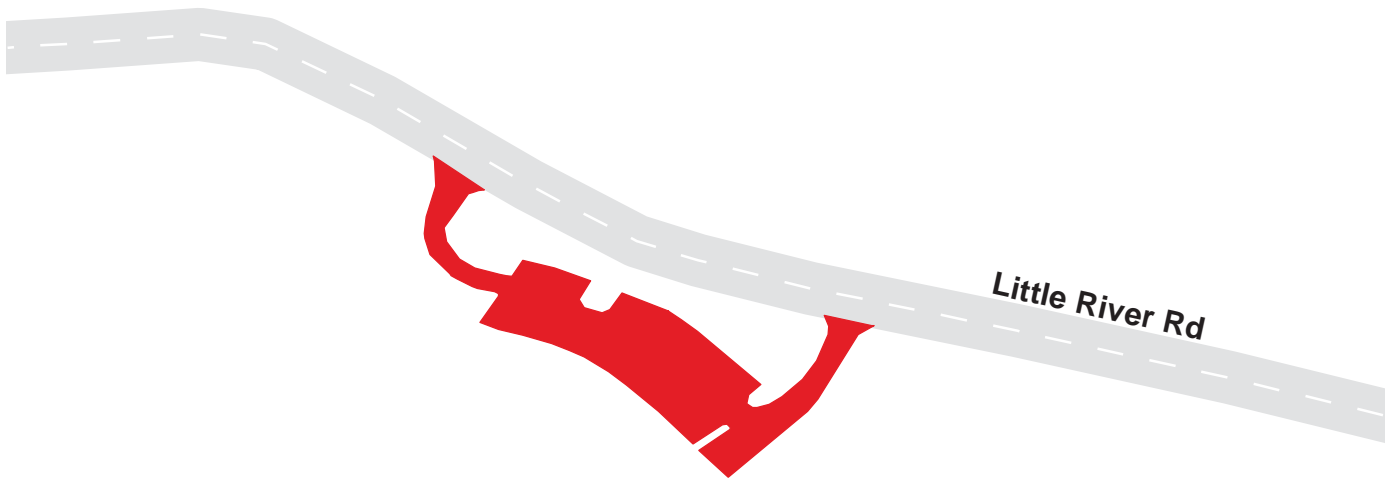
Route 0900

Route	Public / NonPublic	Date Visited	Area (sq ft)	Lane Miles *	Surface Type	Condition / PCR
0900	Public	12/9/2002	22038	0.38	AS	GOOD / 90

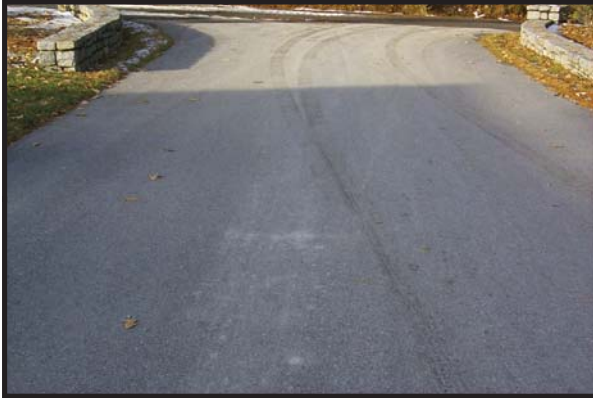
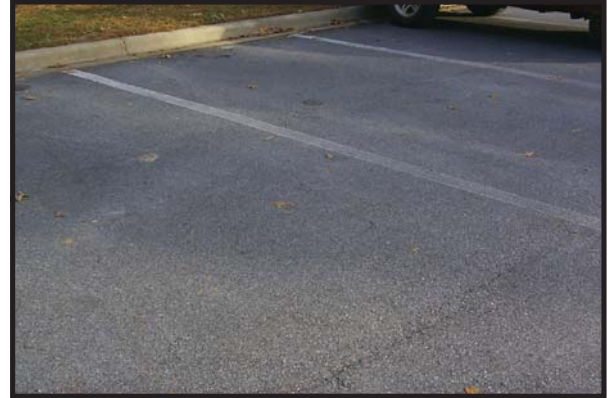
Route 0901

Route	Public / NonPublic	Date Visited	Area (sq ft)	Lane Miles *	Surface Type	Condition / PCR
0901	NonPublic	12/9/2002	6750	0.12	AS	GOOD / 90

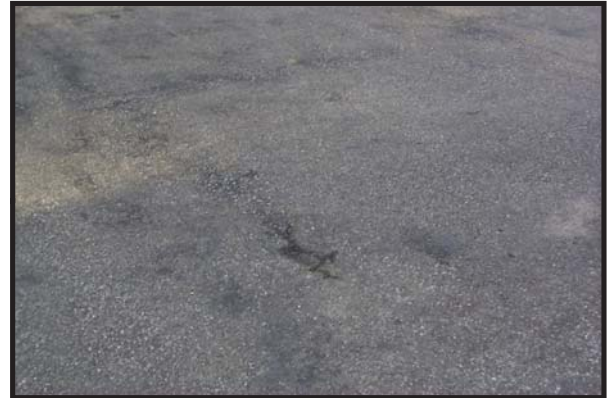
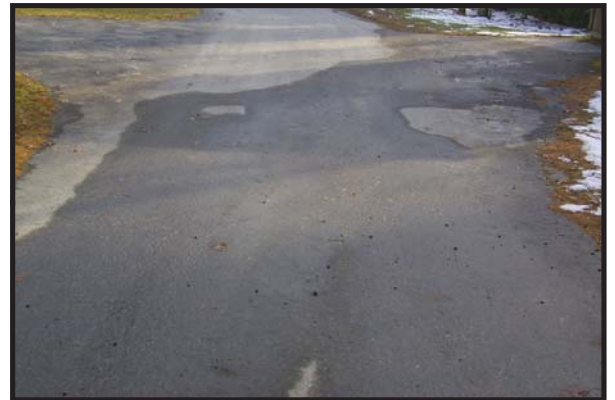
Route 0902

Route	Public / NonPublic	Date Visited	Area (sq ft)	Lane Miles *	Surface Type	Condition / PCR
0902	NonPublic	12/9/2002	6897	0.12	AS	FAIR / 73
