The Road Inventory of Castillo de San Marcos National Monument CASA - 5260

Road Inventory Program

Prepared By:
Federal Highway Administration
Eastern Federal Lands Highway Division
Cycle 3

Castillo de San Marcos National Monument in Florida

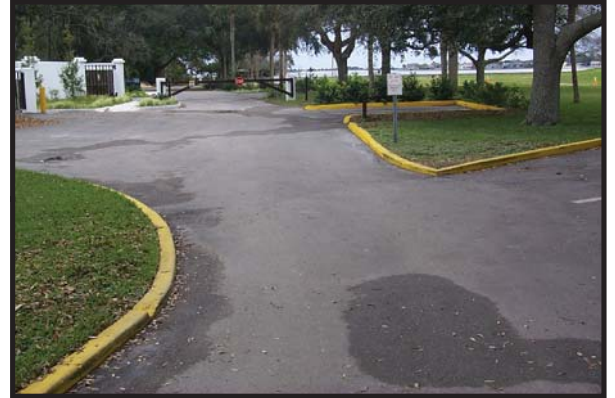
Route 0900

ADMINISTRATIVE AREA
From Castillo Drive

Route	Public / NonPublic	Date Visited	Area (sq ft)	Lane Miles *	Surface Type	Condition / PCR
0900	NonPublic	2/2/2002	17016	0.29	AS	GOOD / 90

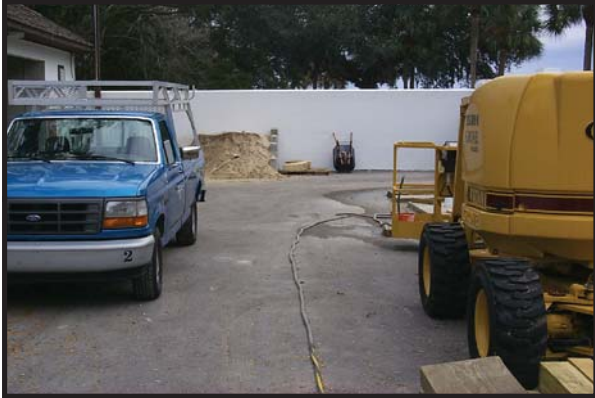
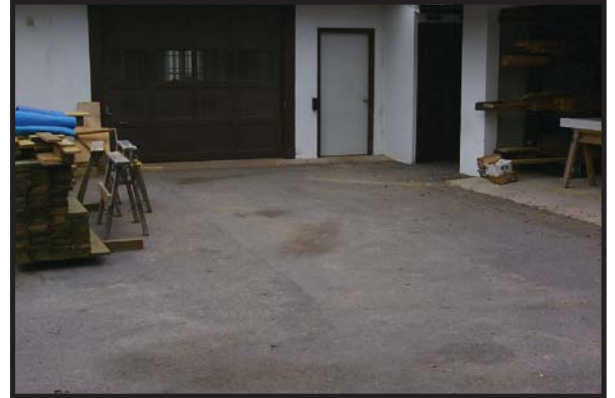
Route 0901

MAINTENANCE AREA

Route	Public / NonPublic	Date Visited	Area (sq ft)	Lane Miles *	Surface Type	Condition / PCR
0901	NonPublic	2/2/2002	5941	0.10	AS	GOOD / 90

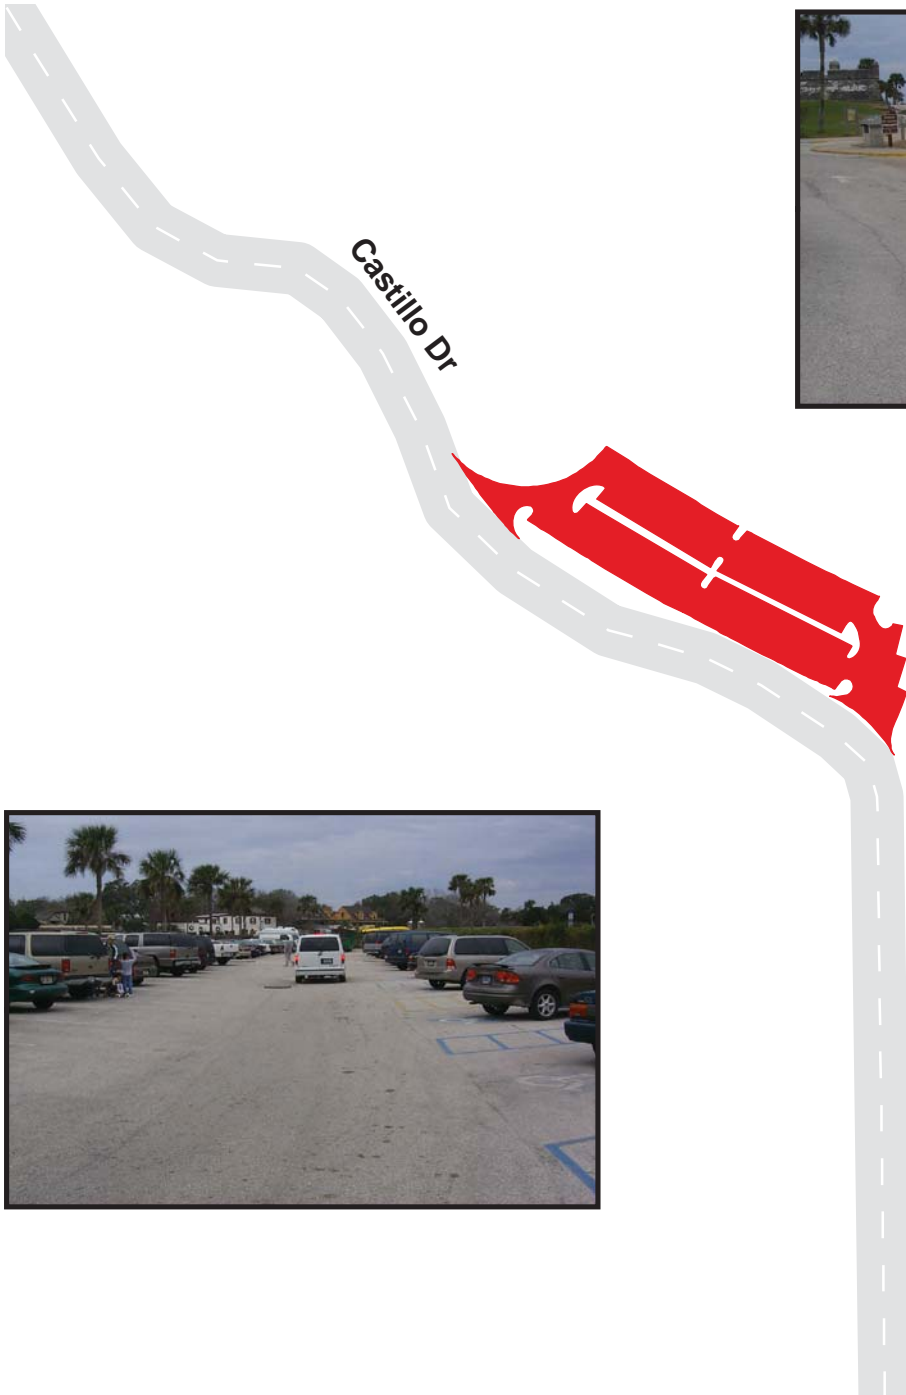
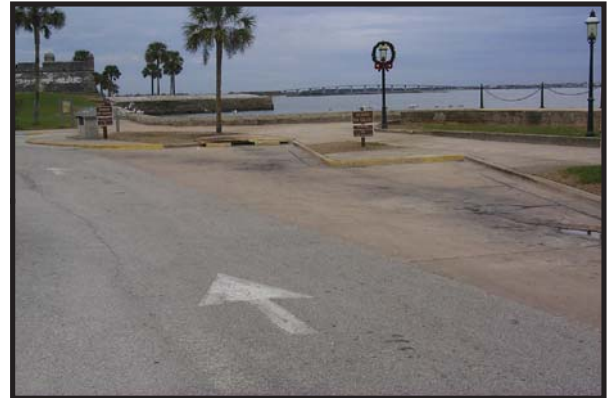
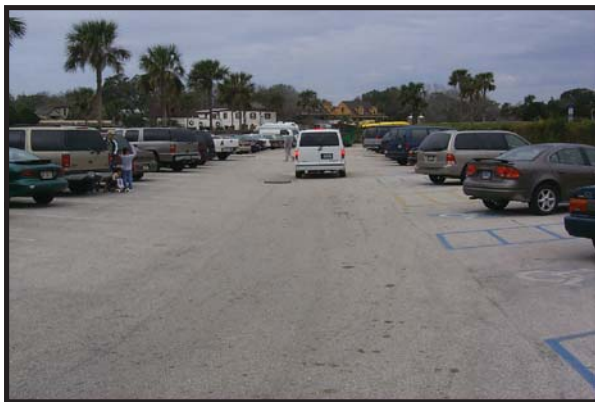
Route 0902

VISITOR PARKING
From Castillo Drive

Route	Public / NonPublic	Date Visited	Area (sq ft)	Lane Miles *	Surface Type	Condition / PCR
0902	Public	2/2/2002	54440	0.94	AS	GOOD / 90

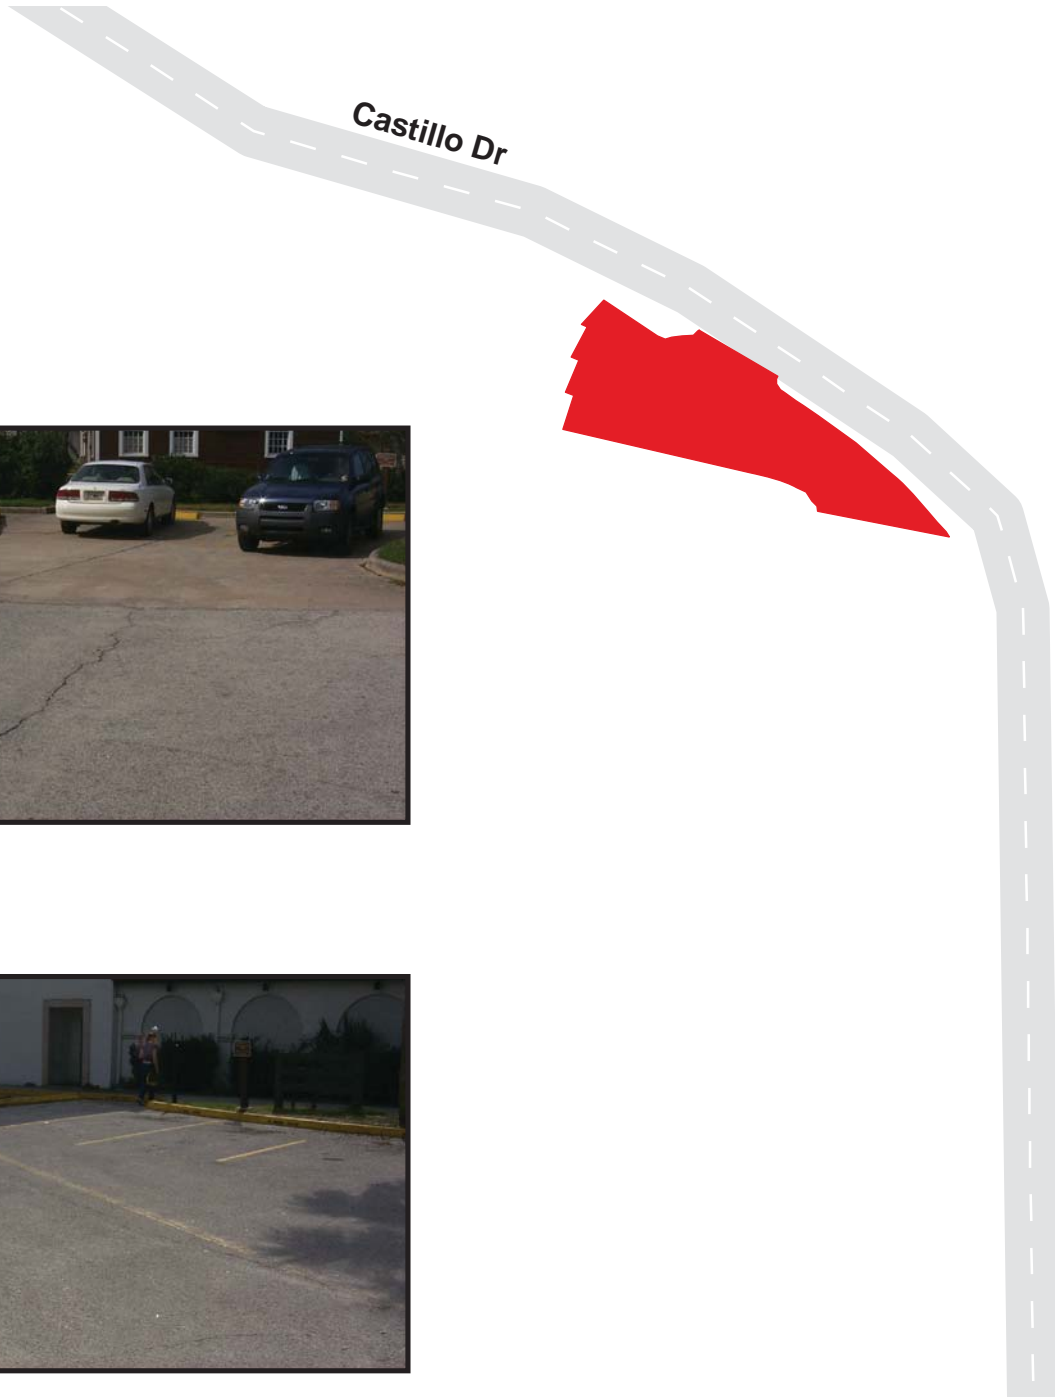
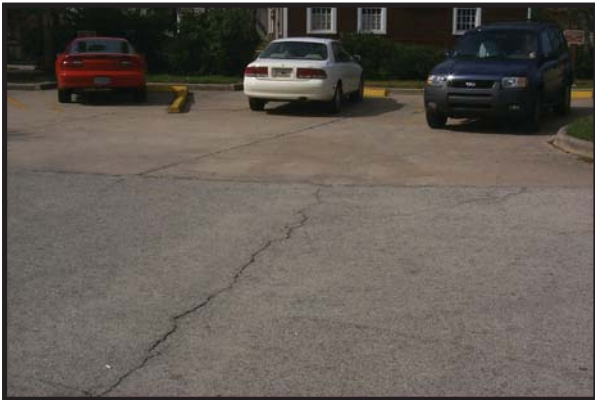
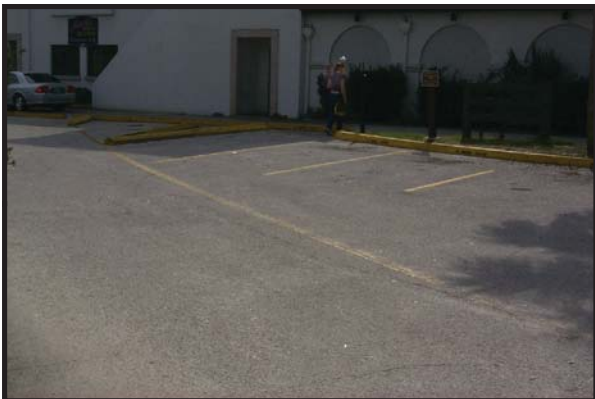
Route 0904

EMPLOYEE PARKING
From Castillo Drive

Route	Public / NonPublic	Date Visited	Area (sq ft)	Lane Miles *	Surface Type	Condition / PCR
0904	NonPublic	2/2/2002	6162	0.11	AS	GOOD / 90
