The Road Inventory of Catoctin Mountain Park CATO - 3200

Road Inventory Program

Prepared By:
Federal Highway Administration
Eastern Federal Lands Highway Division
Cycle 3

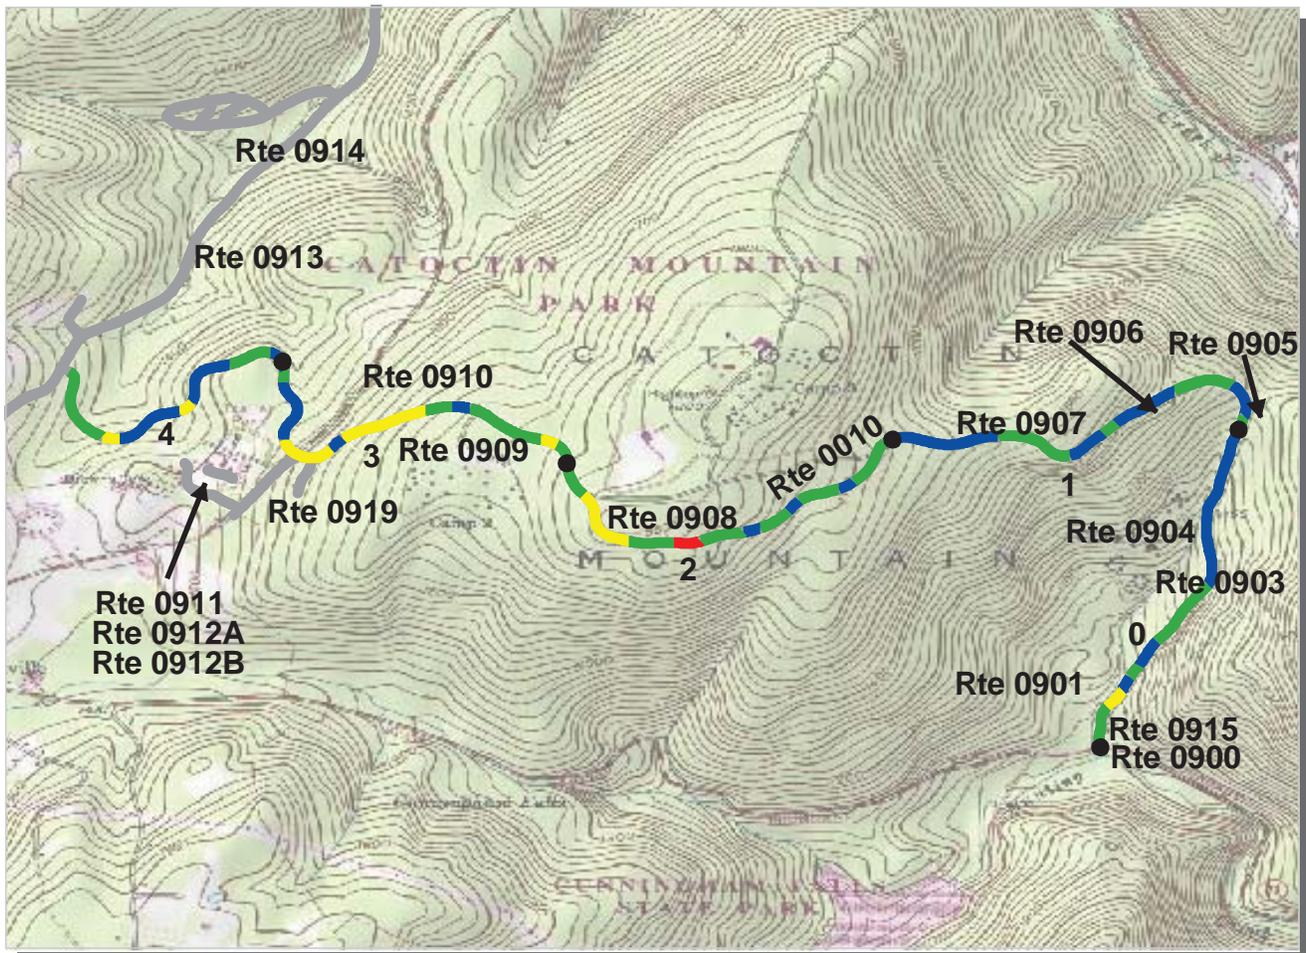
ROUTE: 0010 PARK CENTRAL DRIVE

Section Number	0	1	2	3	4
Section Length (mi)	1.00	1.00	1.00	1.00	0.78
AADT	**				
SADT	**				
ADT Date	**				
Cross Section Information					
Number of Lanes	2	2	2	2	2
Paved Width (ft)	19	18	18	19	19
Lane Width (ft)	9	9	9	10	9
Shoulder Width (ft)	0	0	4	3	4
Roadway Condition Information					
PCR (Pavement Condition Rating)	92	93	88	86	92
RCI (Roughness Condition Index)	86	88	87	77	89
SCR (Surface Condition Rating)	96	97	88	92	94
Alligator Cracking Index	100	100	100	100	100
Rutting Index	96	97	88	92	95
Patching Index	99	100	100	100	100
Transverse Cracking Index	100	100	100	99	99
Longitudinal Cracking Index	100	99	99	99	99
Shoulder Condition Rating	N/A	N/A	GOOD	GOOD	GOOD
Drainage Condition Rating	POOR	POOR	POOR	POOR	POOR

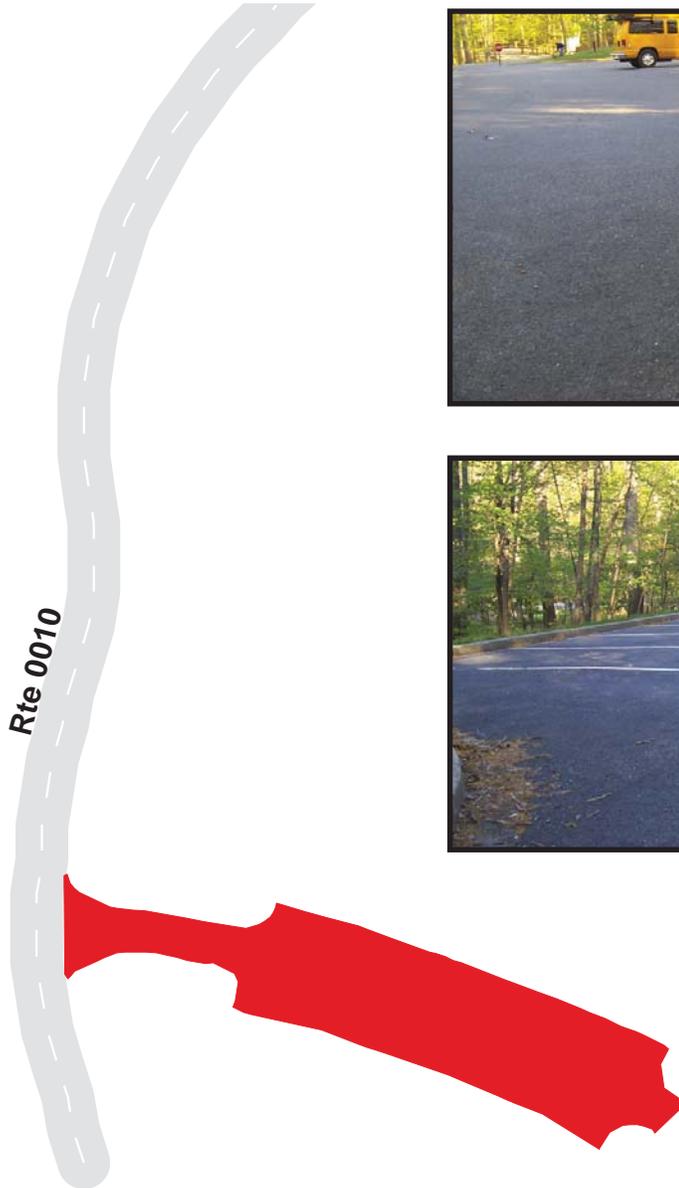
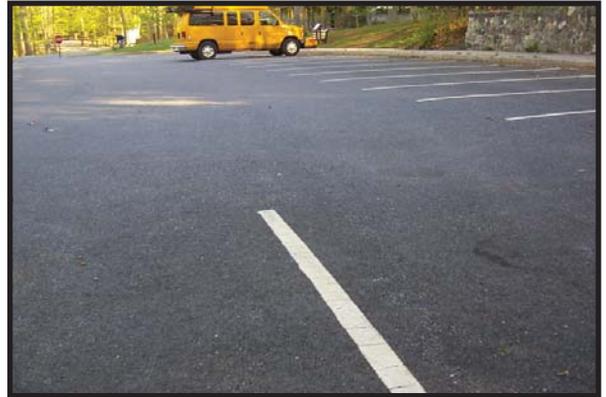
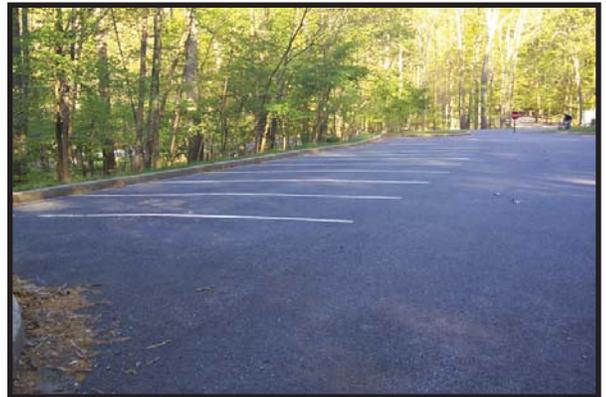
Route	Public / NonPublic	Date Visited	Area (sq ft)	Lane Miles *	Surface Type	Condition / PCR
0900	Public	5/4/2002	12599	0.22	AS	GOOD / 90

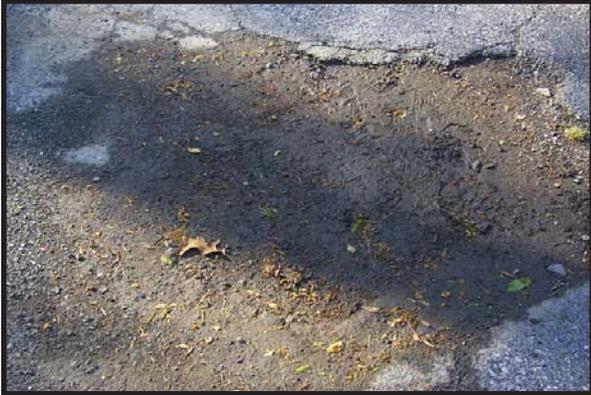
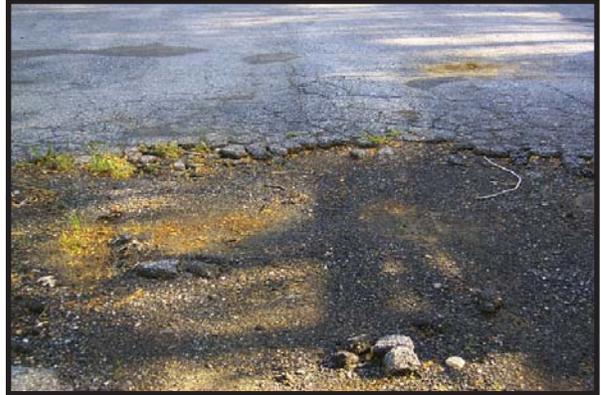
Route 0901

Route	Public / NonPublic	Date Visited	Area (sq ft)	Lane Miles *	Surface Type	Condition / PCR
0901	NonPublic	5/4/2002	16392	0.28	AS	POOR / 45

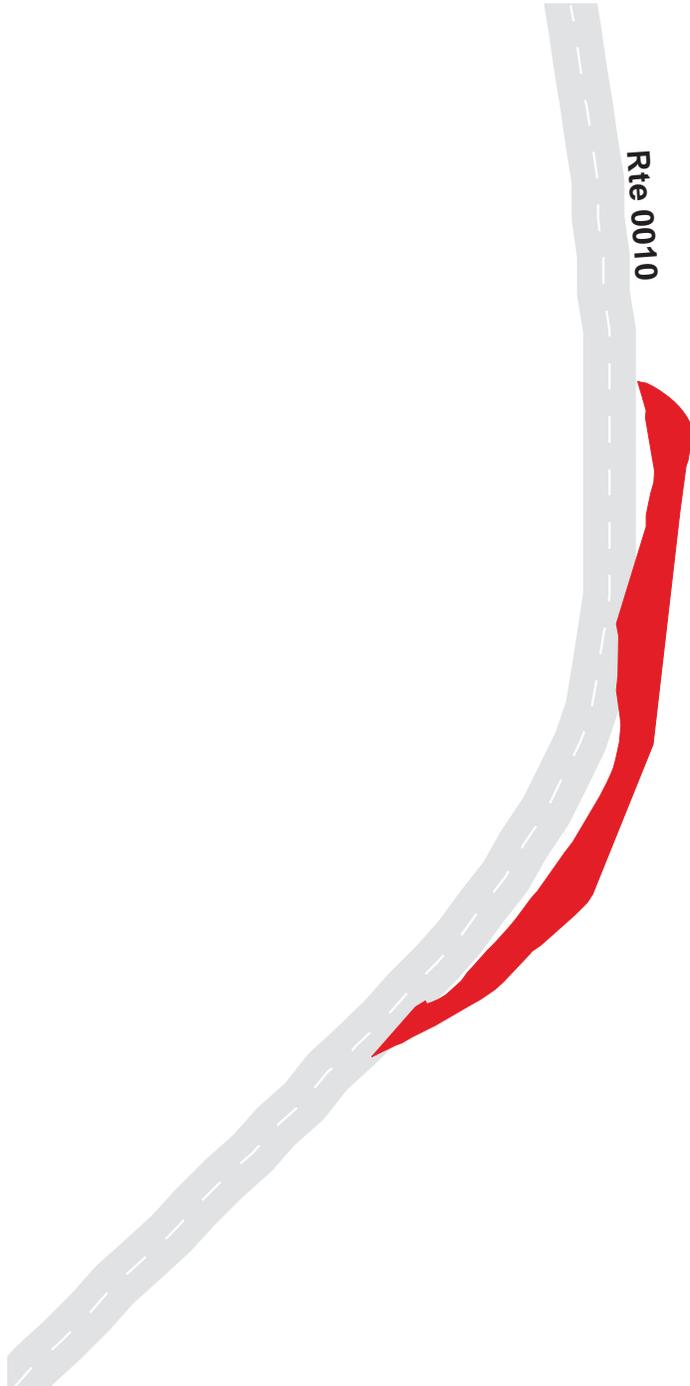
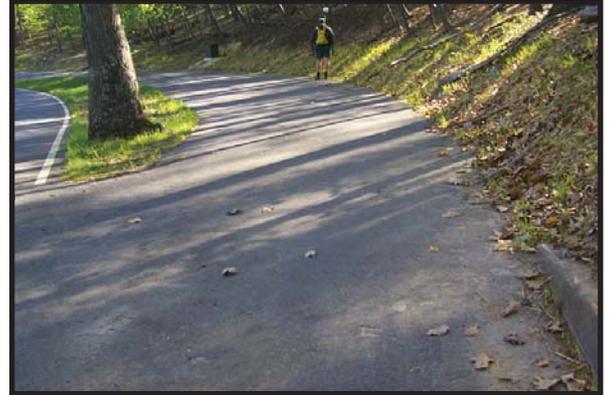
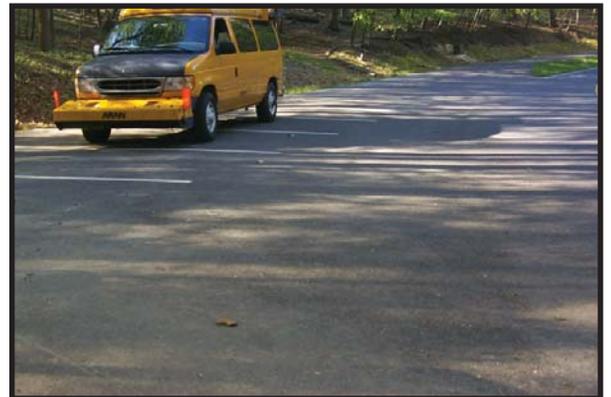
Route 0903

Route	Public / NonPublic	Date Visited	Area (sq ft)	Lane Miles *	Surface Type	Condition / PCR
0903	Public	5/4/2002	4799	0.08	AS	EXCELLENT / 97

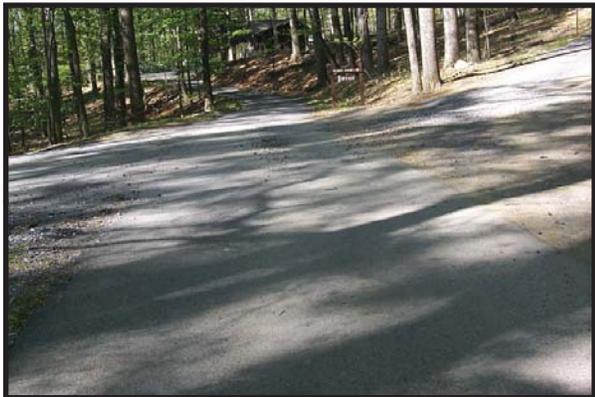
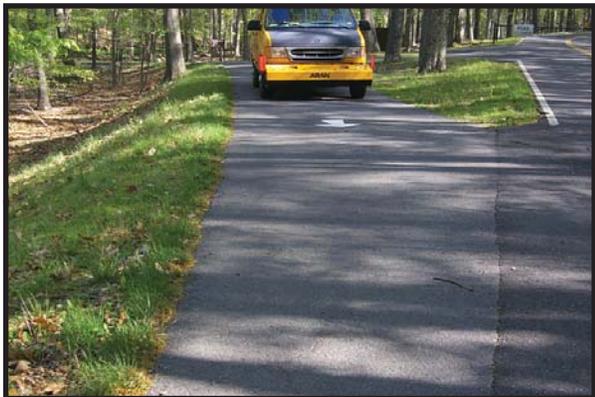
Route 0904

Route	Public / NonPublic	Date Visited	Area (sq ft)	Lane Miles *	Surface Type	Condition / PCR
0904	Public	5/4/2002	27011	0.47	AS	GOOD / 90

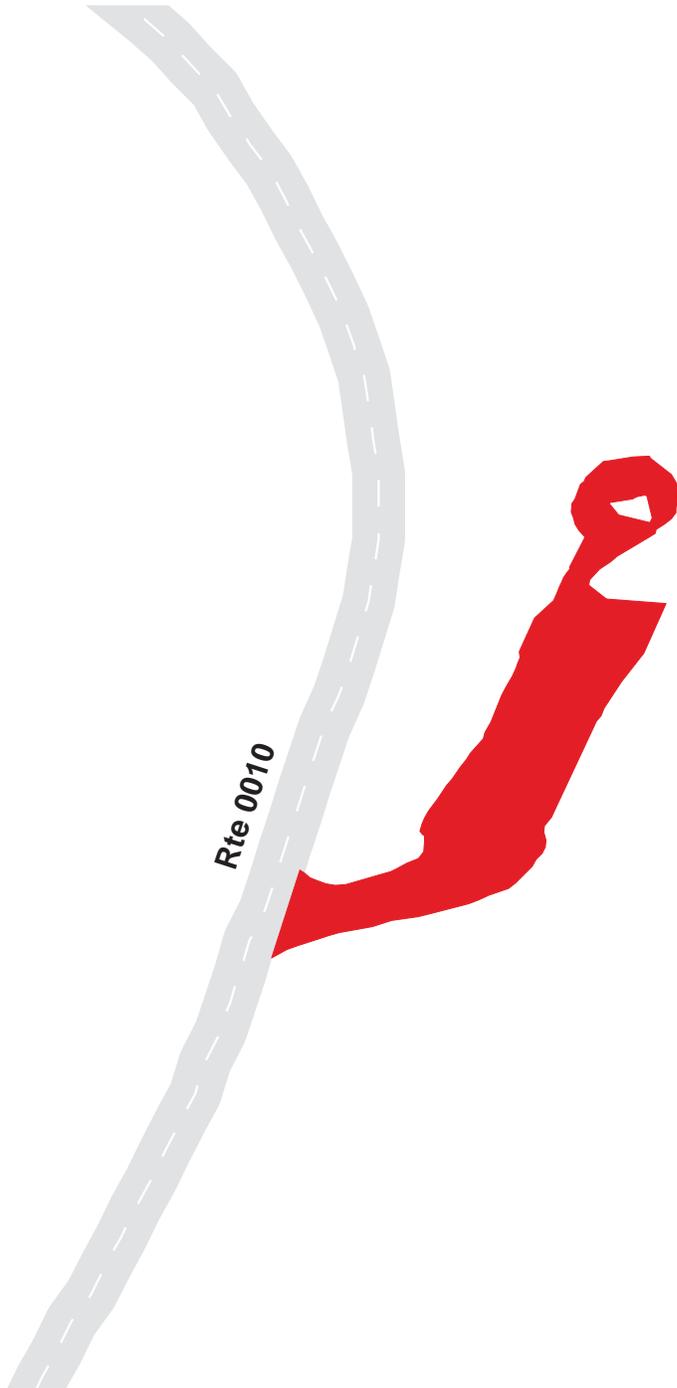
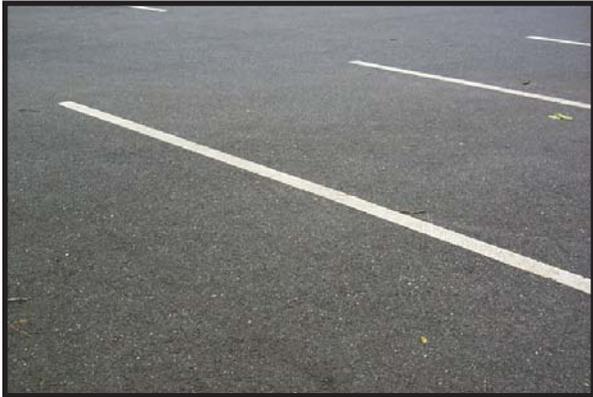
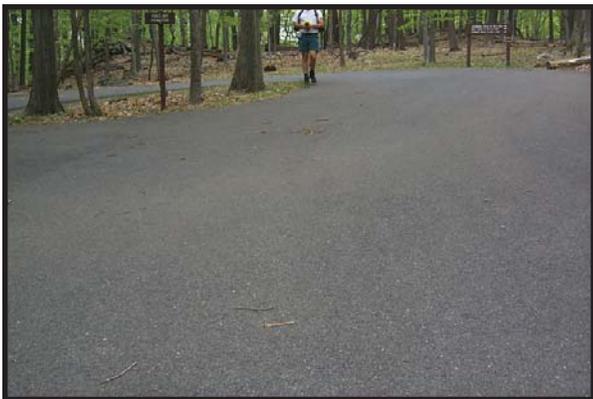
Route 0905

Route	Public / NonPublic	Date Visited	Area (sq ft)	Lane Miles *	Surface Type	Condition / PCR
0905	Public	5/4/2002	12396	0.21	AS	EXCELLENT / 97

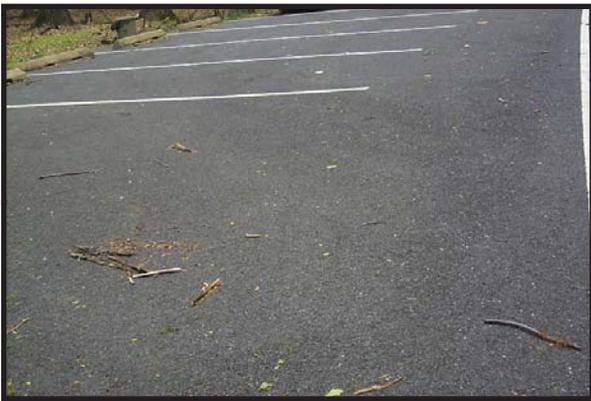
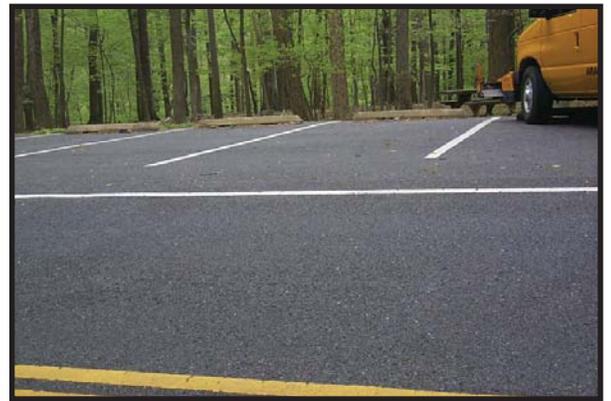
Catoctin Mountain Park
Route 0906
 PARK CENTRAL PICNIC PARKING
 From Route 0010

Route	Public / NonPublic	Date Visited	Area (sq ft)	Lane Miles *	Surface Type	Condition / PCR
0906	Public	5/4/2002	1792	0.03	AS	EXCELLENT / 97

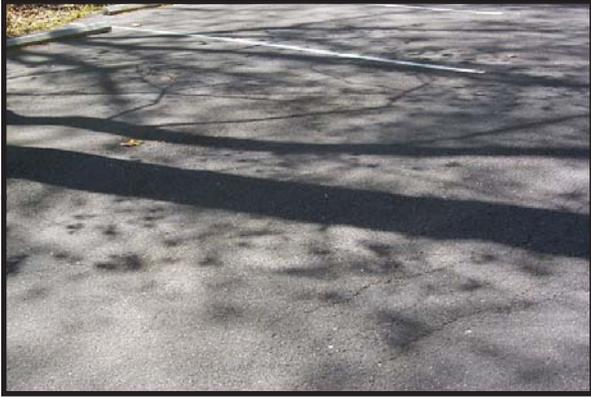
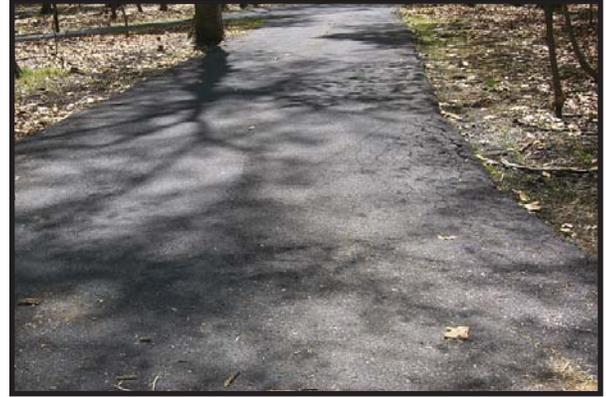
Catoctin Mountain Park
Route 0910
 CHESTNUT PICNIC PARKING
 From Route 0010

Route	Public / NonPublic	Date Visited	Area (sq ft)	Lane Miles *	Surface Type	Condition / PCR
0910	Public	5/4/2002	31802	0.55	AS	FAIR / 73

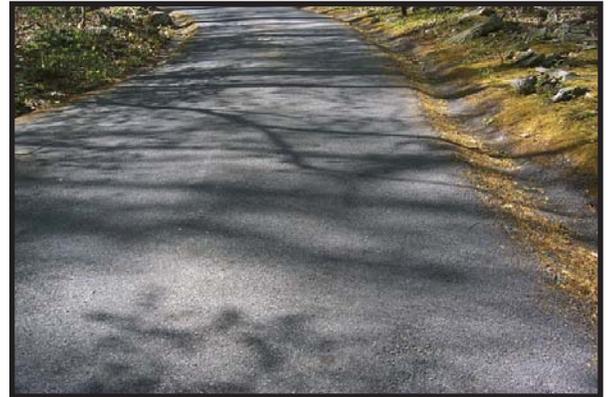
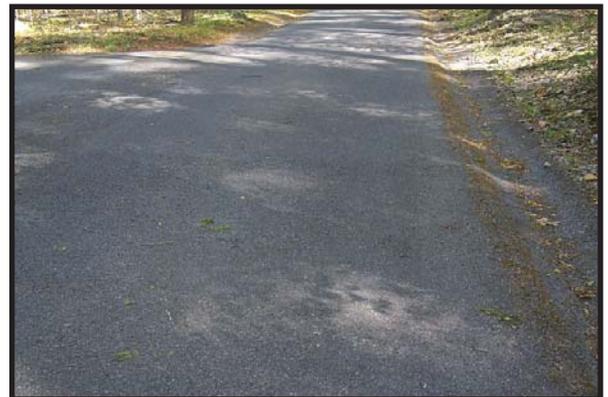
Catoctin Mountain Park
Route 0913
 OWENS CREEK PICNIC PARKING
 From Route 0011

Route	Public / NonPublic	Date Visited	Area (sq ft)	Lane Miles *	Surface Type	Condition / PCR
0913	Public	5/4/2002	27485	0.47	AS	FAIR / 73

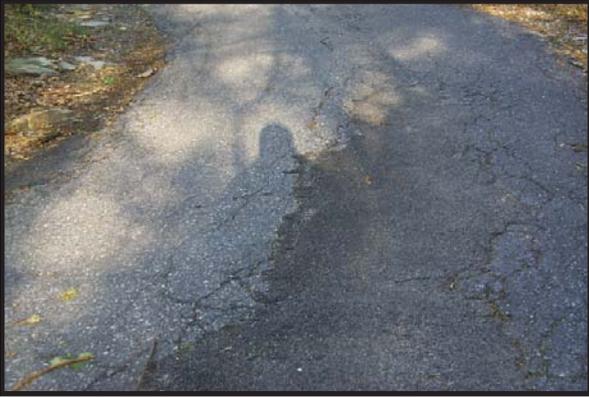
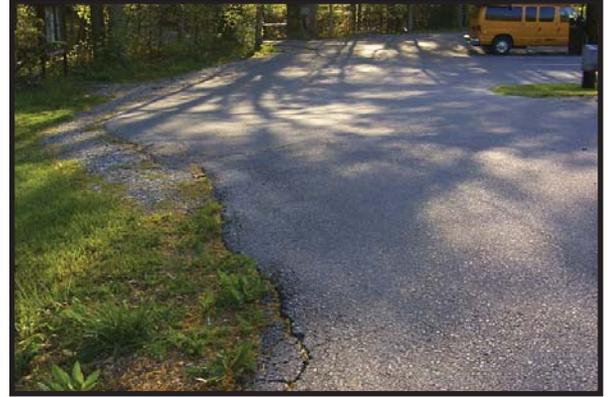
Route 0917

Route	Public / NonPublic	Date Visited	Area (sq ft)	Lane Miles *	Surface Type	Condition / PCR
0917	NonPublic	5/4/2002	12407	0.21	AS	POOR / 45
