# The Road Inventory of Carlsbad Caverns National Park CAVE- 7170

## Road Inventory Program

Prepared By:  
Federal Highway Administration  
Eastern Federal Lands Highway Division  
Cycle 3

# Carlsbad Caverns National Park in New Mexico

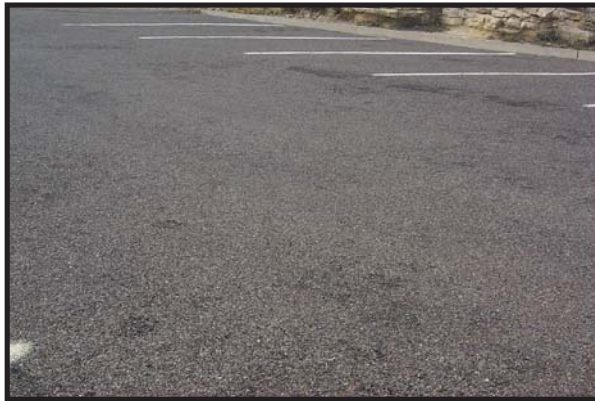
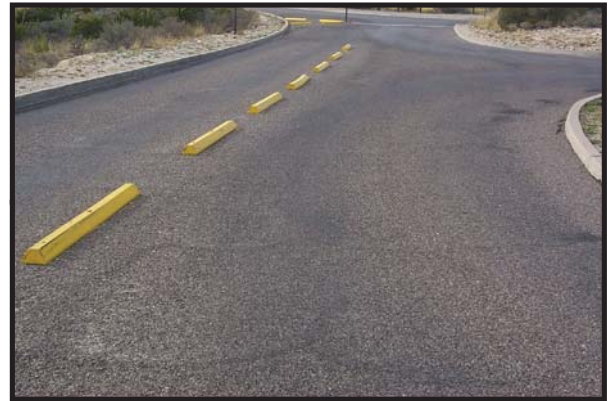
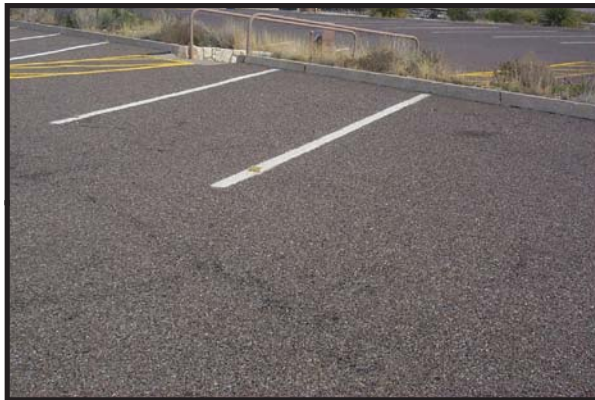
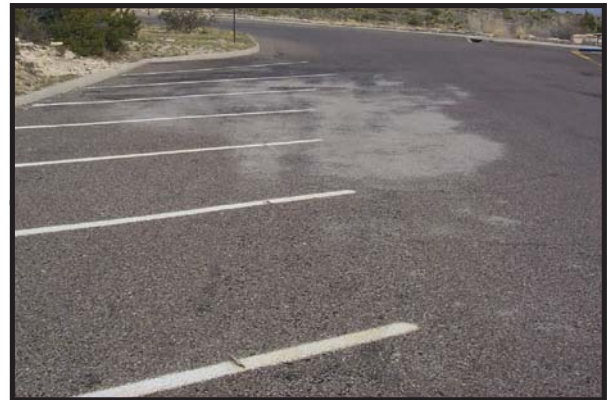
Route	Public / NonPublic	Date Visited	Area (sq ft)	Lane Miles *	Surface Type	Condition / PCR
0900	Public	3/3/2003	164746	2.84	OC	GOOD / 90

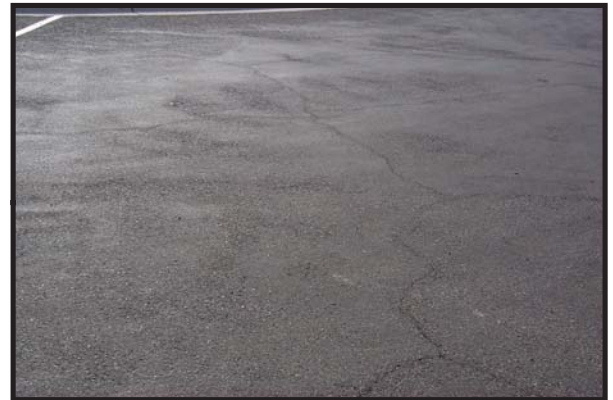
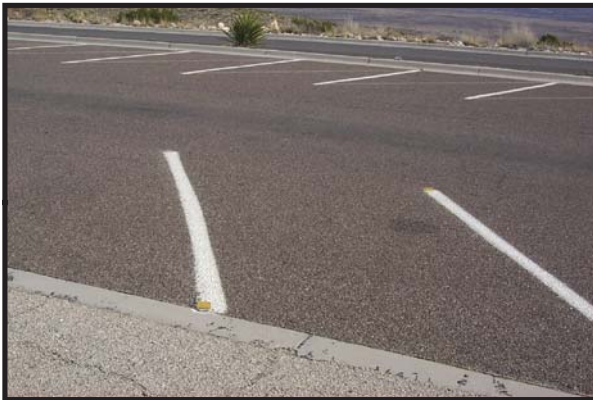
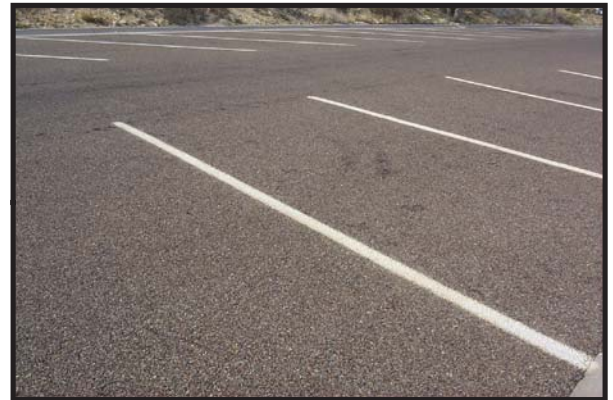
## Route 0901

Route	Public / NonPublic	Date Visited	Area (sq ft)	Lane Miles *	Surface Type	Condition / PCR
0901	Public	3/3/2003	133729	2.30	AS	FAIR / 73

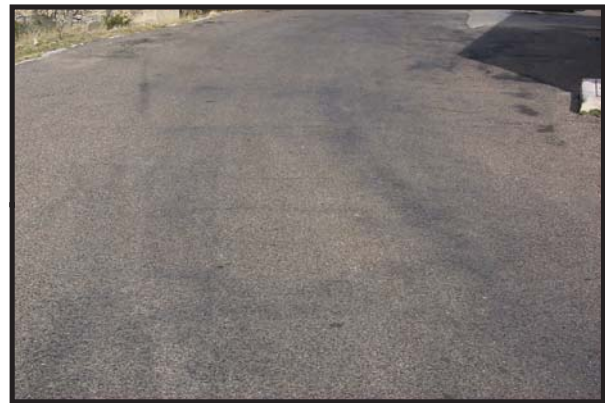
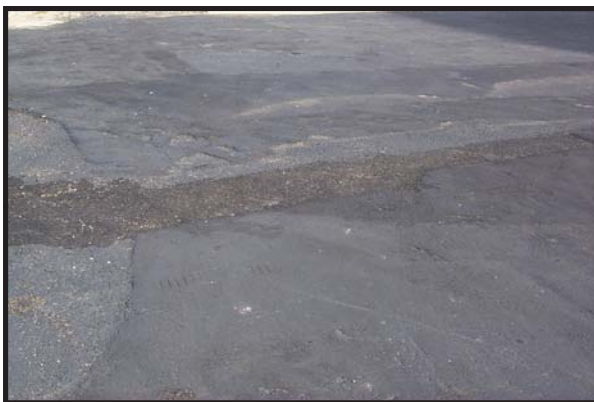
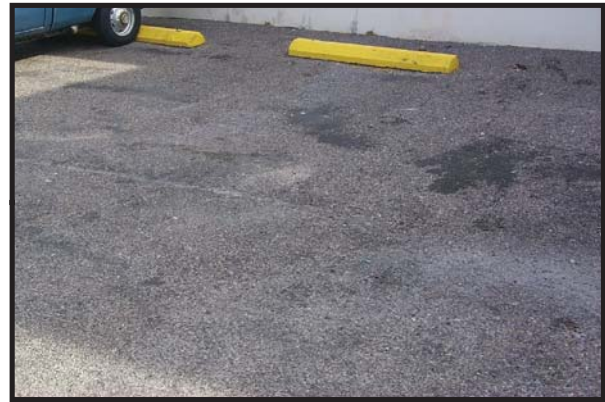
## Route 0902

Route	Public / NonPublic	Date Visited	Area (sq ft)	Lane Miles *	Surface Type	Condition / PCR
0902	NonPublic	3/3/2003	9672	0.17	OC	FAIR / 73

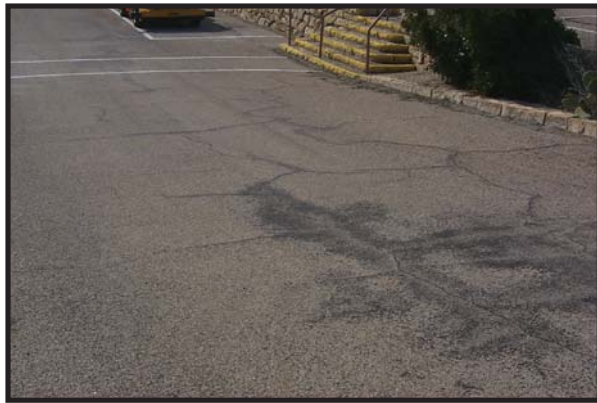
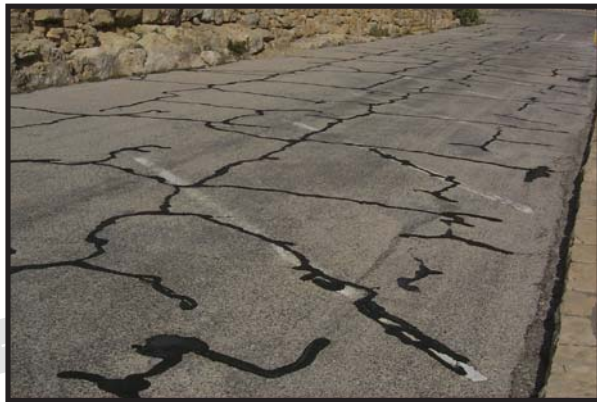
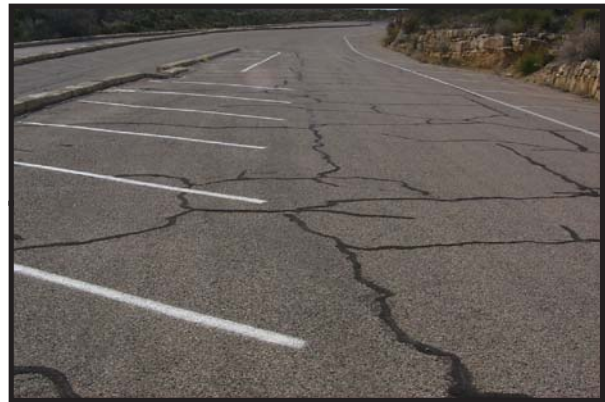
## Route 0903

Route	Public / NonPublic	Date Visited	Area (sq ft)	Lane Miles *	Surface Type	Condition / PCR
0903	Public	3/3/2003	70105	1.21	AS	POOR / 45

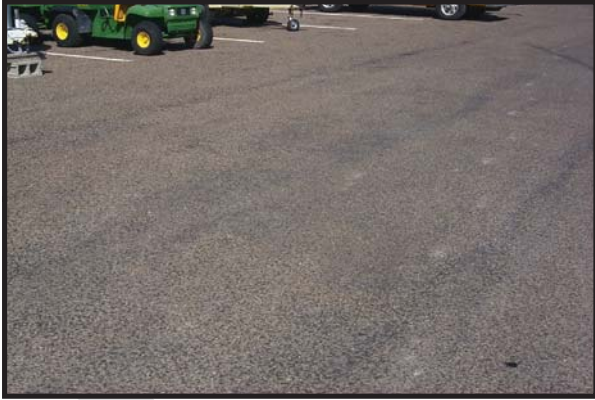
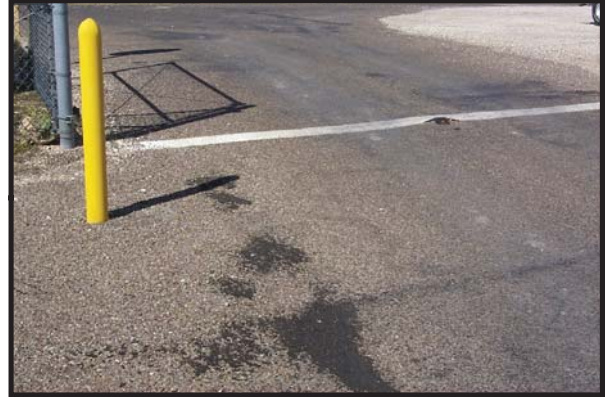
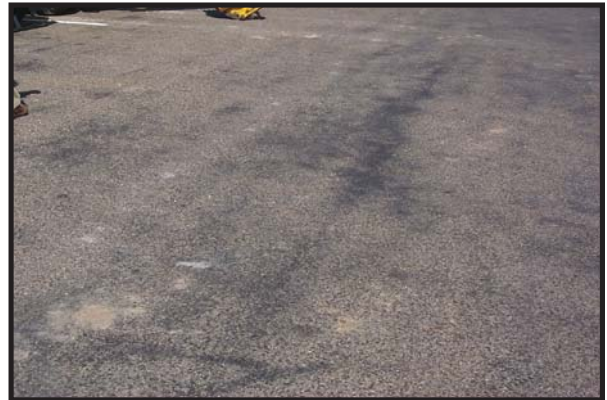
## Route 0904

Route	Public / NonPublic	Date Visited	Area (sq ft)	Lane Miles *	Surface Type	Condition / PCR
0904	NonPublic	3/3/2003	19936	0.34	AS	FAIR / 73

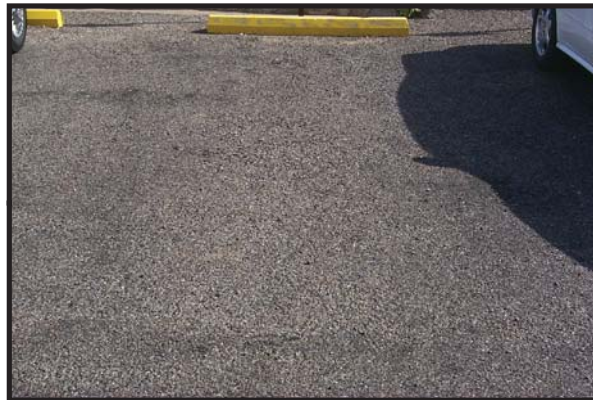
## Route 0908

Route	Public / NonPublic	Date Visited	Area (sq ft)	Lane Miles *	Surface Type	Condition / PCR
0908	NonPublic	3/3/2003	591	0.01	OC	GOOD / 90

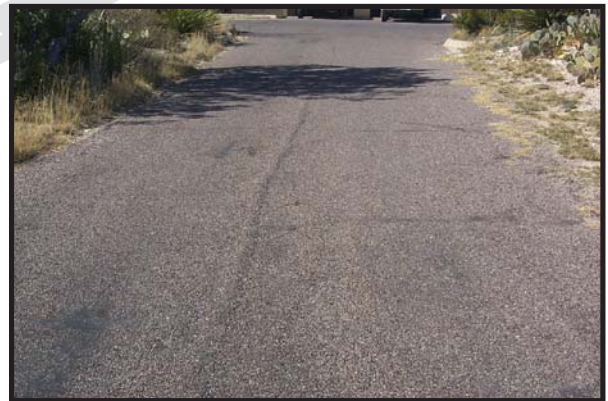
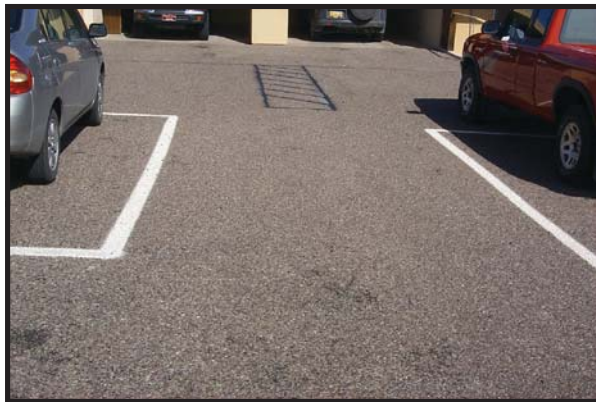
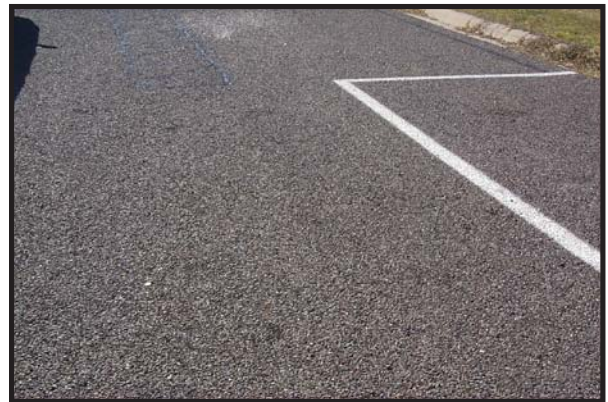
## Route 0910

Route	Public / NonPublic	Date Visited	Area (sq ft)	Lane Miles *	Surface Type	Condition / PCR
0910	NonPublic	3/3/2003	5515	0.09	OC	GOOD / 90

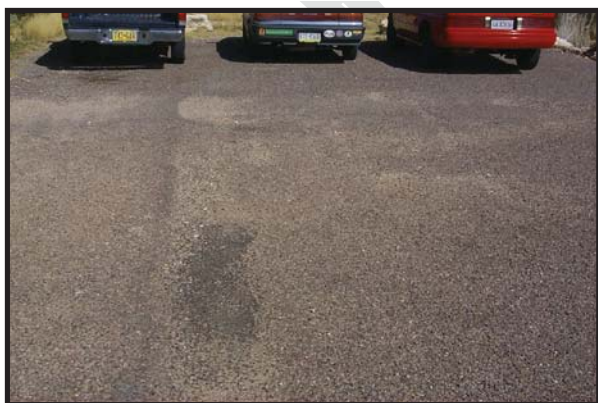
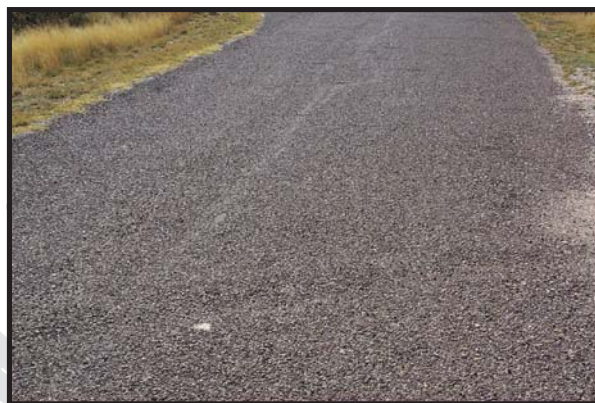
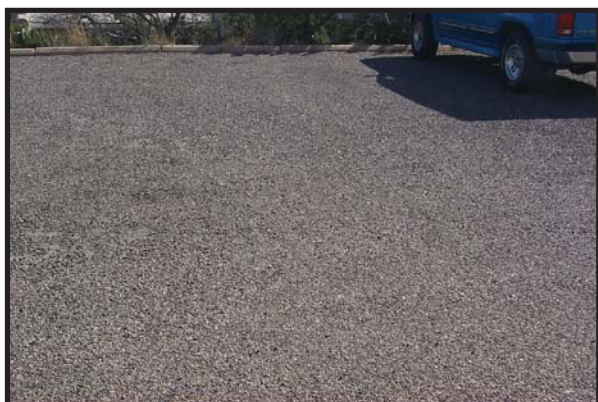
## Route 0911

Route	Public / NonPublic	Date Visited	Area (sq ft)	Lane Miles *	Surface Type	Condition / PCR
0911	NonPublic	3/3/2003	6755	0.12	OC	FAIR / 73

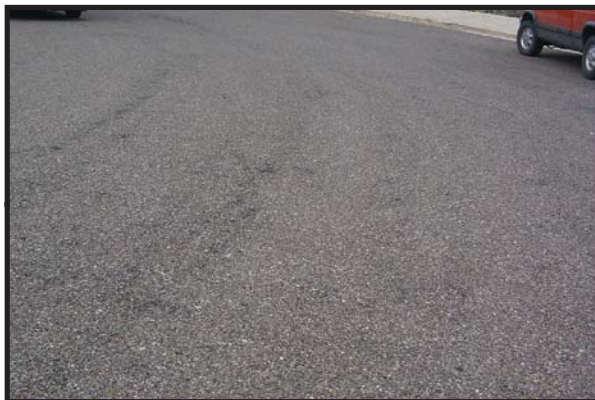
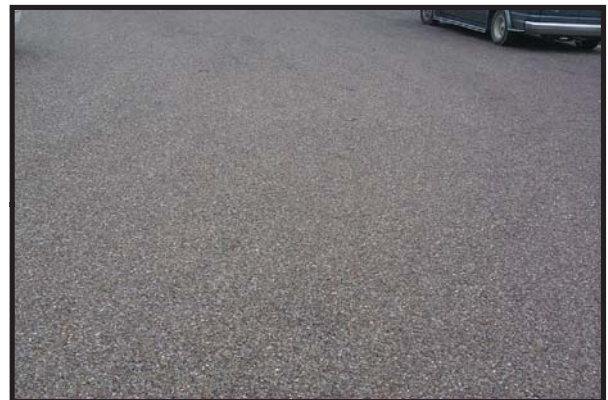
## Route 0914

Route	Public / NonPublic	Date Visited	Area (sq ft)	Lane Miles *	Surface Type	Condition / PCR
0914	Public	3/3/2003	12476	0.21	OC	FAIR / 73

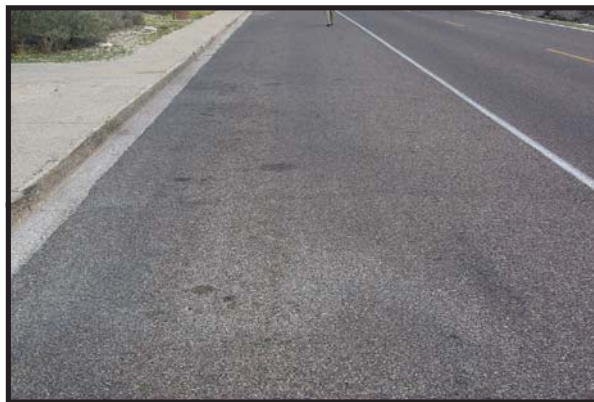
## Route 0915

Route	Public / NonPublic	Date Visited	Area (sq ft)	Lane Miles *	Surface Type	Condition / PCR
0915	Public	3/3/2003	3095	0.05	OC	GOOD / 90
