The Road Inventory of Capulin Volcano National Monument CAVO – 7160

Road Inventory Program

Prepared By:
Federal Highway Administration
Eastern Federal Lands Highway Division
Cycle 3

Capulin Volcano National Monument in New Mexico

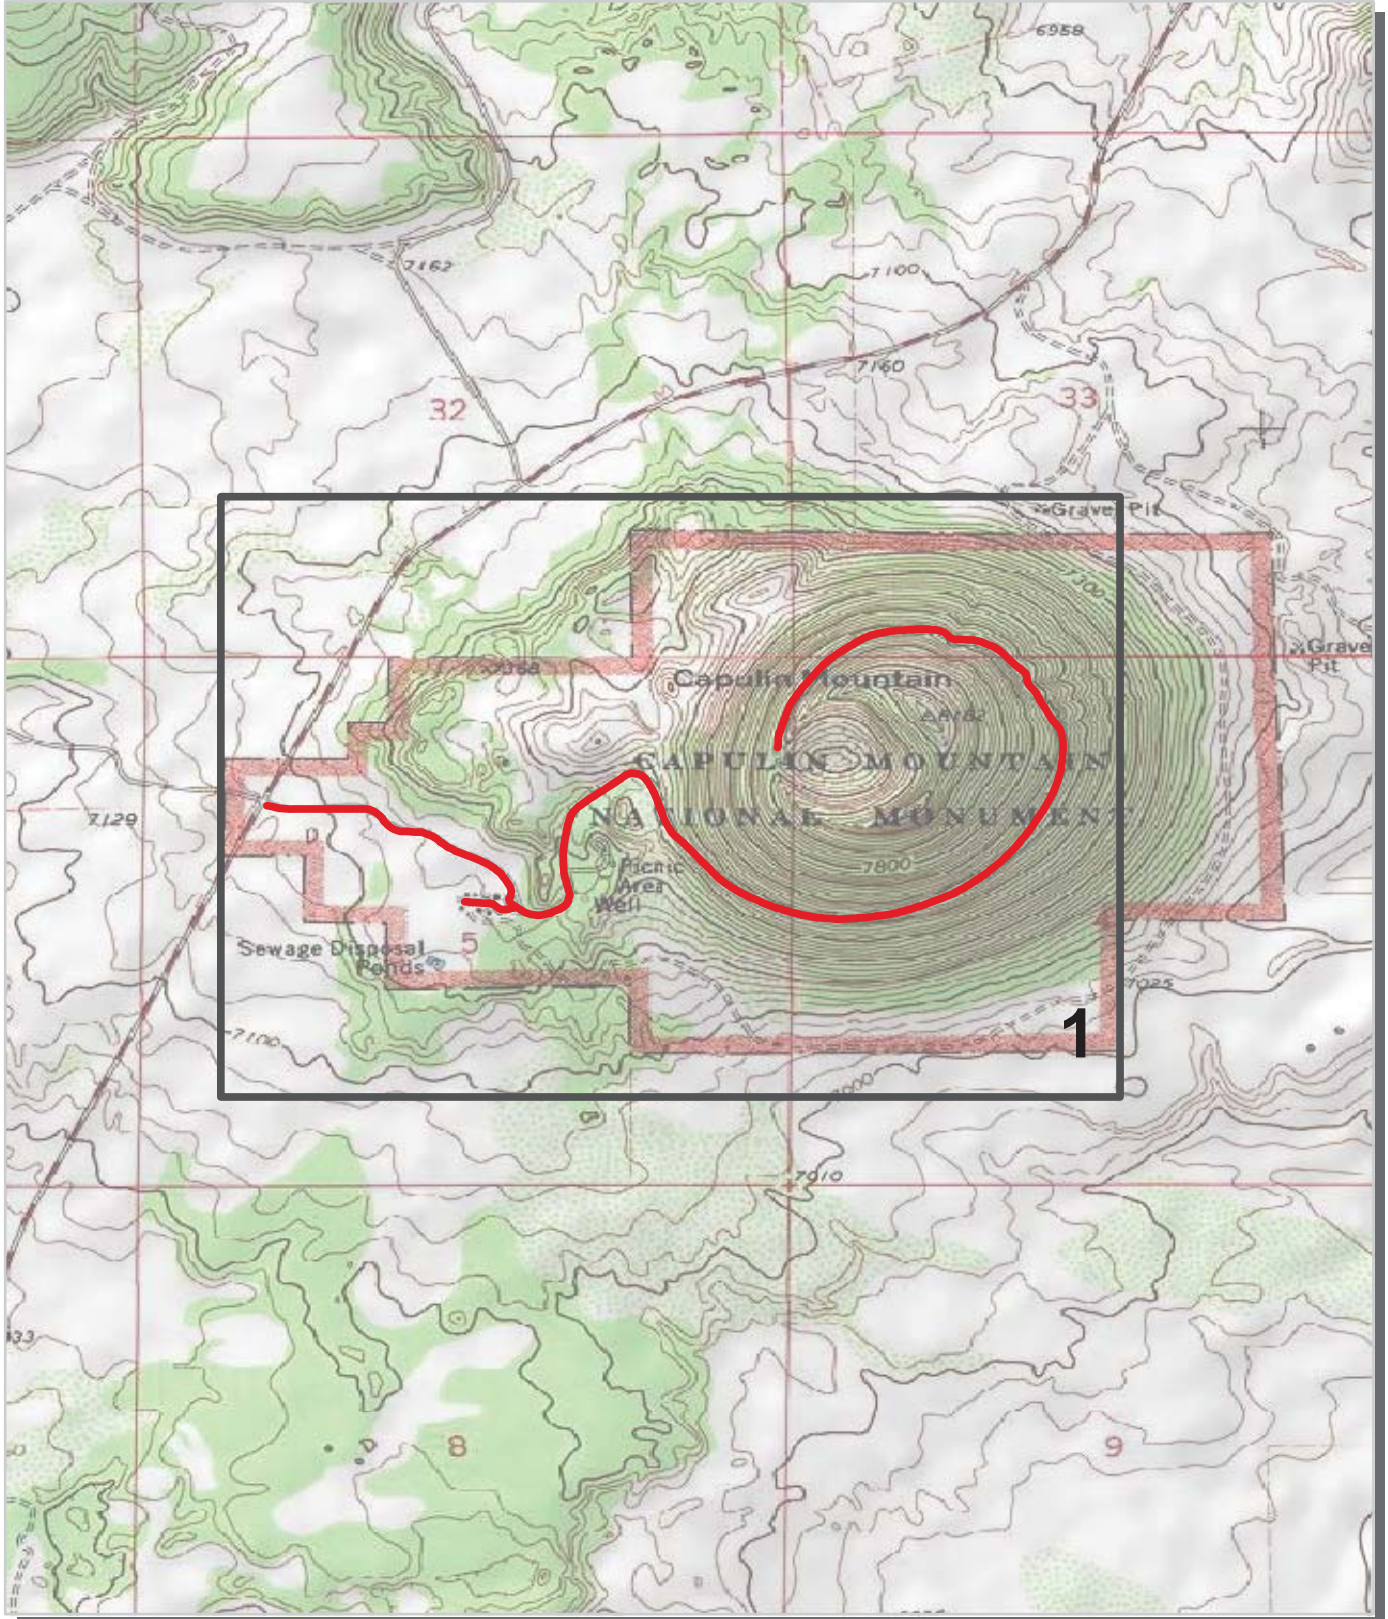
Capulin Volcano National Monument Route Location Key Map

Park Owned Routes

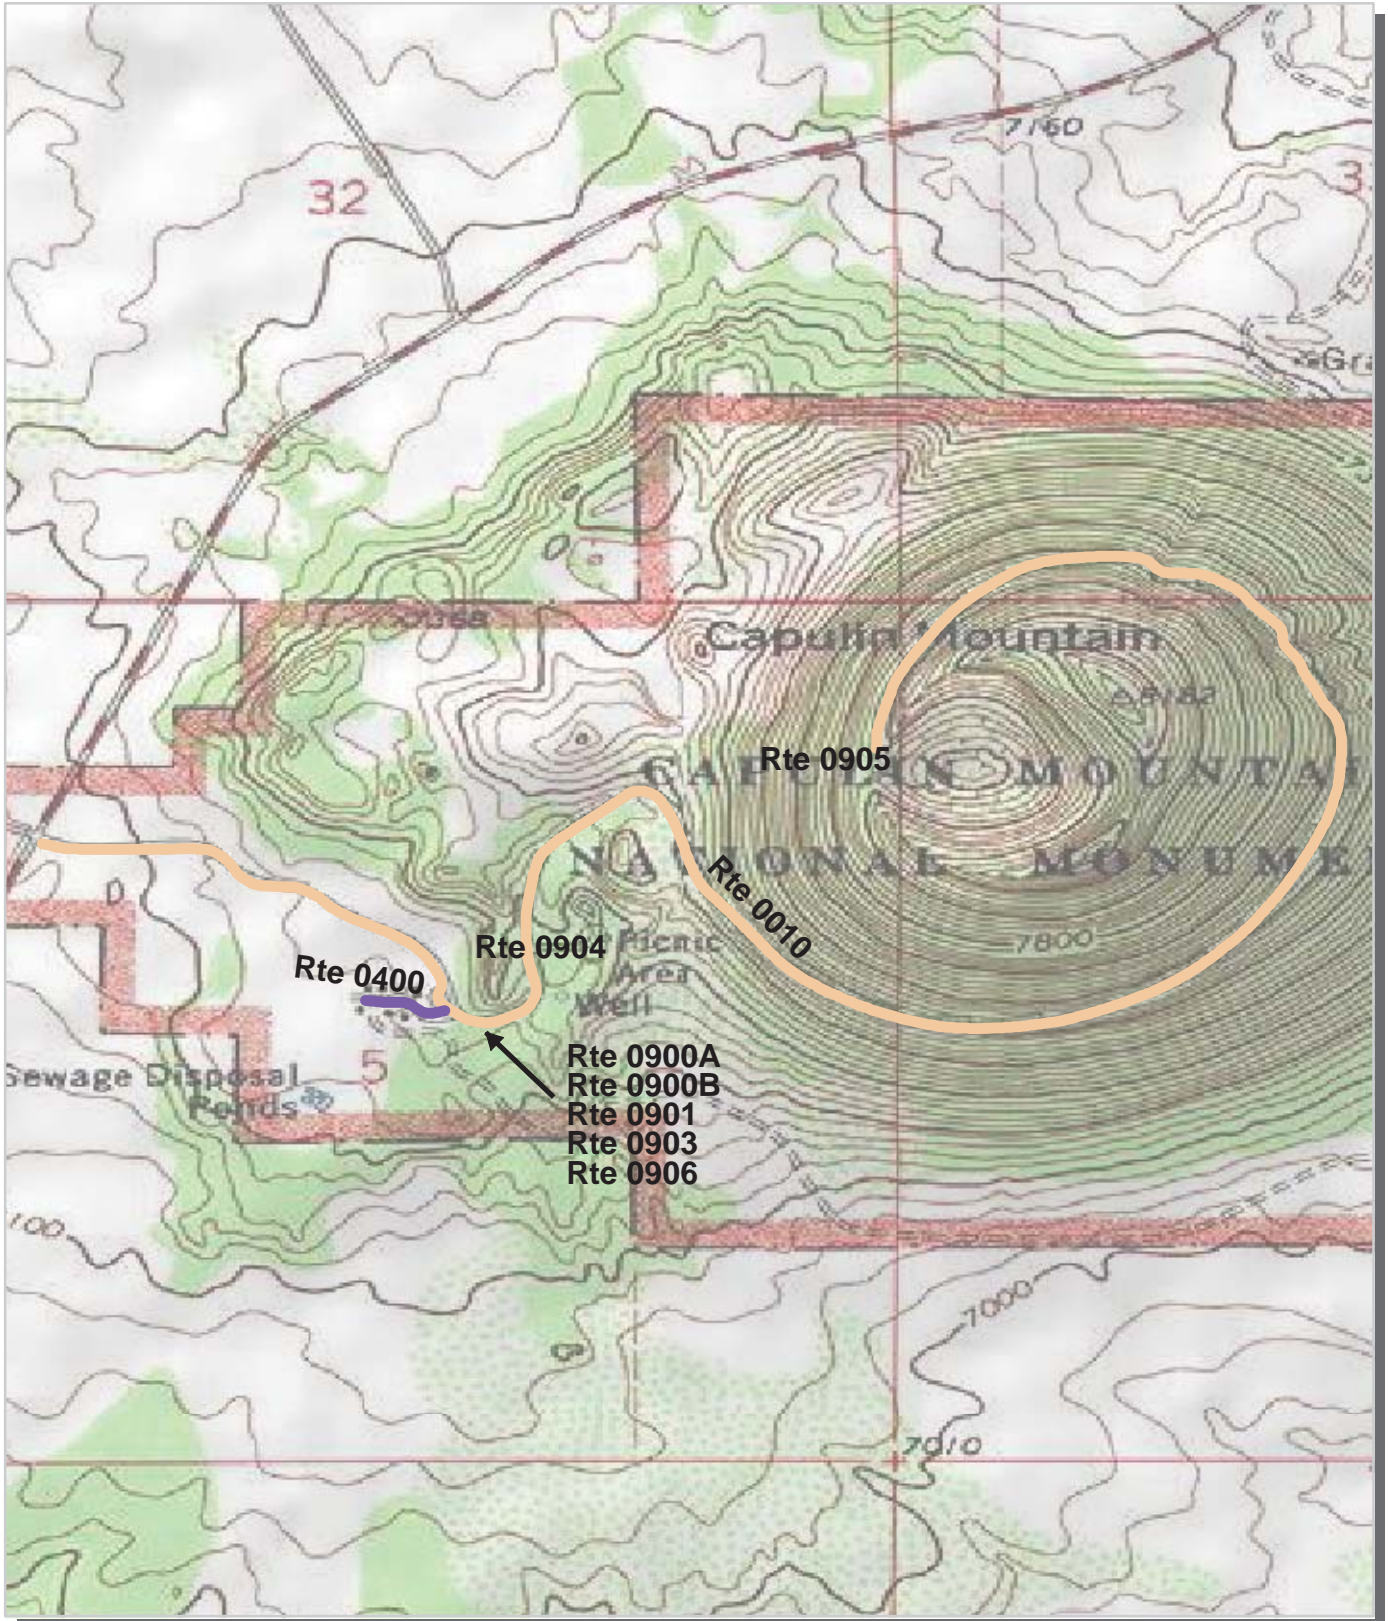
Capulin Volcano National Monument Route Location Area Map 1

Unique colors used to differentiate routes

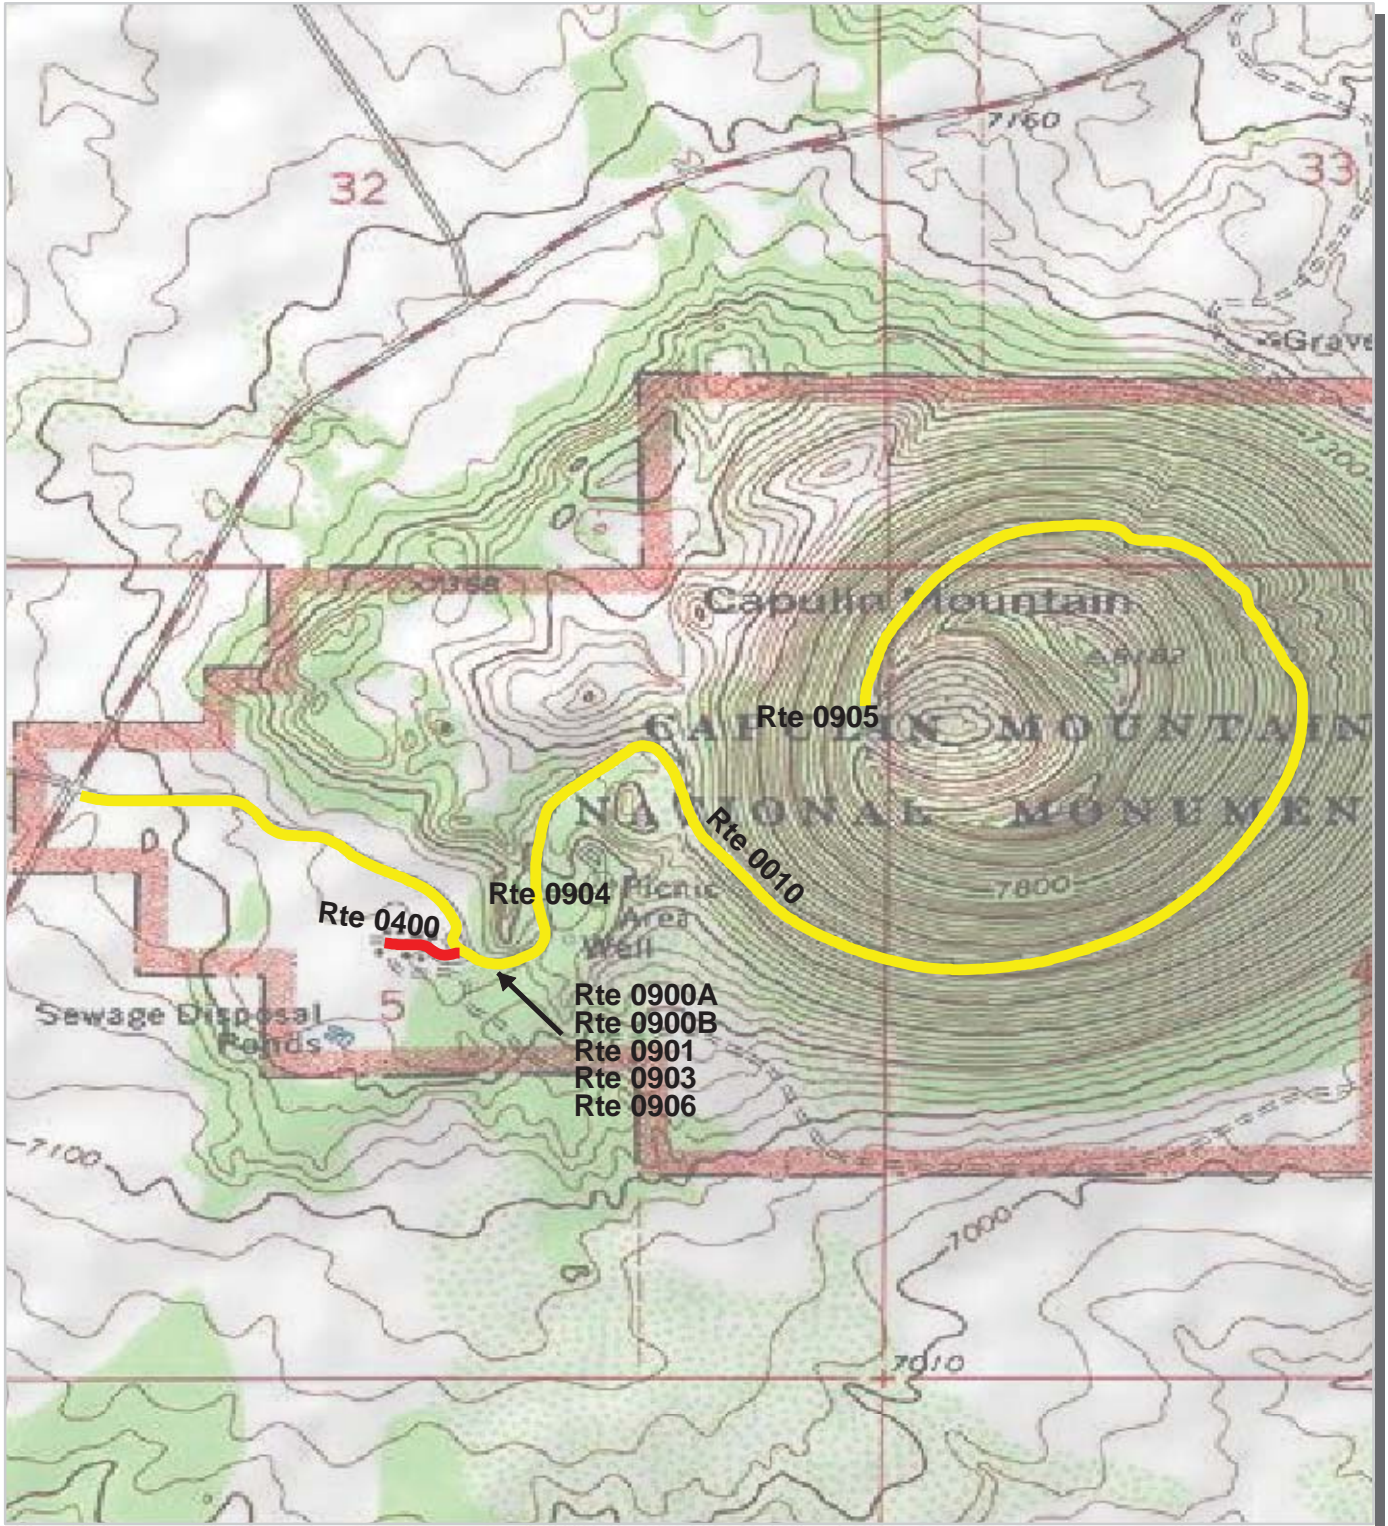
Capulin Volcano National Monument Route Condition Key Map PCR - Mile by Mile

| PCR | Poor | | Fair | | Good | | Excellent | |
| | | (≤ 60) | | (61 - 84) | | (85 - 94) | | (95 - 100) |

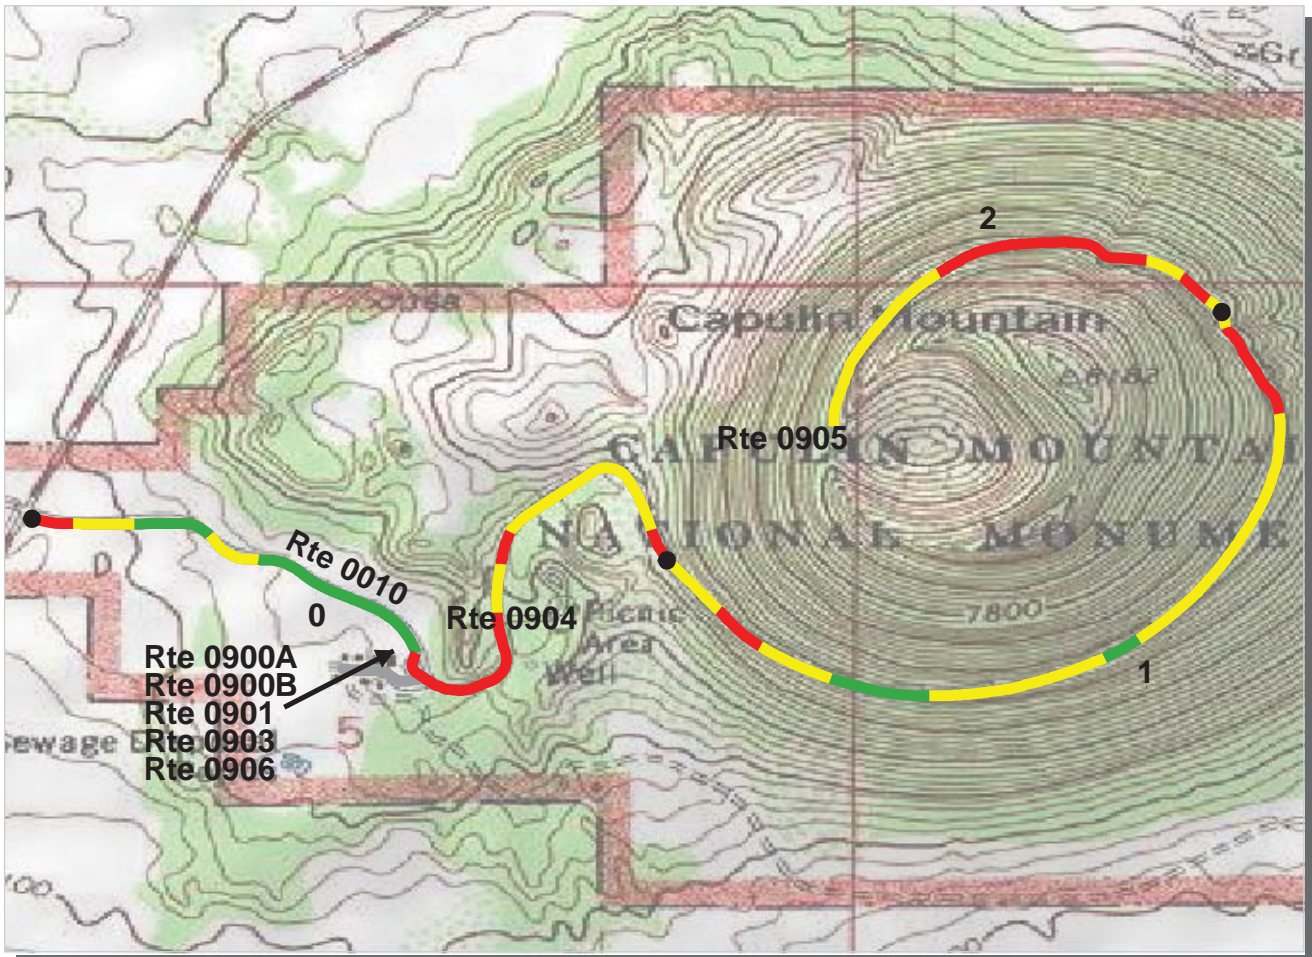
ROUTE: 0010 Capulin Volcano Road **TOTAL LENGTH: 2.55 Miles**

| Section Number | 0 | 1 | 2 | | |
|---|---|---|---|--|--|
| PCR (Pavement Condition Rating) | 68 | 70 | 62 | | |
| RCI (Roughness Condition Index) | 83 | 78 | 74 | | |
| SCR (Surface Condition Rating) | 61 | 64 | 54 | | |
| Shoulder Condition Rating | GOOD | GOOD | GOOD | | |
| Drainage Condition Rating | GOOD | GOOD | GOOD | | |

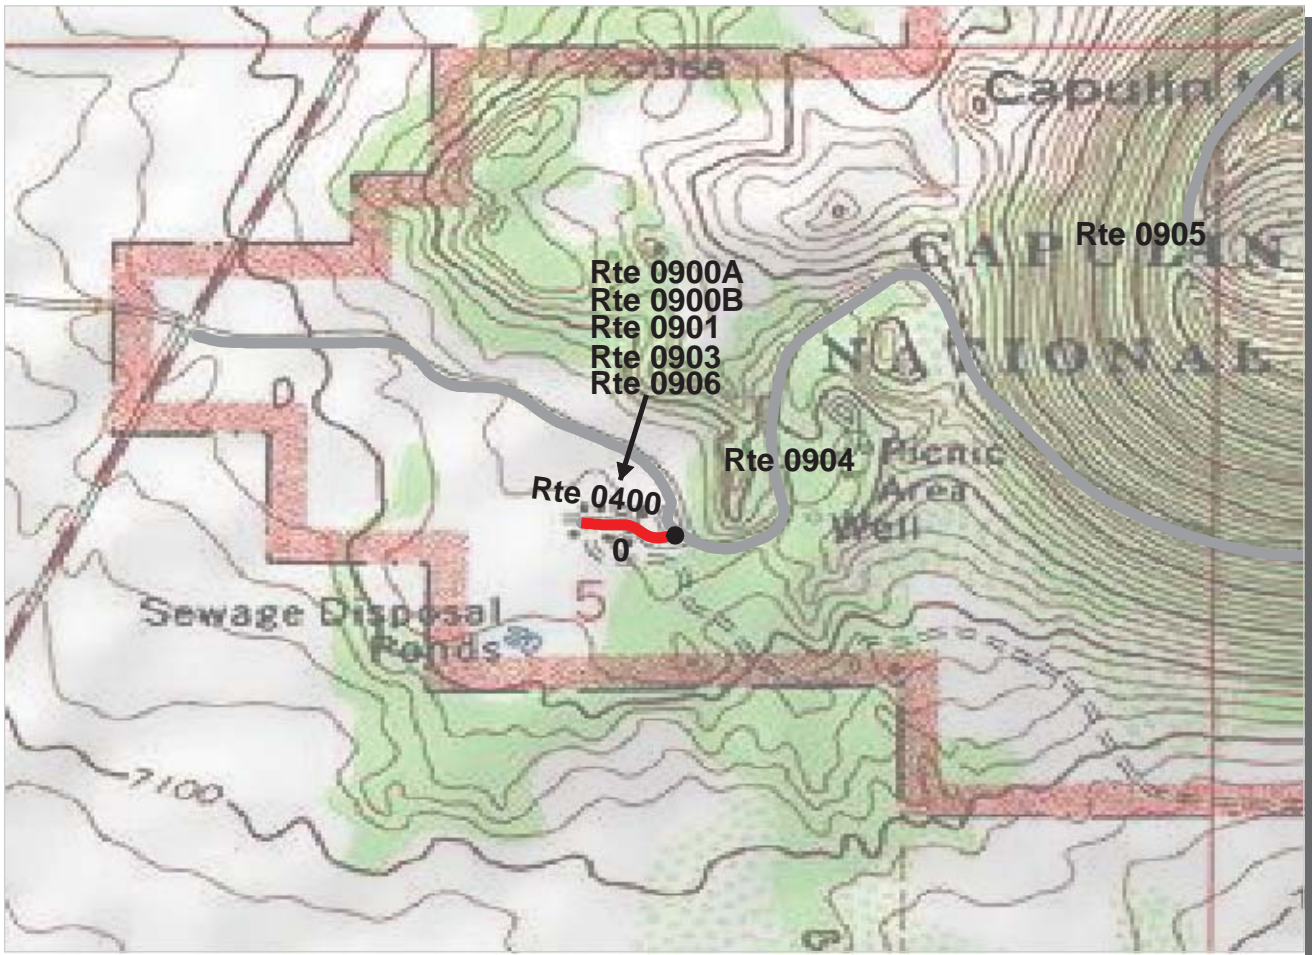
ROUTE: 0400 Maintenance Shop Access/ Residential Road TOTAL LENGTH: 0.10 Miles

| PCR (Pavement Condition Rating) | 24 | | | |
| RCI (Roughness Condition Index) | NC | | | |
| SCR (Surface Condition Rating) | 24 | | | |
| Transverse Cracking Index | 60 | | | |
| Drainage Condition Rating | GOOD | | | |

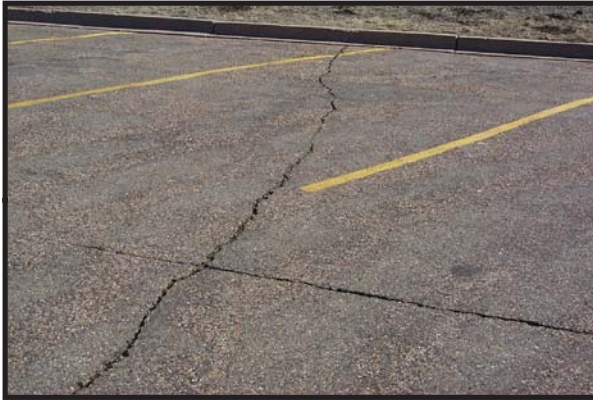
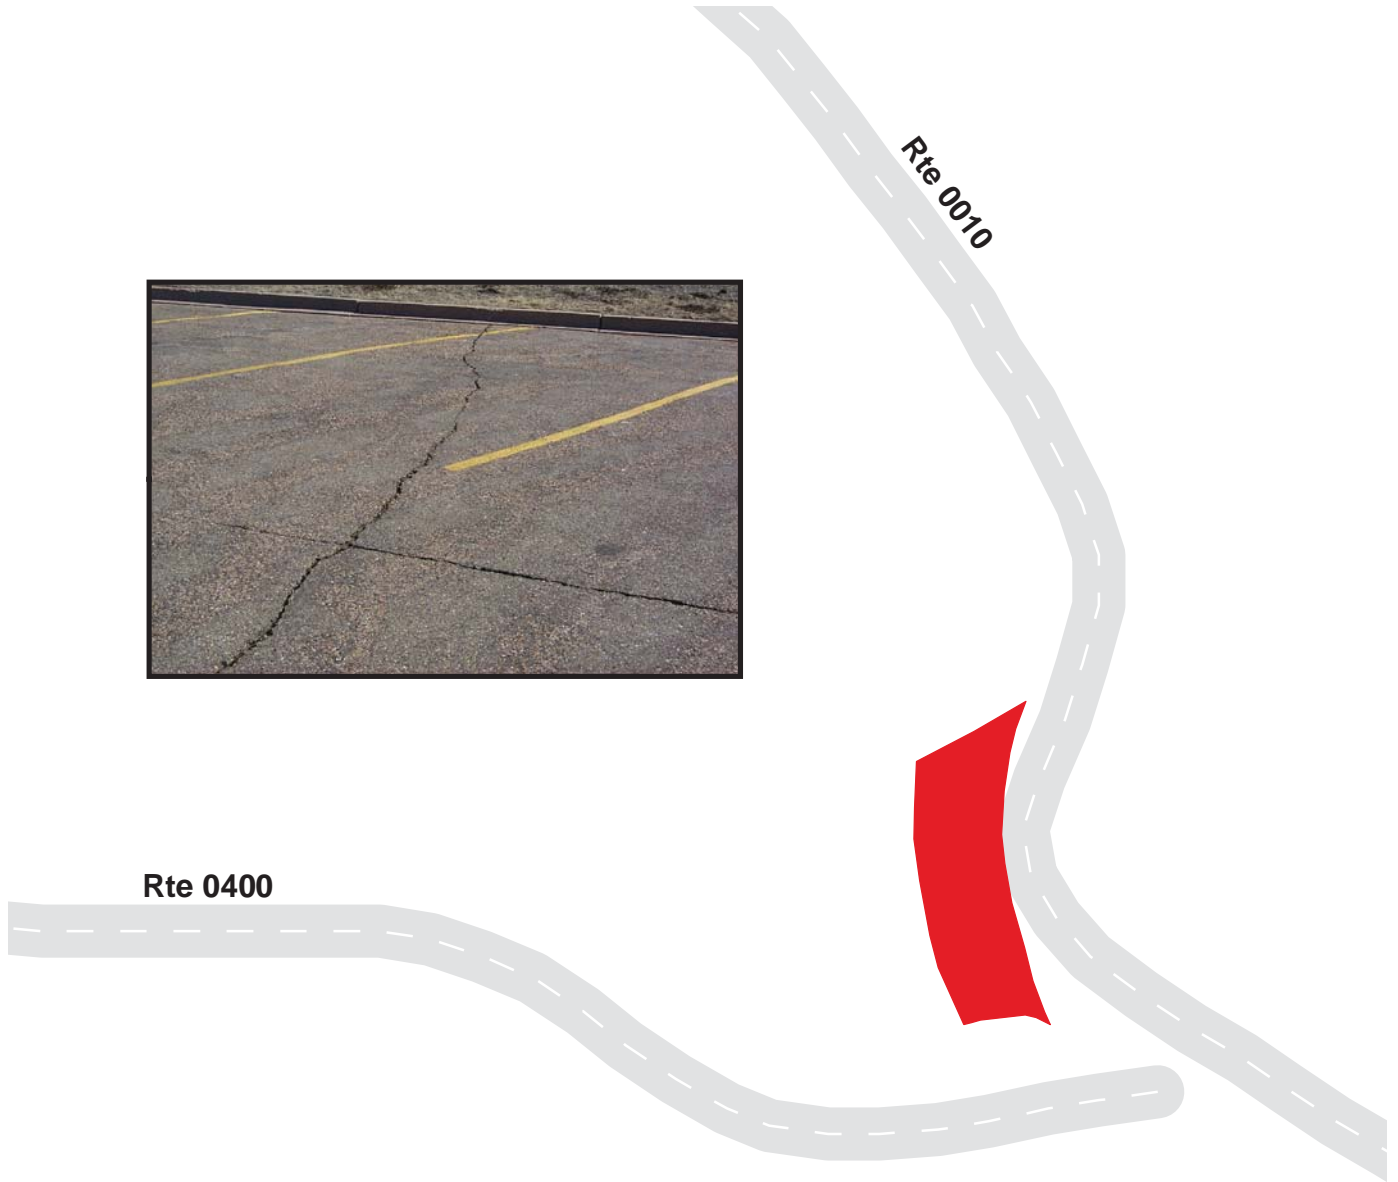
| Route | Public / NonPublic | Date Visited | Area (sq ft) | Lane Miles * | Surface Type | Condition / PCR |
|---|---|---|---|---|---|---|
| 0900A | Public | 3/11/2003 | 2215 | 0.04 | OC | FAIR / 73 |

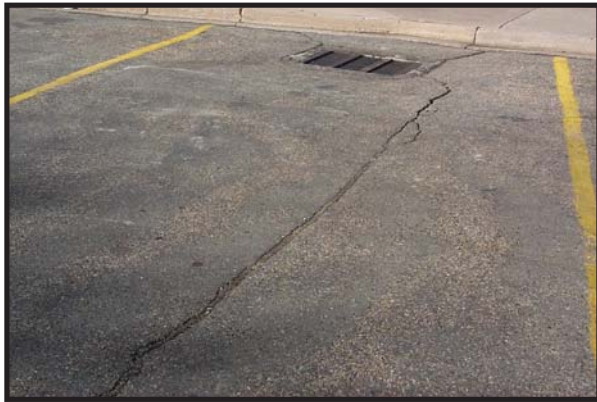
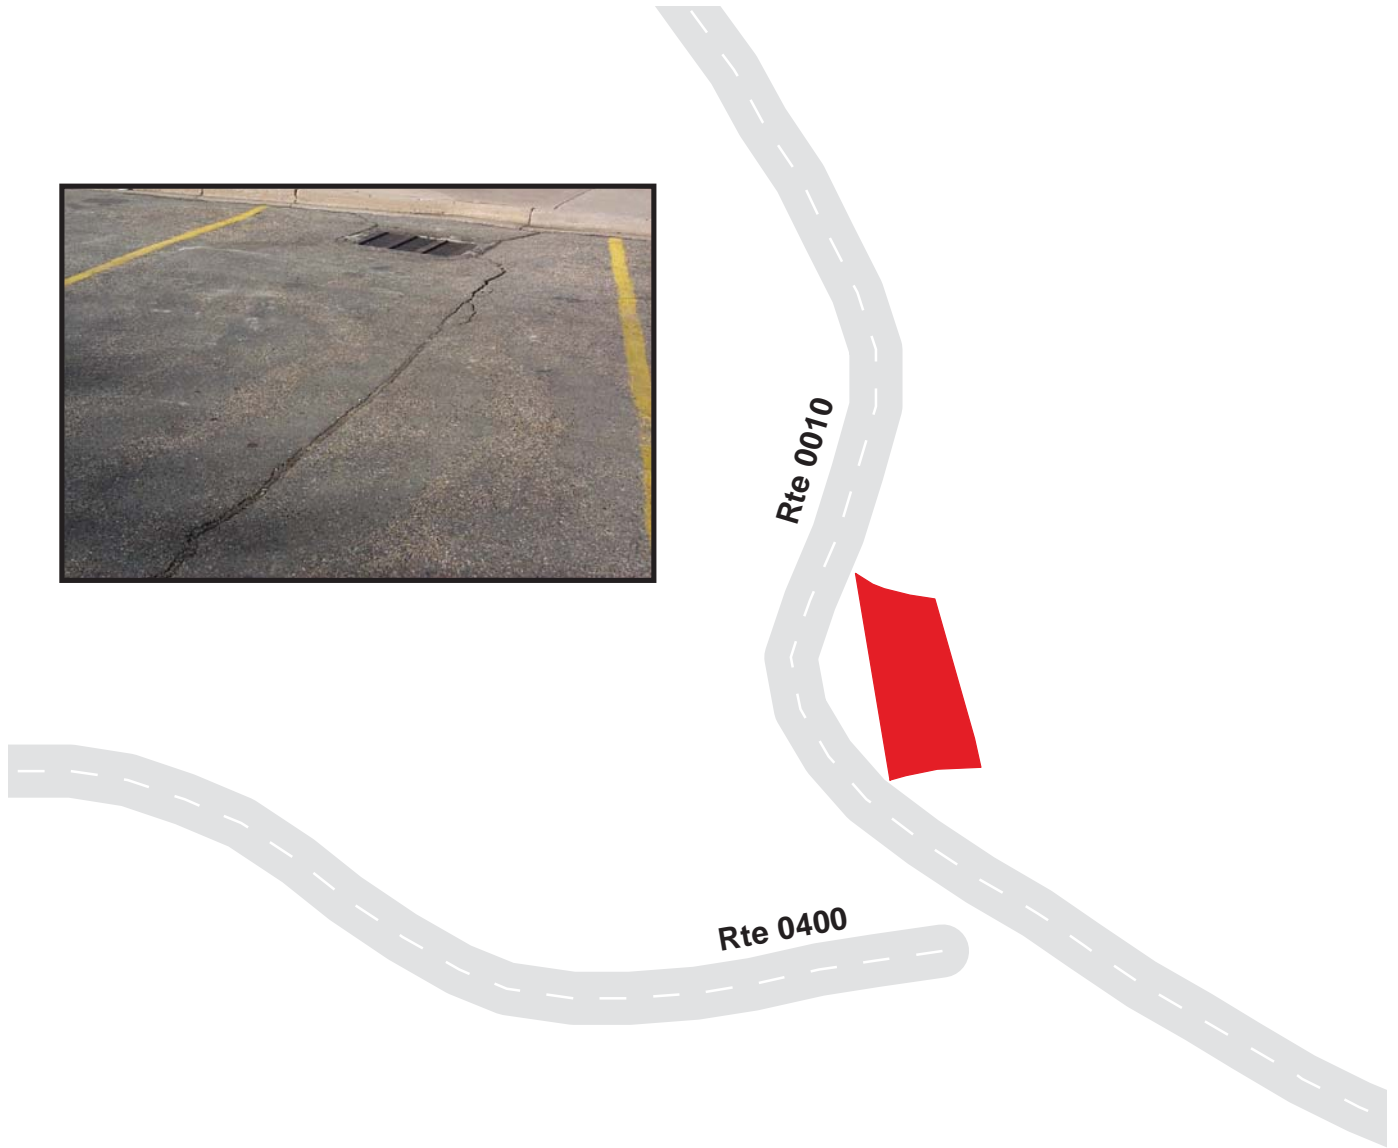
Route 0900B

| Route | Public / NonPublic | Date Visited | Area (sq ft) | Lane Miles * | Surface Type | Condition / PCR |
|---|---|---|---|---|---|---|
| 0900B | Public | 3/11/2003 | 1059 | 0.02 | OC | FAIR / 73 |

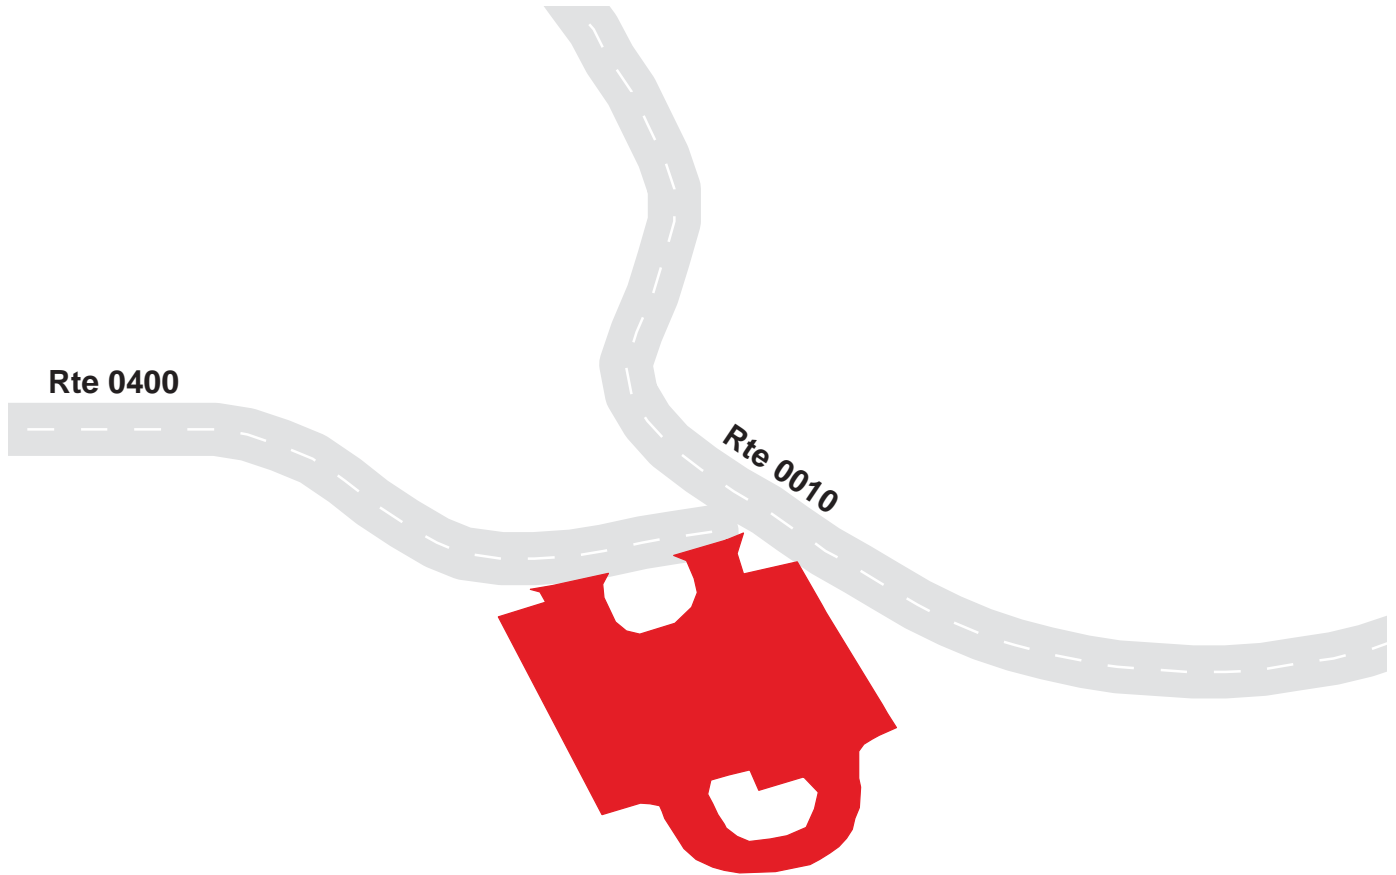
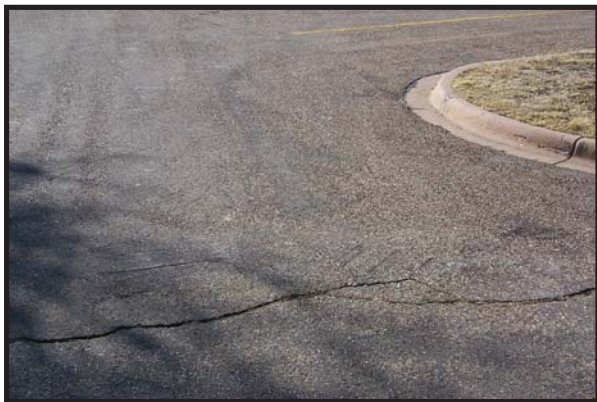
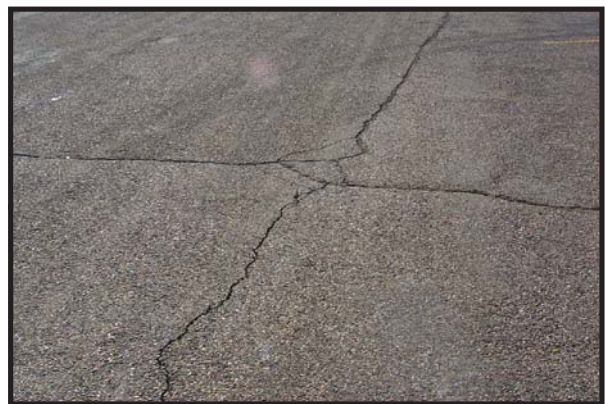
Route 0901

| Route | Public / NonPublic | Date Visited | Area (sq ft) | Lane Miles * | Surface Type | Condition / PCR |
|---|---|---|---|---|---|---|
| 0901 | Public | 3/11/2003 | 15685 | 0.27 | OC | POOR / 45 |

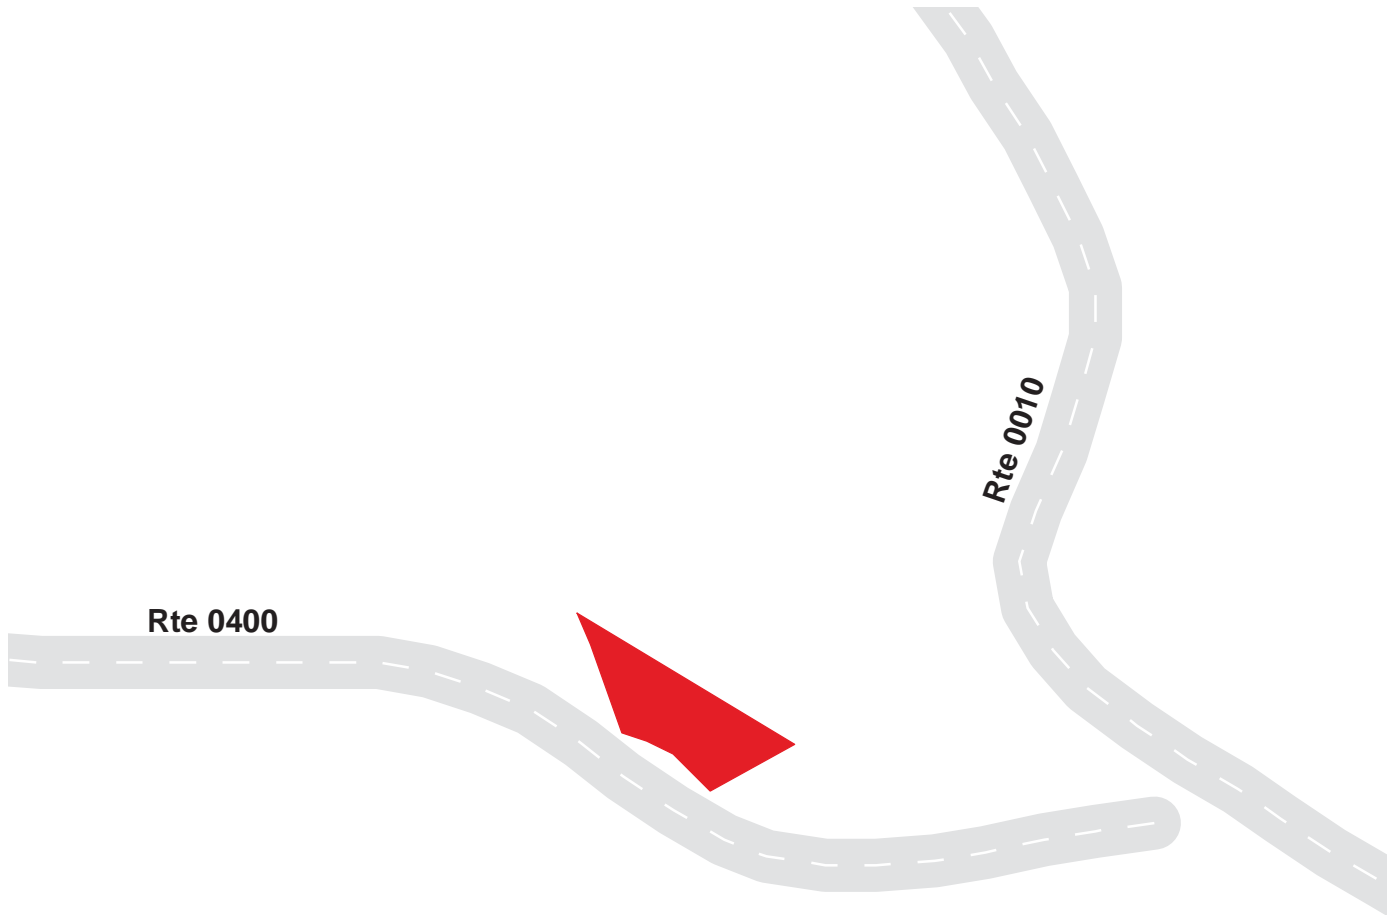
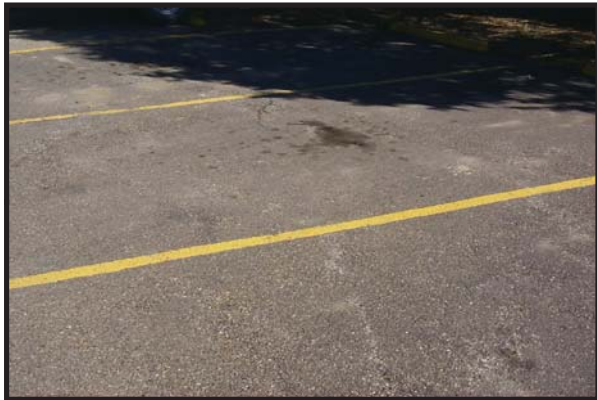
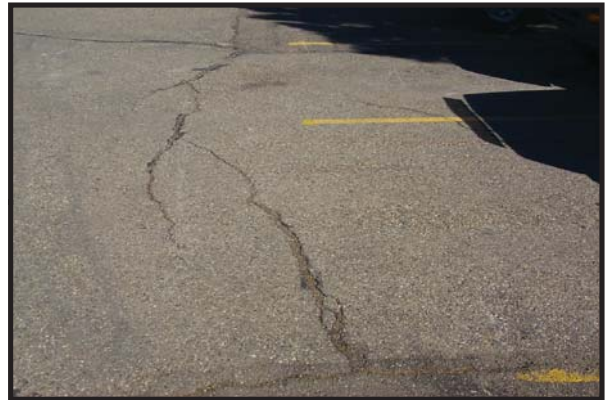
Route 0903

| Route | Public / NonPublic | Date Visited | Area (sq ft) | Lane Miles * | Surface Type | Condition / PCR |
|---|---|---|---|---|---|---|
| 0903 | NonPublic | 3/11/2003 | 1209 | 0.02 | OC | POOR / 45 |

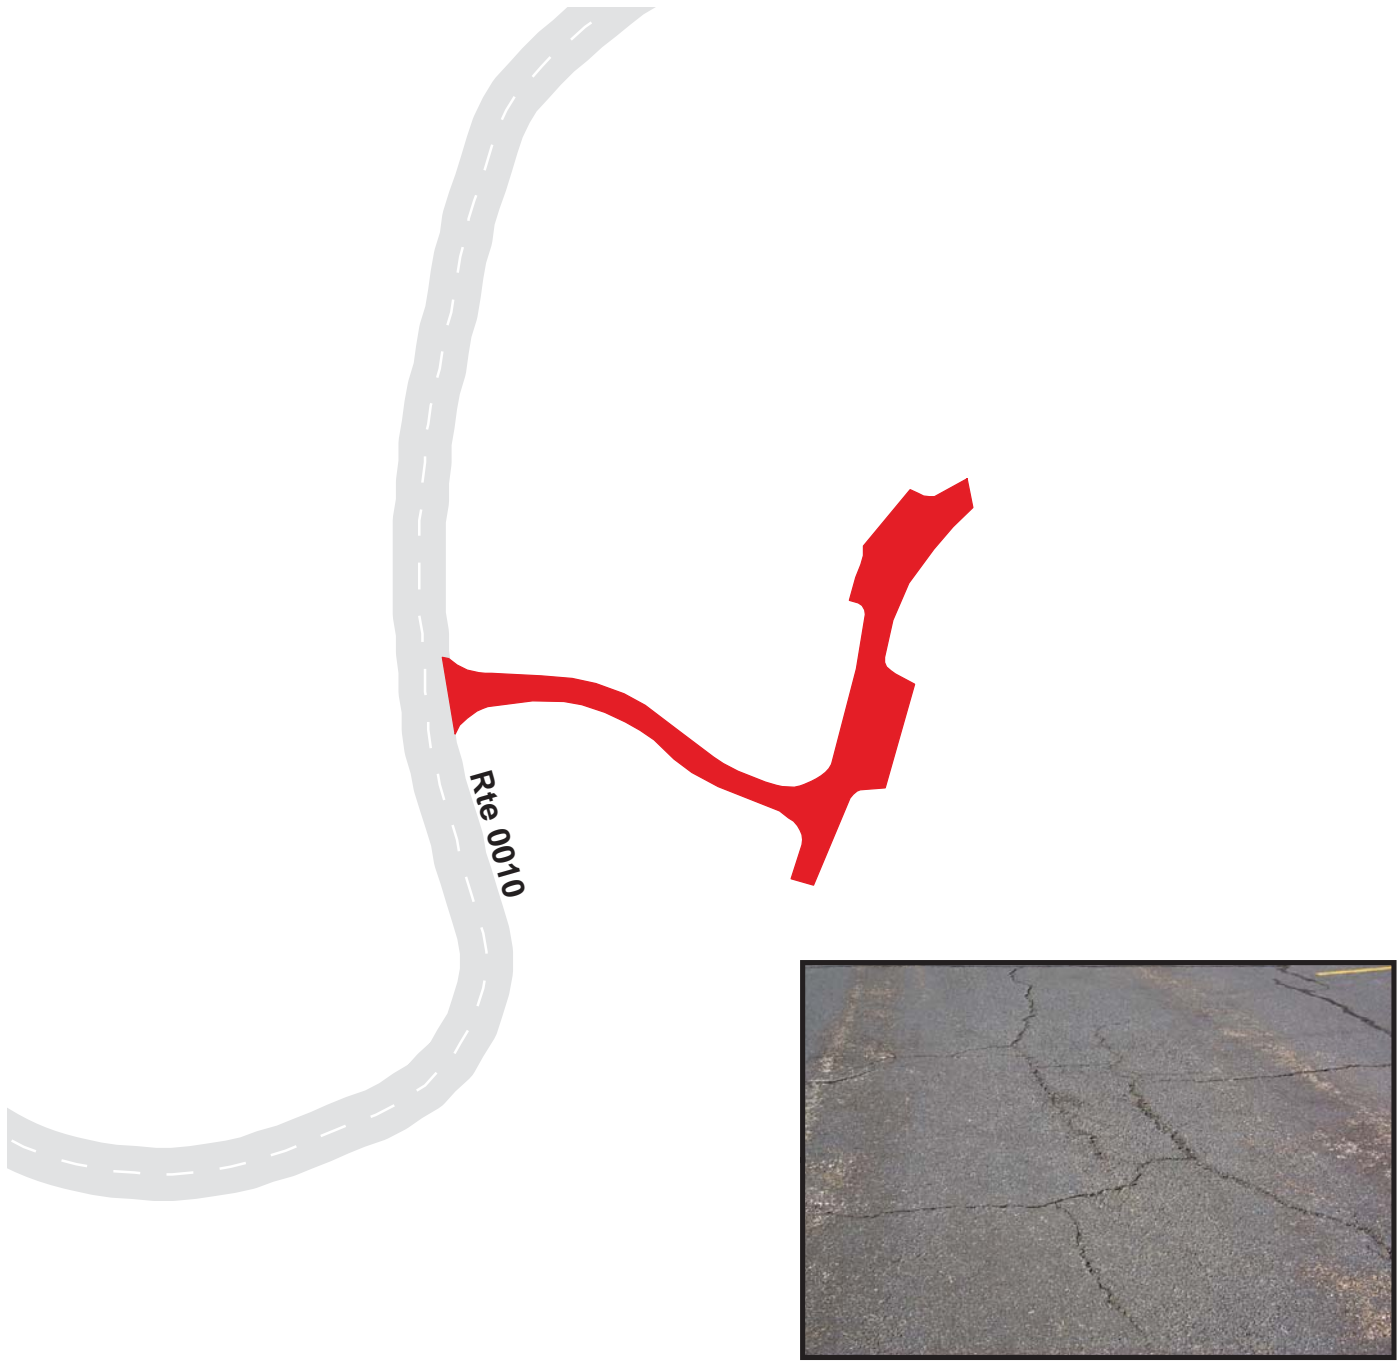
Route 0904

| Route | Public / NonPublic | Date Visited | Area (sq ft) | Lane Miles * | Surface Type | Condition / PCR |
|---|---|---|---|---|---|---|
| 0904 | Public | 3/11/2003 | 22366 | 0.39 | OC | POOR / 45 |

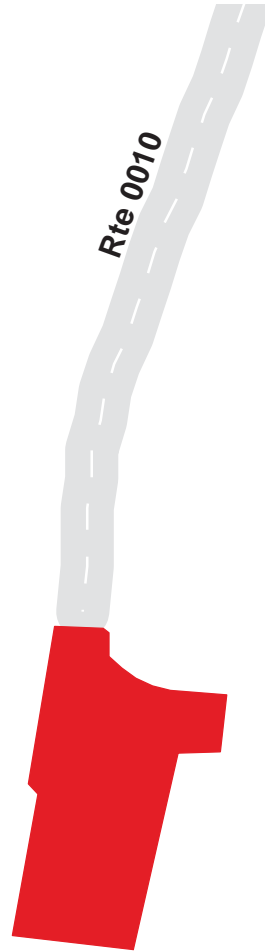
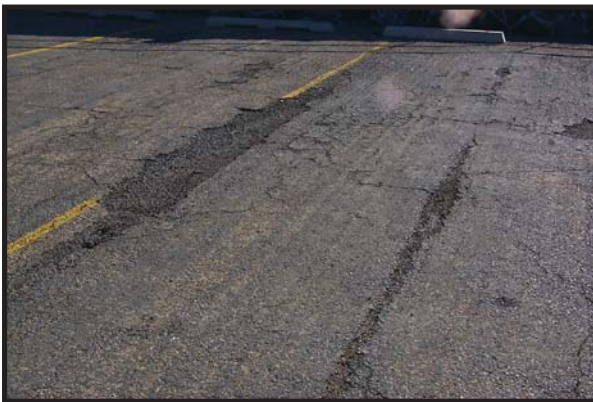
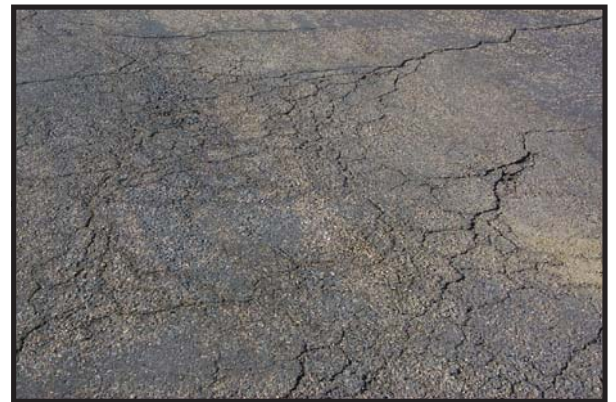
| Route | Public / NonPublic | Date Visited | Area (sq ft) | Lane Miles * | Surface Type | Condition / PCR |
|---|---|---|---|---|---|---|
| 0905 | Public | 3/11/2003 | 12470 | 0.21 | OC | POOR / 45 |

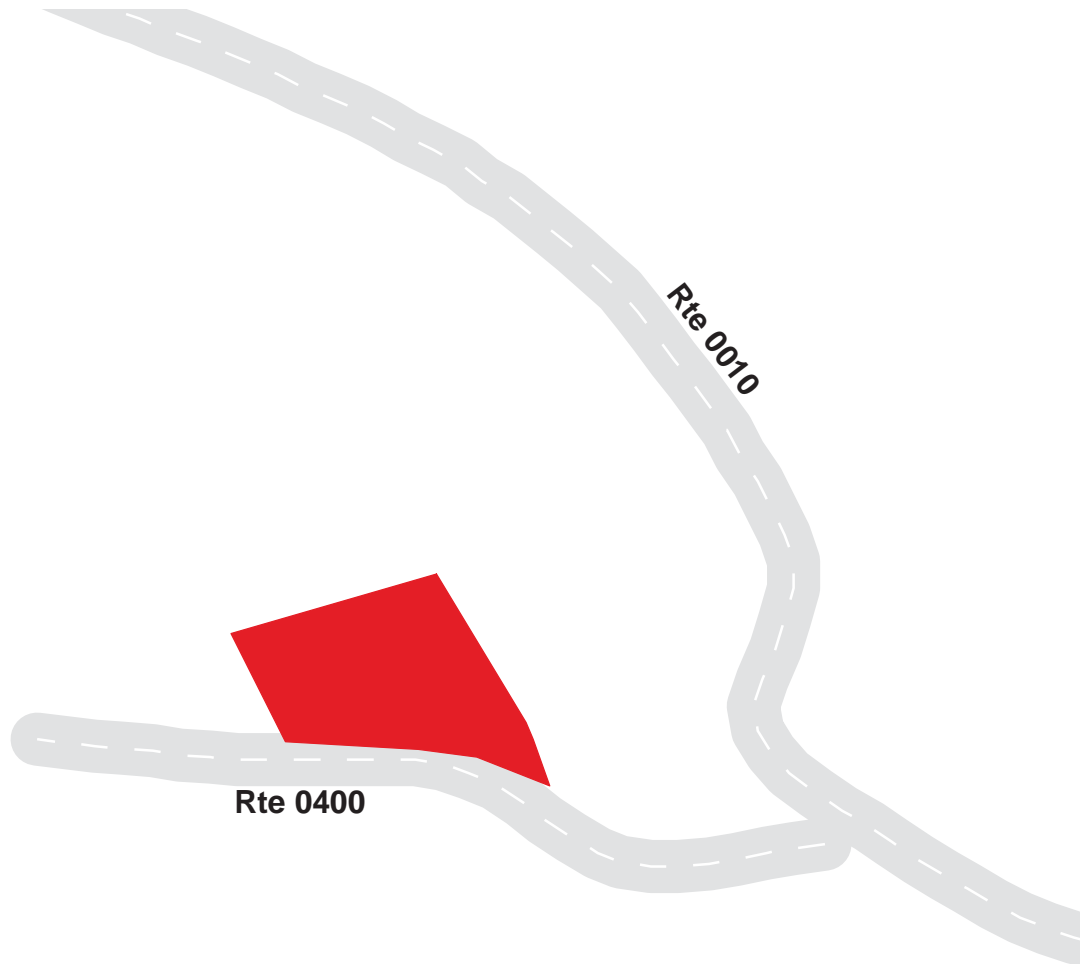
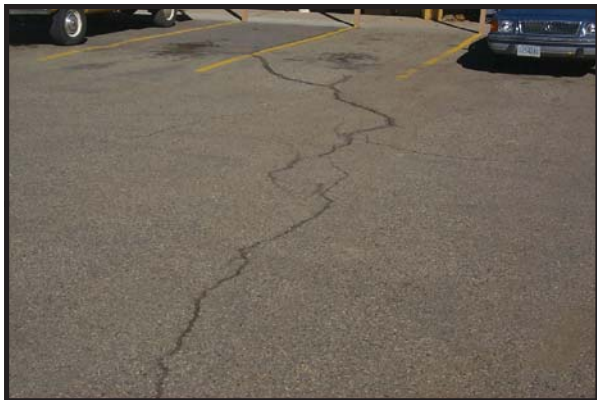
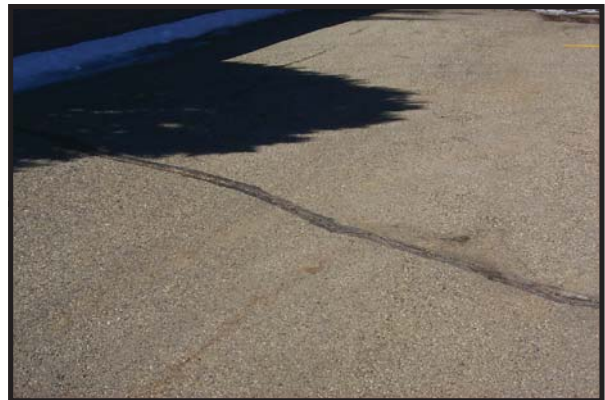
Route 0906

| Route | Public / NonPublic | Date Visited | Area (sq ft) | Lane Miles * | Surface Type | Condition / PCR |
|---|---|---|---|---|---|---|
| 0906 | NonPublic | 3/11/2003 | 11538 | 0.20 | OC | POOR / 45 |
