The Road Inventory of Cedar Breaks National Monument CEBR – 1360

Road Inventory Program

Prepared By:
Federal Highway Administration
Eastern Federal Lands Highway Division
Cycle 3

Cedar Breaks National Monument in Utah

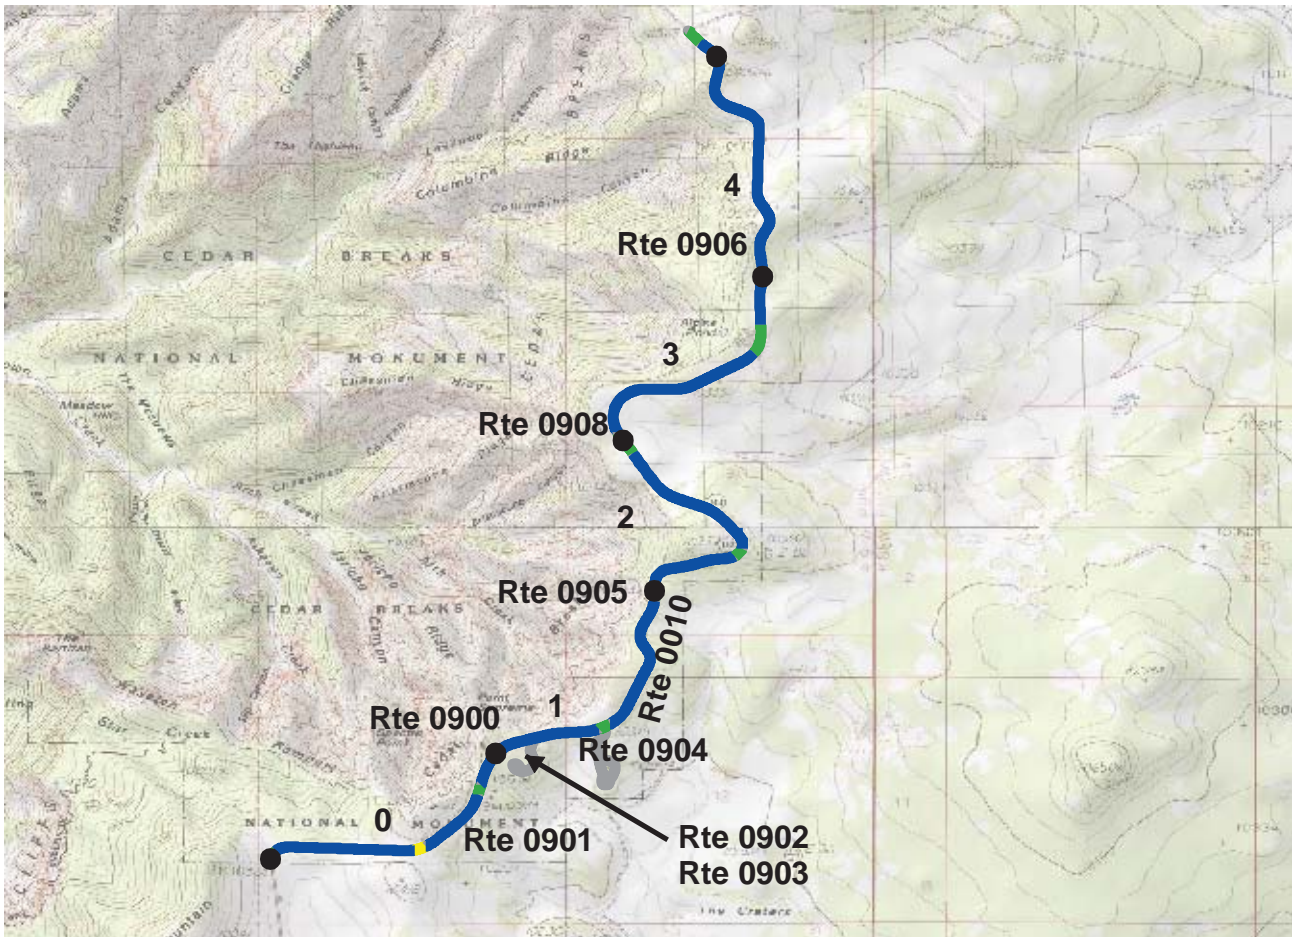
ROUTE: 0010 South Entrance Road

Section Number	0	1	2	3	4
Section Length (mi)	1.00	1.00	1.00	1.00	1.00
AADT	**				
SADT	**				
ADT Date	**				
Cross Section Information					
Number of Lanes	2	2	2	2	2
Paved Width (ft)	20	20	18	18	21
Lane Width (ft)	11	11	9	9	9
Shoulder Width (ft)	4	4	5	5	5
Roadway Condition Information					
PCR (Pavement Condition Rating)	95	97	98	97	98
RCI (Roughness Condition Index)	95	97	98	98	99
SCR (Surface Condition Rating)	96	97	97	96	97
Alligator Cracking Index	100	100	100	100	100
Rutting Index	97	98	97	97	98
Patching Index	98	99	100	99	100
Transverse Cracking Index	99	100	100	100	100
Longitudinal Cracking Index	100	100	100	100	99
Shoulder Condition Rating	GOOD	GOOD	GOOD	GOOD	GOOD
Drainage Condition Rating	GOOD	GOOD	GOOD	GOOD	GOOD

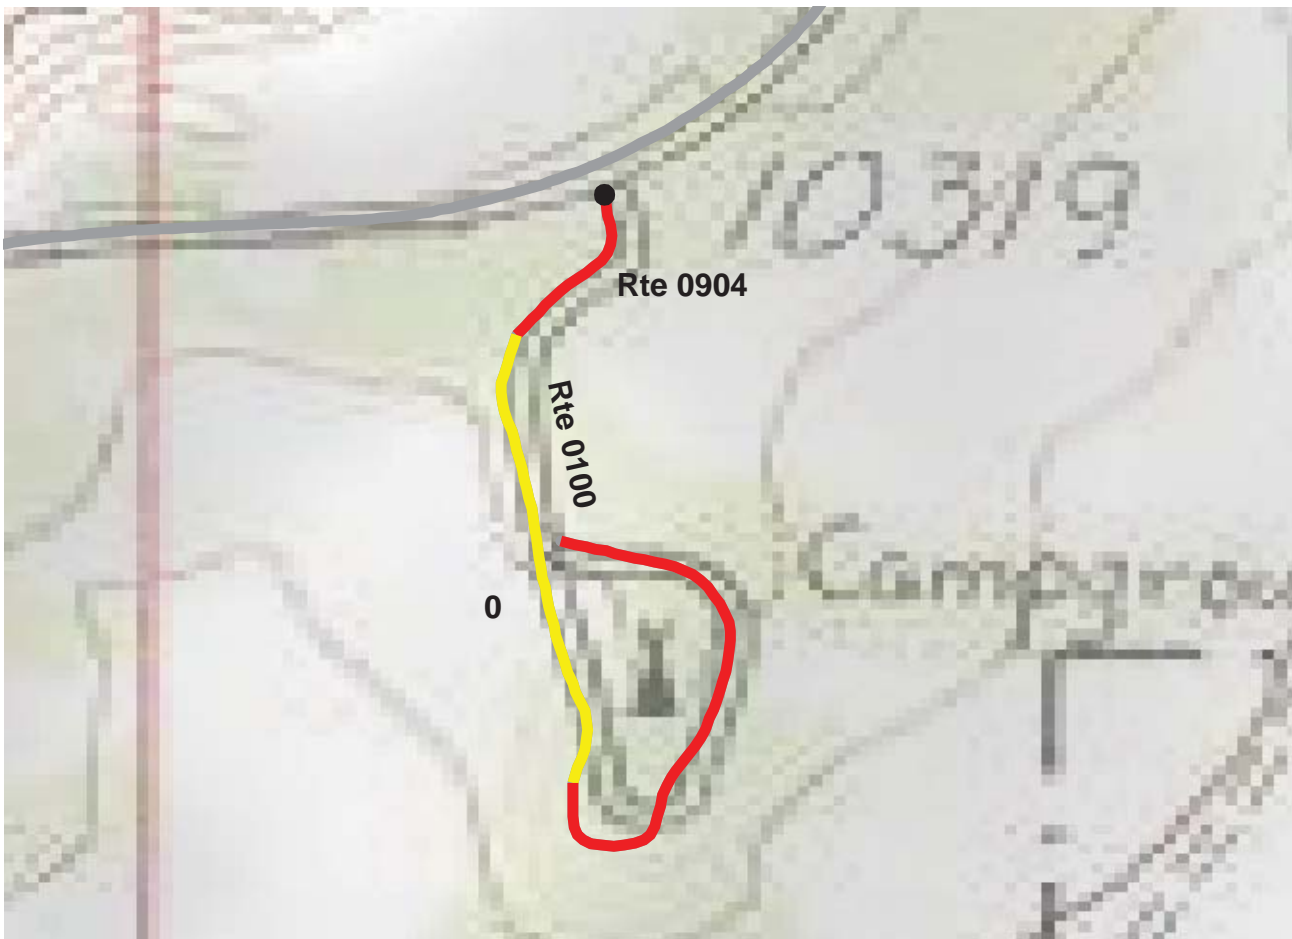
ROUTE: 0100 Campground Loop **TOTAL LENGTH: 0.42 Miles**

Section Number	0				
Section Length (mi)	0.42				
ADT	**				
SADT	**				
ADT Date	**				
Cross Section Information					
Number of Lanes	1				
Paved Width (ft)	15				
Lane Width (ft)	15				
Shoulder Width (ft)	0				
Roadway Condition Information					
PCR (Pavement Condition Rating)	51				
RCI (Roughness Condition Index)	45				
SCR (Surface Condition Rating)	54				
Alligator Cracking Index	99				
Rutting Index	55				
Patching Index	99				
Transverse Cracking Index	99				
Longitudinal Cracking Index	99				
Shoulder Condition Rating	N/A				
Drainage Condition Rating	GOOD

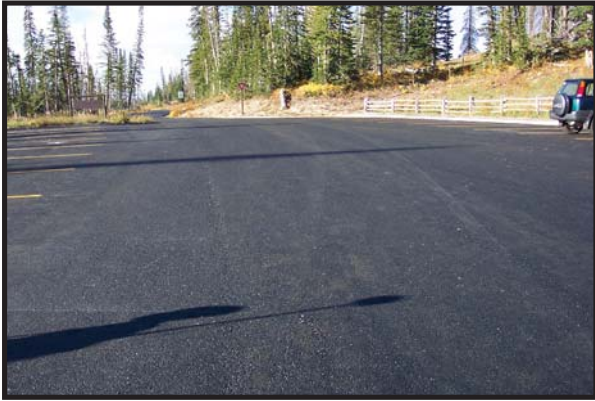
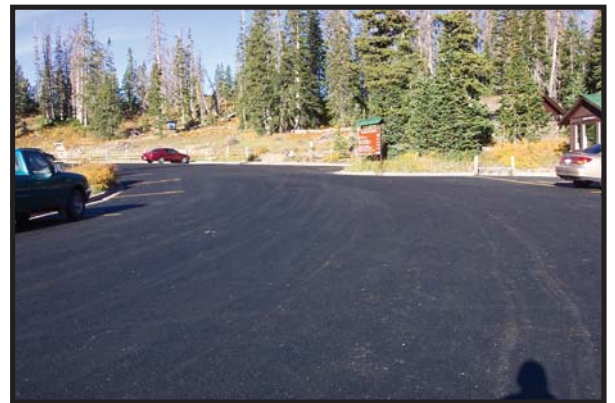
Route	Public / NonPublic	Date Visited	Area (sq ft)	Lane Miles *	Surface Type	Condition / PCR
0900	Public	9/24/2003	27755	0.48	AS	EXCELLENT / 97

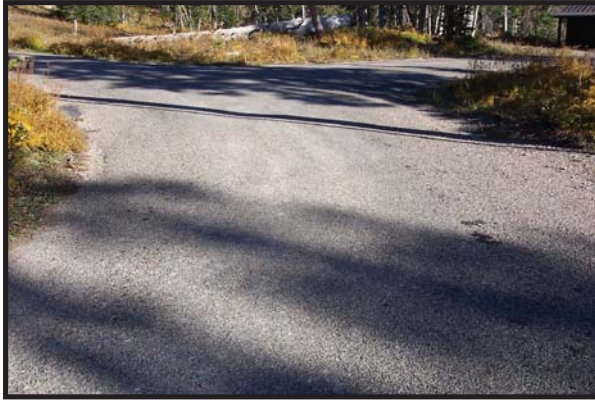
Route	Public / NonPublic	Date Visited	Area (sq ft)	Lane Miles *	Surface Type	Condition / PCR
0901	NonPublic	9/24/2003	9904	0.17	OC	GOOD / 90

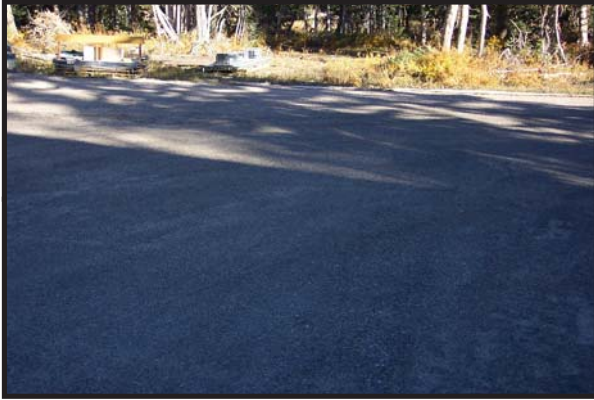
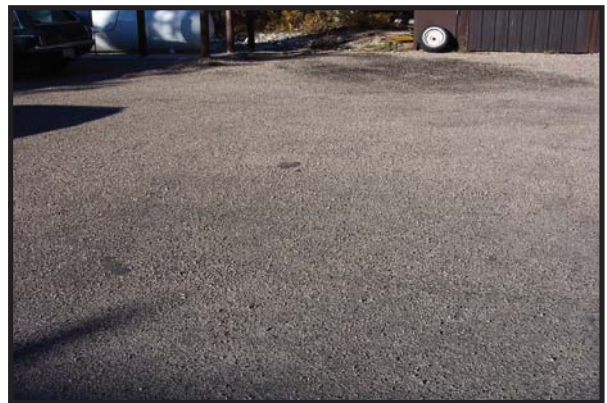
Route	Public / NonPublic	Date Visited	Area (sq ft)	Lane Miles *	Surface Type	Condition / PCR
0902A	NonPublic	9/24/2003	10551	0.18	OC	FAIR / 73

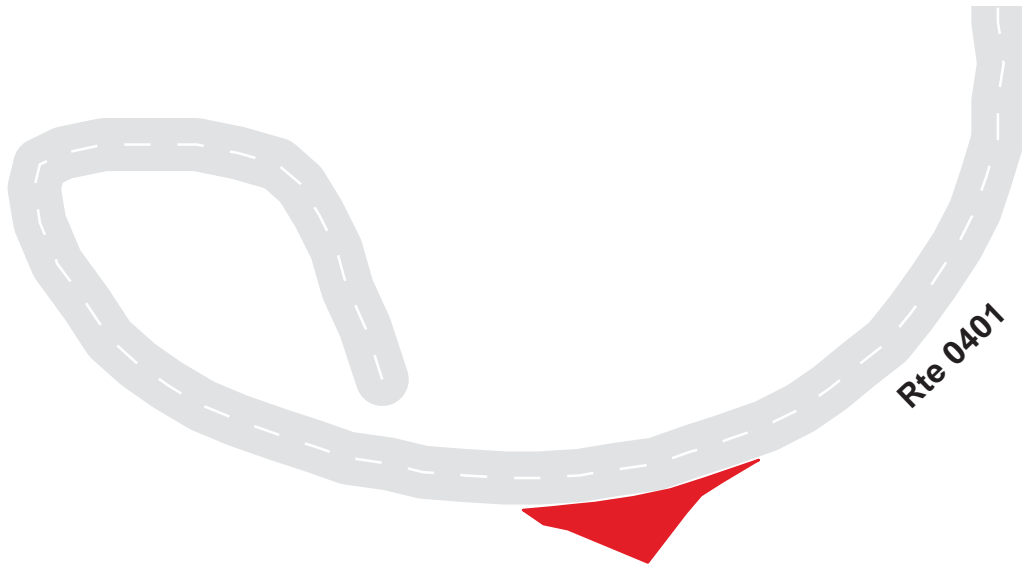
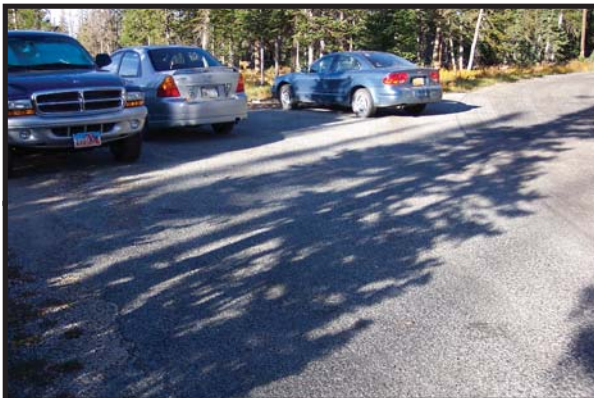
Route 0903

Route	Public / NonPublic	Date Visited	Area (sq ft)	Lane Miles *	Surface Type	Condition / PCR
0903	NonPublic	9/24/2003	1247	0.02	OC	FAIR / 73

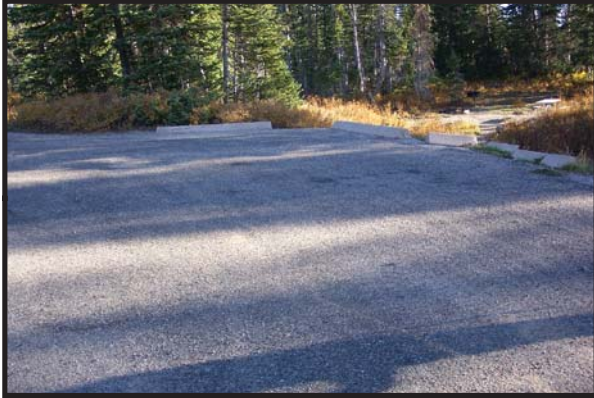
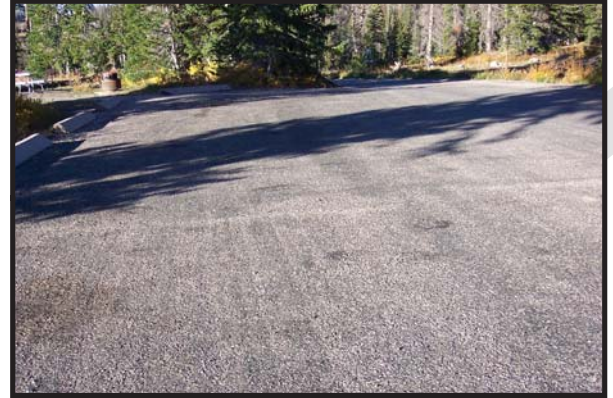
Route 0904

Route	Public / NonPublic	Date Visited	Area (sq ft)	Lane Miles *	Surface Type	Condition / PCR
0904	Public	9/24/2003	3744	0.06	OC	GOOD / 90

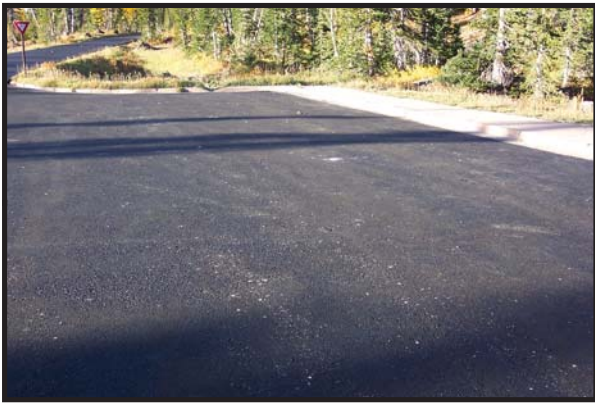
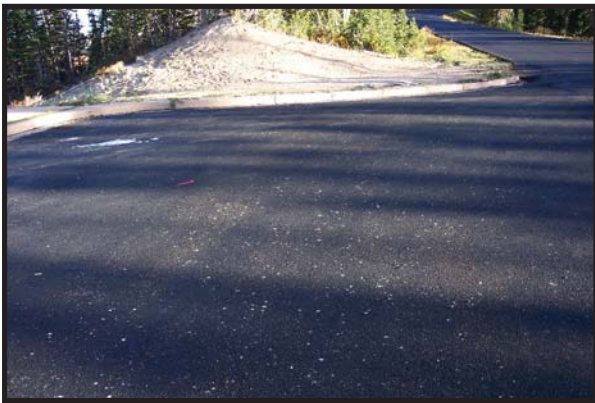
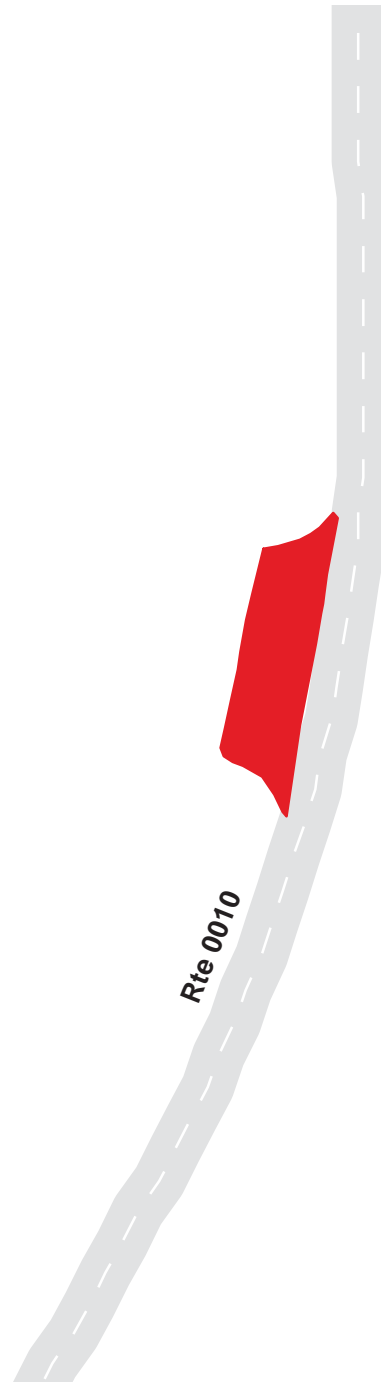
Route 0905

Route	Public / NonPublic	Date Visited	Area (sq ft)	Lane Miles *	Surface Type	Condition / PCR
0905	Public	9/24/2003	3758	0.06	AS	GOOD / 90

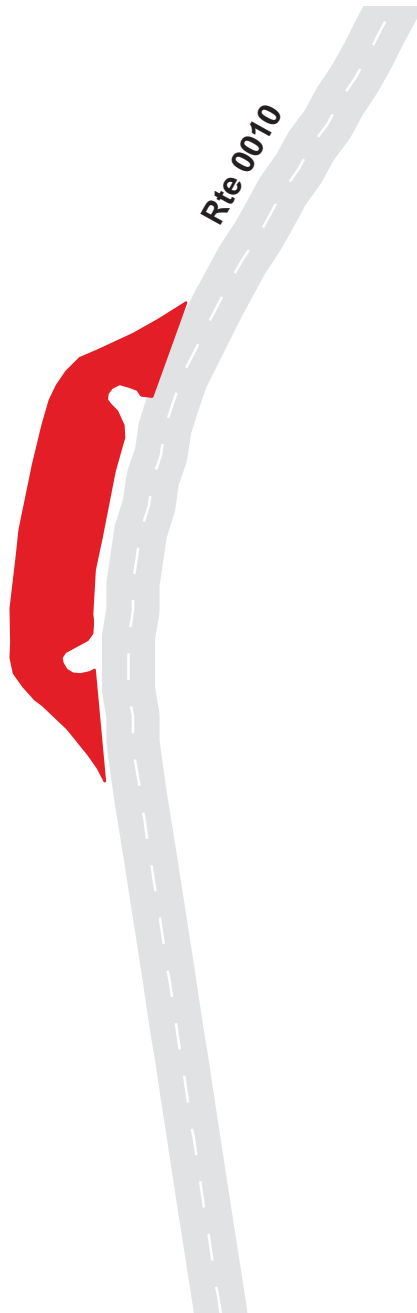
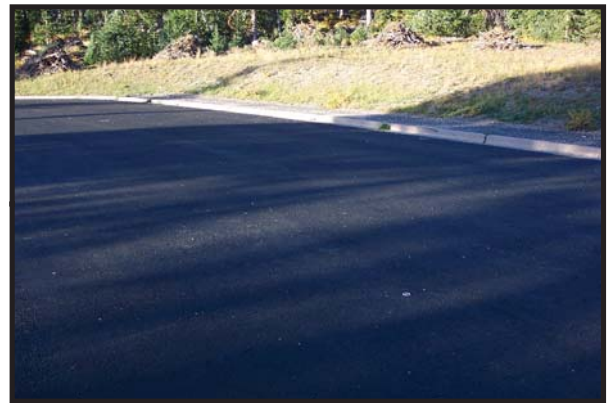
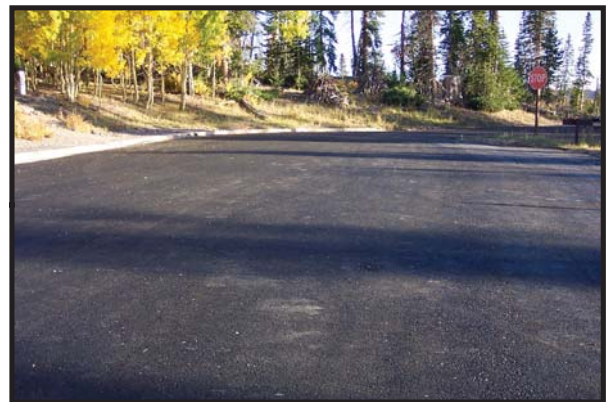
Route 0906

Route	Public / NonPublic	Date Visited	Area (sq ft)	Lane Miles *	Surface Type	Condition / PCR
0906	Public	9/24/2003	11561	0.20	AS	EXCELLENT / 97

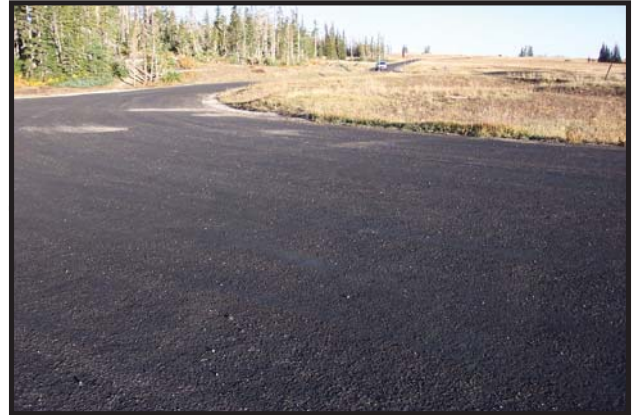
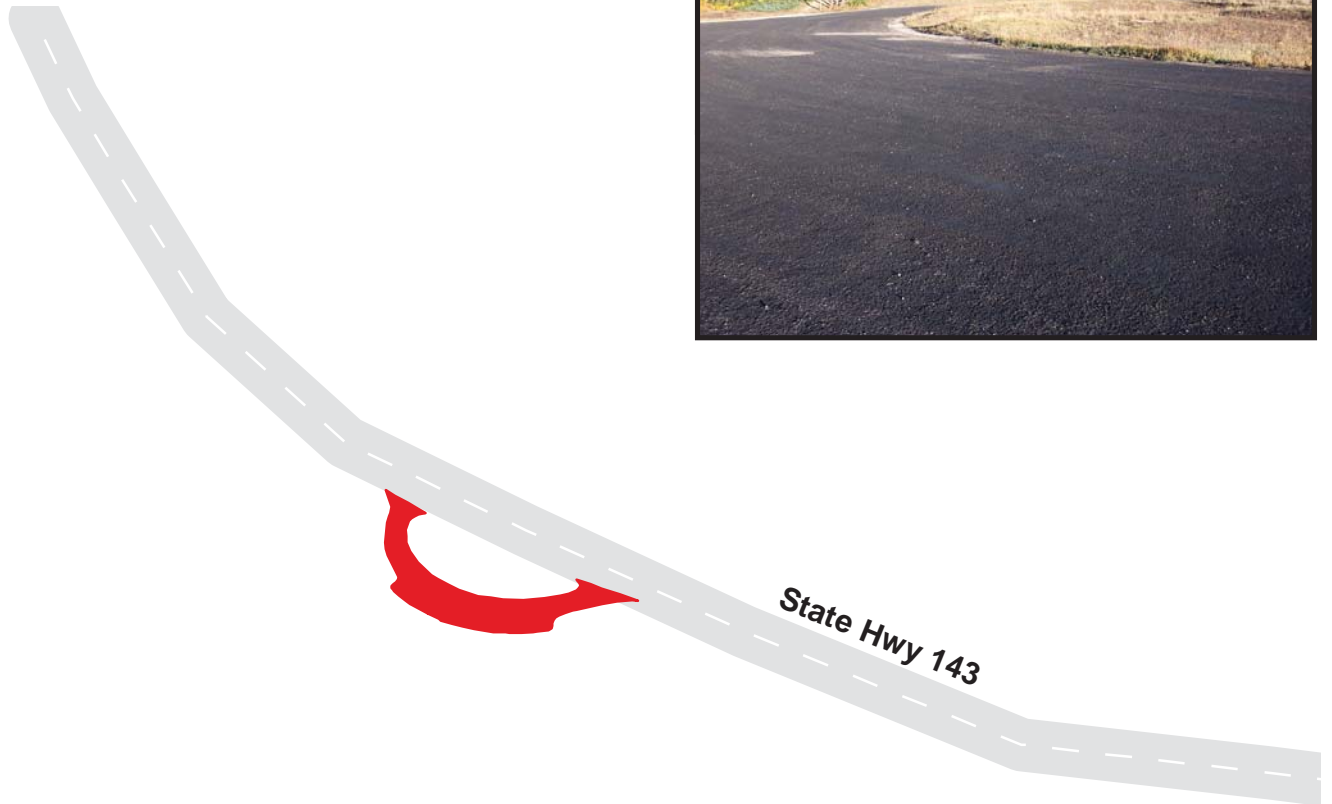
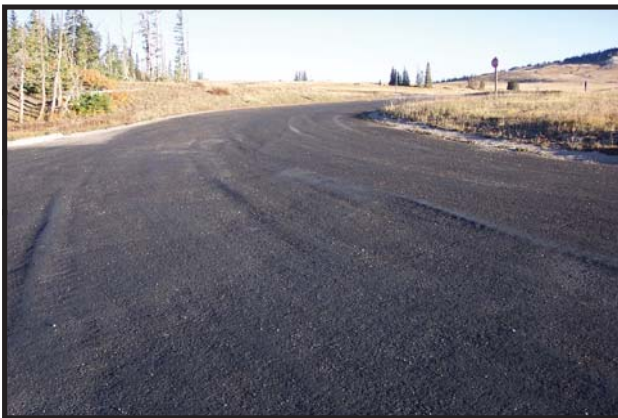
Route 0907

Route	Public / NonPublic	Date Visited	Area (sq ft)	Lane Miles *	Surface Type	Condition / PCR
0907	Public	9/24/2003	19722	0.34	AS	GOOD / 90

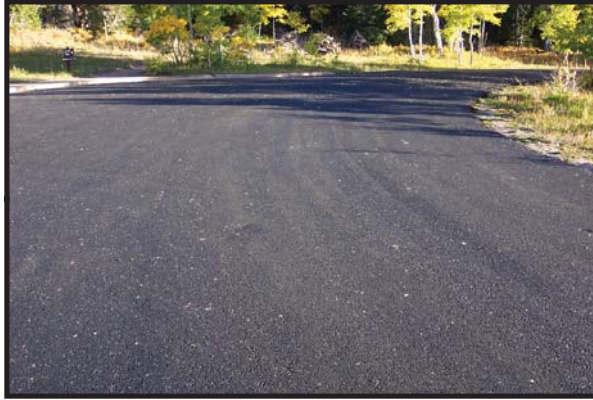
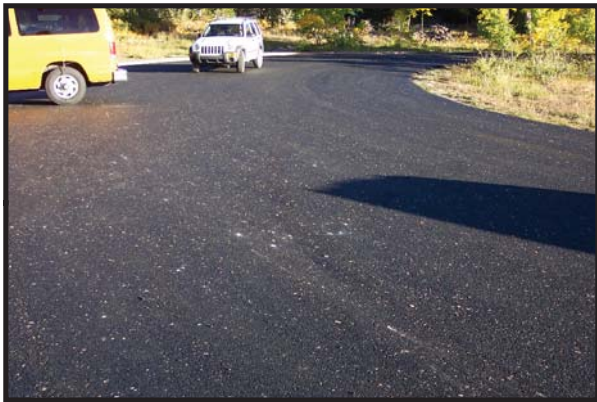
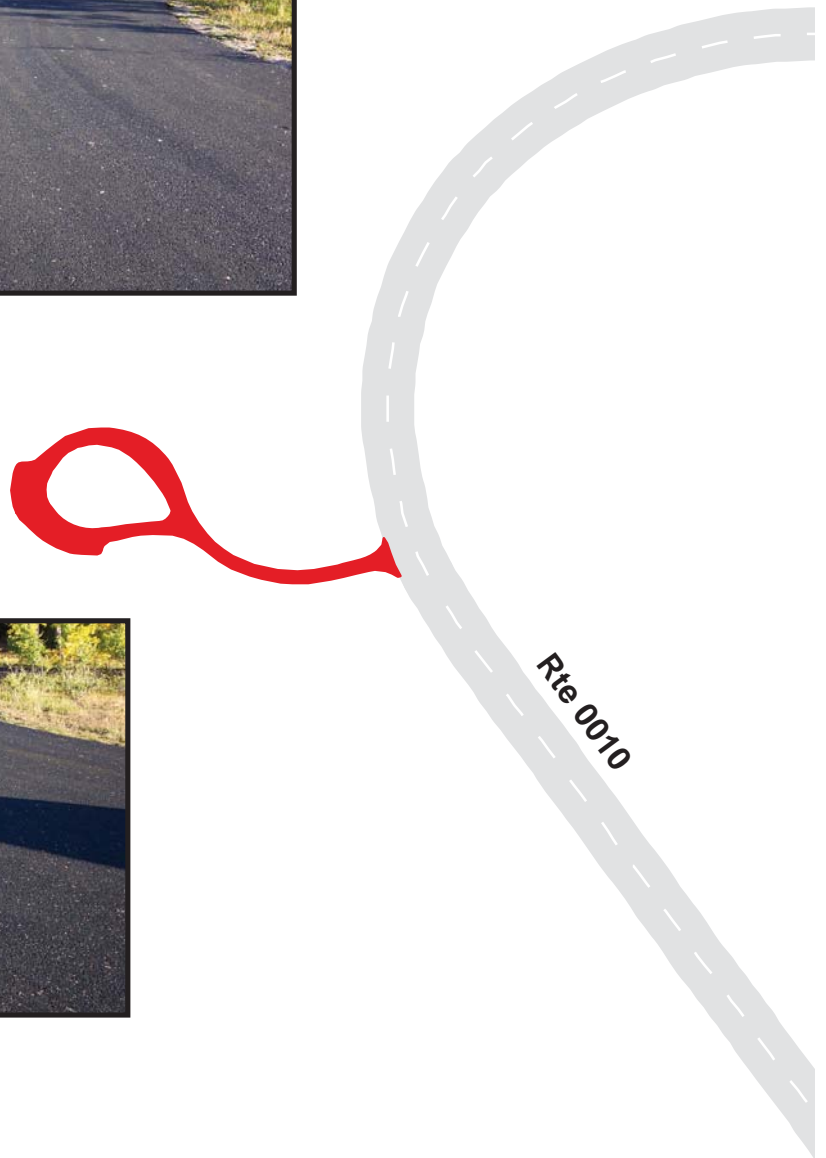
Route 0908

Route	Public / NonPublic	Date Visited	Area (sq ft)	Lane Miles *	Surface Type	Condition / PCR
0908	Public	9/24/2003	24131	0.42	AS	GOOD / 90
