# The Road Inventory of Chamizal National Memorial CHAM - 7210

## Road Inventory Program

Prepared By:  
Federal Highway Administration  
Eastern Federal Lands Highway Division  
Cycle 3

# Chamizal National Memorial in Texas

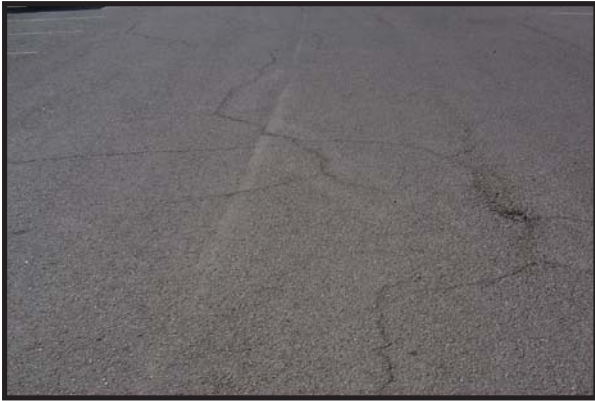
## Route 0900

Route	Public / NonPublic	Date Visited	Area (sq ft)	Lane Miles *	Surface Type	Condition / PCR
0900	Public	3/4/2003	83166	1.43	AS	FAIR / 73

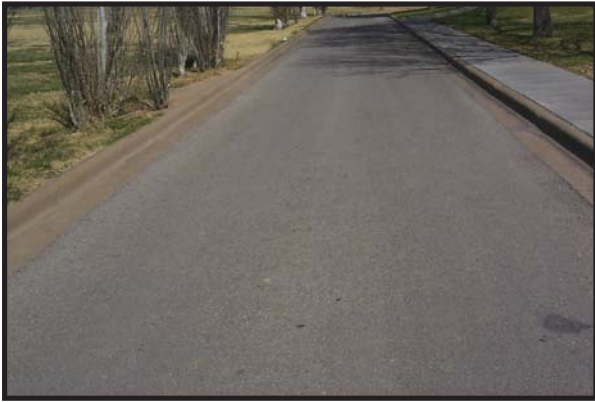
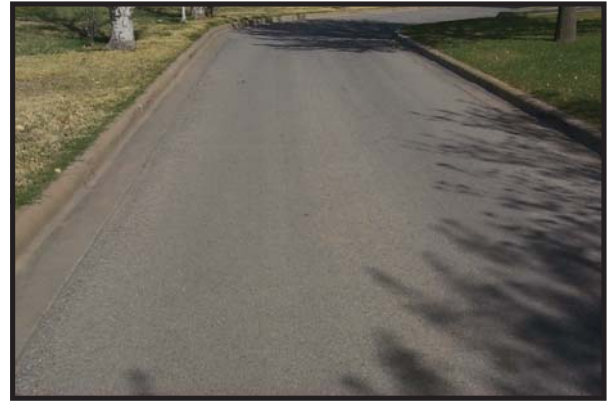
## Route 0901

Route	Public / NonPublic	Date Visited	Area (sq ft)	Lane Miles *	Surface Type	Condition / PCR
0901	NonPublic	3/4/2003	15882	0.27	AS	FAIR / 73
