# The Road Inventory of Chattahoochee River National Recreation Area CHAT - 5340

## Road Inventory Program

Prepared By:  
Federal Highway Administration  
Eastern Federal Lands Highway Division  
Cycle 3

# Chattahoochee River National Recreation in Georgia

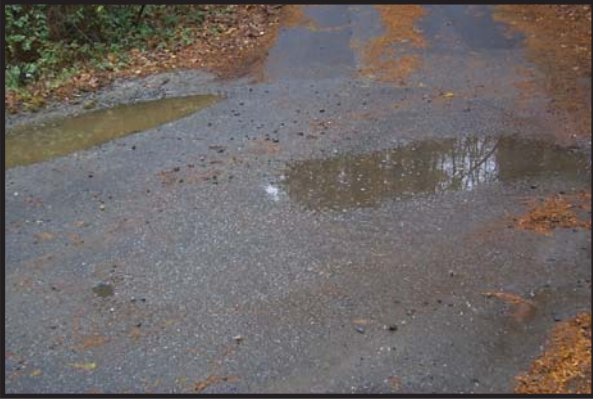
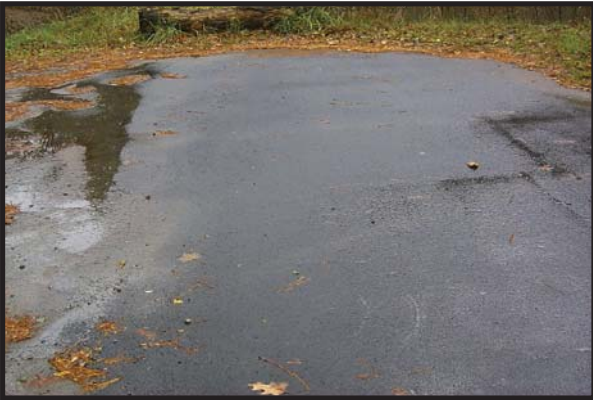
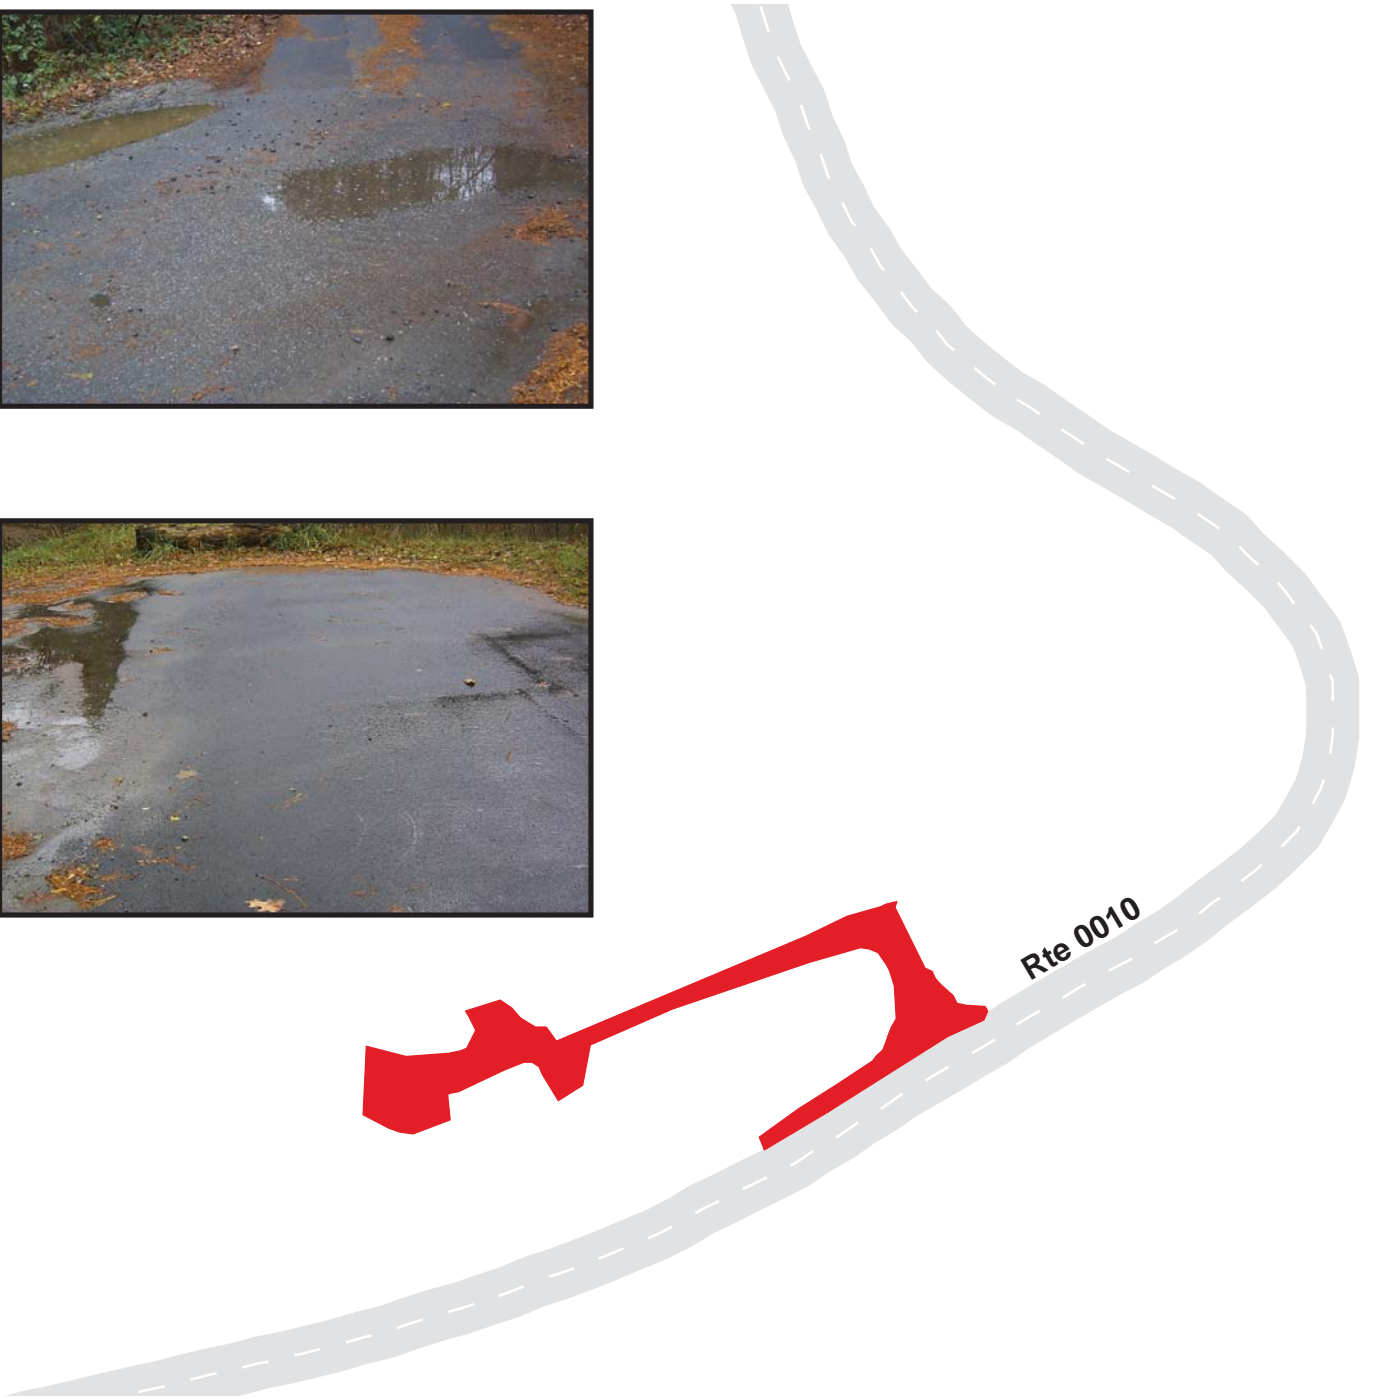
Route	Public / NonPublic	Date Visited	Area (sq ft)	Lane Miles *	Surface Type	Condition / PCR
0903	NonPublic	12/11/2002	12615	0.22	AS	POOR / 45

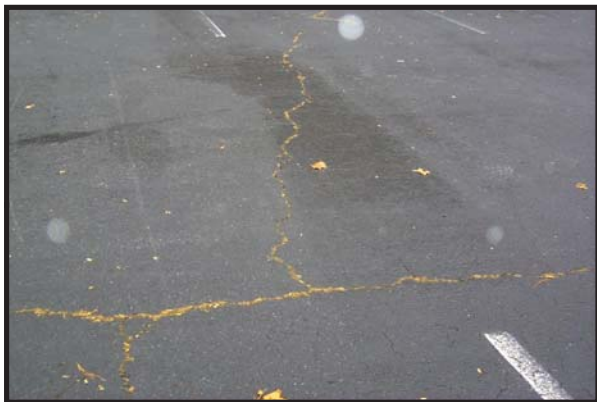
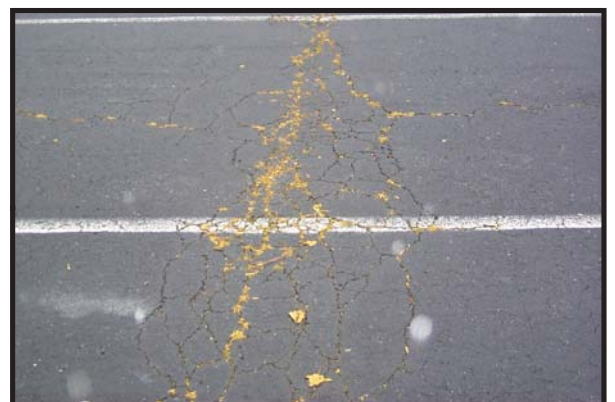
## Route 0906

Route	Public / NonPublic	Date Visited	Area (sq ft)	Lane Miles *	Surface Type	Condition / PCR
0906	Public	12/10/2002	74422	1.28	AS	POOR / 45

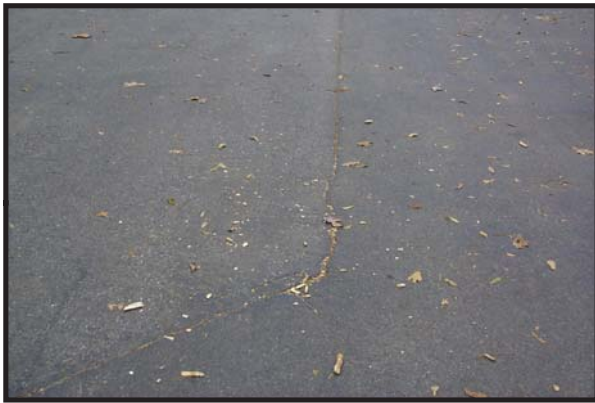
## Route 0908A

Route	Public / NonPublic	Date Visited	Area (sq ft)	Lane Miles *	Surface Type	Condition / PCR
0908A	Public	12/10/2002	17001	0.29	AS	POOR / 45

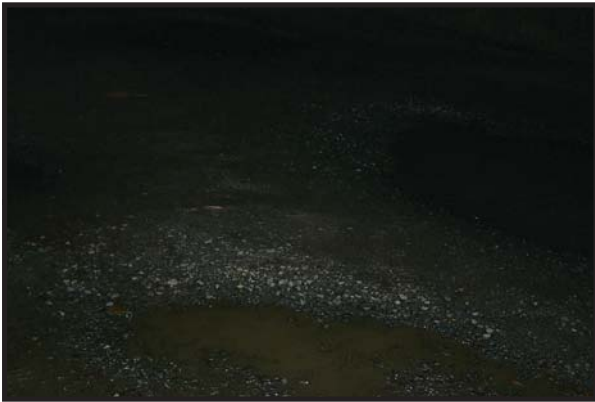
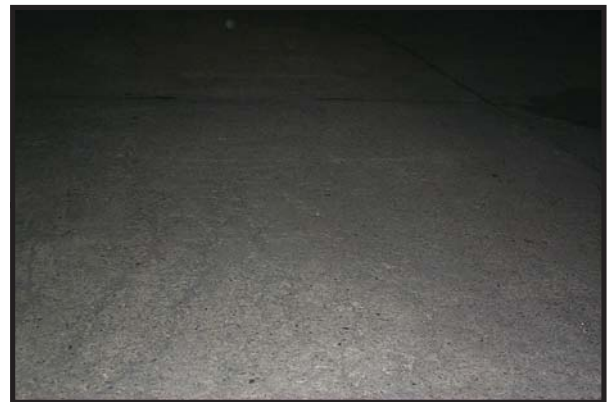
## Route 0911

Route	Public / NonPublic	Date Visited	Area (sq ft)	Lane Miles *	Surface Type	Condition / PCR
0911	Public	2/23/2003	10506	0.18	CO	POOR / 45
