The Road Inventory of Chaco Culture National Historical Park CHCU - 7400

Road Inventory Program

Prepared By:
Federal Highway Administration
Eastern Federal Lands Highway Division
Cycle 3

Chaco Culture National Historical Park in New Mexico

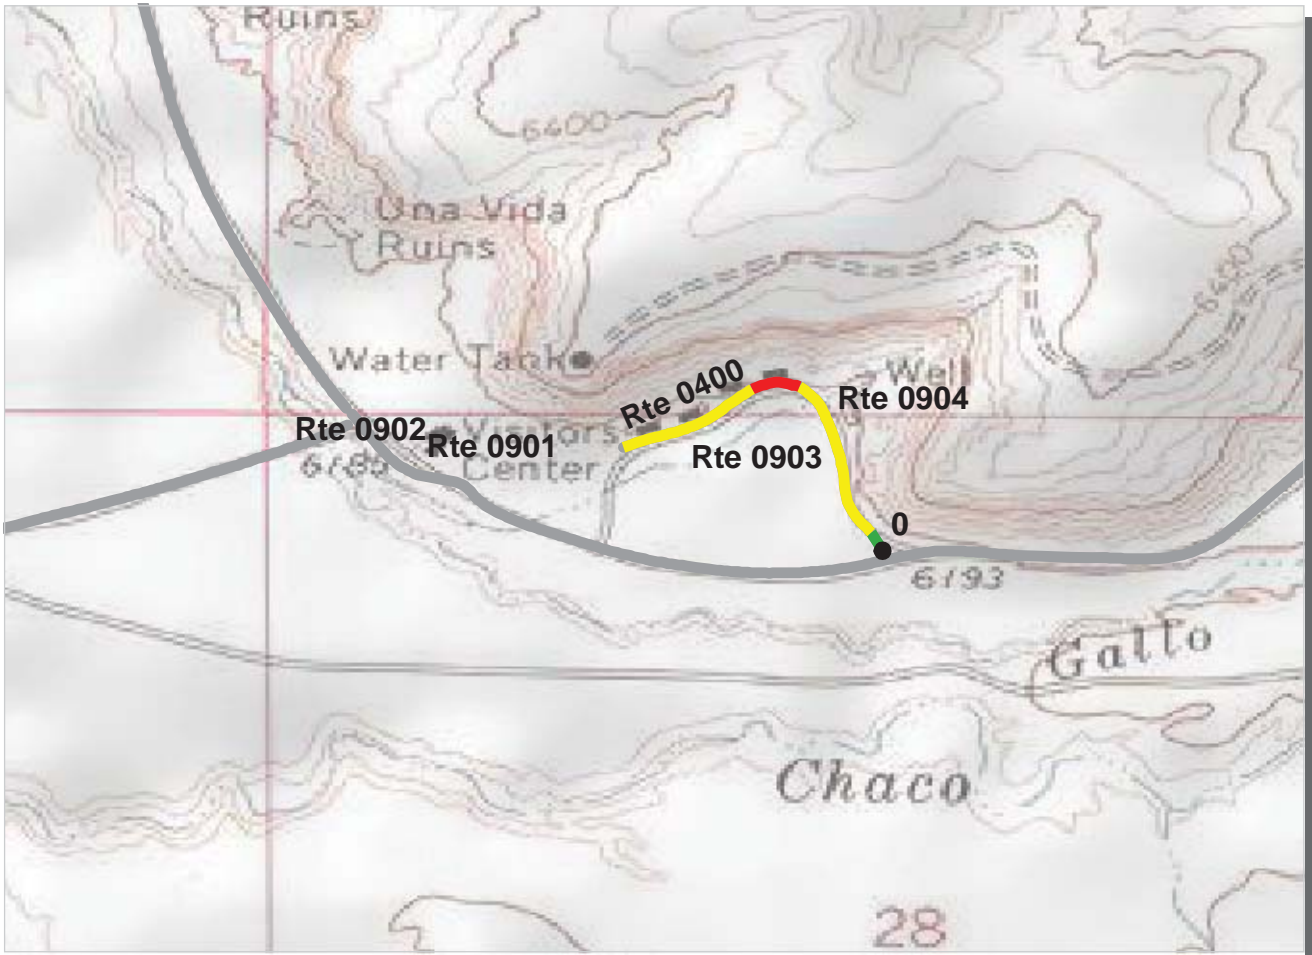
ROUTE: 0400 EMPLOYEE HOUSING ROAD **TOTAL LENGTH: 0.35 Miles**

Section Number	0				
Section Length (mi)	0.35				
AADT	**				
SADT	**				
ADT Date	**				
Cross Section Information					
Number of Lanes	2				
Paved Width (ft)	20				
Lane Width (ft)	11				
Shoulder Width (ft)	0				
Roadway Condition Information					
PCR (Pavement Condition Rating)	68				
RCI (Roughness Condition Index)	61				
SCR (Surface Condition Rating)	71				
Alligator Cracking Index	100				
Rutting Index	76				
Patching Index	99				
Transverse Cracking Index	96				
Longitudinal Cracking Index	98				
Shoulder Condition Rating	N/A				
Drainage Condition Rating	GOOD

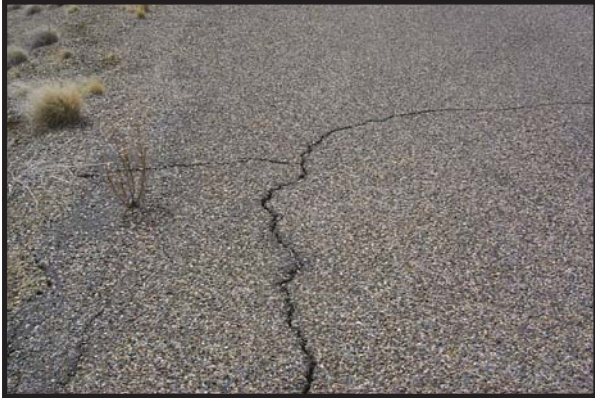
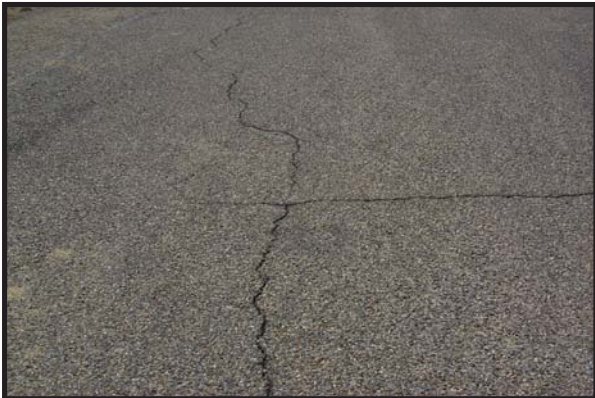
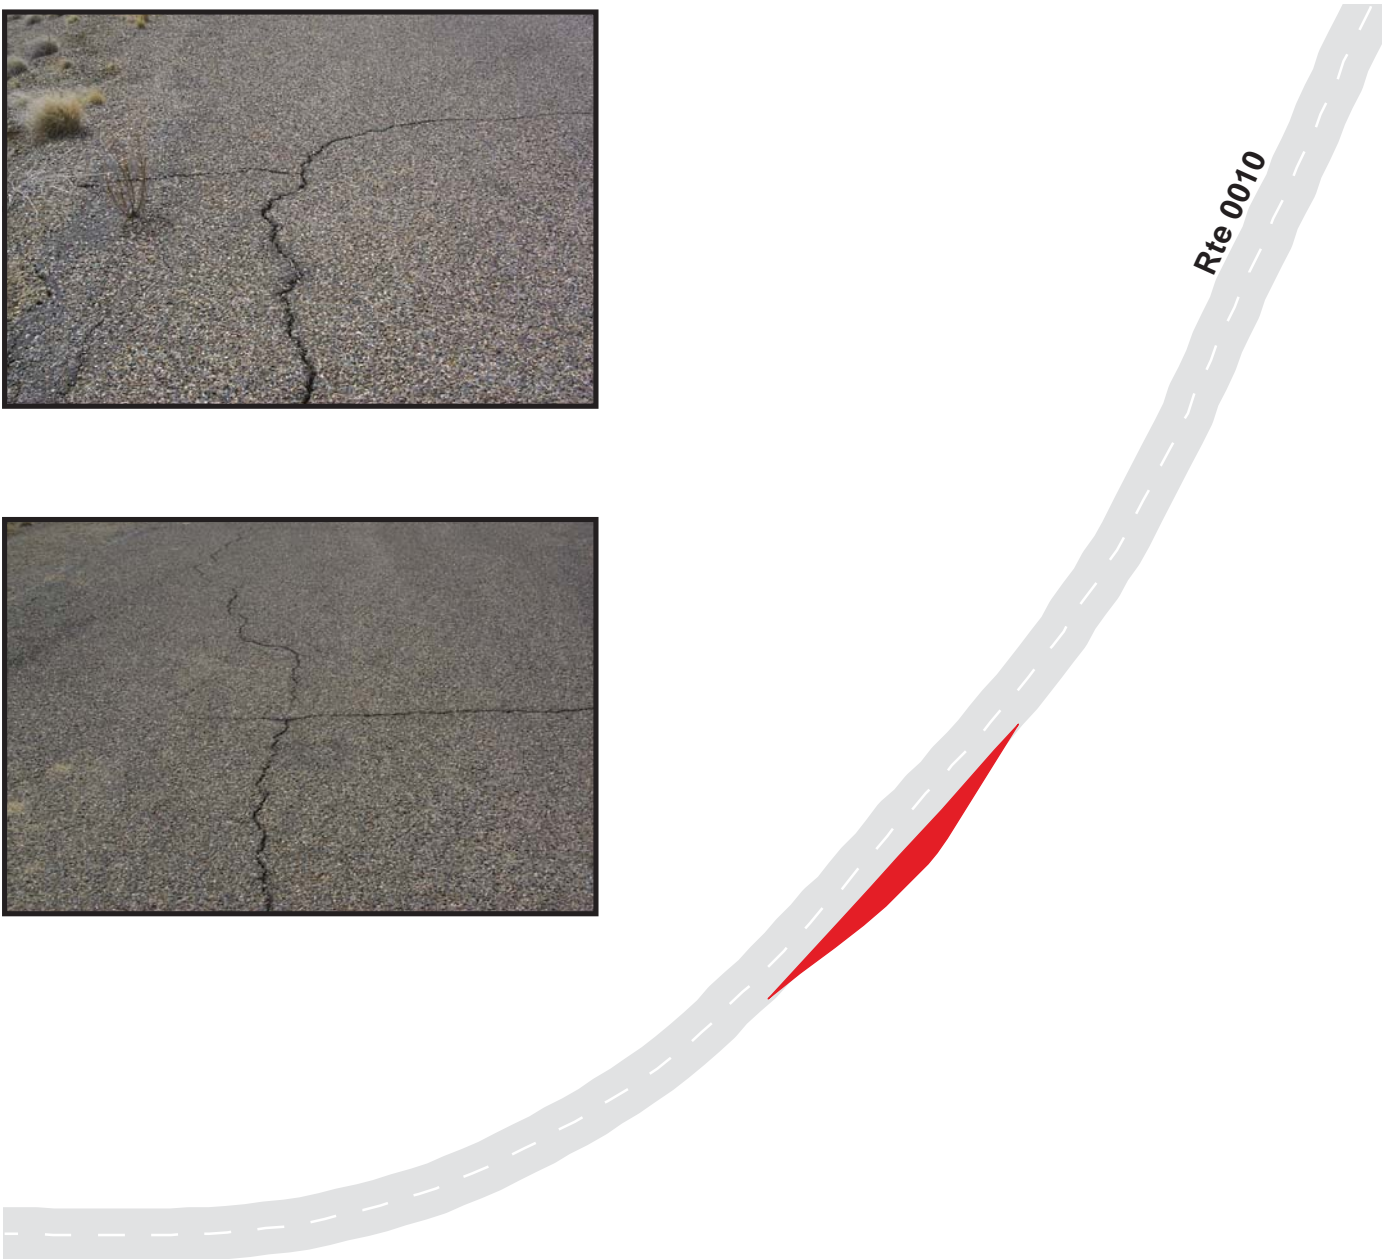
Route	Public / NonPublic	Date Visited	Area (sq ft)	Lane Miles *	Surface Type	Condition / PCR
0900	Public	4/3/2003	4099	0.07	OC	FAIR / 73

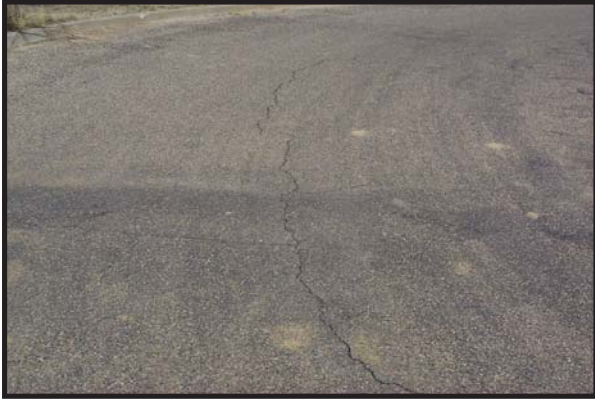
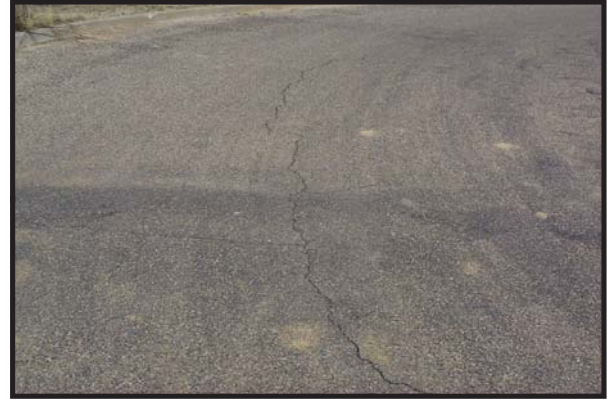
Route 0901

Route	Public / NonPublic	Date Visited	Area (sq ft)	Lane Miles *	Surface Type	Condition / PCR
0901	Public	4/3/2003	38918	0.67	OC	FAIR / 73

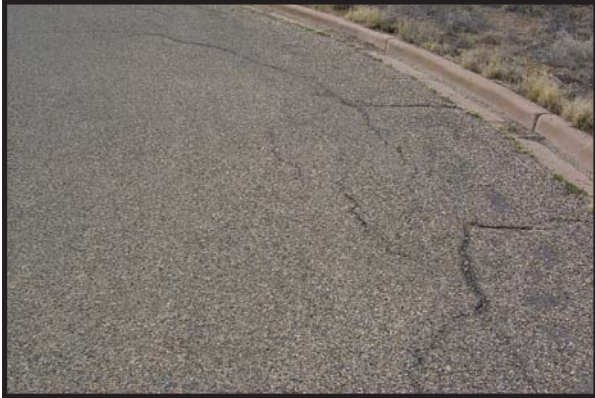
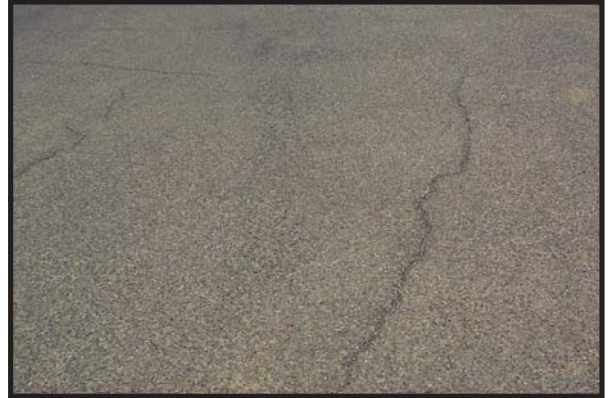
Route 0902

Route	Public / NonPublic	Date Visited	Area (sq ft)	Lane Miles *	Surface Type	Condition / PCR
0902	NonPublic	4/3/2003	12539	0.22	OC	FAIR / 73

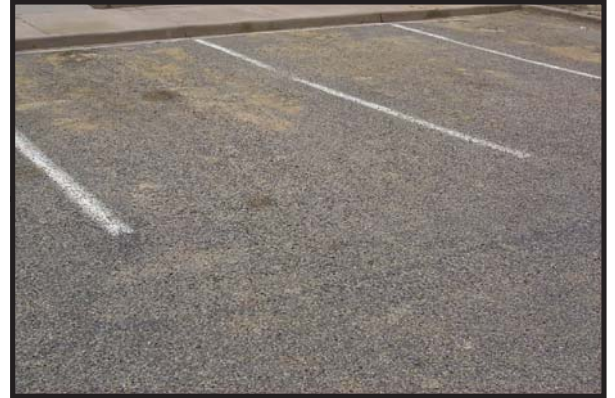
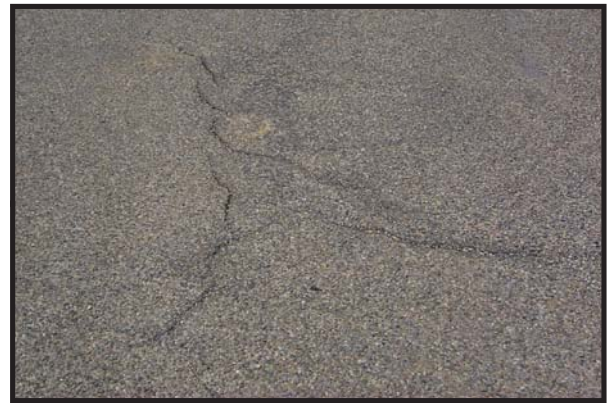
Route 0903

Route	Public / NonPublic	Date Visited	Area (sq ft)	Lane Miles *	Surface Type	Condition / PCR
0903	NonPublic	4/3/2003	7182	0.12	OC	FAIR / 73

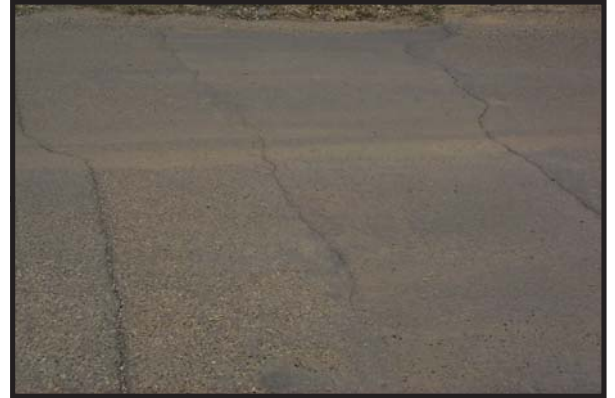
Route 0904

Route	Public / NonPublic	Date Visited	Area (sq ft)	Lane Miles *	Surface Type	Condition / PCR
0904	NonPublic	4/3/2003	25773	0.44	OC	FAIR / 73

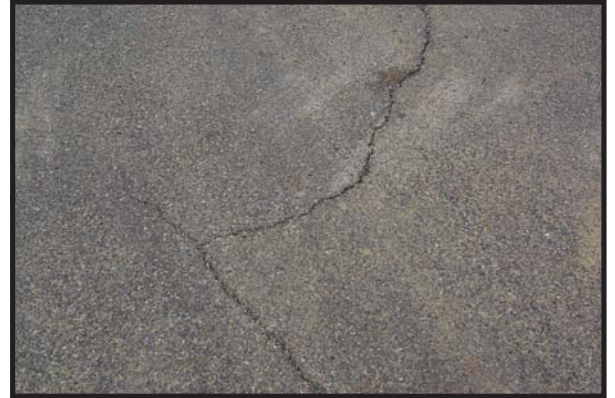
Route 0905

Route	Public / NonPublic	Date Visited	Area (sq ft)	Lane Miles *	Surface Type	Condition / PCR
0905	Public	4/3/2003	22981	0.40	OC	FAIR / 73

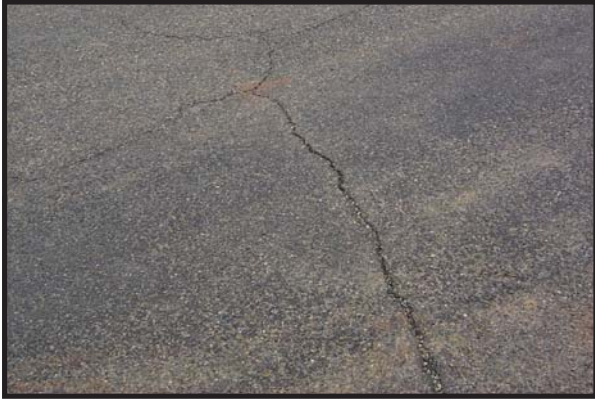
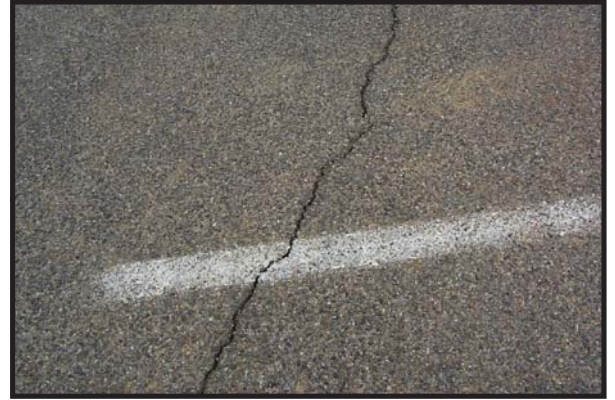
Route 0906

Route	Public / NonPublic	Date Visited	Area (sq ft)	Lane Miles *	Surface Type	Condition / PCR
0906	Public	4/3/2003	67895	1.17	OC	FAIR / 73

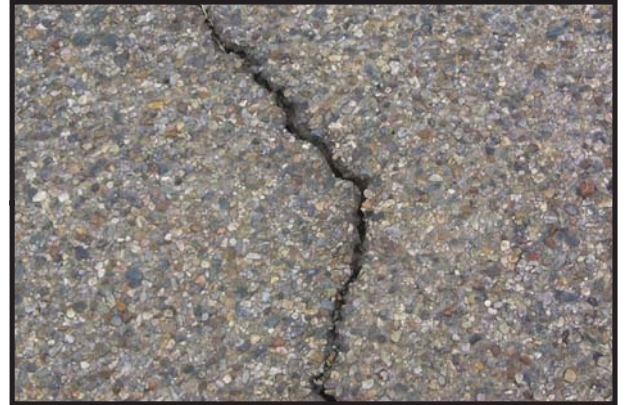
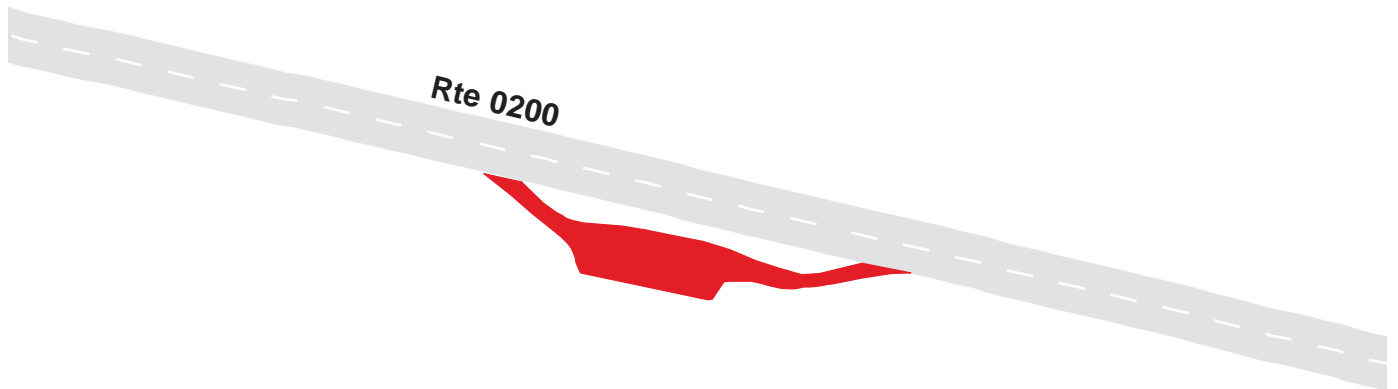
Route 0907

Route	Public / NonPublic	Date Visited	Area (sq ft)	Lane Miles *	Surface Type	Condition / PCR
0907	Public	4/3/2003	12139	0.21	OC	FAIR / 73

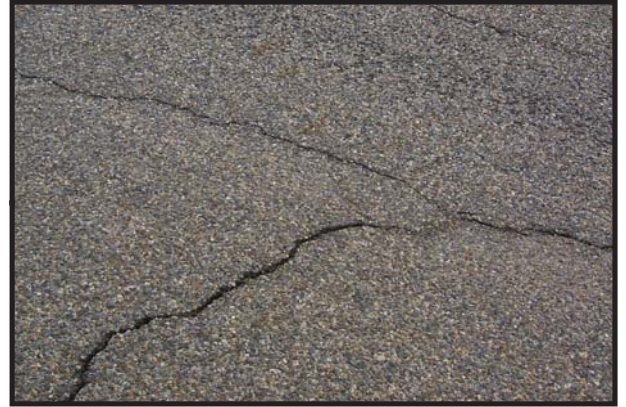
Route	Public / NonPublic	Date Visited	Area (sq ft)	Lane Miles *	Surface Type	Condition / PCR
0908	Public	4/3/2003	5001	0.09	OC	FAIR / 73
