The Road Inventory of Chickasaw National Recreation Area CHIC – 7510

Road Inventory Program

Prepared By:
Federal Highway Administration
Eastern Federal Lands Highway Division
Cycle 3

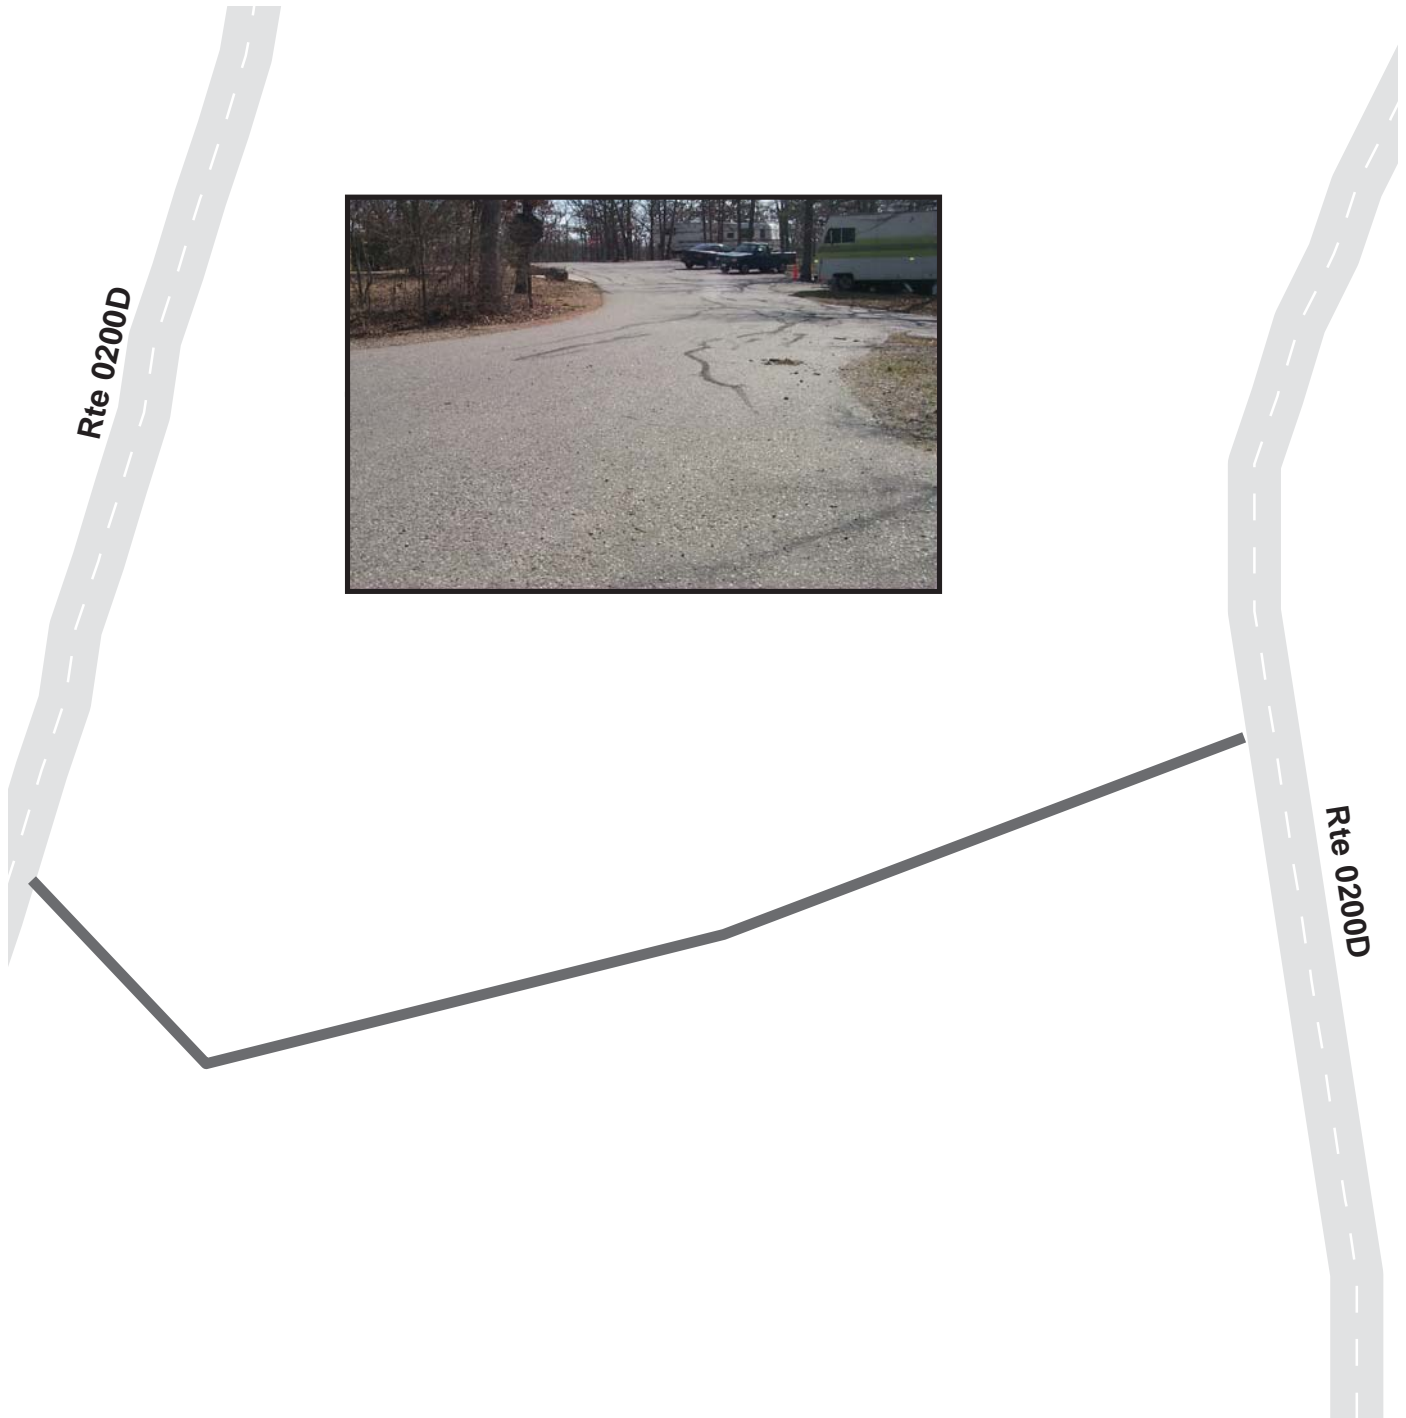
Route 0200DA

Route	Length (mi)	Width (ft)	Area (sq ft)	Lane Miles *	Condition / PCR	Surface Type
0200DA	0.06	16.00	4731	0.08	FAIR / 73	AS

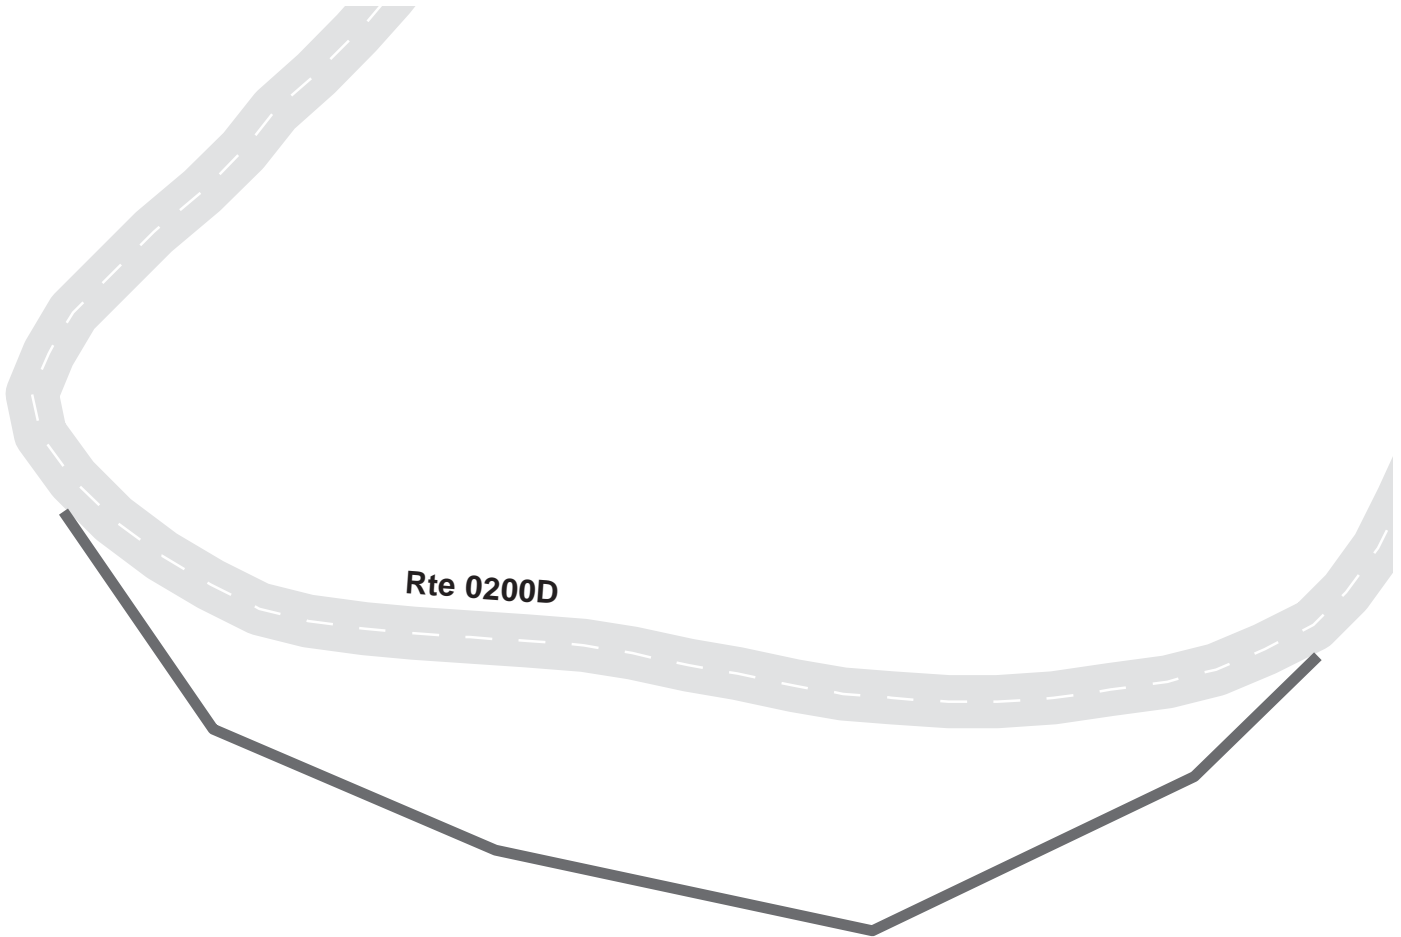
Route 0200DB

Route	Length (mi)	Width (ft)	Area (sq ft)	Lane Miles *	Condition / PCR	Surface Type
0200DB	0.08	16.00	7096	0.12	FAIR / 73	AS

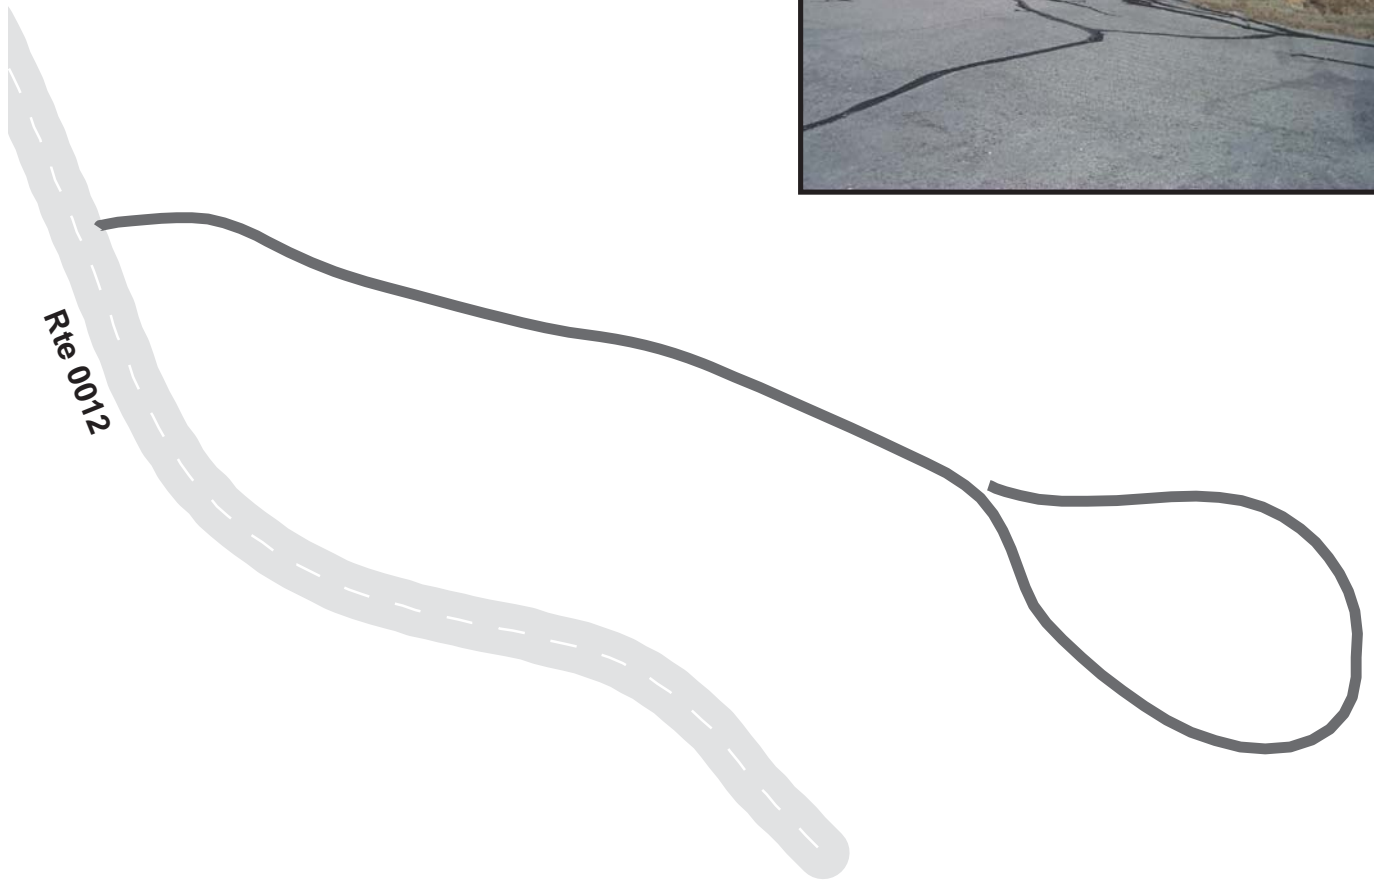
Route 0201

Route	Length (mi)	Width (ft)	Area (sq ft)	Lane Miles *	Condition / PCR	Surface Type
0201	0.42	14.00	30751	0.53	FAIR / 73	AS

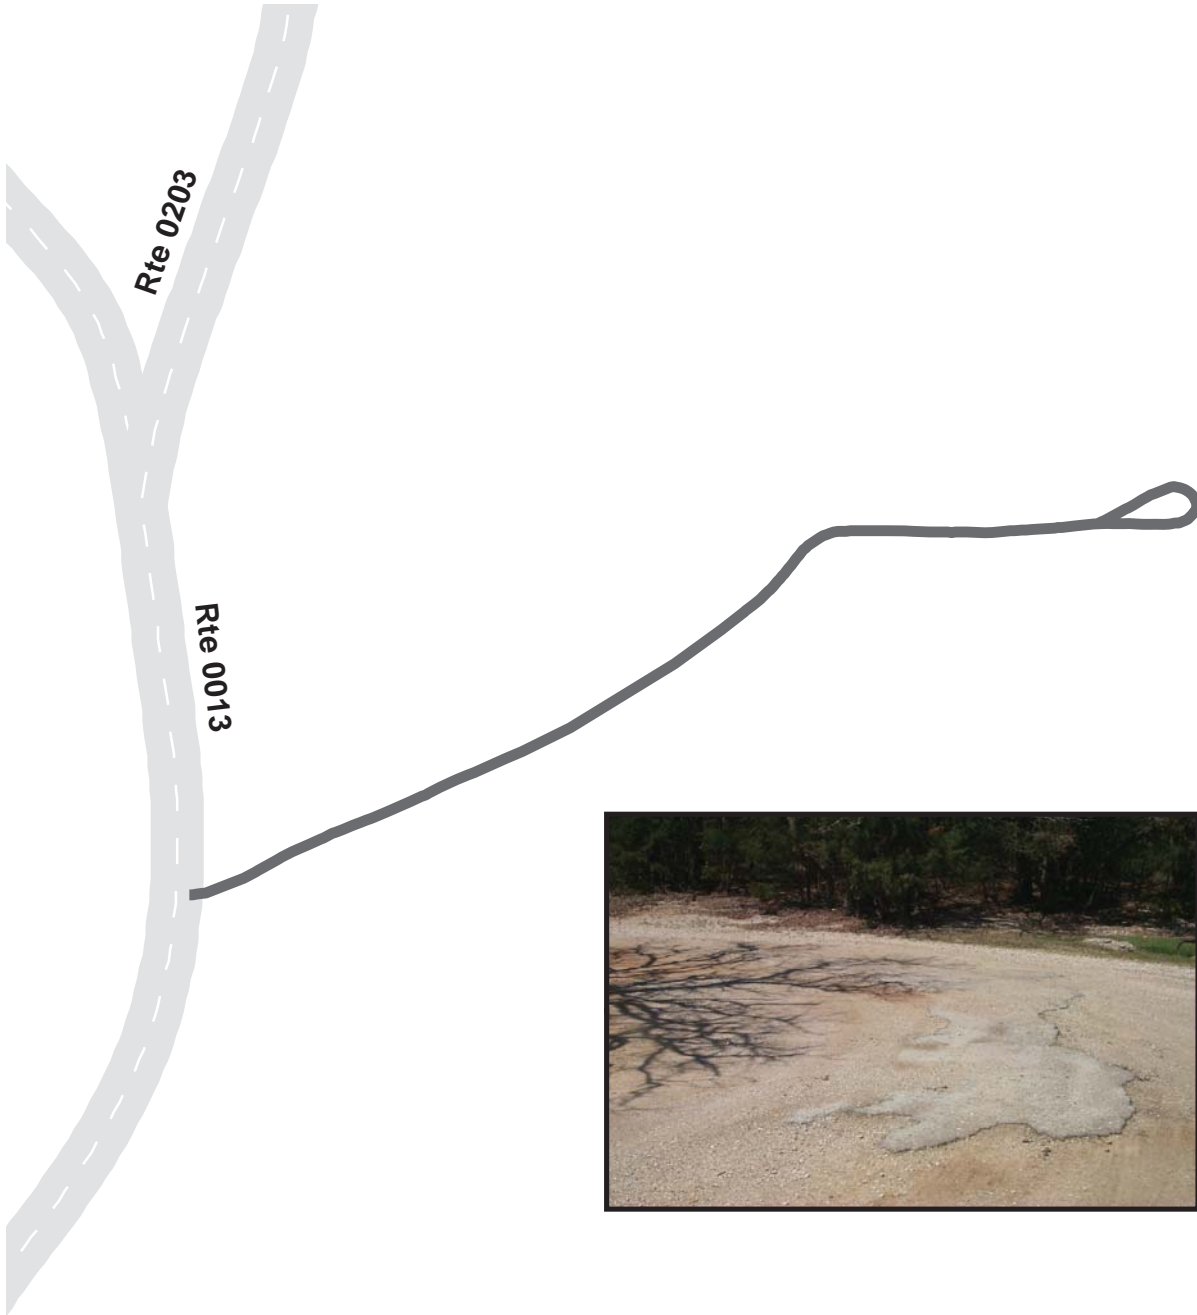
Route 0202

Route	Length (mi)	Width (ft)	Area (sq ft)	Lane Miles *	Condition / PCR	Surface Type
0202	0.32	13.00	21896	0.38	POOR / 45	AS

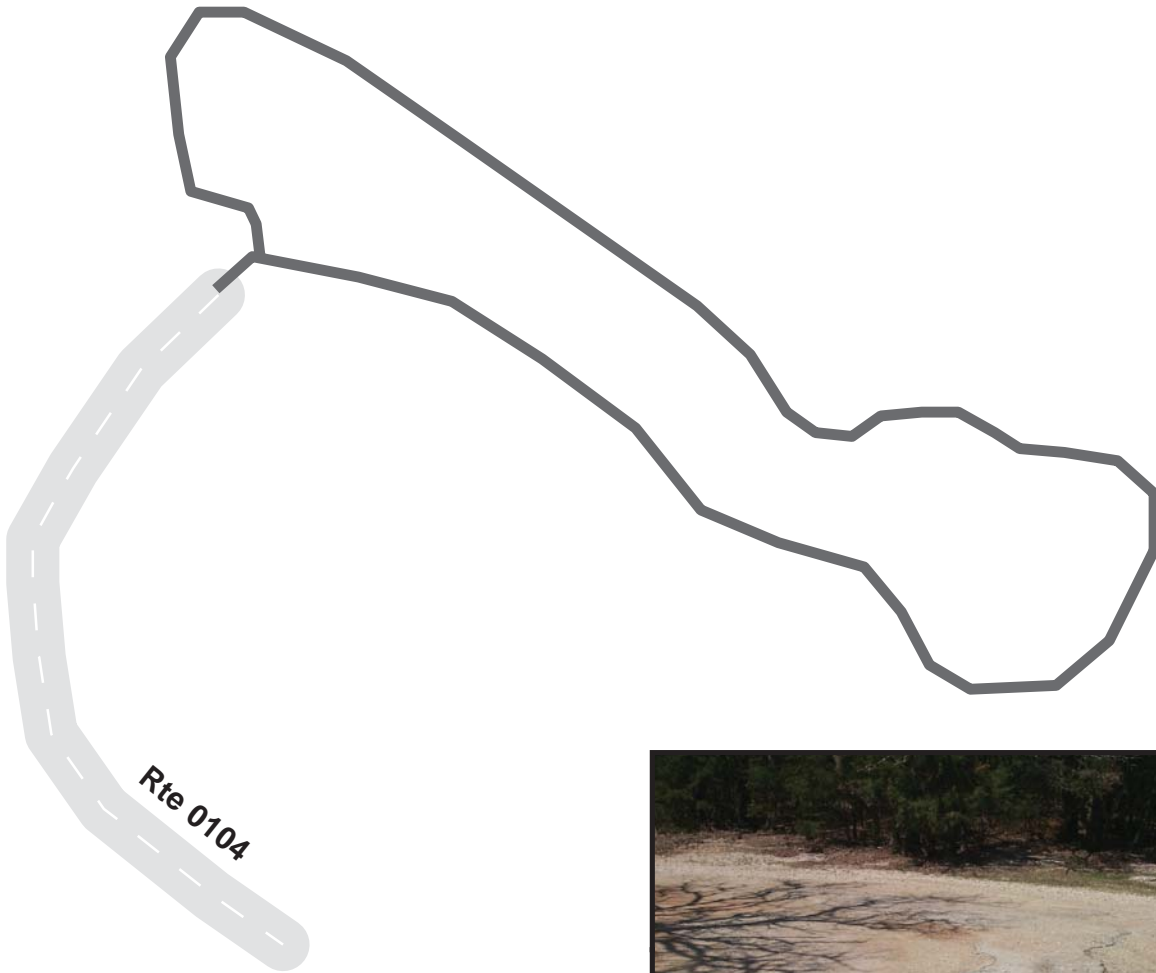
Route 0204

Route	Length (mi)	Width (ft)	Area (sq ft)	Lane Miles *	Condition / PCR	Surface Type
0204	0.84	13.00	57658	0.99	FAIR / 73	AS

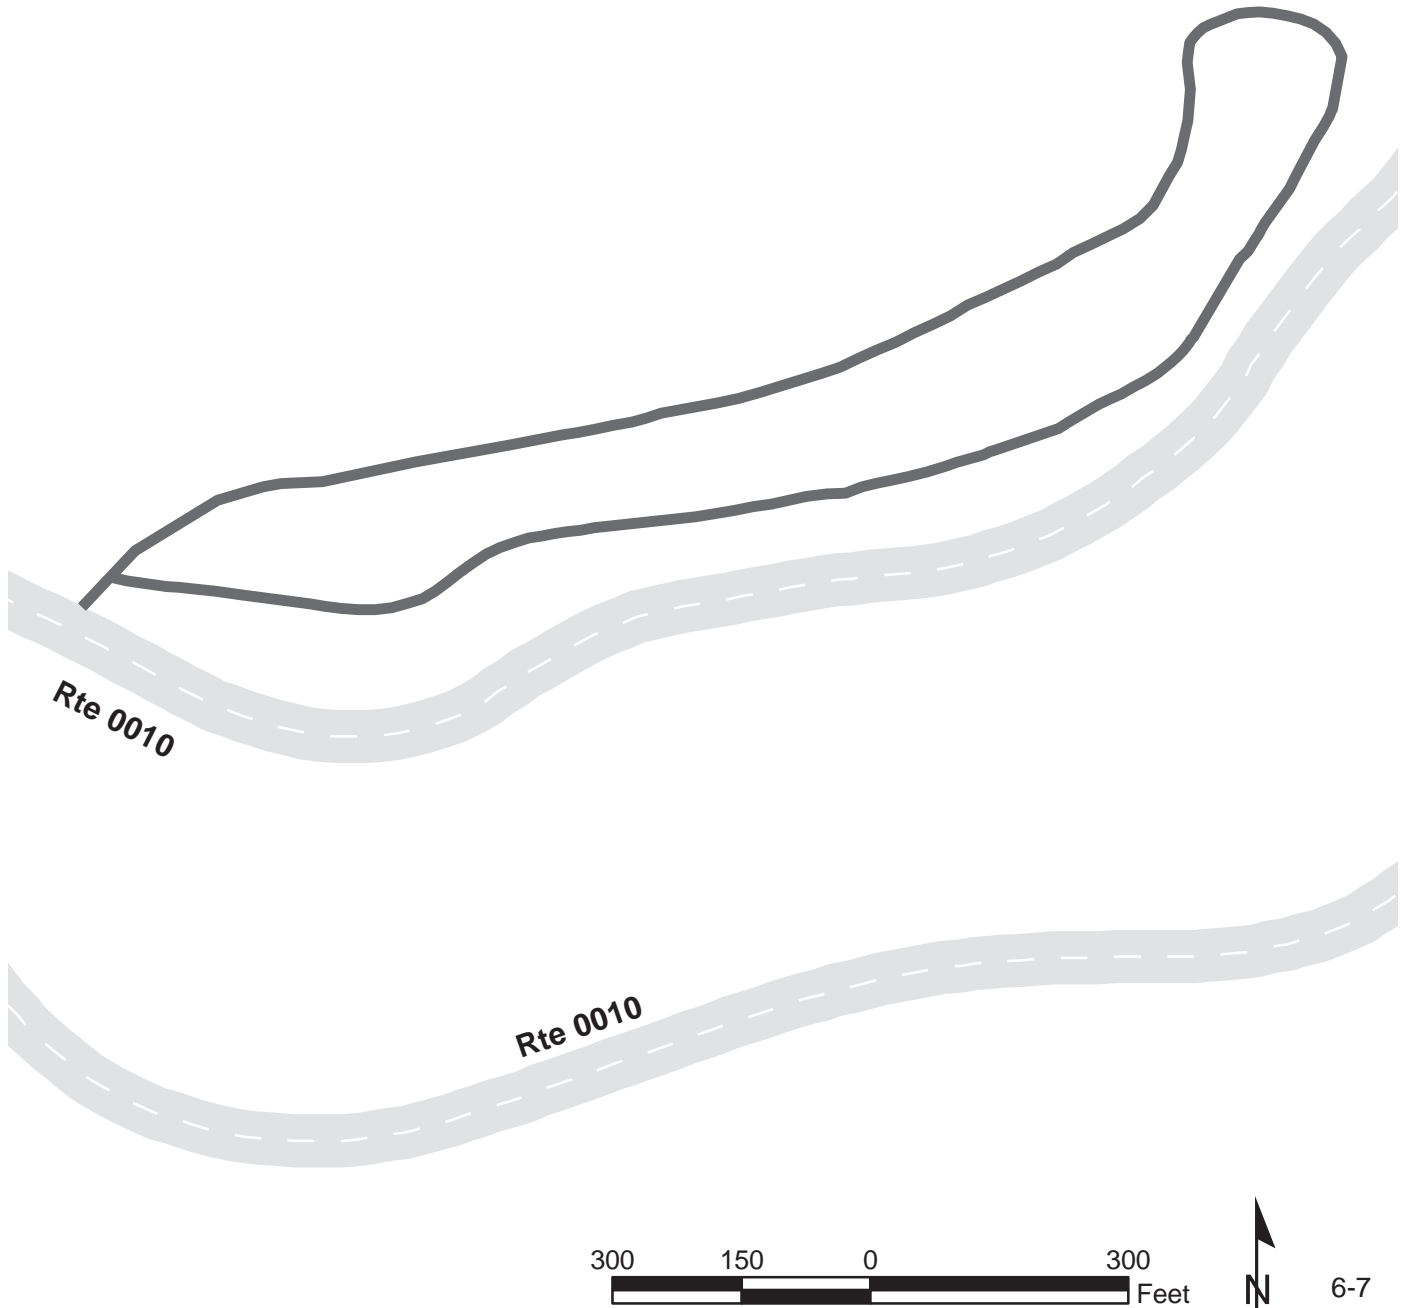
Route 0207A

Route	Length (mi)	Width (ft)	Area (sq ft)	Lane Miles *	Condition / PCR	Surface Type
0207A	0.57	10.00	30202	0.52	POOR / 45	OC

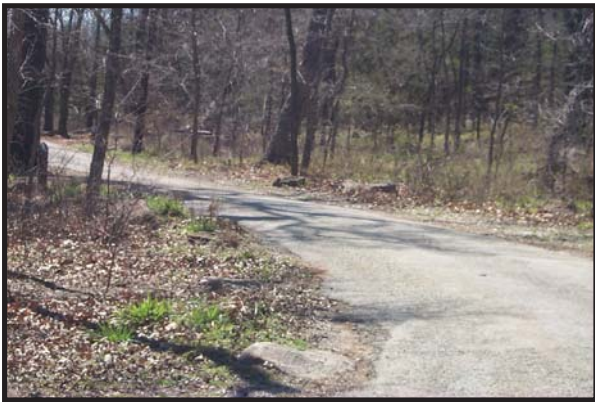
Route 0207C

Route	Length (mi)	Width (ft)	Area (sq ft)	Lane Miles *	Condition / PCR	Surface Type
0207C	0.03	11.00	1800	0.03	POOR / 45	OC

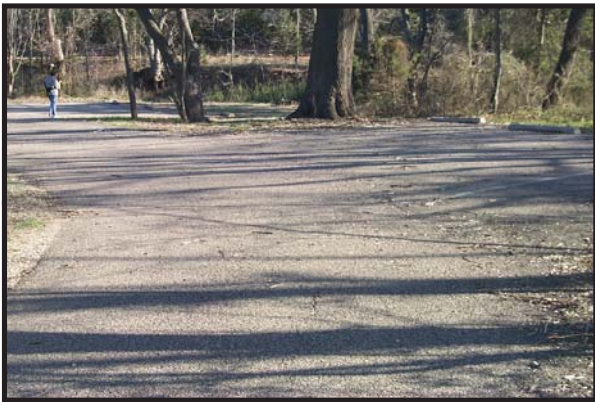
Route 0209

Route	Length (mi)	Width (ft)	Area (sq ft)	Lane Miles *	Condition / PCR	Surface Type
0209	1.62	12.00	102707	1.77	POOR / 45	OC

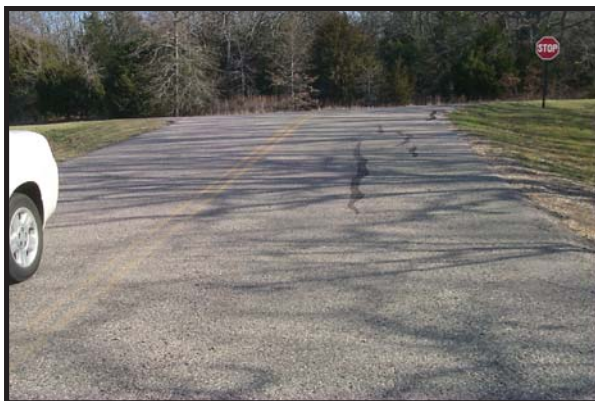
Route 0220

Route	Length (mi)	Width (ft)	Area (sq ft)	Lane Miles *	Condition / PCR	Surface Type
0220	0.15	0.00	8672	0.15	GOOD / 90	CO

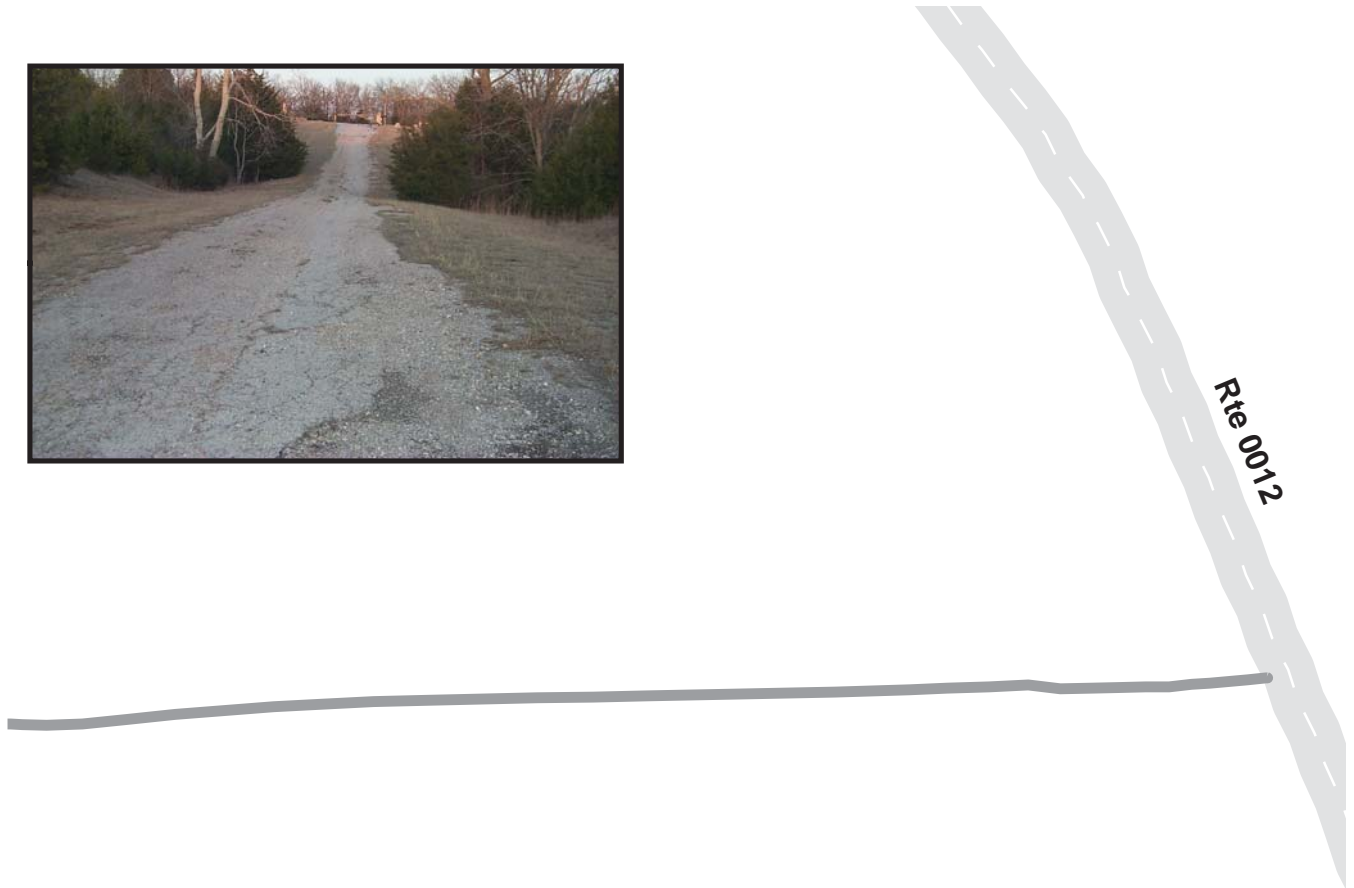
Route 0406

Route	Length (mi)	Width (ft)	Area (sq ft)	Lane Miles *	Condition / PCR	Surface Type
0406	0.10	14.00	7762	0.13	POOR / 45	OC

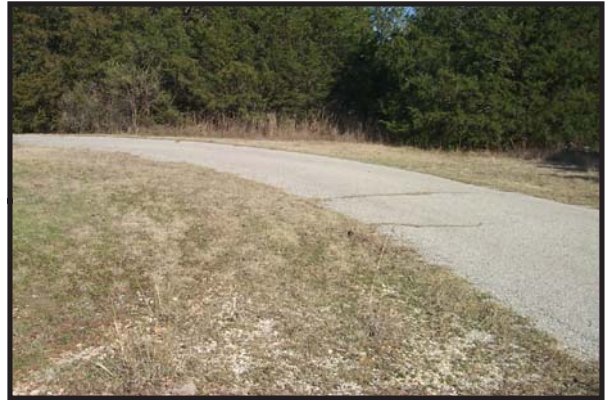
Route 0900

Route	Public / NonPublic	Date Visited	Area (sq ft)	Lane Miles *	Surface Type	Condition / PCR
0900	Public	12/1/2003	43560	0.75	OC	GOOD / 90

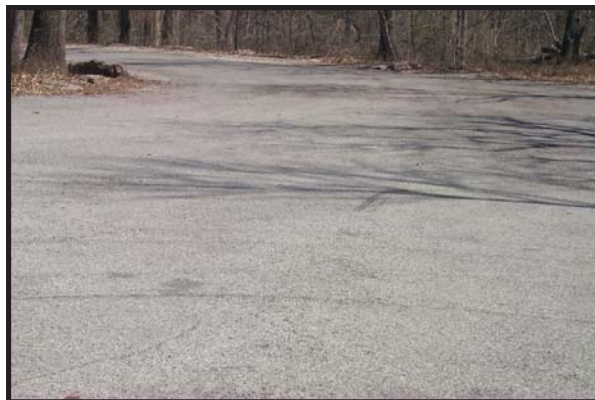
Route 0902

Route	Public / NonPublic	Date Visited	Area (sq ft)	Lane Miles *	Surface Type	Condition / PCR
0902	Public	12/1/2003	2783	0.05	OC	GOOD / 90

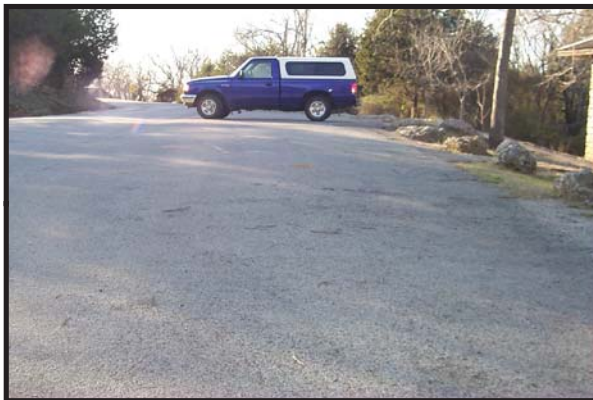
Route 0903

Route	Public / NonPublic	Date Visited	Area (sq ft)	Lane Miles *	Surface Type	Condition / PCR
0903	Public	12/1/2003	13596	0.23	OC	GOOD / 90

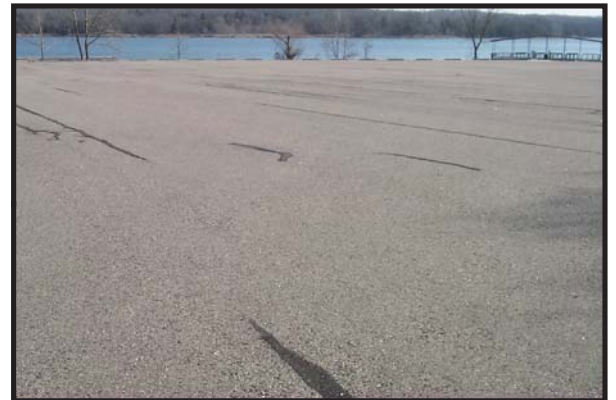
Route 0911

Route	Public / NonPublic	Date Visited	Area (sq ft)	Lane Miles *	Surface Type	Condition / PCR
0911	Public	12/1/2003	105309	1.81	AS	GOOD / 90

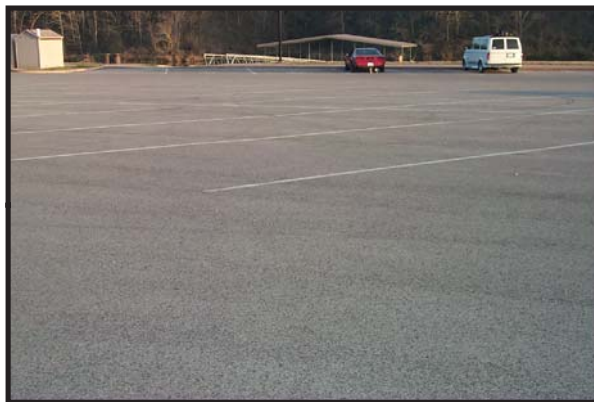
Route 0912

Route	Public / NonPublic	Date Visited	Area (sq ft)	Lane Miles *	Surface Type	Condition / PCR
0912	Public	12/1/2003	43687	0.75	OC	FAIR / 73

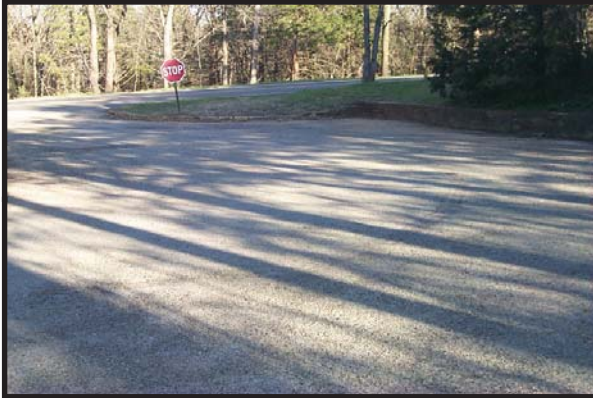
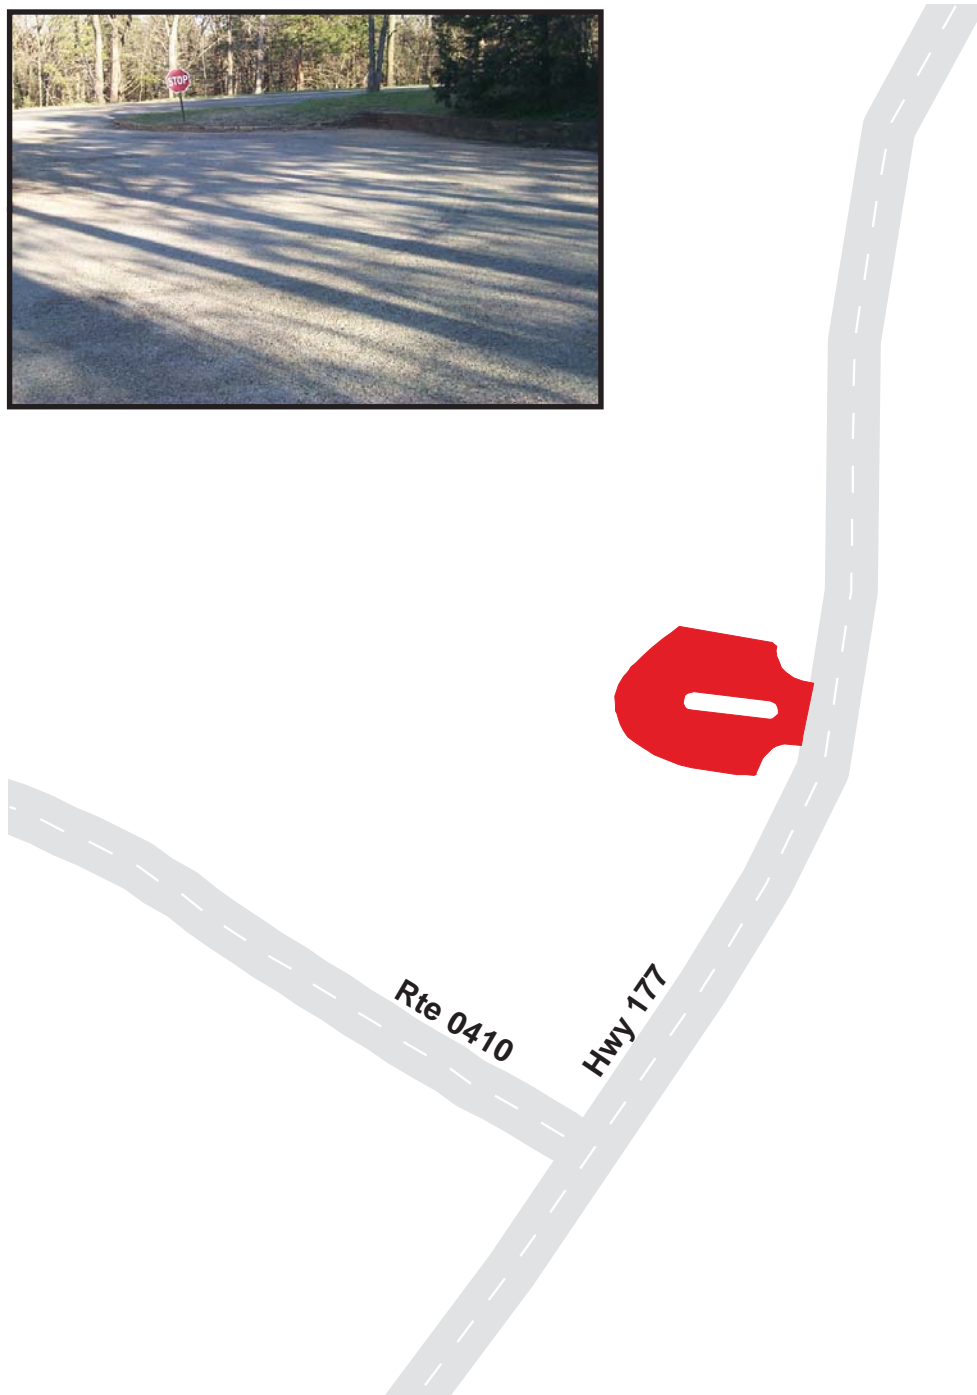
Route 0915A

Route	Public / NonPublic	Date Visited	Area (sq ft)	Lane Miles *	Surface Type	Condition / PCR
0915A	Public	12/1/2003	7023	0.12	OC	GOOD / 90

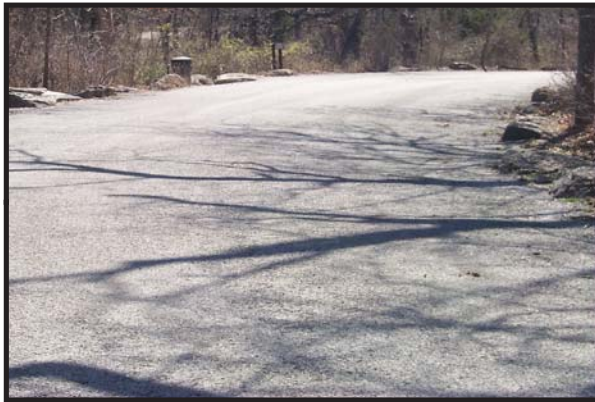
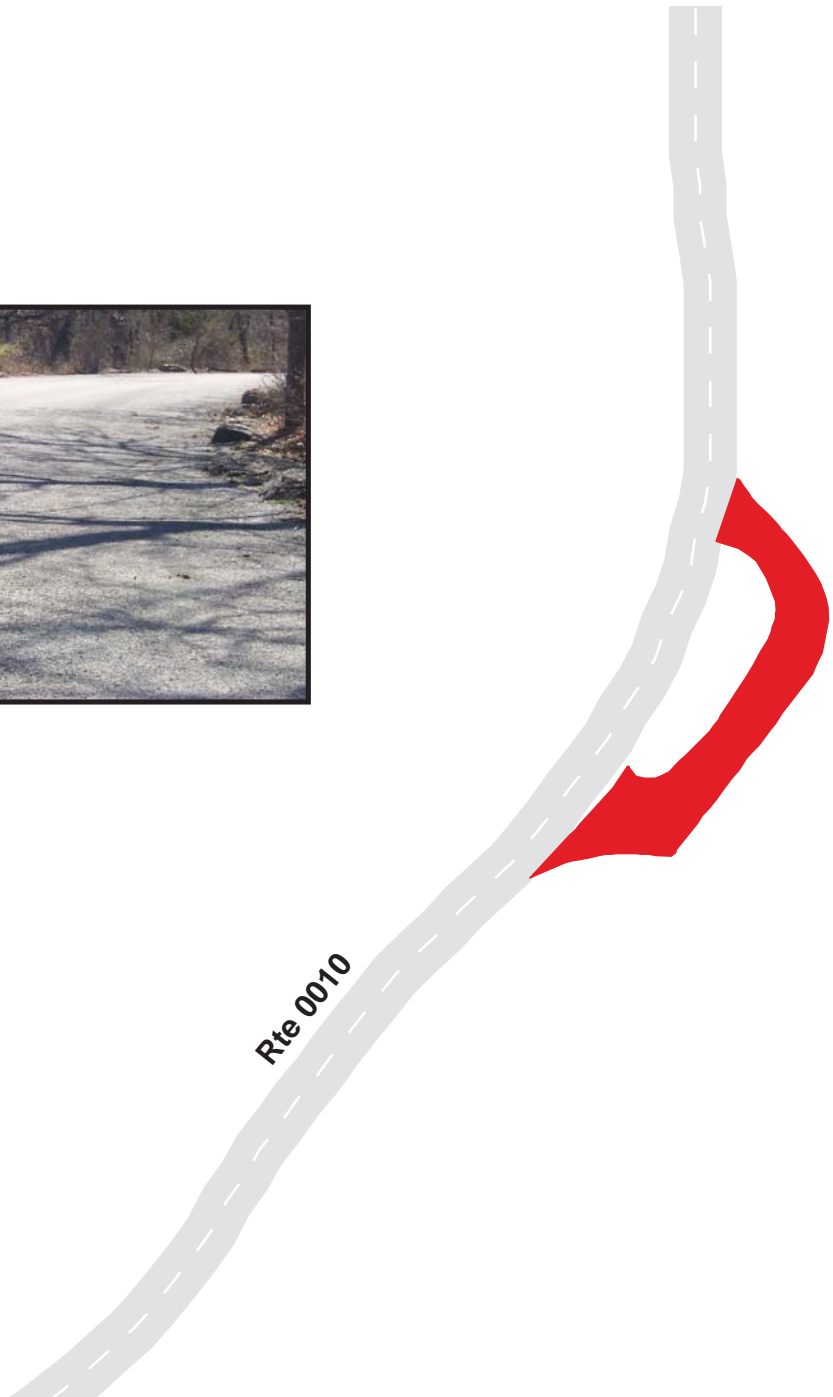
Route 0915B

Route	Public / NonPublic	Date Visited	Area (sq ft)	Lane Miles *	Surface Type	Condition / PCR
0915B	Public	12/1/2003	3295	0.06	OC	POOR / 45

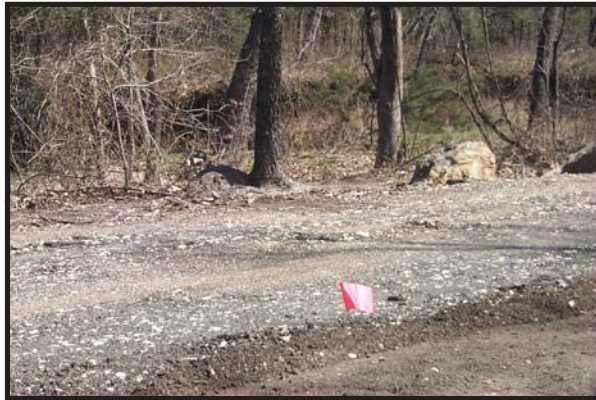
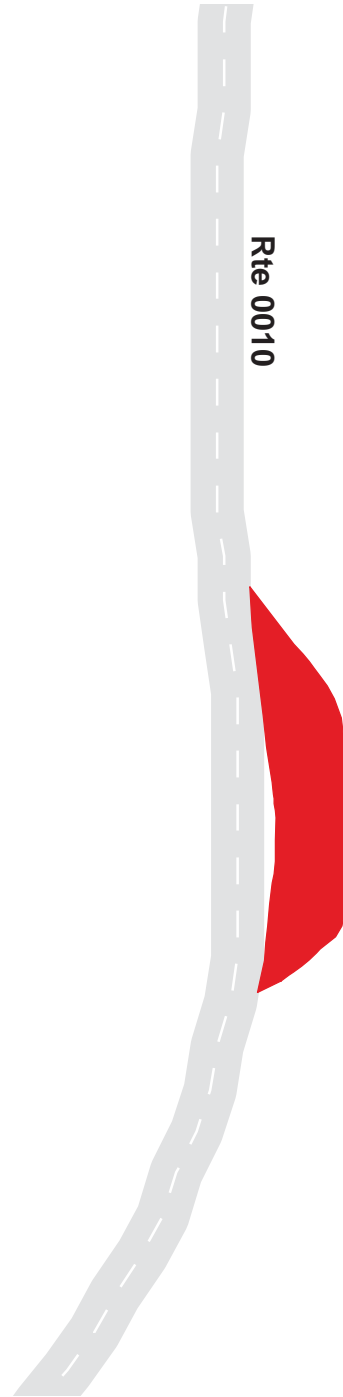
Route 0916

Route	Public / NonPublic	Date Visited	Area (sq ft)	Lane Miles *	Surface Type	Condition / PCR
0916	Public	12/1/2003	18191	0.31	AS	GOOD / 90

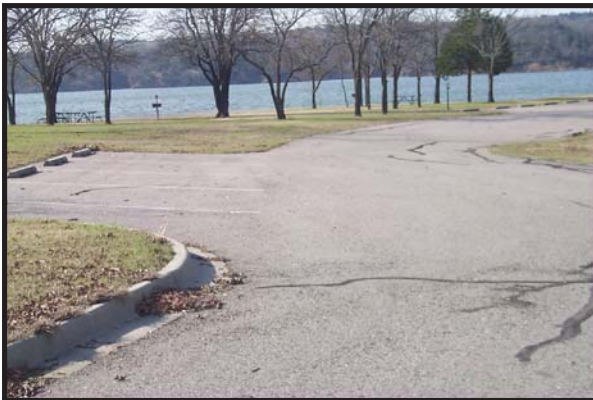
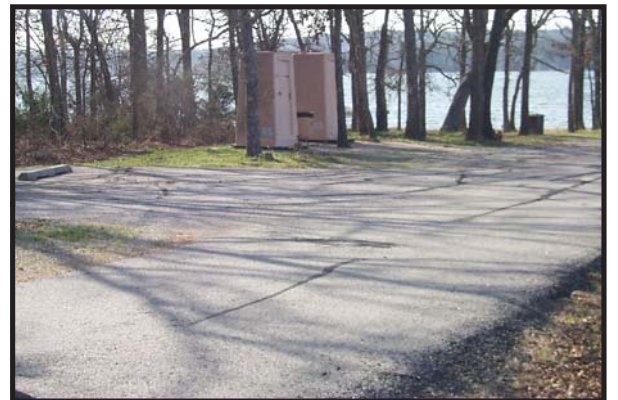
Route 0917

Route	Public / NonPublic	Date Visited	Area (sq ft)	Lane Miles *	Surface Type	Condition / PCR
0917	Public	12/1/2003	16298	0.28	AS	GOOD / 90

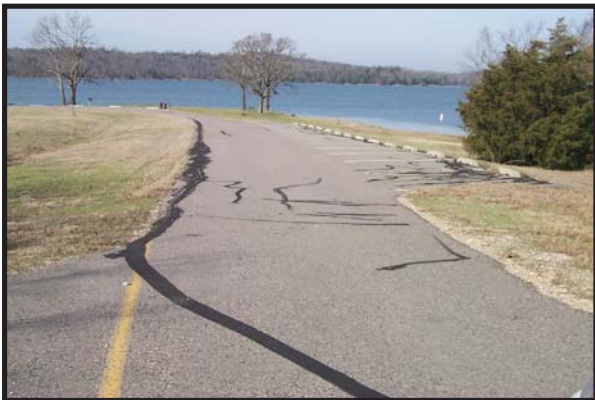
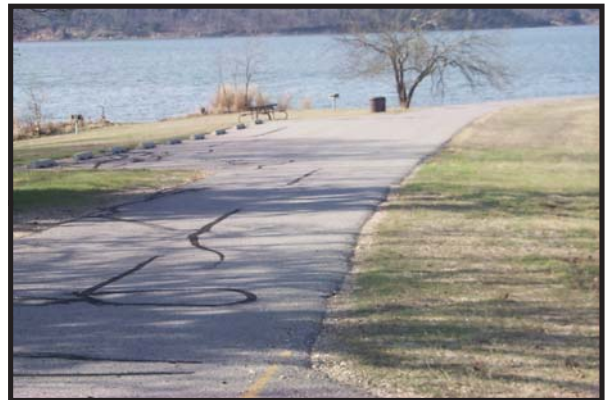
Route 0920

Route	Public / NonPublic	Date Visited	Area (sq ft)	Lane Miles *	Surface Type	Condition / PCR
0920	Public	12/1/2003	1684	0.03	AS	FAIR / 73

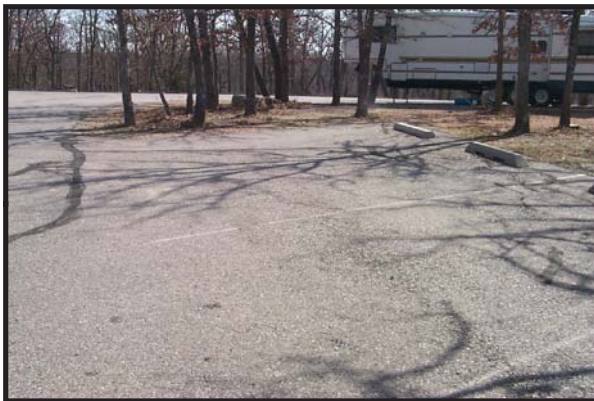
Route 0921

Route	Public / NonPublic	Date Visited	Area (sq ft)	Lane Miles *	Surface Type	Condition / PCR
0921	Public	12/1/2003	18361	0.32	AS	GOOD / 90

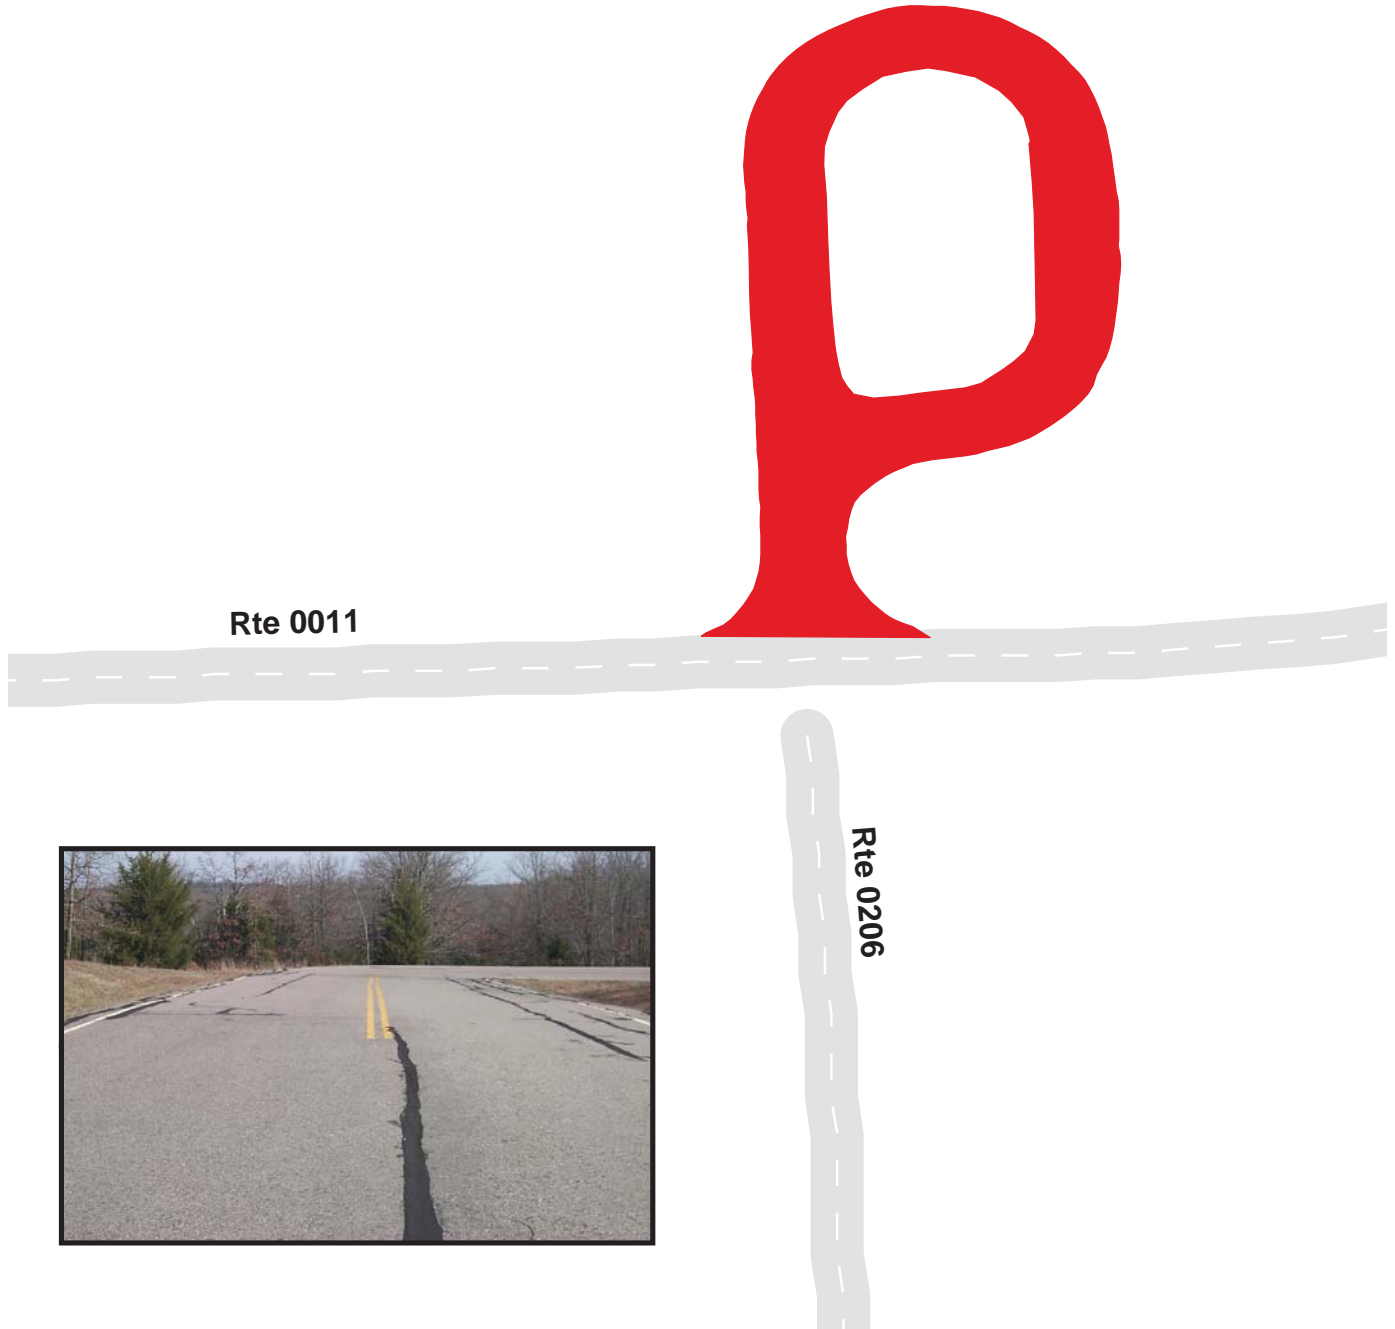
Route 0923

Route	Public / NonPublic	Date Visited	Area (sq ft)	Lane Miles *	Surface Type	Condition / PCR
0923	Public	12/1/2003	6979	0.12	AS	FAIR / 73

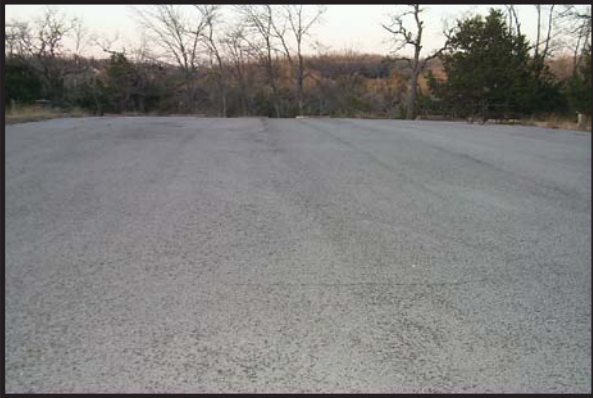
Route 0924

Route	Public / NonPublic	Date Visited	Area (sq ft)	Lane Miles *	Surface Type	Condition / PCR
0924	Public	12/1/2003	5593	0.10	OC	POOR / 45

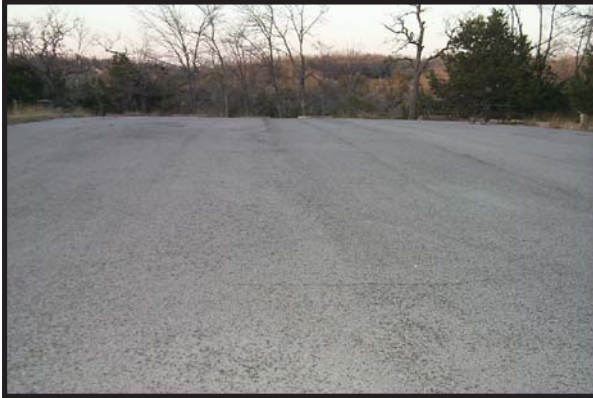
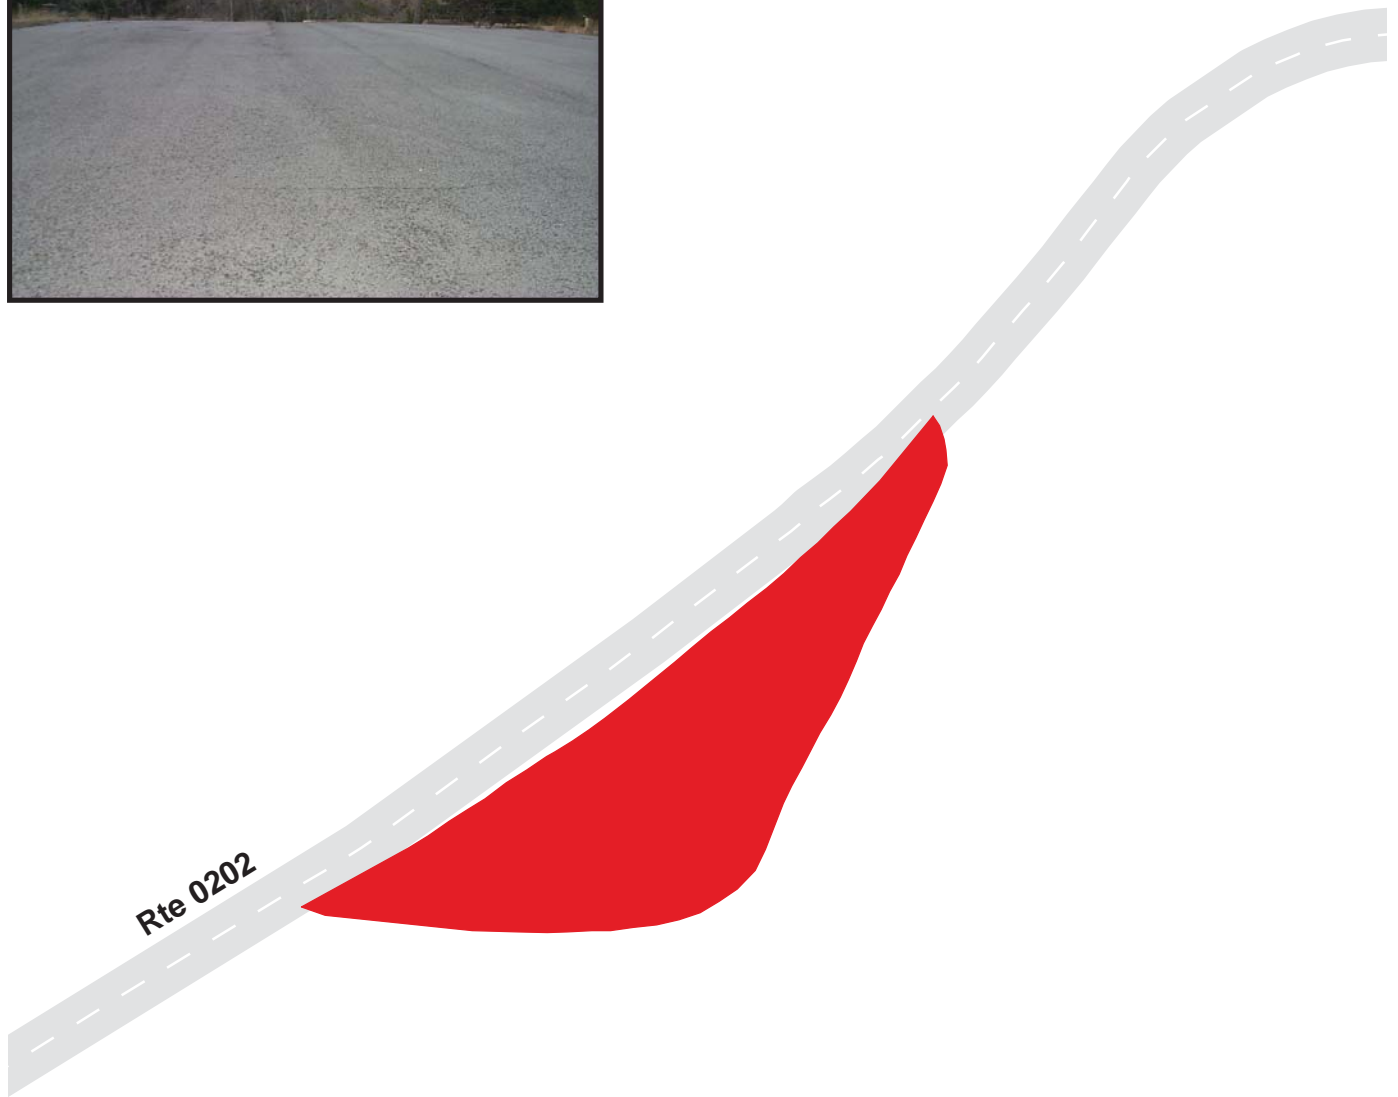
Route 0926A

Route	Public / NonPublic	Date Visited	Area (sq ft)	Lane Miles *	Surface Type	Condition / PCR
0926A	Public	12/1/2003	1179	0.02	NC	GOOD / 90

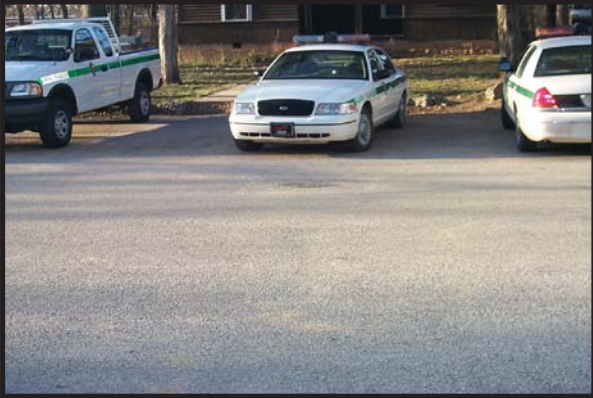
Route 0926B

Route	Public / NonPublic	Date Visited	Area (sq ft)	Lane Miles *	Surface Type	Condition / PCR
0926B	Public	12/1/2003	3909	0.07	OC	GOOD / 90

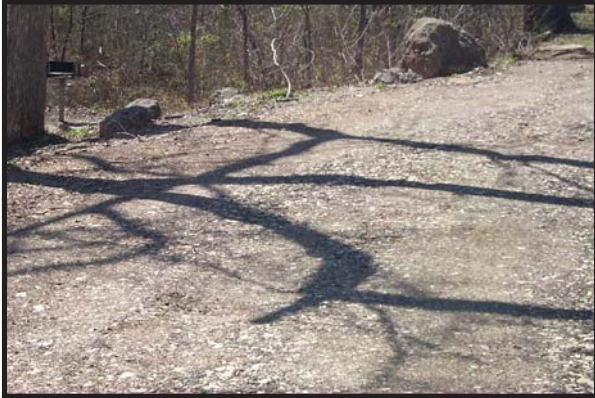
Route 0928

Route	Public / NonPublic	Date Visited	Area (sq ft)	Lane Miles *	Surface Type	Condition / PCR
0928	NonPublic	12/1/2003	15811	0.27	NC	FAIR / 73

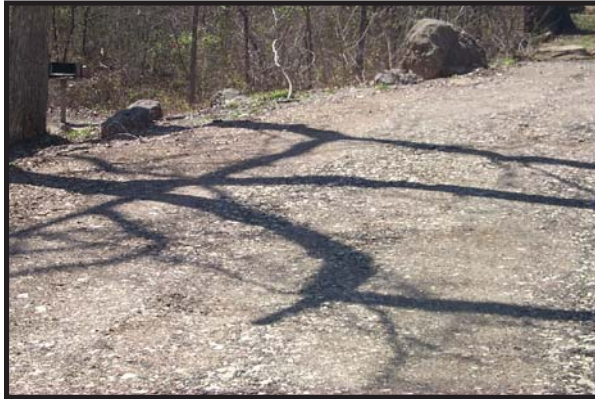
Chickasaw National Recreation Area
Route 0940
 BUCKHORN WALK-IN CAMPGROUND PARKING
 Adjacent To Route 0200DB

Route	Public / NonPublic	Date Visited	Area (sq ft)	Lane Miles *	Surface Type	Condition / PCR
0940	Public	12/1/2003	4306	0.07	AS	FAIR / 73

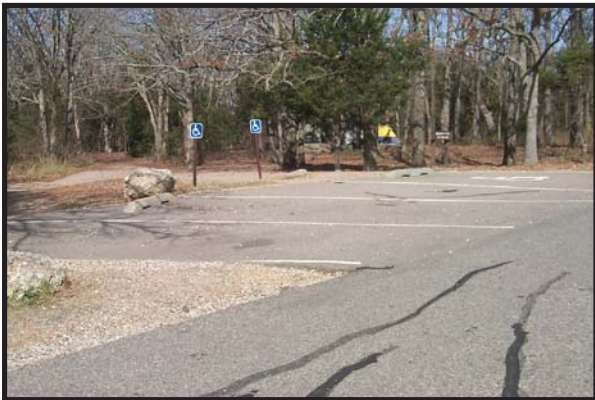
Route 0941

Route	Public / NonPublic	Date Visited	Area (sq ft)	Lane Miles *	Surface Type	Condition / PCR
0941	Public	12/1/2003	3847	0.07	AS	FAIR / 73
