The Road Inventory of Chickasaw National Recreation Area CHIC – 7510

Road Inventory Program

Prepared By:
Federal Highway Administration
Eastern Federal Lands Highway Division
Cycle 3

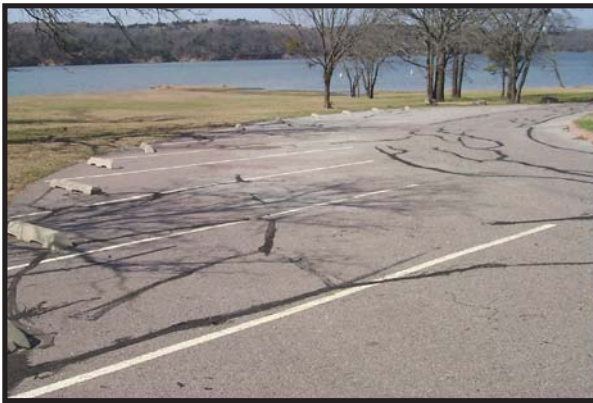
Route 0942

Route	Public / NonPublic	Date Visited	Area (sq ft)	Lane Miles *	Surface Type	Condition / PCR
0942	Public	12/1/2003	1742	0.03	AS	GOOD / 90

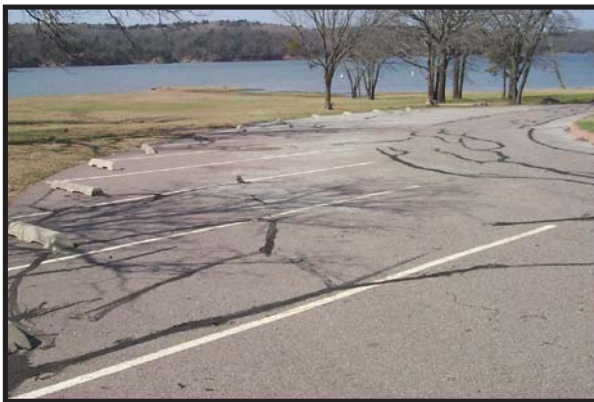
Route 0943

Route	Public / NonPublic	Date Visited	Area (sq ft)	Lane Miles *	Surface Type	Condition / PCR
0943	Public	3/27/2002	3399	0.06	AS	FAIR / 73

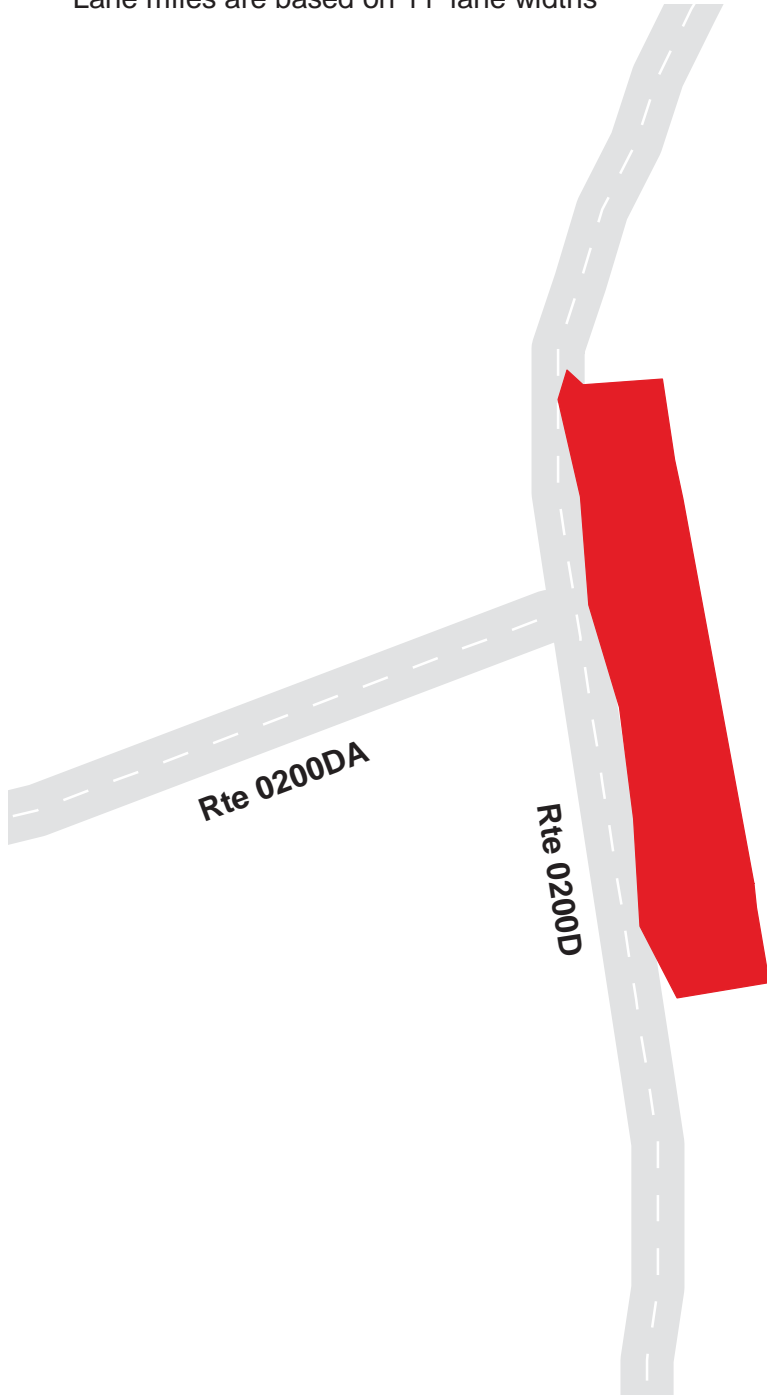
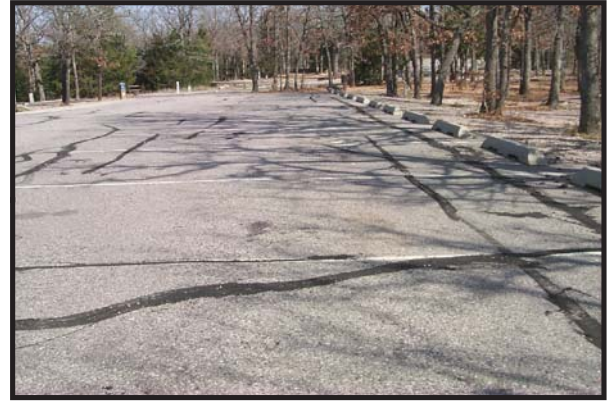
Route 0944

Route	Public / NonPublic	Date Visited	Area (sq ft)	Lane Miles *	Surface Type	Condition / PCR
0944	Public	3/27/2002	1131	0.02	AS	GOOD / 90

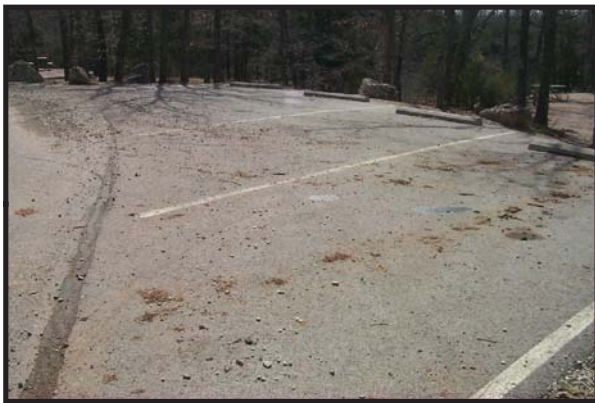
Route 0945

Route	Public / NonPublic	Date Visited	Area (sq ft)	Lane Miles *	Surface Type	Condition / PCR
0945	Public	3/27/2002	3612	0.06	AS	FAIR / 73

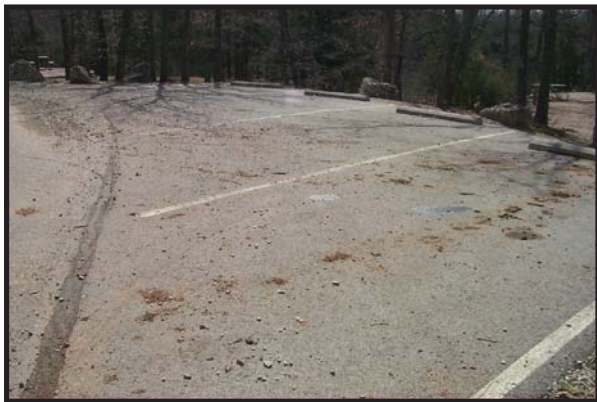
Route 0946

Route	Public / NonPublic	Date Visited	Area (sq ft)	Lane Miles *	Surface Type	Condition / PCR
0946	Public	3/27/2002	1679	0.03	AS	GOOD / 90

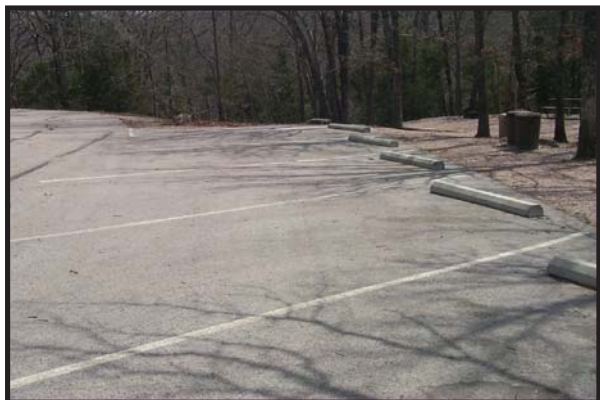
Route 0947

Route	Public / NonPublic	Date Visited	Area (sq ft)	Lane Miles *	Surface Type	Condition / PCR
0947	Public	3/27/2002	9248	0.16	AS	FAIR / 73

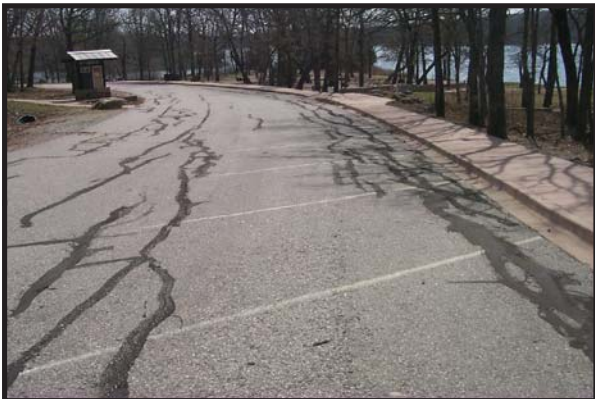
Route 0948

Route	Public / NonPublic	Date Visited	Area (sq ft)	Lane Miles *	Surface Type	Condition / PCR
0948	Public	3/27/2002	1361	0.02	AS	GOOD / 90

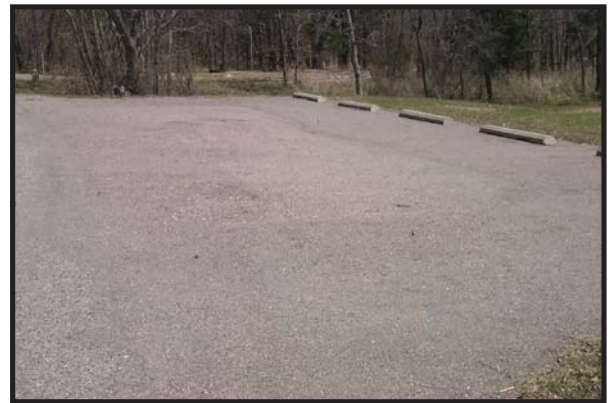
Route 0949

Route	Public / NonPublic	Date Visited	Area (sq ft)	Lane Miles *	Surface Type	Condition / PCR
0949	Public	3/27/2002	645	0.01	AS	GOOD / 90

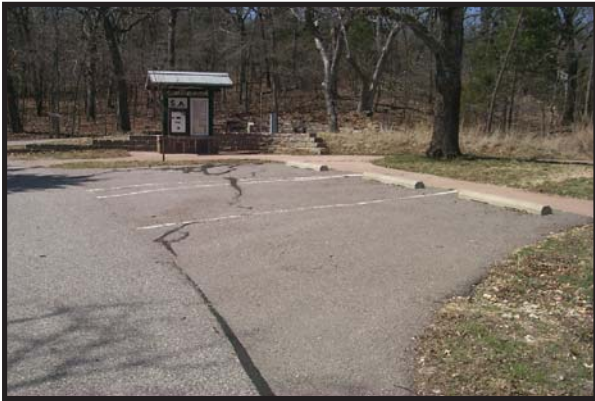
Route 0950

Route	Public / NonPublic	Date Visited	Area (sq ft)	Lane Miles *	Surface Type	Condition / PCR
0950	Public	3/27/2002	2142	0.04	AS	GOOD / 90

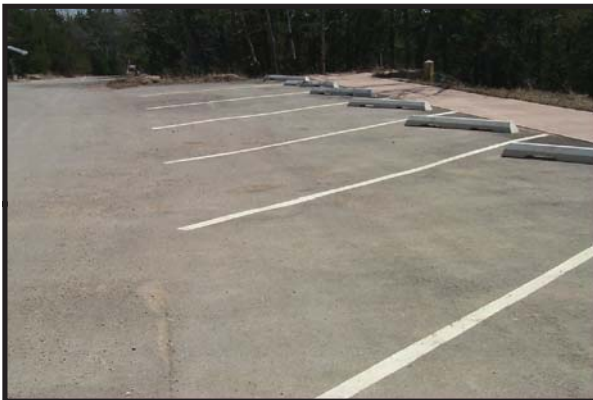
Route 0951

Route	Public / NonPublic	Date Visited	Area (sq ft)	Lane Miles *	Surface Type	Condition / PCR
0951	Public	3/27/2002	2713	0.05	AS	GOOD / 90

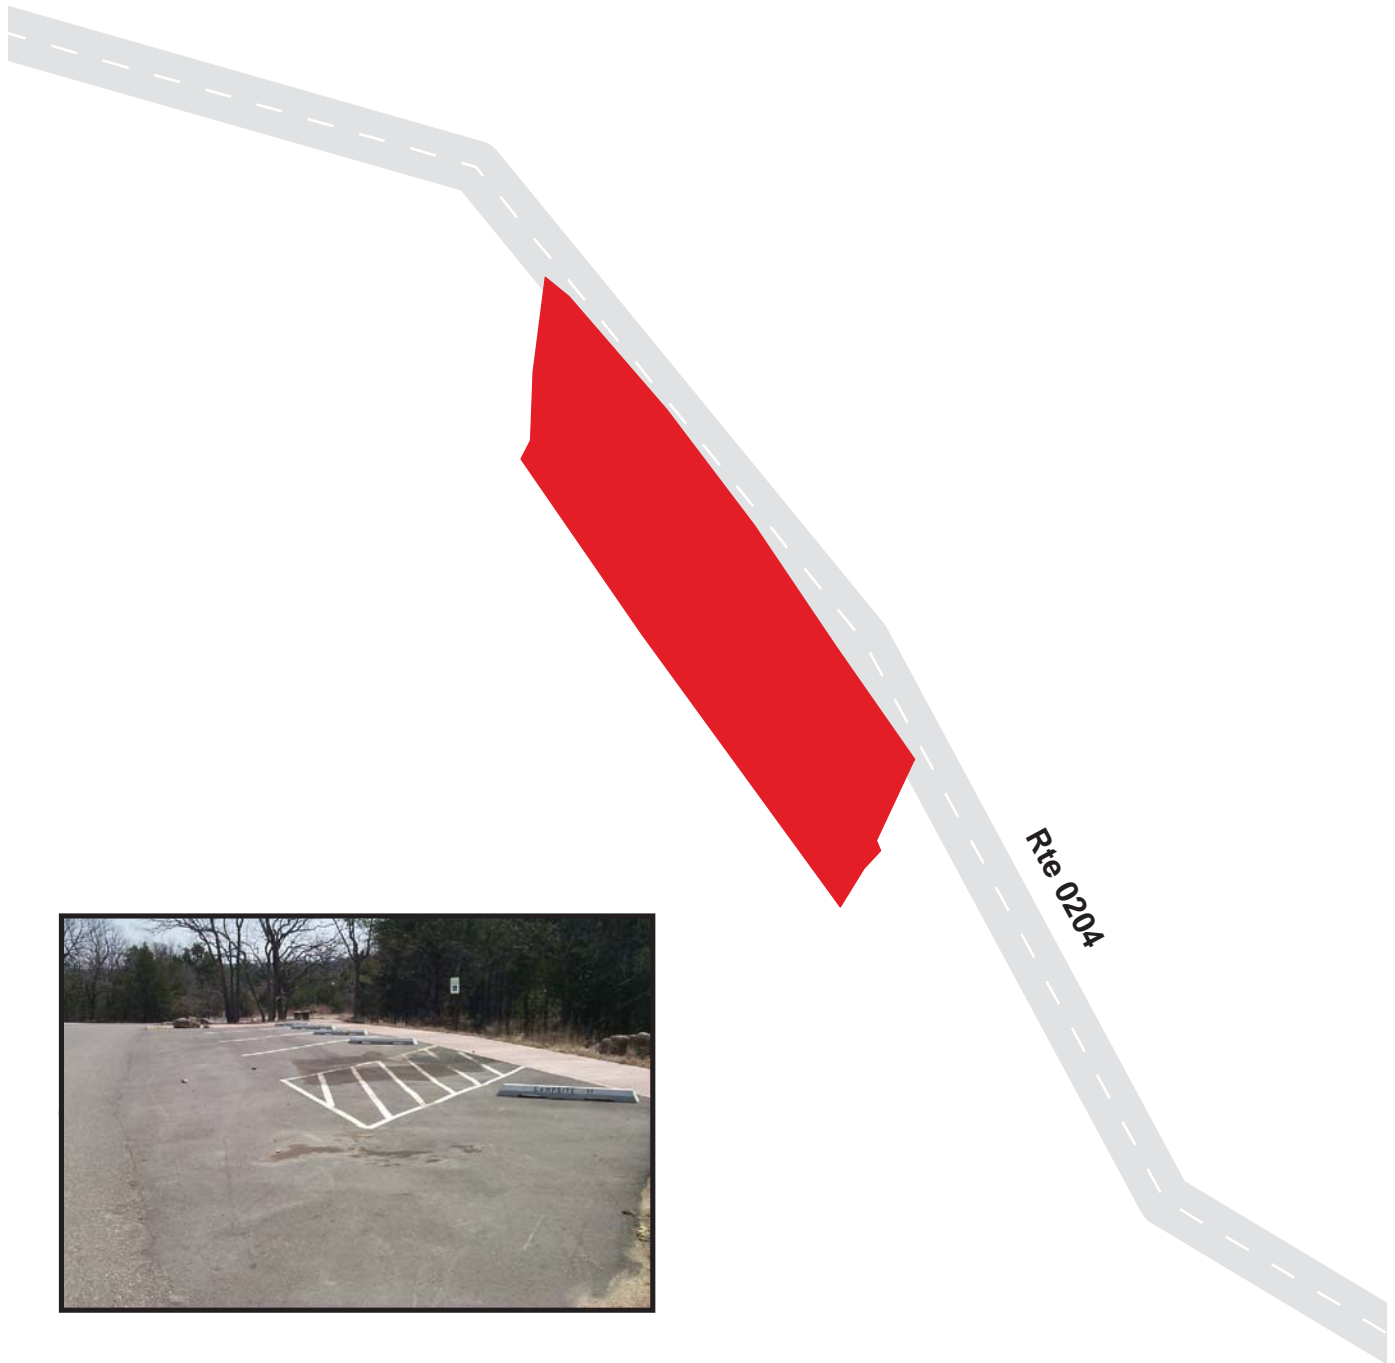
Route 0953

Route	Public / NonPublic	Date Visited	Area (sq ft)	Lane Miles *	Surface Type	Condition / PCR
0953	Public	3/27/2002	4002	0.07	AS	EXCELLENT / 97

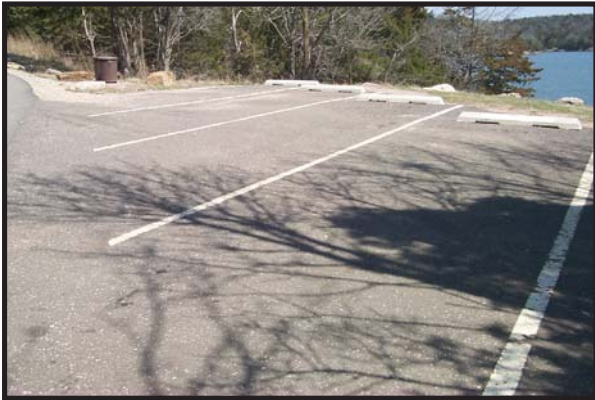
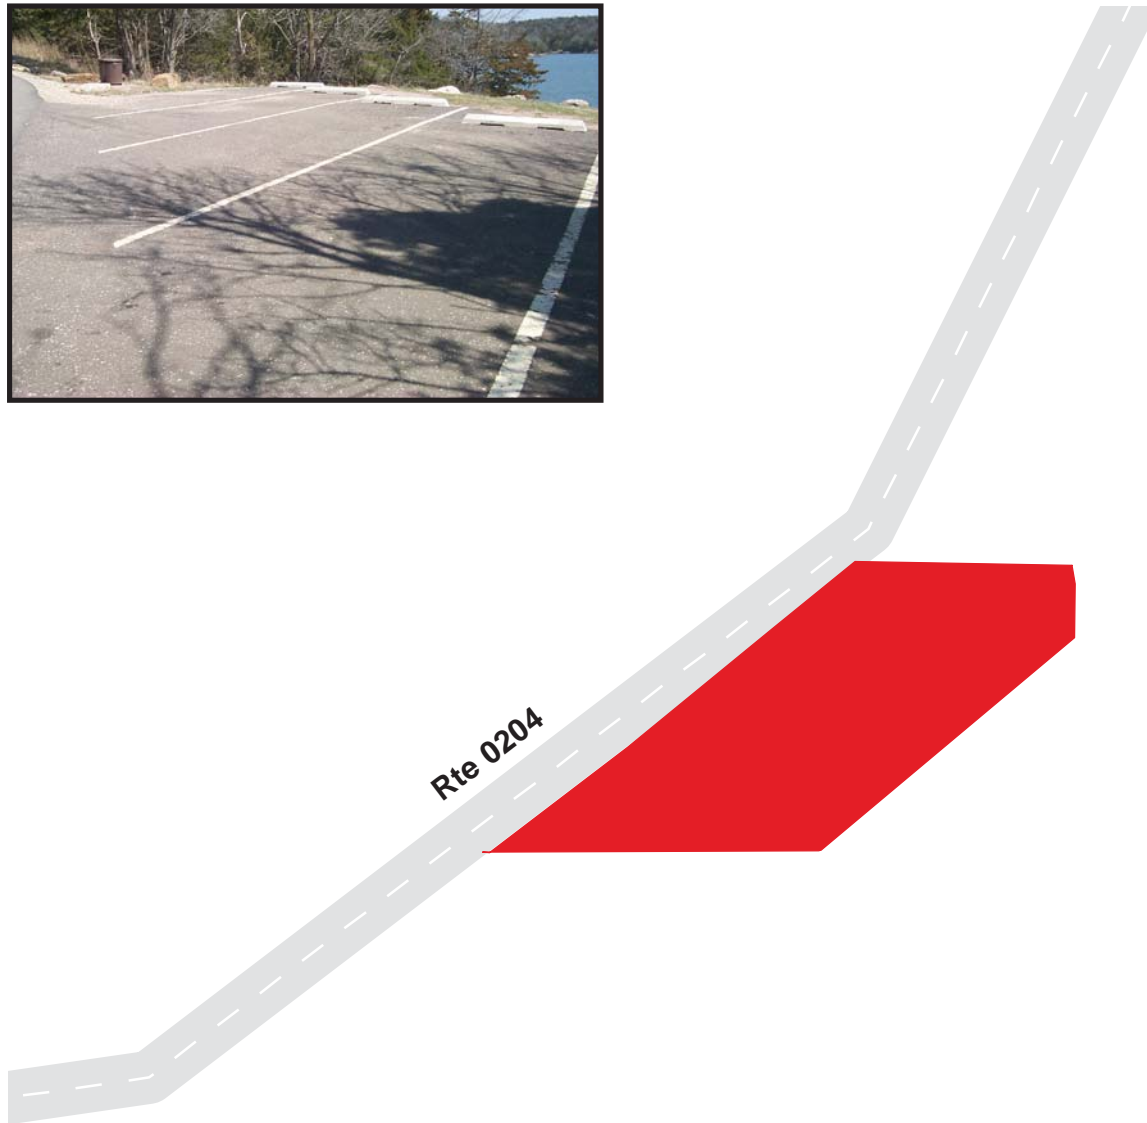
Route 0955

Route	Public / NonPublic	Date Visited	Area (sq ft)	Lane Miles *	Surface Type	Condition / PCR
0955	Public	3/27/2002	871	0.01	AS	EXCELLENT / 97

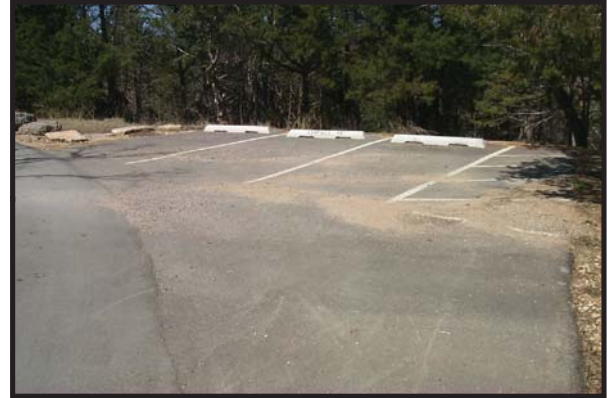
Route 0956

Route	Public / NonPublic	Date Visited	Area (sq ft)	Lane Miles *	Surface Type	Condition / PCR
0956	Public	3/27/2002	1785	0.03	AS	EXCELLENT / 97

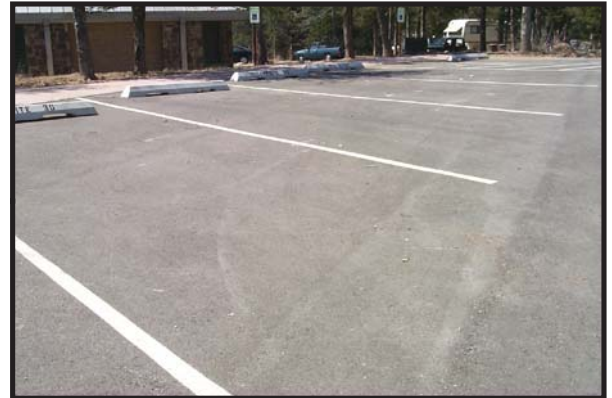
Route 0957

Route	Public / NonPublic	Date Visited	Area (sq ft)	Lane Miles *	Surface Type	Condition / PCR
0957	Public	3/27/2002	1053	0.02	AS	GOOD / 90

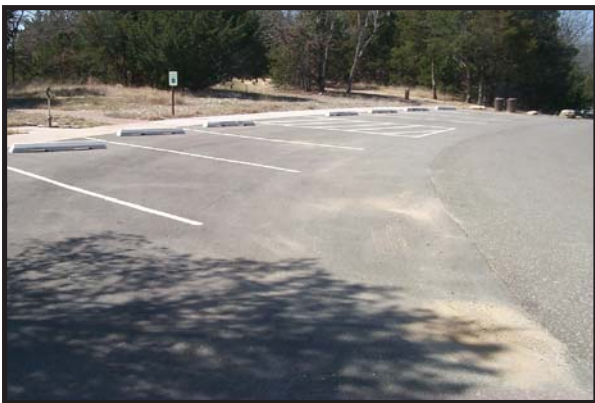
Route 0959

Route	Public / NonPublic	Date Visited	Area (sq ft)	Lane Miles *	Surface Type	Condition / PCR
0959	Public	3/27/2002	12366	0.21	AS	EXCELLENT / 97
