The Road Inventory of Channel Islands National Park CHIS - 8120

Prepared By:
Federal Highway Administration
Eastern Federal Lands Highway Division
Cycle 3

Channel Islands National Park in California

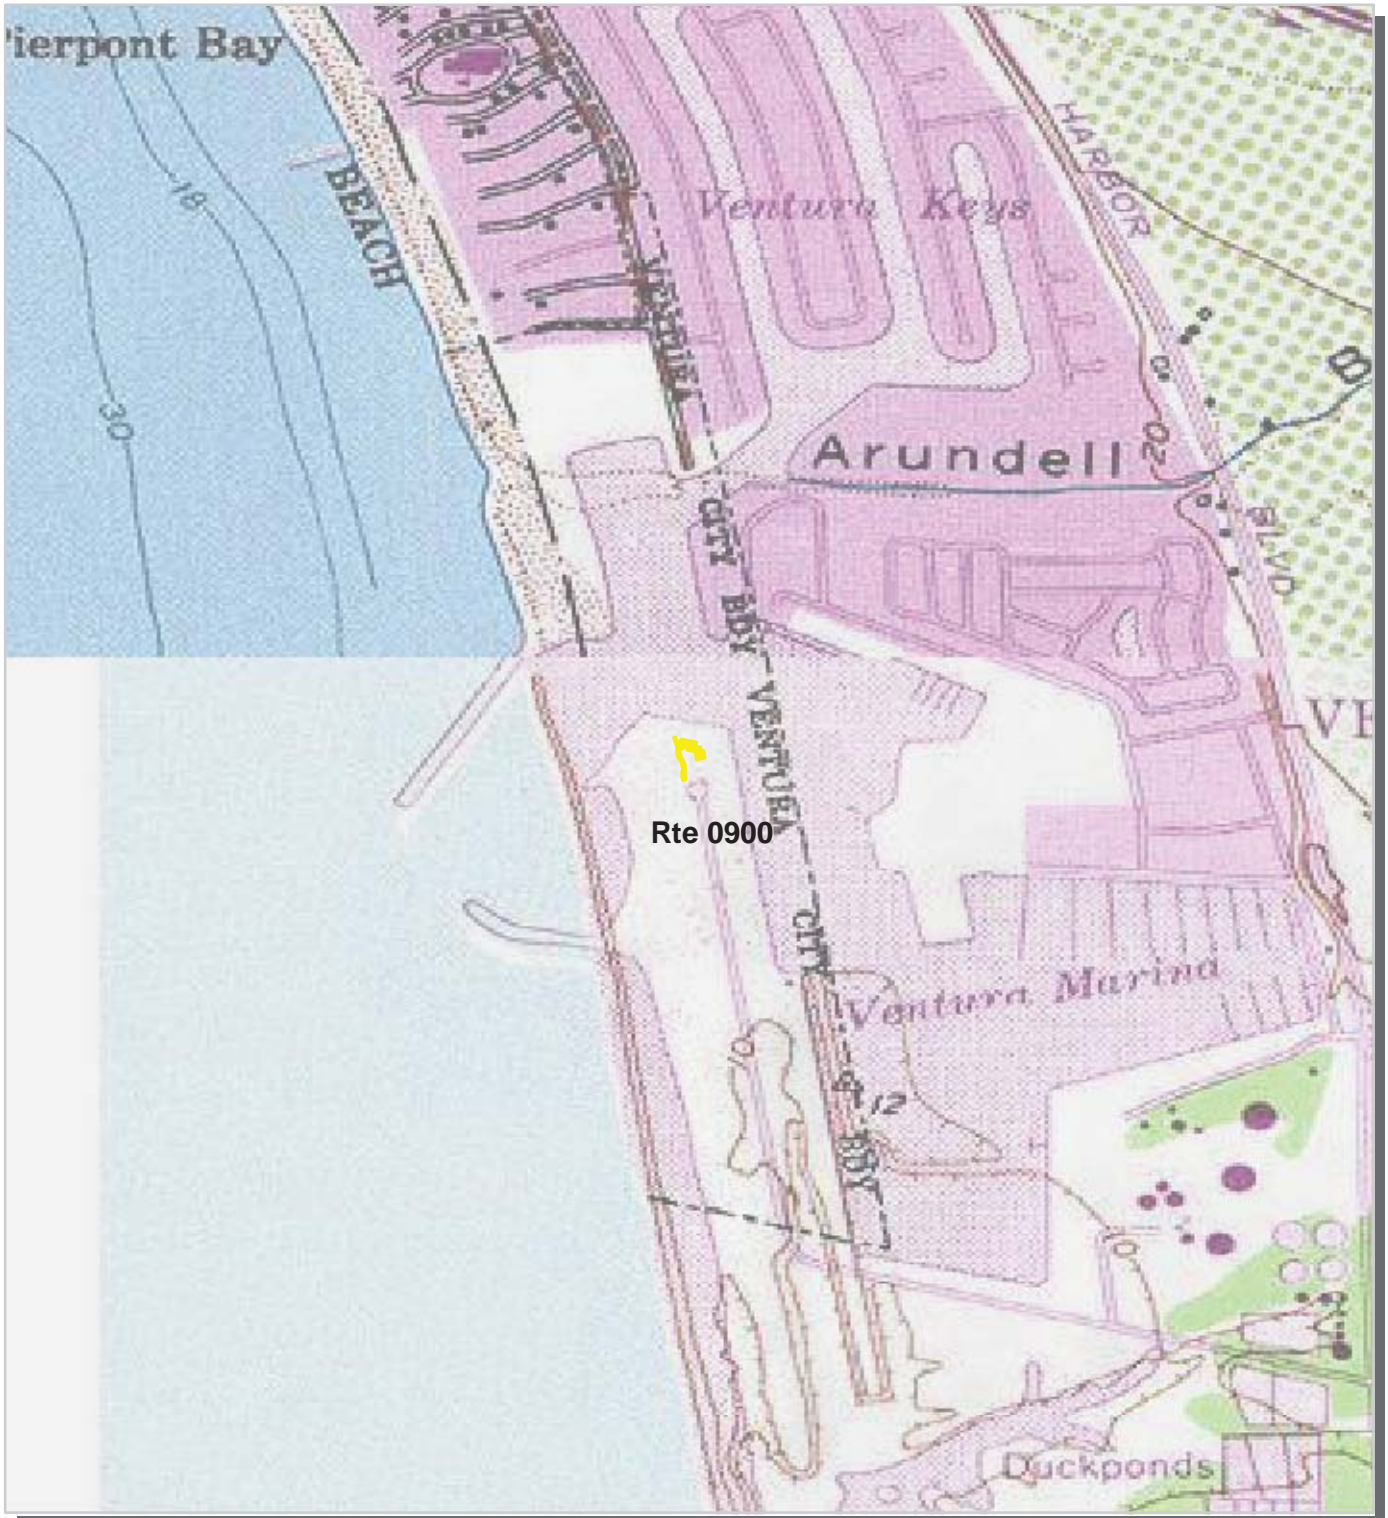
Channel Islands National Park Route Condition Key Map PCR - Mile by Mile

PCR	Poor	Fair	Good	Excellent
	(≤ 60)	(61 - 84)	(85 - 94)	(95 - 100)

* If the PCR rating is not available for a section, the SCR rating will be displayed. See appendix for definitions and formulas.

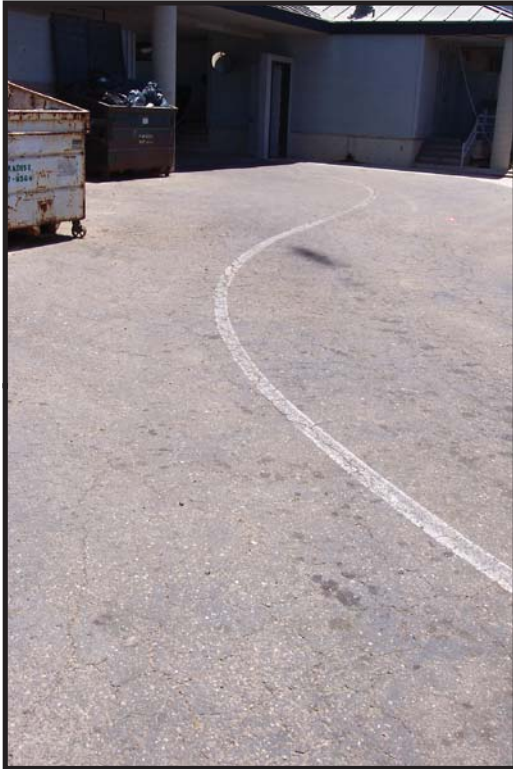
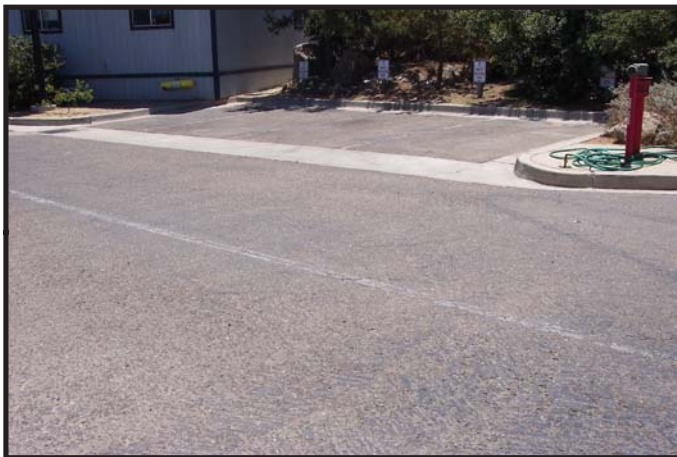
Route 0900

Maintenance Parking
From Spinnaker Drive

Route	Public / NonPublic	Date Visited	Area (sq ft)	Lane Miles *	Surface Type	Condition / PCR
0900	NonPublic	5/19/2004	10500	0.18	AS	FAIR / 73
