**The Road Inventory
of
Chesapeake & Ohio Canal National Historical Park
CHOH - 3100**

Prepared By:
Federal Highway Administration
Eastern Federal Lands Highway Division
Cycle 3

Chesapeake and Ohio Canal National Historical Park in Maryland

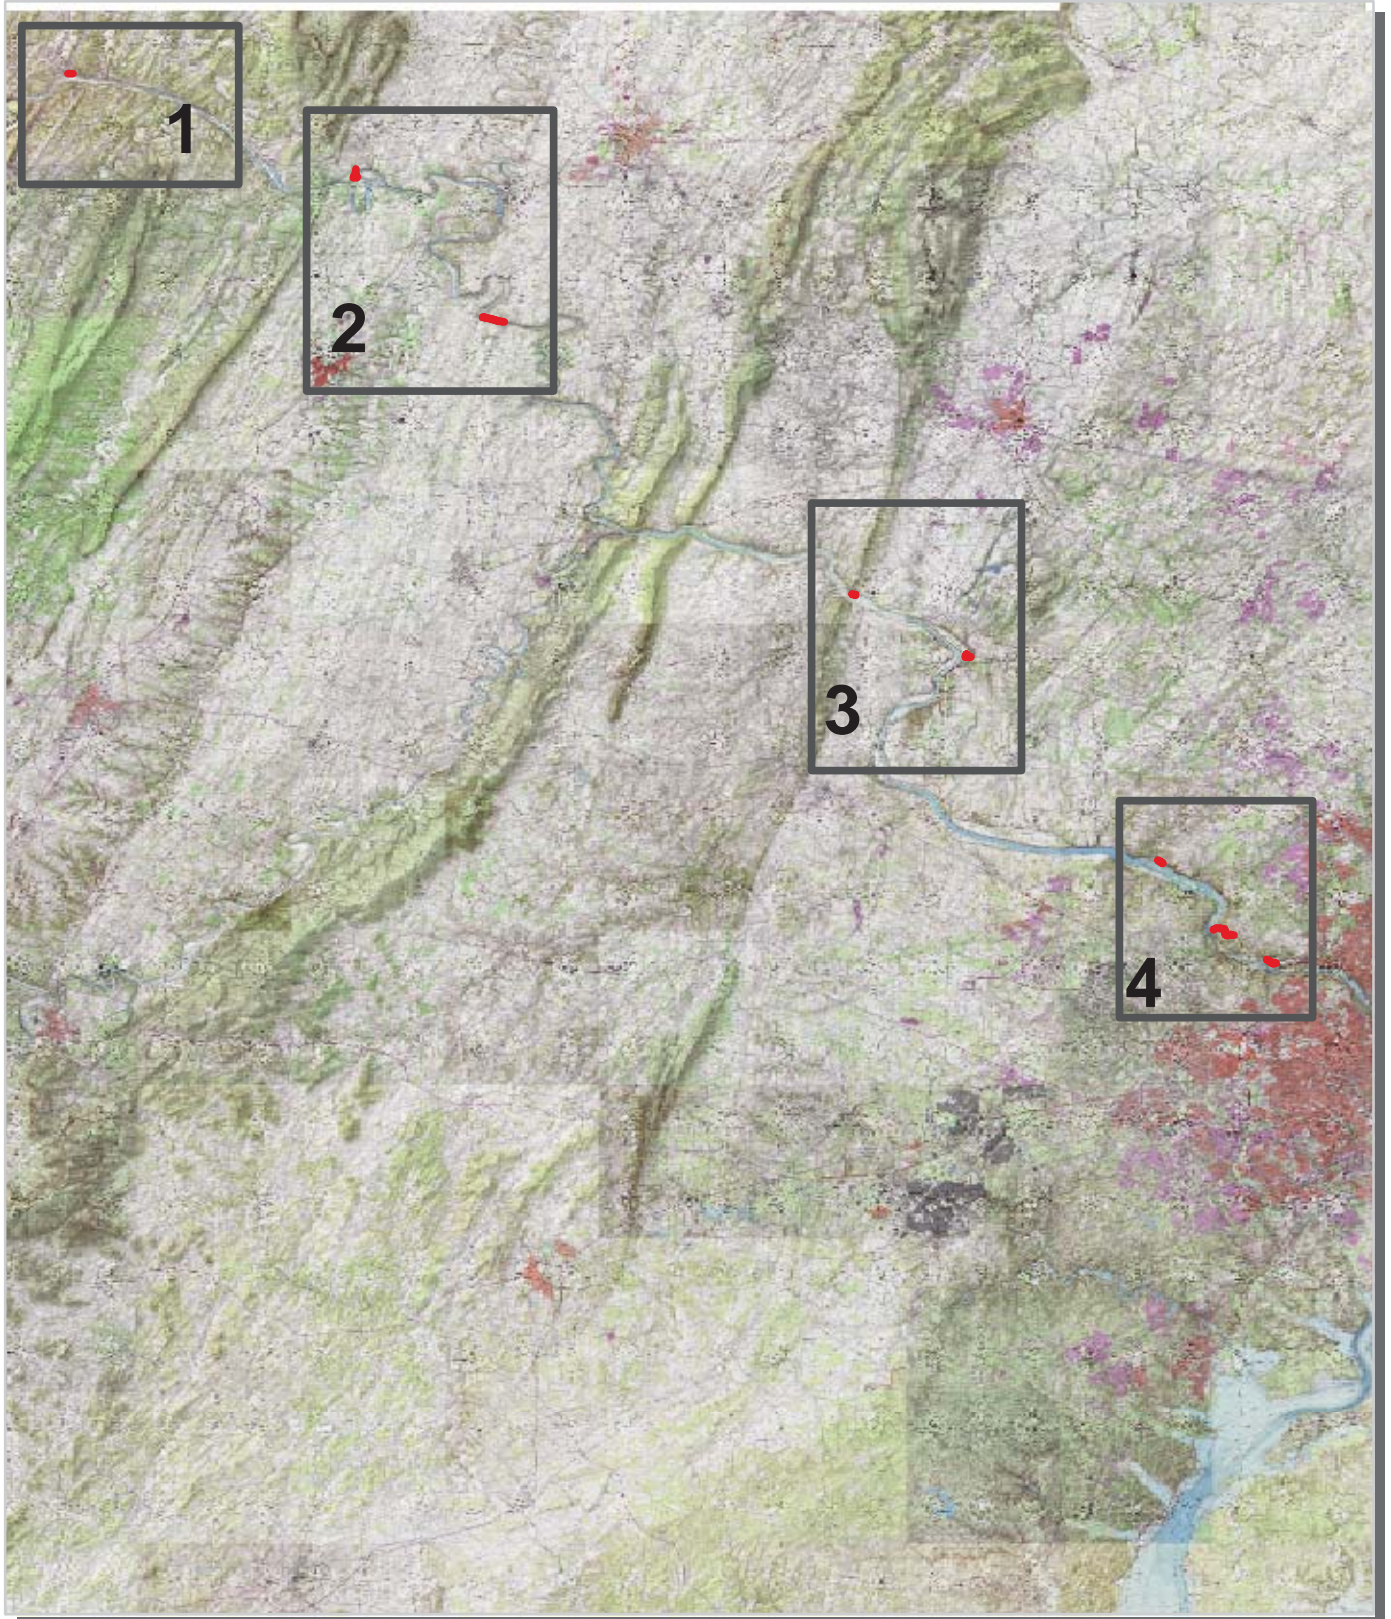
Chesapeake & Ohio Canal National Historical Park Route Location Key Map

— Park Owned Routes

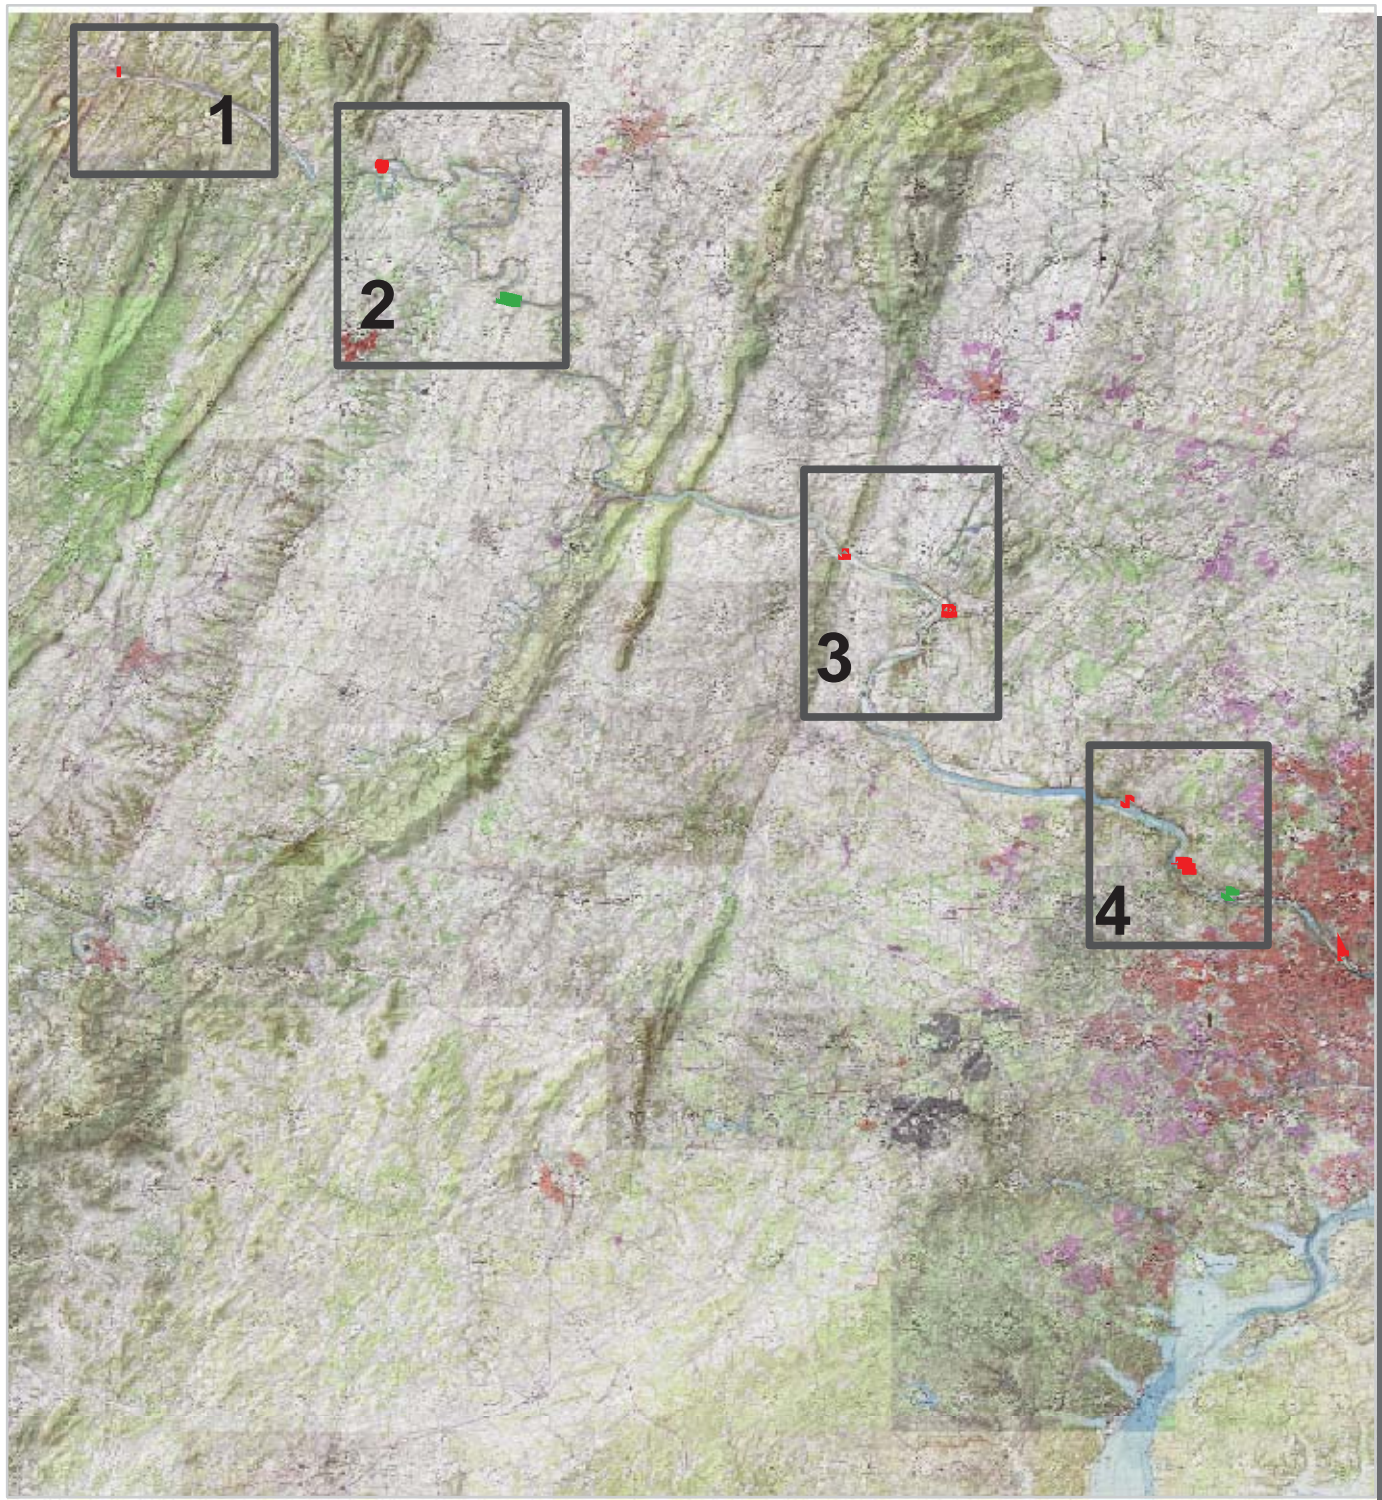
Route Condition Key Map

PCR - Mile by Mile

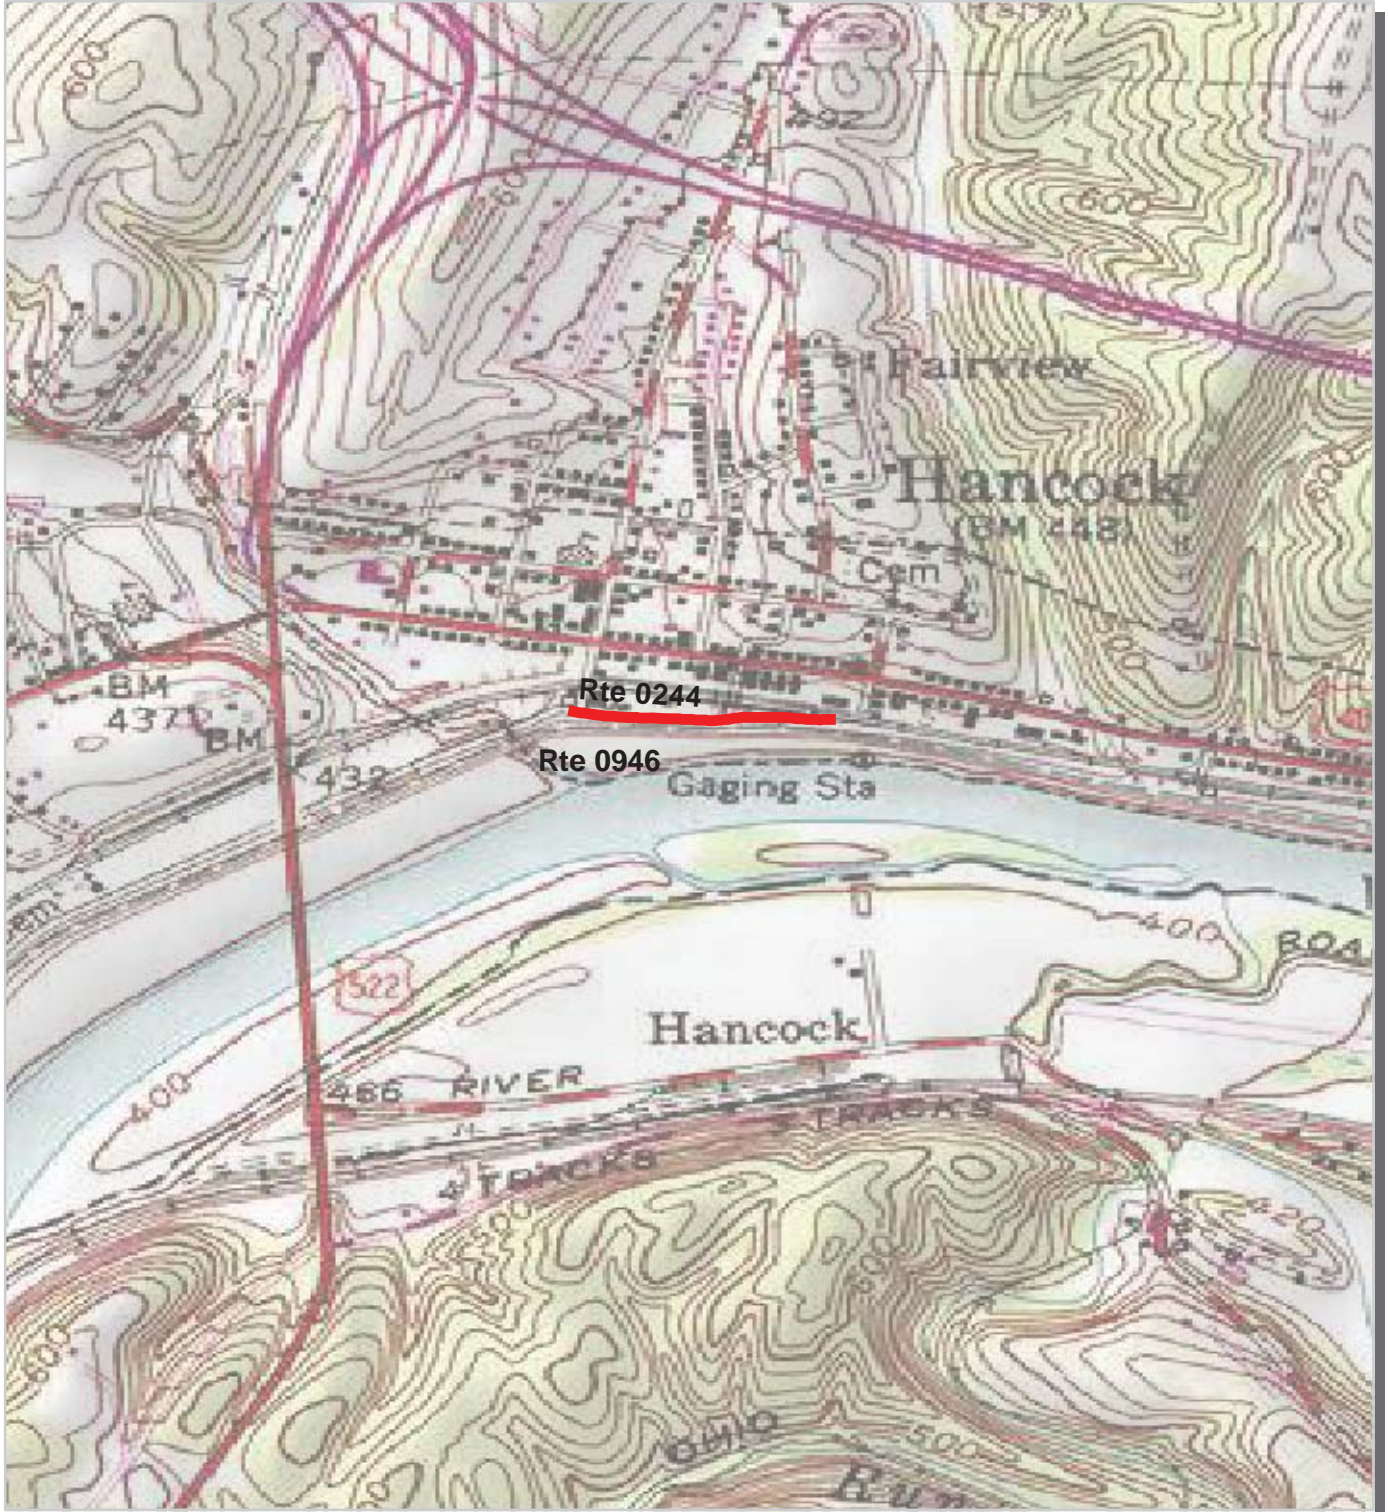
Route Condition Area Map 1

PCR - Mile by Mile

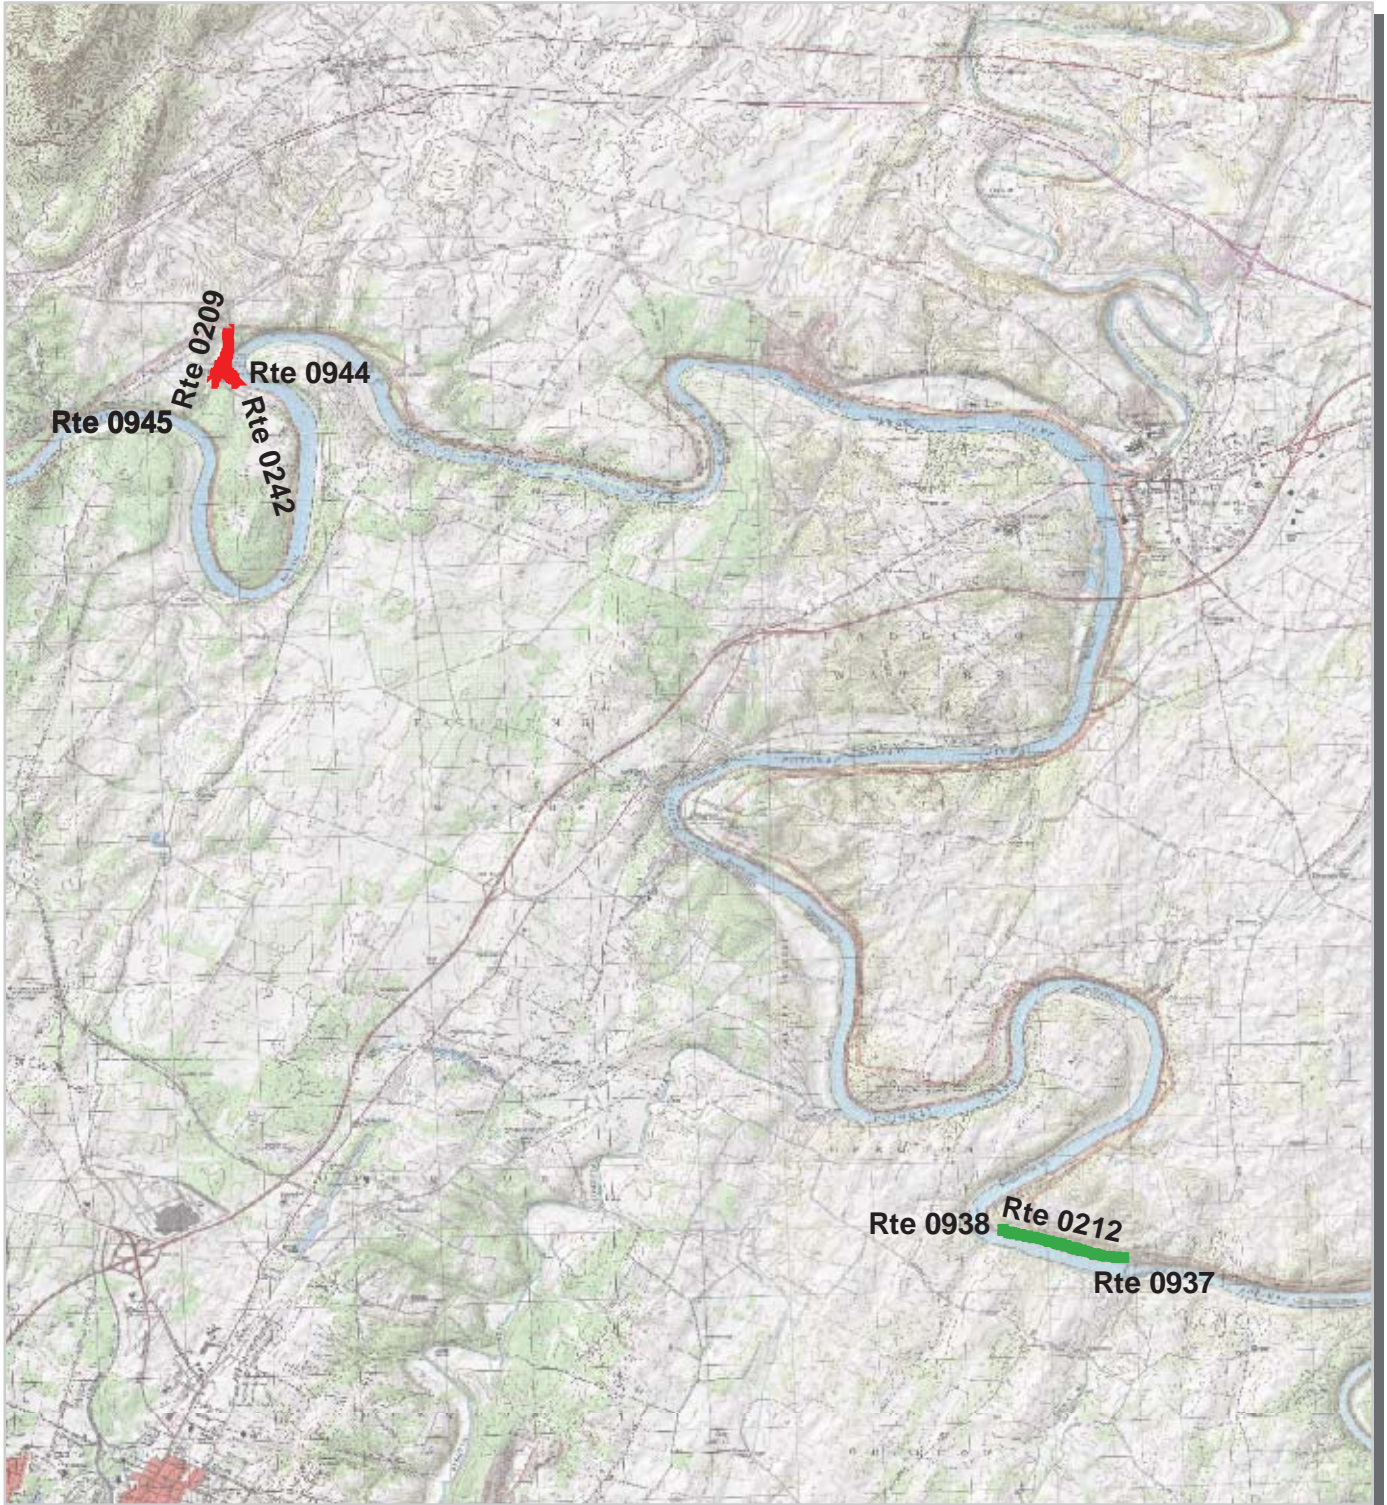
Route Condition Area Map 2

PCR - Mile by Mile

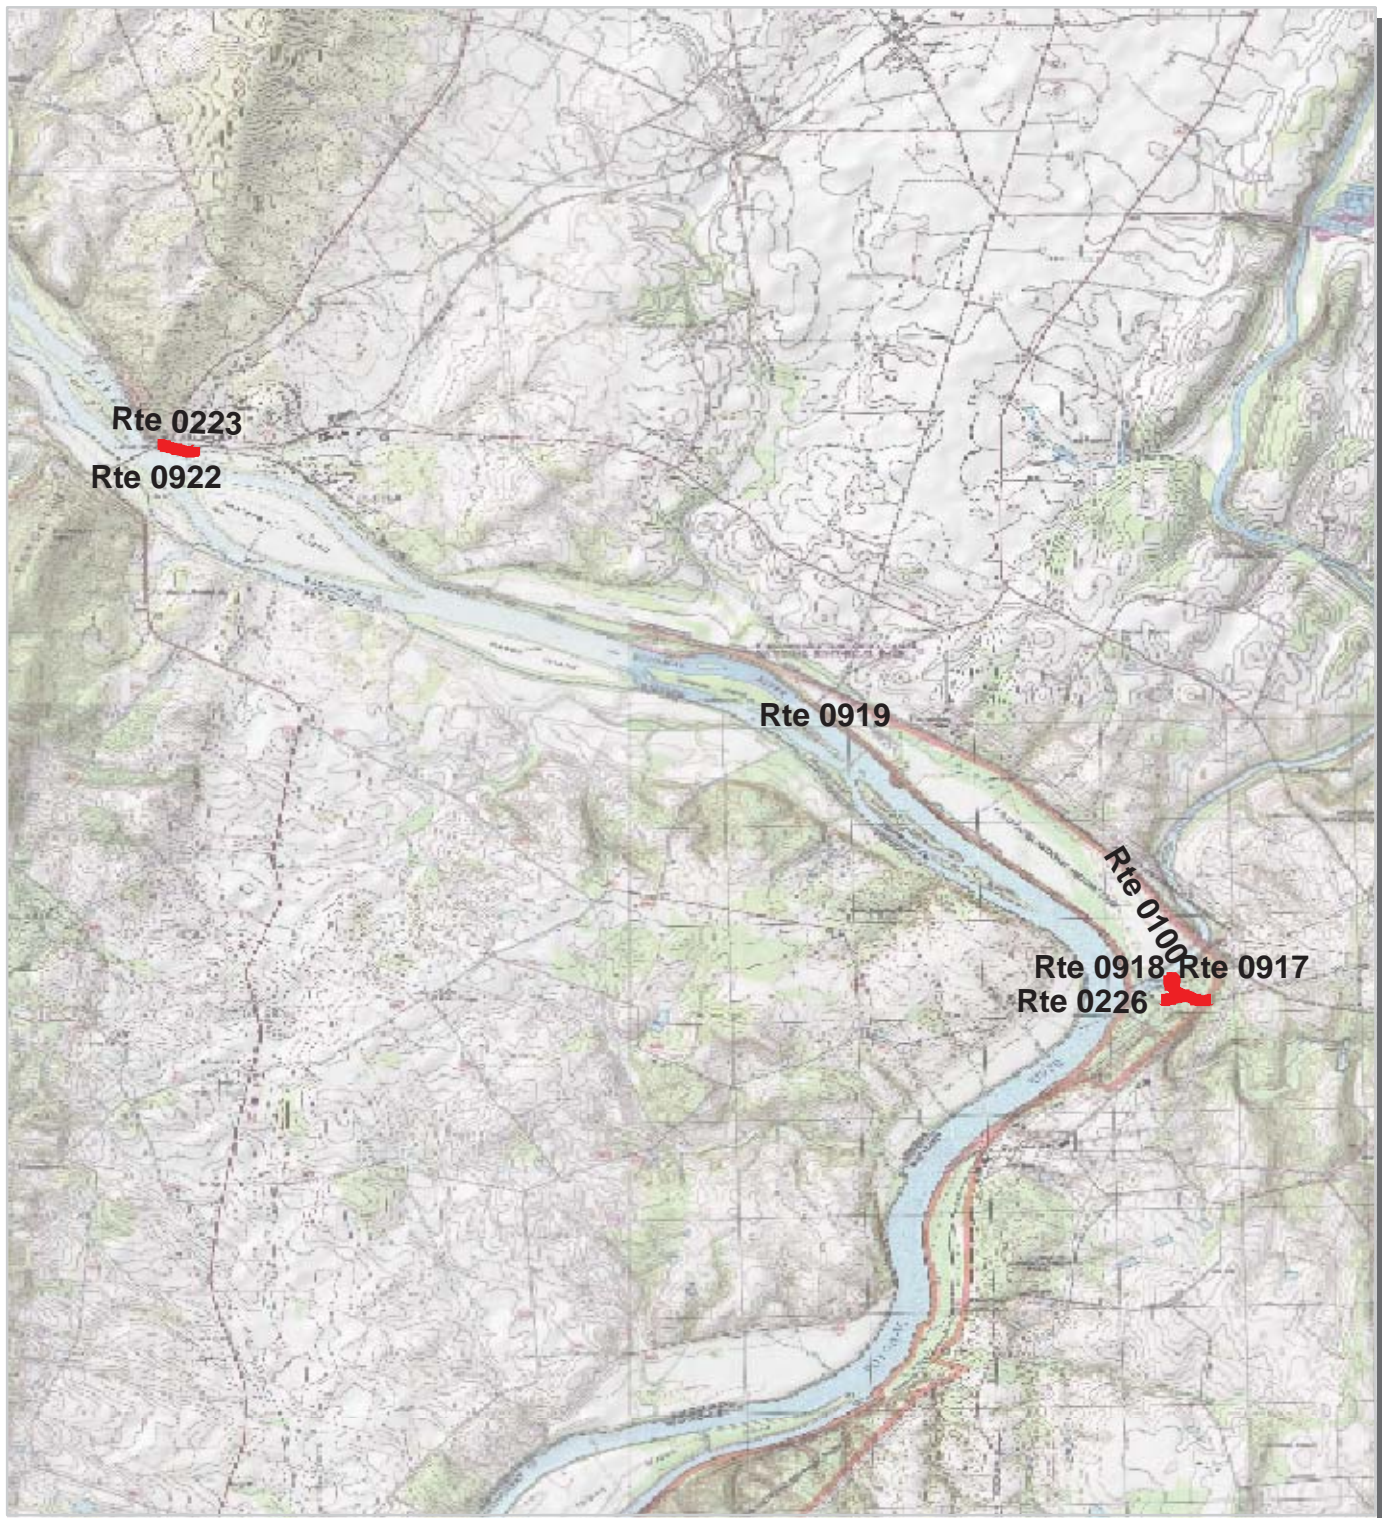
Route Condition Area Map 3

PCR - Mile by Mile

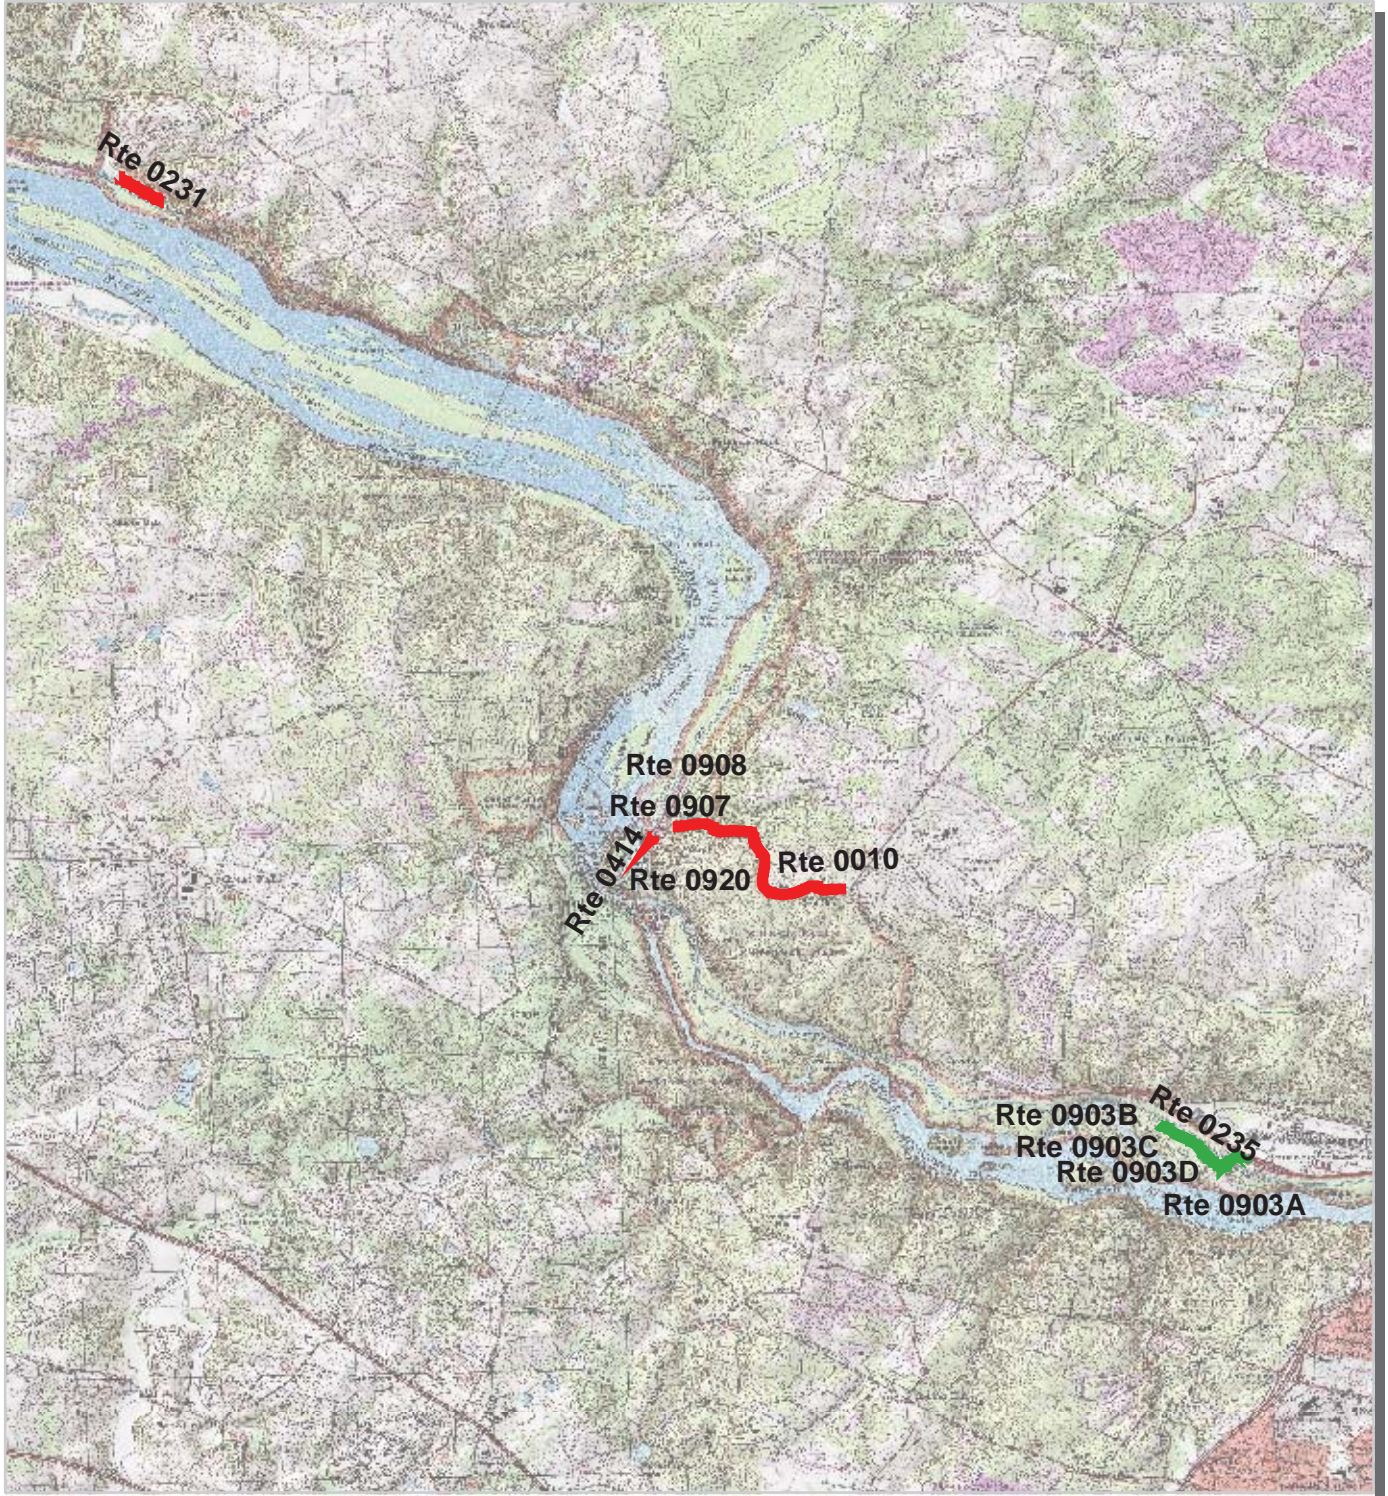
Route Condition Area Map 4

PCR - Mile by Mile

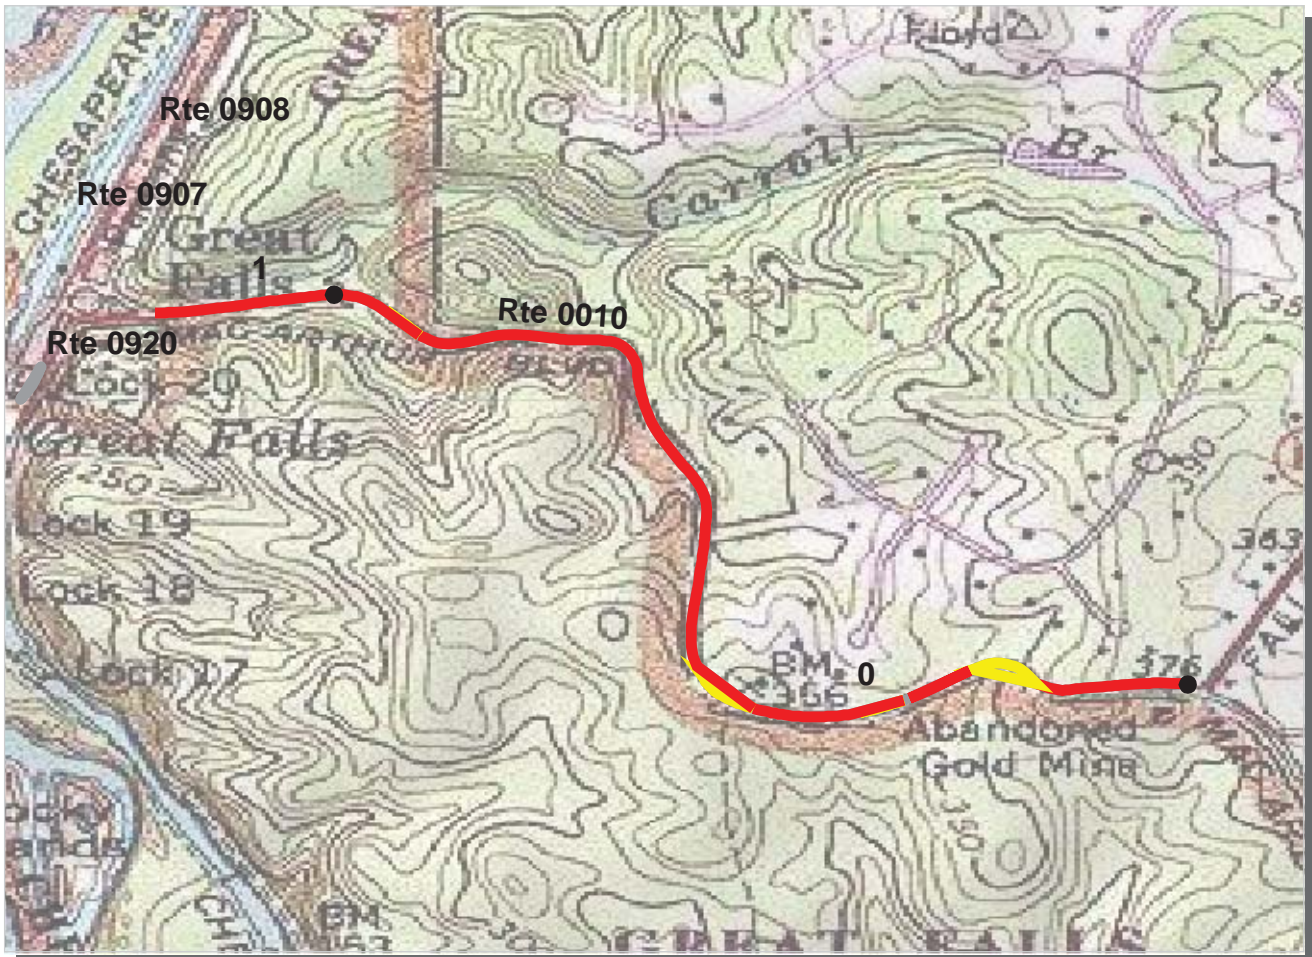
ROUTE: 0010 Great Falls Access Road

Section Number	0	1			
Section Length (mi)	1.00	0.15			
AADT	**				
SADT	**				
ADT Date	**				
Cross Section Information					
Number of Lanes	2	2			
Paved Width (ft)	18	18			
Lane Width (ft)	9	9			
Shoulder Width (ft)	0	0			
Roadway Condition Information					
PCR (Pavement Condition Rating)	51	51			
RCI (Roughness Condition Index)	64	56			
SCR (Surface Condition Rating)	43	48			
Alligator Cracking Index	76	97			
Rutting Index	67	58			
Patching Index	99	99			
Transverse Cracking Index	99	99			
Longitudinal Cracking Index	94	93			
Shoulder Condition Rating	N/A	N/A			
Drainage Condition Rating	GOOD	GOOD

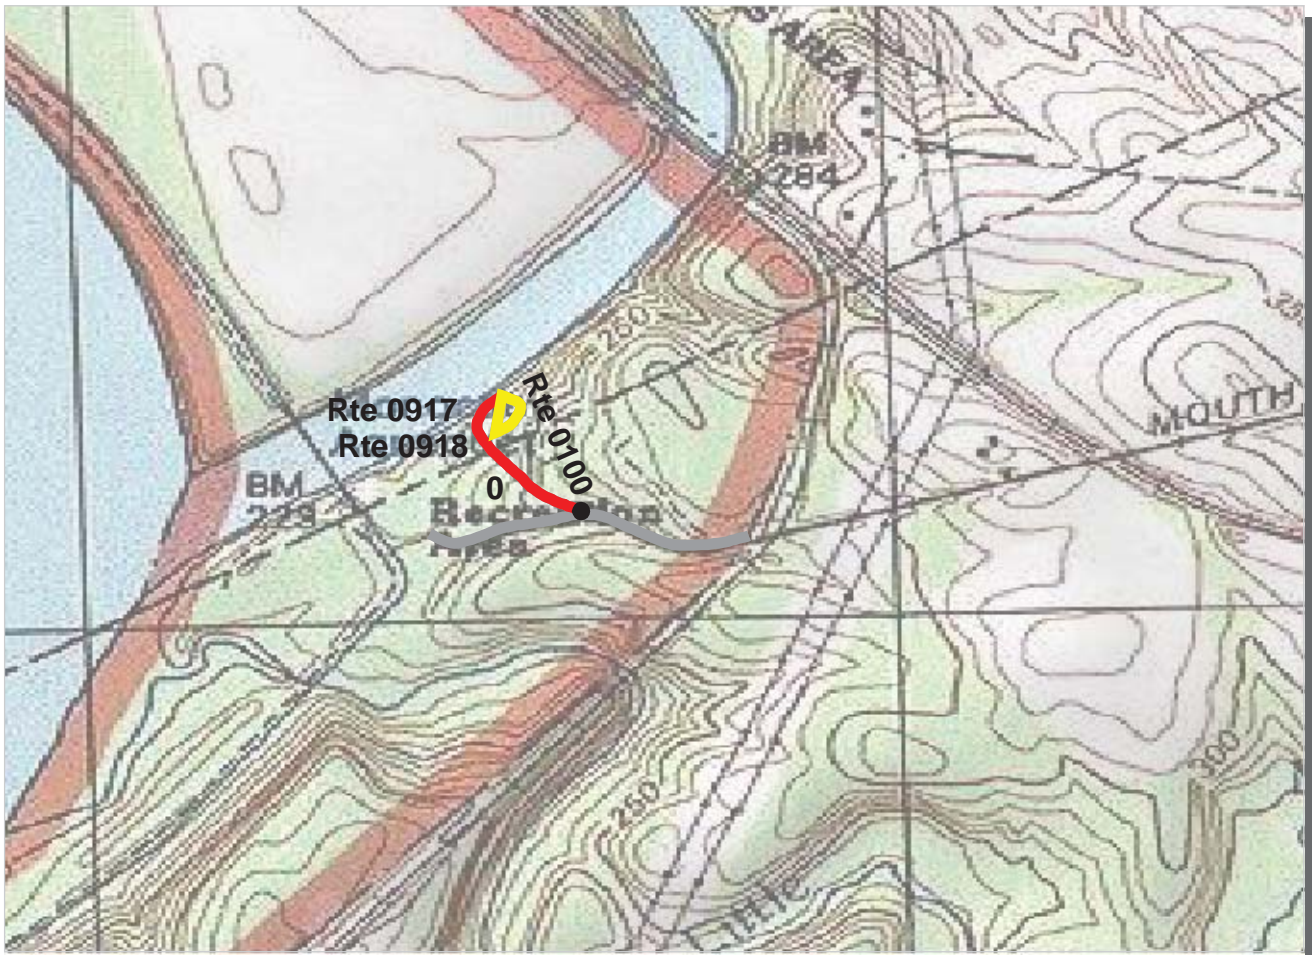
ROUTE: 0100 Monocacy Boat Ramp Access **TOTAL LENGTH: 0.24 Miles**

Section Number	0			
Section Length (mi)	0.24			
AADT	**			
SADT	**			
ADT Date	**			
Cross Section Information				
Number of Lanes	2			
Paved Width (ft)	17			
Lane Width (ft)	9			
Shoulder Width (ft)	0			
Roadway Condition Information				
PCR (Pavement Condition Rating)	33			
RCI (Roughness Condition Index)	48			
SCR (Surface Condition Rating)	31			
Alligator Cracking Index	71			
Rutting Index	58			
Patching Index	97			
Transverse Cracking Index	96			
Longitudinal Cracking Index	94			
Shoulder Condition Rating	N/A			
Drainage Condition Rating	N/C

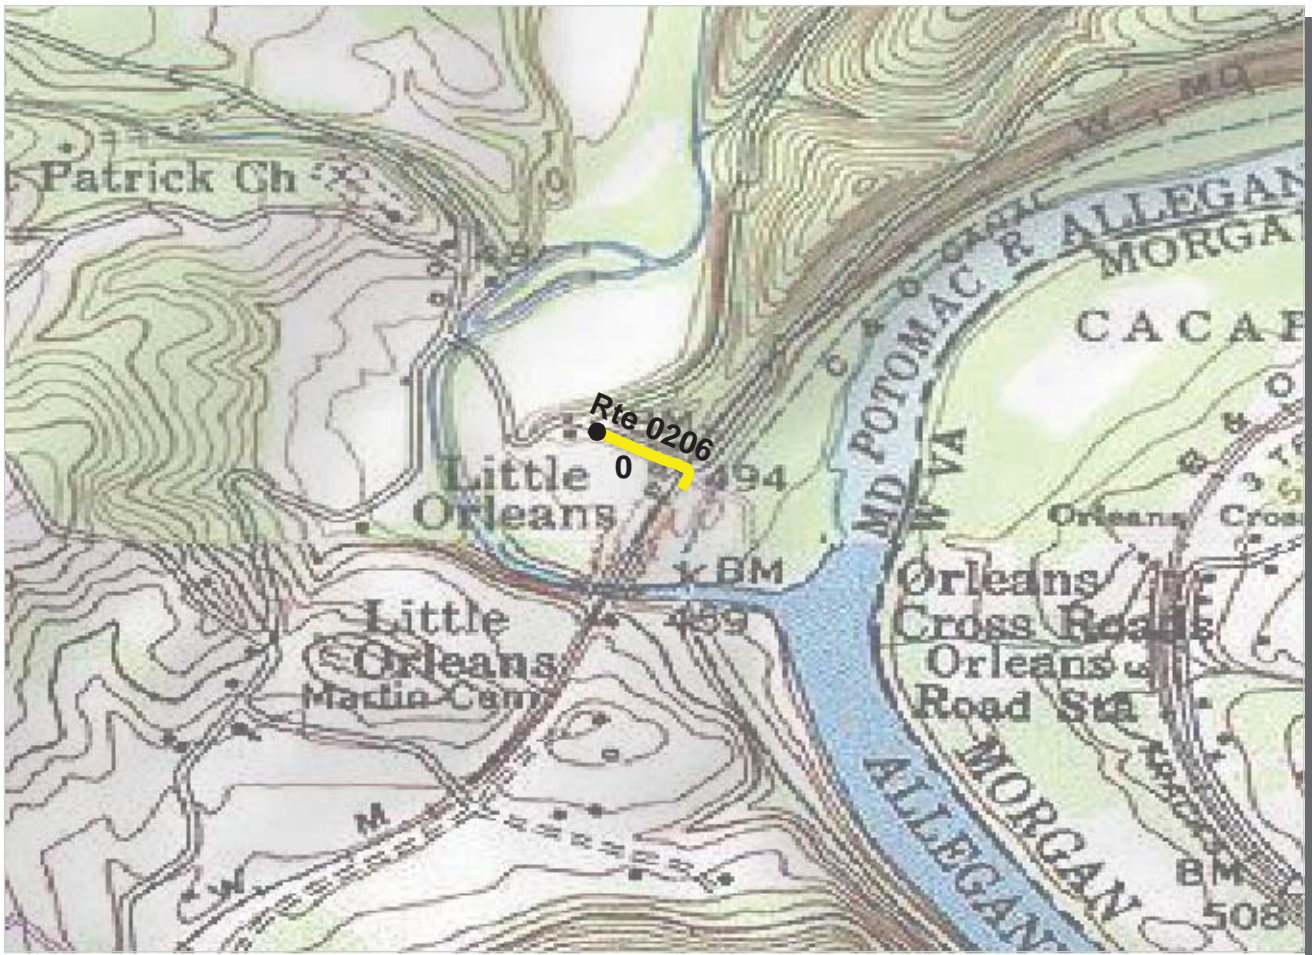
ROUTE: 0206 Fifteen Mile Creek Road **TOTAL LENGTH: 0.12 Miles**

Section Number	0				
Section Length (mi)	0.12				
AADT	**				
SADT	**				
ADT Date	**				
Cross Section Information					
Number of Lanes	2				
Paved Width (ft)	23				
Lane Width (ft)	9				
Shoulder Width (ft)	0				
Roadway Condition Information					
PCR (Pavement Condition Rating)	56				
RCI (Roughness Condition Index)	NC				
SCR (Surface Condition Rating)	56				
Alligator Cracking Index	100				
Rutting Index	56				
Patching Index	100				
Transverse Cracking Index	100				
Longitudinal Cracking Index	100				
Shoulder Condition Rating	N/A				
Drainage Condition Rating	POOR

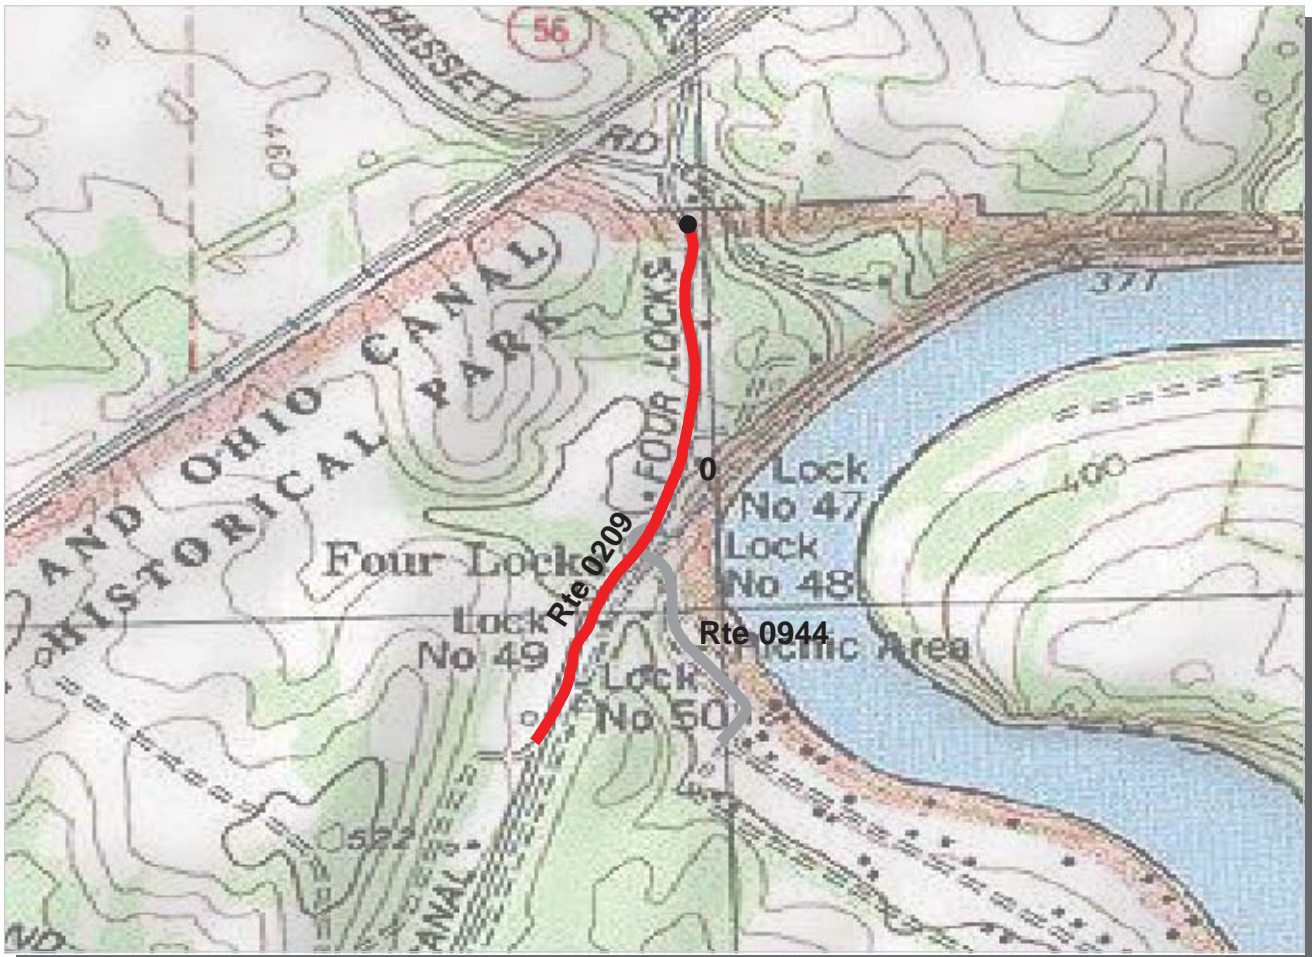
ROUTE: 0209 Four Locks Road

Section Number	0				
Section Length (mi)	0.55				
AADT	**				
SADT	**				
ADT Date	**				
Cross Section Information					
Number of Lanes	2				
Paved Width (ft)	17				
Lane Width (ft)	8				
Shoulder Width (ft)	0				
Roadway Condition Information					
PCR (Pavement Condition Rating)	37				
RCI (Roughness Condition Index)	30				
SCR (Surface Condition Rating)	40				
Alligator Cracking Index	93				
Rutting Index	48				
Patching Index	99				
Transverse Cracking Index	99				
Longitudinal Cracking Index	98				
Shoulder Condition Rating	N/A				
Drainage Condition Rating	GOOD

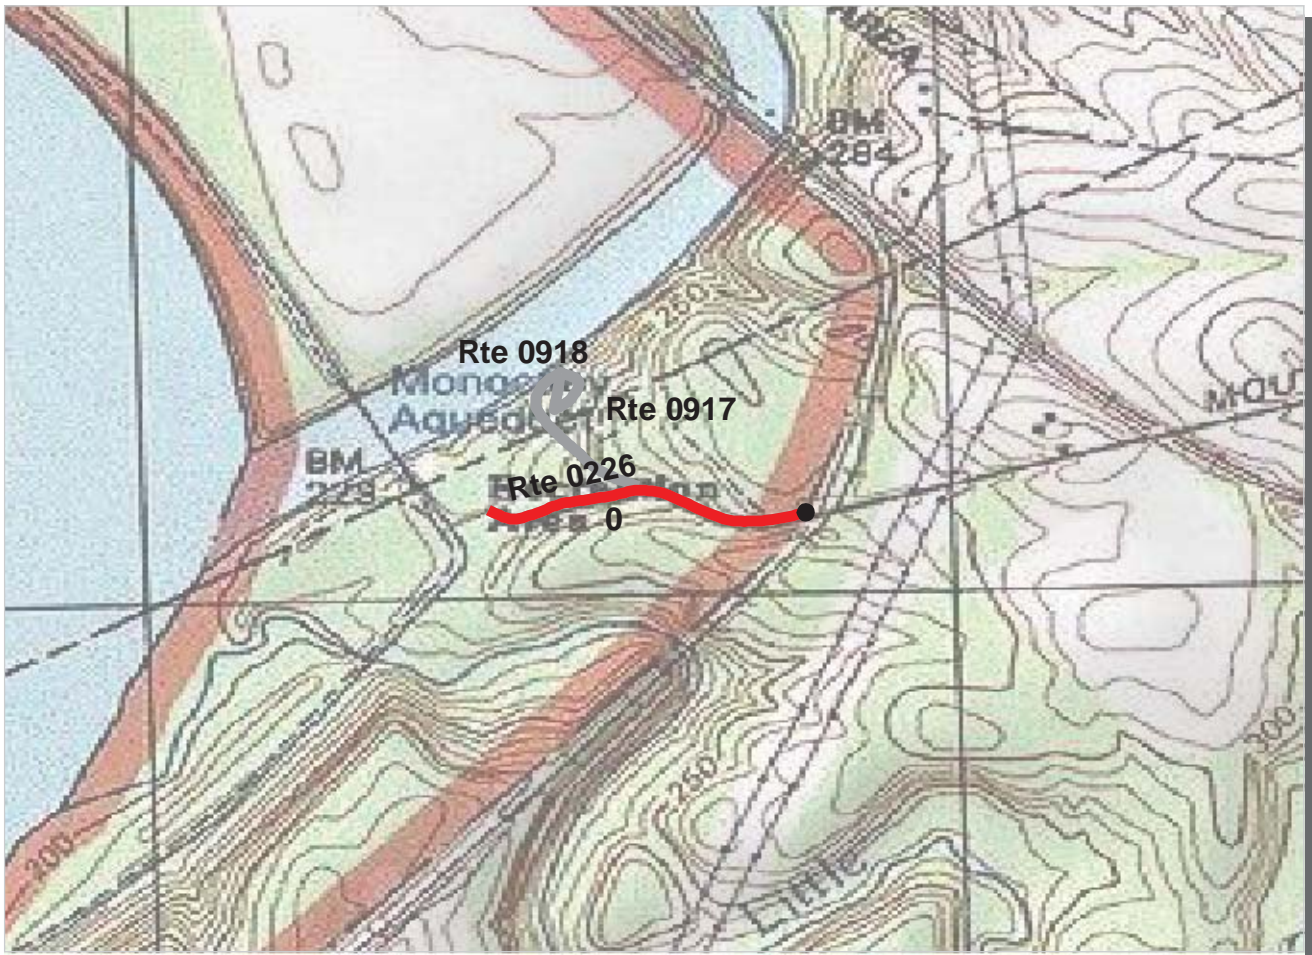
ROUTE: 0226 Monocacy Road **TOTAL LENGTH: 0.27 Miles**

Section Number	0				
Section Length (mi)	0.27				
AADT	**				
SADT	**				
ADT Date	**				
Cross Section Information					
Number of Lanes	1				
Paved Width (ft)	15				
Lane Width (ft)	15				
Shoulder Width (ft)	0				
Roadway Condition Information					
PCR (Pavement Condition Rating)	27				
RCI (Roughness Condition Index)	38				
SCR (Surface Condition Rating)	21				
Alligator Cracking Index	53				
Rutting Index	59				
Patching Index	88				
Transverse Cracking Index	98				
Longitudinal Cracking Index	88				
Shoulder Condition Rating	N/A				
Drainage Condition Rating	GOOD

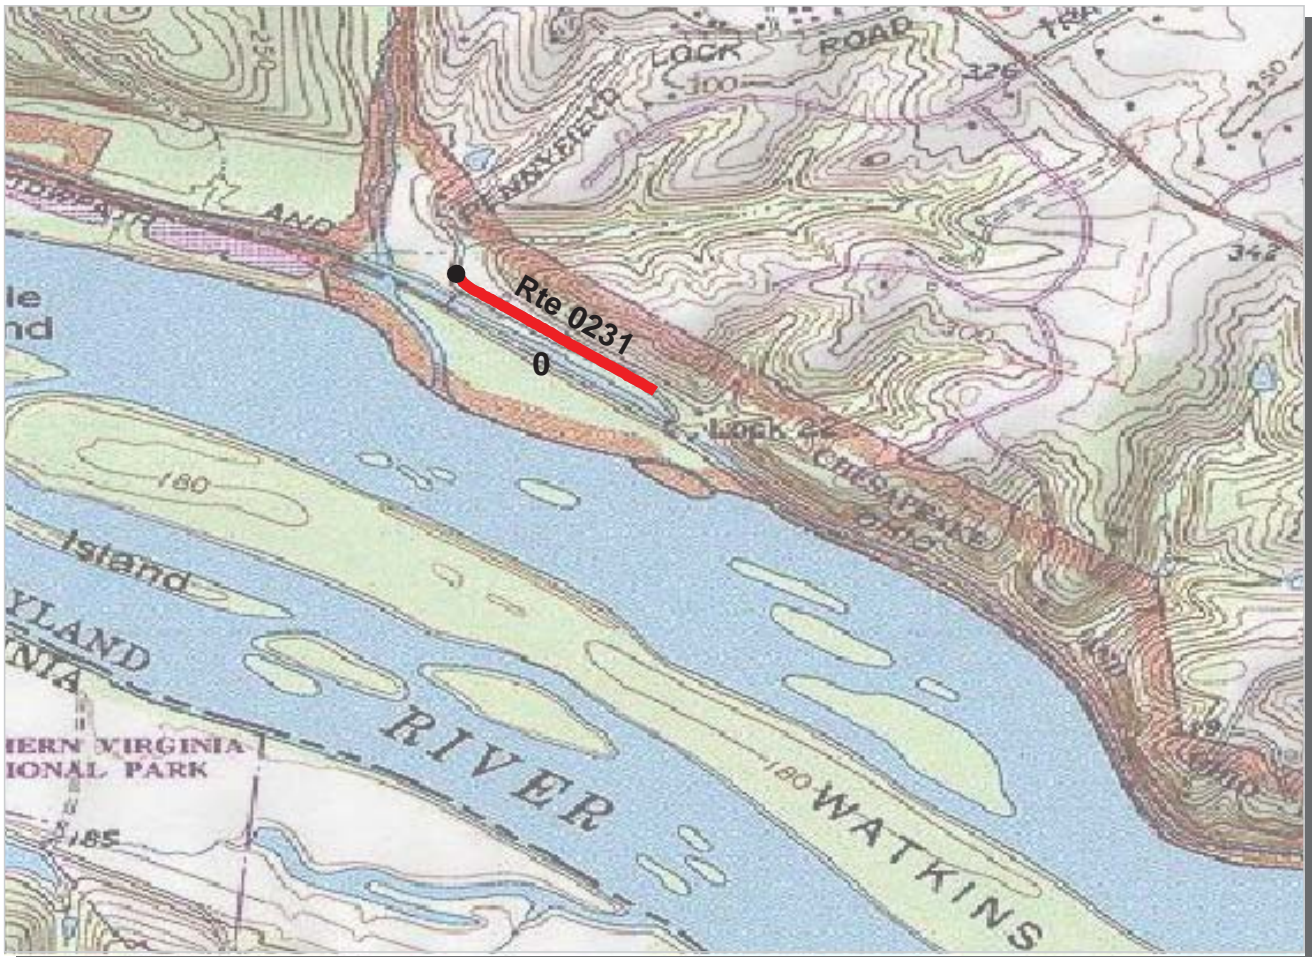
ROUTE: 0231 Pennyfield Lock Road

Section Number	0				
Section Length (mi)	0.28				
AADT	**				
SADT	**				
ADT Date	**				
Cross Section Information					
Number of Lanes	1				
Paved Width (ft)	9				
Lane Width (ft)	9				
Shoulder Width (ft)	0				
Roadway Condition Information					
PCR (Pavement Condition Rating)	29				
RCI (Roughness Condition Index)	61				
SCR (Surface Condition Rating)	24				
Alligator Cracking Index	63				
Rutting Index	46				
Patching Index	99				
Transverse Cracking Index	94				
Longitudinal Cracking Index	97				
Shoulder Condition Rating	N/A				
Drainage Condition Rating	POOR

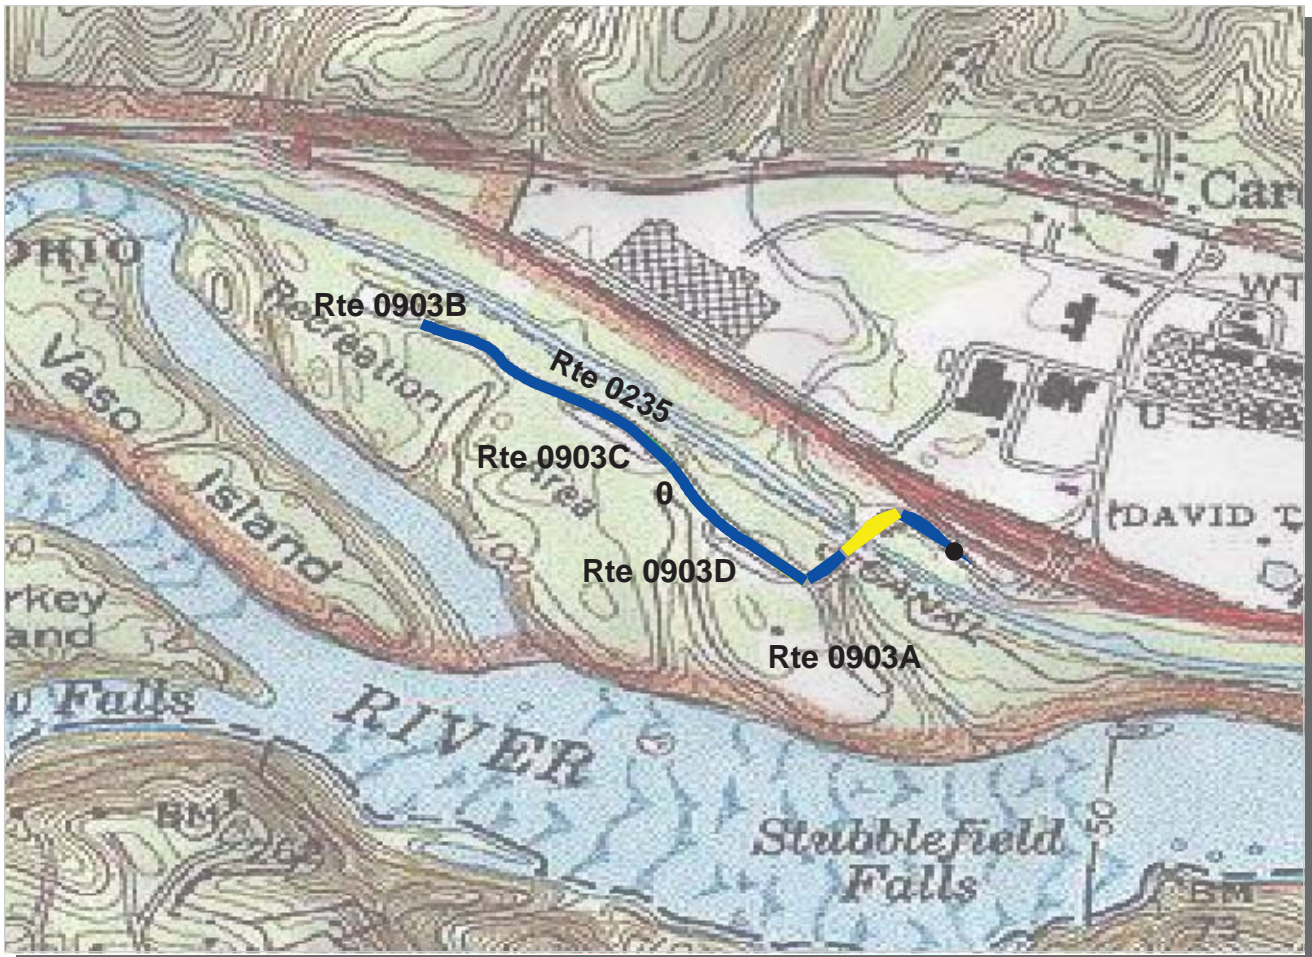
ROUTE: 0235 Carderock Picnic Area Road **TOTAL LENGTH: 0.57 Miles**

Section Number	0				
Section Length (mi)	0.57				
AADT	**				
SADT	**				
ADT Date	**				
Cross Section Information					
Number of Lanes	2				
Paved Width (ft)	21				
Lane Width (ft)	12				
Shoulder Width (ft)	0				
Roadway Condition Information					
PCR (Pavement Condition Rating)	89				
RCI (Roughness Condition Index)	83				
SCR (Surface Condition Rating)	92				
Alligator Cracking Index	100				
Rutting Index	92				
Patching Index	100				
Transverse Cracking Index	100				
Longitudinal Cracking Index	100				
Shoulder Condition Rating	N/A				
Drainage Condition Rating	GOOD
