**The Road Inventory
of
Chesapeake & Ohio Canal National Historical Park
CHOH - 3100**

Prepared By:
Federal Highway Administration
Eastern Federal Lands Highway Division
Cycle 3

Chesapeake and Ohio Canal National Historical Park in Maryland

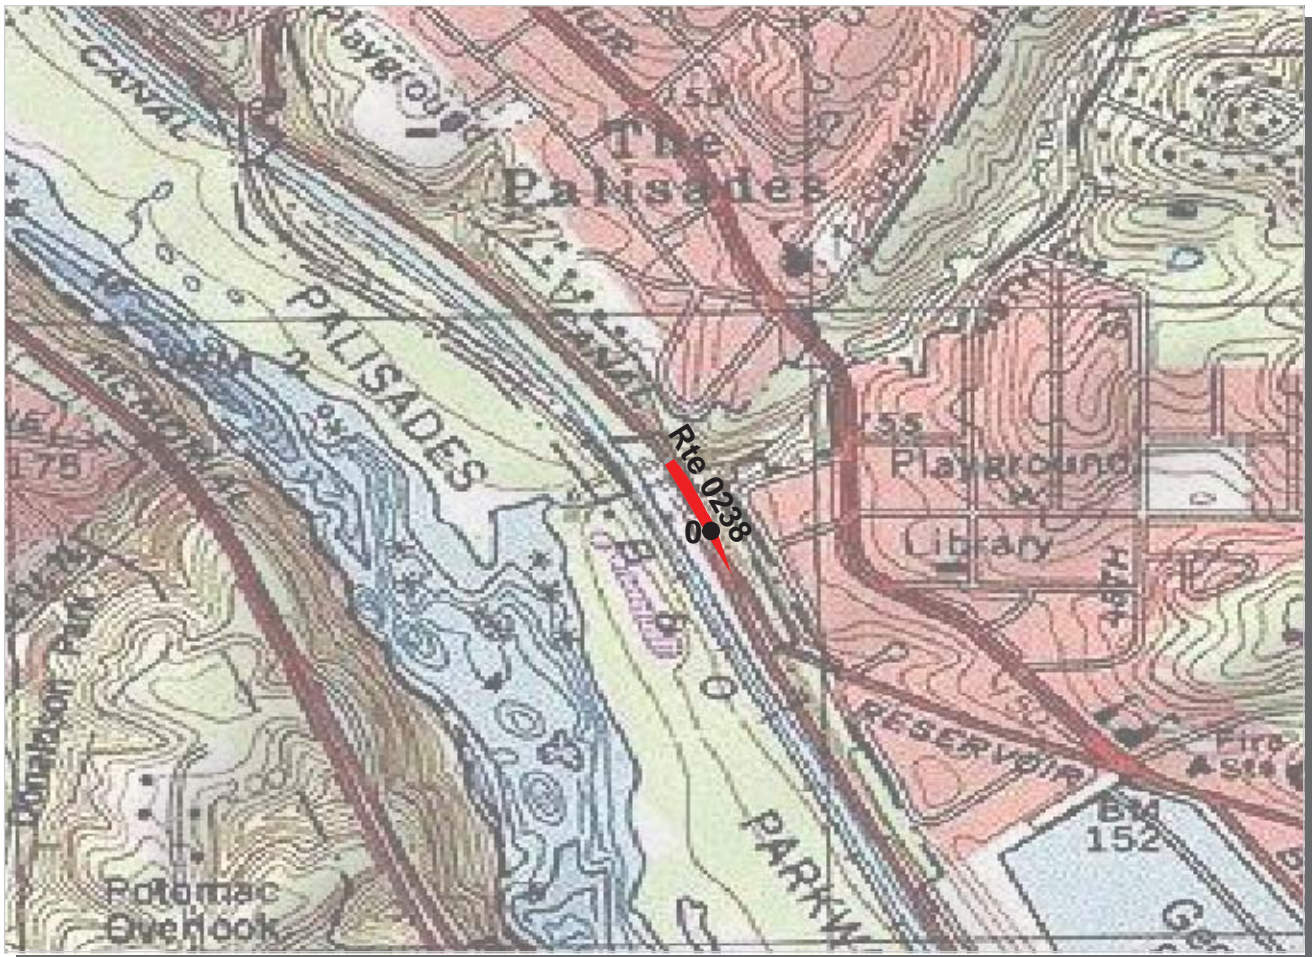
ROUTE: 0238 Fletchers Boat House Access Road

Section Number	0				
Section Length (mi)	0.10				
AADT	**				
SADT	**				
ADT Date	**				
Cross Section Information					
Number of Lanes	1				
Paved Width (ft)	12				
Lane Width (ft)	12				
Shoulder Width (ft)	0				
Roadway Condition Information					
PCR (Pavement Condition Rating)	31				
RCI (Roughness Condition Index)	NC				
SCR (Surface Condition Rating)	31				
Alligator Cracking Index	92				
Rutting Index	32				
Patching Index	100				
Transverse Cracking Index	99				
Longitudinal Cracking Index	98				
Shoulder Condition Rating	N/A				
Drainage Condition Rating	POOR

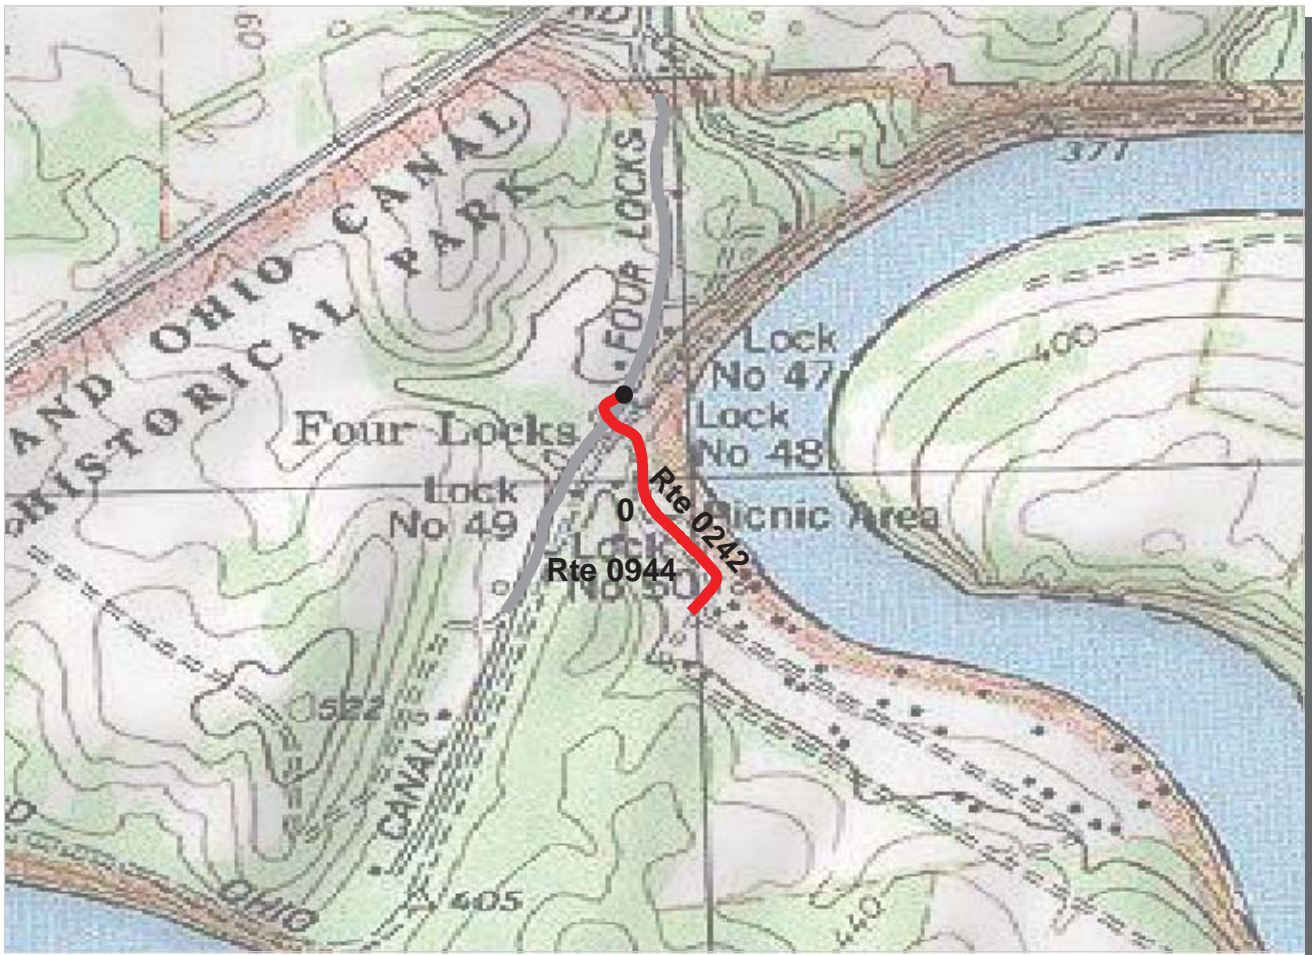
ROUTE: 0242 Ankeney Lane

Section Number	0				
Section Length (mi)	0.27				
AADT	**				
SADT	**				
ADT Date	**				
Cross Section Information					
Number of Lanes	2				
Paved Width (ft)	17				
Lane Width (ft)	9				
Shoulder Width (ft)	0				
Roadway Condition Information					
PCR (Pavement Condition Rating)	5				
RCI (Roughness Condition Index)	51				
SCR (Surface Condition Rating)	0				
Alligator Cracking Index	32				
Rutting Index	22				
Patching Index	97				
Transverse Cracking Index	90				
Longitudinal Cracking Index	94				
Shoulder Condition Rating	N/A				
Drainage Condition Rating	POOR

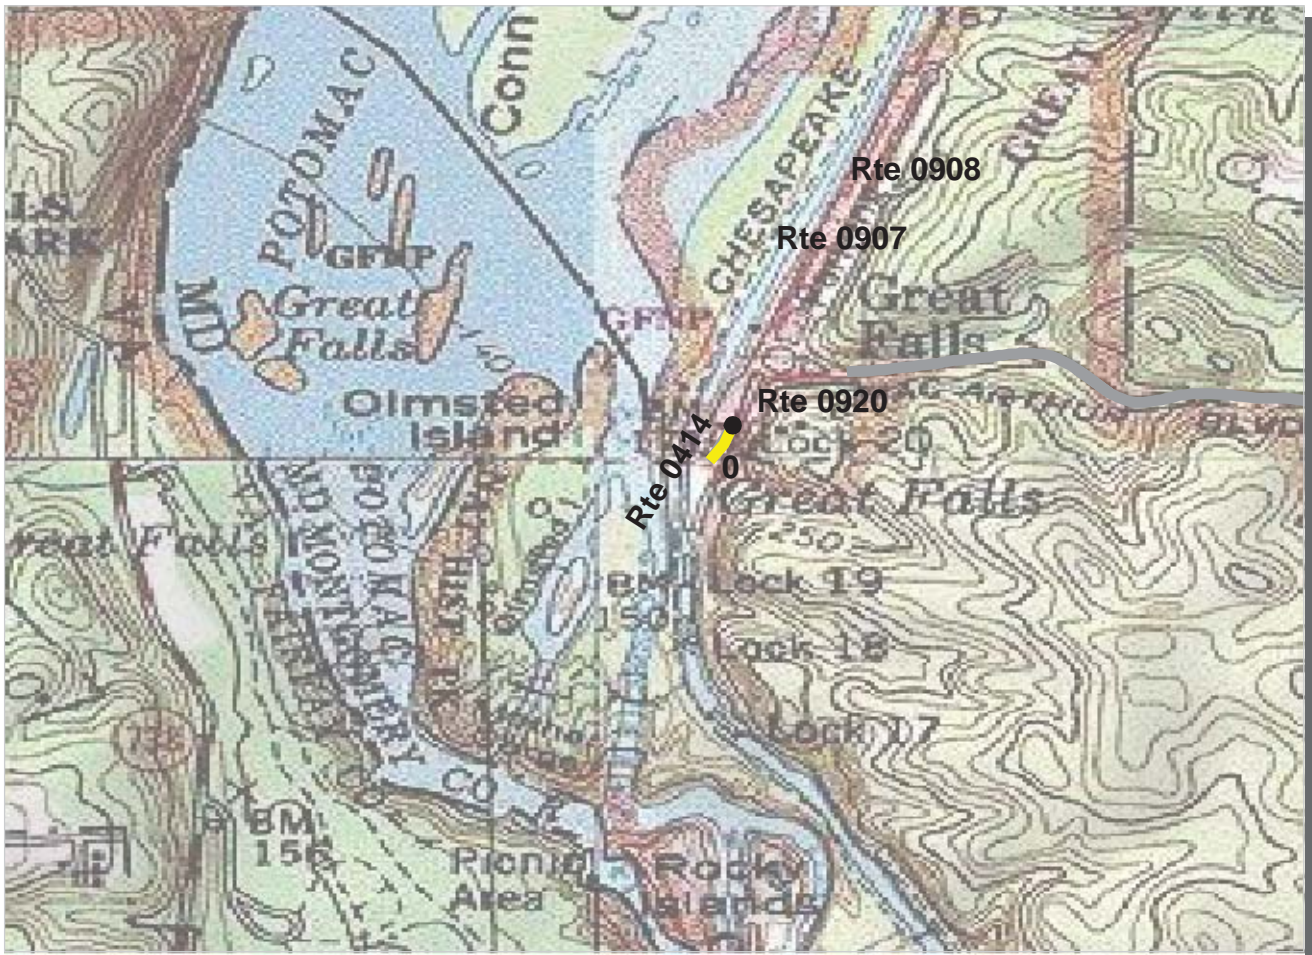
ROUTE: 0414 Lock 19 Access Road **TOTAL LENGTH: 0.06 Miles**

Section Number	0				
Section Length (mi)	0.06				
AADT	**				
SADT	**				
ADT Date	**				
Cross Section Information					
Number of Lanes	1				
Paved Width (ft)	9				
Lane Width (ft)	9				
Shoulder Width (ft)	0				
Roadway Condition Information					
PCR (Pavement Condition Rating)	57				
RCI (Roughness Condition Index)	NC				
SCR (Surface Condition Rating)	57				
Alligator Cracking Index	100				
Rutting Index	58				
Patching Index	99				
Transverse Cracking Index	100				
Longitudinal Cracking Index	100				
Shoulder Condition Rating	N/A				
Drainage Condition Rating	GOOD

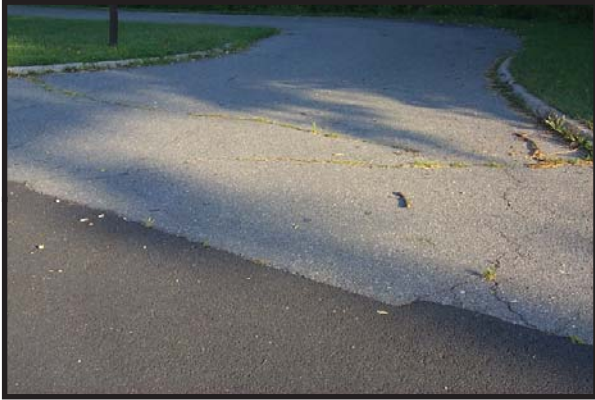
Route 0903A

Route	Public / NonPublic	Date Visited	Area (sq ft)	Lane Miles *	Surface Type	Condition / PCR
0903A	Public	7/17/2002	26439	0.46	AS	EXCELLENT / 97

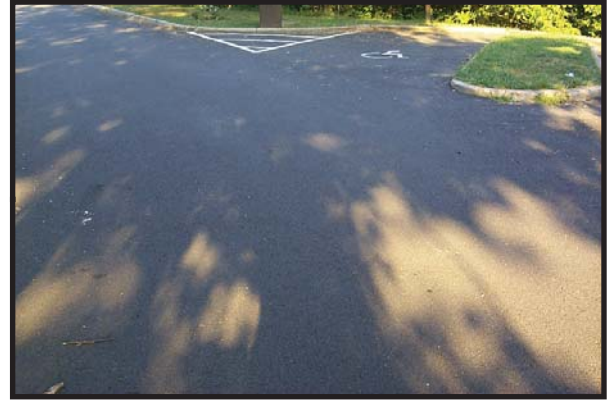
Route 0902

Route	Public / NonPublic	Date Visited	Area (sq ft)	Lane Miles *	Surface Type	Condition / PCR
0902	Public	7/16/2002	19833	0.34	AS	GOOD / 90

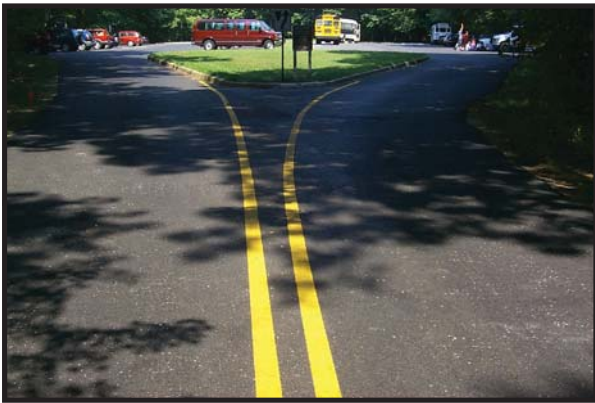
Route 0903C

Route	Public / NonPublic	Date Visited	Area (sq ft)	Lane Miles *	Surface Type	Condition / PCR
0903C	Public	7/17/2002	25887	0.45	AS	FAIR / 73

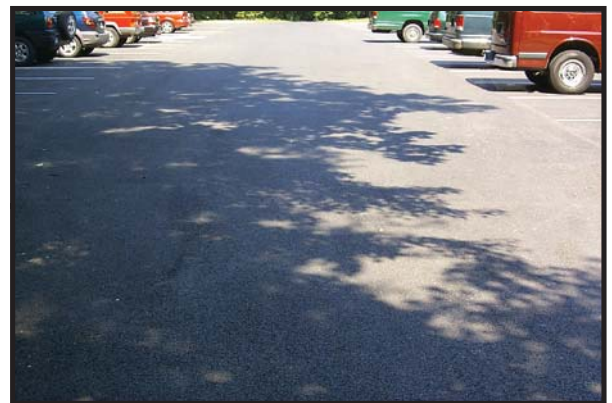
Route 0903B

Route	Public / NonPublic	Date Visited	Area (sq ft)	Lane Miles *	Surface Type	Condition / PCR
0903B	Public	7/17/2002	30159	0.52	AS	EXCELLENT / 97

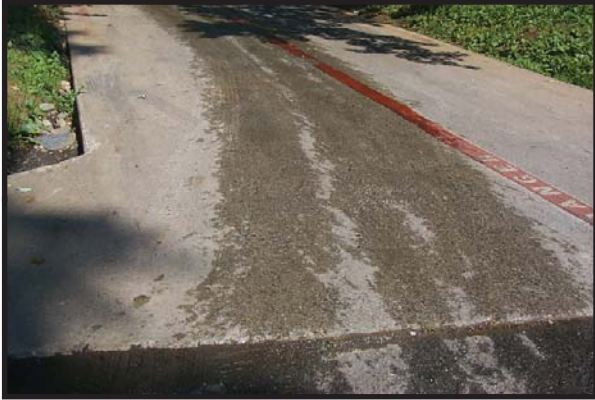
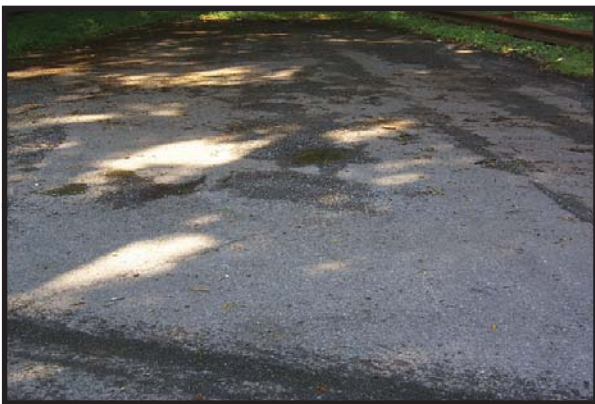
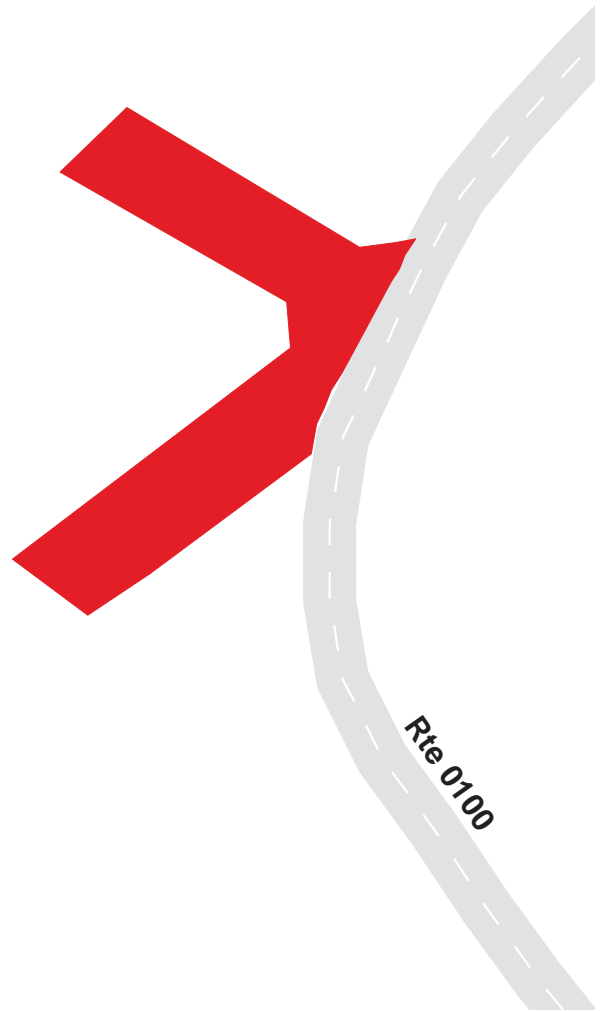
Route 0918

Route	Public / NonPublic	Date Visited	Area (sq ft)	Lane Miles *	Surface Type	Condition / PCR
0918	Public	7/15/2002	2242	0.04	AS	GOOD / 90

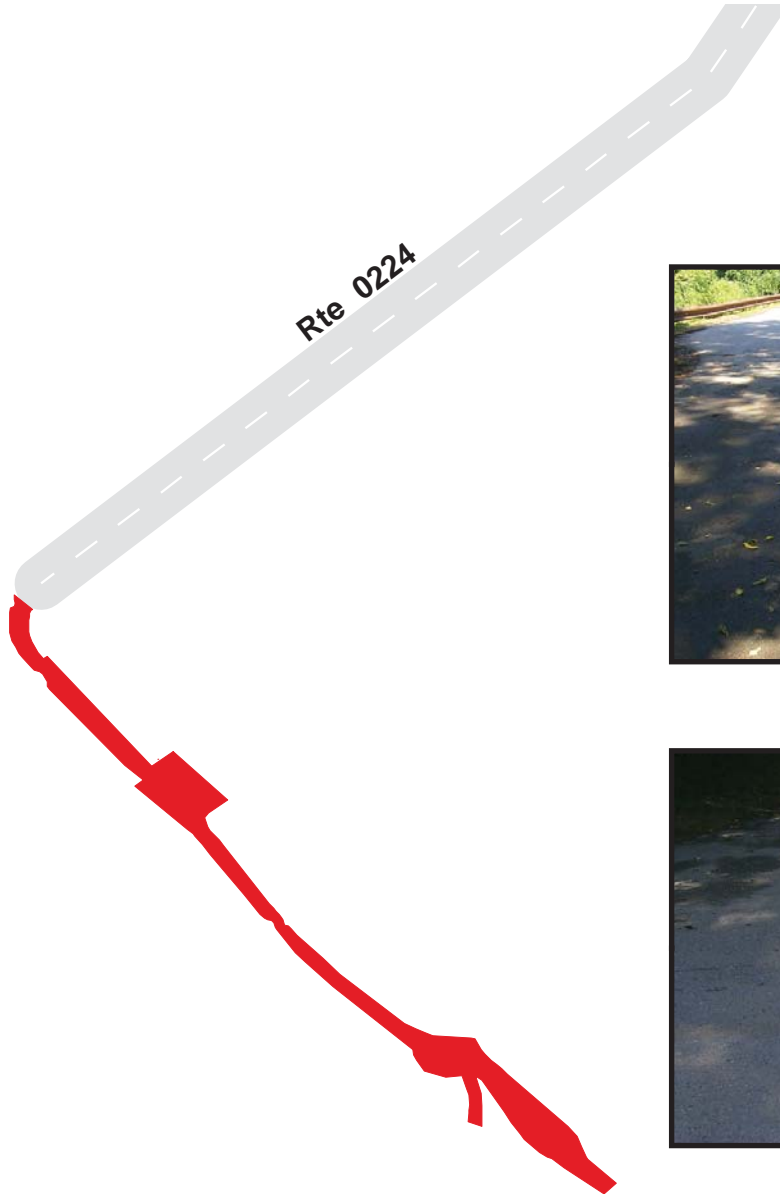
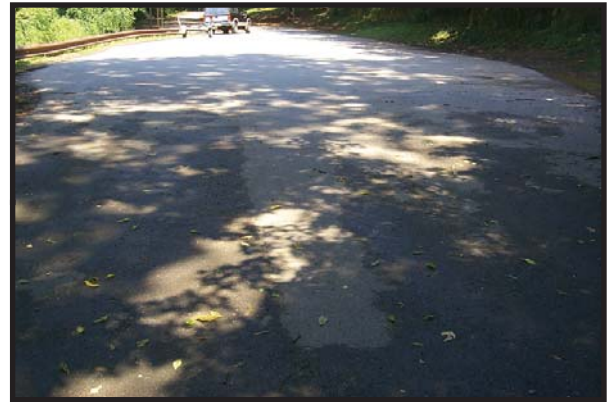
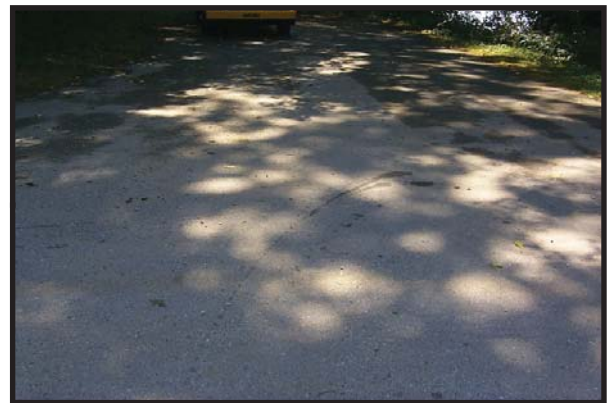
Route 0919

Route	Public / NonPublic	Date Visited	Area (sq ft)	Lane Miles *	Surface Type	Condition / PCR
0919	Public	7/15/2002	27639	0.48	AS	GOOD / 90

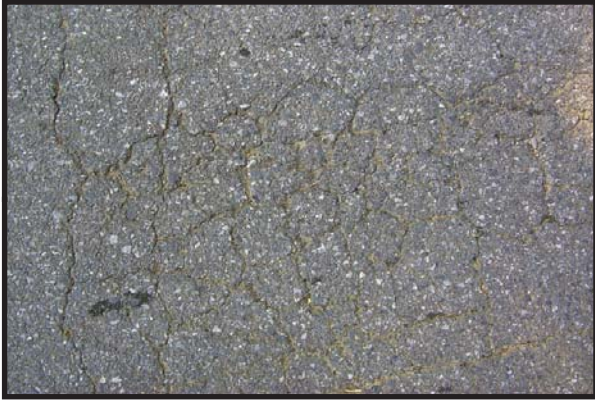
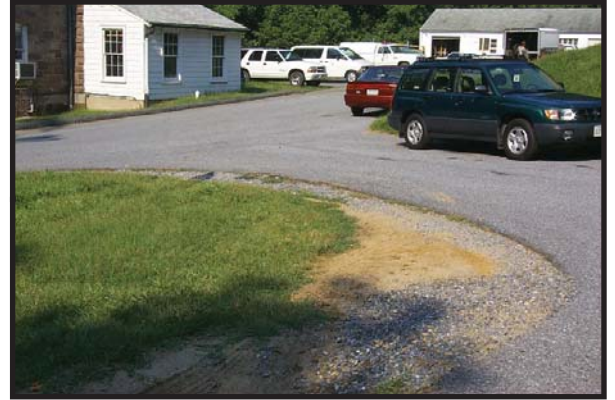
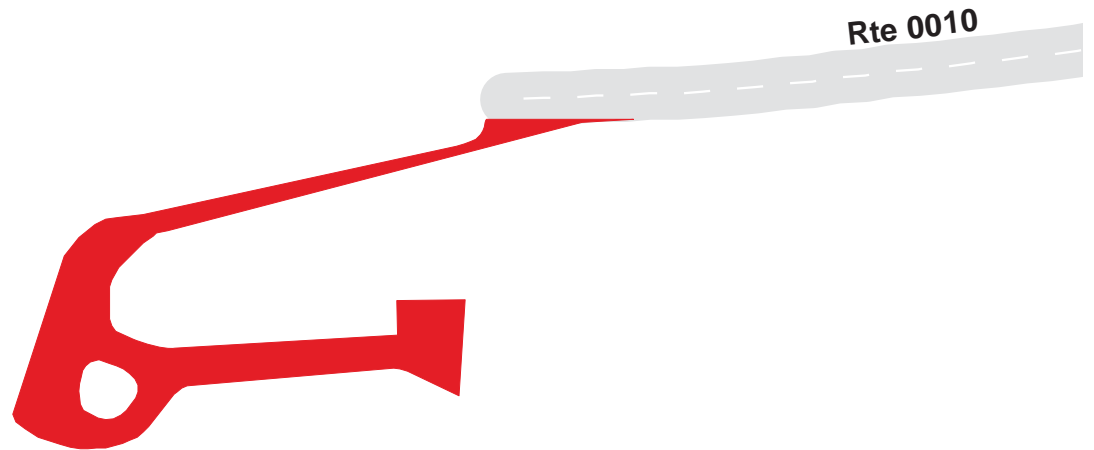
Route 0920

Route	Public / NonPublic	Date Visited	Area (sq ft)	Lane Miles *	Surface Type	Condition / PCR
0920	NonPublic	7/17/2002	14357	0.25	AS	FAIR / 73

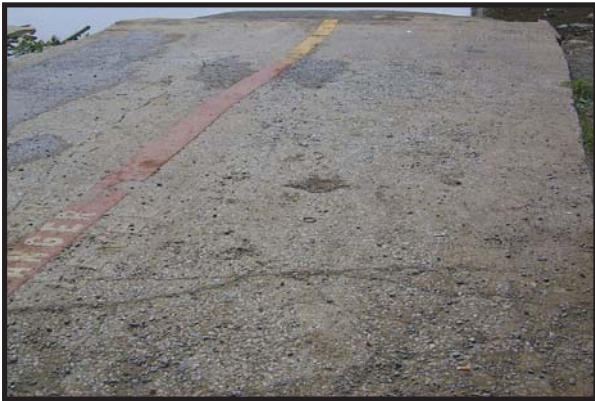
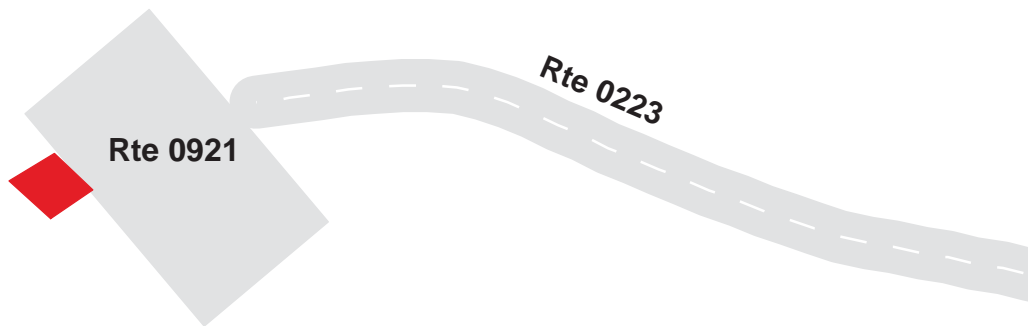
Route 0922

Route	Public / NonPublic	Date Visited	Area (sq ft)	Lane Miles *	Surface Type	Condition / PCR
0922	Public	7/15/2002	940	0.02	CO	FAIR / 73

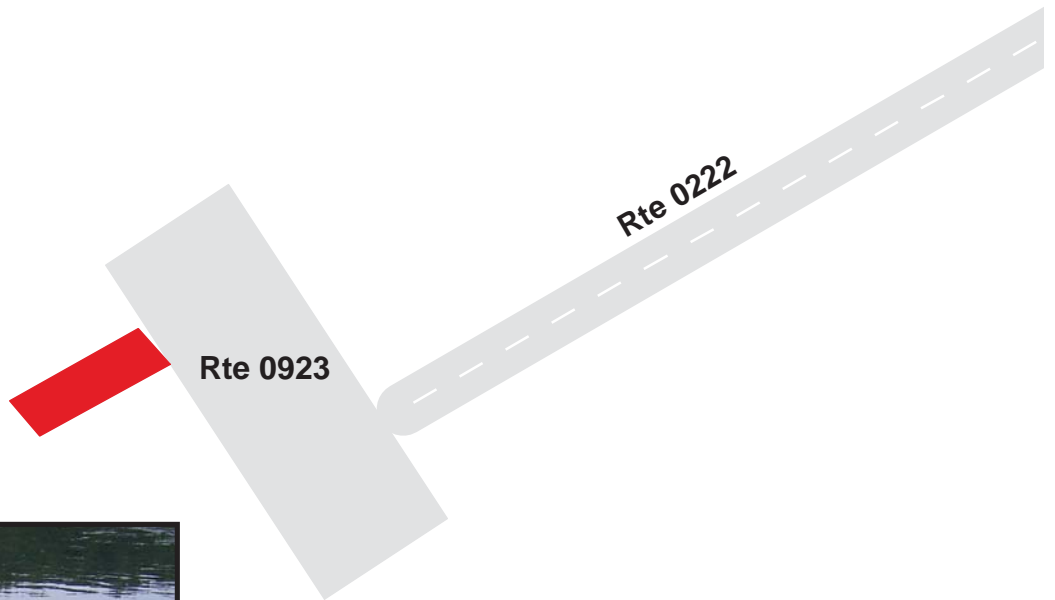
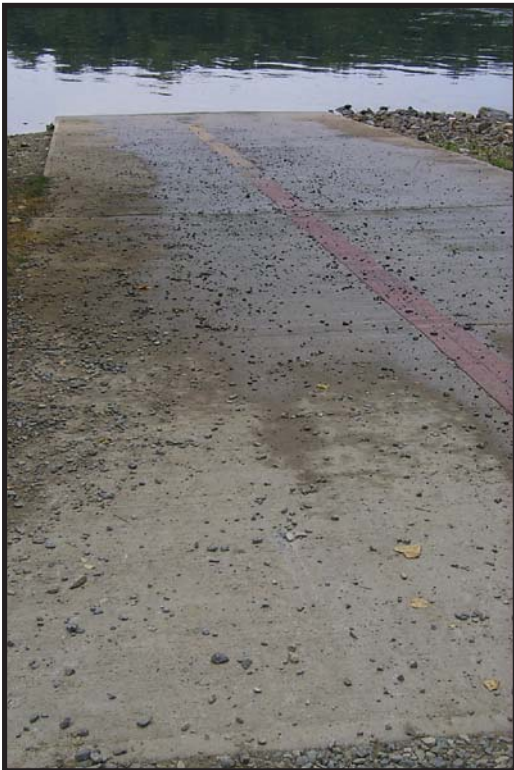
Route 0924

Route	Public / NonPublic	Date Visited	Area (sq ft)	Lane Miles *	Surface Type	Condition / PCR
0924	Public	7/13/2002	1076	0.02	CO	GOOD / 90

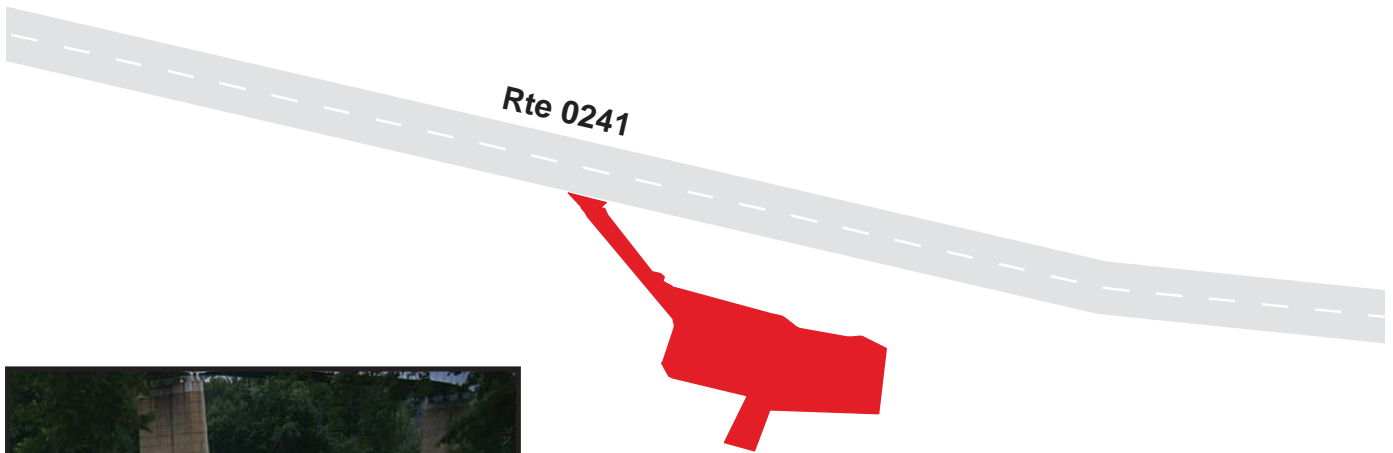
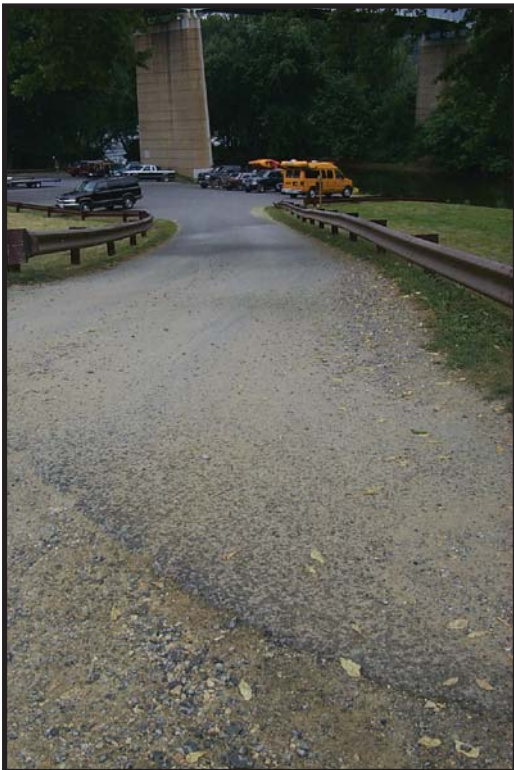
Route 0925

Route	Public / NonPublic	Date Visited	Area (sq ft)	Lane Miles *	Surface Type	Condition / PCR
0925	Public	7/13/2002	17292	0.30	AS	GOOD / 90

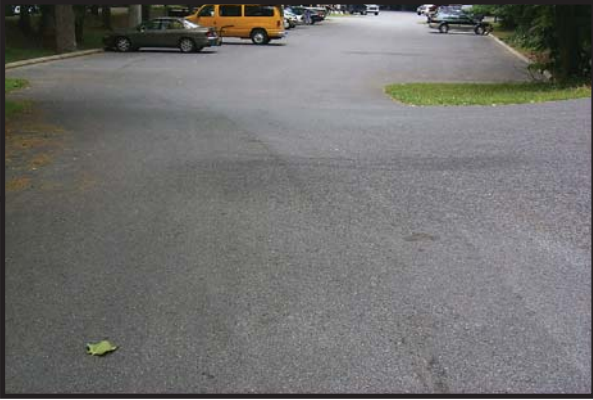
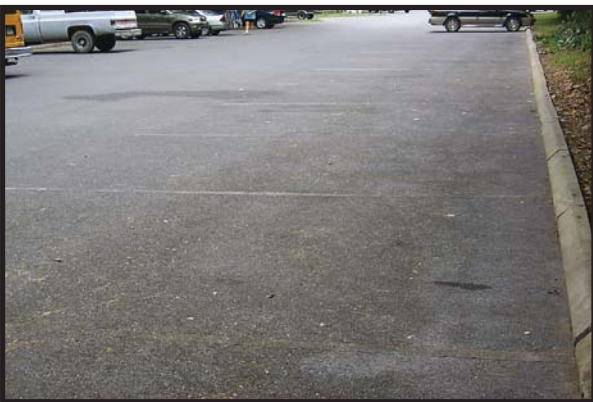
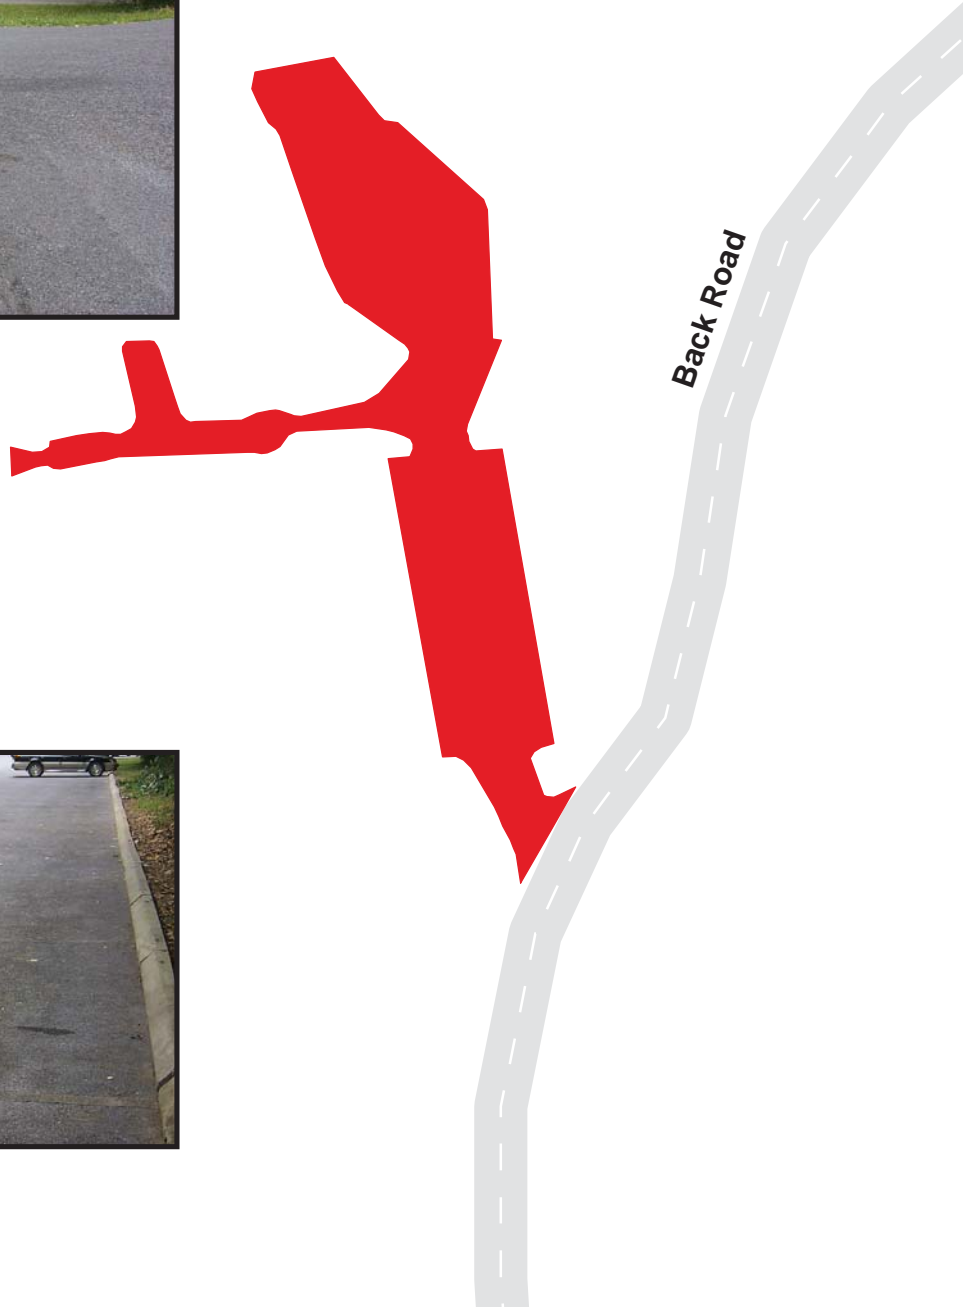
Route 0928

Route	Public / NonPublic	Date Visited	Area (sq ft)	Lane Miles *	Surface Type	Condition / PCR
0928	Public	7/13/2002	38000	0.65	AS	GOOD / 90

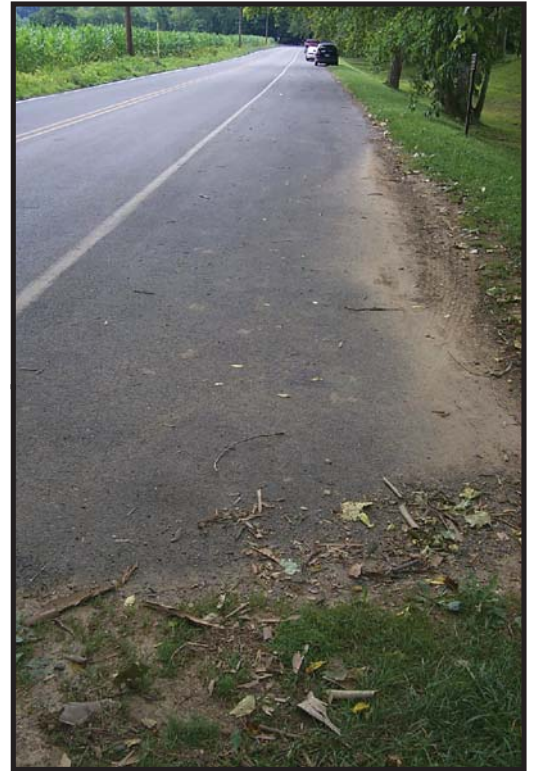
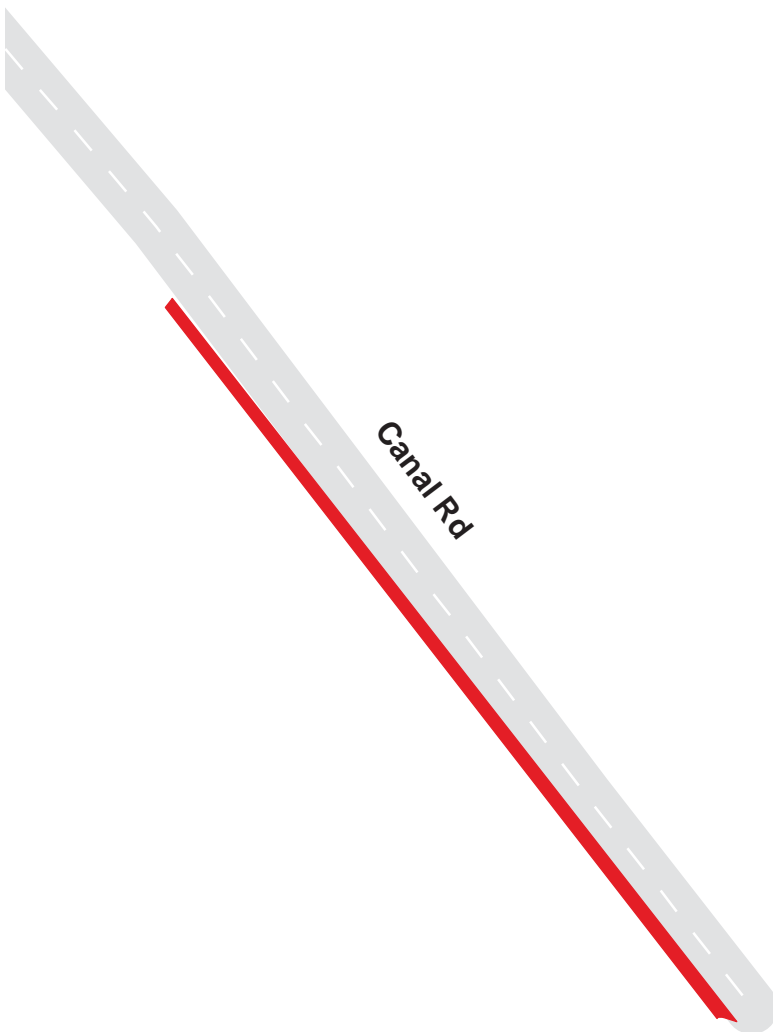
Route 0930A

Route	Public / NonPublic	Date Visited	Area (sq ft)	Lane Miles *	Surface Type	Condition / PCR
0930A	Public	7/13/2002	10480	0.18	AS	GOOD / 90

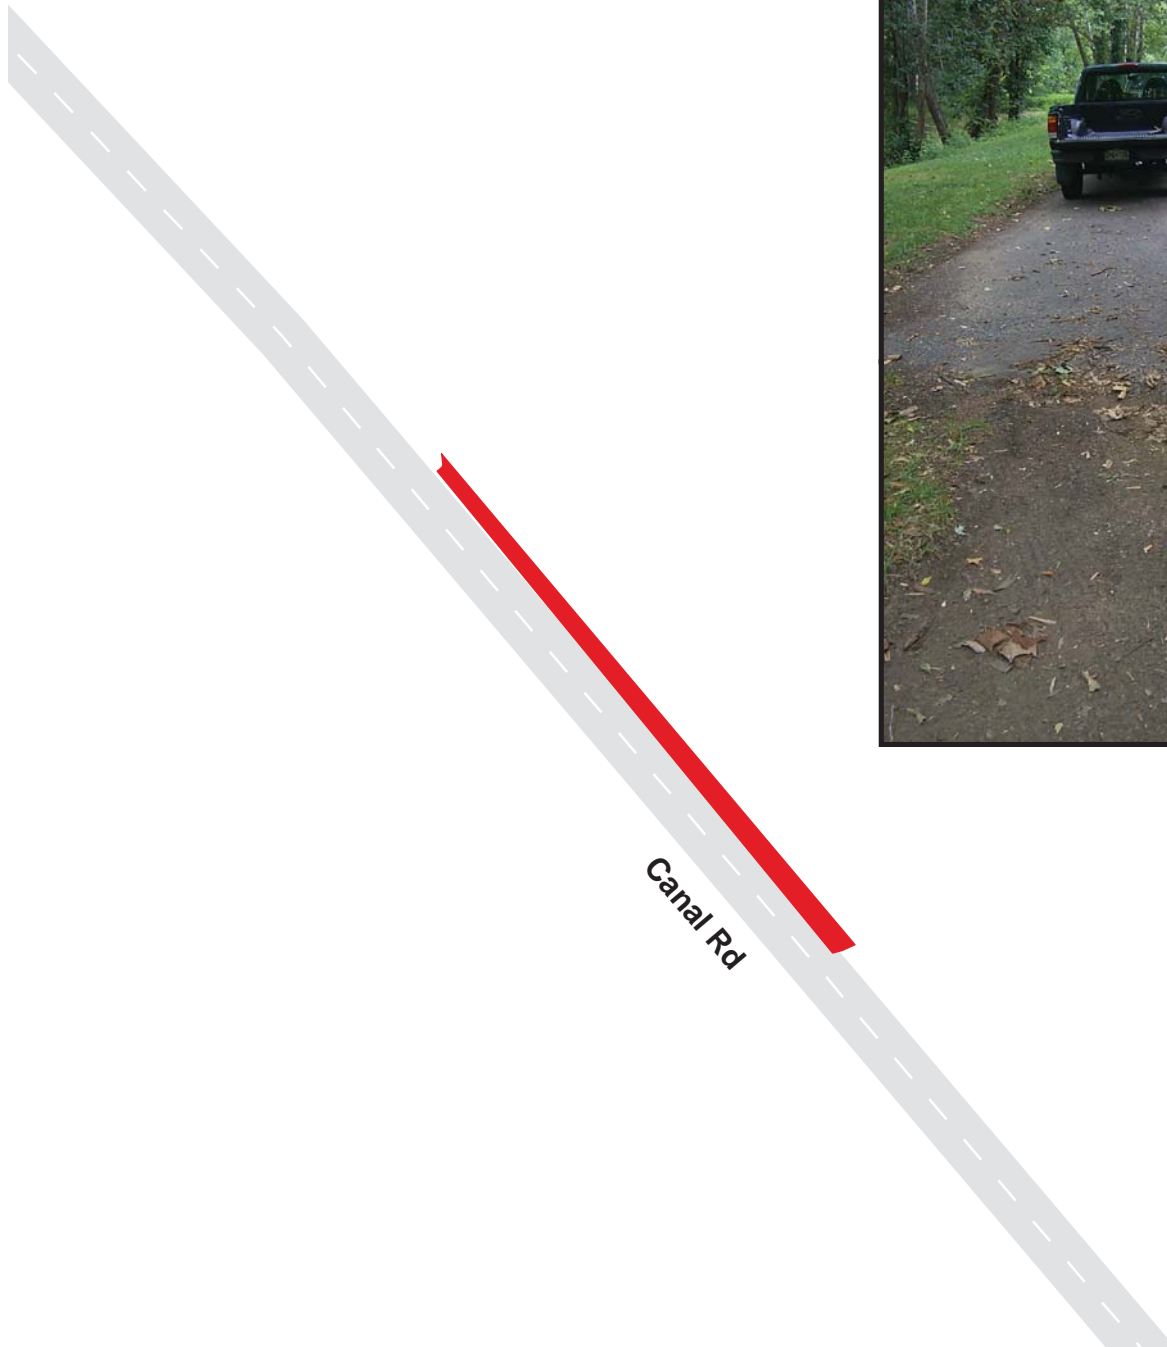
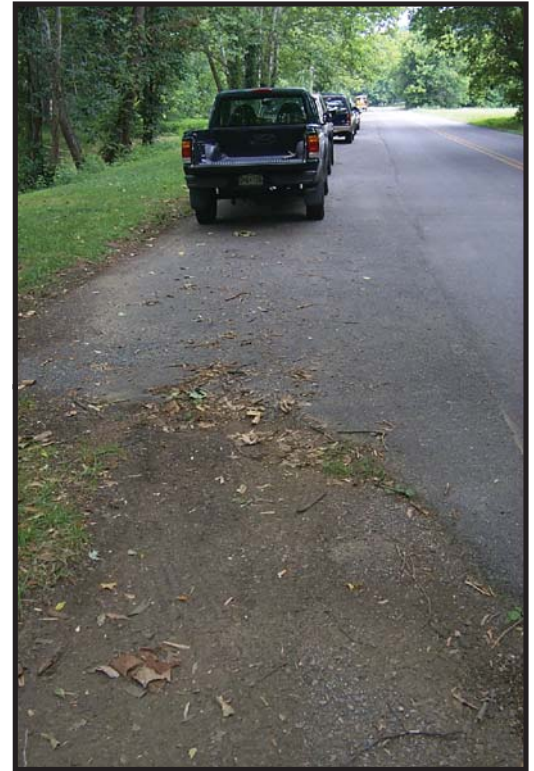
Route 0930B

Route	Public / NonPublic	Date Visited	Area (sq ft)	Lane Miles *	Surface Type	Condition / PCR
0930B	Public	7/13/2002	5518	0.10	AS	GOOD / 90

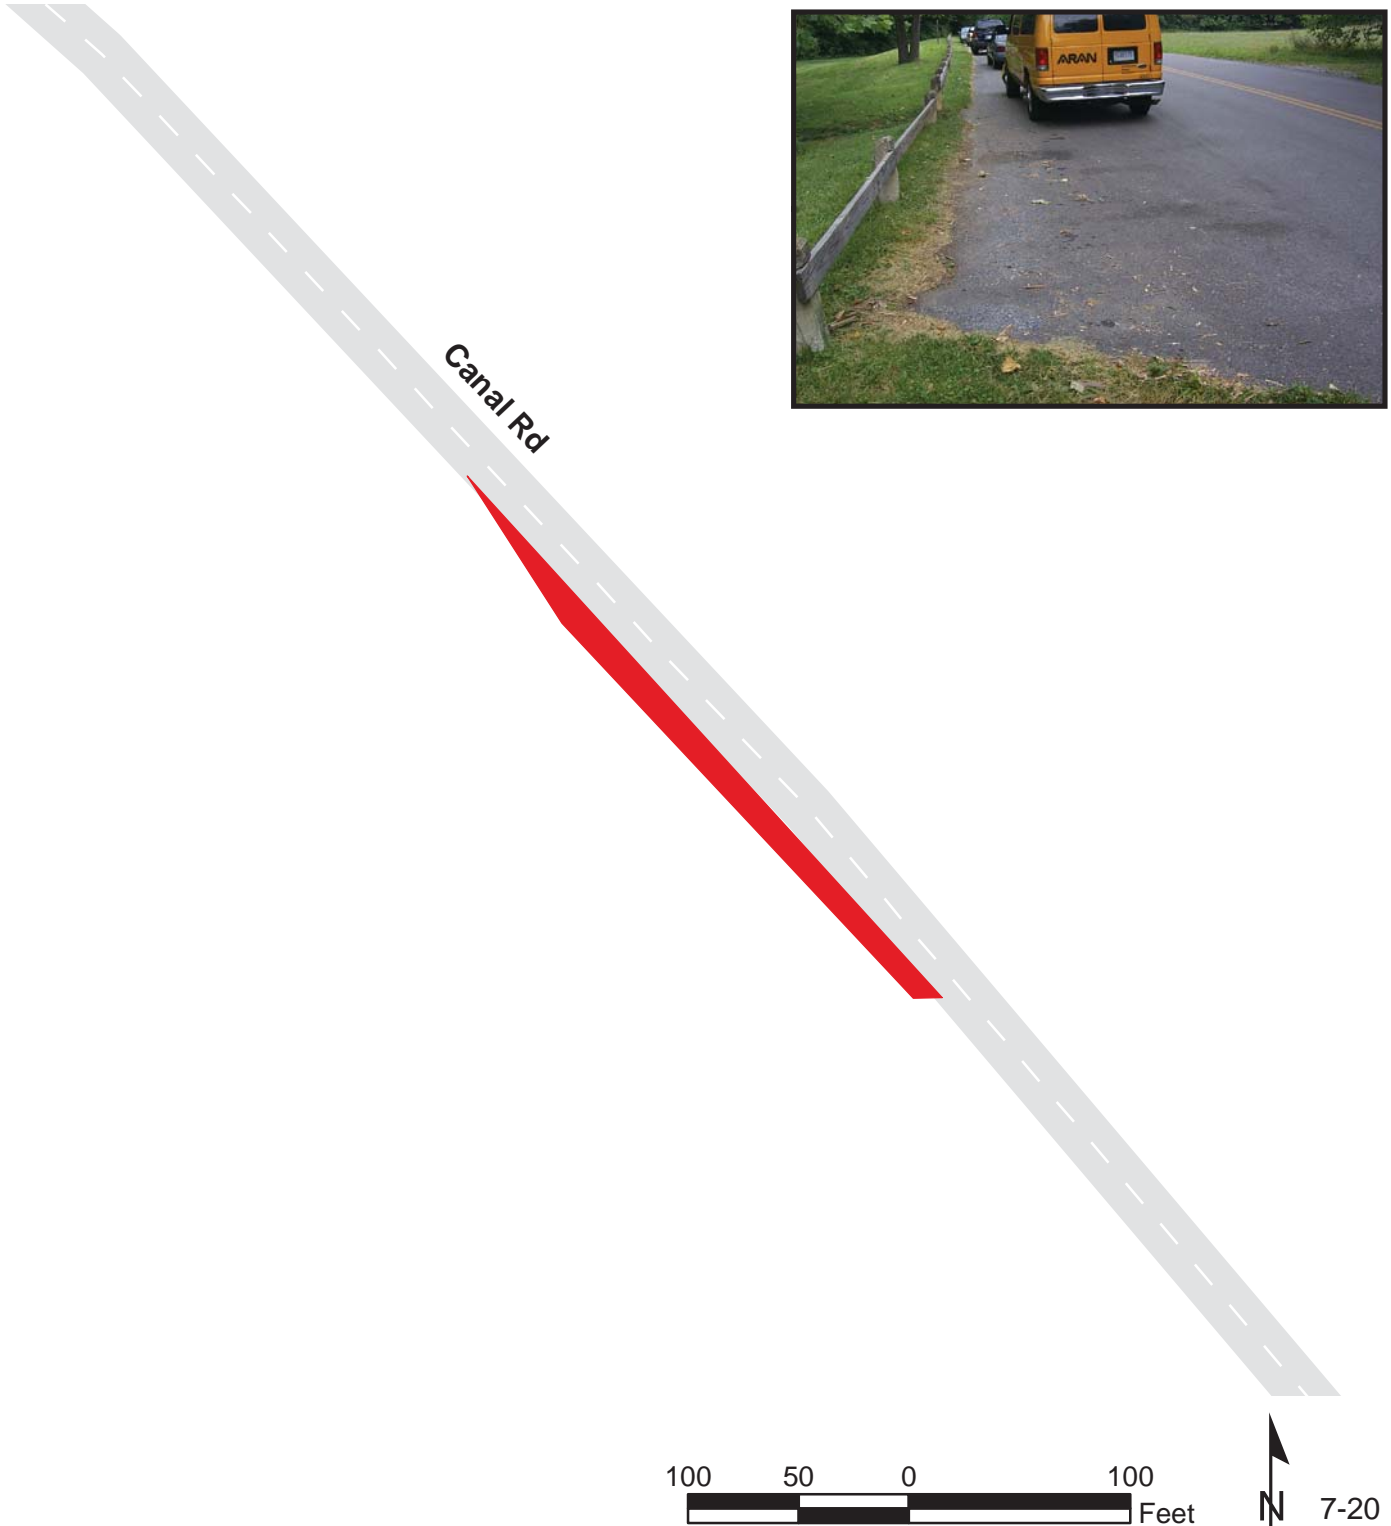
Route 0930C

Route	Public / NonPublic	Date Visited	Area (sq ft)	Lane Miles *	Surface Type	Condition / PCR
0930C	Public	7/13/2002	2512	0.04	AS	GOOD / 90

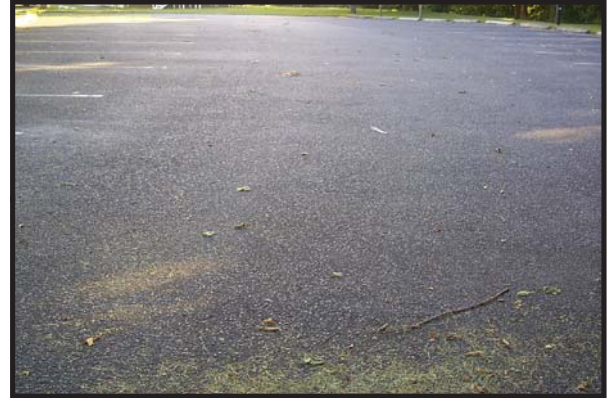
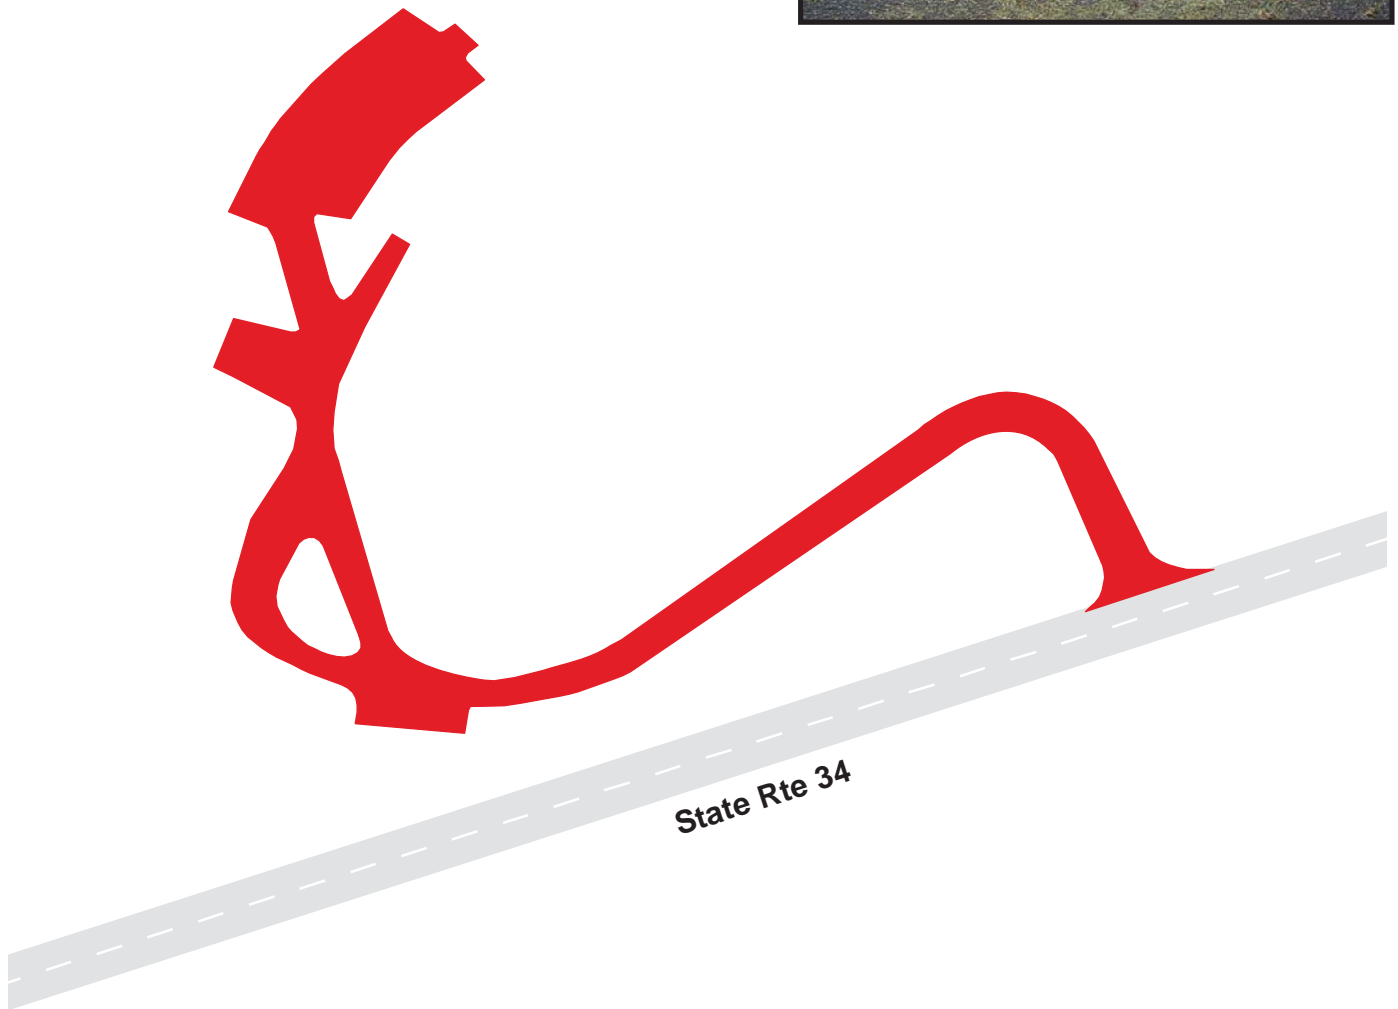
Route 0932

Route	Public / NonPublic	Date Visited	Area (sq ft)	Lane Miles *	Surface Type	Condition / PCR
0932	Public	7/12/2002	29358	0.51	AS	GOOD / 90

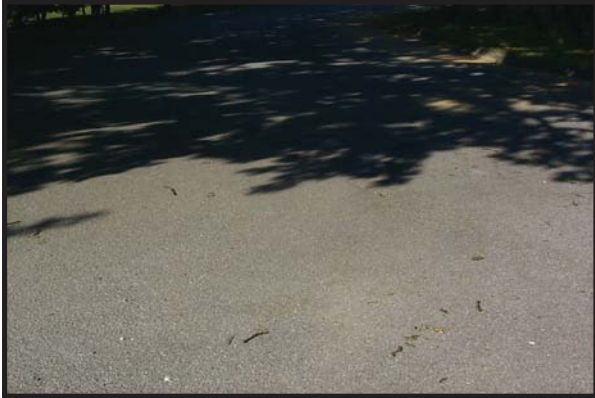
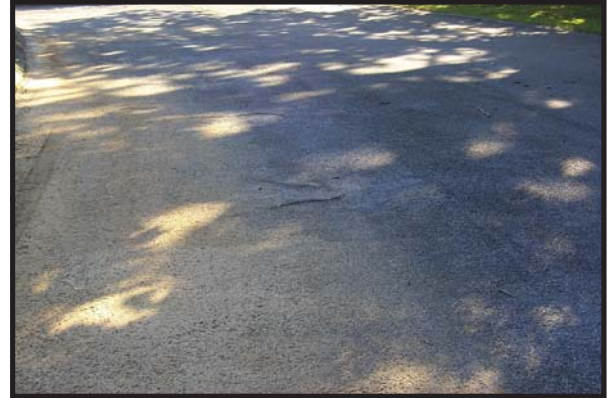
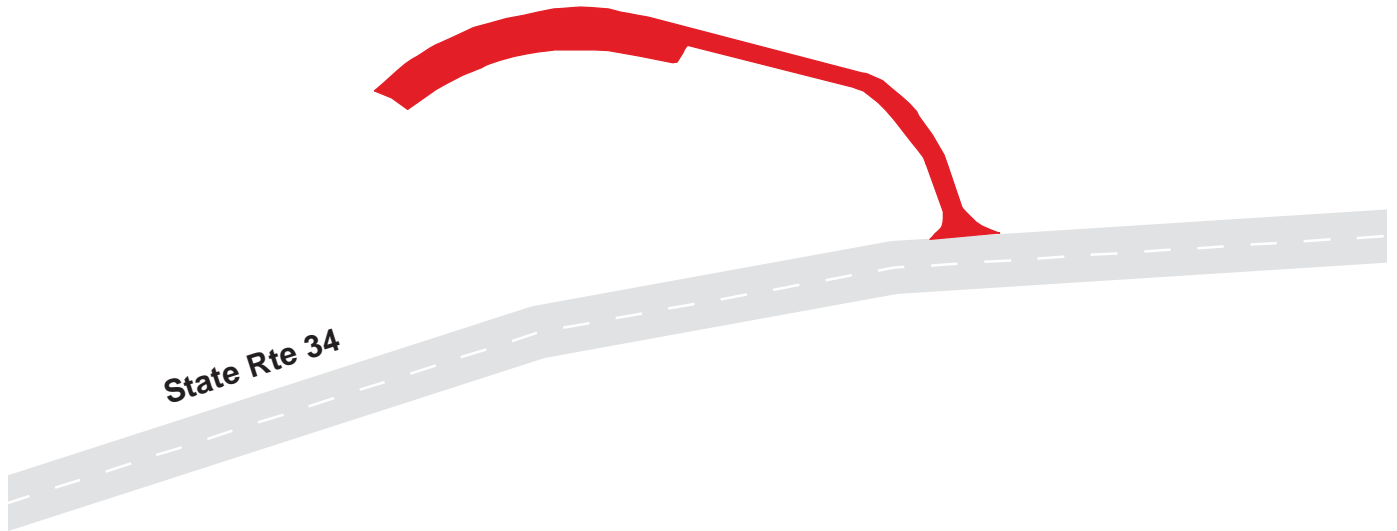
Route 0933

Route	Public / NonPublic	Date Visited	Area (sq ft)	Lane Miles *	Surface Type	Condition / PCR
0933	Public	7/12/2002	14933	0.26	AS	FAIR / 73
