**The Road Inventory
of
Chesapeake & Ohio Canal National Historical Park
CHOH - 3100**

Prepared By:
Federal Highway Administration
Eastern Federal Lands Highway Division
Cycle 3

Chesapeake and Ohio Canal National Historical Park in Maryland

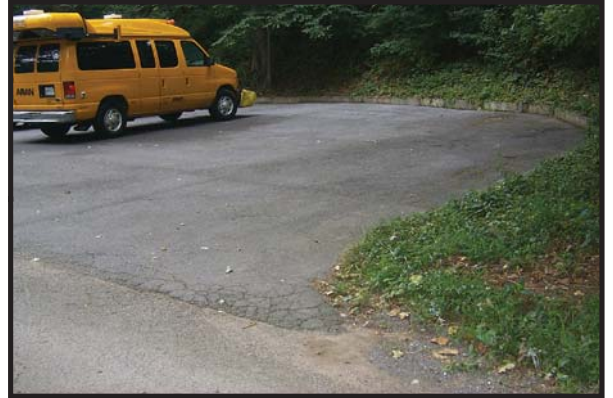
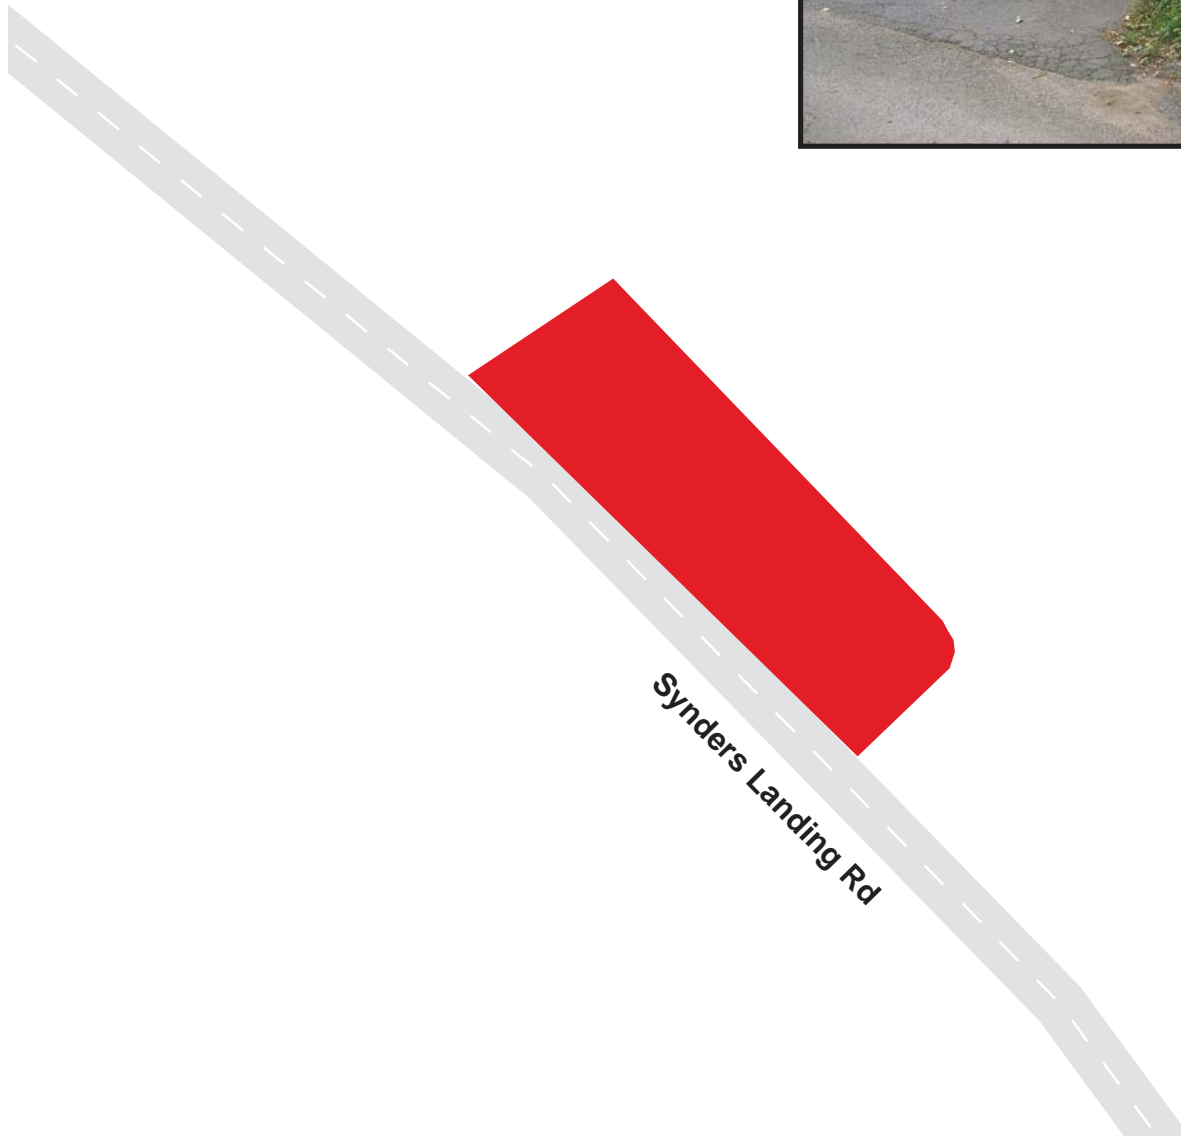
Route 0934

Route	Public / NonPublic	Date Visited	Area (sq ft)	Lane Miles *	Surface Type	Condition / PCR
0934	Public	7/13/2002	7685	0.13	AS	GOOD / 90

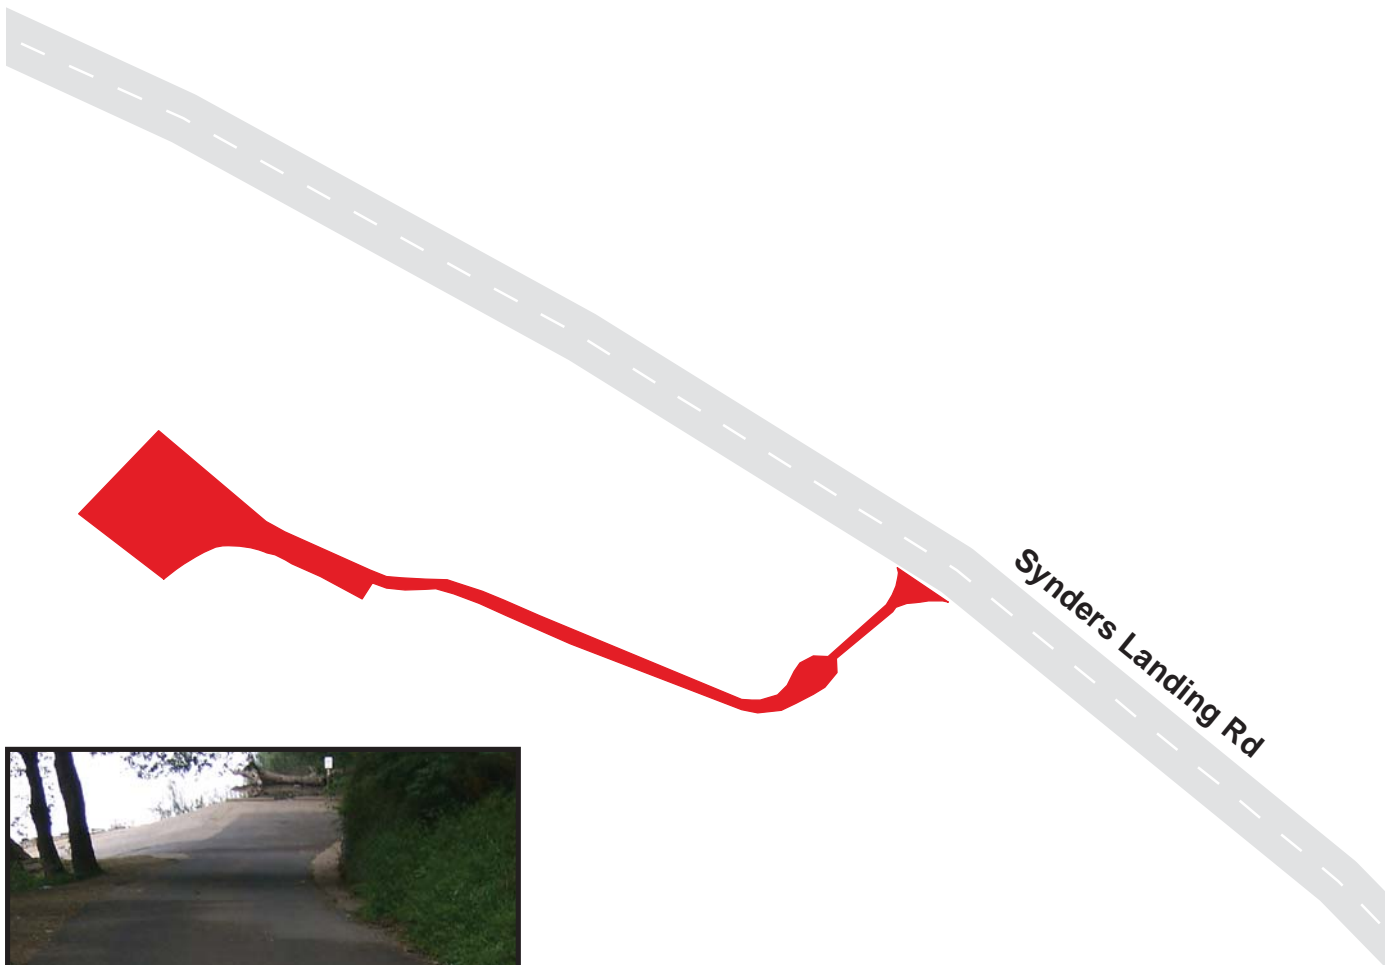
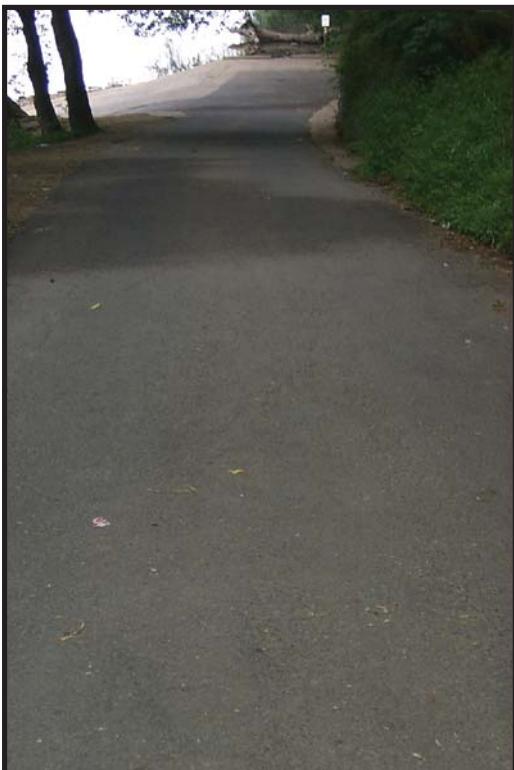
Route 0936

Route	Public / NonPublic	Date Visited	Area (sq ft)	Lane Miles *	Surface Type	Condition / PCR
0936	Public	7/12/2002	19798	0.34	AS	GOOD / 90

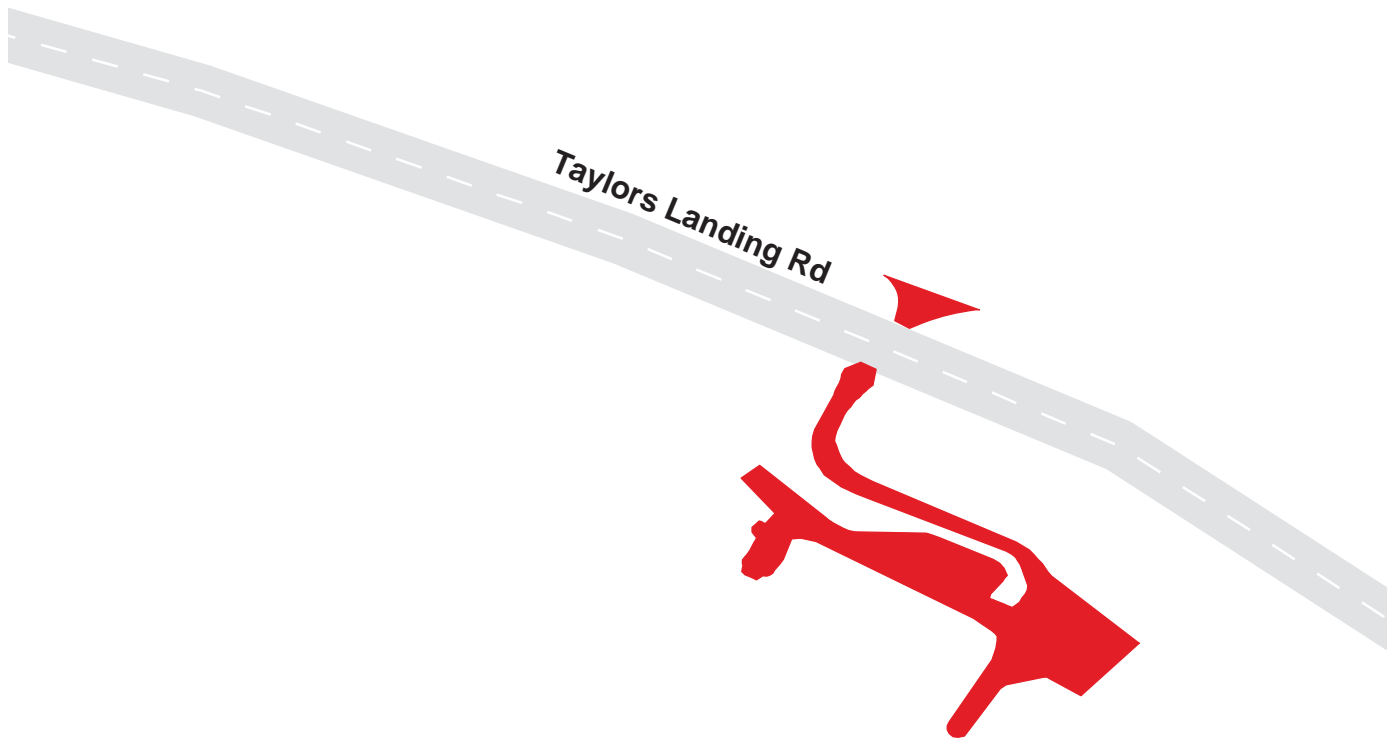
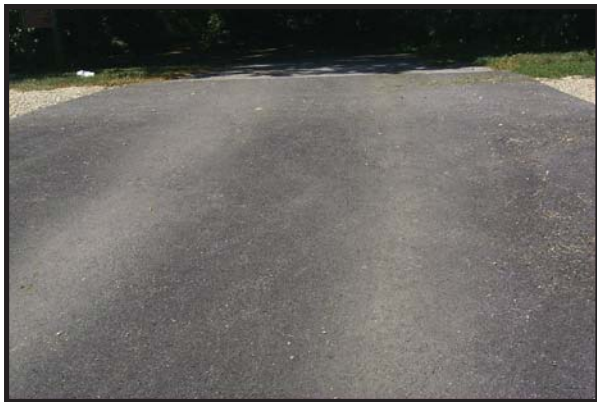
Route 0937

Route	Public / NonPublic	Date Visited	Area (sq ft)	Lane Miles *	Surface Type	Condition / PCR
0937	Public	7/12/2002	2048	0.04	AS	GOOD / 90

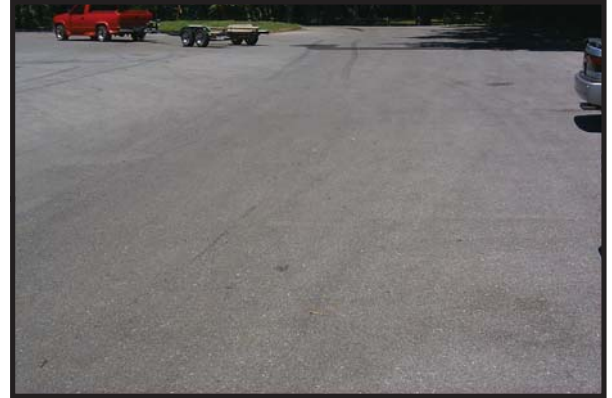
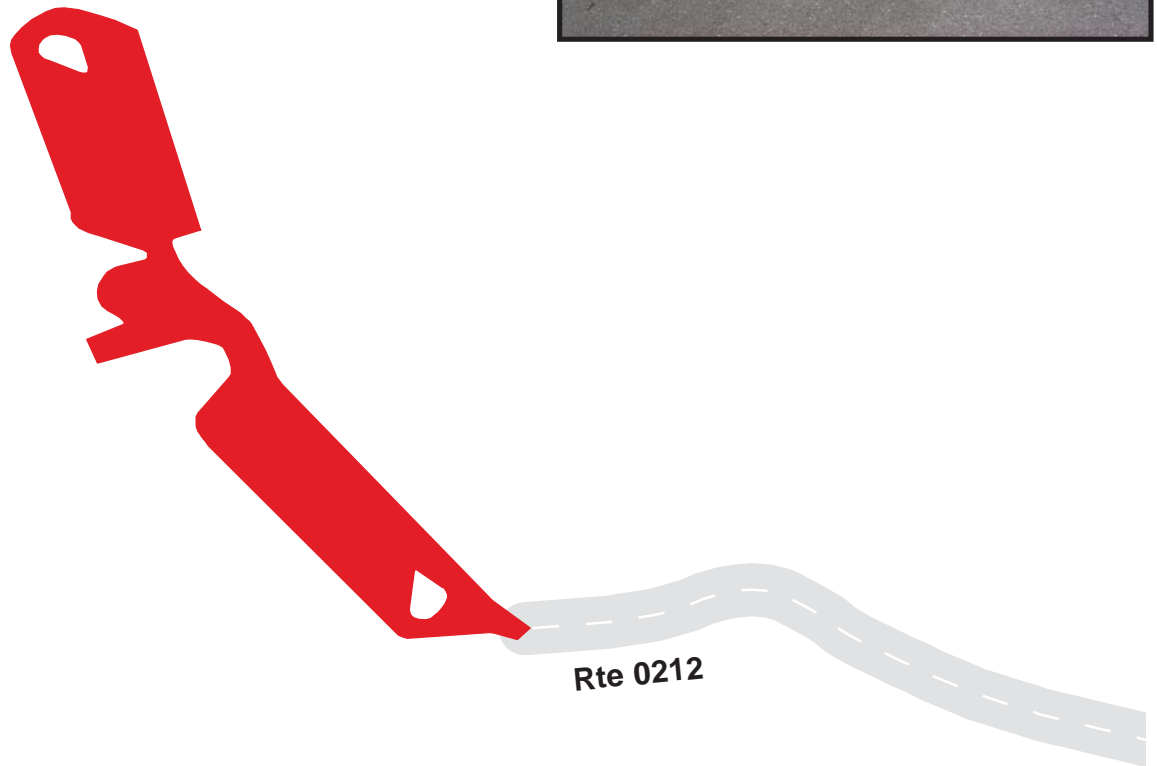
Route 0944

Route	Public / NonPublic	Date Visited	Area (sq ft)	Lane Miles *	Surface Type	Condition / PCR
0944	Public	7/11/2002	47228	0.81	AS	GOOD / 90

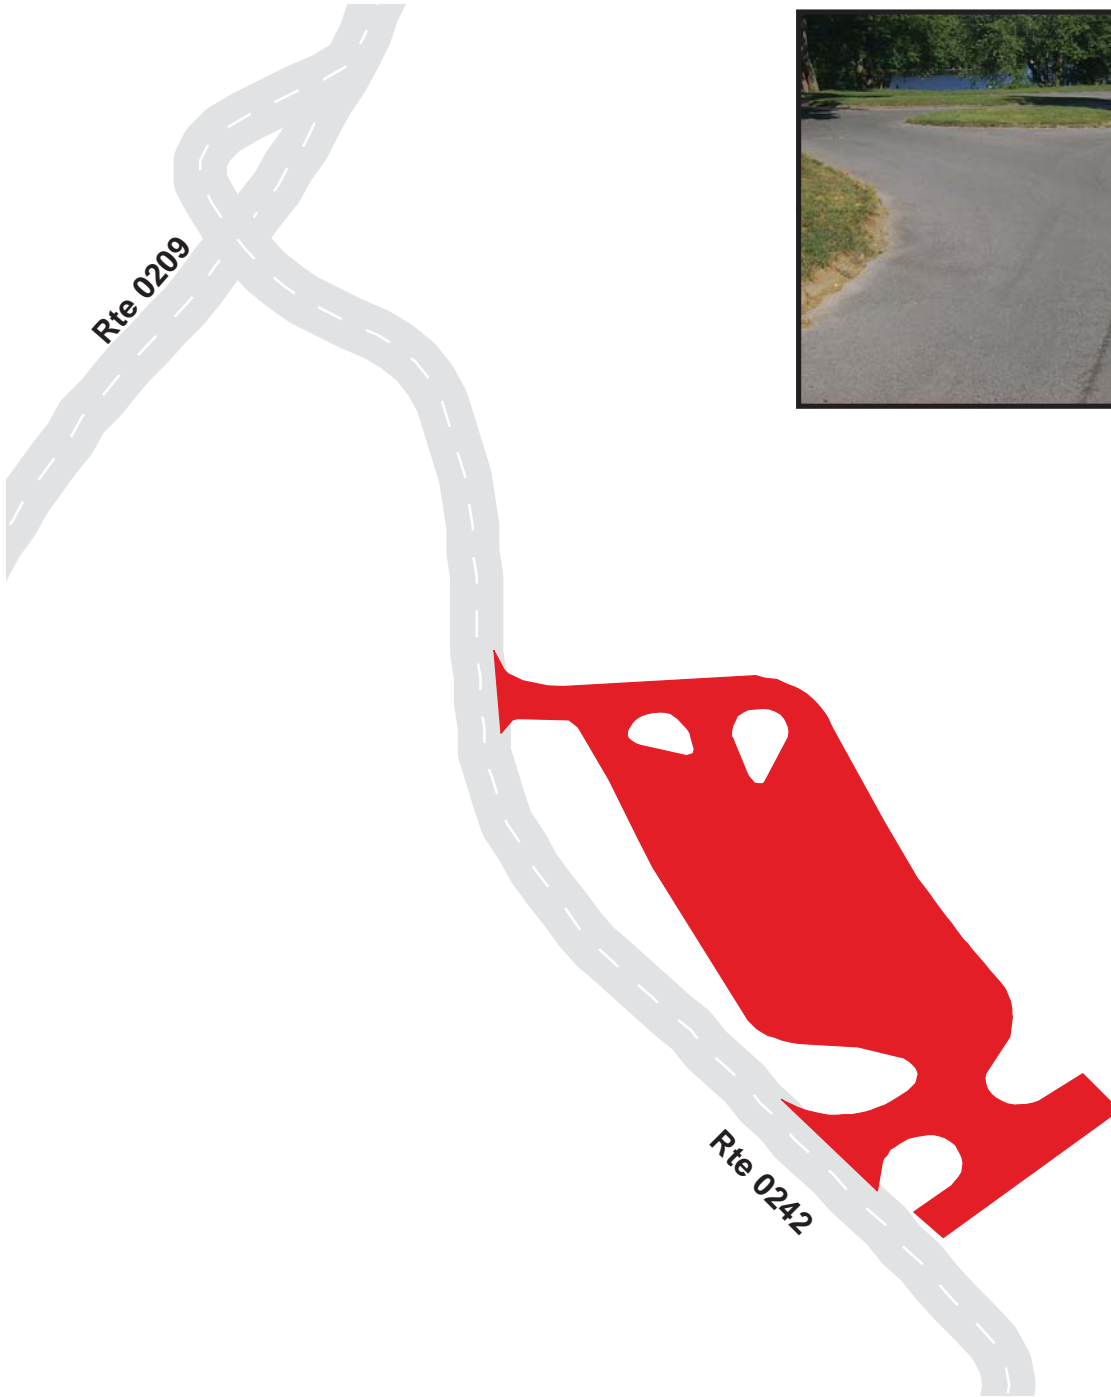
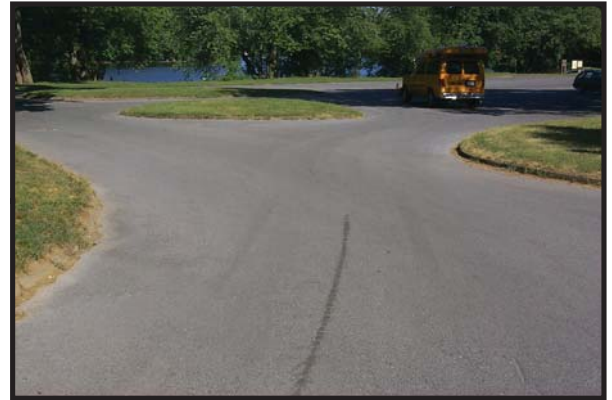
Route 0945

Route	Public / NonPublic	Date Visited	Area (sq ft)	Lane Miles *	Surface Type	Condition / PCR
0945	Public	7/11/2002	29241	0.50	AS	GOOD / 90

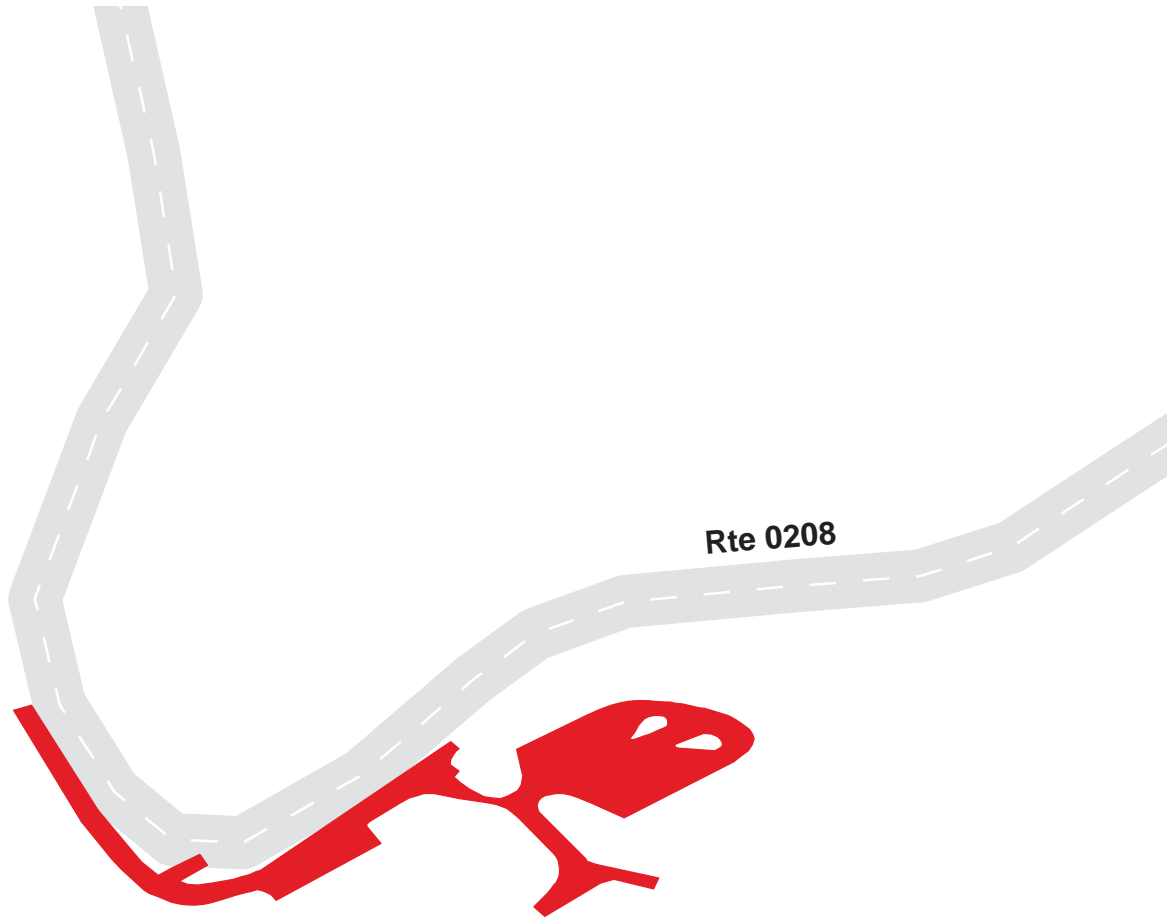
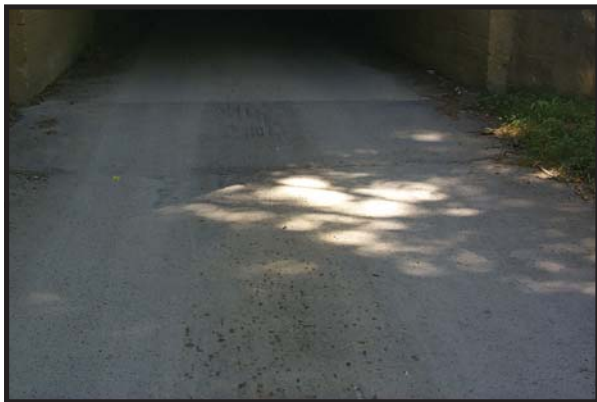
Route 0946

Route	Public / NonPublic	Date Visited	Area (sq ft)	Lane Miles *	Surface Type	Condition / PCR
0946	Public	7/10/2002	16952	0.29	AS	GOOD / 90

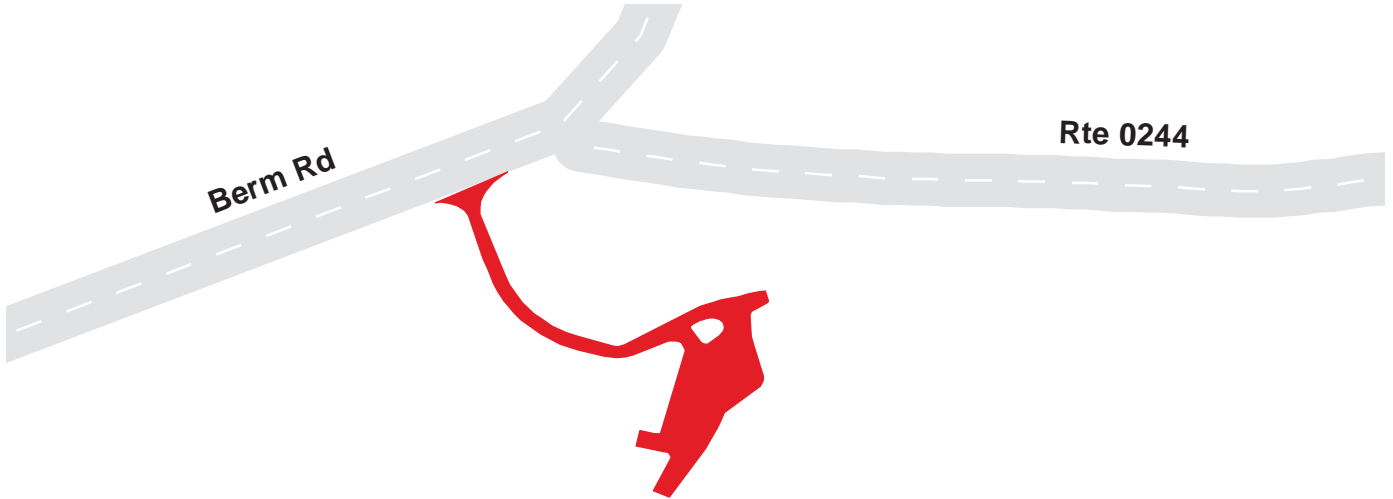
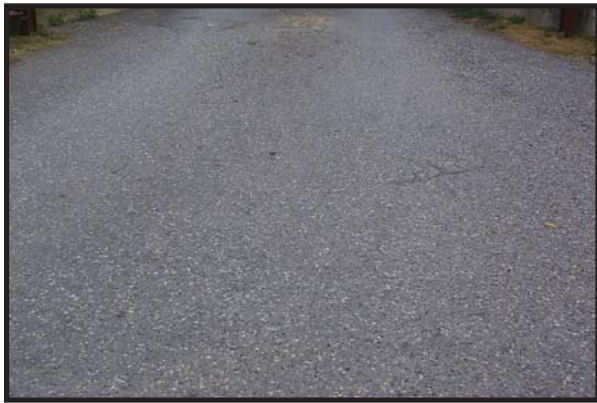
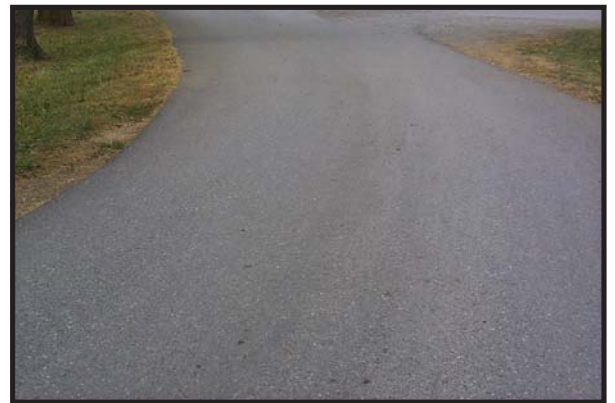
Route 0948

Route	Public / NonPublic	Date Visited	Area (sq ft)	Lane Miles *	Surface Type	Condition / PCR
0948	NonPublic	7/10/2002	9187	0.16	AS	POOR / 45
