# The Road Inventory of Christiansted National Historic Site CHRI - 5380

## Road Inventory Program

Prepared By:  
Federal Highway Administration  
Eastern Federal Lands Highway Division  
Cycle 3

# Christiansted National Historic Site in St. Croix

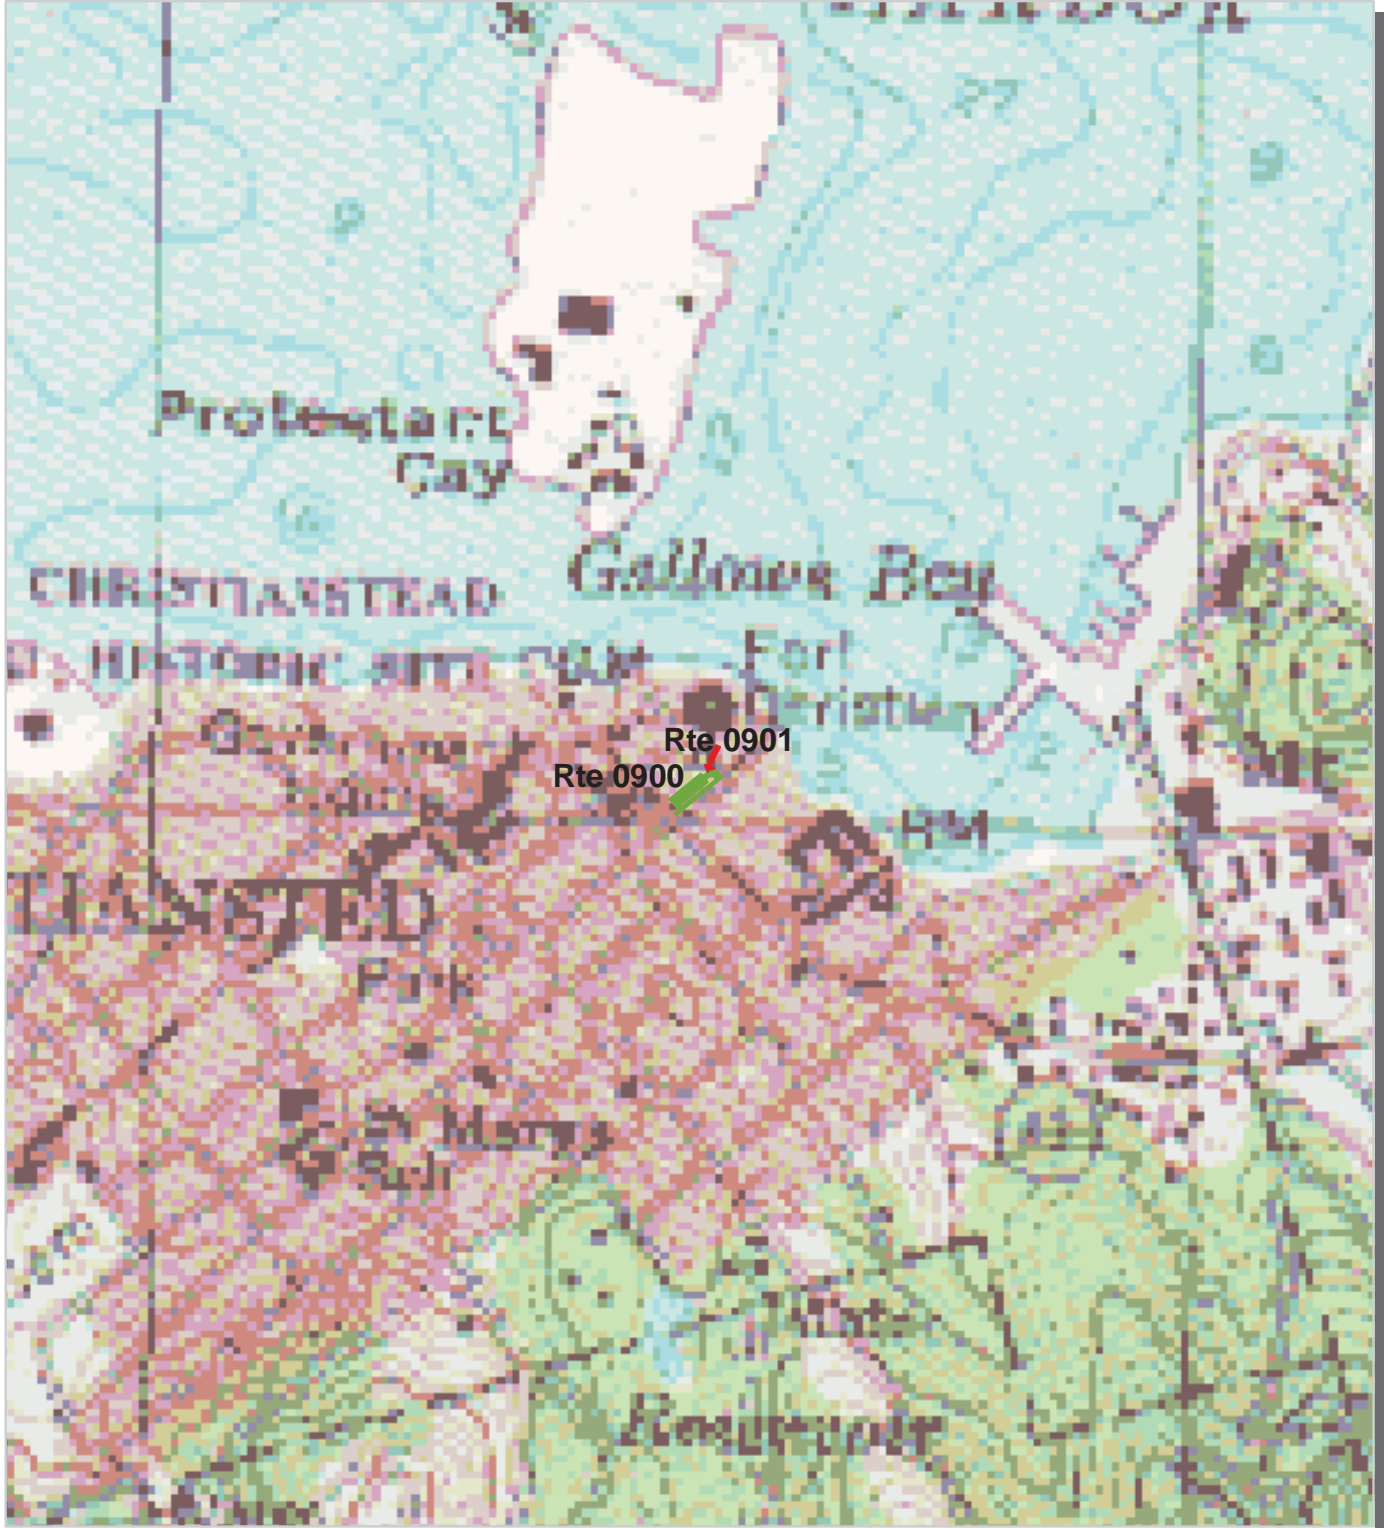
# Christiansted National Historic Site Route Condition Key Map PCR - Mile by Mile

PCR	Poor

Fair

Good

Excellent

(<=60)		(61 - 84)		(85 - 94)		(95 - 100)

\* If the PCR rating is not available for a section, the SCR rating will be displayed. See appendix for definitions and formulas.

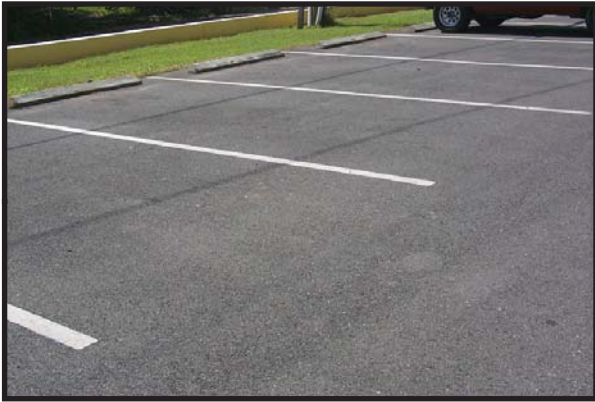
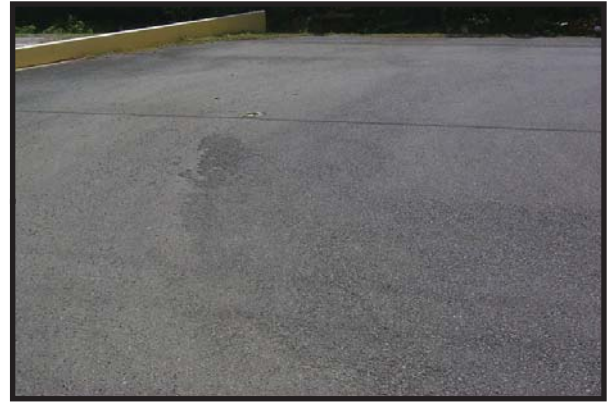
## Route 0900

Visitor Center Parking  
From Hospital Street

Route	Public / NonPublic	Date Visited	Area (sq ft)	Lane Miles *	Surface Type	Condition / PCR
0900	Public	2/14/2002	22098	0.38	AS	GOOD / 90

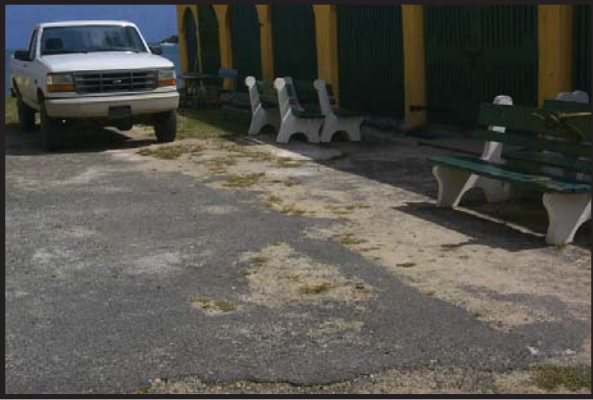
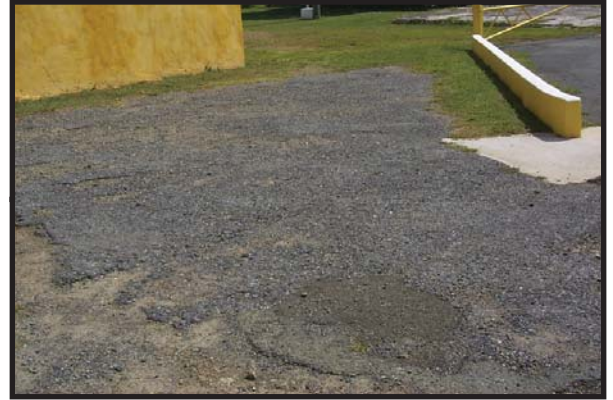
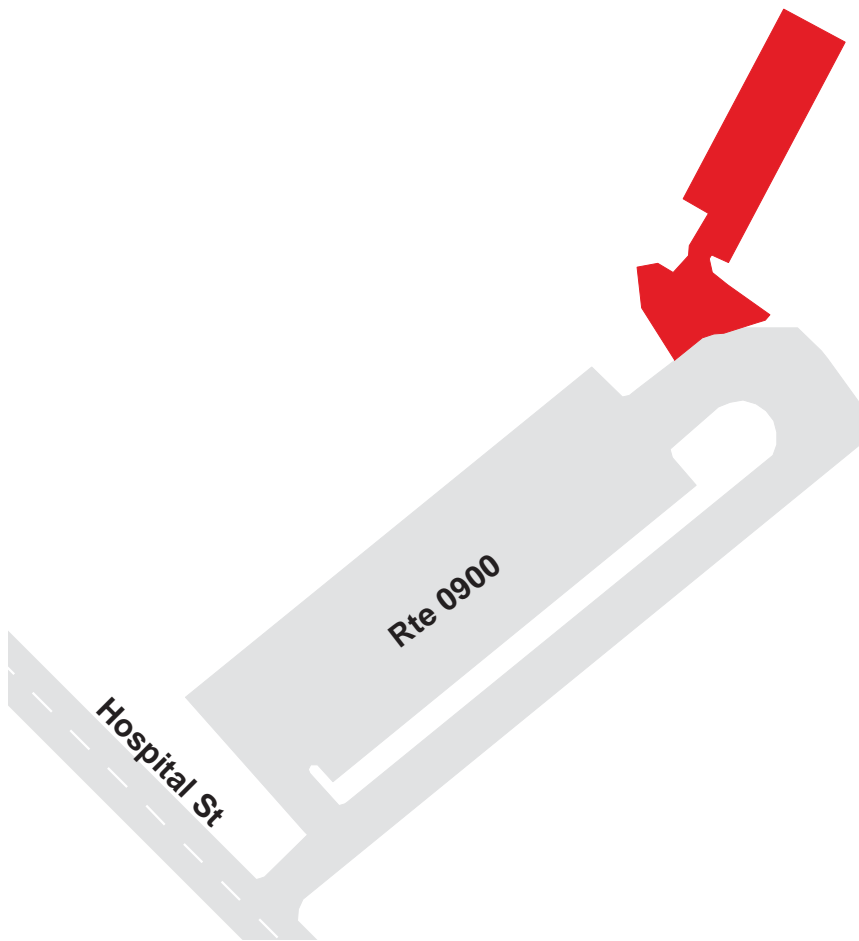
## Route 0901

Maintenance Area  
From Route 0900

Route	Public / NonPublic	Date Visited	Area (sq ft)	Lane Miles *	Surface Type	Condition / PCR
0901	NonPublic	2/14/2002	3930	0.07	AS	POOR / 45
