**The Road Inventory  
of  
Central High School National Historic Site  
CHSC - 6020**

**Road Inventory Program**

Prepared By:  
Federal Highway Administration  
Eastern Federal Lands Highway Division  
Cycle 3

# Central High School National Historic Site in Arkansas

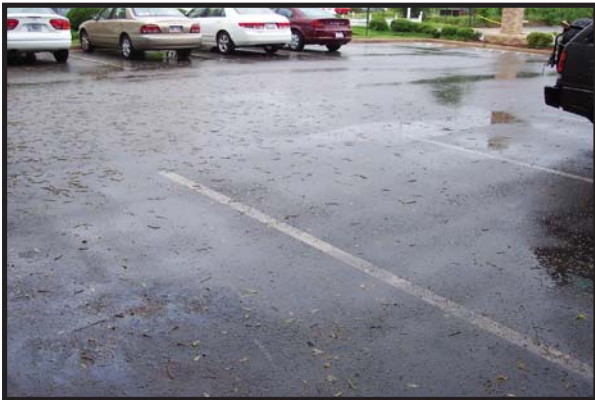
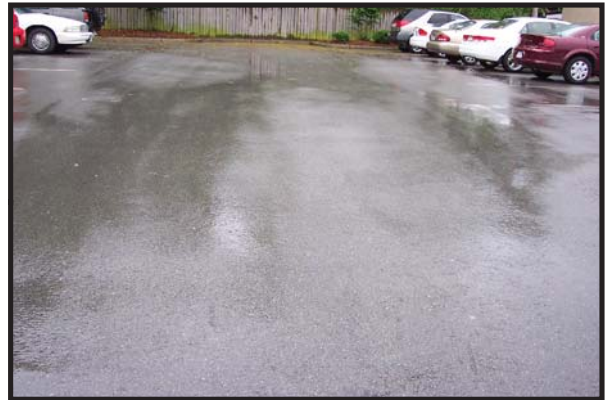
## Route 0900

Visitor Center Parking

From Daisy L. Gatson Bates Drive

Route	Public / NonPublic	Date Visited	Area (sq ft)	Lane Miles *	Surface Type	Condition / PCR
0900	Public	5/12/2004	5141	0.09	AS	GOOD / 90
