# The Road Inventory Of Colorado National Monument COLM - 1378

## Road Inventory Program

Prepared By:  
Federal Highway Administration  
Eastern Federal Lands Highway Division  
Cycle 3

# Colorado National Monument in Colorado

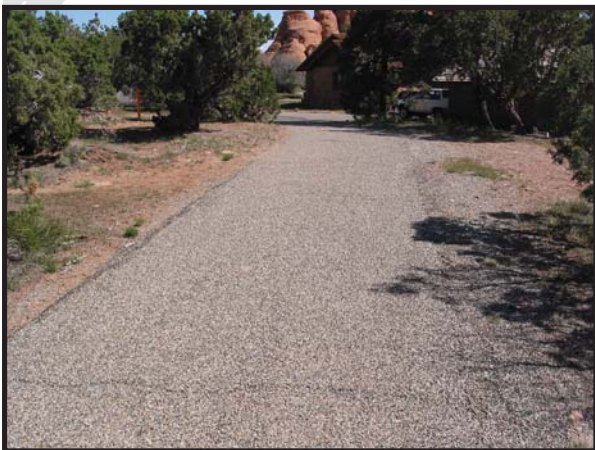
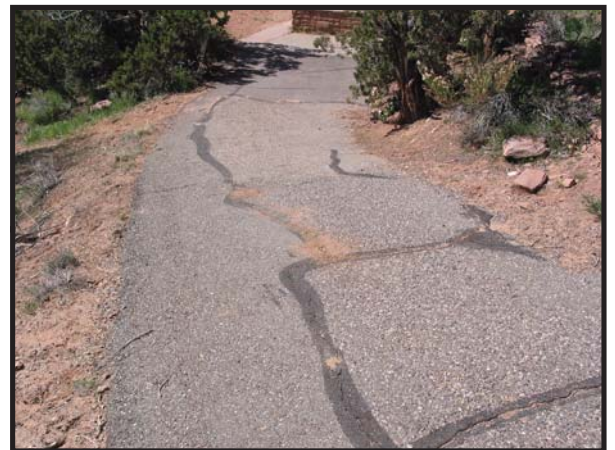
## Route 0900

Route	Public / NonPublic	Date Visited	Area (sq ft)	Lane Miles *	Surface Type	Condition / PCR
0900	Public	12/11/1999	26488	0.46	OC	FAIR / 73

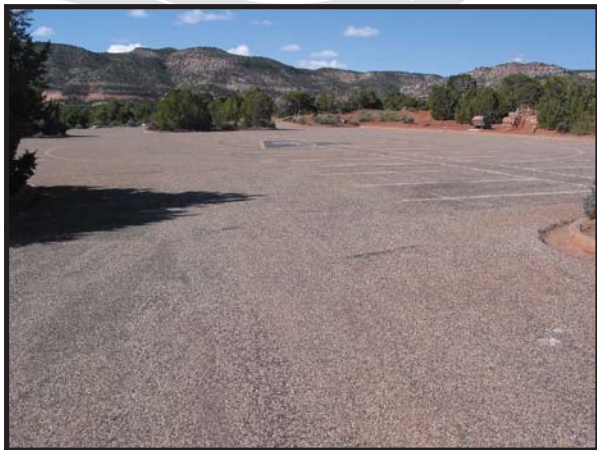
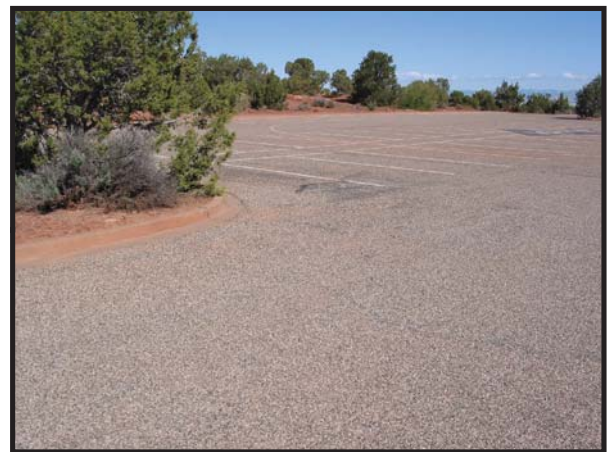
## Route 0903

Route	Public / NonPublic	Date Visited	Area (sq ft)	Lane Miles *	Surface Type	Condition / PCR
0903	Public	12/11/1999	3838	0.07	OC	FAIR / 73

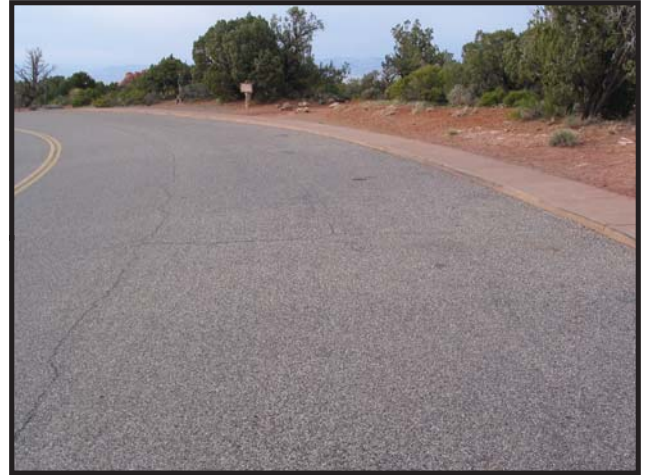
## Route 0904

Route	Public / NonPublic	Date Visited	Area (sq ft)	Lane Miles *	Surface Type	Condition / PCR
0904	Public	12/11/1999	3820	0.07	OC	GOOD / 90

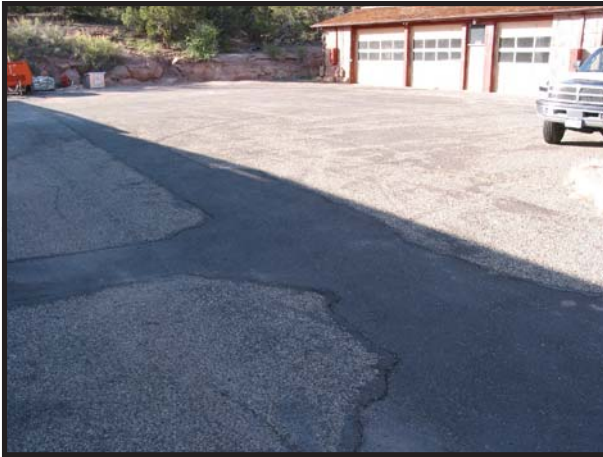
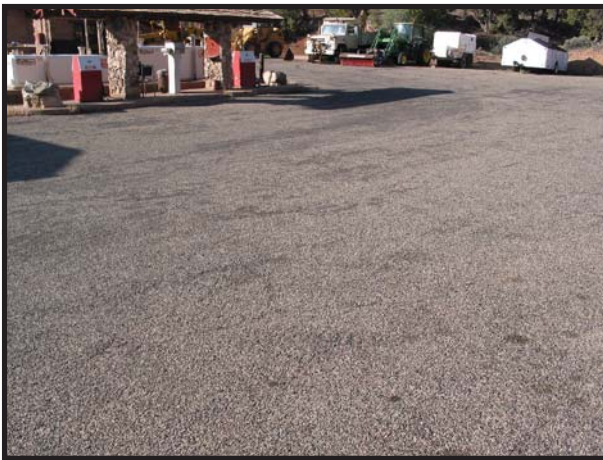
## Route 0905

Route	Public / NonPublic	Date Visited	Area (sq ft)	Lane Miles *	Surface Type	Condition / PCR
0905	NonPublic	12/11/1999	30740	0.53	OC	POOR / 45

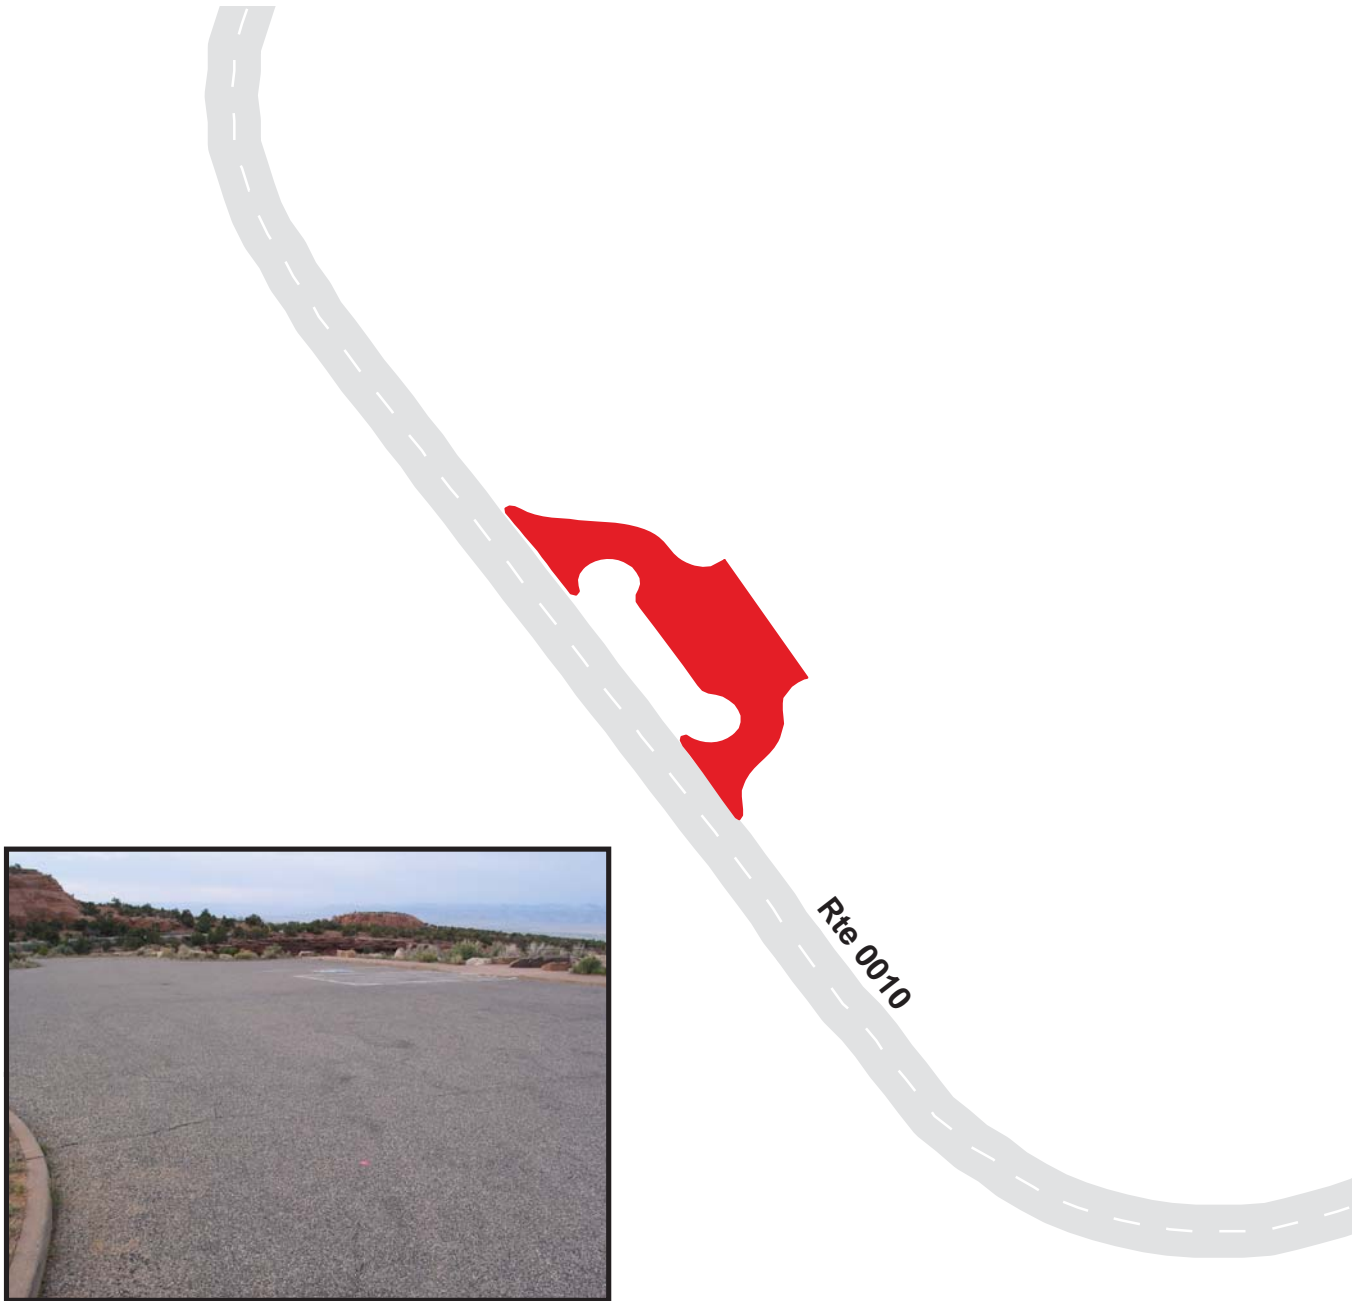
## Route 0908

Route	Public / NonPublic	Date Visited	Area (sq ft)	Lane Miles *	Surface Type	Condition / PCR
0908	Public	12/11/1999	5770	0.10	OC	FAIR / 73

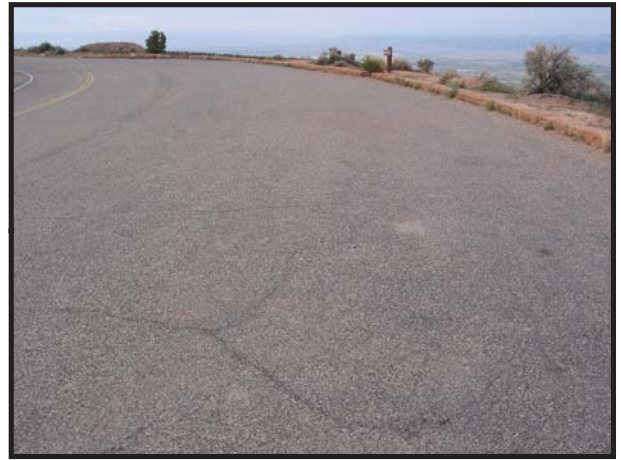
## Route 0909

Route	Public / NonPublic	Date Visited	Area (sq ft)	Lane Miles *	Surface Type	Condition / PCR
0909	Public	12/11/1999	4907	0.08	OC	FAIR / 73

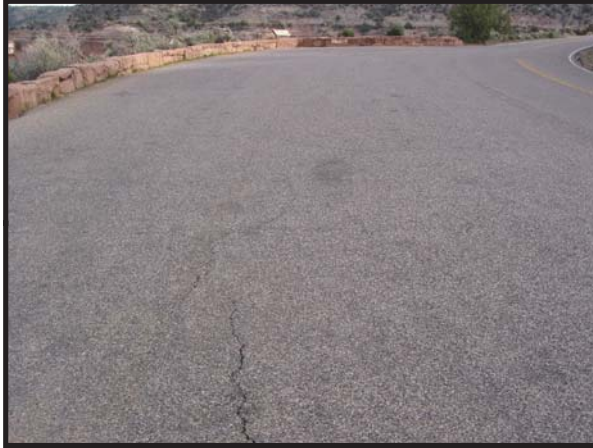
## Route 0910

Route	Public / NonPublic	Date Visited	Area (sq ft)	Lane Miles *	Surface Type	Condition / PCR
0910	Public	12/11/1999	6271	0.11	OC	FAIR / 73

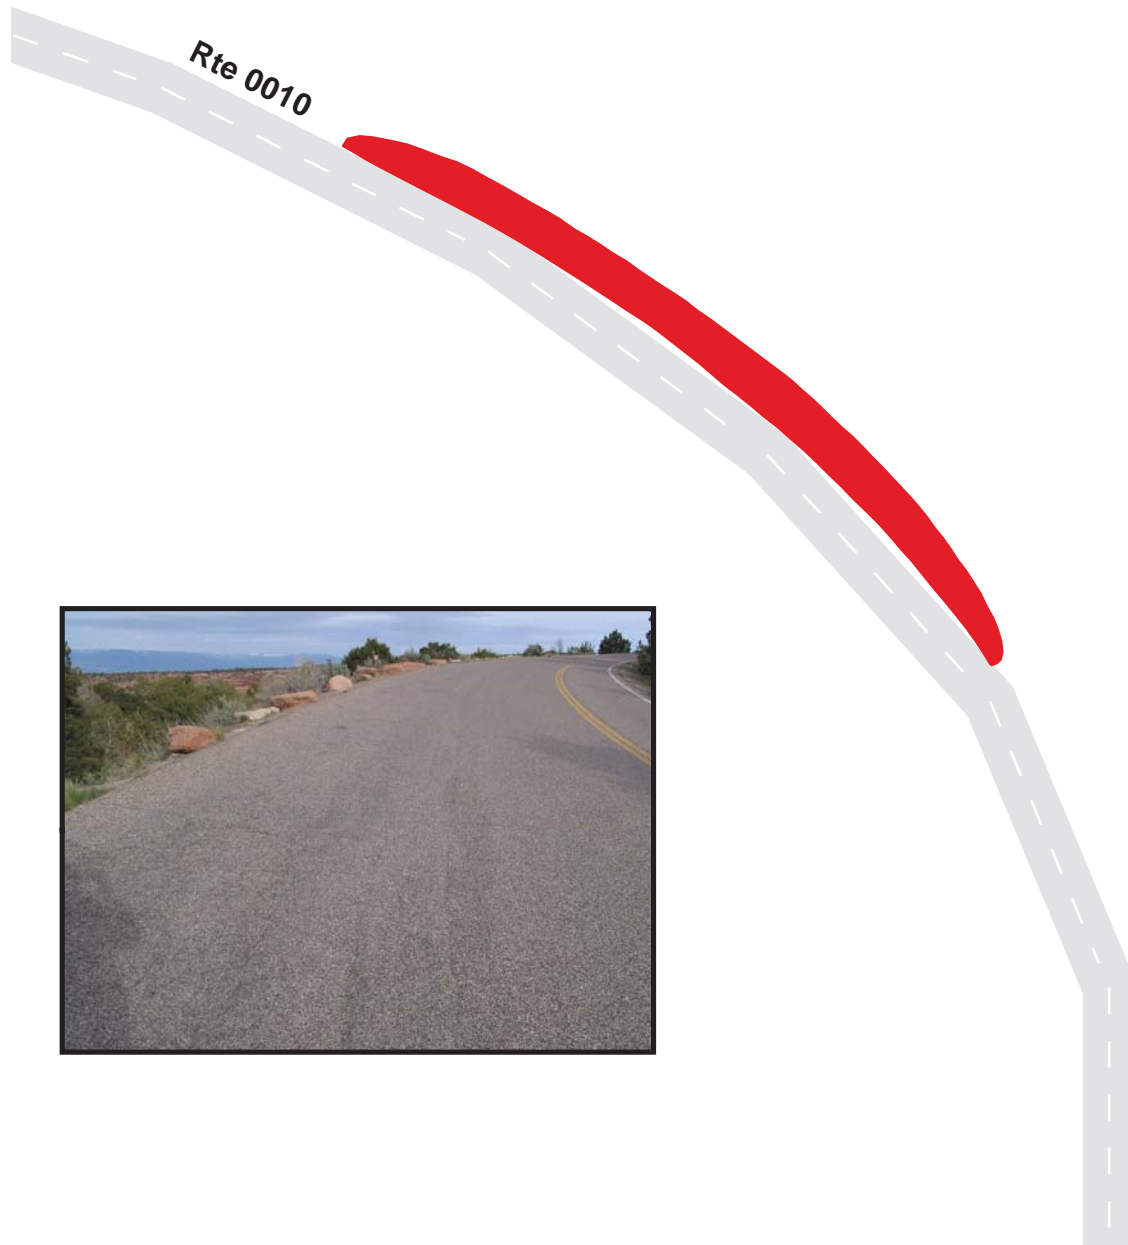
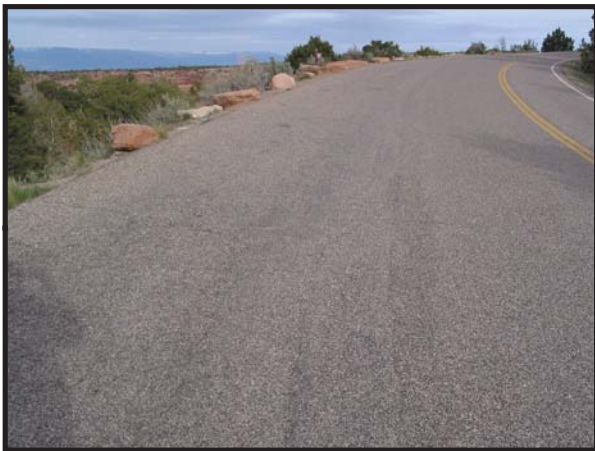
Route	Public / NonPublic	Date Visited	Area (sq ft)	Lane Miles *	Surface Type	Condition / PCR
0930	Public	12/12/1999	3041	0.05	OC	FAIR / 73

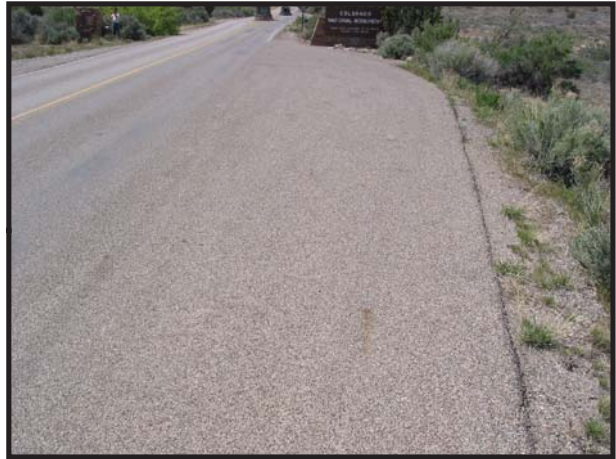
## Route 0933

Route	Public / NonPublic	Date Visited	Area (sq ft)	Lane Miles *	Surface Type	Condition / PCR
0933	Public	4/24/2003	1535	0.03	OC	GOOD / 90
